**CWA COMPLIANCE EVALUATION INSPECTION REPORT  
U.S. ENVIRONMENTAL PROTECTION AGENCY, REGION 5**

**Facility:** J&G Storage  
West of the Intersection Wisconsin State Route 47 and Larch Road  
Parcel #10-706-01  
Lac du Flambeau, Wisconsin 54538

**Date of Inspection:** December 14-15, 2023

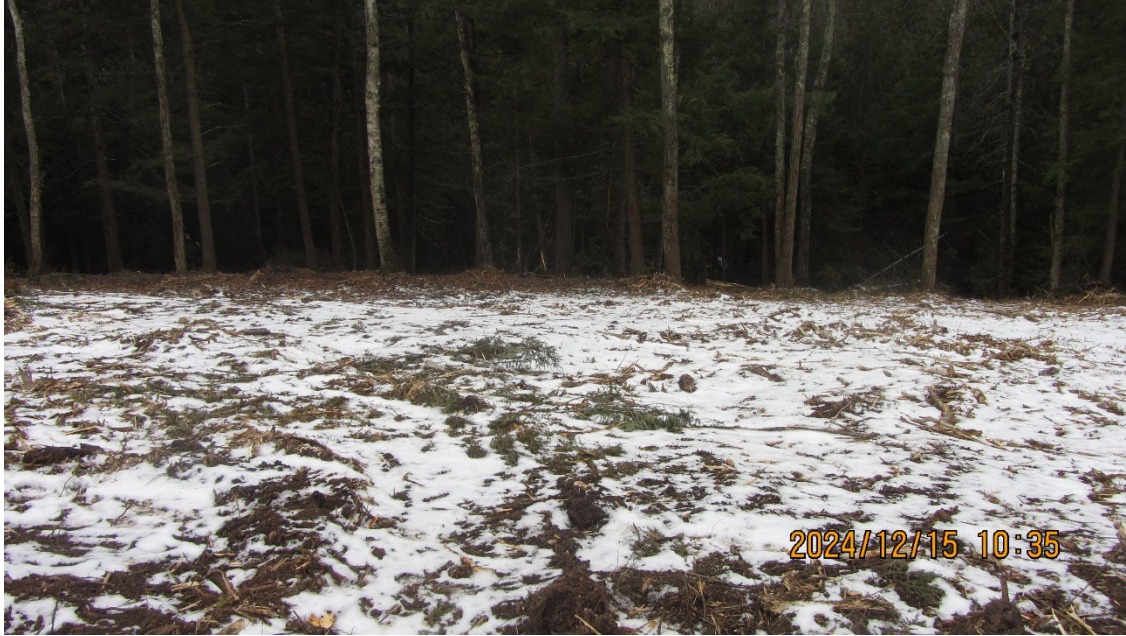
42. IMG\_0880

Description: South/Southwest Side of J&G Storage Site

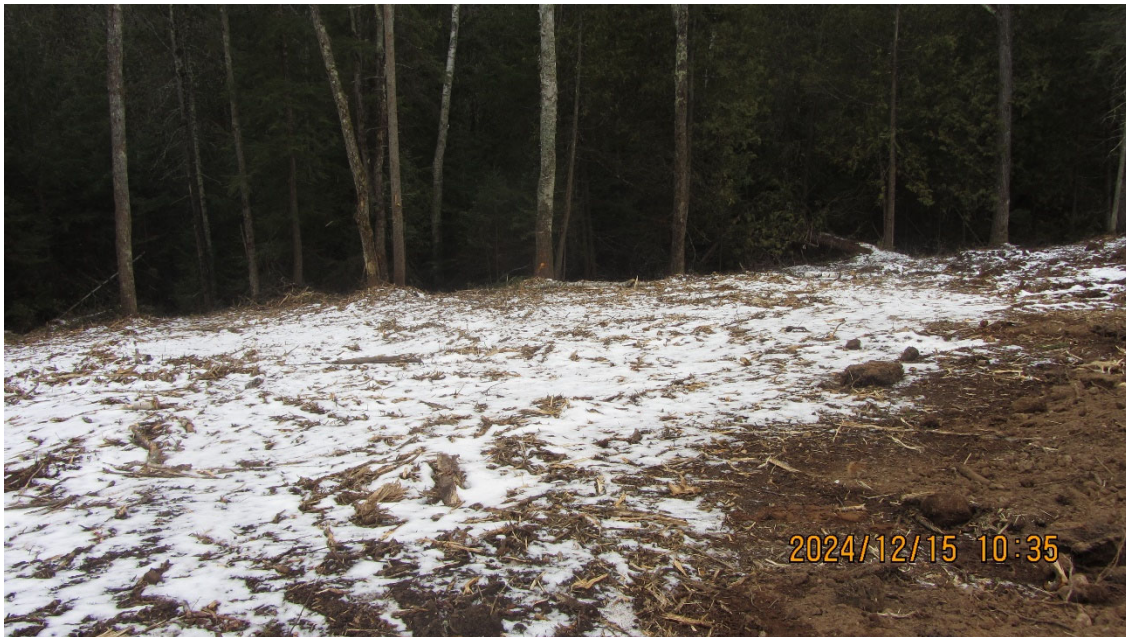
43. IMG\_0881

Description: Southwest Side of J&G Storage Site

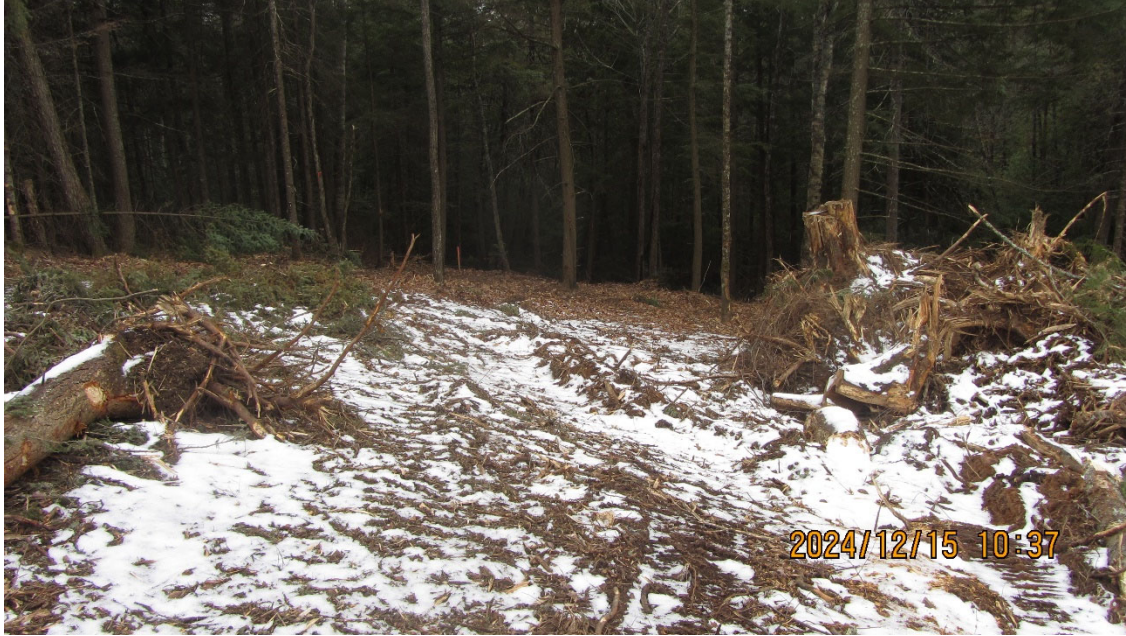
44. IMG\_0882

Description: Southwest Side of J&G Storage Site

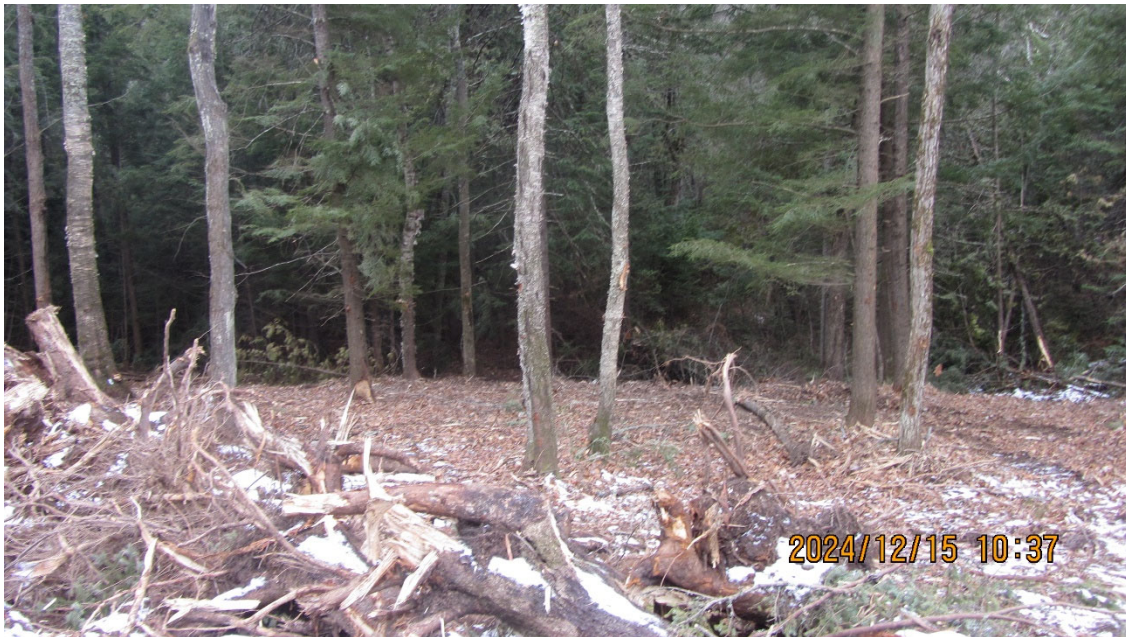
45. IMG\_0883

Description: Southwest Side of J&G Storage Site

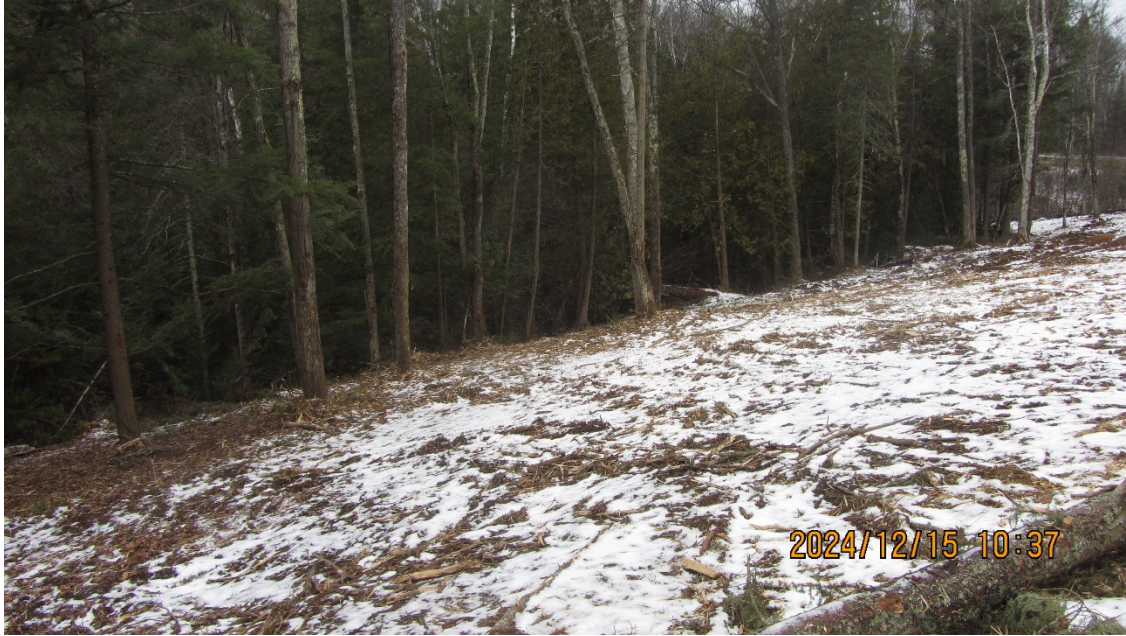
46. IMG\_0884

Description: West Side of J&G Storage Site – Looking Towards Silt Fence Section

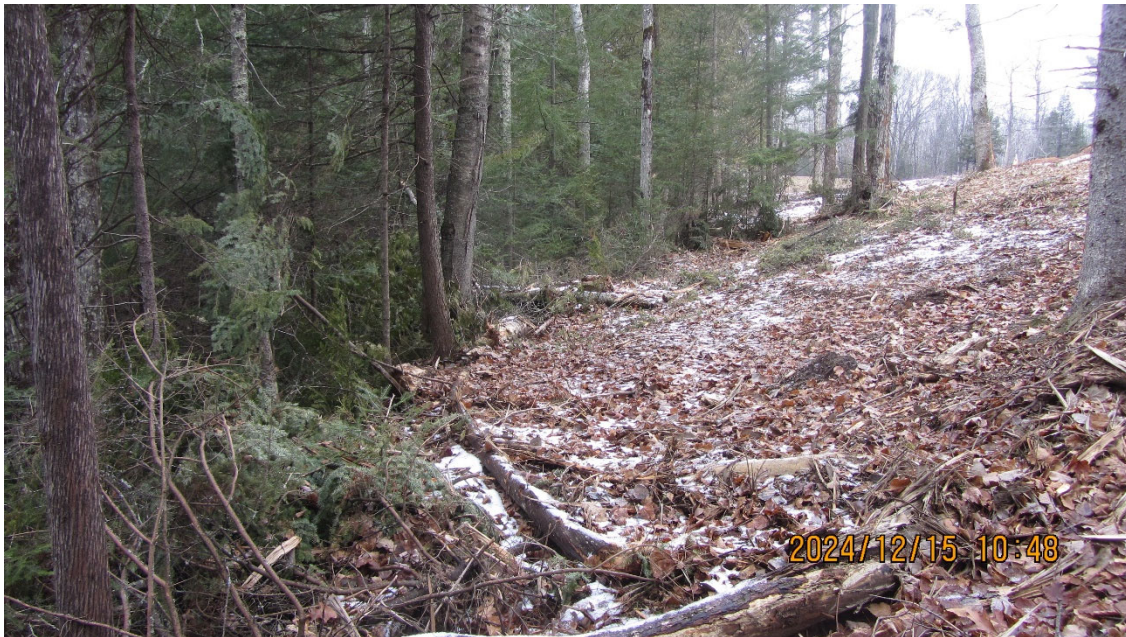
47. IMG\_0885

Description: Southwest Side of J&G Storage Site – Looking Into Forested Area

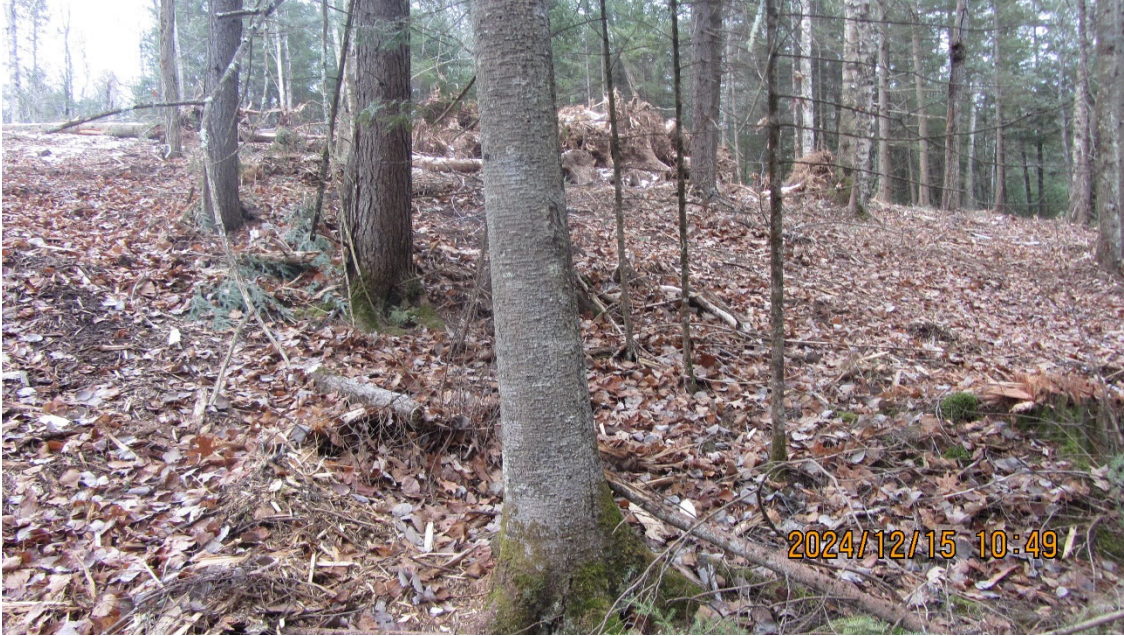
48. IMG\_0886

Description: Tree Stump Pile and Southern Portion of J&G Storage Site

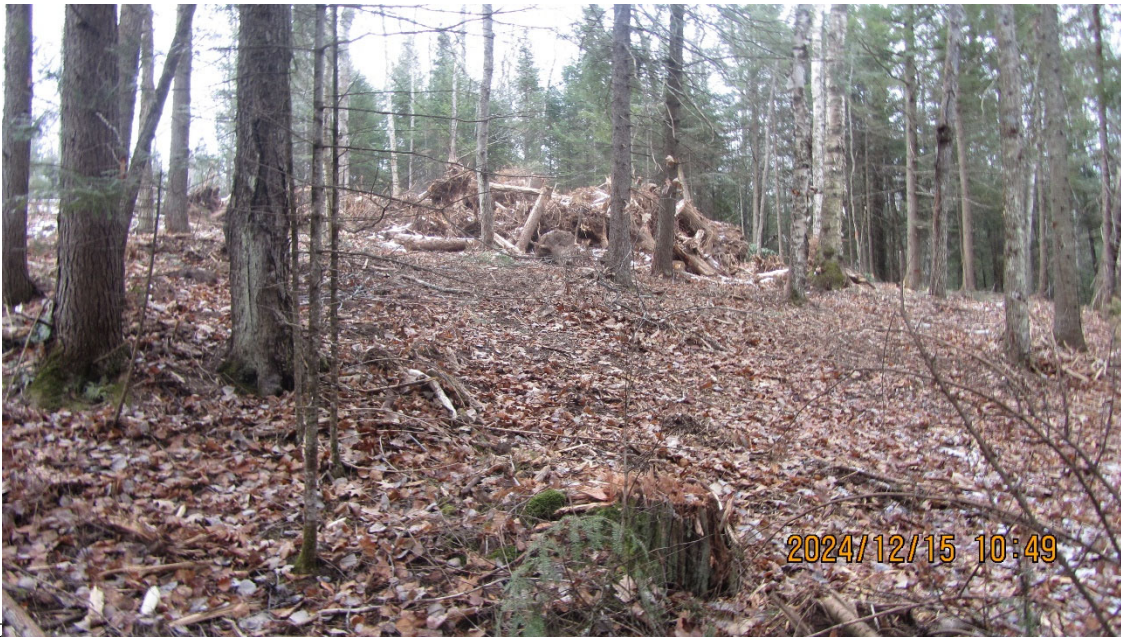
49. IMG\_0887

Description: Tree Stump Pile and Southern Portion of J&G Storage Site

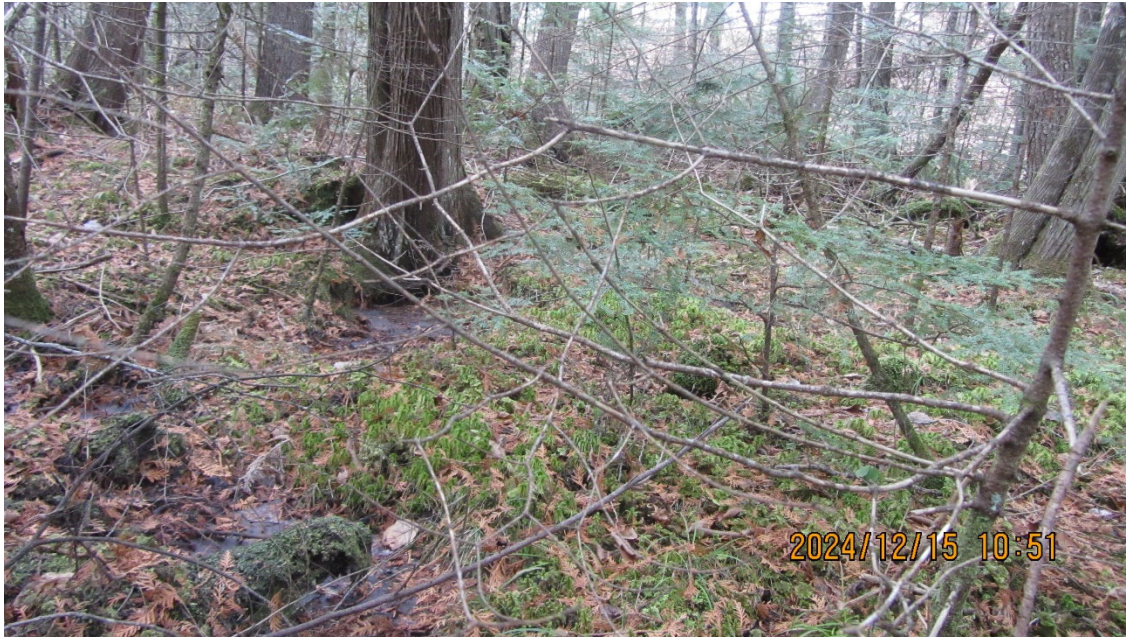
50. IMG\_0888

At approximately 10:50 am, EPA walked to the southwest corner of the site where land clearing had occurred and walked offsite into the undisturbed area. Photographs 50-53 in Attachment A document this undisturbed area. In this undisturbed area, EPA observed soft/wet soil and forest undergrowth consistent with a potential forested wetland area. EPA did not observe flowing water or a waterbody in the undisturbed area, although EPA was only able to traverse approximately 75 feet into the undisturbed area.

Description: Undisturbed Forested Area - Southwest of J&G Storage Site (Looking Towards Construction Site)

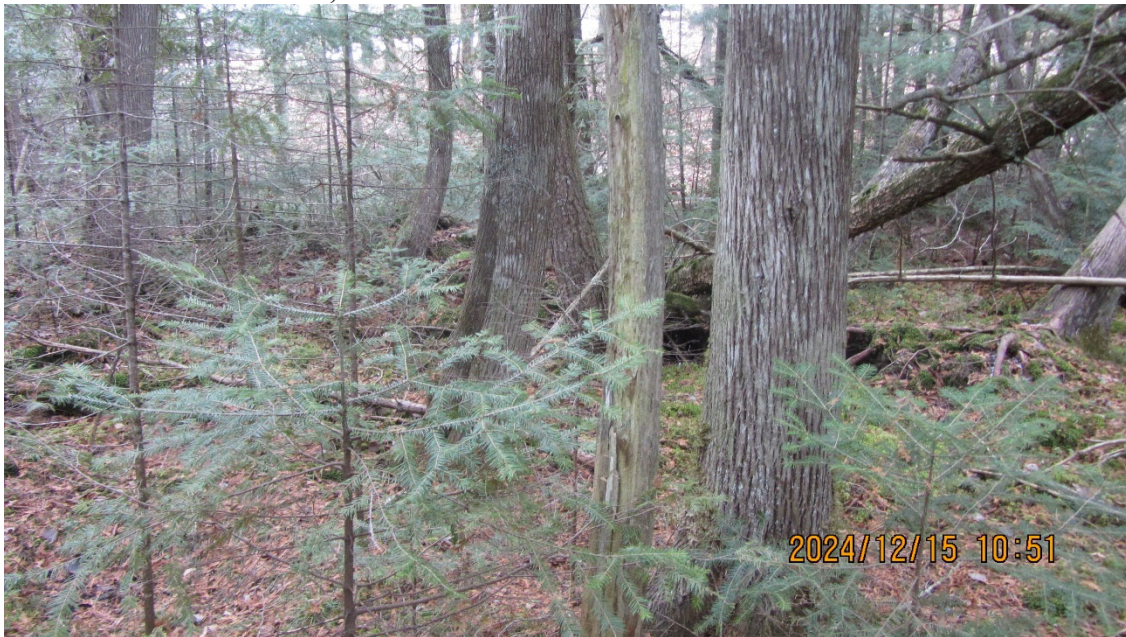
51. IMG\_0889

Description: Undisturbed Forested Area - Southwest of J&G Storage Site (Looking Towards Construction Site)

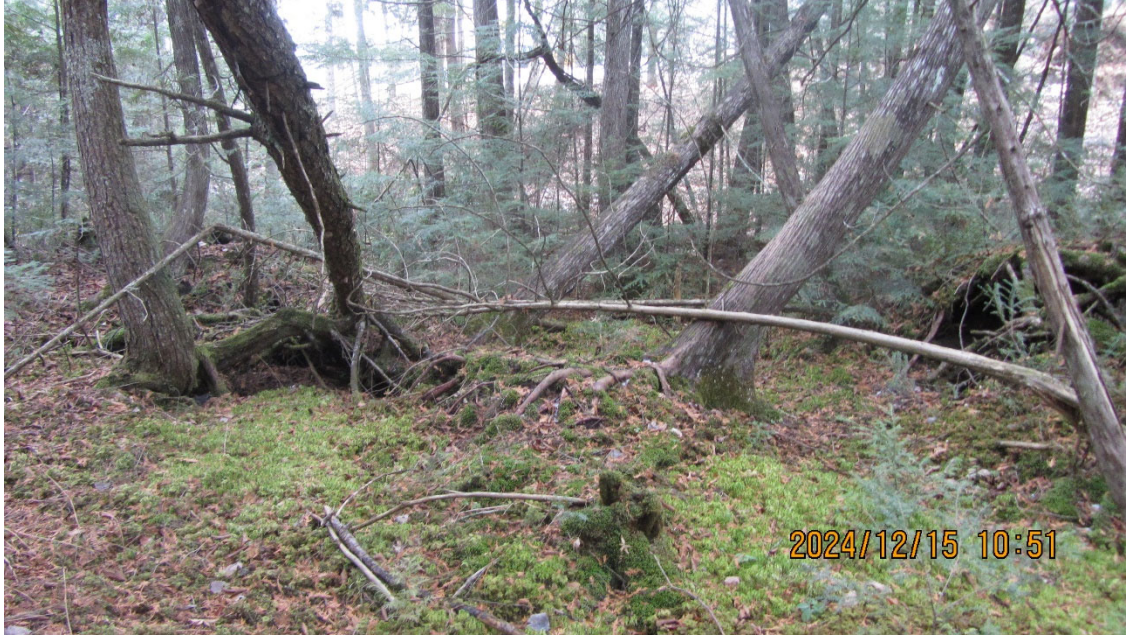
52. IMG\_0890

Description: Undisturbed Forested Area - Southwest of J&G Storage Site (Looking Towards Construction Site)

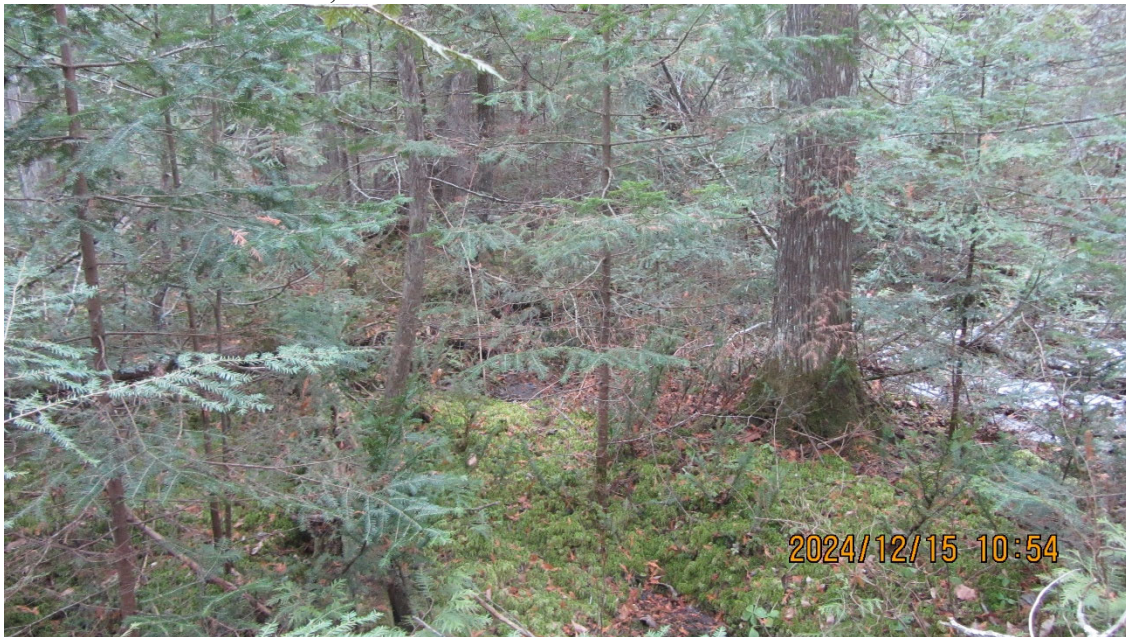
53. IMG\_0891

Description: Undisturbed Forested Area - Southwest of J&G Storage Site (Looking Away From Construction Site)

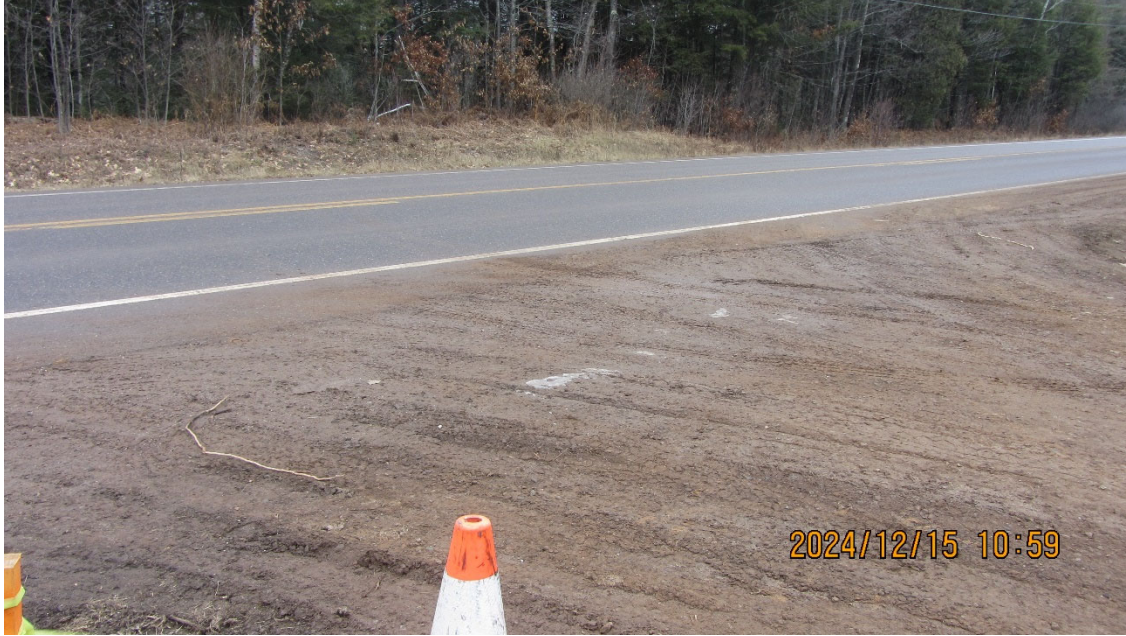
54. IMG\_0892

Description: Construction Site Entrance

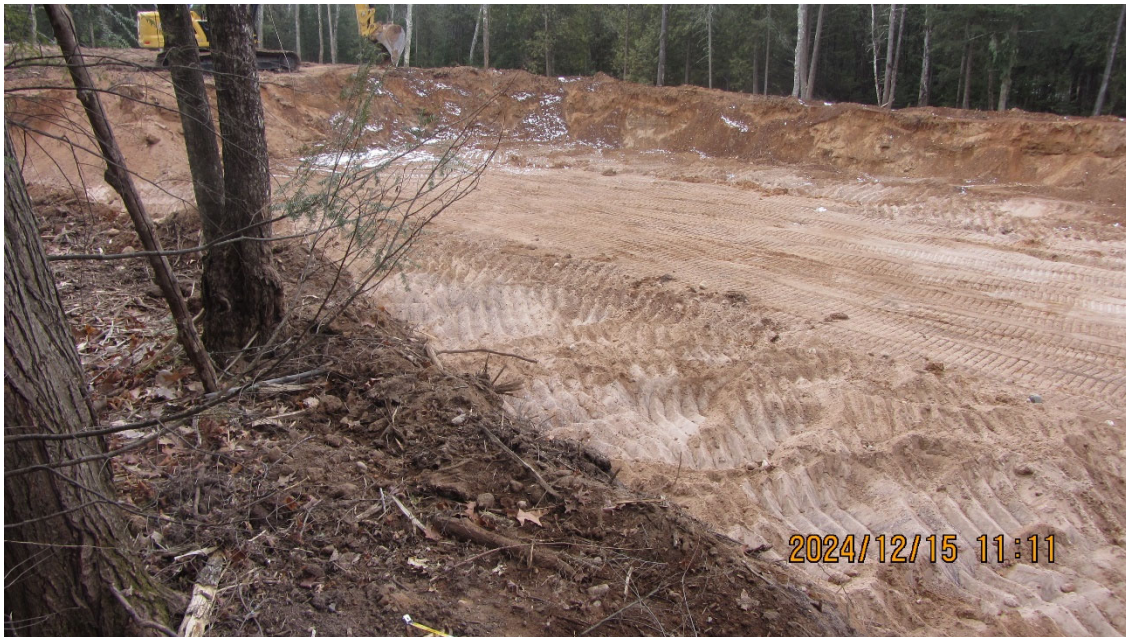
55. IMG\_0893

Description: Excavated Area of J&G Storage Site

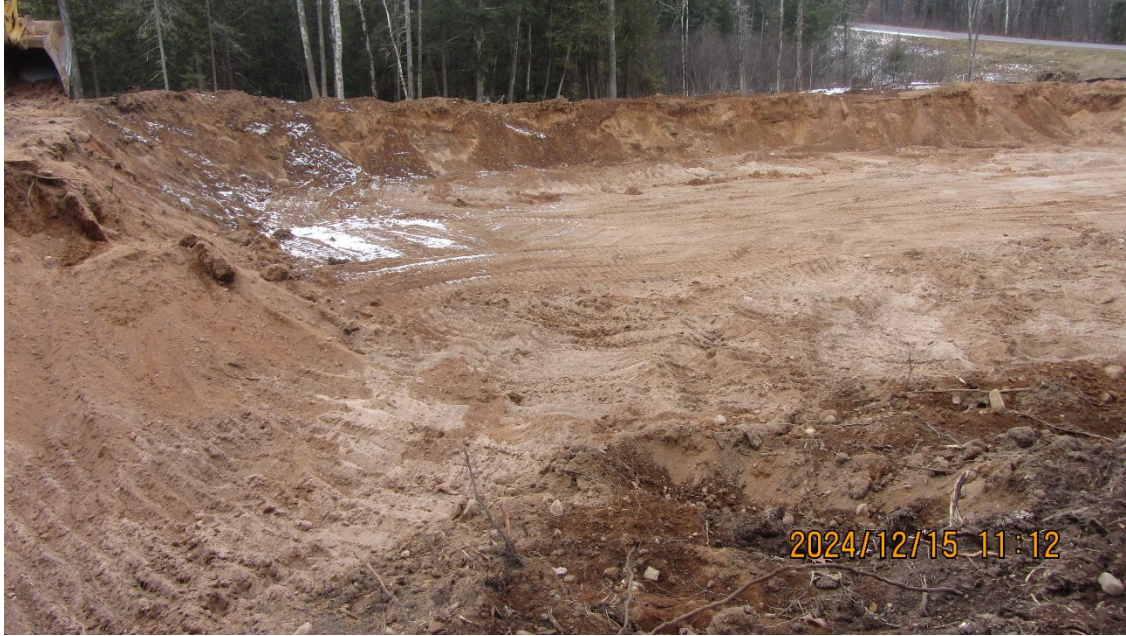
56. IMG\_0894

Description: Excavated Area of J&G Storage Site

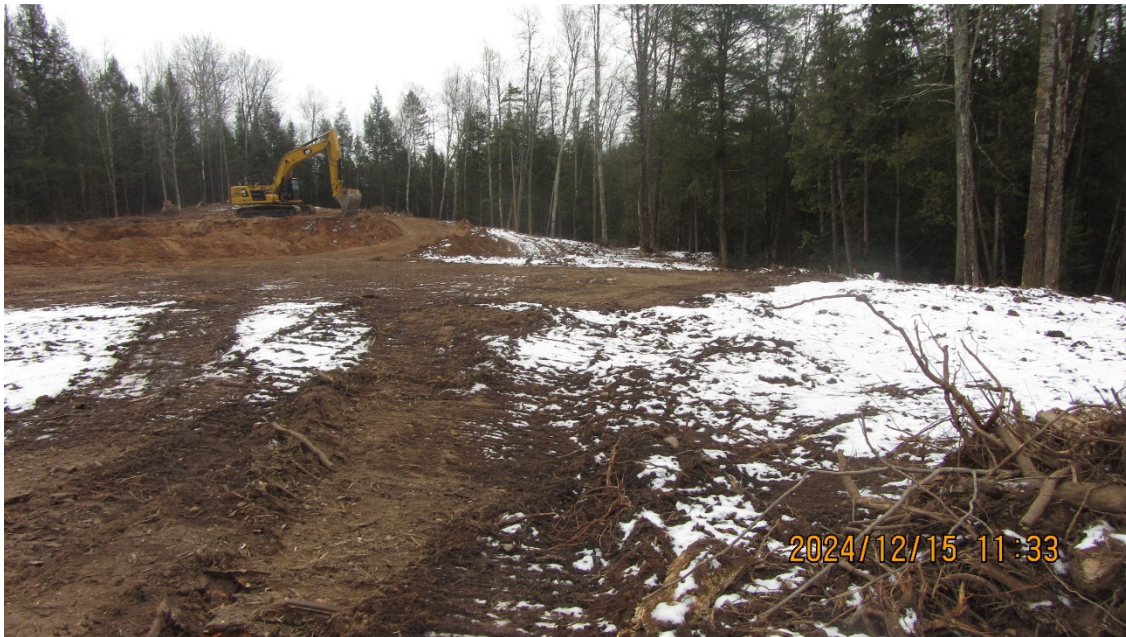
57. IMG\_0895

Description: Excavated Area of J&G Storage Site and Area West of Excavation

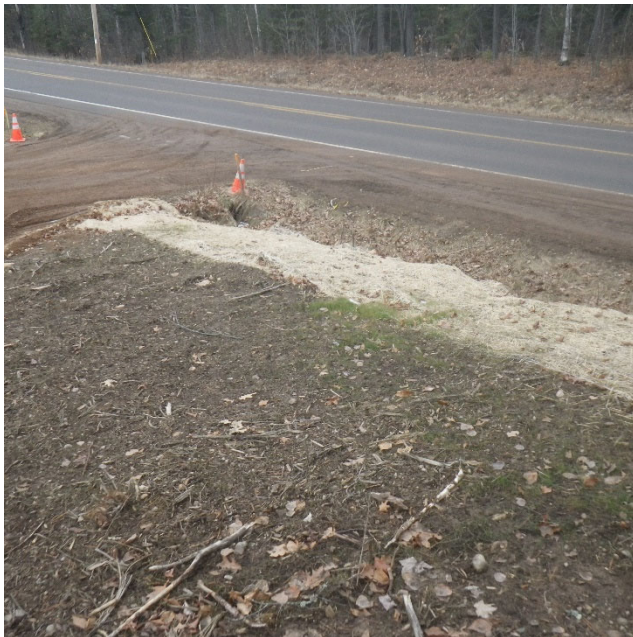
59. IMG0027.JPG

Description: J&G Storage Site Entrance

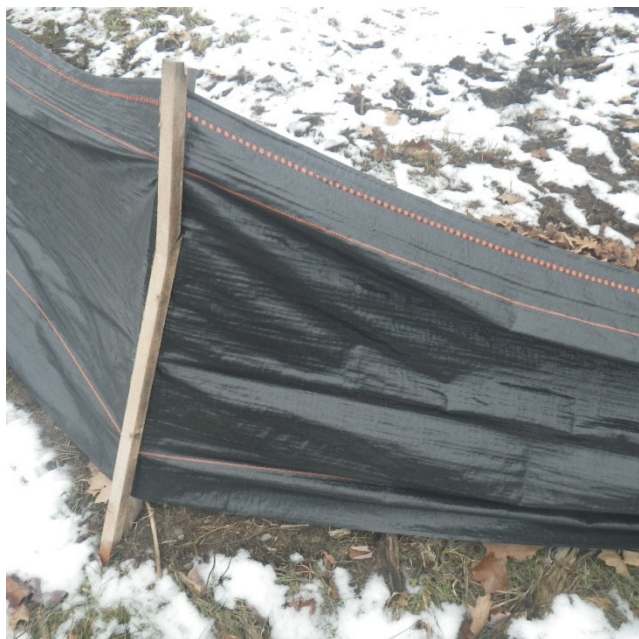
60. IMGP0028

Description: Northwest Corner of Site Silt Fence

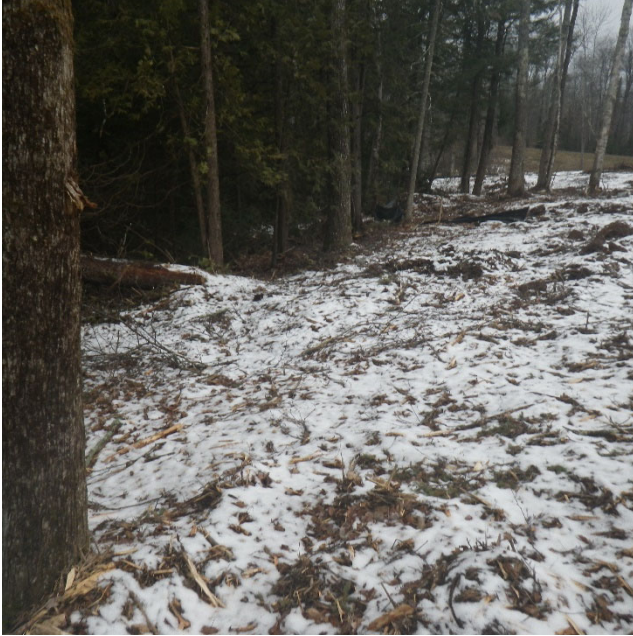
62. IMGP0030

Description: West Side of Site

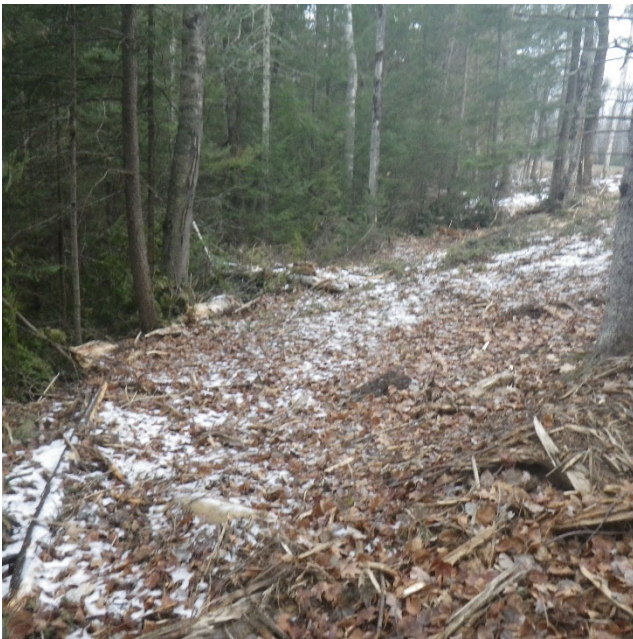
63. IMGP0031

Description: West Side of Site

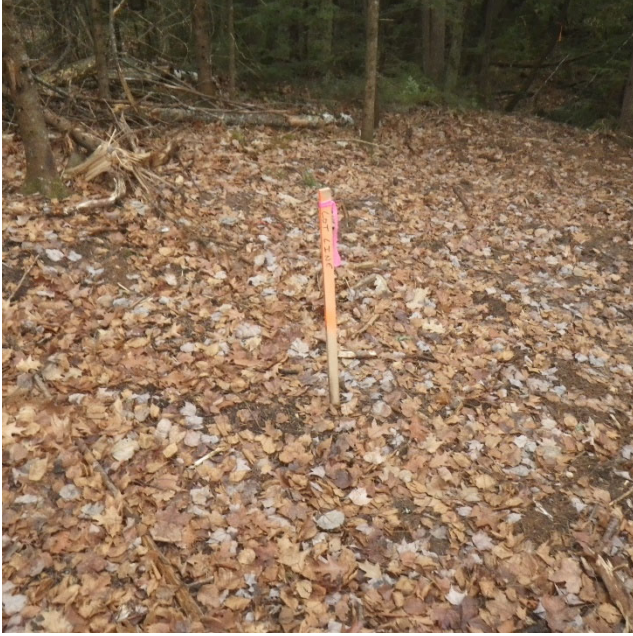
64. IMGP0032

Description: South Side of Site

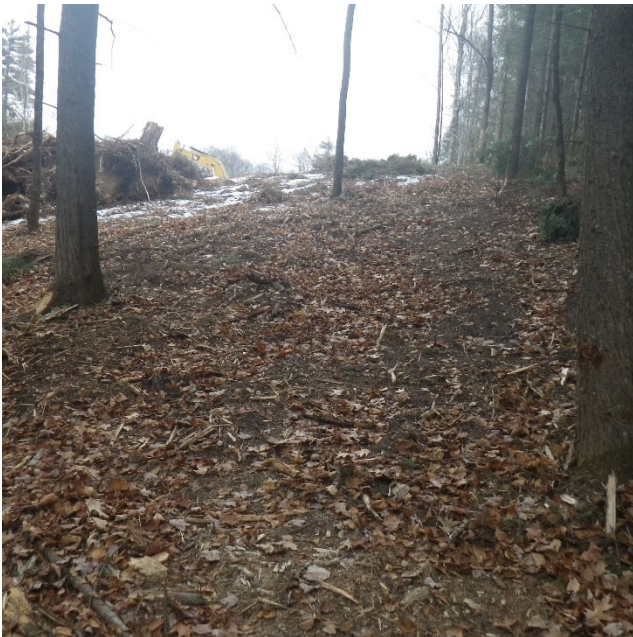
65. IMGP0033

Description: Southeast Corner of Site

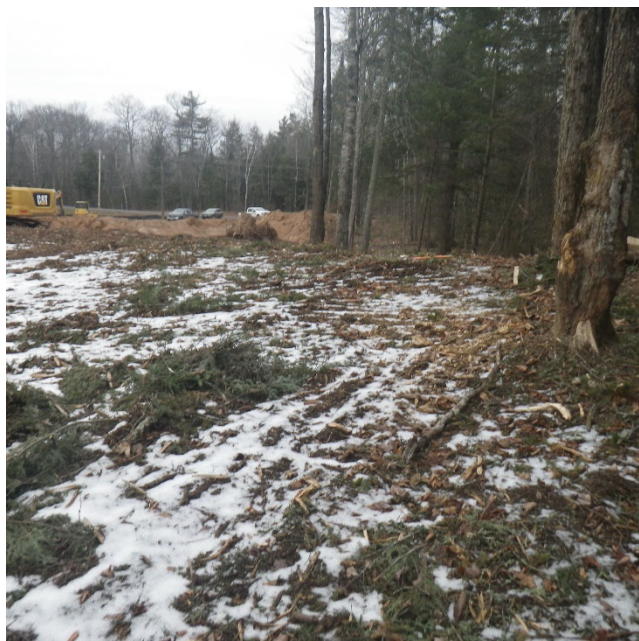
66. IMGP0034

Description: East Side of Site

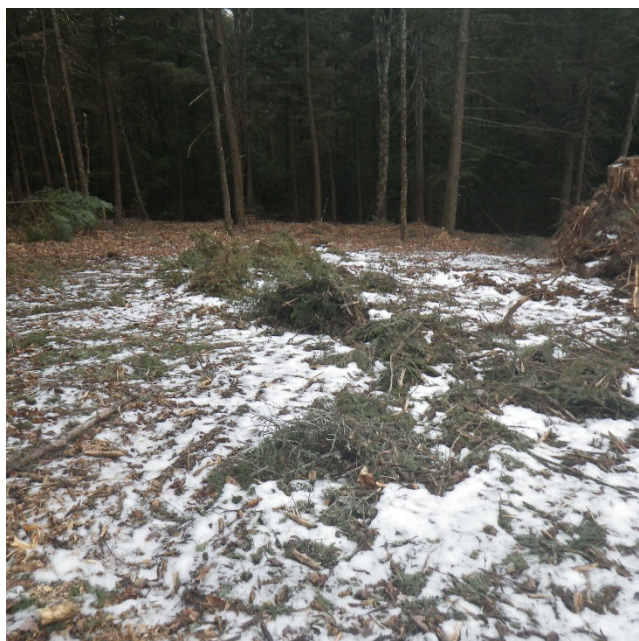
67. IMGP0035

Description: East Side of Site and Southeast Site Corner

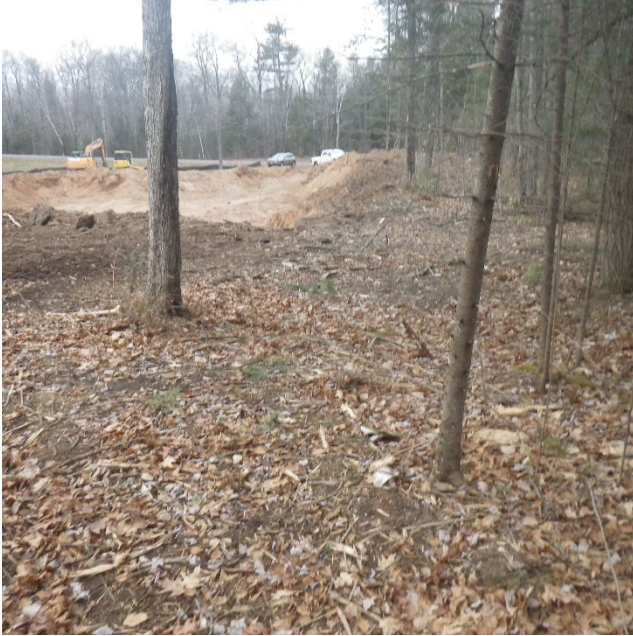
68. IMGP0036

Description: East Side of Site
