**Report Title:** Clean Water Act, Section 404 Inspection Report, Groff  
**Inspection Date(s):** September 19, 2023  
**Start Time:** 9:10 AM **End Time:** 1:45 PM  
**Regulatory Program(s):** Clean Water Act, Sections 308 & 404 (33 U.S.C. §§ 1318 & 1344)

**Site Name:** Groff Site  
**Site Location:** 100 Mill Road, Turbotville, PA 17772 (Montour County)  
**Latitude:** 41.095859 **Longitude:** -76.727306  
**County/Parish:** Montour

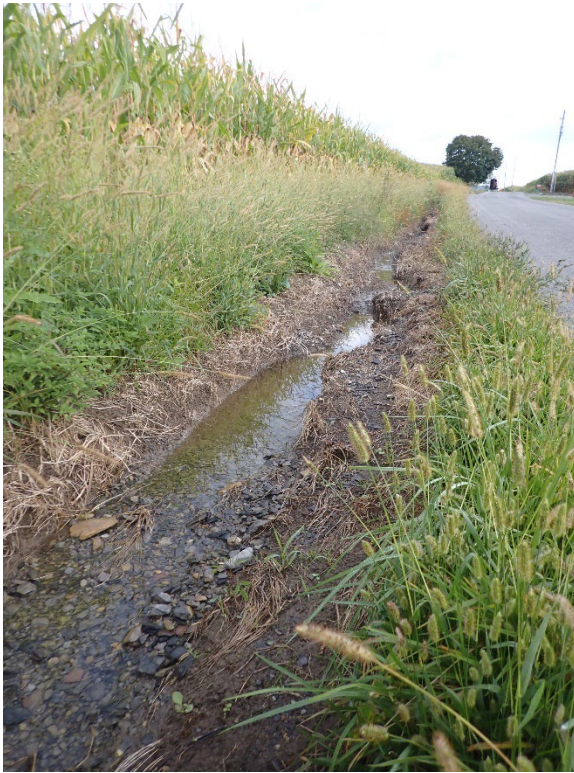
**Photograph I.A.** Flowing water between corn field and Mill Road. Facing North.

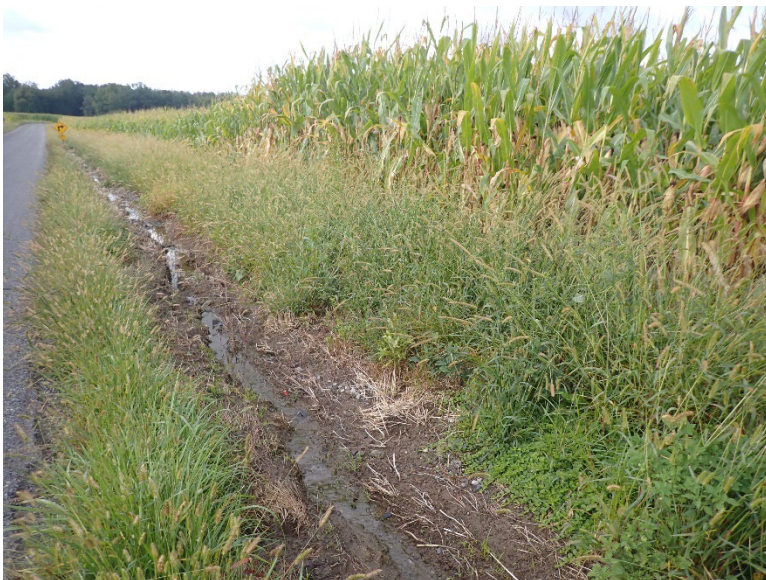
**Photograph I.B.** Flowing water between corn field and Mill Road. Facing South.

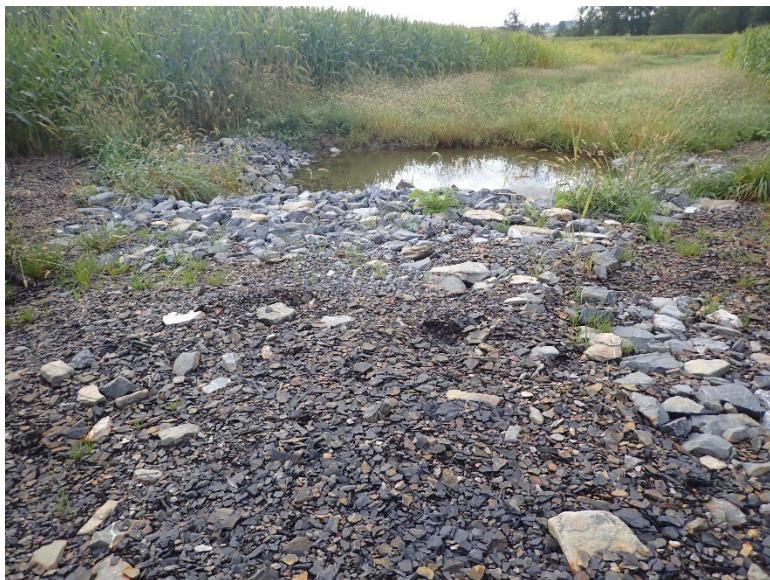
**Photograph II.B.** Shale fragments in swale at northwest corner of Wetland 19. Facing South.

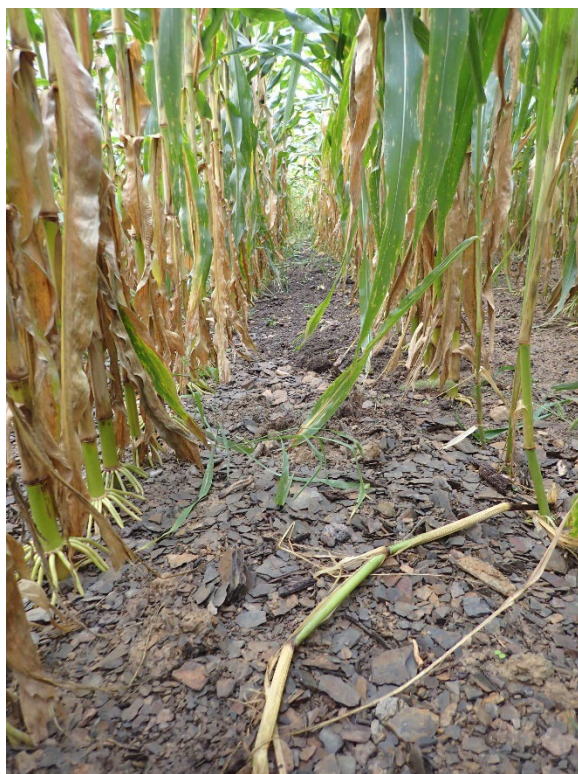
**Photograph II.E.** Grubbed and graded interior of corn crops planted in Wetland 19.

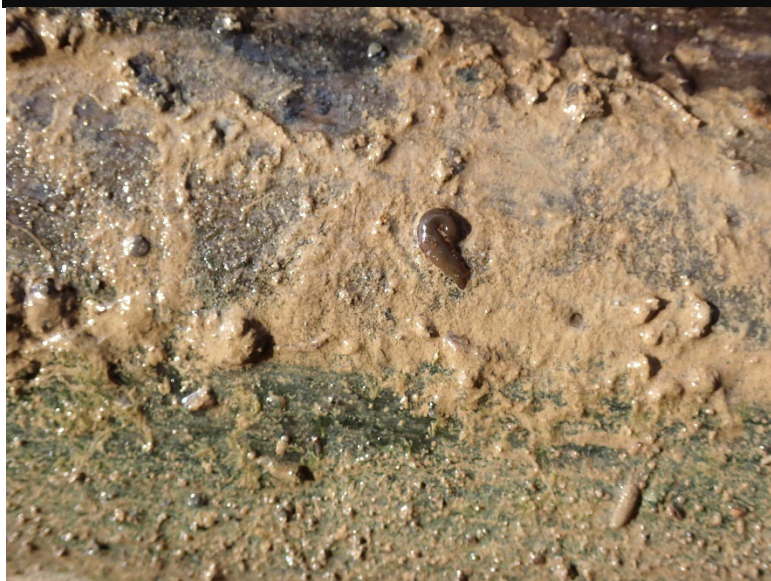
Benthic invertebrates, fish, algae, wrack lines, water-stained vegetation, and floating pondweed (*Potamogeton natans*) were observed along the excavated tributary (Photograph V.A – V.F). Evidence of earth-moving activities, including tree-clearing, grubbing, and grading were observed as burned bits of tree stumps were found within the corn field populating Wetland 16 (Photograph V.G).

**Photograph V.A.** Benthic invertebrates observed within Wetland 16 tributary.

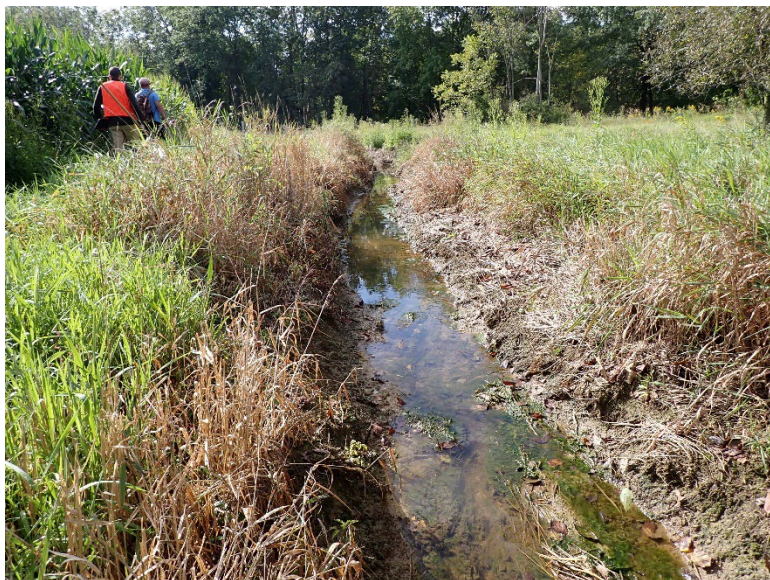
**Photograph V.D.** Excavated Wetland 16 tributary. Facing South.

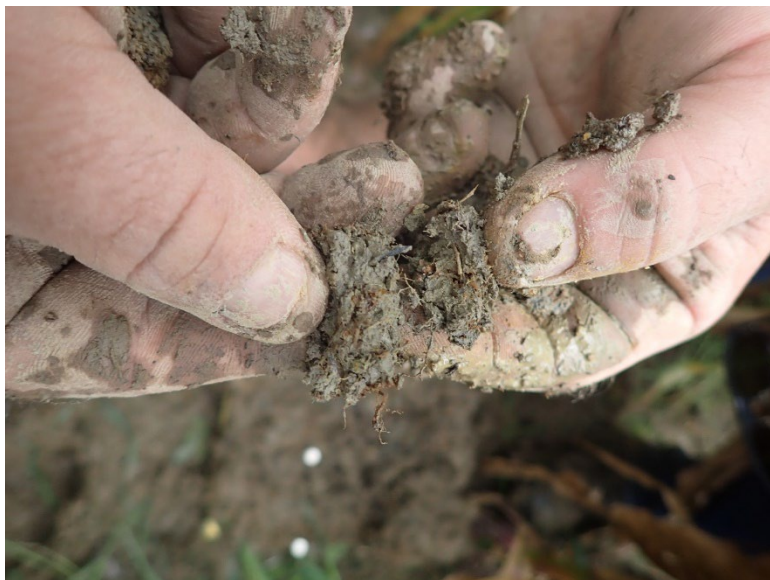
**Photograph VI.G.** DP2: Oxidized rhizospheres on living roots.

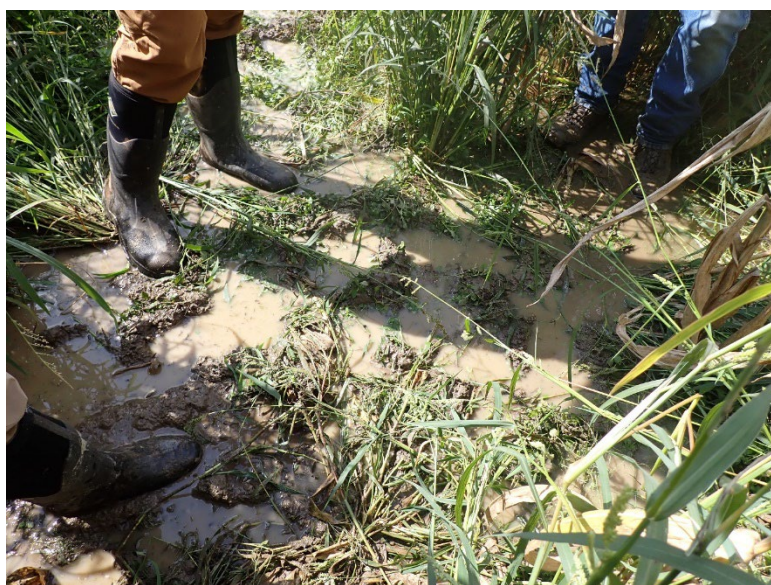
Primary indicators of wetland hydrology were observed, including a high-water table and surface water at a depth of 9.5 inches from the soil surface (Photograph VI.I – VI.J). The soil profile met the technical definition of a hydric soil (Indicator F3). The corn and rough barnyard grass (*Echinochloa muricata*) dominated the herbaceous stratum. All three parameters (i.e., vegetation, soil, and hydrology) were significantly disturbed by land clearing, grubbing, and grading.

**Photograph VI.J.** DP2: Surface water.

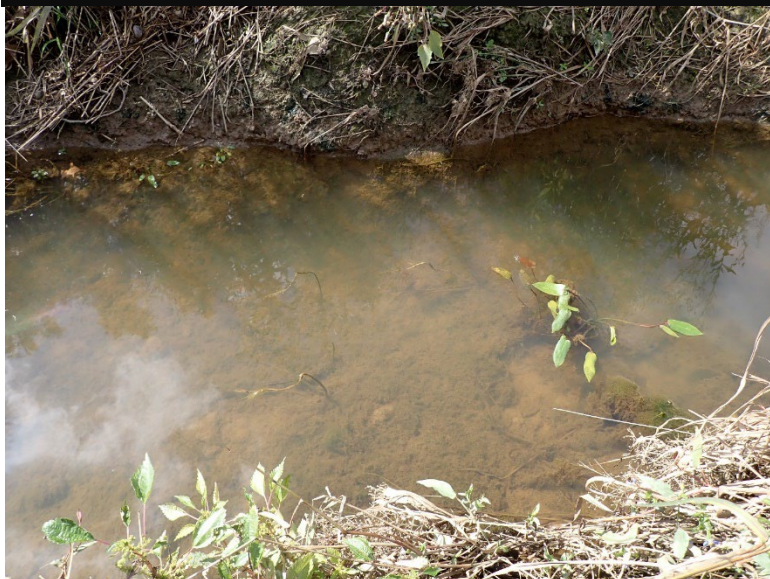
The inspection walkthrough continued from P3, southeast along the pipeline easement. Floating pondweed, fish, and mechanized tire tracks were observed (Photograph VII.A – VII.F).

**Photograph VII.A.** Floating pondweed observed in the Railroad tributary.

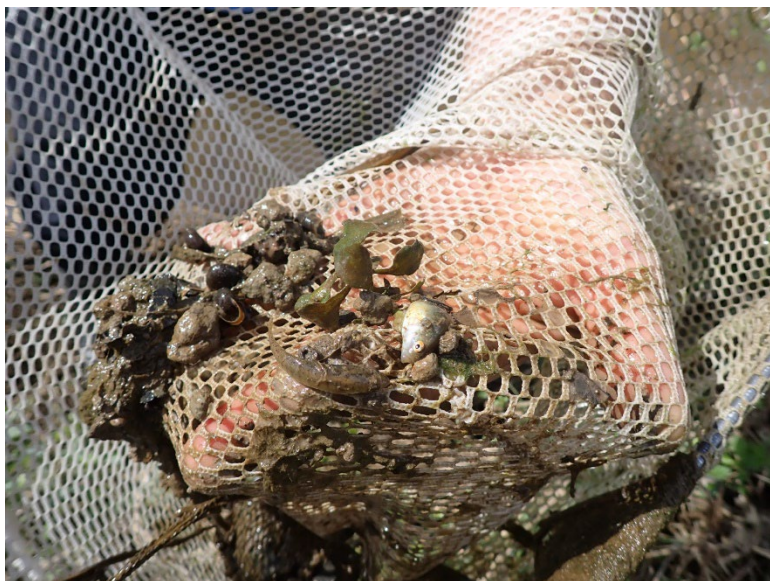
**Photograph VII.B.** Fish observed in the Railroad tributary.

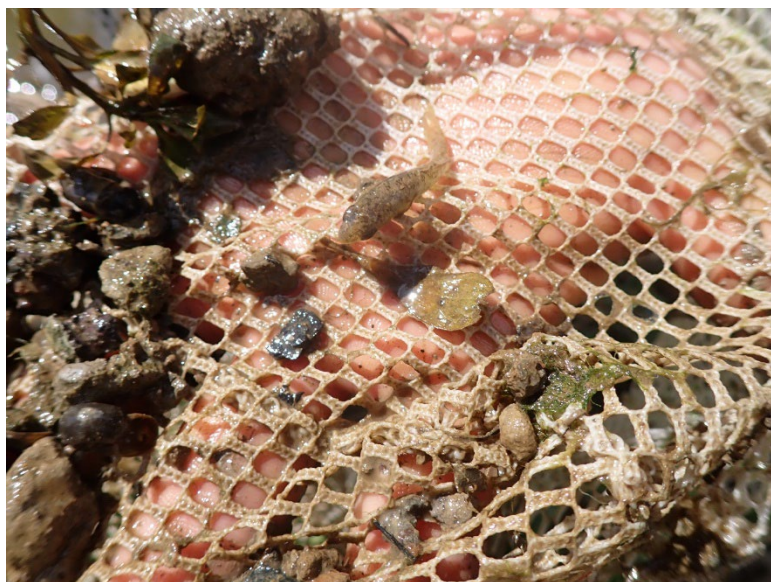
**Photograph VII.C.** Fish observed in the Railroad tributary.

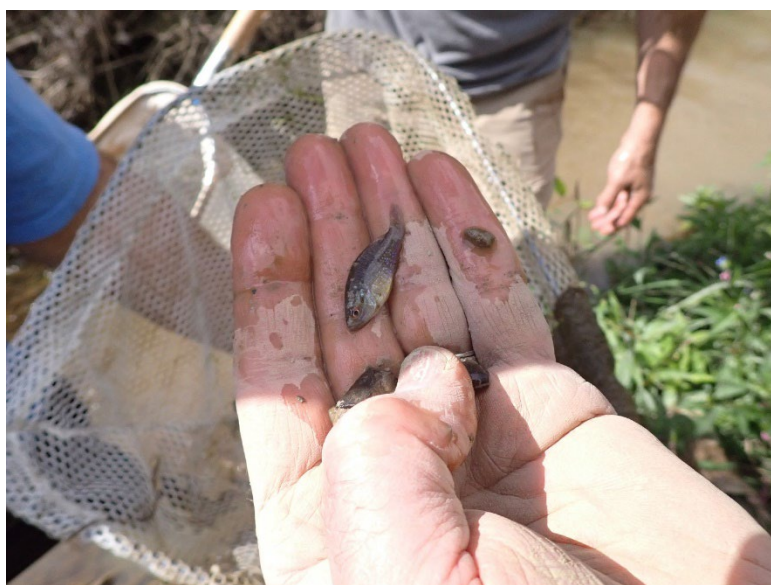
**Photograph VII.D.** Fish observed in the Railroad tributary.

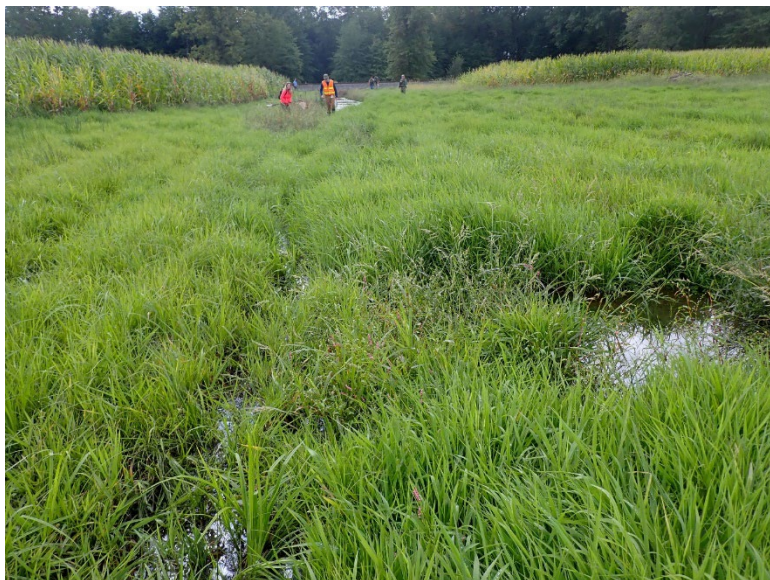
A direct connection between the two water bodies was documented in Photograph VIII.A. Flowing water, wrack lines, algae, and plow lines were observed in the area, as well as dying and stunted corn crops within Wetland 19 (Photograph VIII.B – VIII.I).

**Photograph VIII.E.** Excavated Wetland 19 tributary. Facing south.

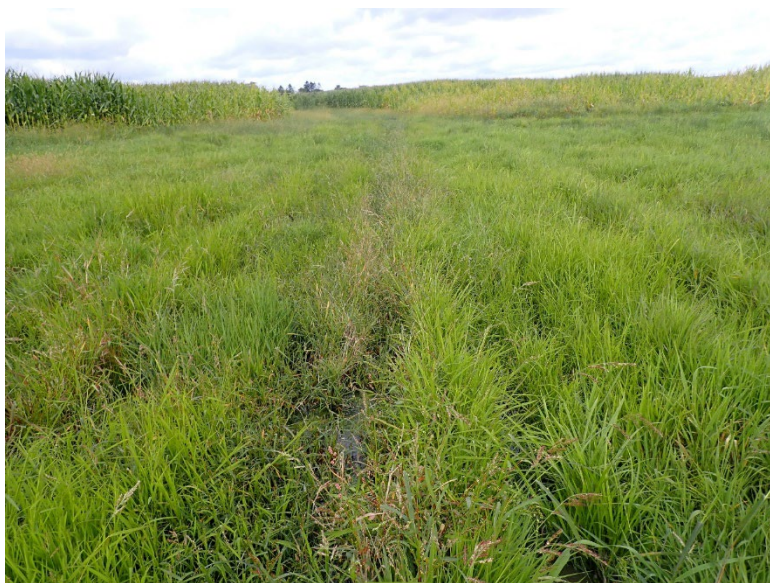
**Photograph VIII.F.** Excavated Wetland 19 tributary. Facing north.

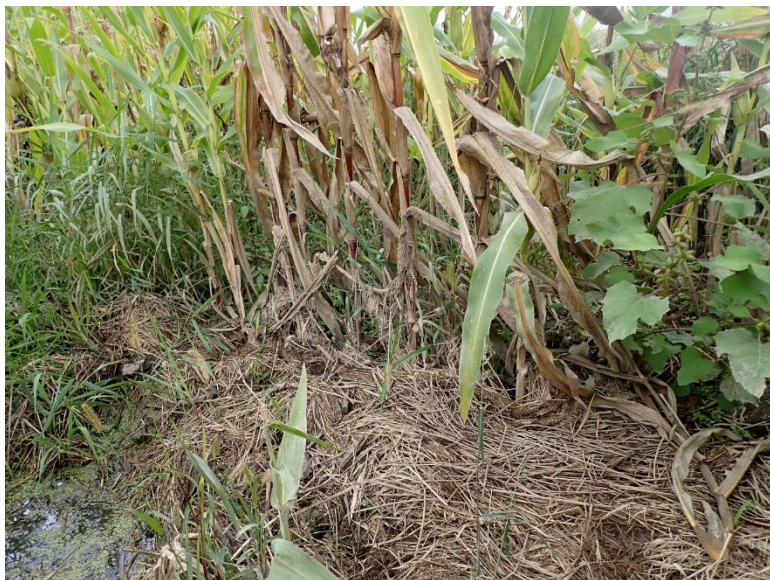
**Photograph VIII.I.** Wrack lines observed along corn crops planted in Wetland 19.

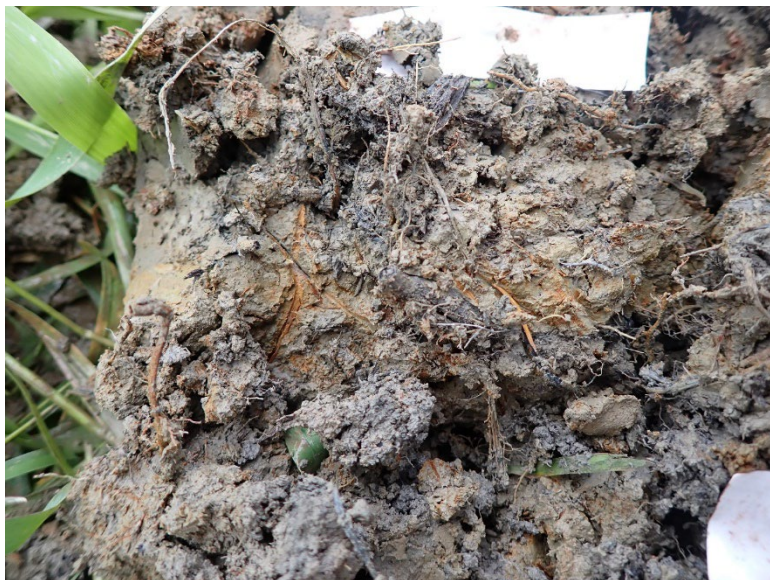
**Photograph VIII.K.** DP3: Oxidized rhizospheres on living roots.

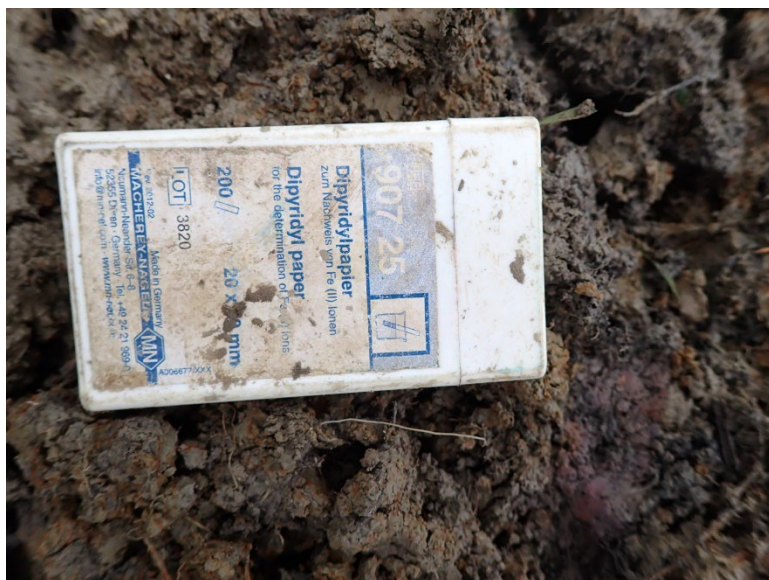
The presence of reduced iron in the soil was observed through the use of Dipyriddy paper strips on the soil profile (Photograph VIII.L – VIII.M); this satisfies the presence of reduced iron (C4) indicator for wetland hydrology. Primary indicators of wetland hydrology were observed, including a high-water table and surface water at a depth of 10 inches from the soil surface (Photograph VIII.N). The soil profile met the technical definition of a hydric soil (Indicator F3). Reed canary grass (*Phalaris arundinacea*) dominated the herbaceous stratum. All three parameters (i.e., vegetation, soil, and hydrology) were significantly disturbed by land clearing, grubbing, and grading.

**Photograph VIII.M.** Dipyridyl paper strips used on DP3.

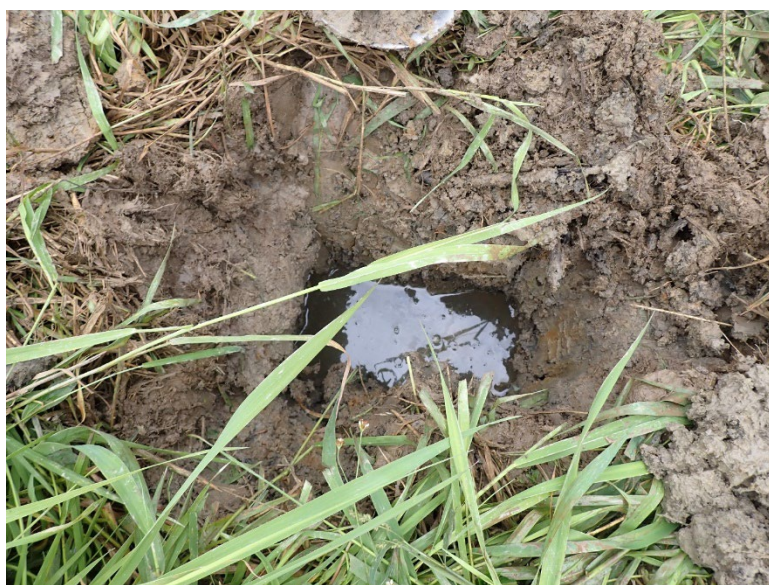
**Photograph VIII.N.** DP3: High water table observed in soil sampling location.

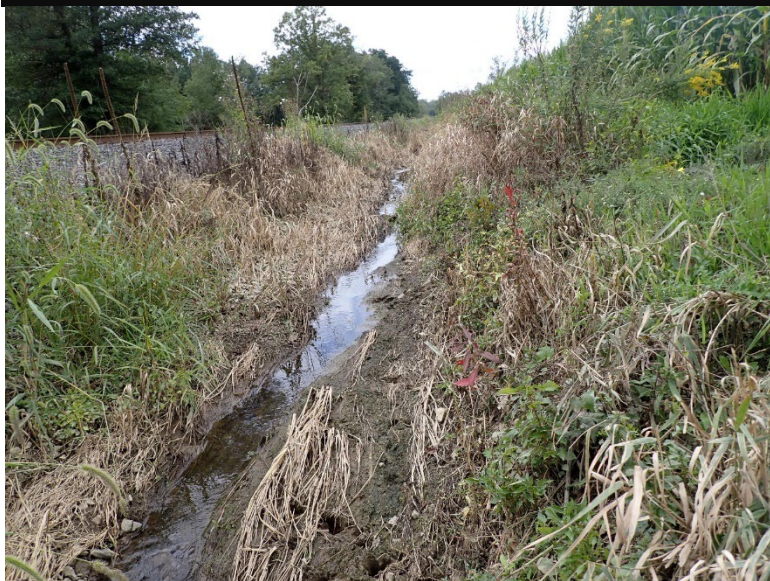
The inspection walkthrough continued from P4, southeast along the pipeline easement. Flowing water, wrack lines, and fish were observed (Photograph IX.A – IX.B).

**Photograph IX.A.** Railroad tributary. Facing northwest.

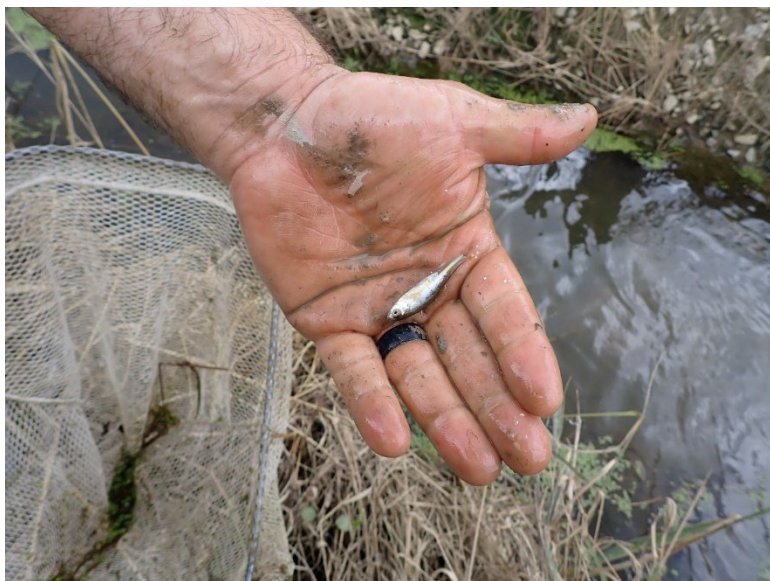
**Photograph IX.B.** Fish observed in Railroad tributary.

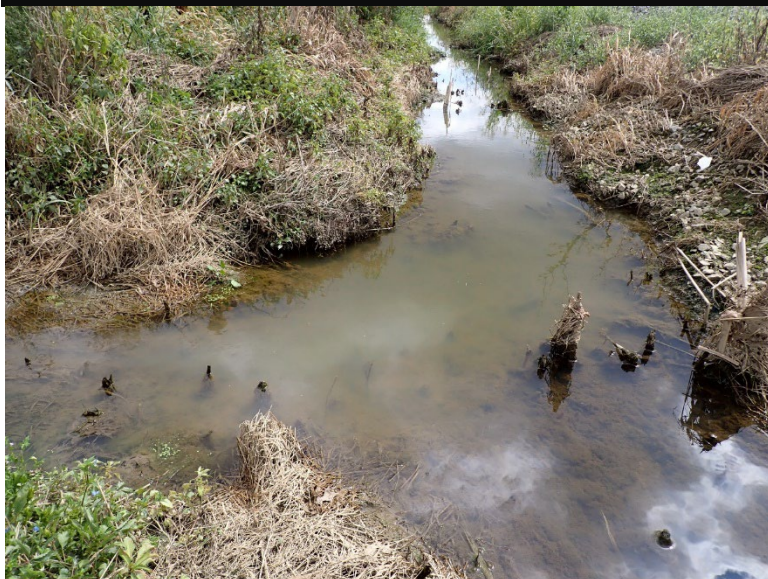
The inspection walkthrough continued to P5: the confluence of UNT-1 and the Railroad tributary (Photograph X.A – X.B). A direct connection between the two water bodies was documented in Photographs X.A and X.B. Wrack lines were observed along the banks of UNT-1 (Photograph X.C – X.F). Corn crops growing within the boundary of the pipeline easement, as indicated by the water pipeline post, were observed (Photograph X.G).

**Photograph X.A.** Confluence of Railroad tributary and UNT-1.

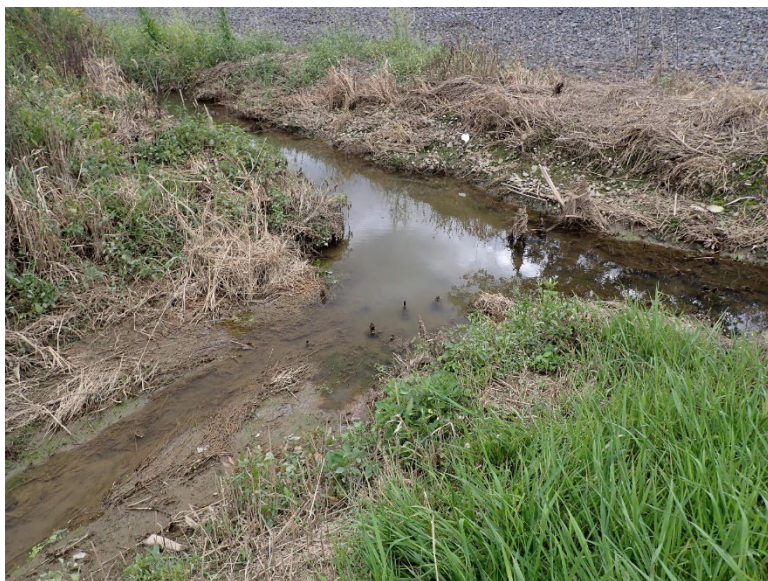
**Photograph X.B.** Confluence of UNT-1 and Railroad tributary. Facing South.

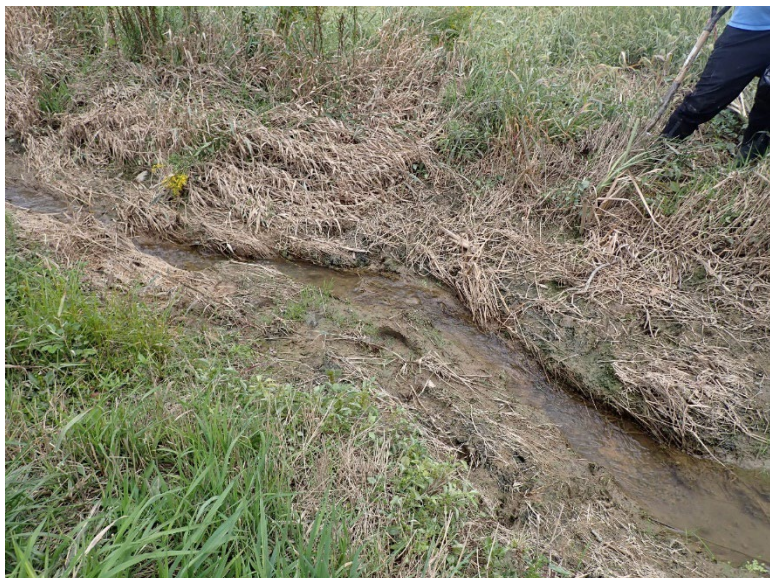
**Photograph X.C.** Wrack lines along southern portion of UNT-1.

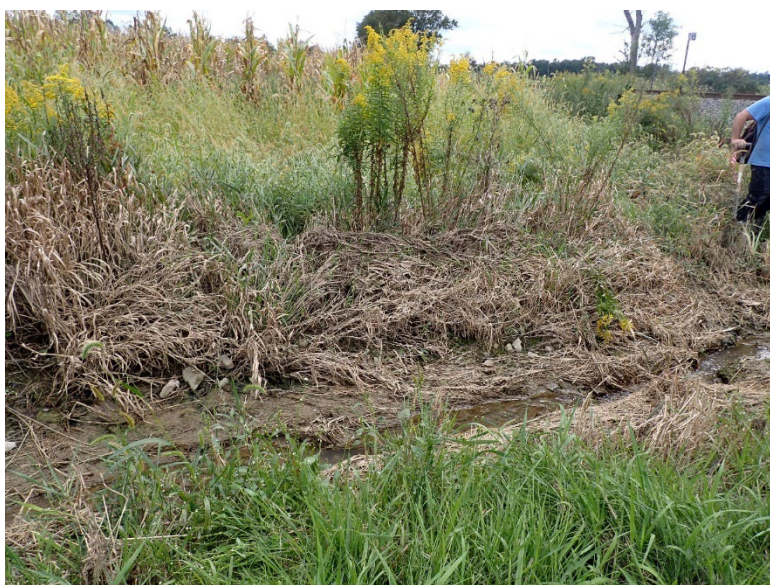
**Photograph X.D.** Wrack lines along southern portion of UNT-1.

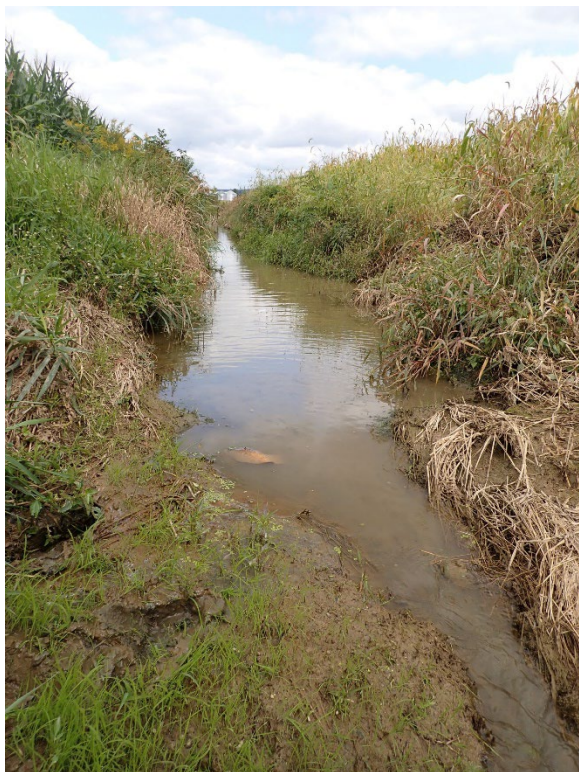
**Photograph X.E.** UNT-1. Facing north.

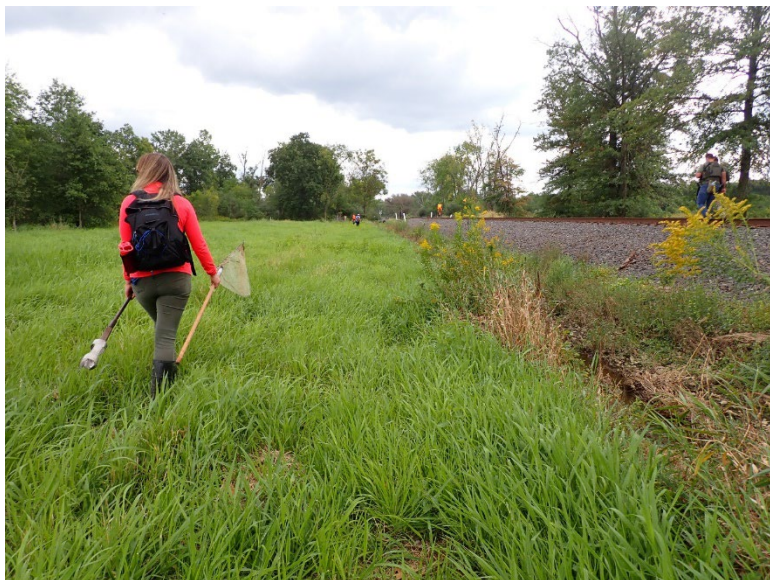
**Photograph XI.D.** Easement. South of Wetland 8, facing southeast.

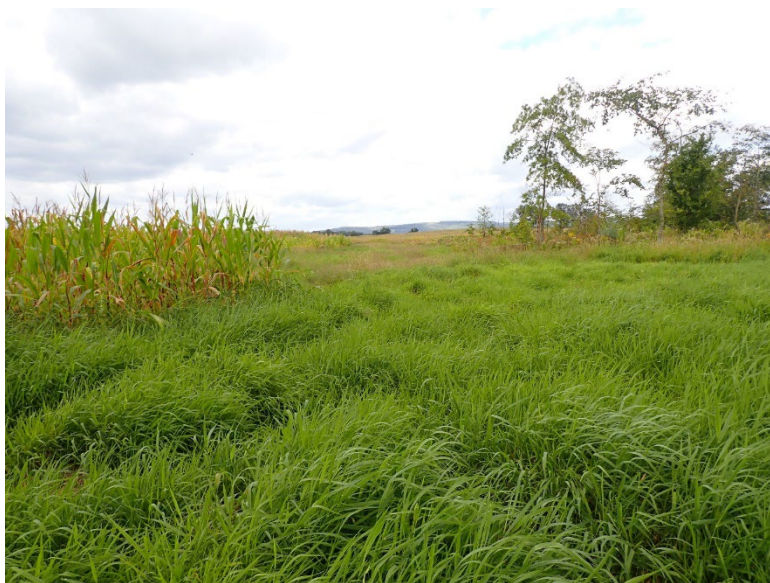
The inspection walkthrough continued from Point 5, southeast along the pipeline easement. A culvert draining water out of Wetland 8 into the Railroad tributary was observed (Photograph XI.A – B). Reed canary grass (*Phalaris arundinacea*) dominated the area (Photograph XI.C – XI.D). Evidence of tree-clearing in Wetland 8 was observed (Photograph XI.E – XI.G).

**Photograph XI.E.** Wetland 8. Facing north from easement.

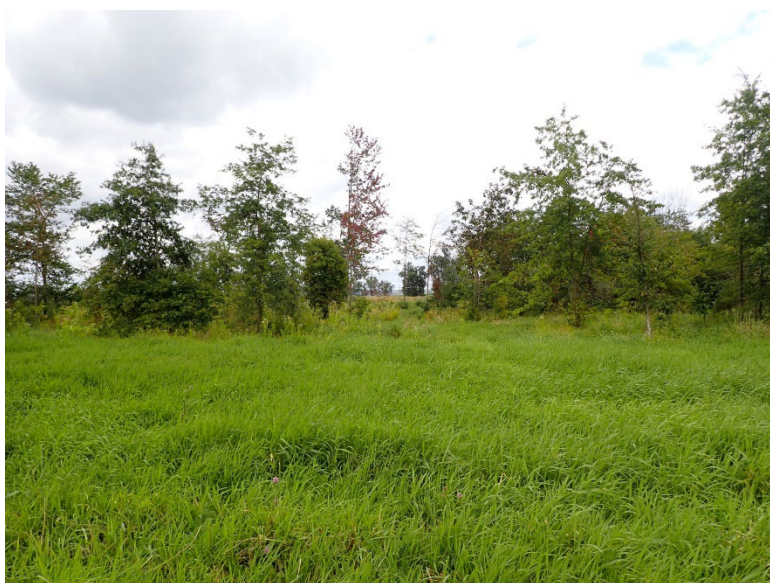
**Photograph XI.G.** Wetland 8. Facing north from easement.

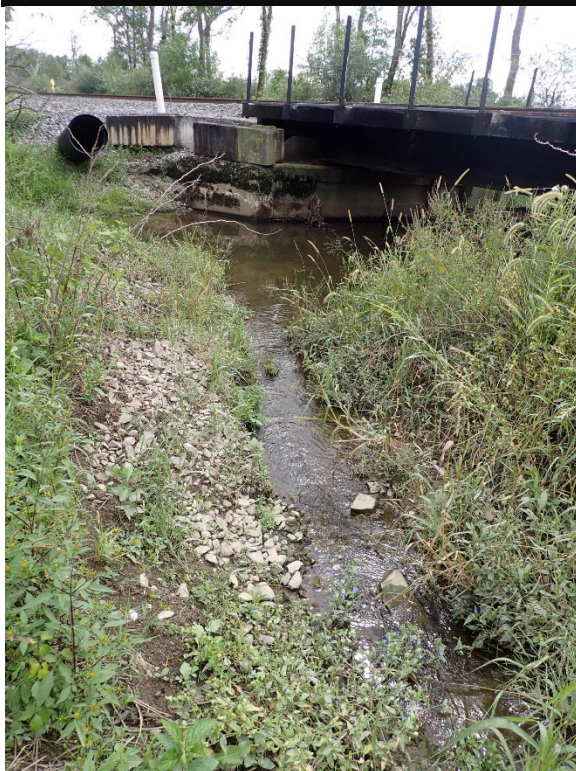
**Photograph XII.A.** Confluence of Railroad tributary and Beaver Run. Facing southeast.

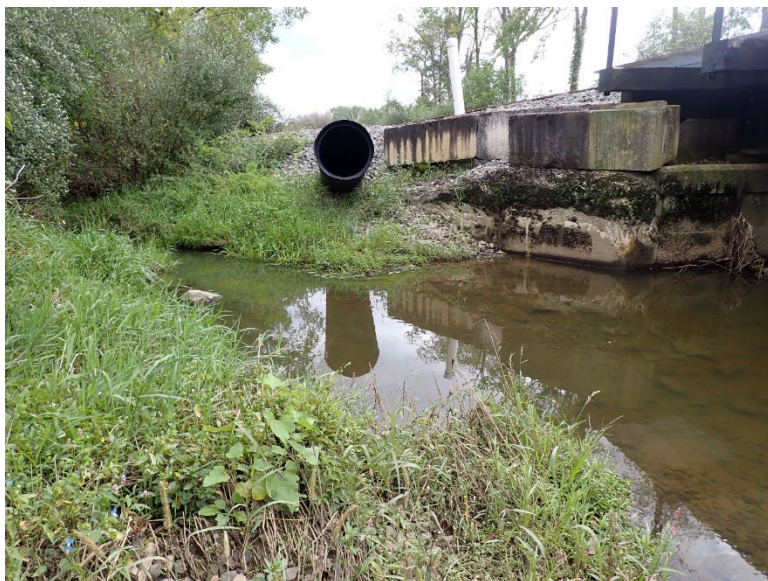
**Photograph XII.B.** Confluence of Railroad tributary and Beaver Run. Facing southeast.

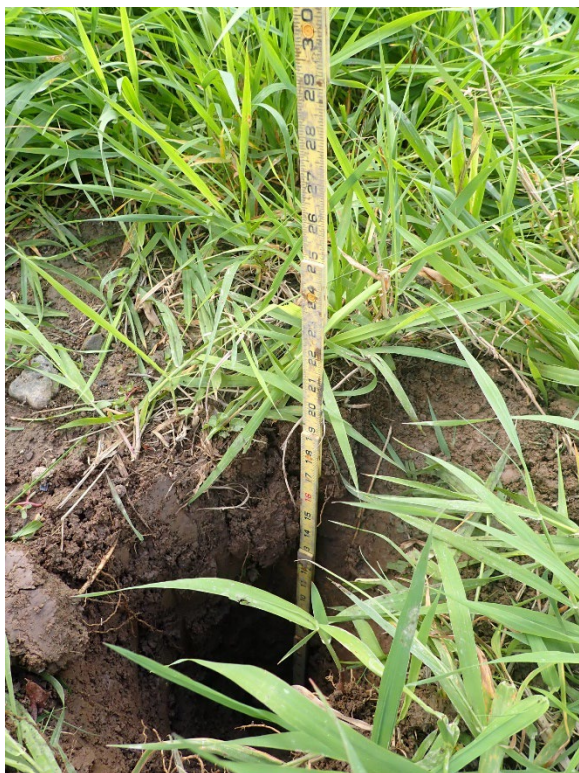
**Photograph XIII.B.** DP4: Depth of soil profile.

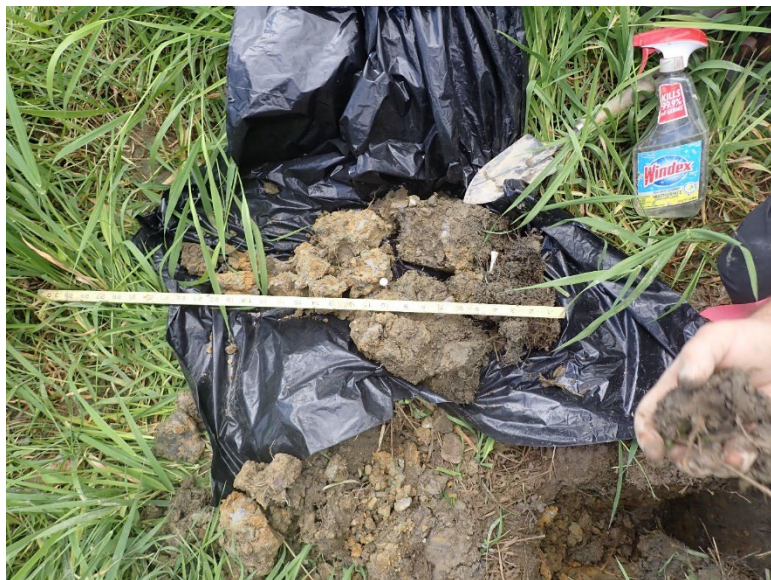
**Photograph XIII.C.** DP4: Soil profile.

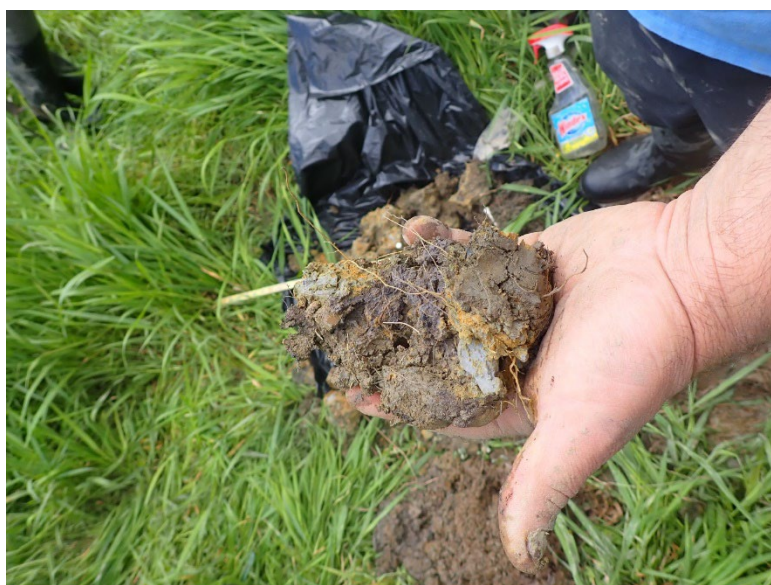
**Photograph XIII.D.** DP4: Oxidized rhizospheres in soil profile.

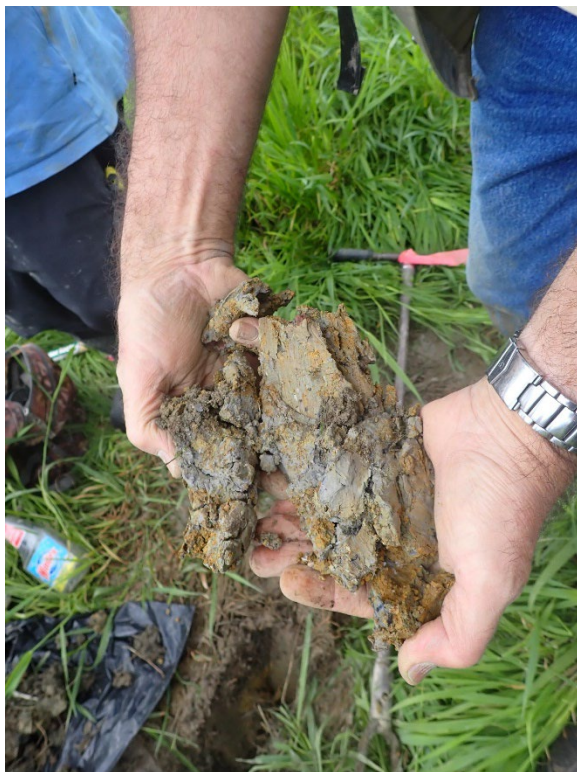
**Photograph XIII.E.** DP4: Mixed matrix.

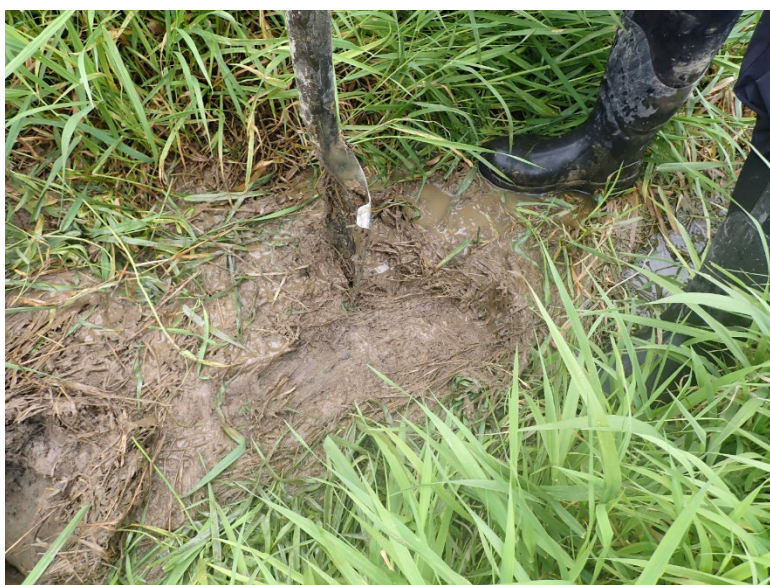
Surface water was observed within the area (Photograph XIII.F). Soil profile met the technical definition of a hydric soil (Indicator F3). Reed canary grass (*Phalaris arundinacea*) dominated the herbaceous stratum. All three parameters (i.e., vegetation, soil, and hydrology) were significantly disturbed by land clearing, grubbing, and grading.

**Photograph XIII.F.** DP4: Surface water within area.

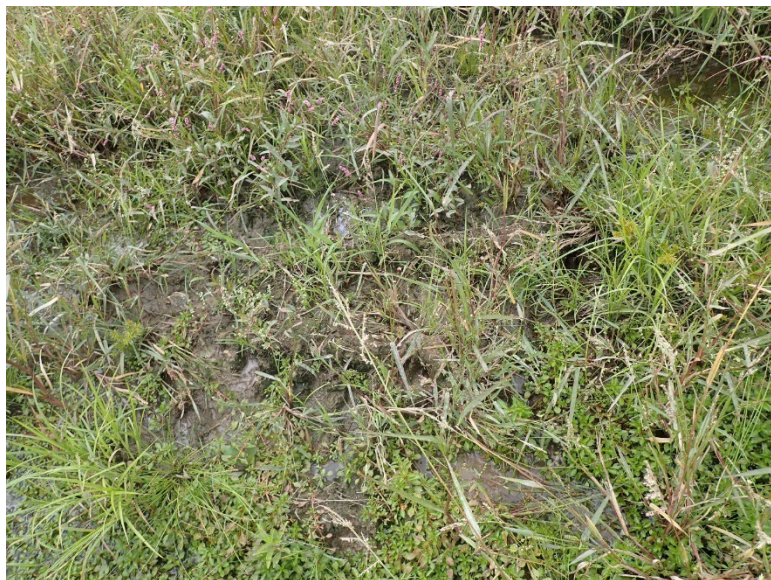
The inspection walkthrough continued from DP4, northwest along Wetland 8. A culvert draining Wetland 8, a drain line, mechanized tire tracks, wrack lines, and burned tree stumps were observed (Photograph XIII.G – XIII.K).

**Photograph XIII.I.** Wetland 8: tire tracks.

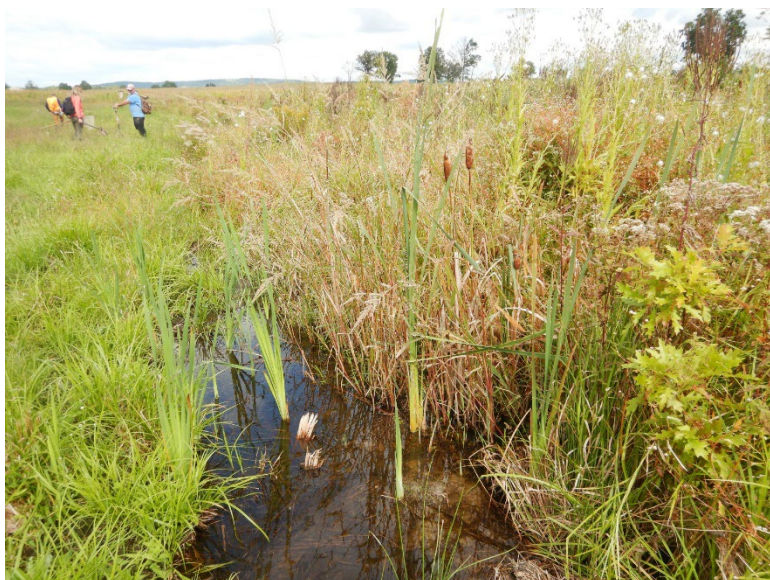
The inspection walkthrough continued to P7: the northwest boundary of Wetland 8. Evidence of tree clearing was apparent, as Wetland 8 was sparsely vegetated (Photograph XIV.A). Broadleaf cattail (*Typha latifolia*), burned tree stumps, and iron deposits in standing surface water were observed (Photograph XIV.B – XIV.E).

**Photograph XIV.B.** Standing water and cattails along the western border of Wetland 8. Facing north.

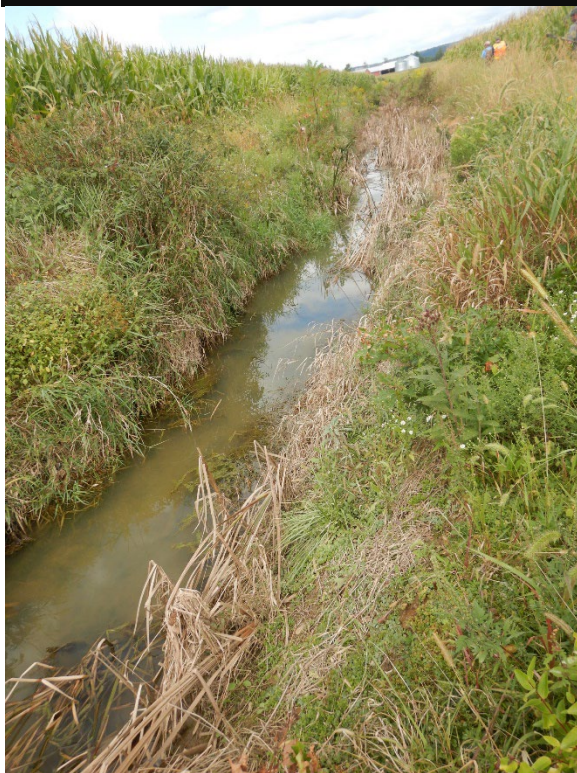
**Photograph XV.A.** UNT-1. Facing north.

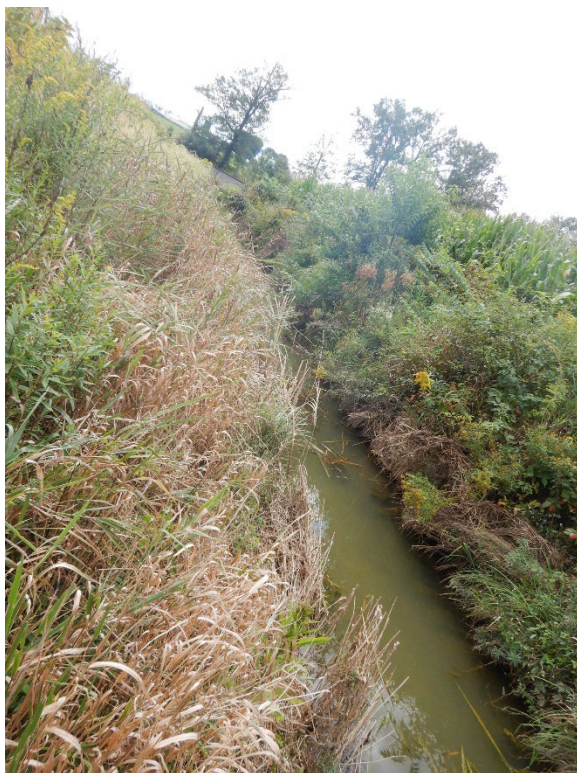
**Photograph XV.B.** UNT-1. Facing south.

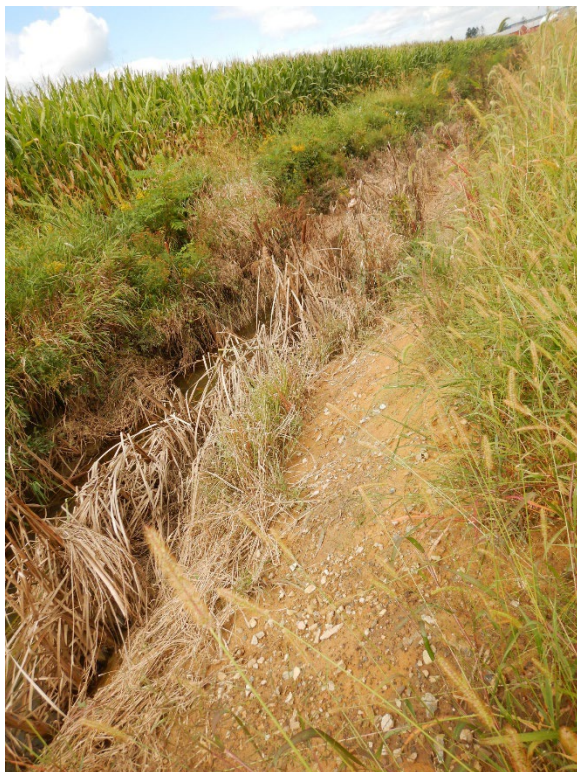
**Photograph XV.C.** UNT-1. Facing north.

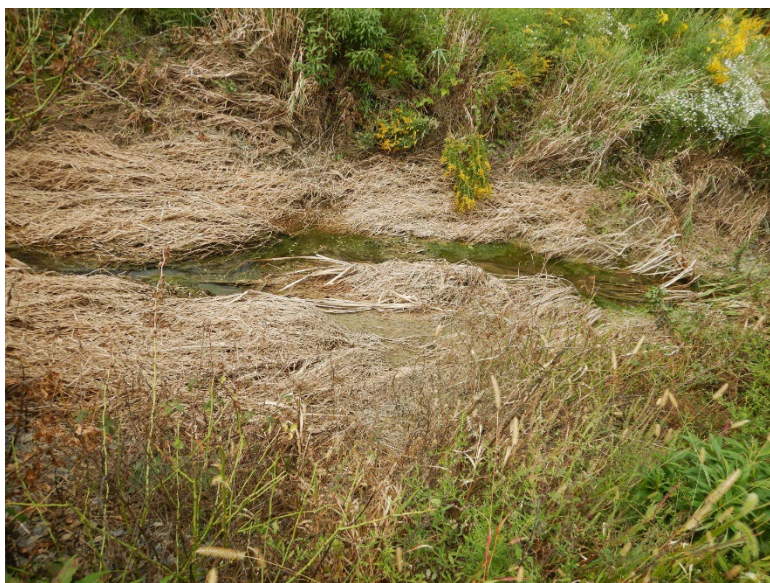
The inspection walkthrough continued to P8: the eastern side of the confluence of the Railroad tributary and UNT-1. Flowing water, wrack lines, and stunted corn crops planted in Wetland 19 were observed (Photograph XV.A – XV.E). Evidence of herbicide application and earth-moving activities, including tree-clearing, grubbing, and grading were observed as Wetland 19 had been significantly disturbed and converted into an active cornfield.

**Photograph XV.D.** Wrack lines observed in UNT-1.

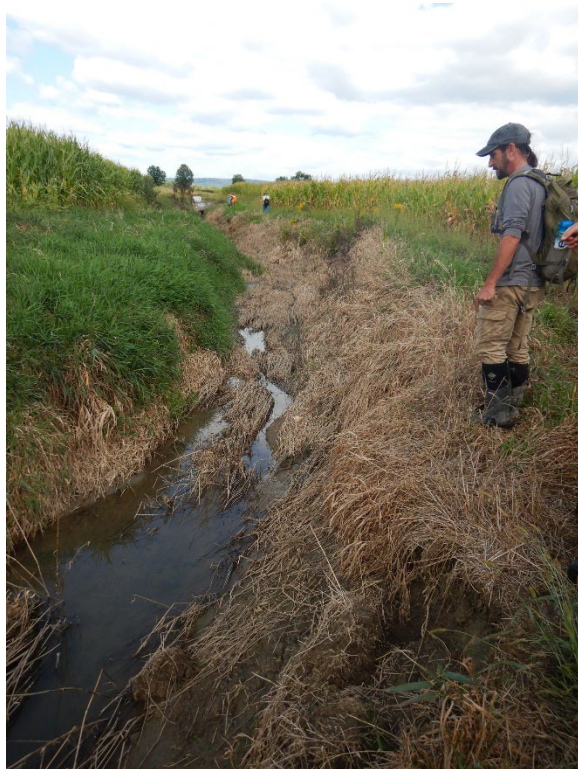
**Photograph XVI.B.** UNT-1. Facing north.

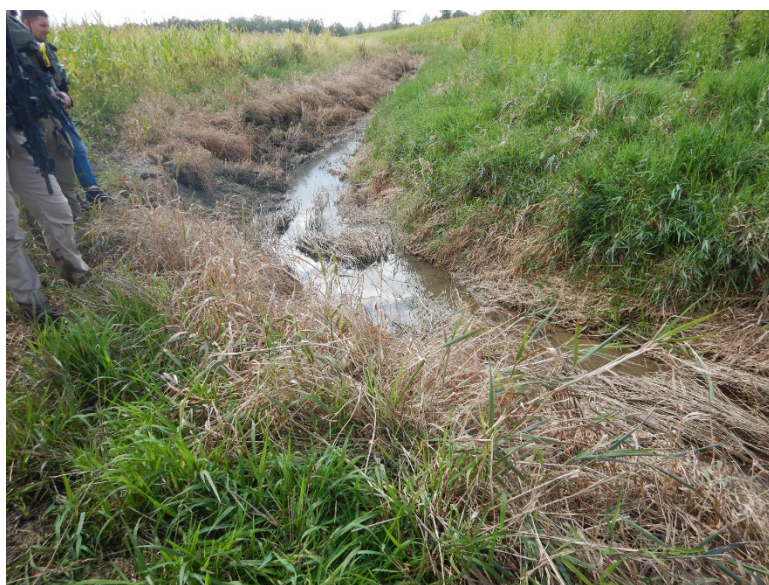
**Photograph XVI.C.** UNT-1. Facing south.

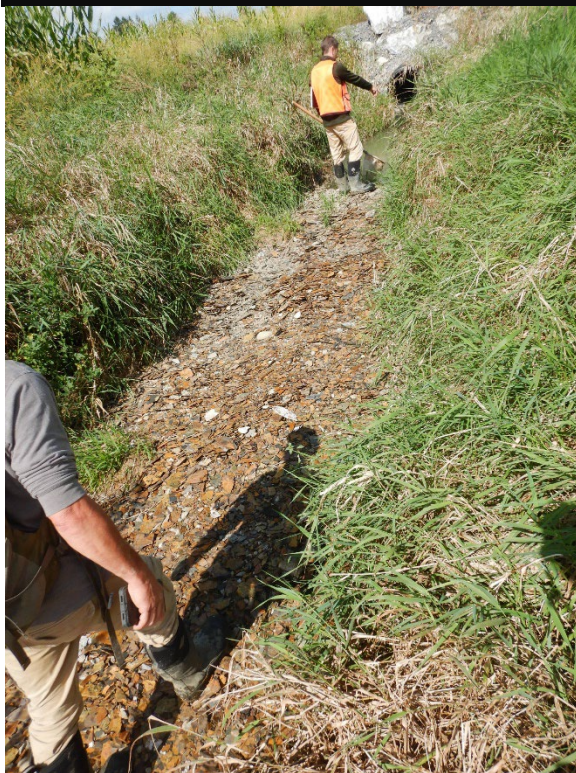
The inspection walkthrough continued to P9: the midway location along UNT-1 where a culvert connects both the northern and southern extensions of UNT-1. Shale deposits, a swale containing fish, and the northern extent of UNT-1 north of the culvert were observed (Photograph XVII.A – XVII.E). Evidence of herbicide application and earth-moving activities, including tree-clearing, grubbing, and grading were observed as Wetland 19 had been significantly disturbed and converted into an active cornfield.

**Photograph XVII.A.** Shale deposits along UNT-1. Facing north.

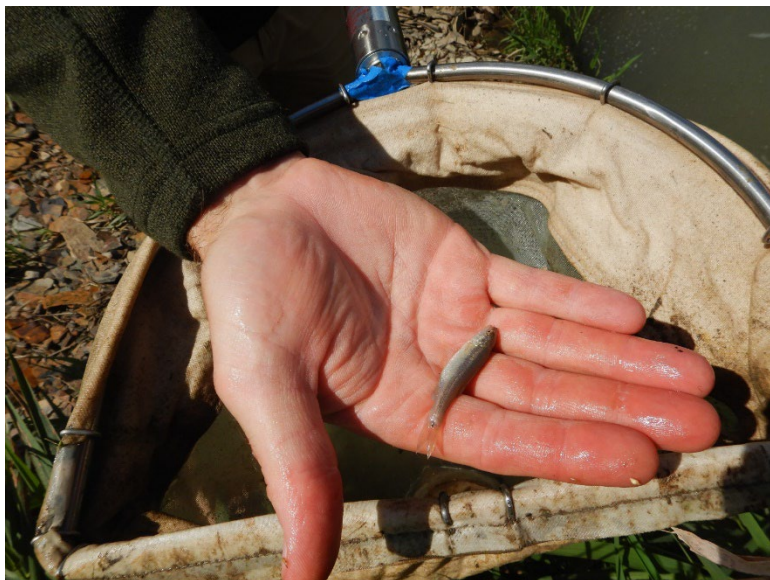
**Photograph XVII.C.** Fish observed in swale along UNT-1.
