**RE: ALCOA BUILDING ENVIRONMENTAL ASSESSMENT  
MODIFIED PHASE I FINAL REPORT**

**RE: ALCOA BUILDING - MODIFIED PHASE I  
ENVIRONMENTAL ASSESSMENT DRAFT REPORT**

Subject: Phase I Environmental Assessment  
Alcoa Building  
Color Photos from Final Report

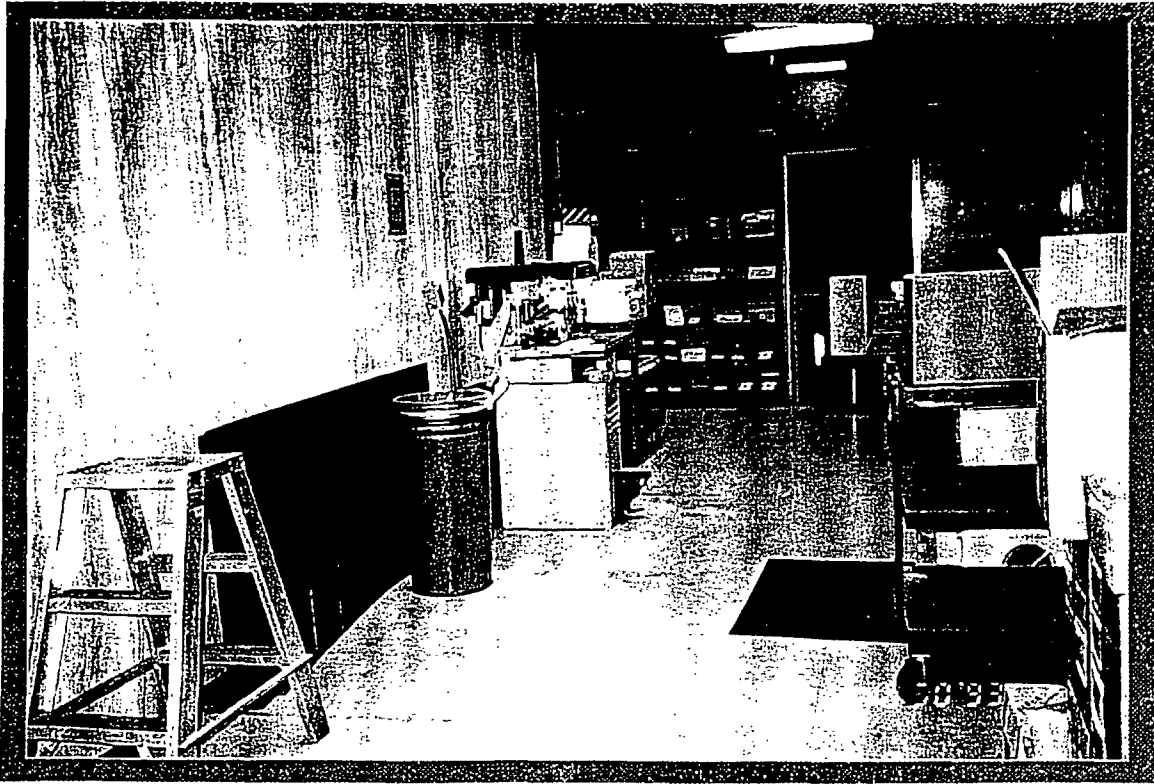
1. Chemically stained shelves and floor tile were observed in the old darkroom located in the former duplication center in the basement. This would be a minor finding that could be easily remedied.

*General condition of former duplication center in basement (rooms B-58, B-58A, & B-58B).*

3. Don Burrell has informed me that the problem with the stained shelves and floor tile in the basement has been corrected.
4. The hydraulic lift in the Executive Annex is inspected regularly and has not presented a problem. Future building owners would be responsible for proper maintenance.

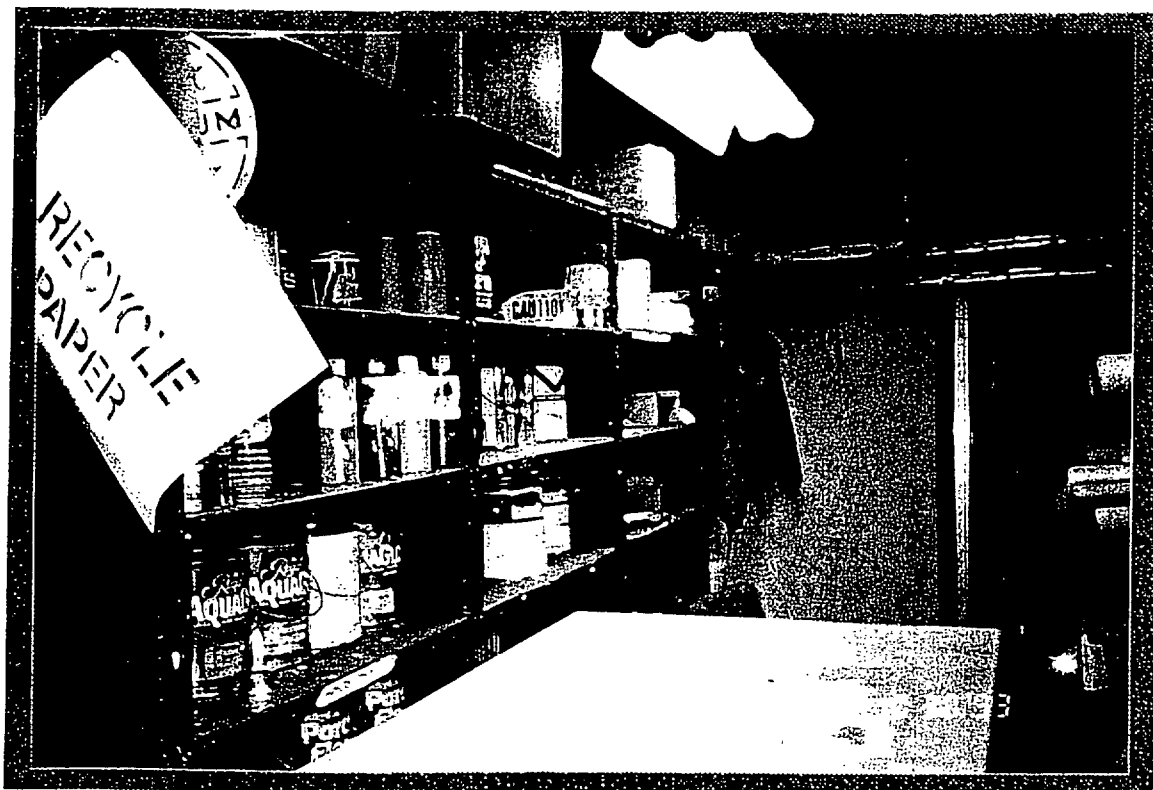
*Paint storage area in basement, room B-28B.*

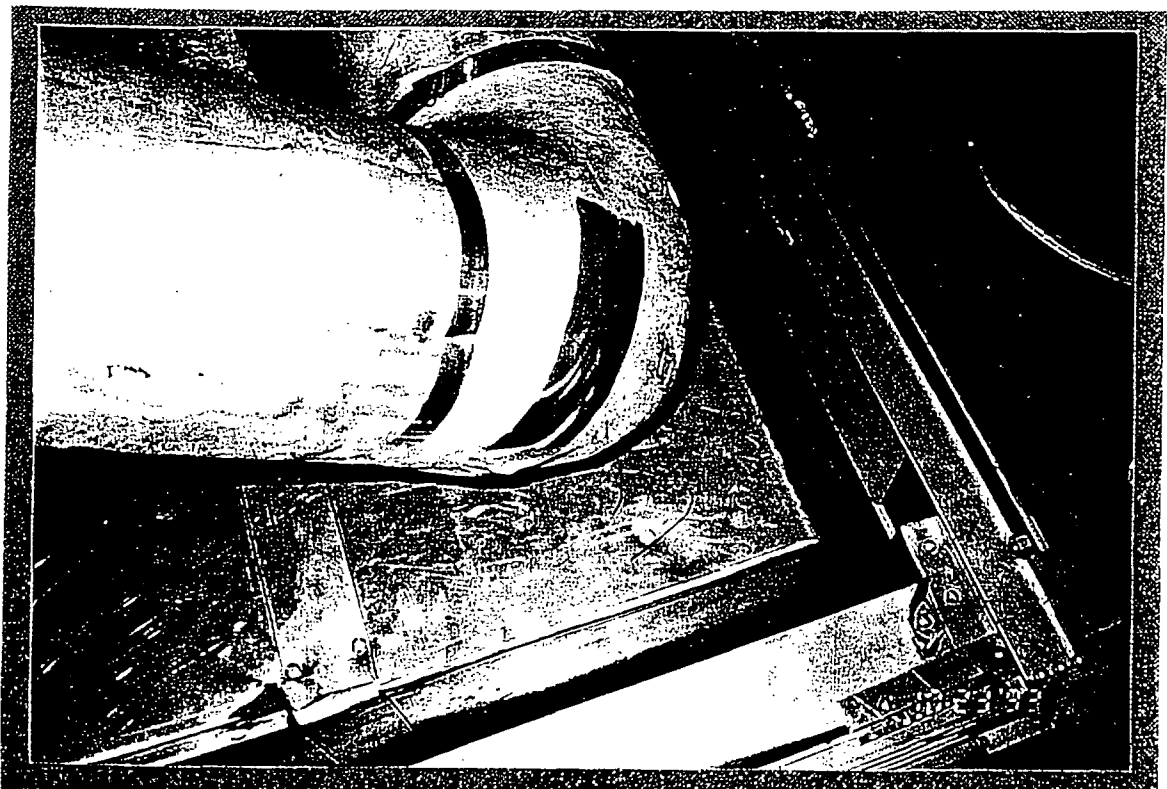
*Pipe insulation in lobby ceiling near high-rise elevator bay (asbestos sample 1-2B).*
