## MULTI-SECTOR GENERAL PERMIT NON-FILER INSPECTION CHECKLIST

| <b>Inspection Date(s):</b> | 2/7/2023 | |
| <b>Operator Name:</b> | Price's Auto Salvage (formerly B F Leidy & Sons Inc.) | |

**Appendix A. Aerial Map**  
**Clean Water Act Inspection**  
**Price's Auto Salvage**

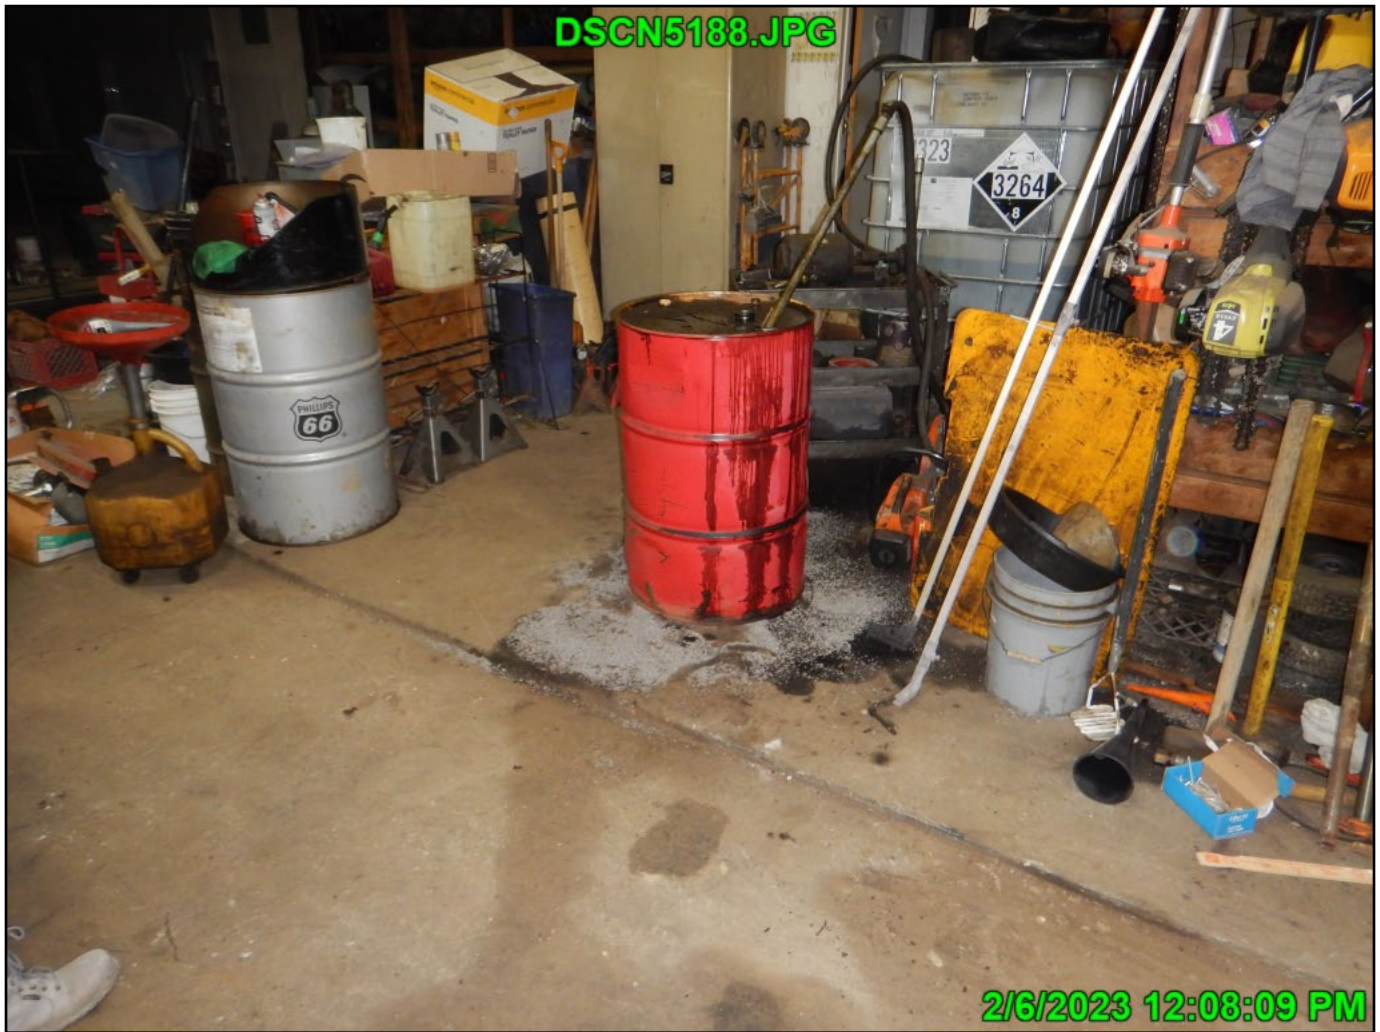
| Description | Waste oil stored inside the primary Facility building without secondary containment. Note the absorbent material on the ground. |

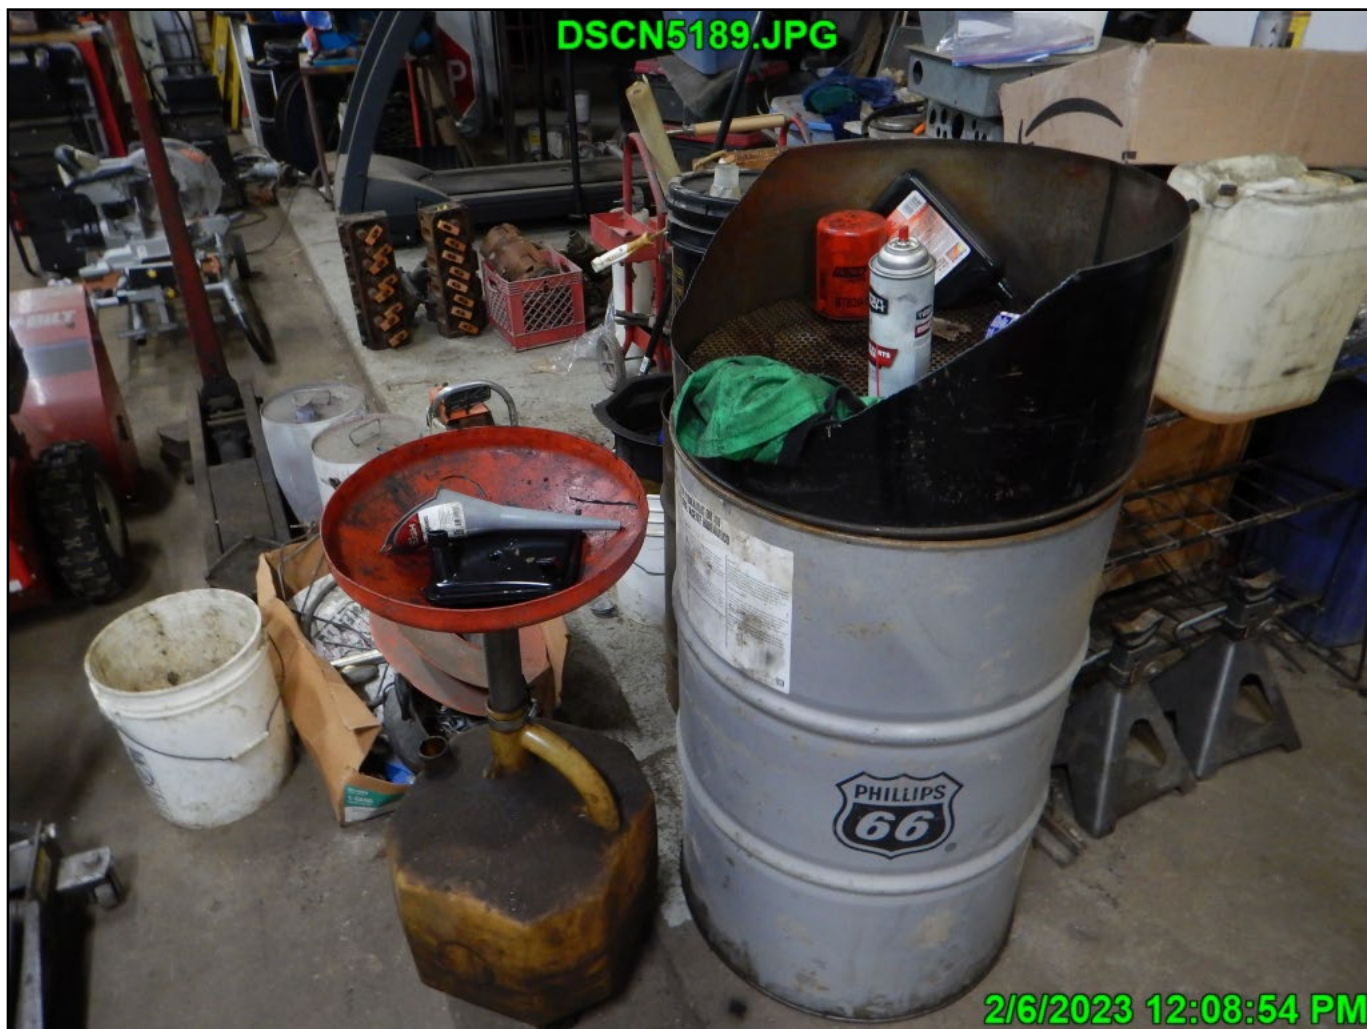
| Description | Waste oil storage inside the primary Facility building shown in Photograph DSCN5188. Note the lack of secondary containment measures. |

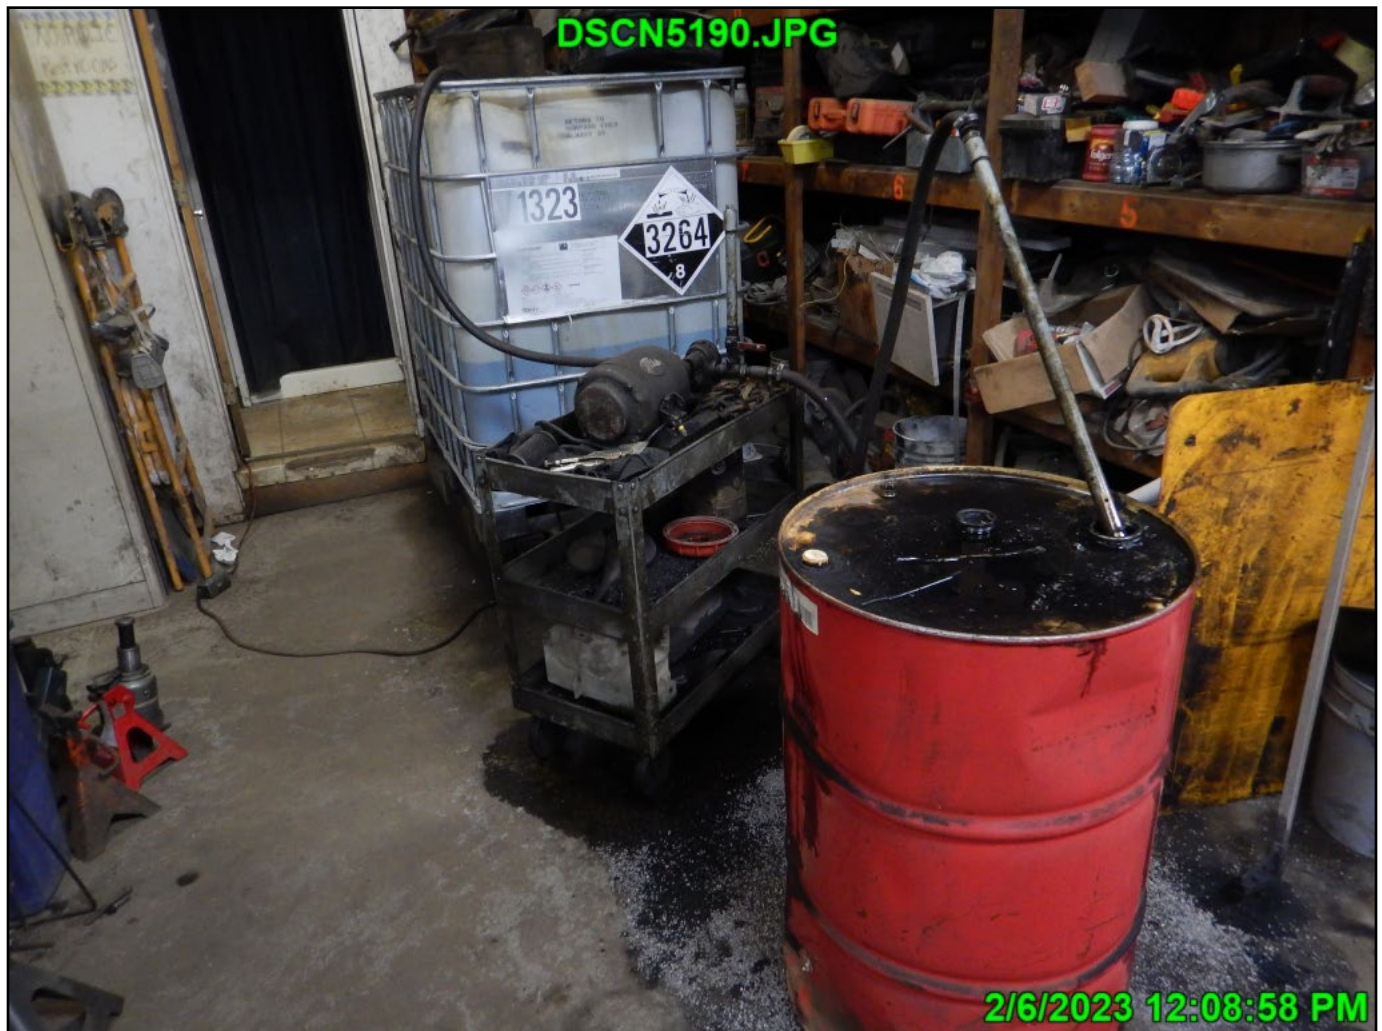
| Description | Waste oil storage inside the primary Facility building. Note the absorbent material on the ground and the lack of secondary containment measures. |

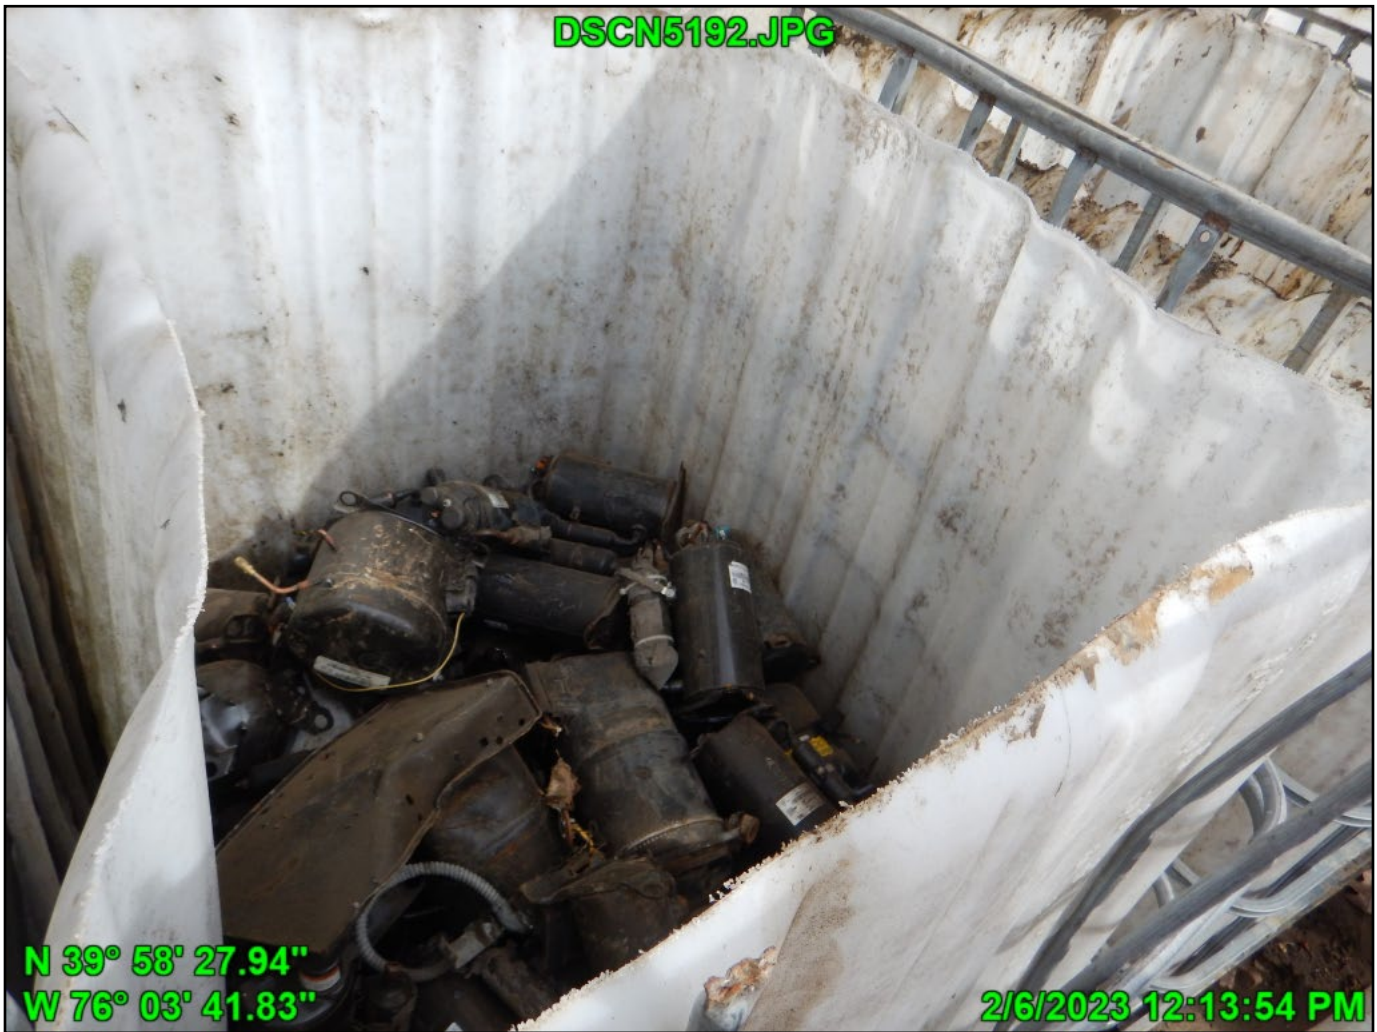
| Description | Automotive parts stored outside the primary Facility building without cover. |

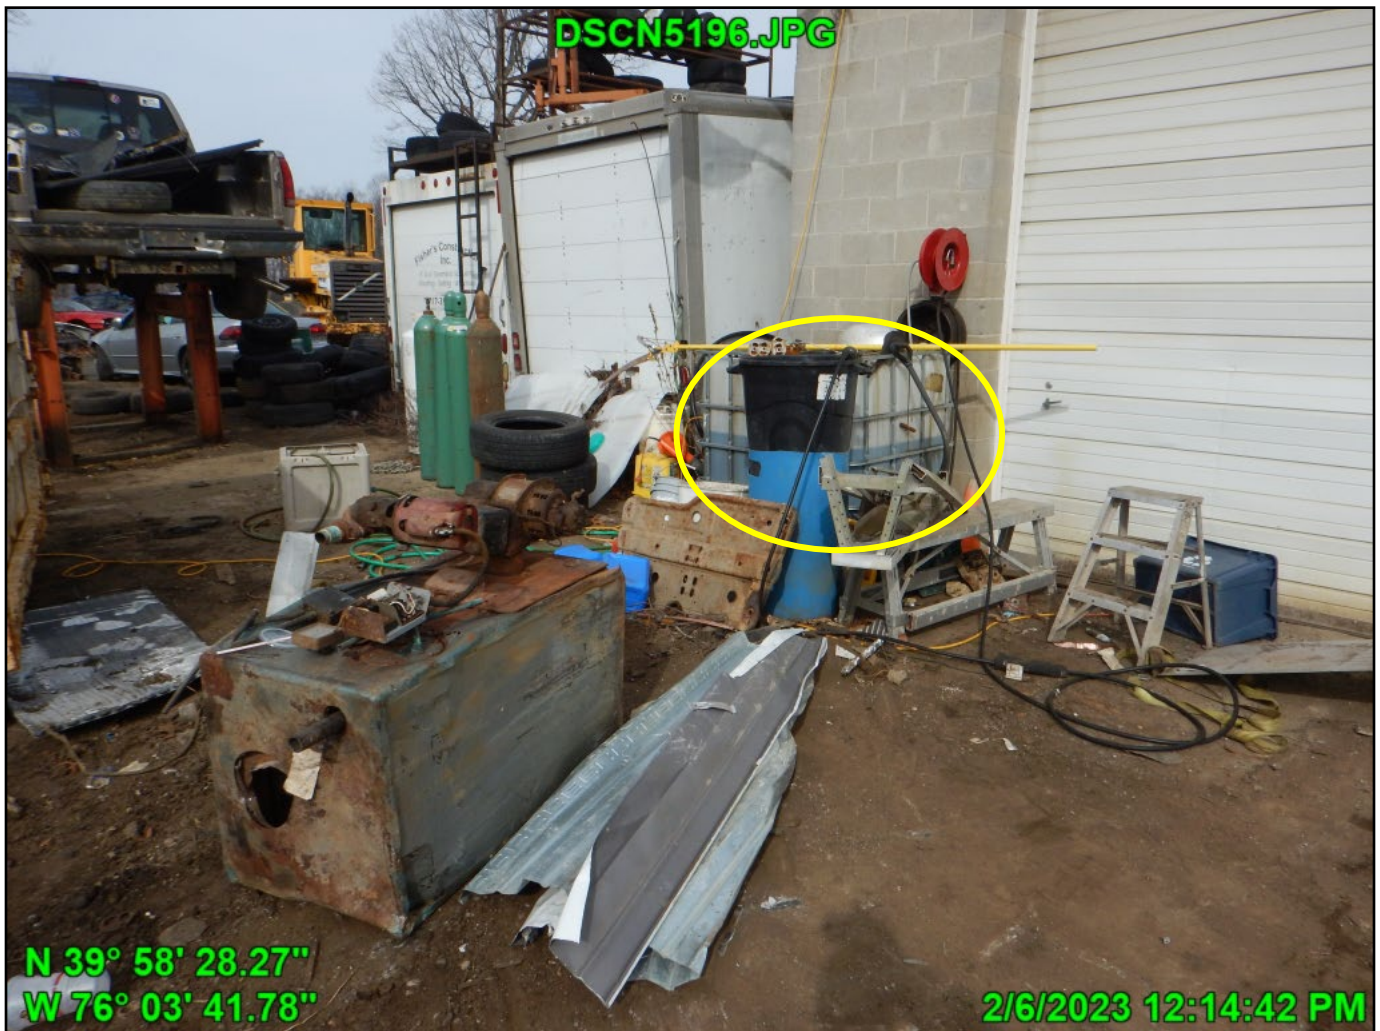
- 3) The EPA Inspection Team observed waste oil totes stored outside without cover or secondary containment (refer to Appendix B, Photographs DSCN5206 and DSCN5207).

| Description | Various vehicle parts being stored outside, as well as a 275-gallon waste oil tote without secondary containment. |

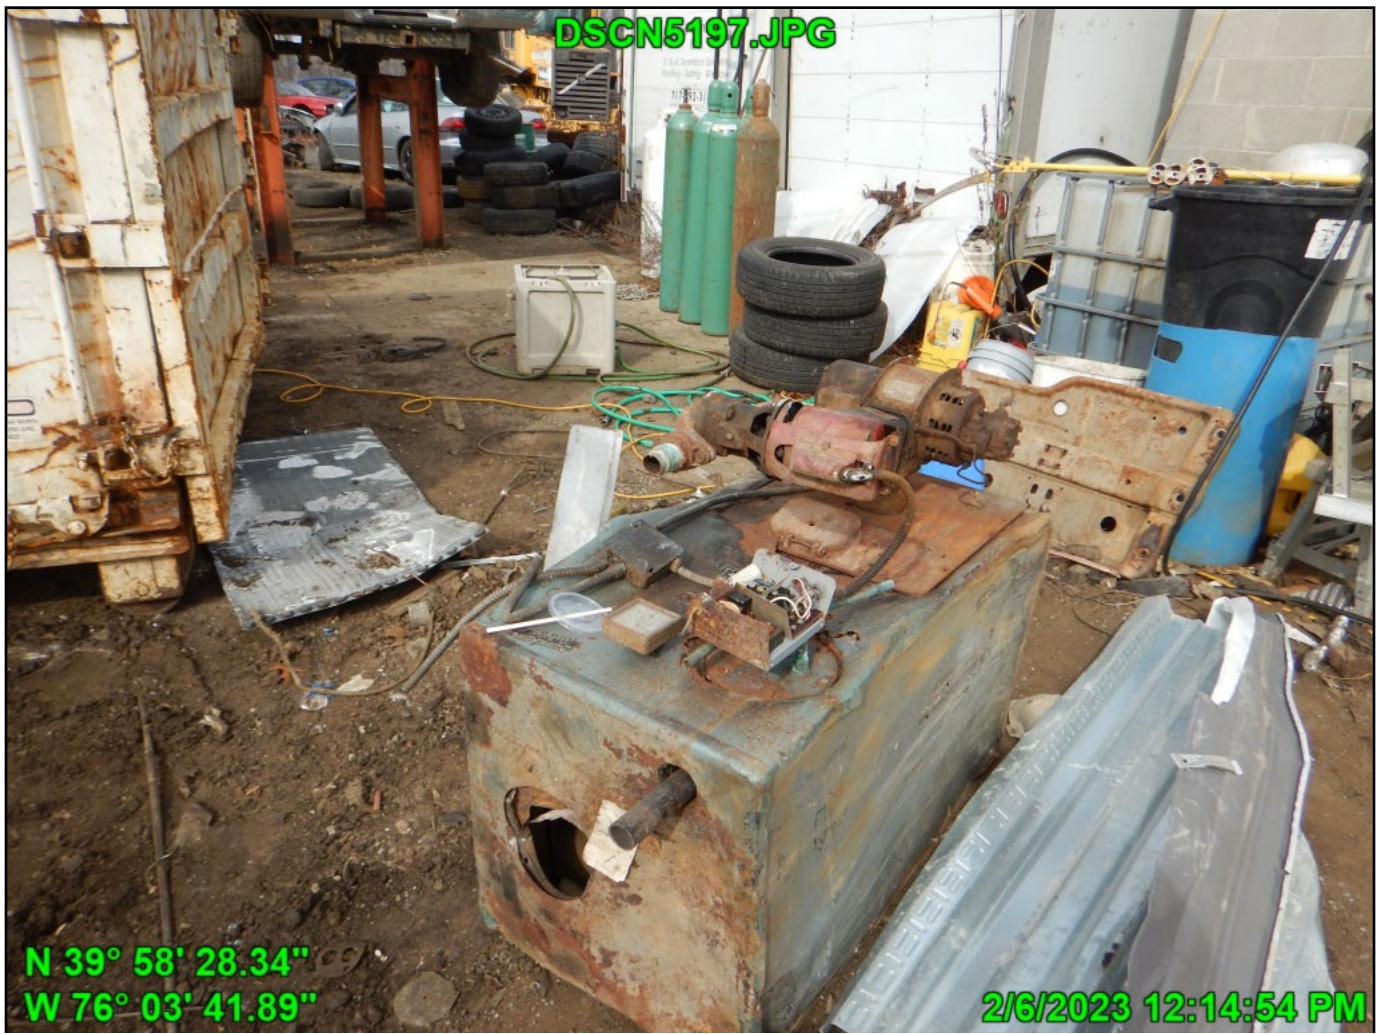
| Description | Various vehicle parts being stored outside, as well as a 275-gallon waste oil tote shown in Photograph DSCN5196. |

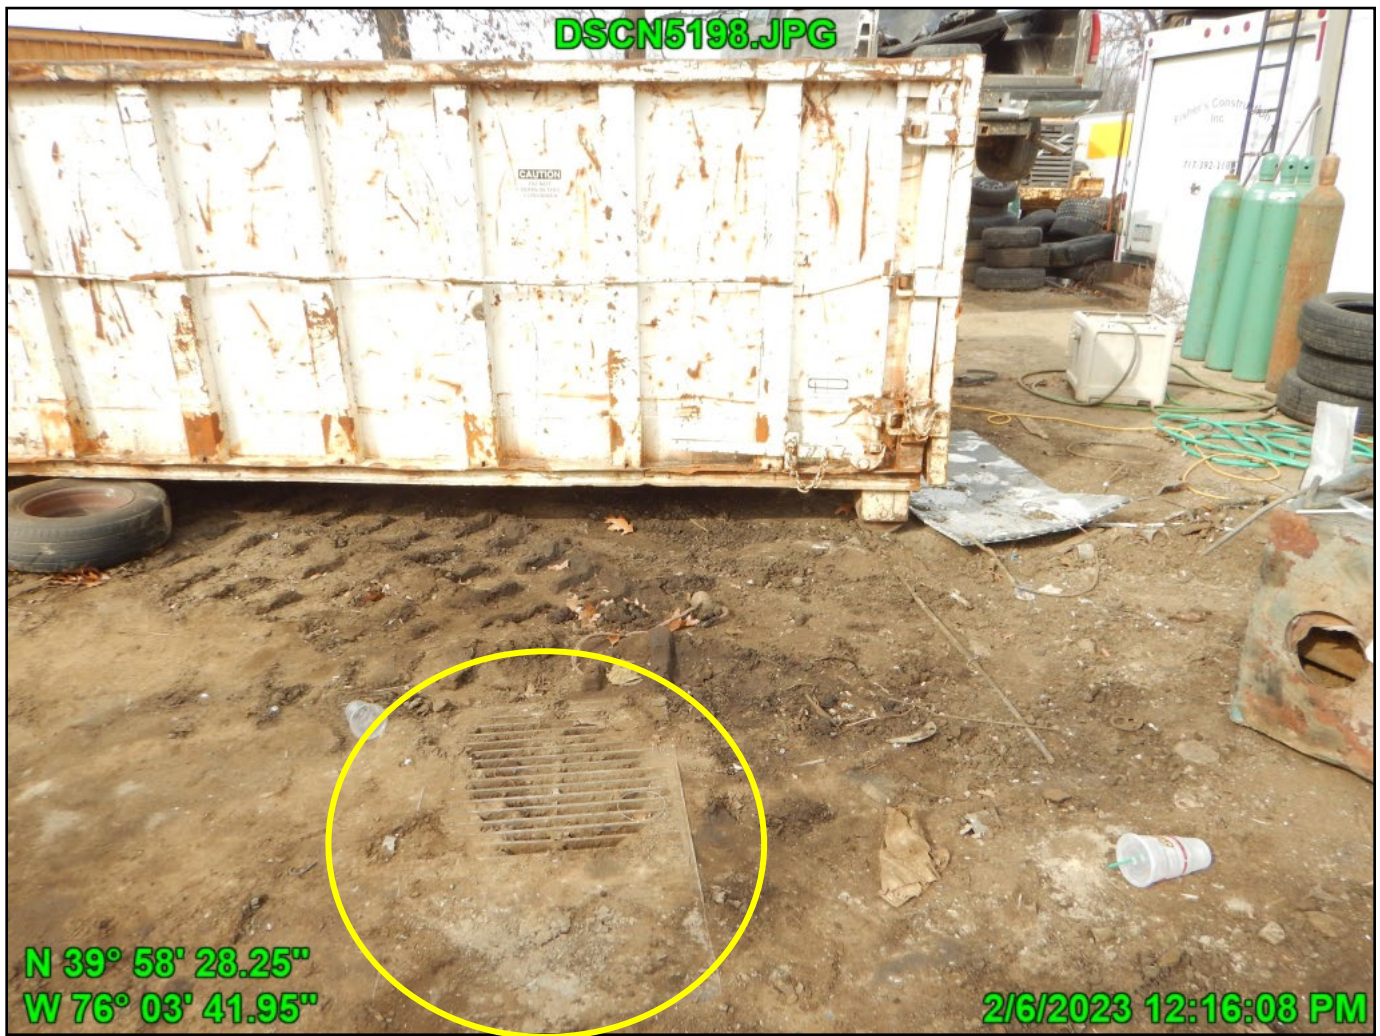
| Description | Storm drain inlet connected to the outlet pipe shown in Photograph DSCN5214. Note the lack of inlet protection. |

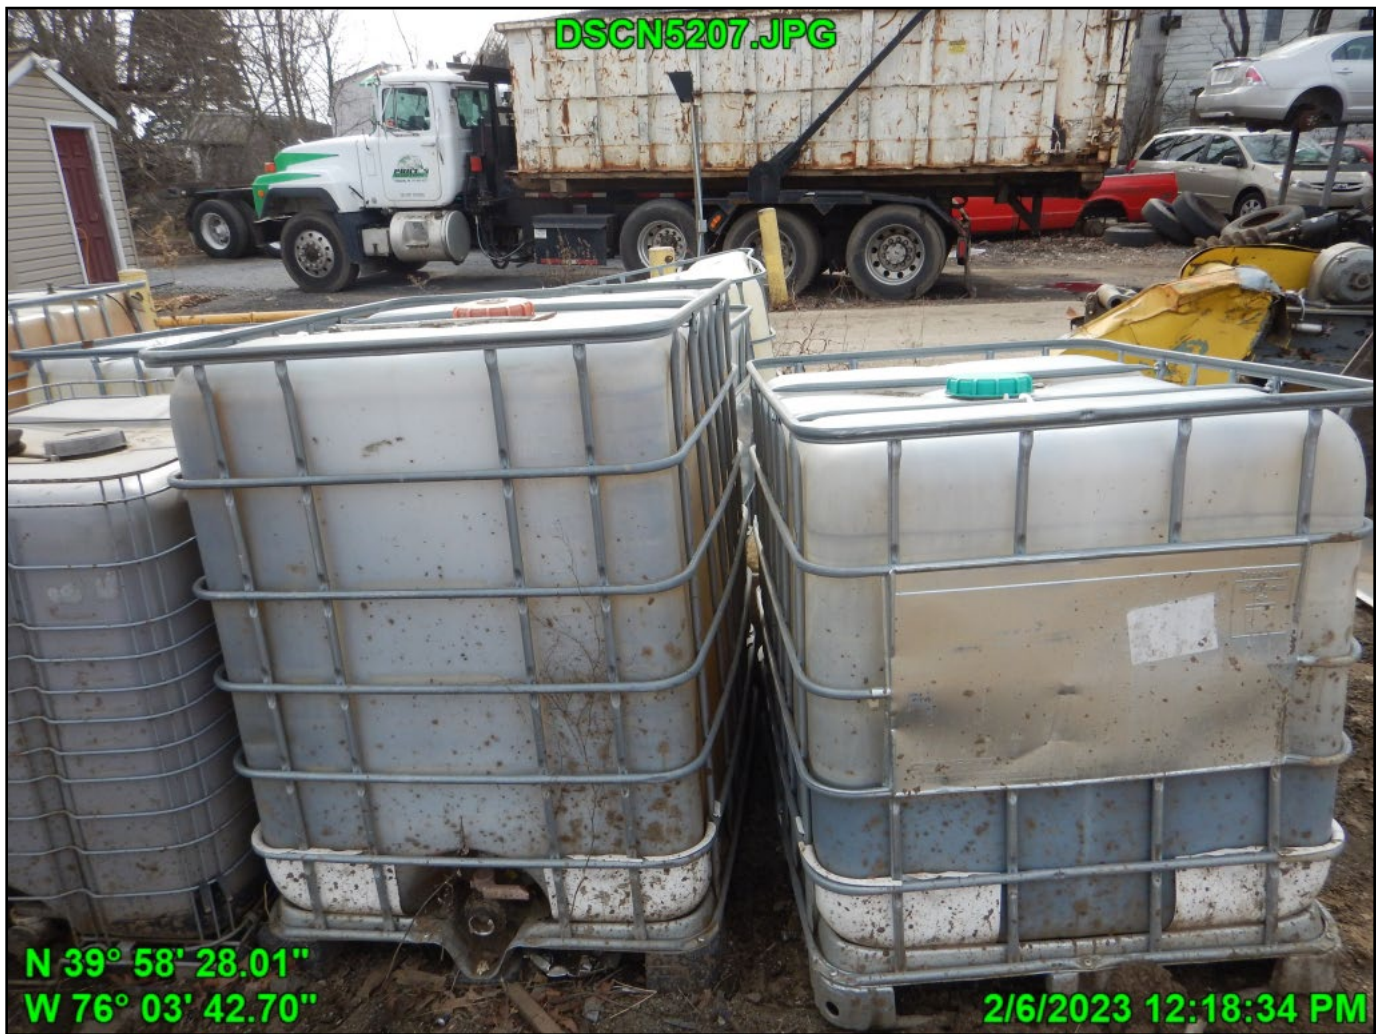
| Description | Approximately eleven 275-gallon waste oil totes shown in Photograph DSCN5206, of which 7 appeared to be full. |

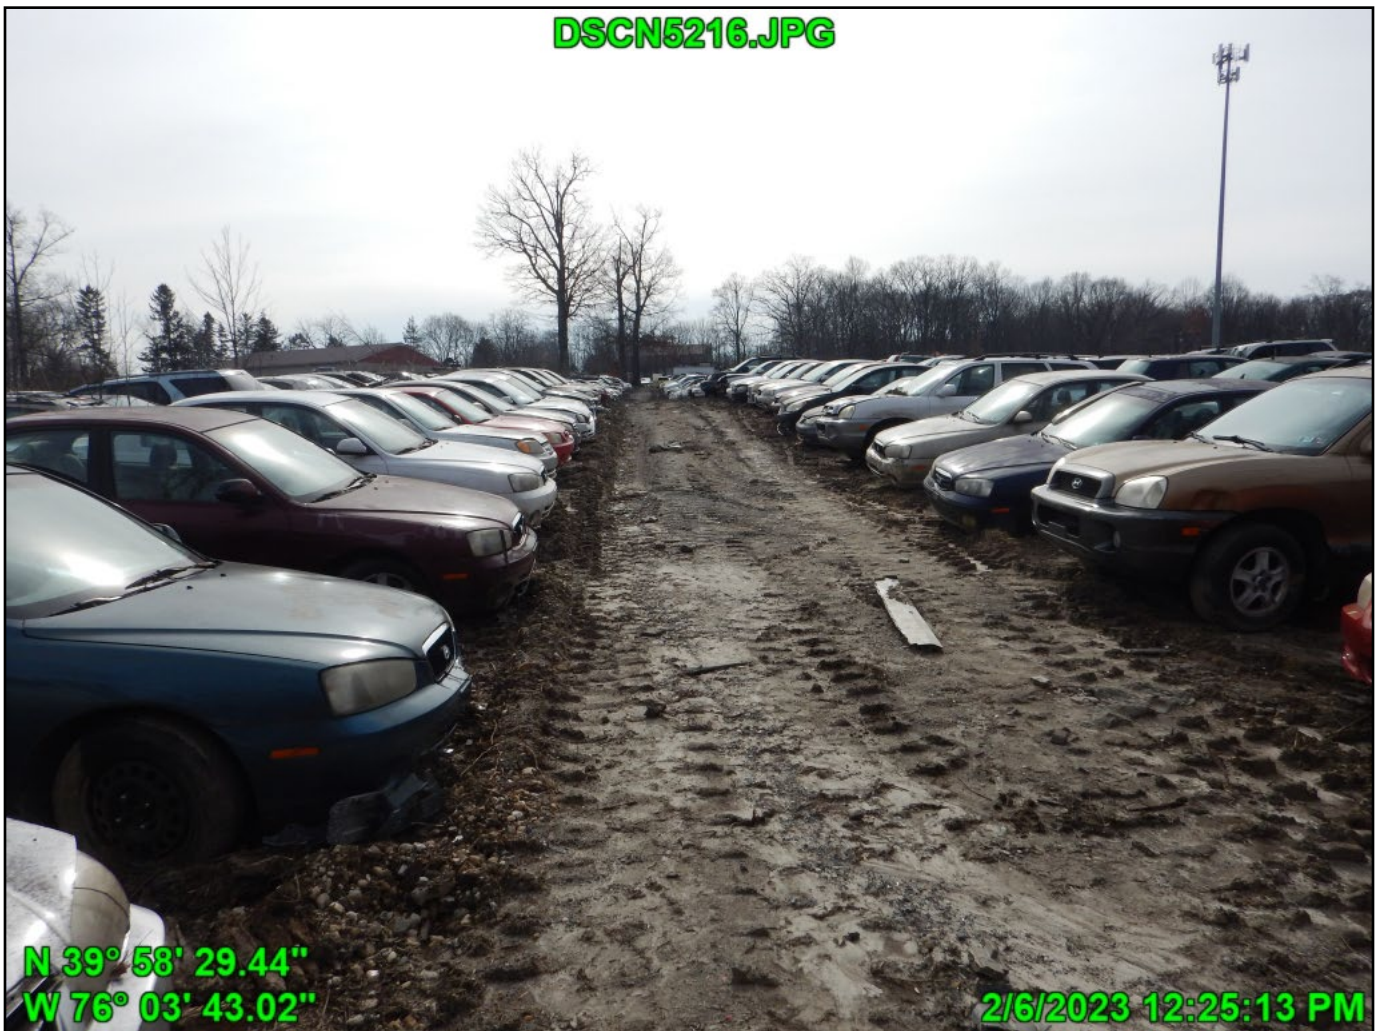
DSCN5216.JPG

Used vehicle storage in the middle of the Facility.

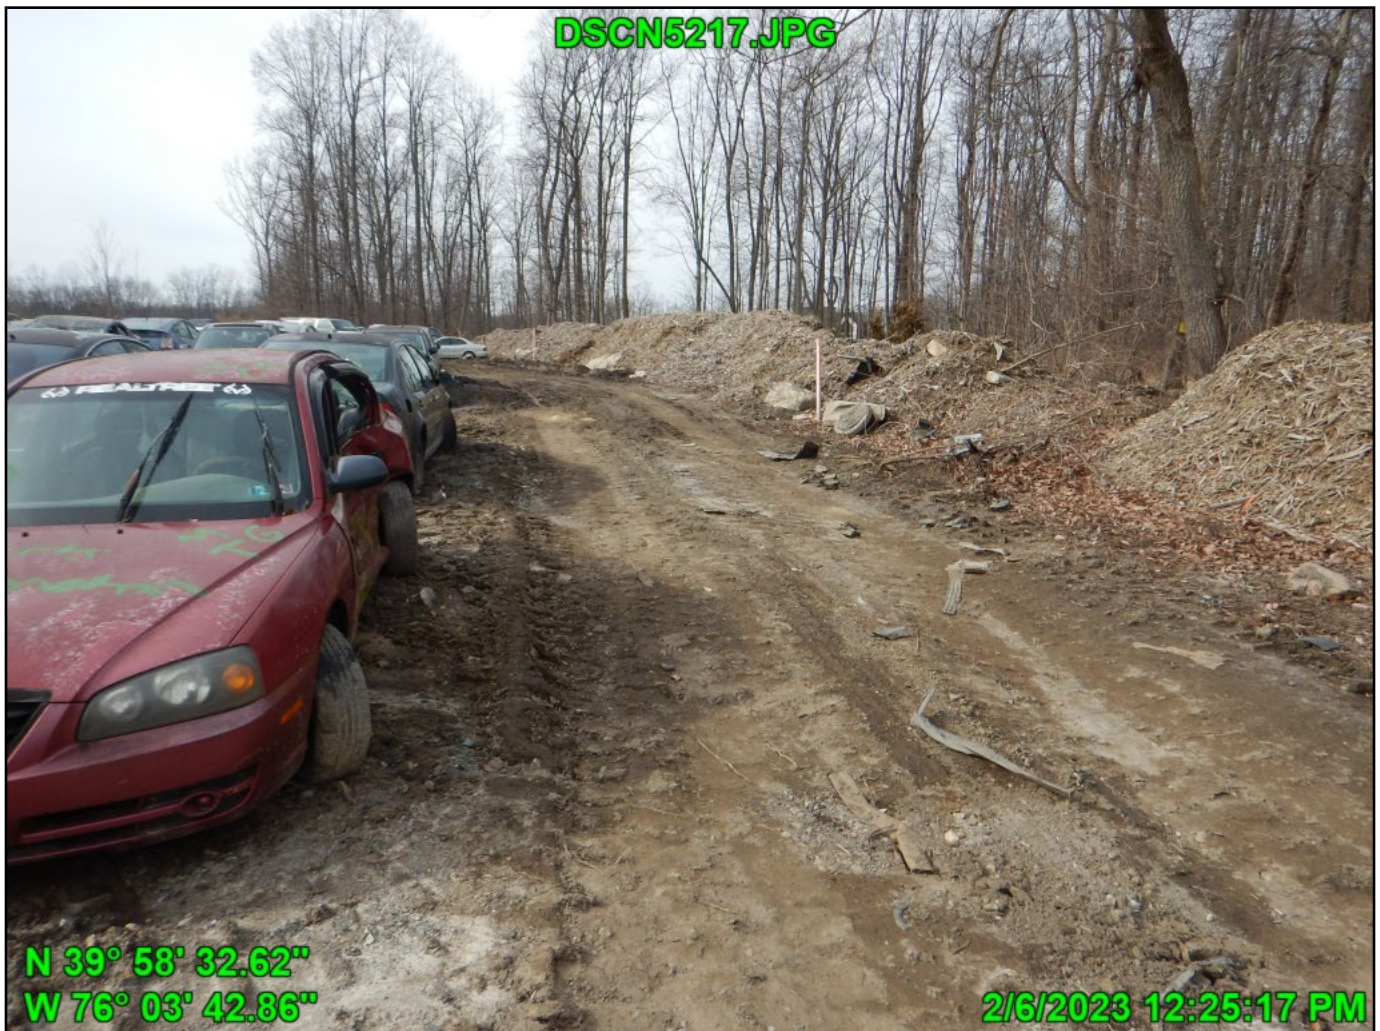
| Description | Northern boundary for the Facility. According to the Facility representative, an adjacent property owner installed the berm. |

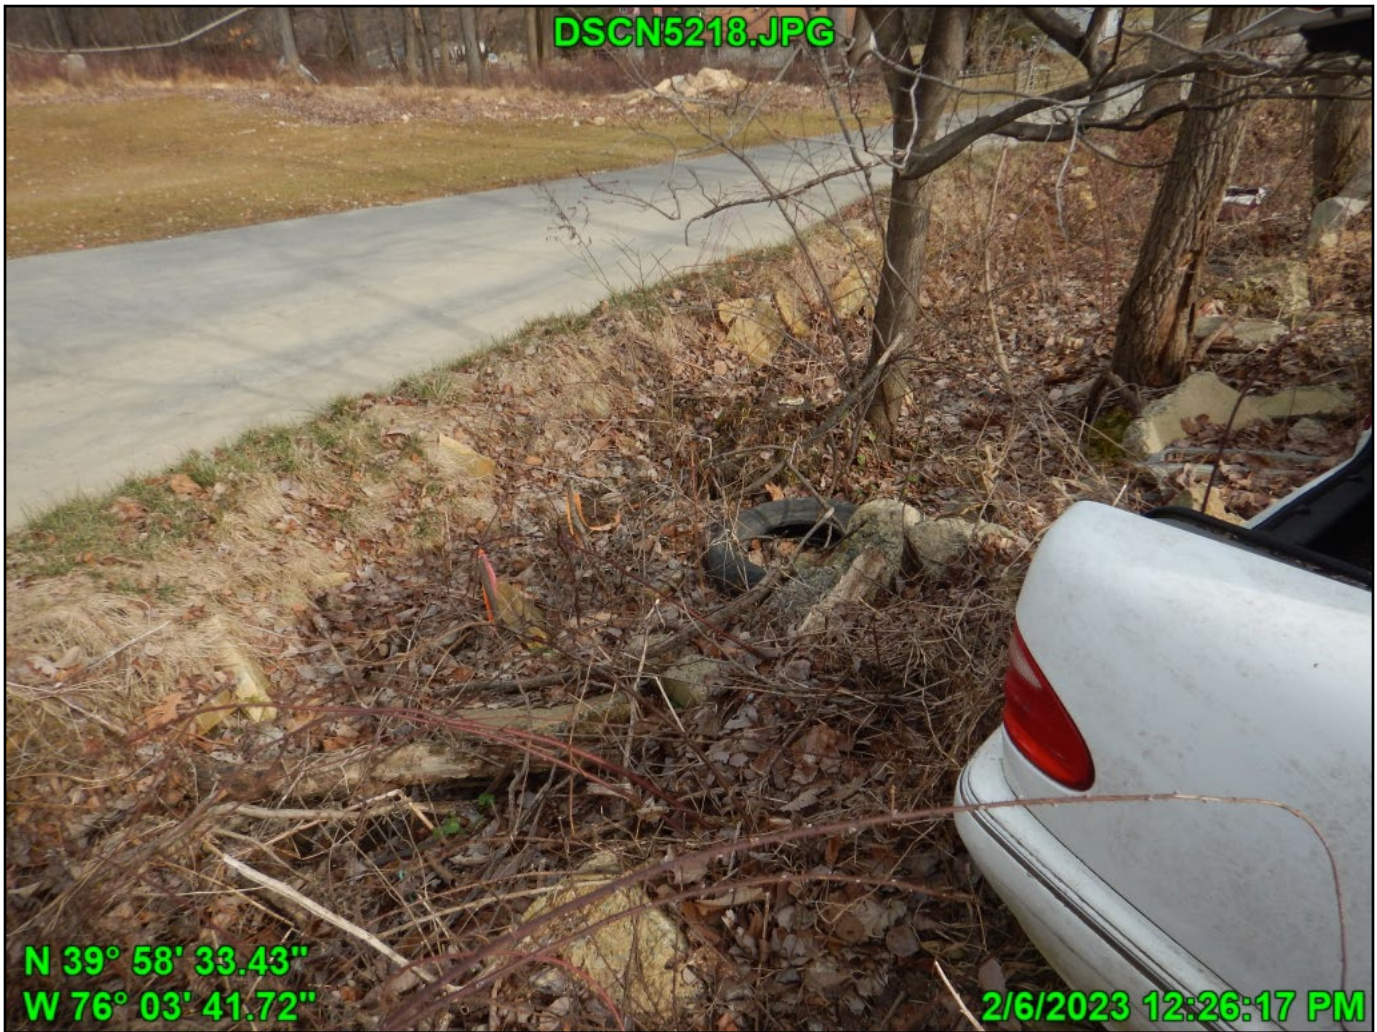
| Description | Northern boundary for the Facility. The road services several adjacent properties and the sediment tracking appeared to be from construction on one of the adjacent properties. |

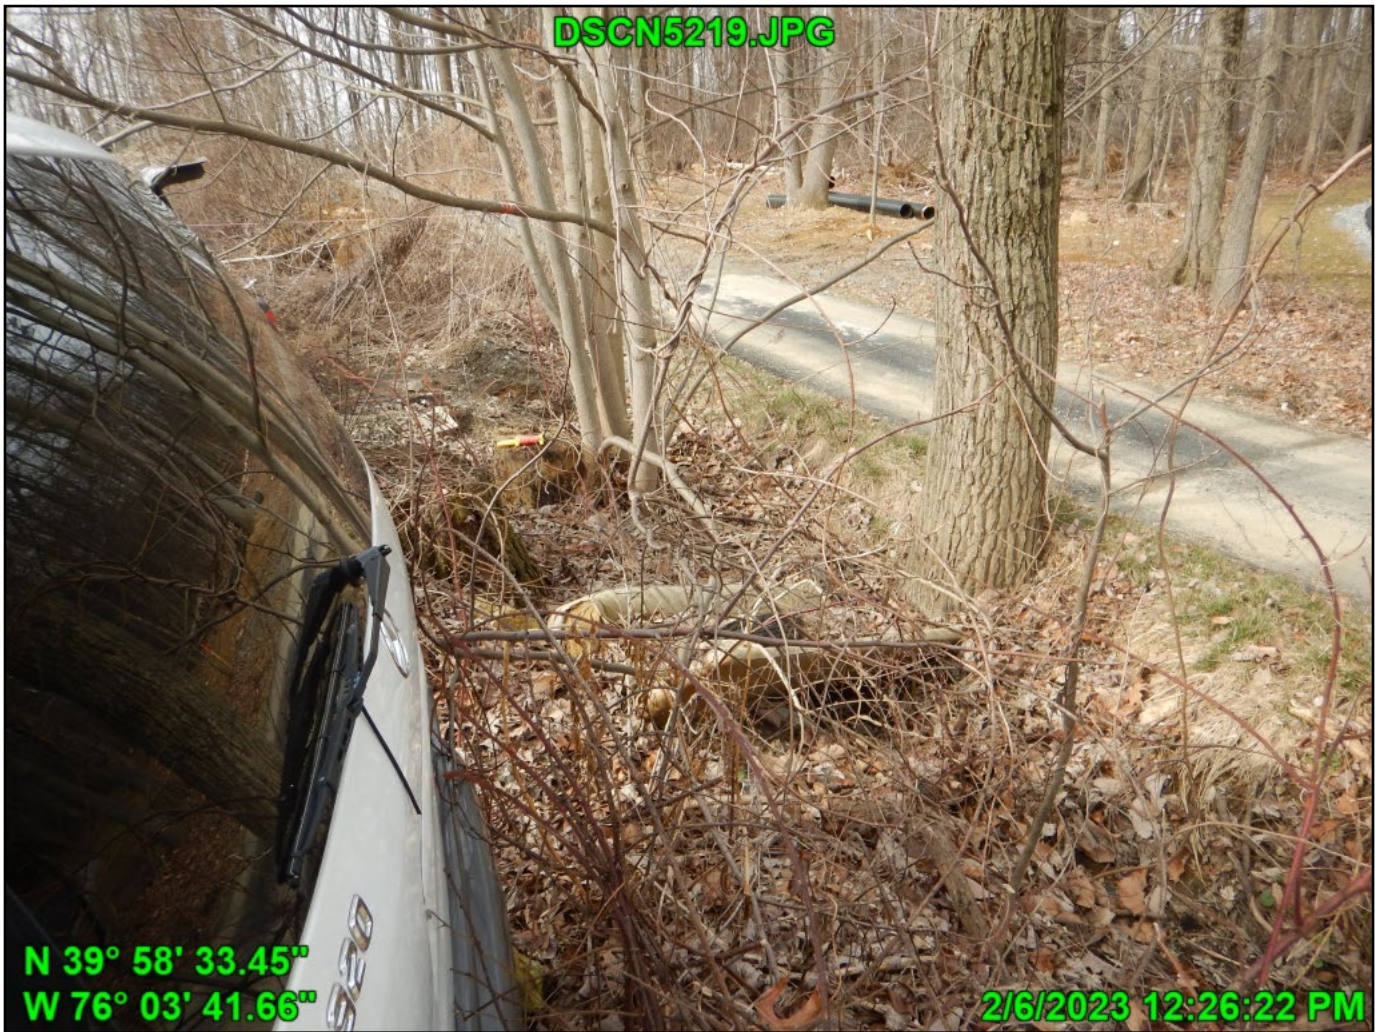
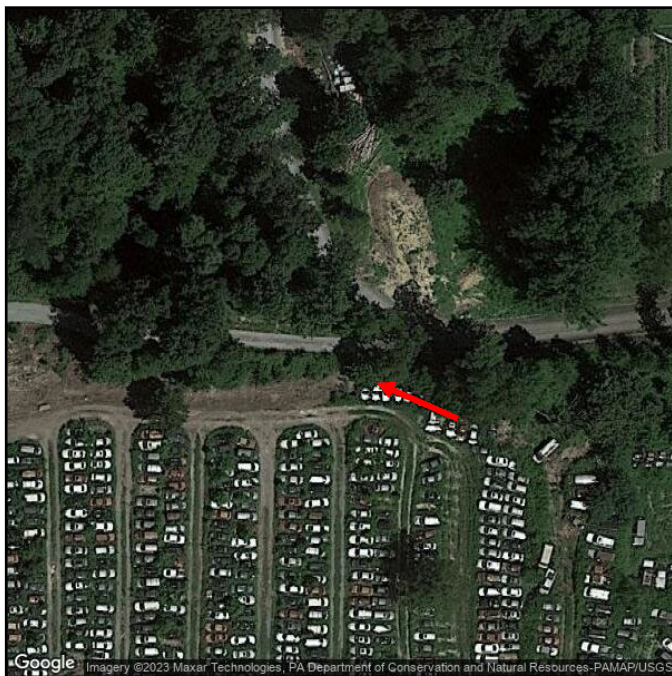
| Description | Additional view of the northern boundary for the Facility shown in Photograph DSCN5128. The road services several adjacent properties. |

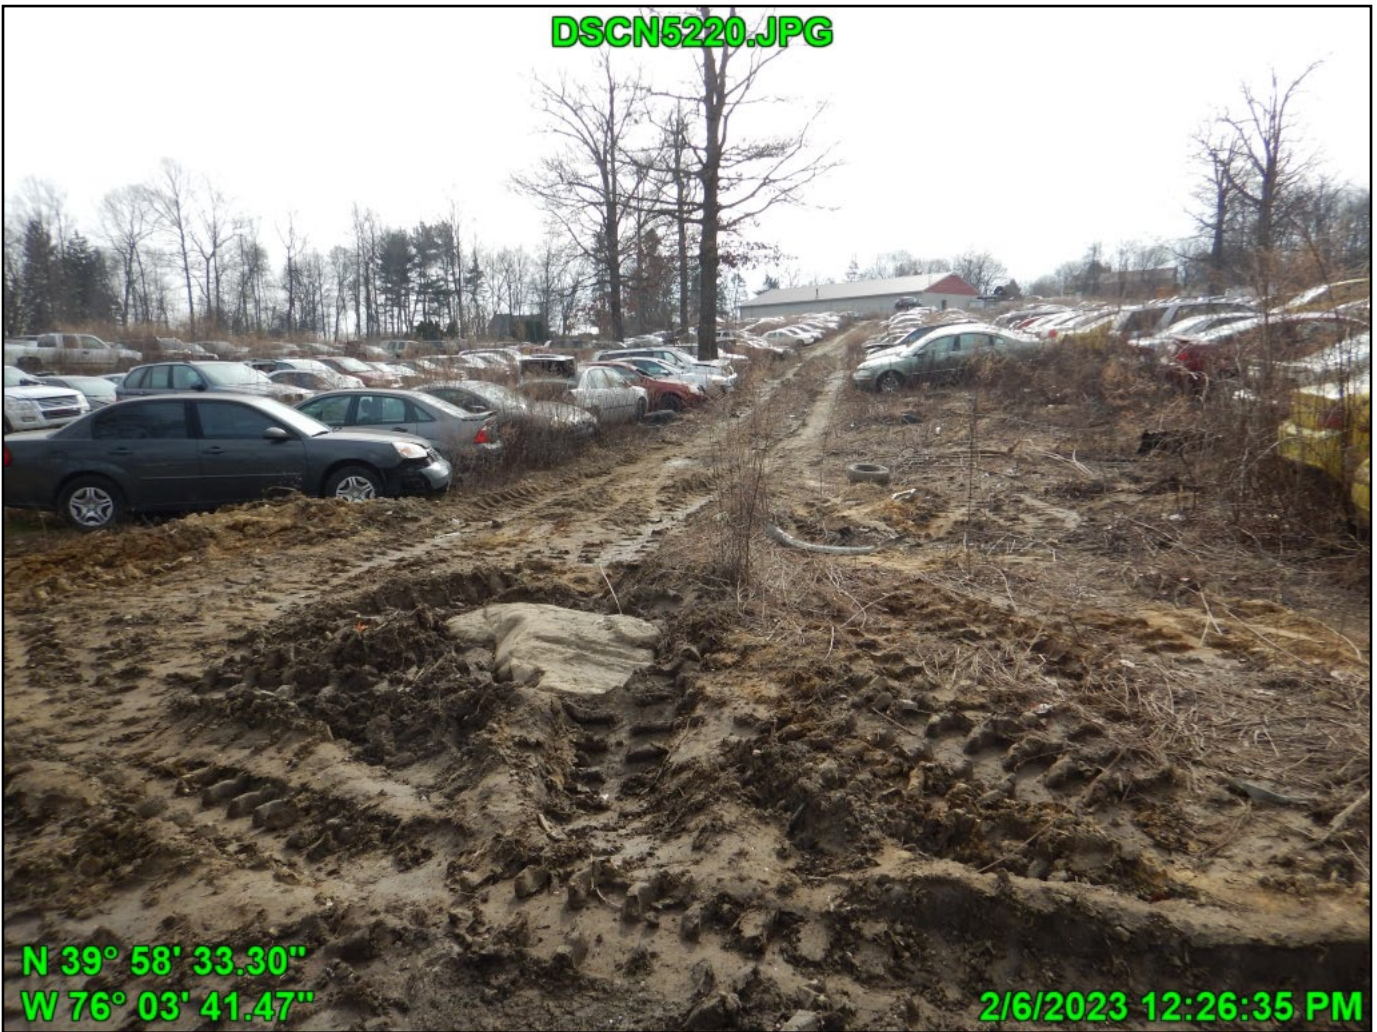
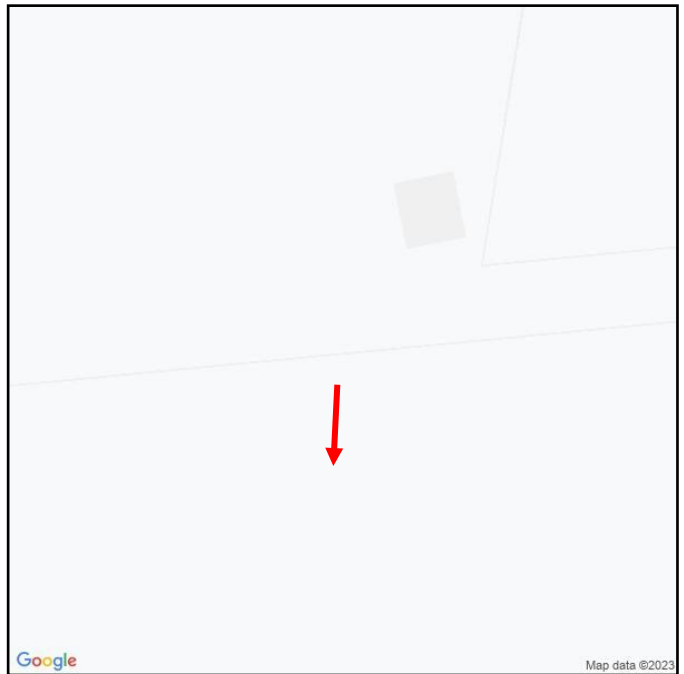
DSCN5220.JPG

| Description | Upgradient view of the used vehicle storage area in the north portion of the Facility. |

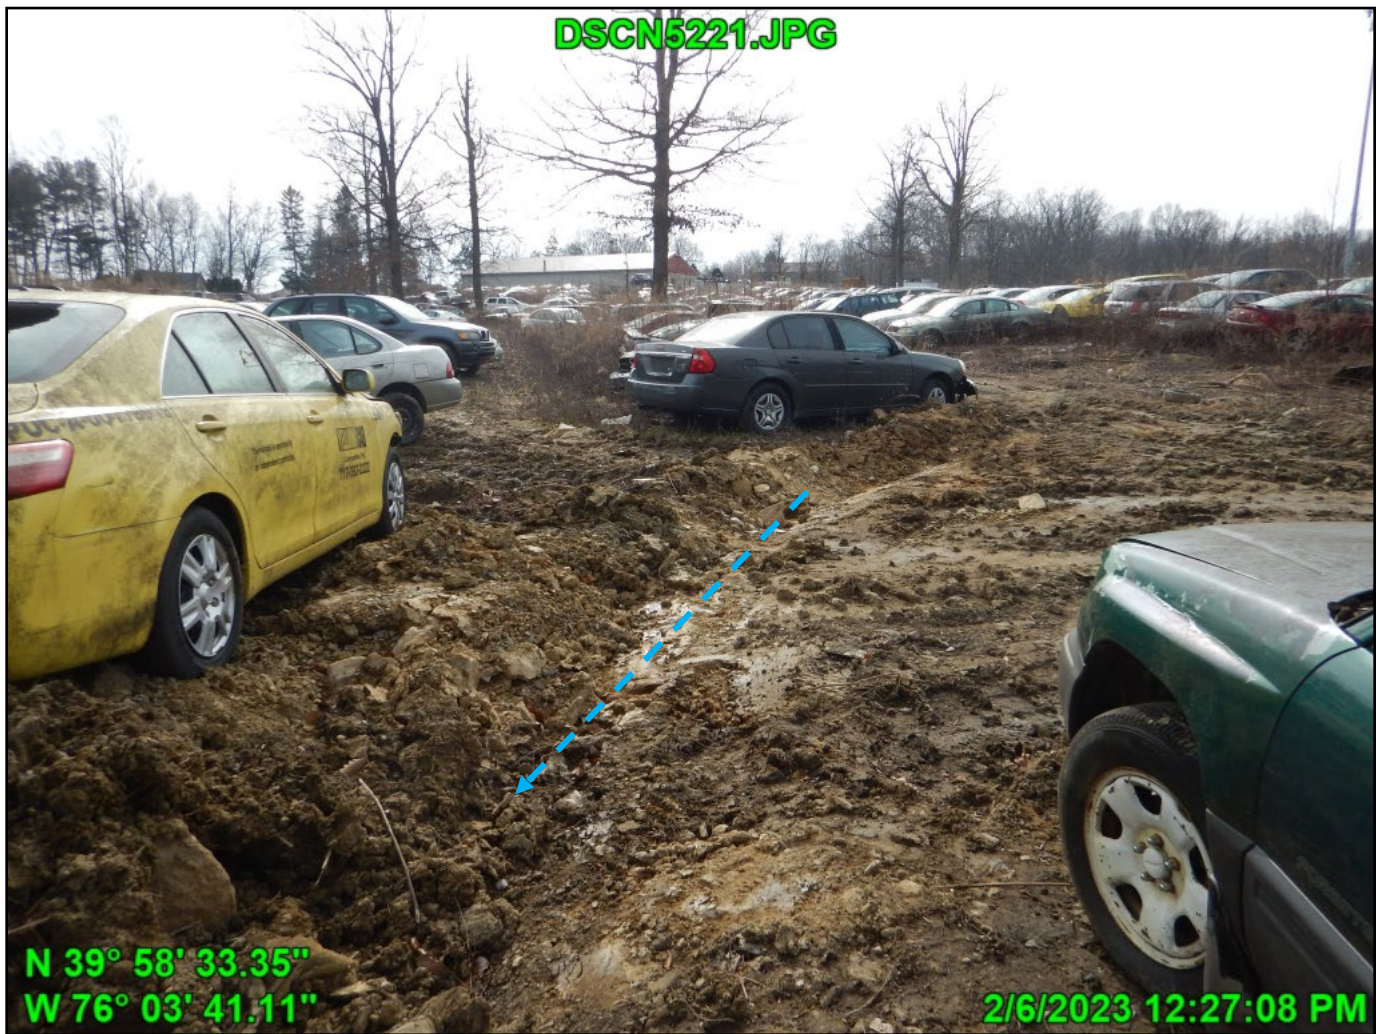
| Description | Estimated drainage path towards the ravine on the northern Facility boundary shown in Photographs DSCN5223 and DSCN5224. |

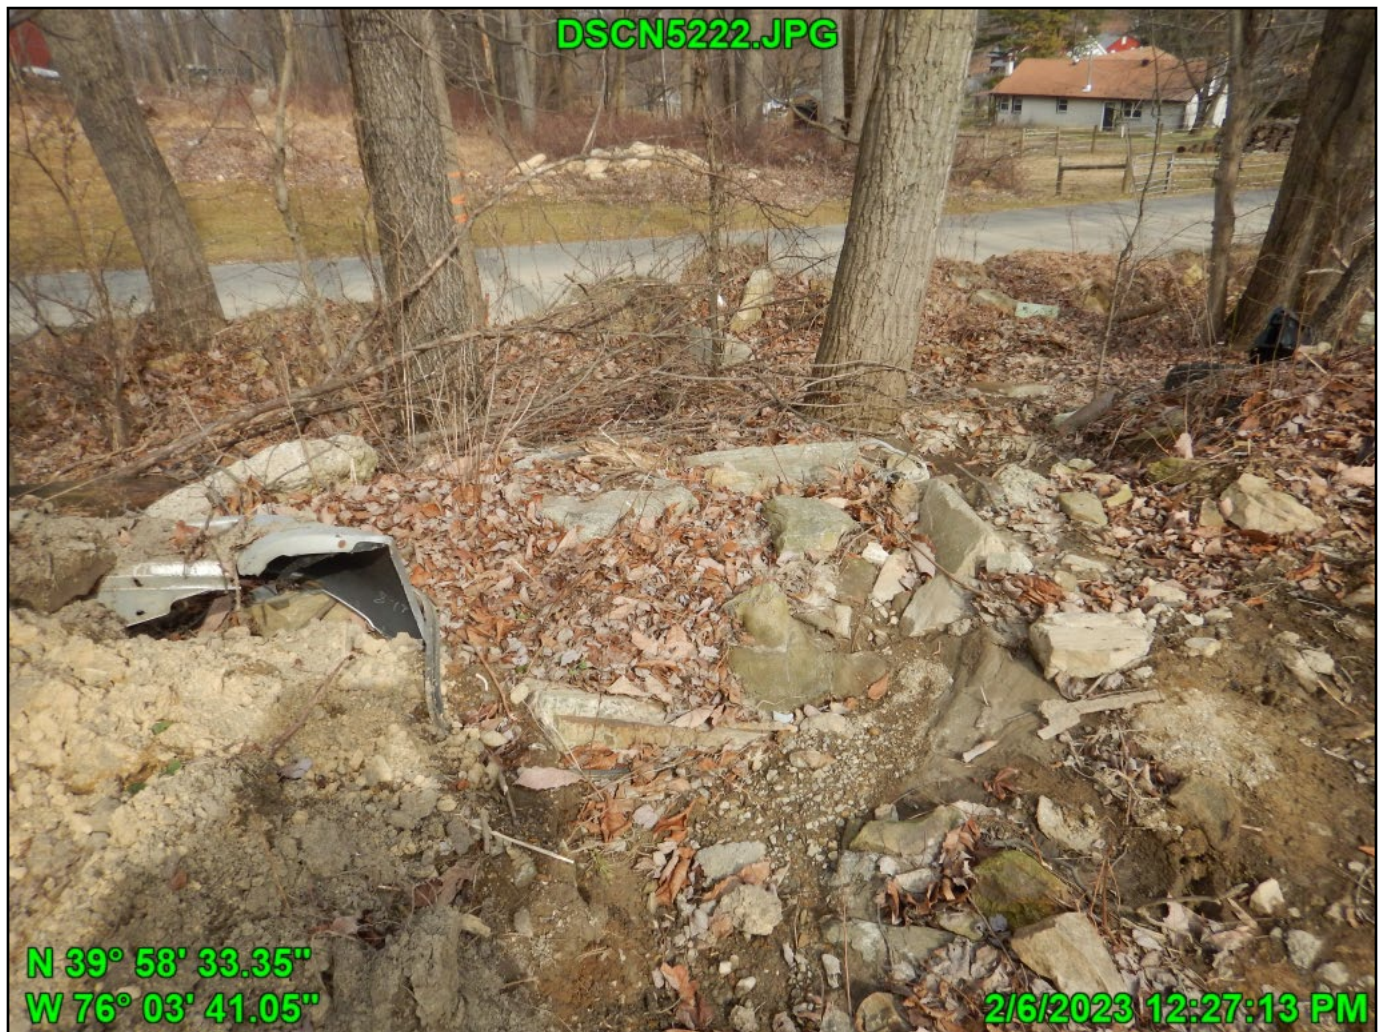
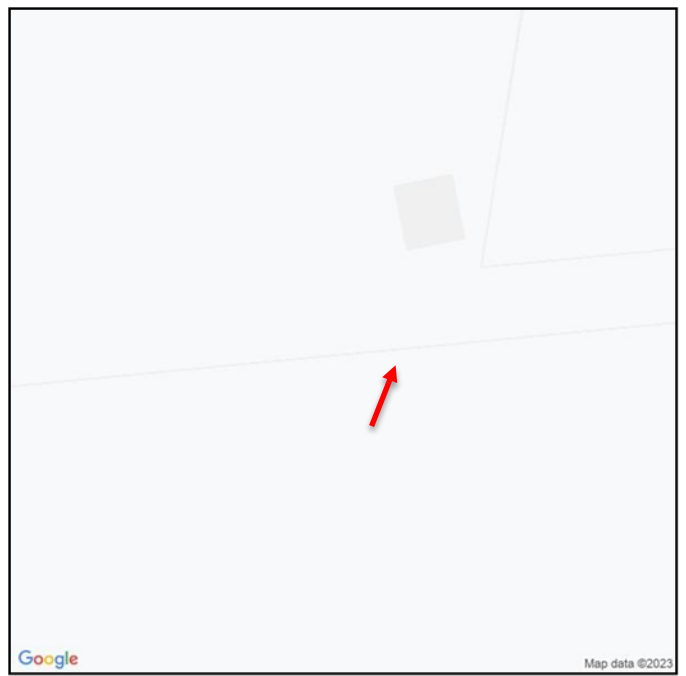
| Description | Additional view of the northern boundary for the Facility shown in Photograph DSCN5219. The private road services several adjacent properties. |
