## MULTI-SECTOR GENERAL PERMIT NON-FILER INSPECTION CHECKLIST

| <b>Inspection Date(s):</b> | 2/7/2023 | |
| <b>Operator Name:</b> | Price's Auto Salvage (formerly B F Leidy & Sons Inc.) | |

**Appendix A. Aerial Map**  
**Clean Water Act Inspection**  
**Price's Auto Salvage**

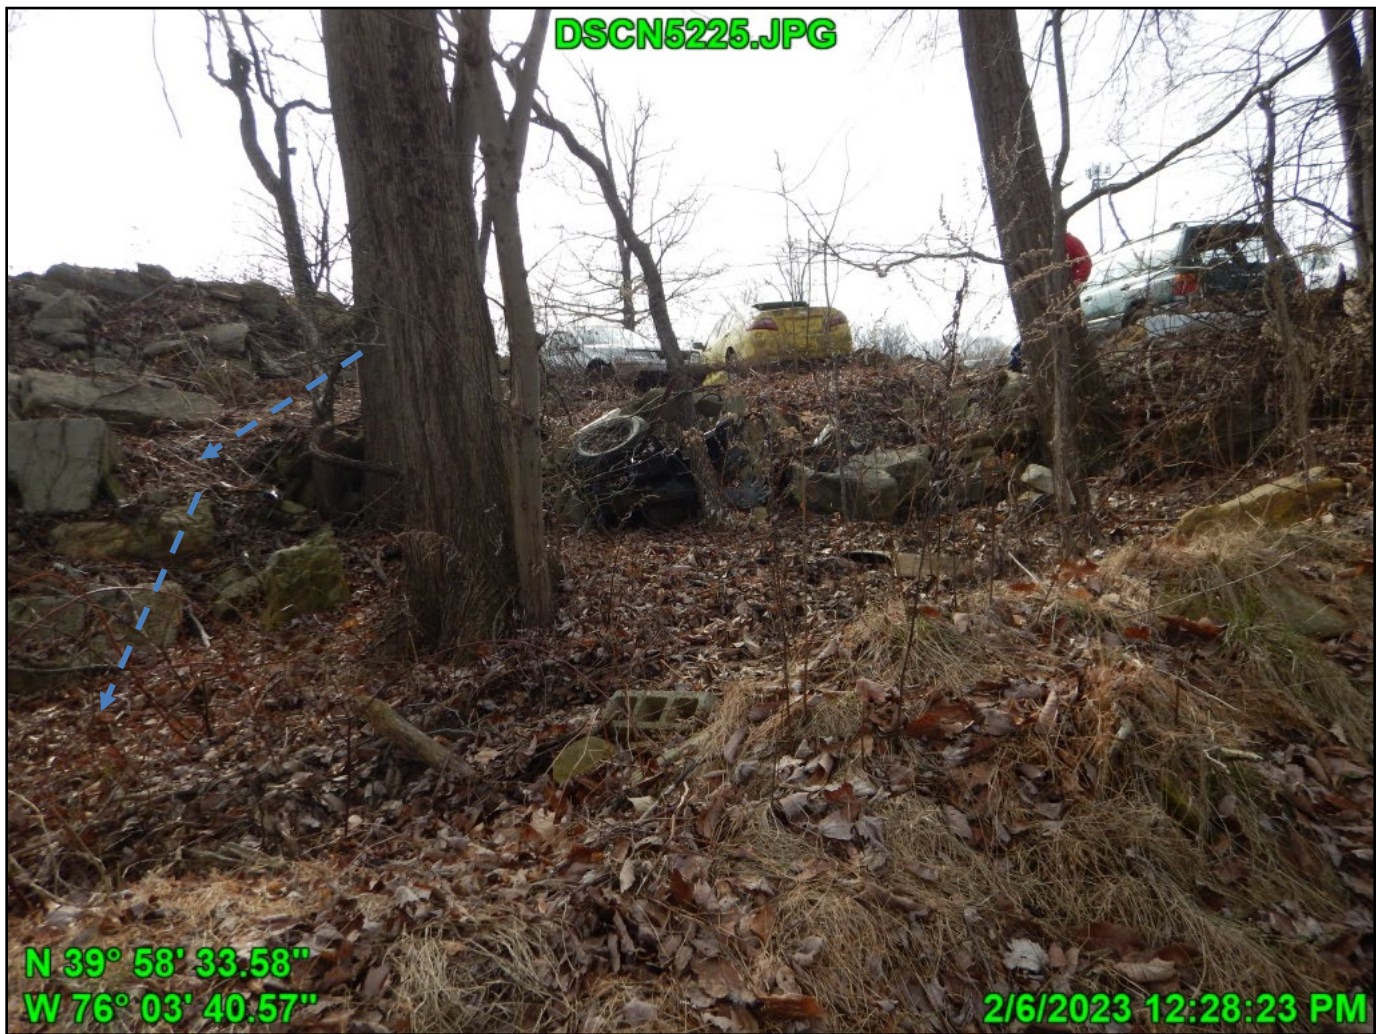
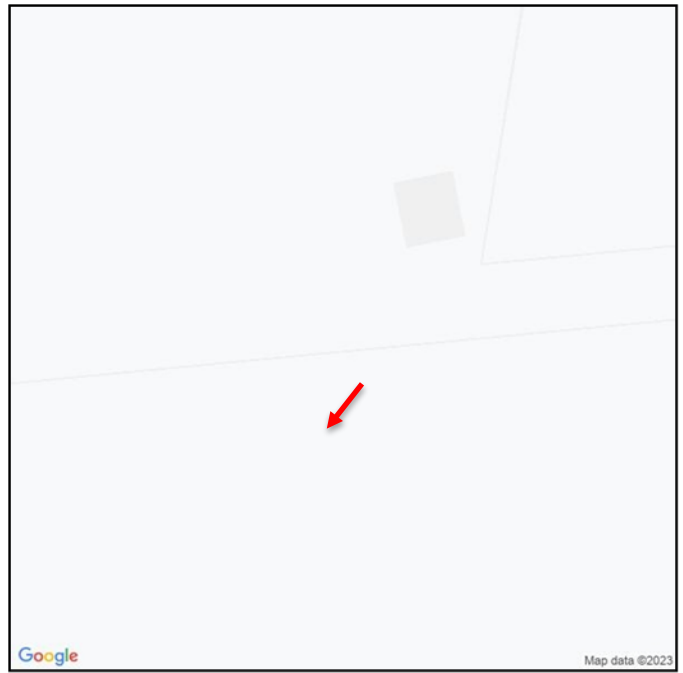
| Description | Upgradient view of the slope above the ravine located on the Facility's northern boundary, also shown in Photograph DSCN5222. Note the estimated direction of stormwater flow. |

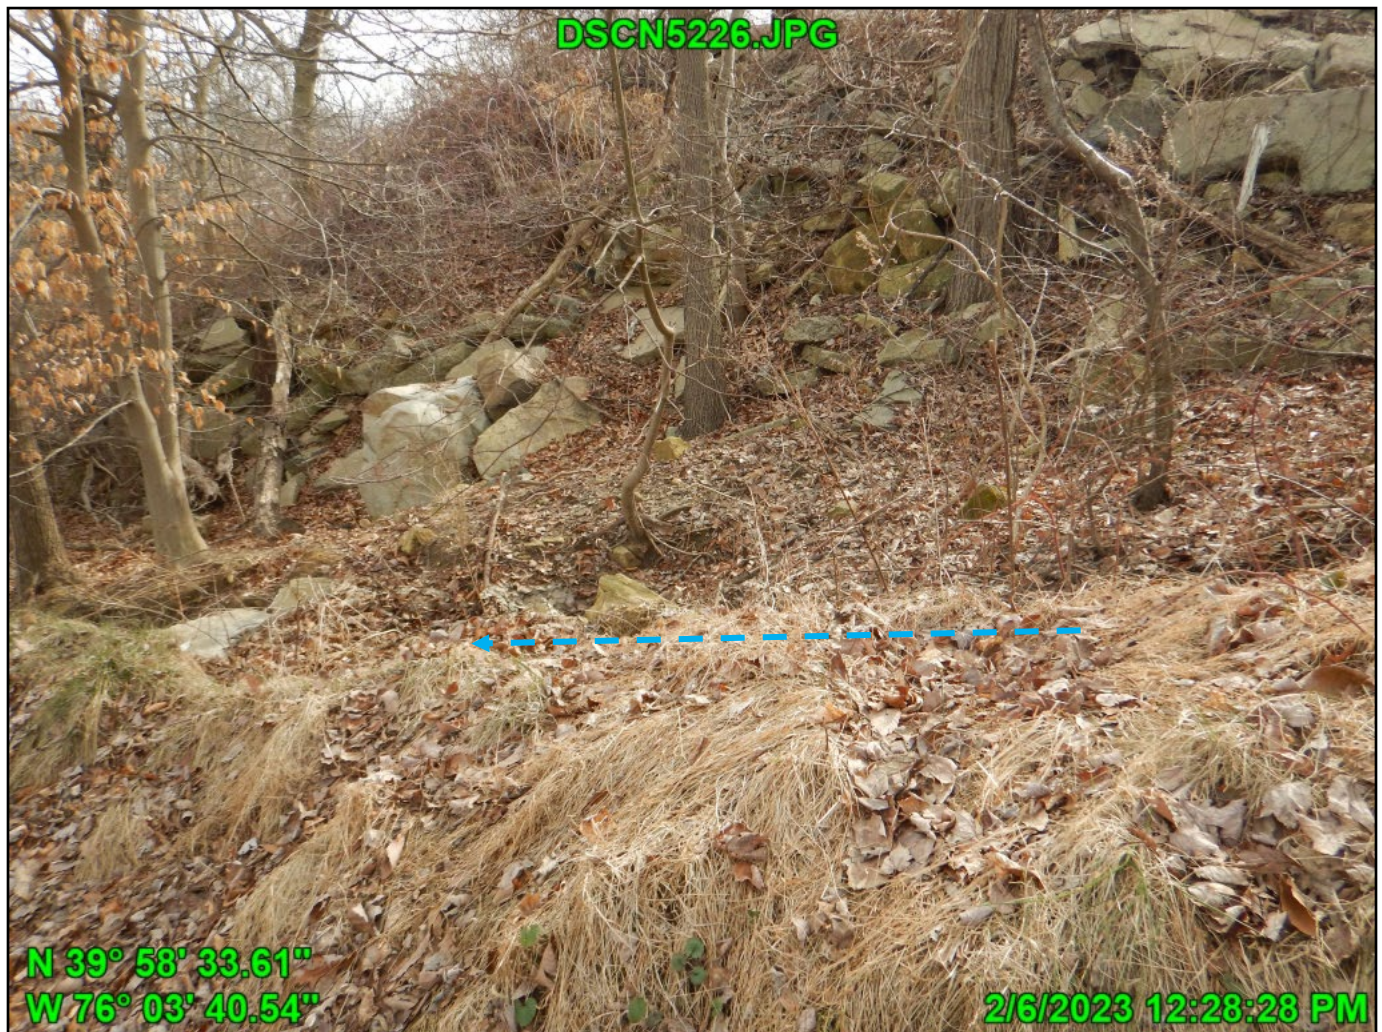
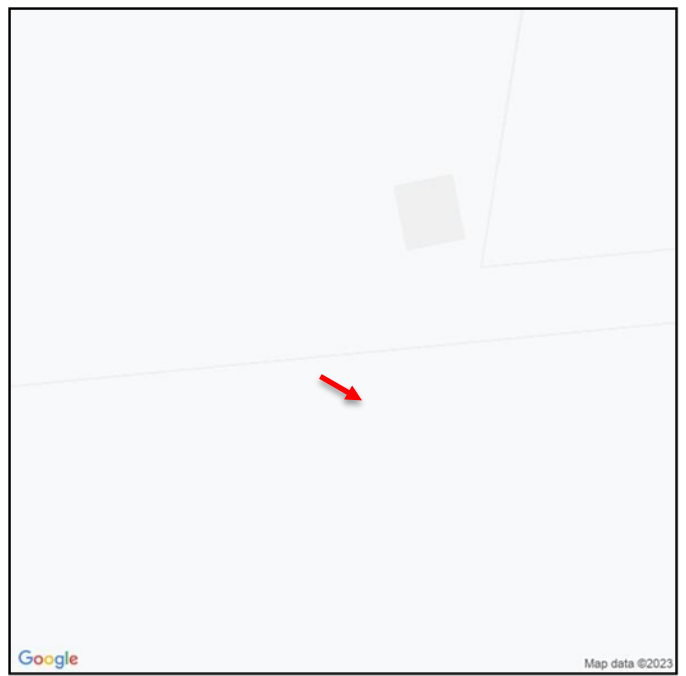
| Description | Ravine slope located on the Facility's northern boundary as shown in Photograph DSCN5224. Note the estimated direction of stormwater flow. |

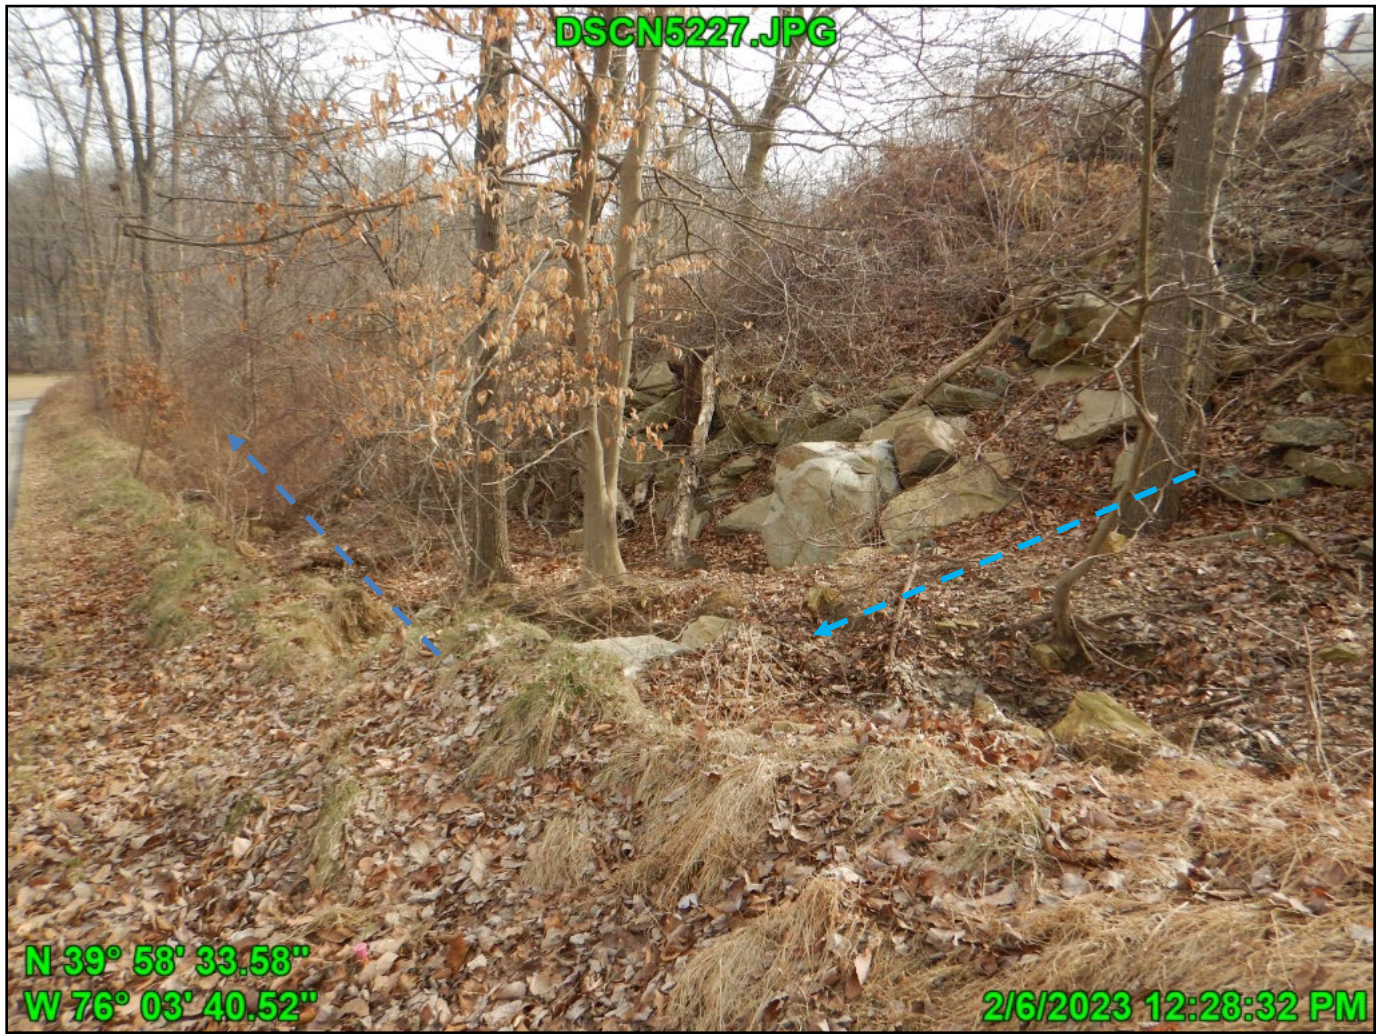
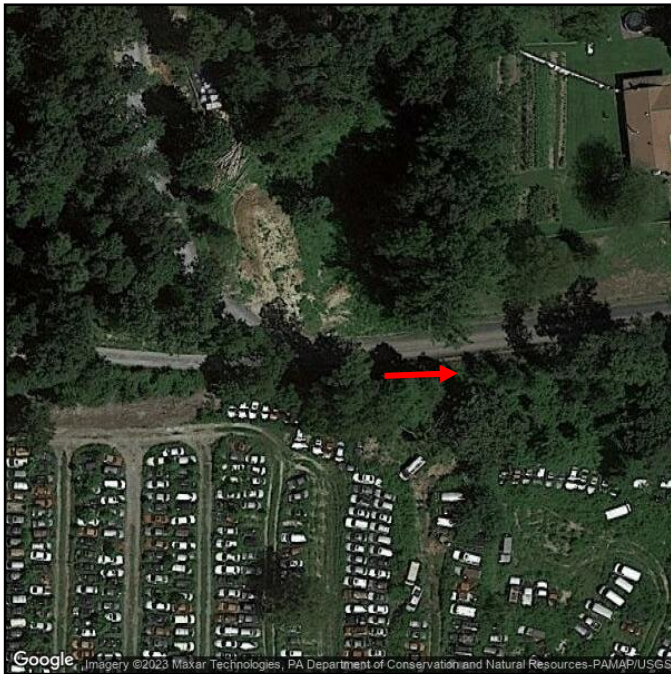
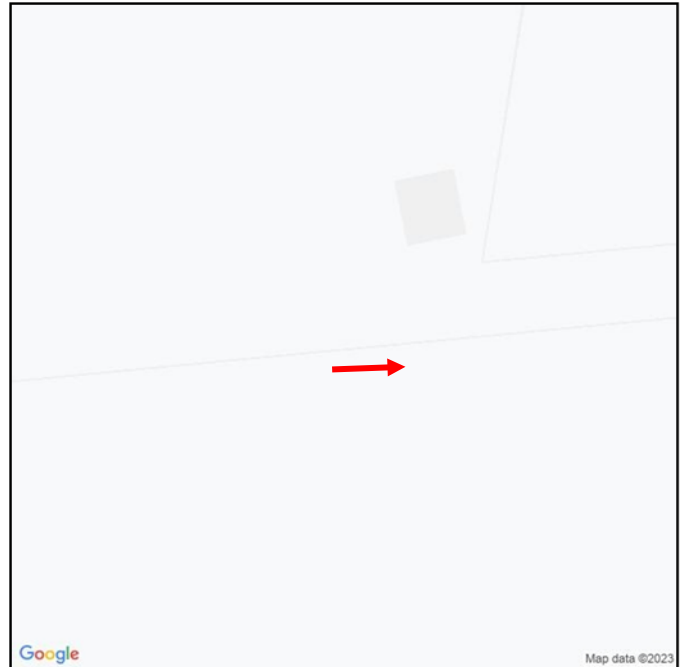
| Description | Ravine on the northern Facility boundary. Note the estimated direction of stormwater flow. |

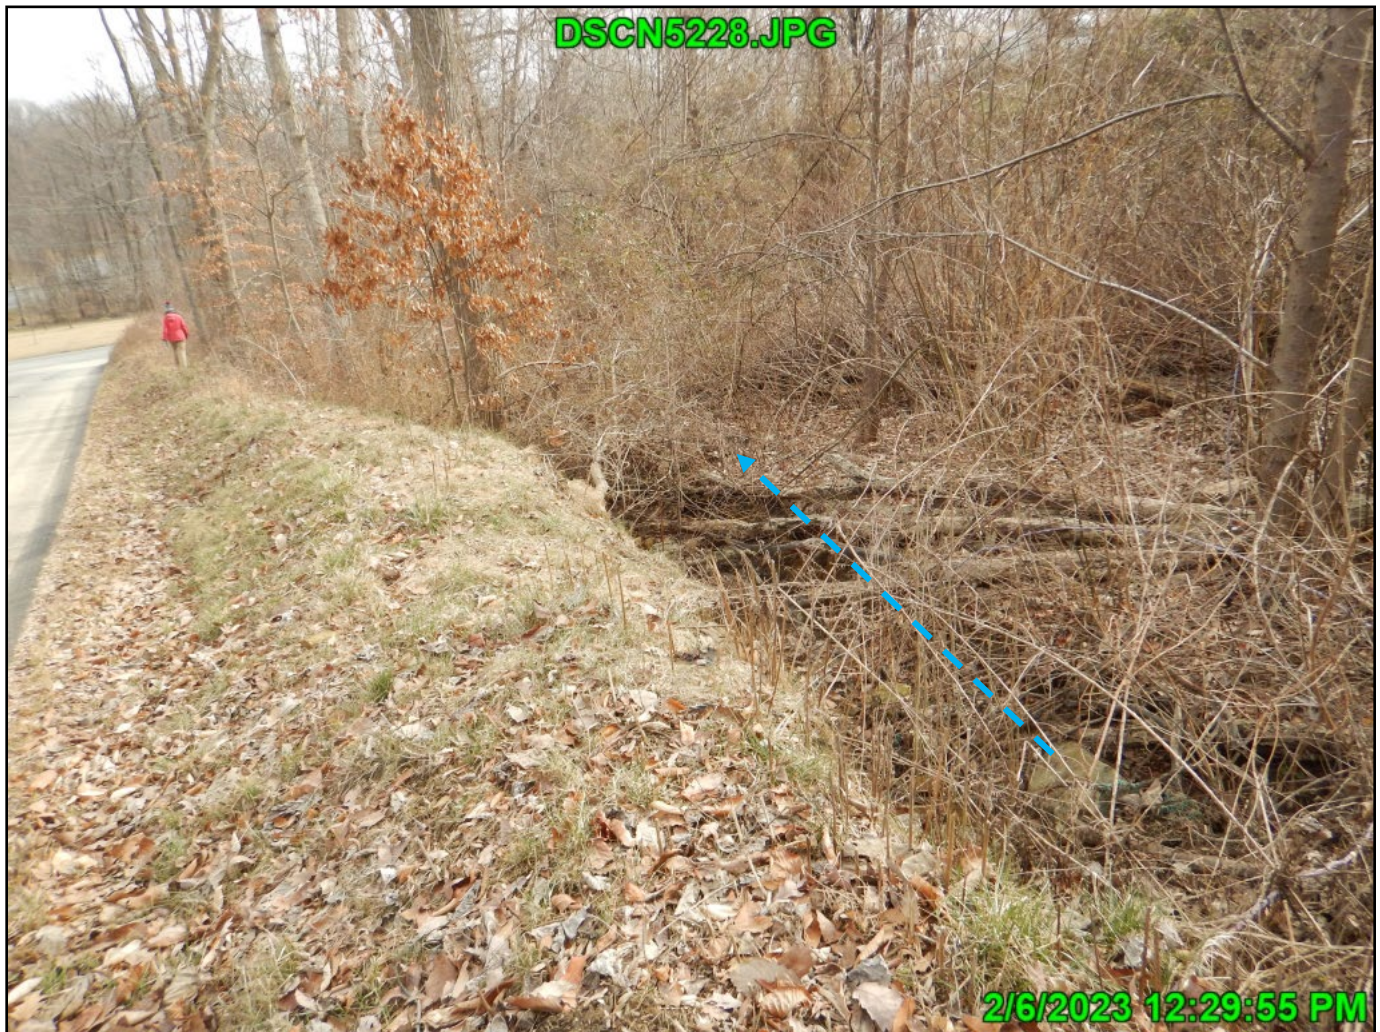
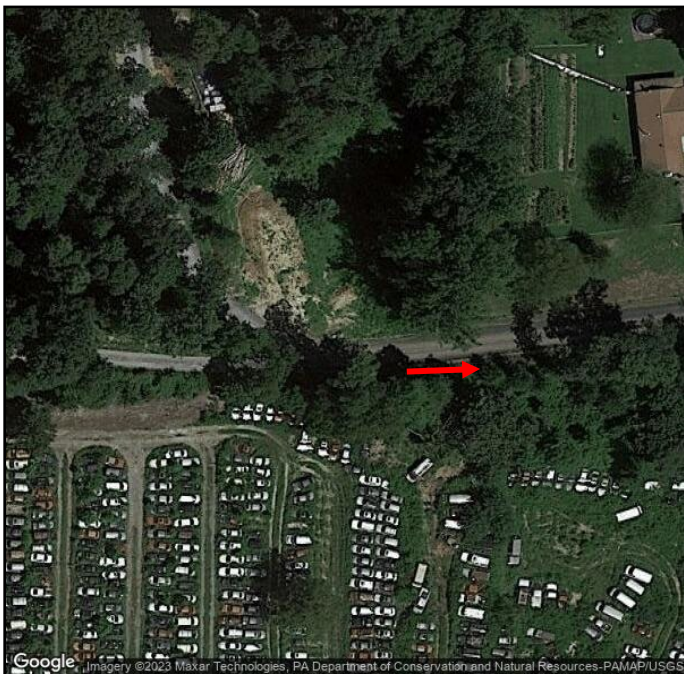
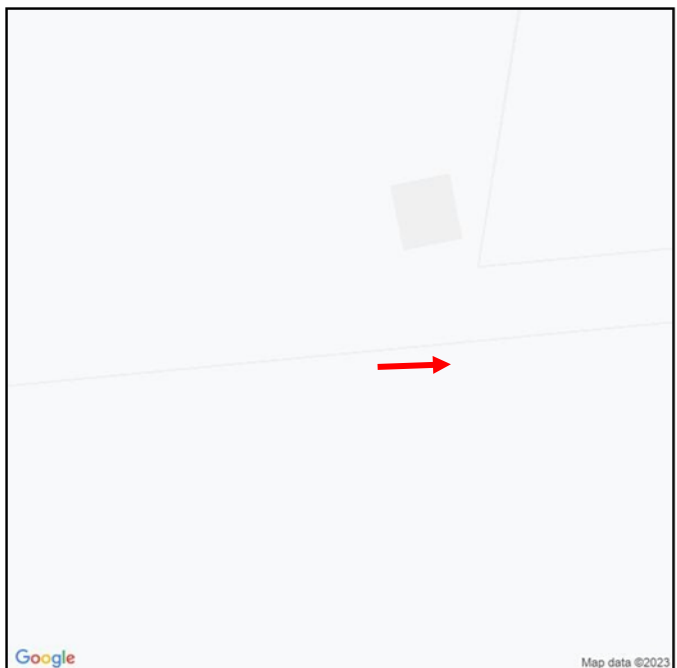
| Description | Ravine on the northern Facility boundary shown in Photograph DSCN5227. Note the estimated direction of stormwater flow. |

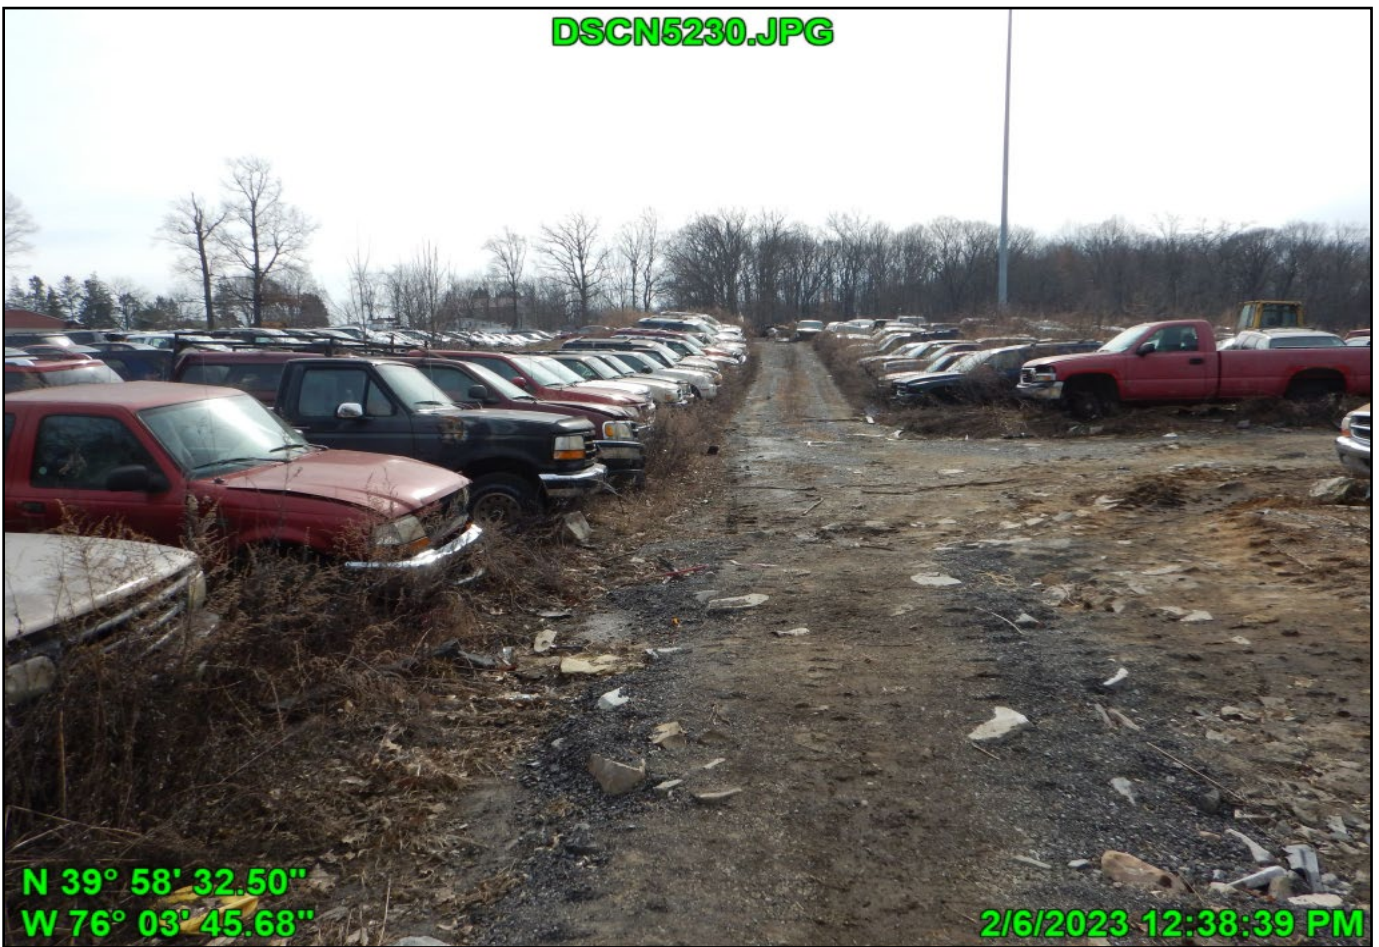
DSCN5230.JPG

| Description | Scrap vehicles stored in the north portion of the Facility. |

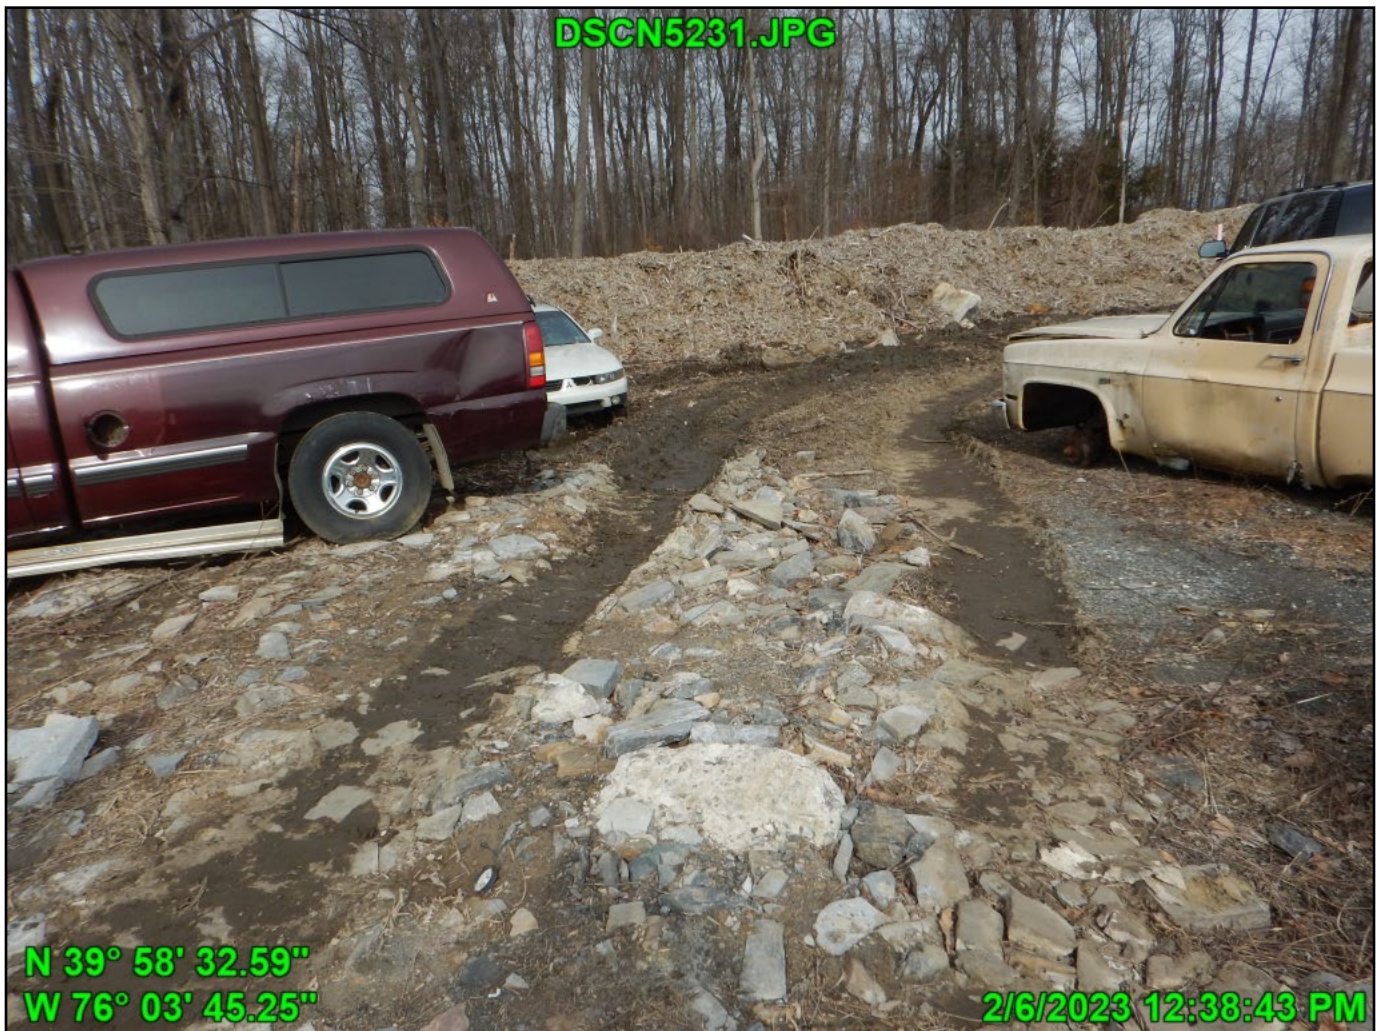
| Description | North boundary berm for the Facility shown in Photograph DSCN5217. |

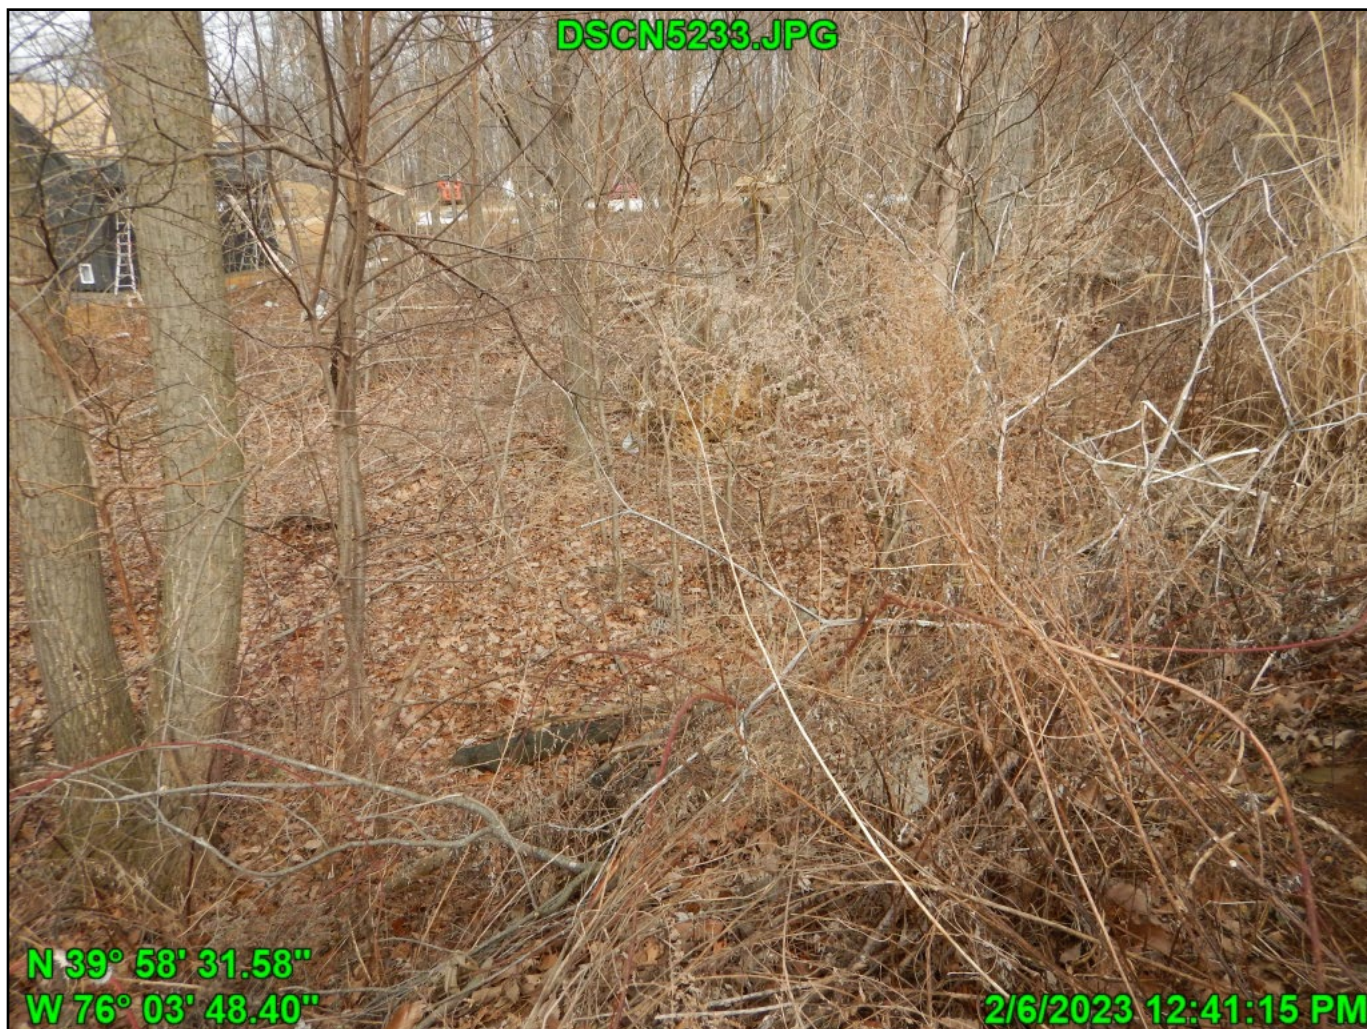
| Description | View looking north, off property to an adjacent wooded area north of the Facility. |

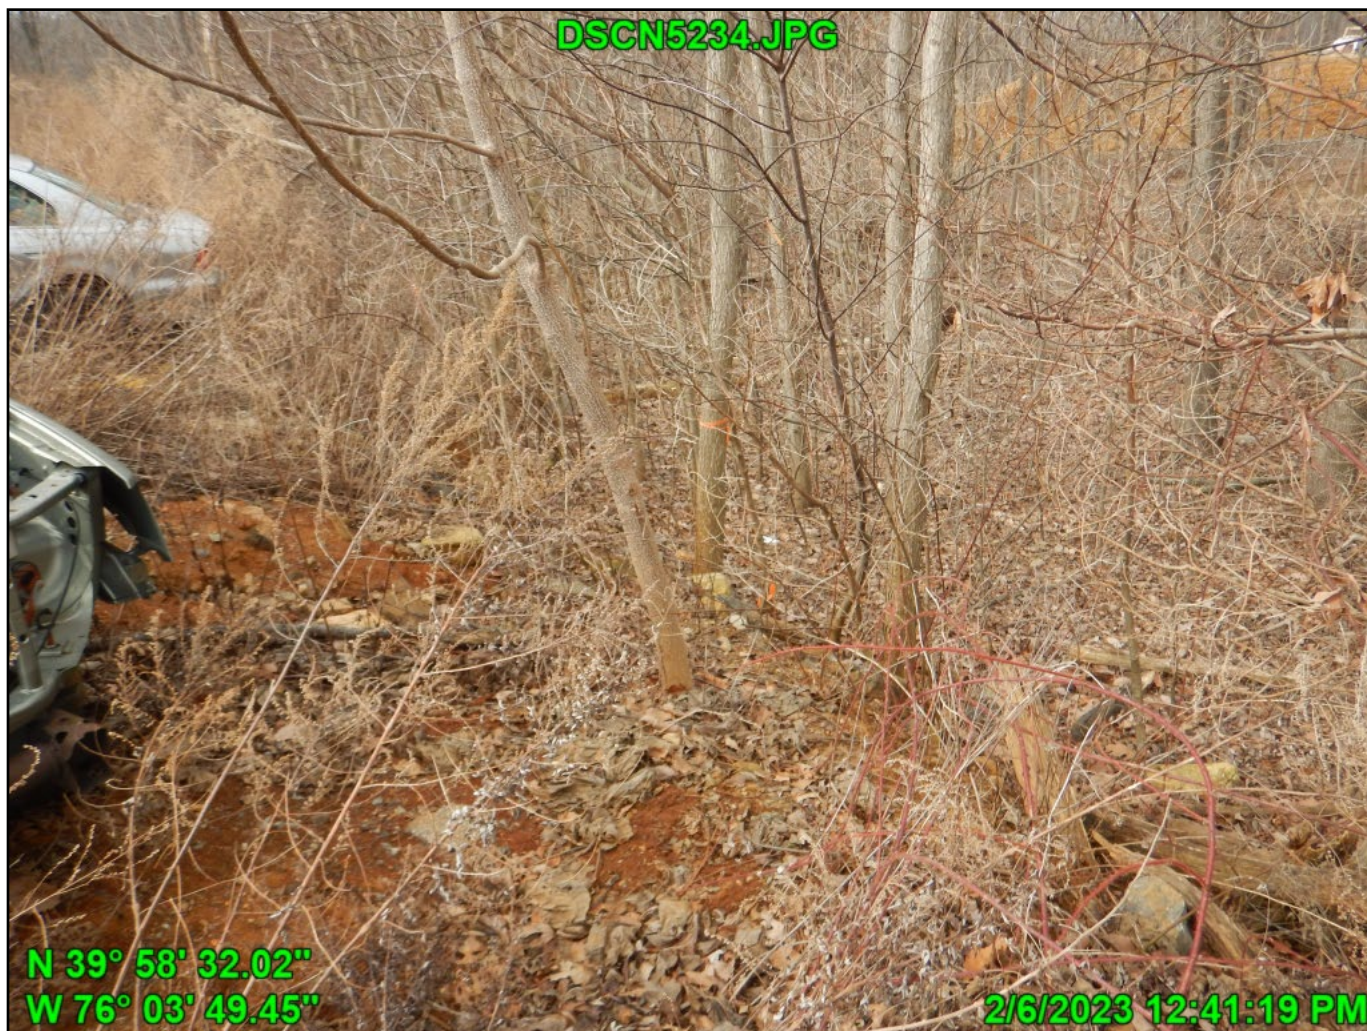
| Description | View off property to an adjacent wooded area north of the Facility shown in Photograph DSCN5233. |

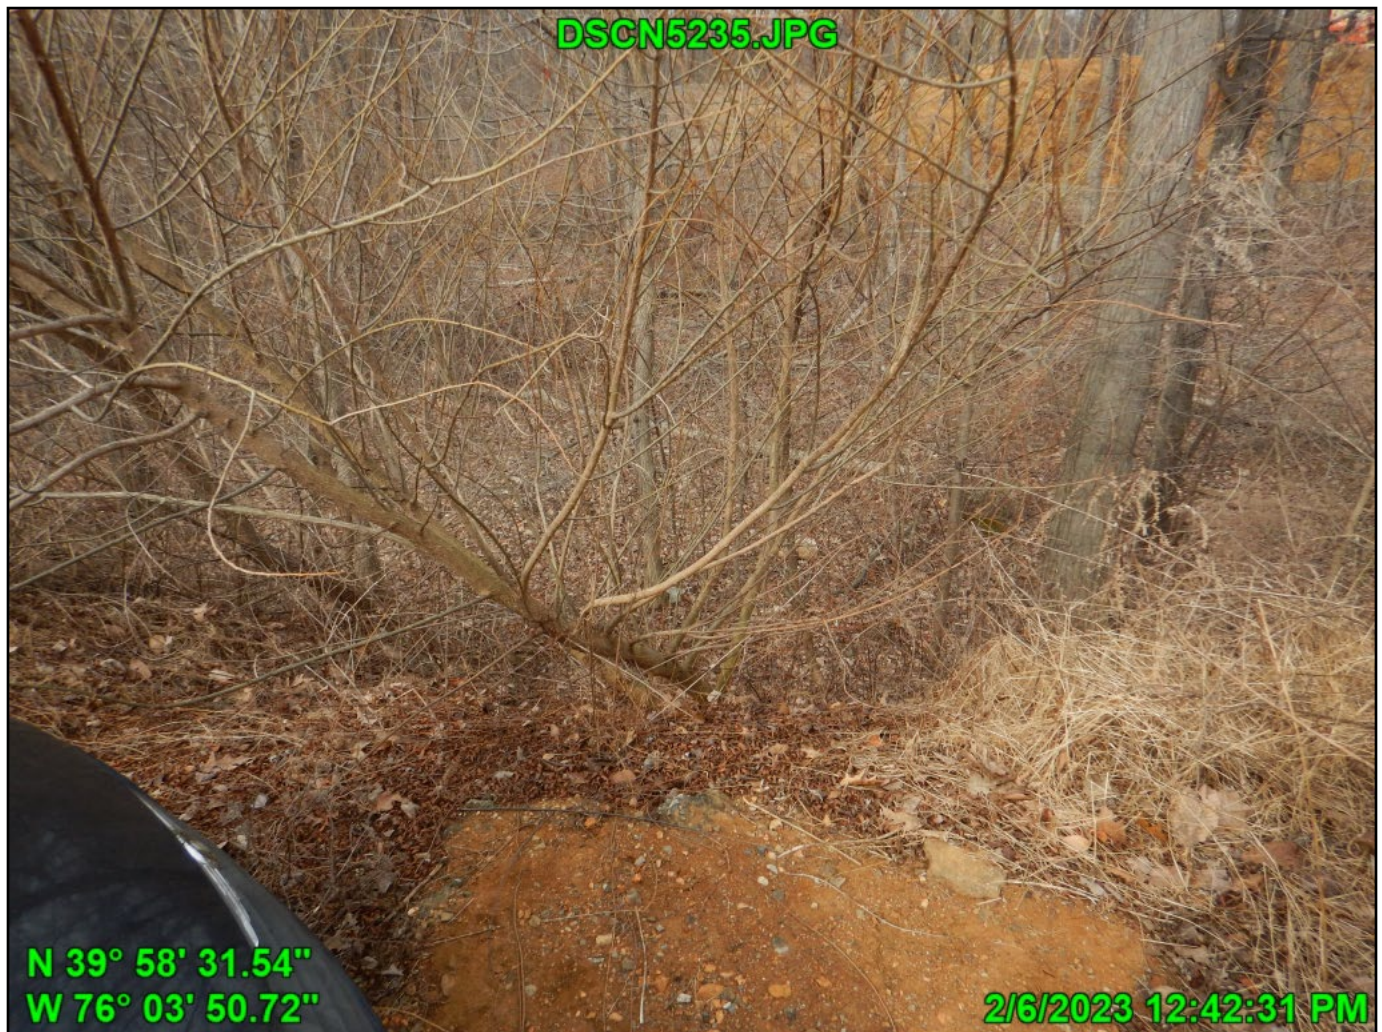
| Description | View off property to an adjacent wooded area northwest of the Facility. |

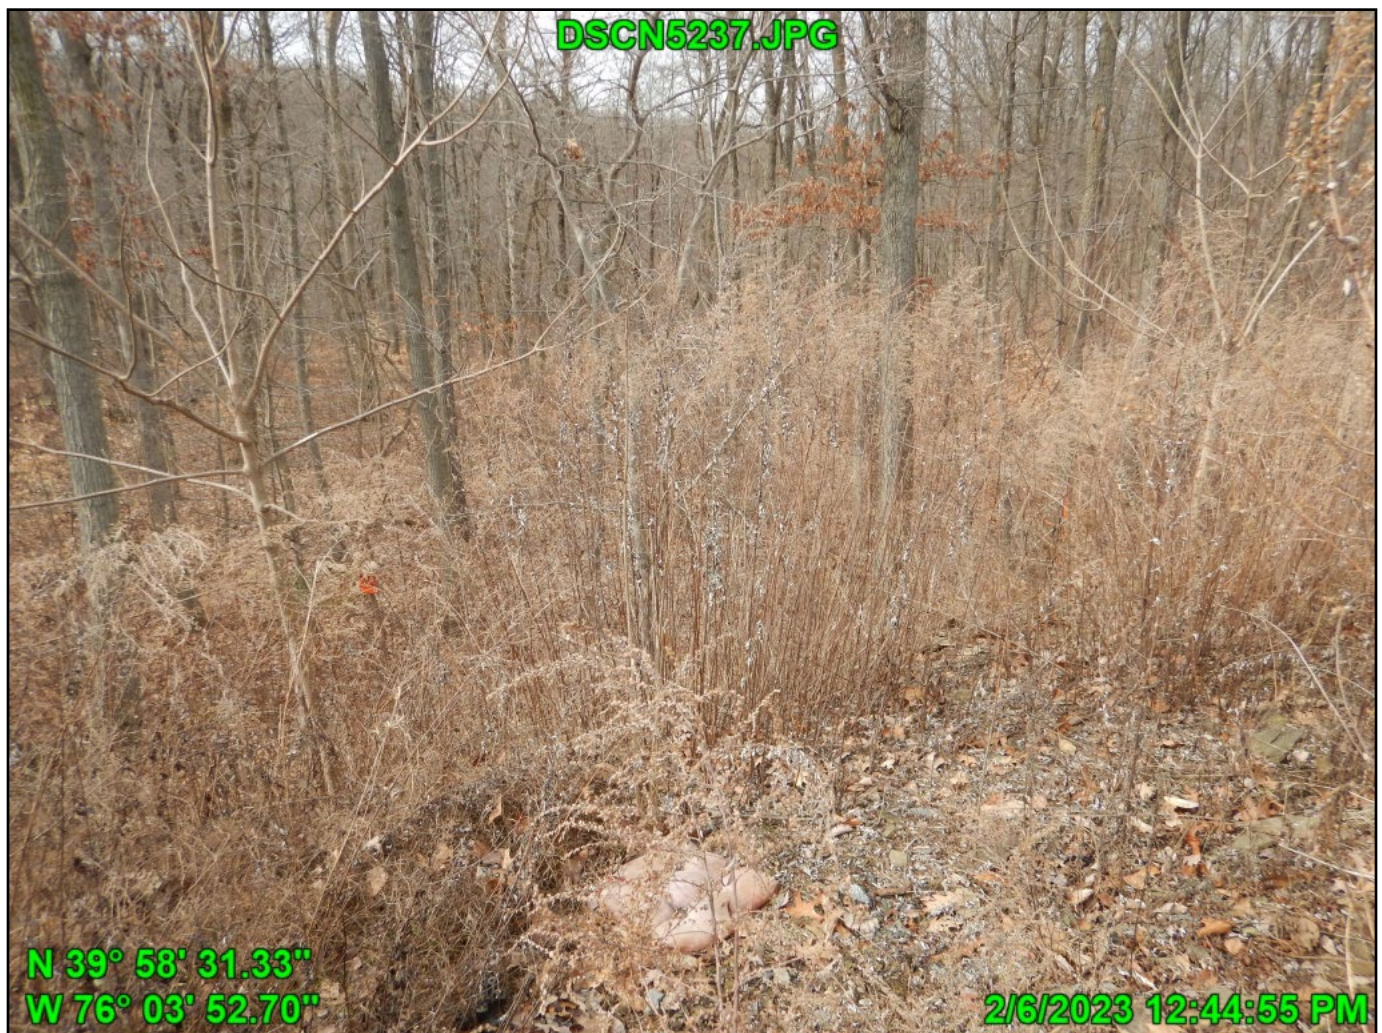
| Description | View off property to an adjacent wooded area shown in Photograph DSCN5235. |

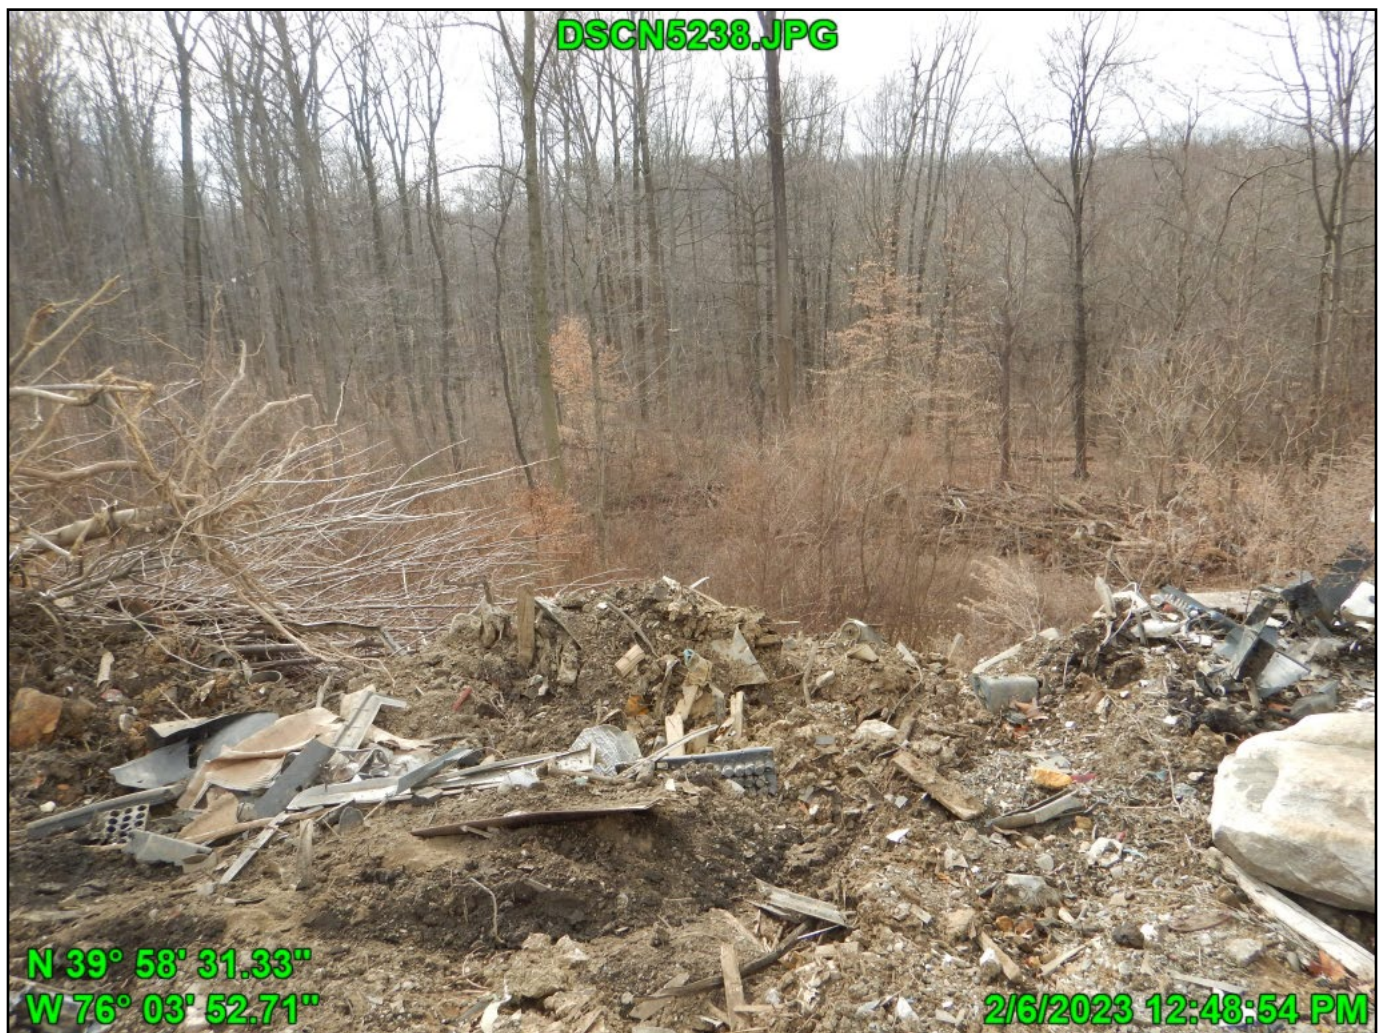
| Description | View off property to an adjacent wooded area shown in Photograph DSCN5236. |

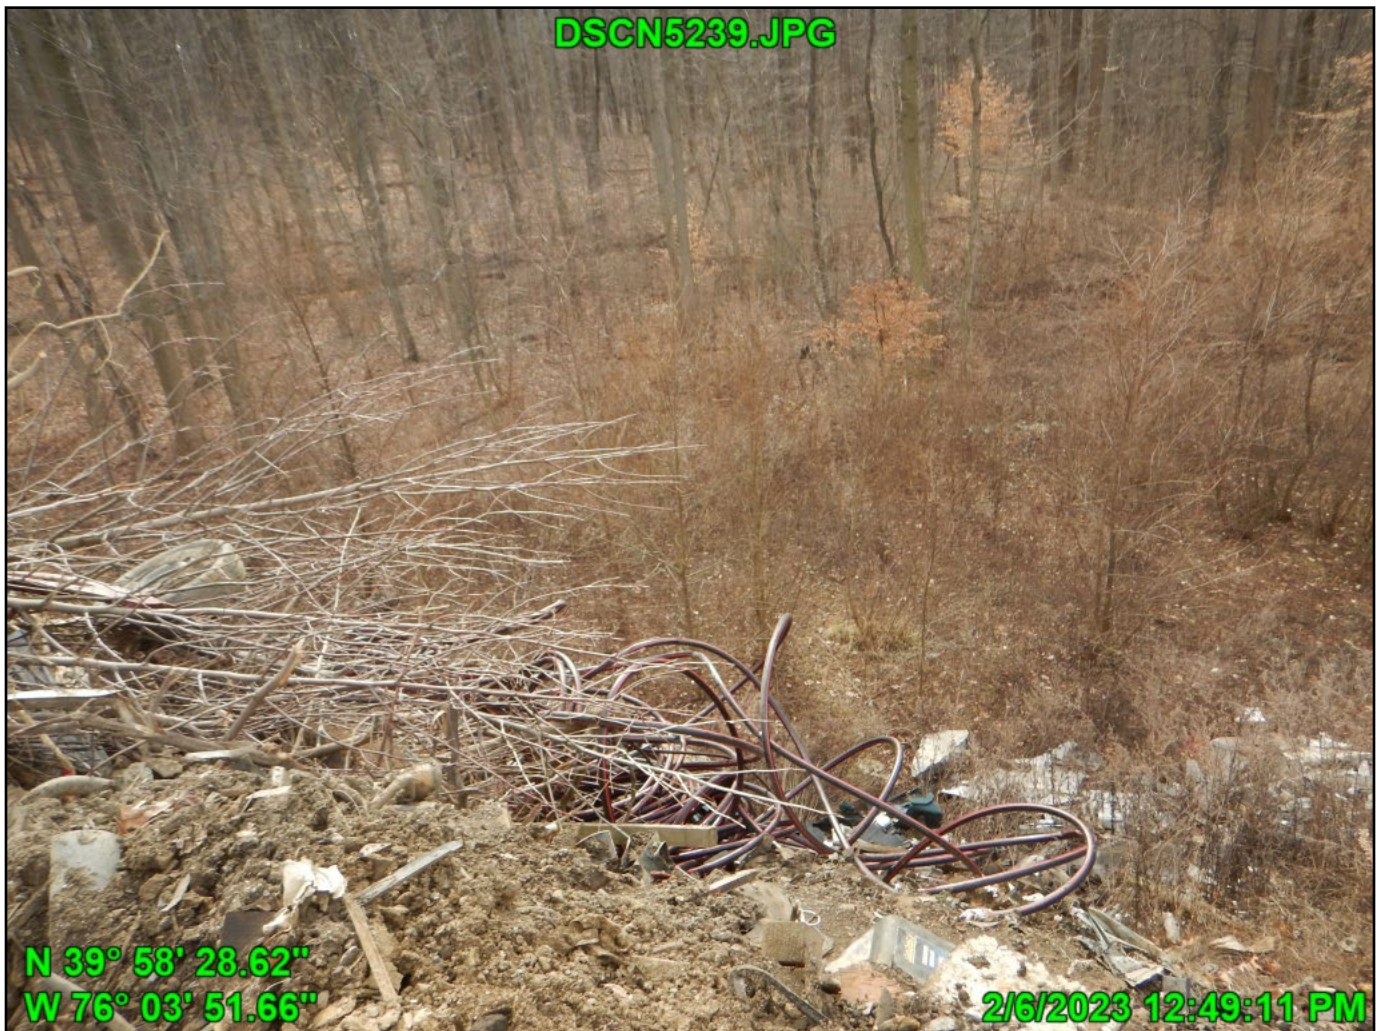
| Description | View off property to an adjacent wooded area northwest of the Facility. |

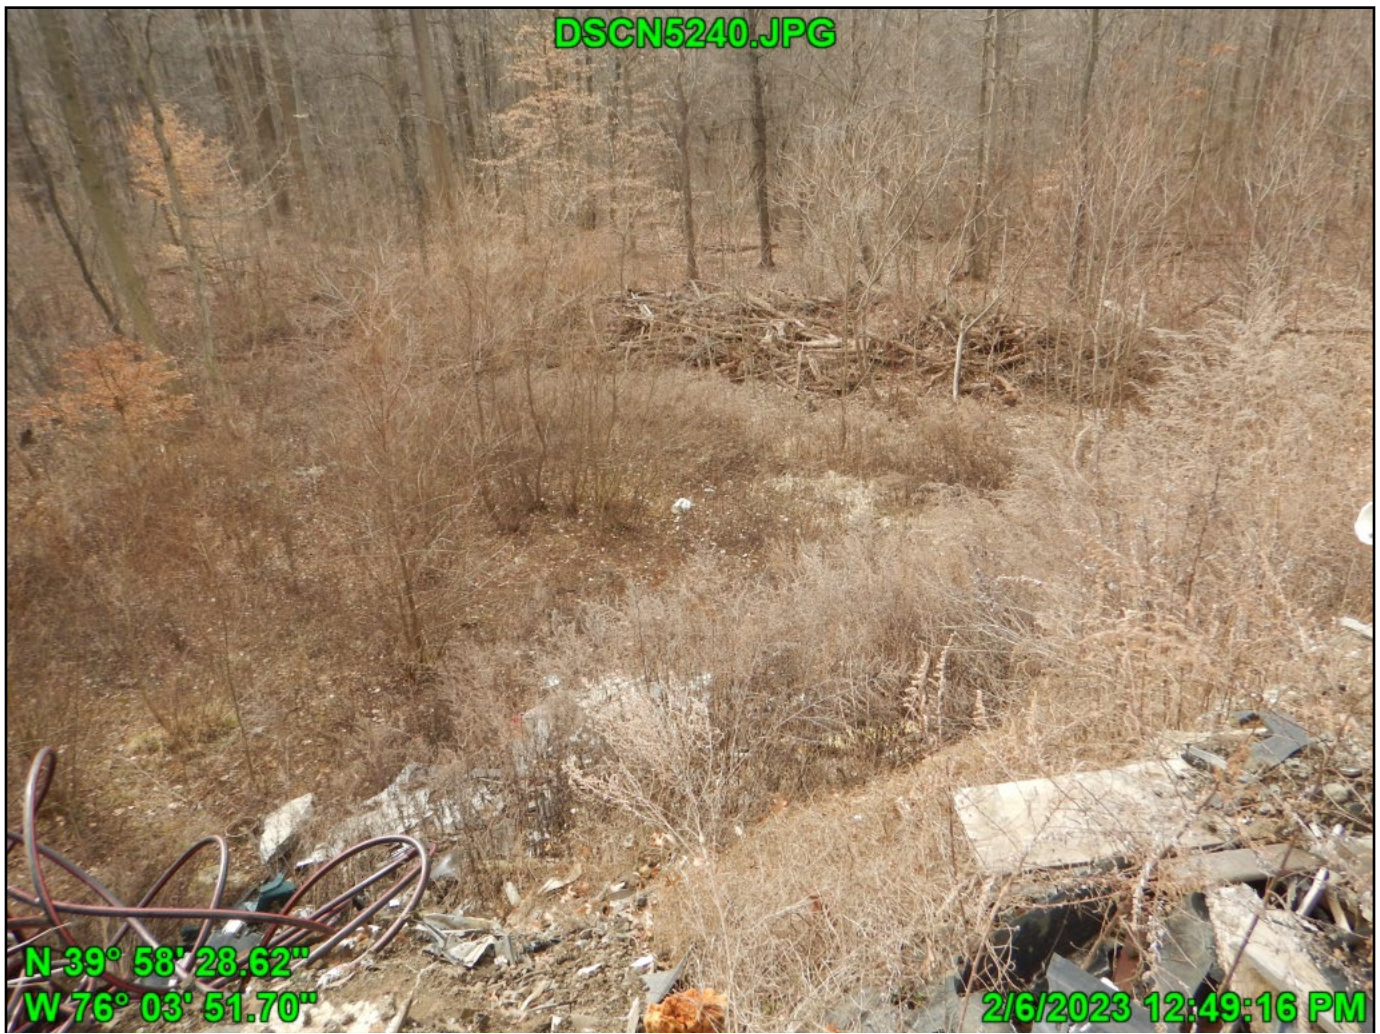
| Description | View off property to an adjacent wooded area southwest of the Facility. |

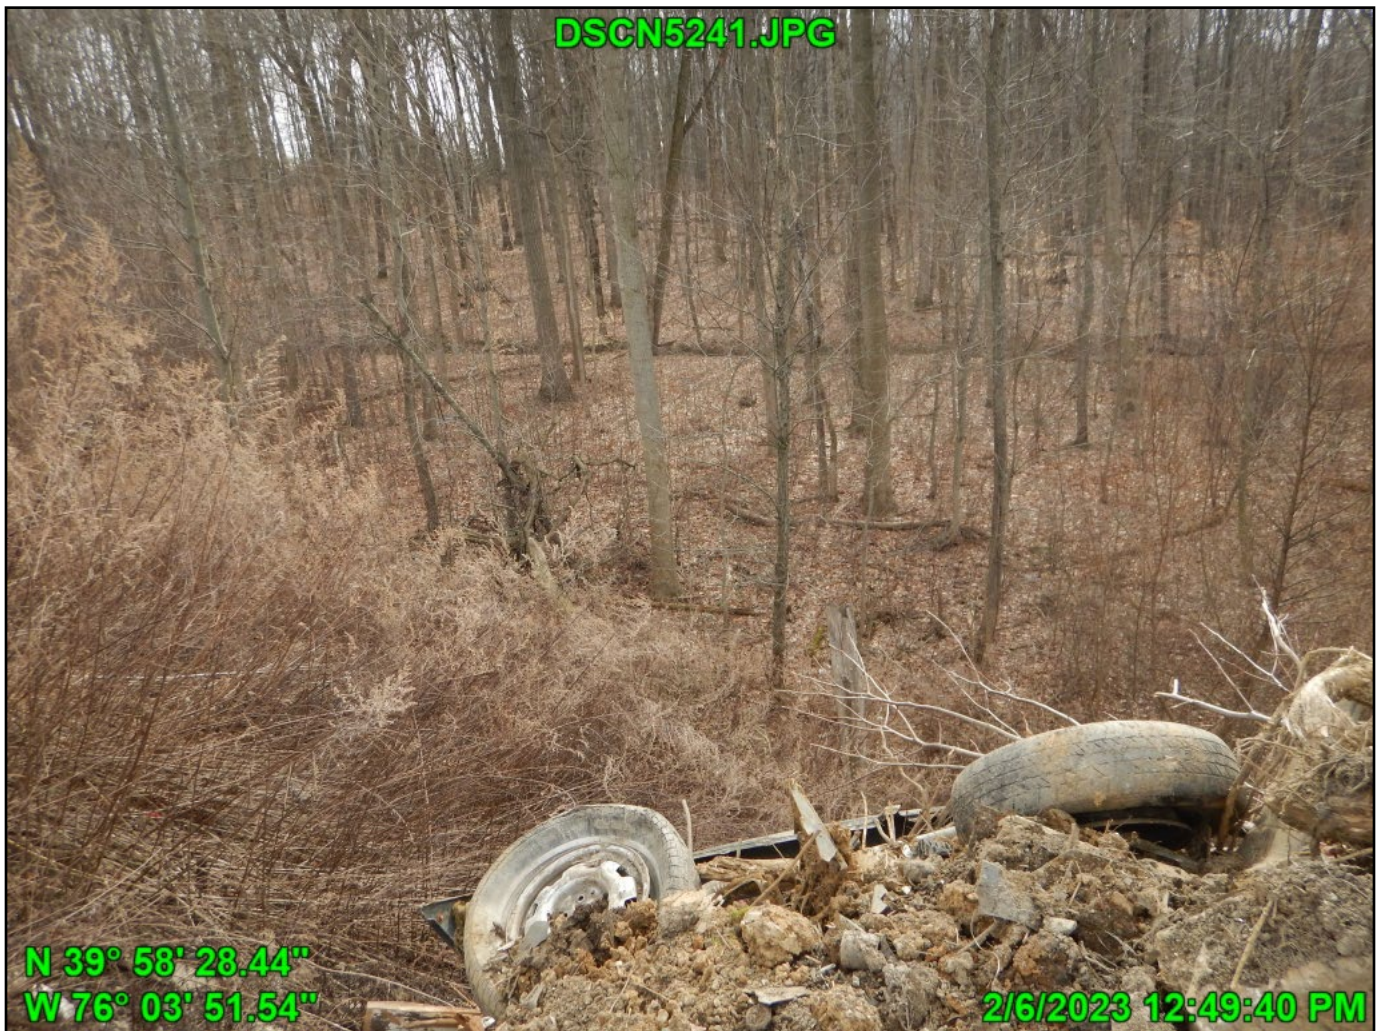
| Description | View off property to an adjacent wooded area shown in Photograph DSCN5239. |
