## MULTI-SECTOR GENERAL PERMIT NON-FILER INSPECTION CHECKLIST

| <b>Inspection Date(s):</b> | 2/7/2023 | |
| <b>Operator Name:</b> | Price's Auto Salvage (formerly B F Leidy & Sons Inc.) | |

**Appendix A. Aerial Map**  
**Clean Water Act Inspection**  
**Price's Auto Salvage**

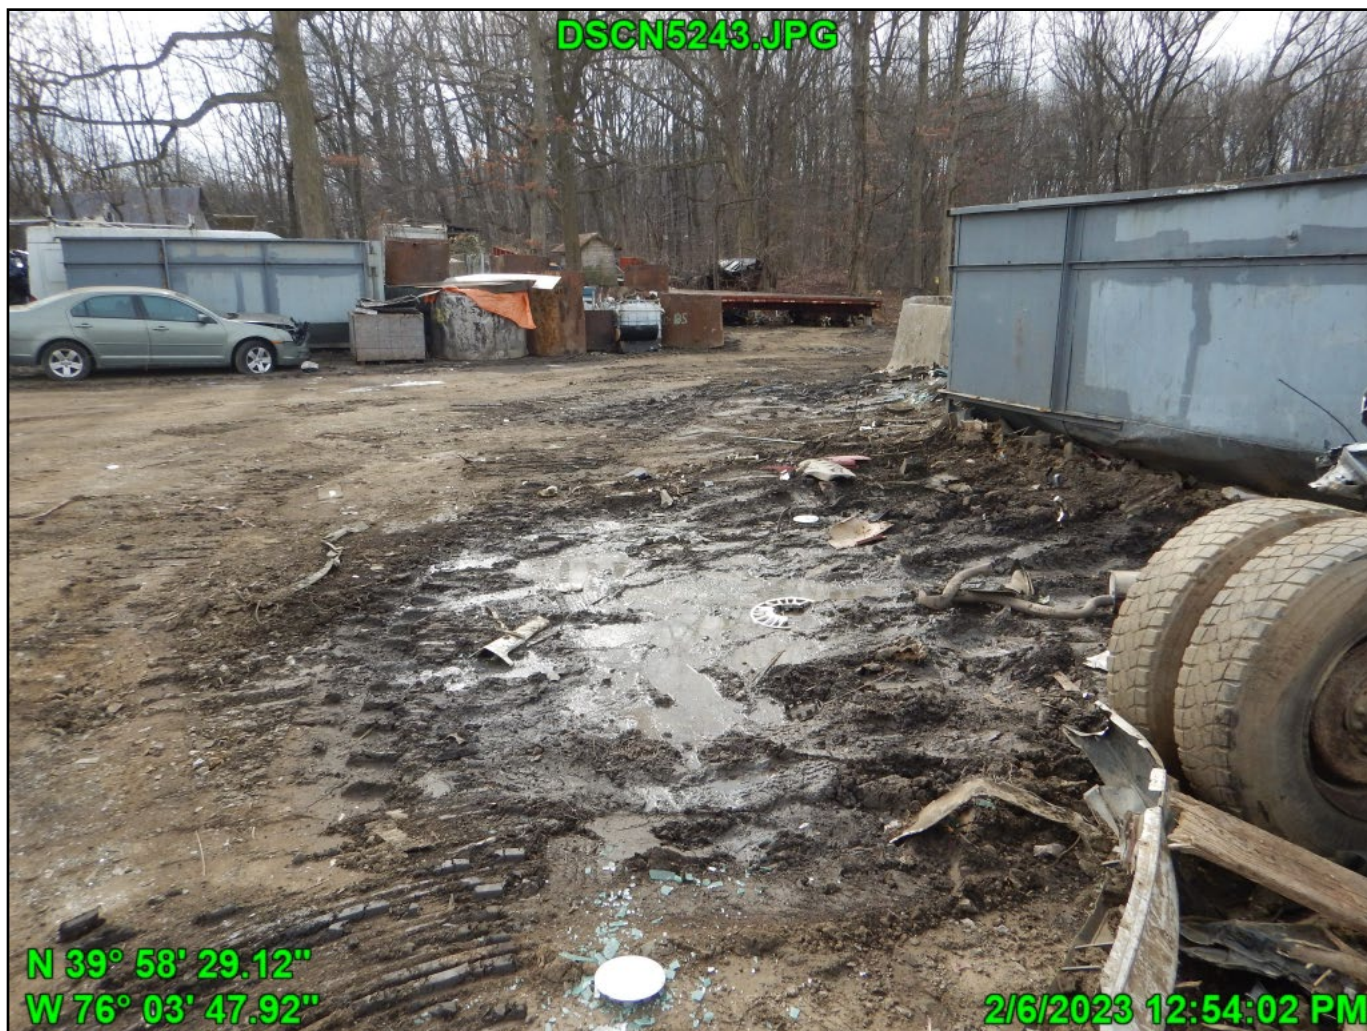
| Description | Scrap vehicle stored in the south part of the Facility with the hood open and battery still inside. |

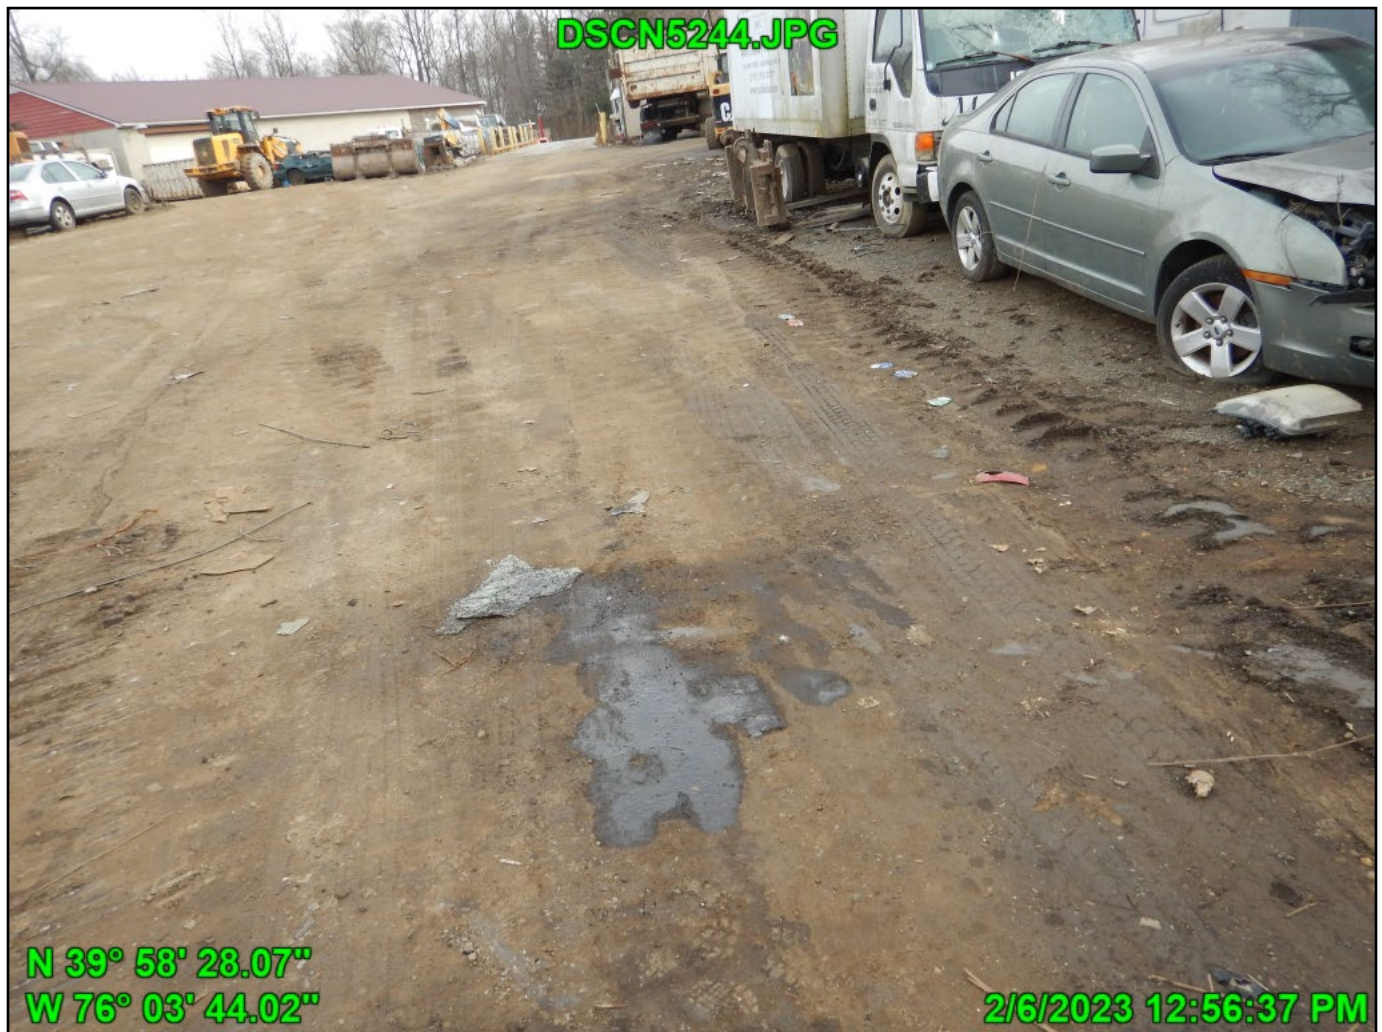
| Description | Upgradient view of pooled stormwater near the scrap metal storage area in the south part of the Facility. |

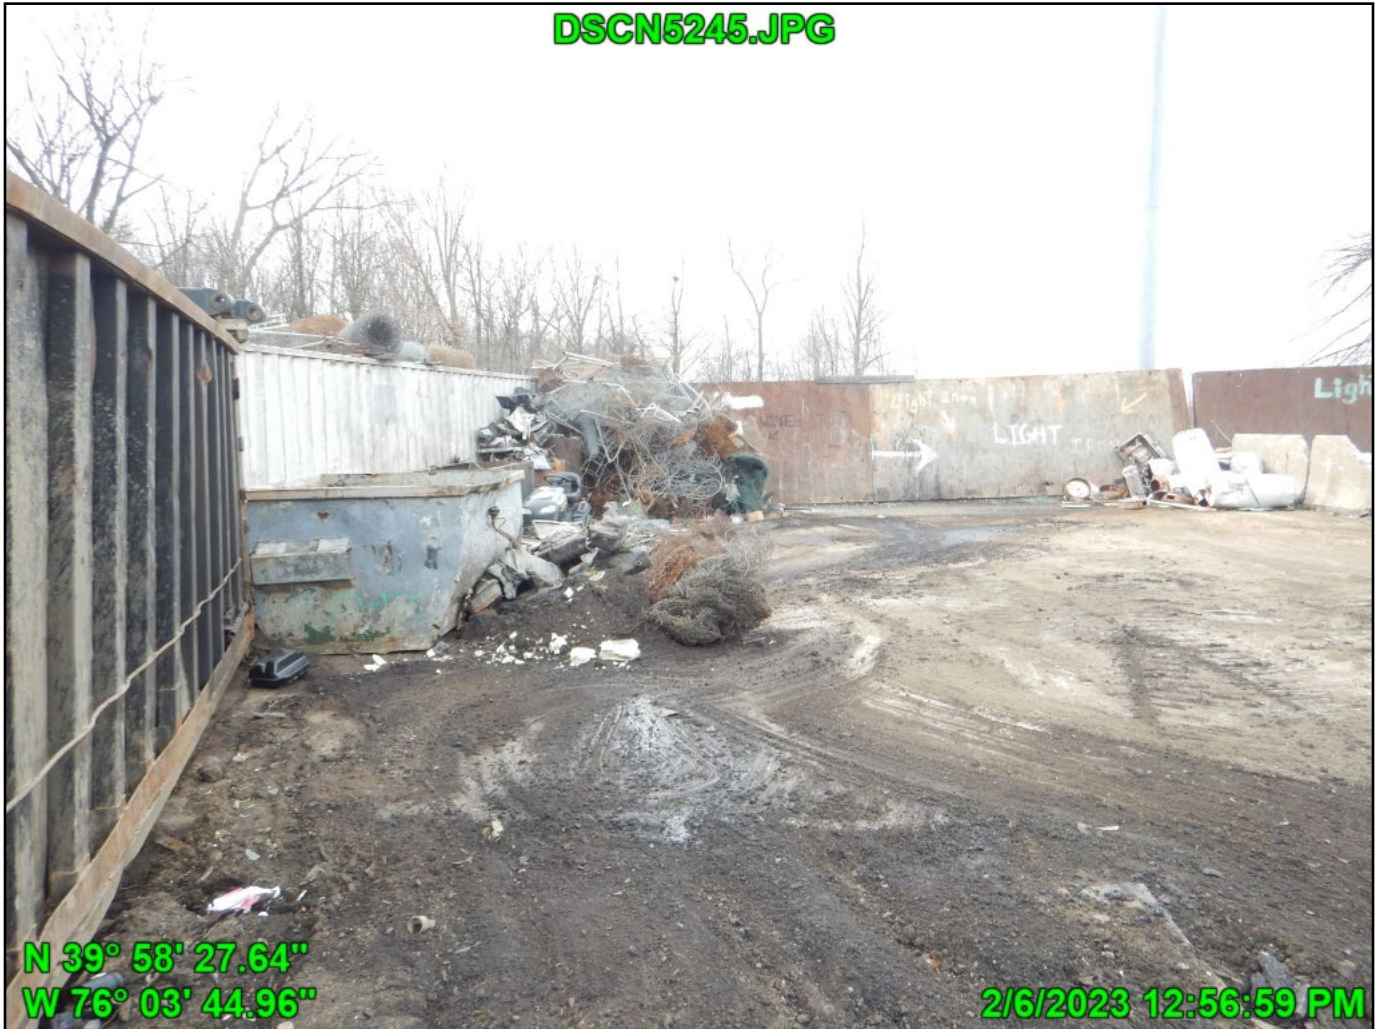
DSCN5245.JPG

| Description | Scrap metal storage area in the south part of the Facility. |

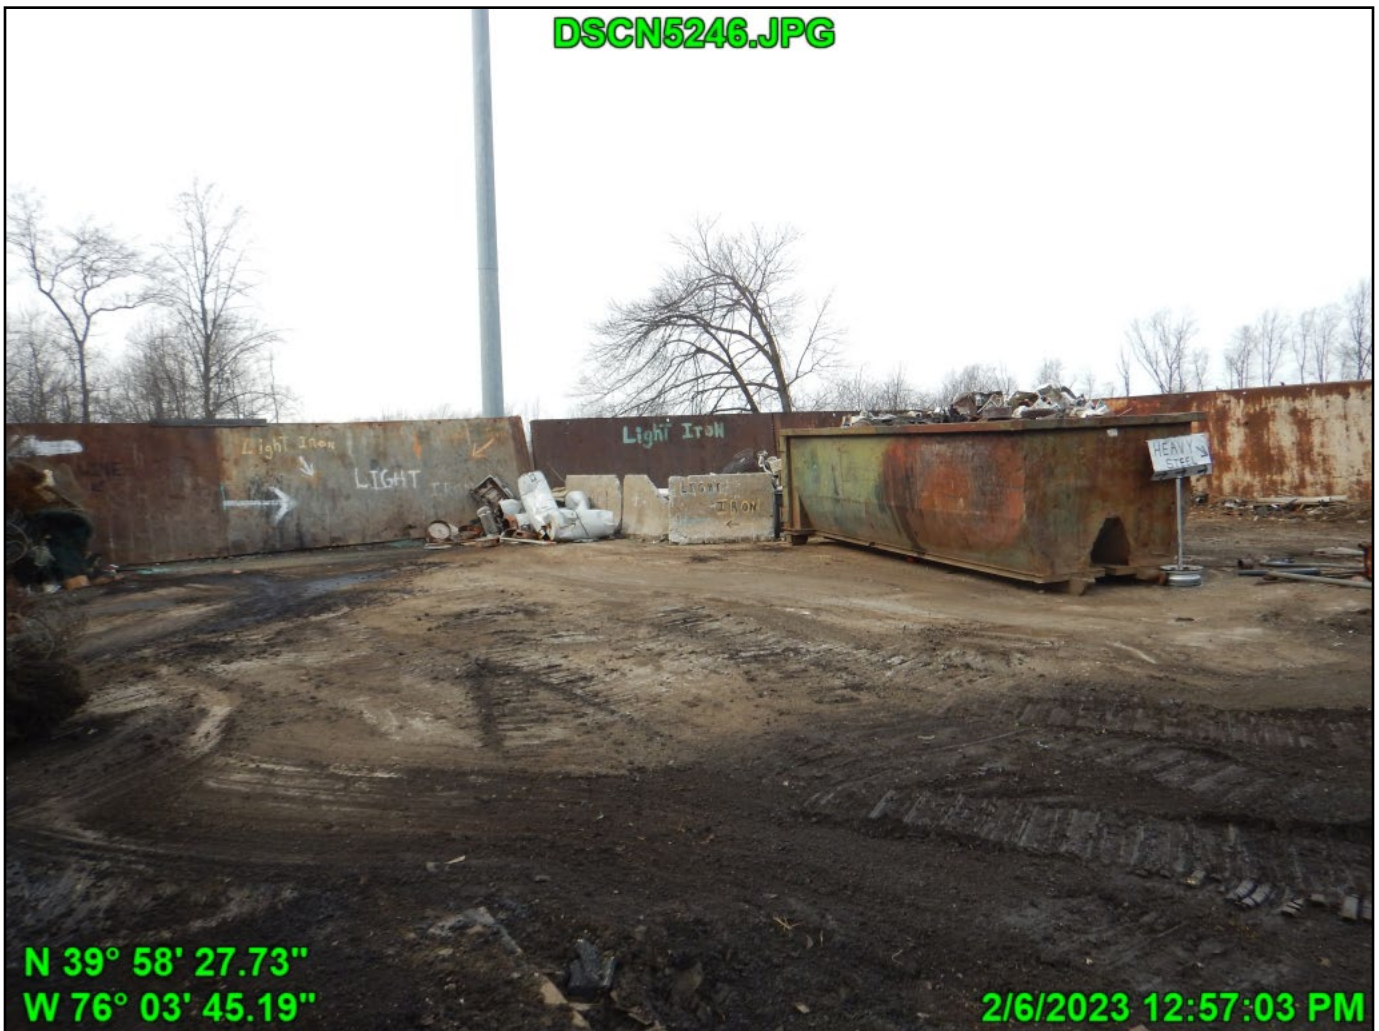
DSCN5246.JPG

- c. The Facility did not have coverage under a Permit at the time of the inspection.
- 2) The EPA Inspection Team observed numerous outdoor areas at the Facility with scrap or waste vehicle parts exposed to stormwater (refer to Appendix B, Photographs DSCN5192, DSCN5196, DSCN5200, DSCN5203, and DSCN5246).

| Description | Scrap metal storage area shown in Photograph DSCN5245. |

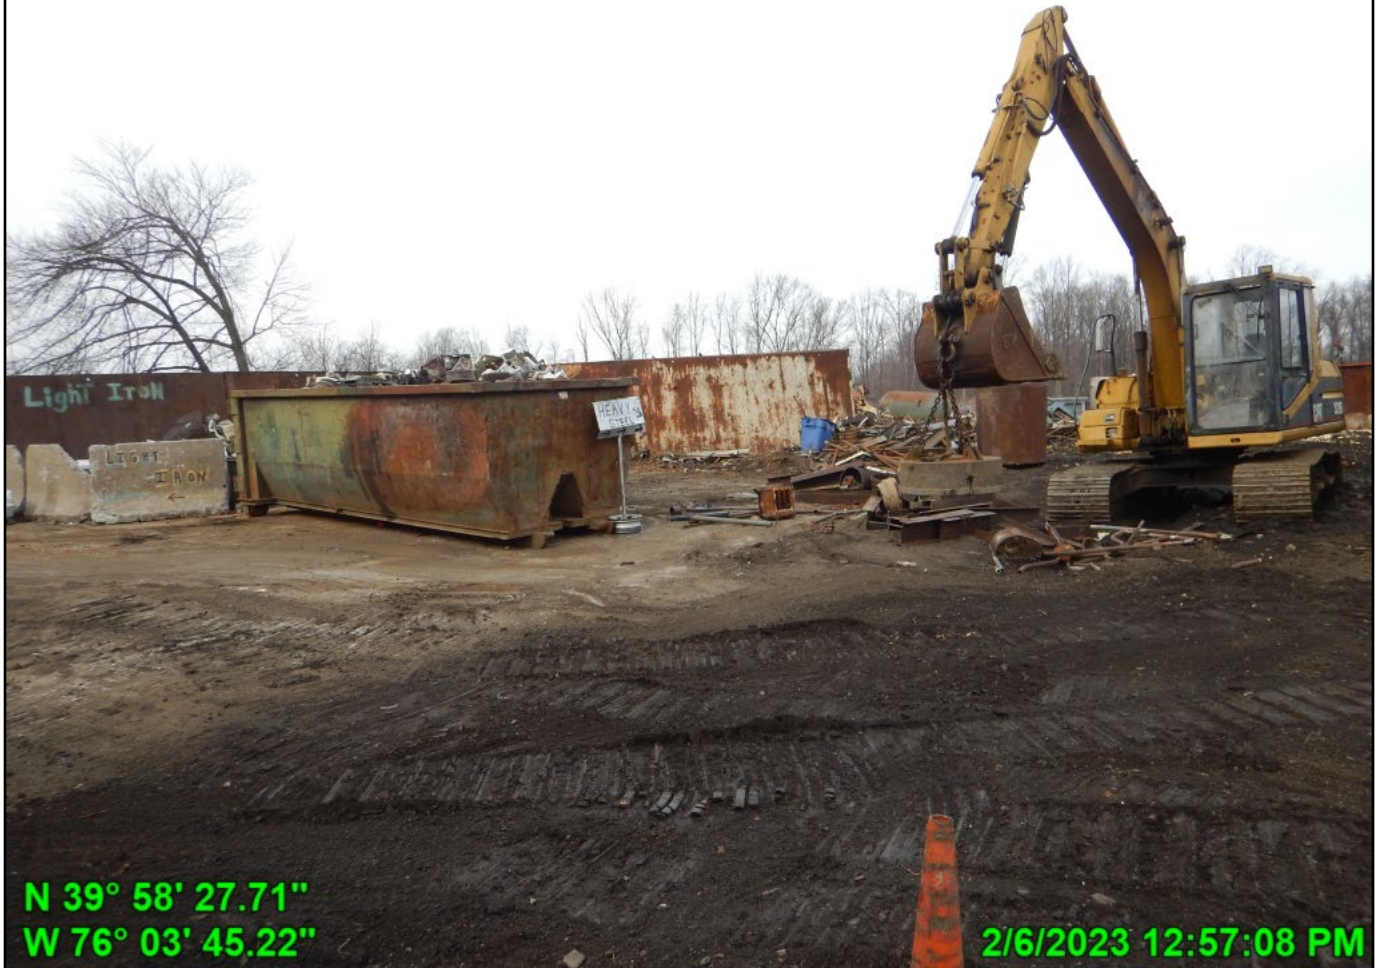
DSCN5247.JPG

| Description | Scrap metal storage area shown in Photographs DSCN5245 and DSCN5246. |
