**UNITED STATES ENVIRONMENTAL PROTECTION AGENCY, REGION 2**  
**Enforcement and Compliance Assurance Division Water**  
**Compliance Branch**

| <b>Clean Water Act (CWA) Inspection</b><br><b>Report Program:</b> Industrial Stormwater | <b>Inspection Type:</b> Compliance Evaluation Inspection |
| <b>Site Name:</b> Curran Renewable Energy LLC<br>(Does not have a permit) | <b>NPDES/ICIS No.:</b> NYU065324 |

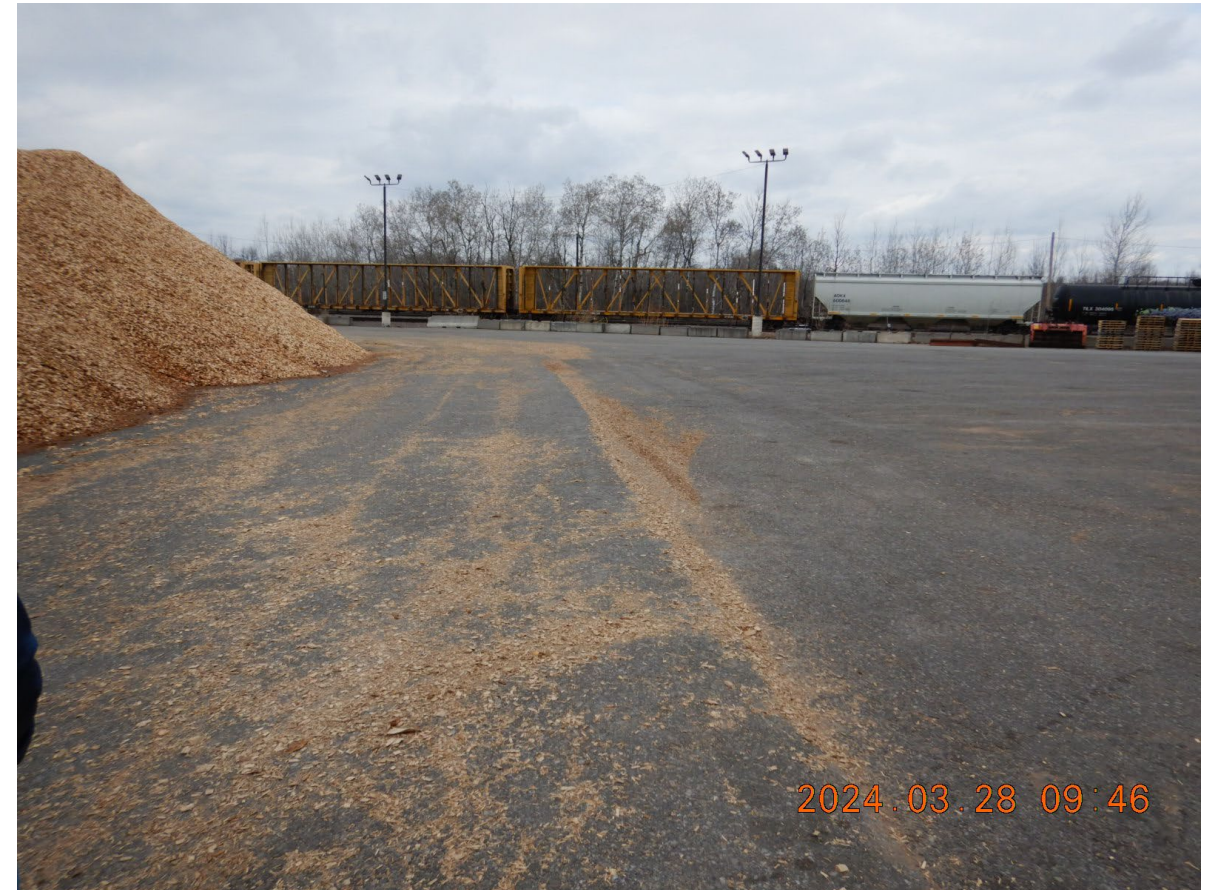
At the time of the CEI, water was observed in channels/drainages along the West and Southwest edge of the Site (Attachment 1; DSCN2667, DSCN2686, DSCN2690, DSCN2697 and DSCN2699). Mr. Measheaw stated that during wet weather water would flow from a catch basin in the parking lot outside of the packaging warehouse to an outlet on the West edge of the Site (Attachment 1; DSCN2661, DSCN2662, DSCN2668, DSCN2669, DSCN2671 and DSCN2672). EPA representatives numbered catch basins in the order that they were observed during the inspection. Along the west edge of the site, EPA representatives observed a railroad catch basin as well as an outlet pipe leading to areas thought to be railroad property (Attachment 1;

- b. EPA observed lack of effective structural or stabilization methods to prevent or minimize stormwater contact and runoff at the centrally located and southern stockpiles (Attachment 1; DSCN2665, DSCN2667, DSCN2703, DSCN2707, DSCN2708, DSCN2709, DSCN2710, DSCN2716, DSCN2717, DSCN2719, DSCN2731, DSCN2732, DSCN2734, DSCN2735, DSCN2736, DSCN2739, DSCN2741, DSCN2744, DSCN2745, DSCN2746, DSCN2748, DSCN2749, DSCN2750, and DSCN2751).

DSCN2667 - View of the W edge of Site from woodchip storage area

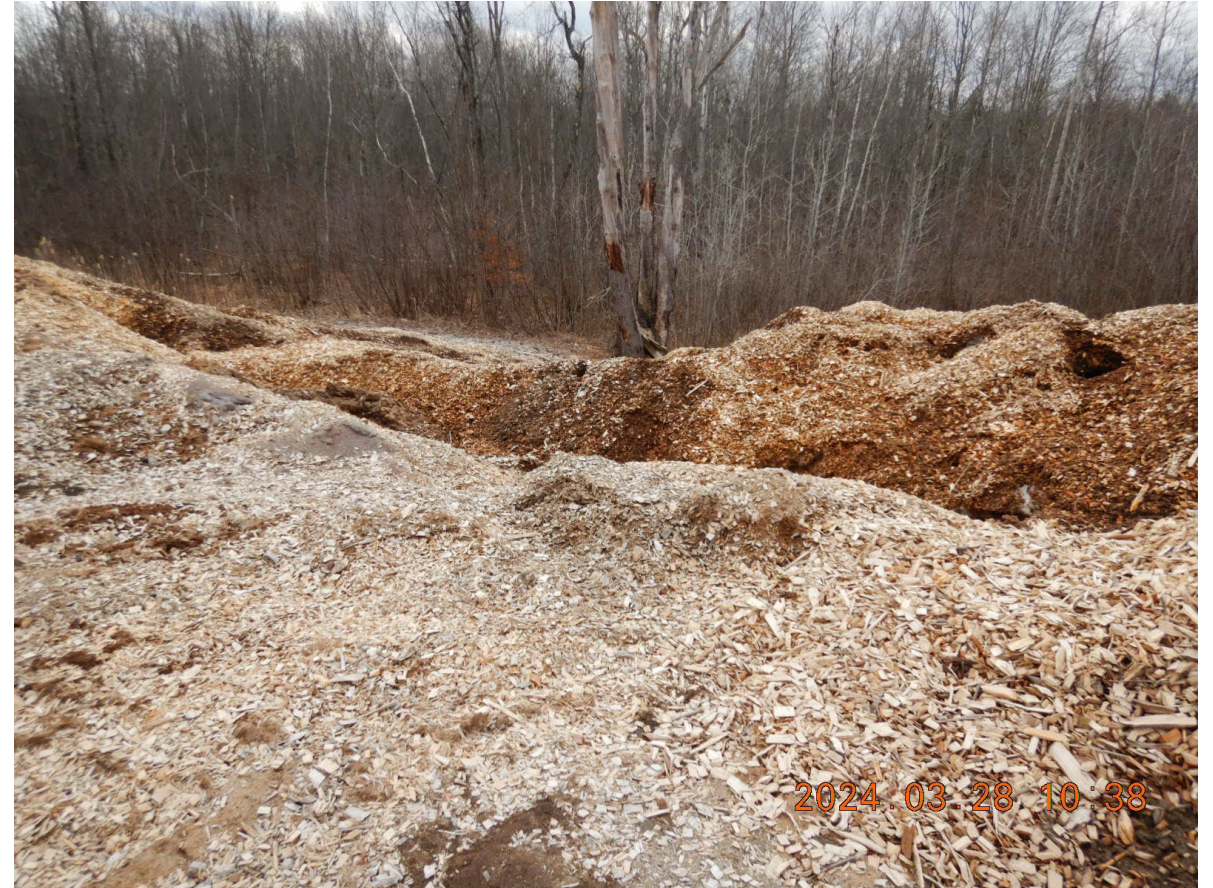
DSCN2735 - Mixture of woodchips and pellet ash

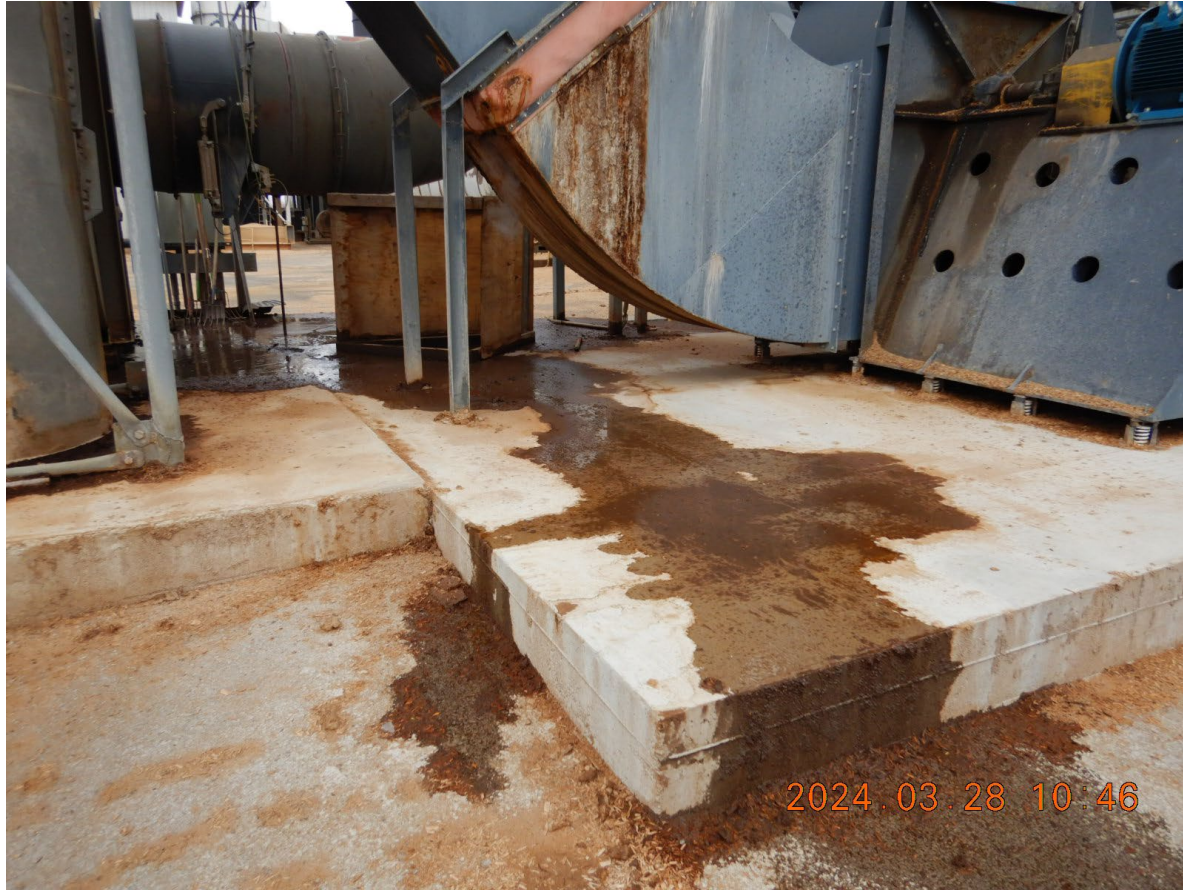
- c. Runoff of condensate from the Facility equipment towards a stormwater channel (Attachment 1; DSCN2751, DSCN2749, DSCN2750, and DSCN2748). Part I.B.2 of the MSGP does not authorize non-stormwater discharges of condensate of gas streams (except for uncontaminated steam or air conditioning condensate) as cited in 6 NYCRR 750-1.2(a)(29)(vi).

DSCN2751 - Runoff from manufacturing equipment

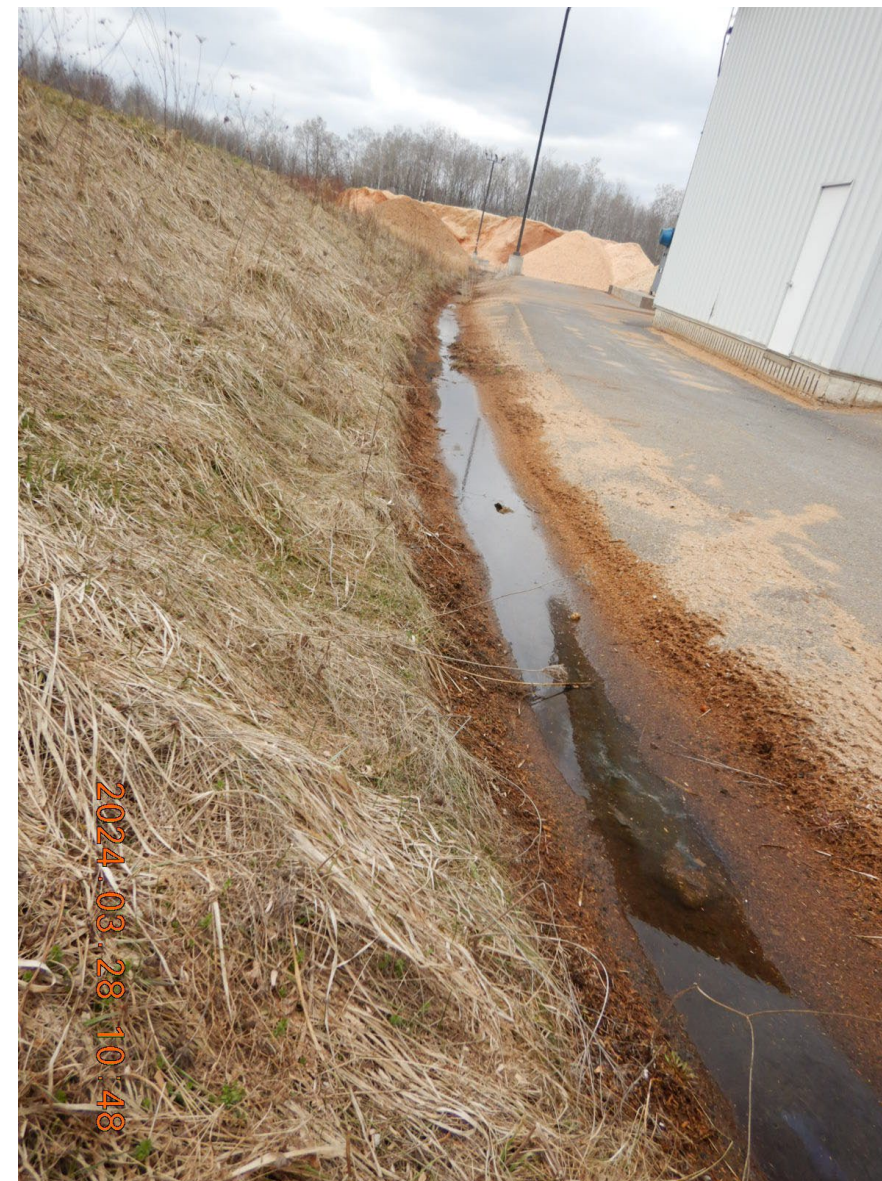
DSCN2673, DSCN2691, and DSCN2693). A retention pond and a gravel drive built over the stormwater channel was also observed by EPA representatives (Attachment 1, DSCN2674, DSCN2675 and DSCN2676). In addition to the collection of water on the west side of the Site, EPA observed water collected and flows from the central stockpile area and South stockpile lot (Attachment 1; DSCN2665, DSCN2667, DSCN2703, DSCN2707, DSCN2708, DSCN2709, DSCN2710, DSCN2716, DSCN2717, and DSCN2719). Mr. Measheaw stated that waste ash (from burning wood in boilers) created during pellet manufacturing was collected into two (2) metal collection bins (Attachment 1; DSCN2724). These bins are then emptied outside at the most southern waste stockpile lot. At the time of the CEI, EPA representatives also observed runoff and condensate flows from industrial equipment at the Site (Attachment 1; DSCN2666, DSCN2748, DSCN2749, DSCN2750 and DSCN2751). EPA observed a catch basin near the south side of the pellet manufacturing building filled with woodchip and pellet debris. EPA observed that this catch basin emptied to the south side of the Site (Attachment 1; DSCN2753, DSCN2754, DSCN2752, DSCN2755, DSCN2756, DSCN2757 and DSCN2758).

DSCN2758 - Drainage with water flowing towards S side of Site

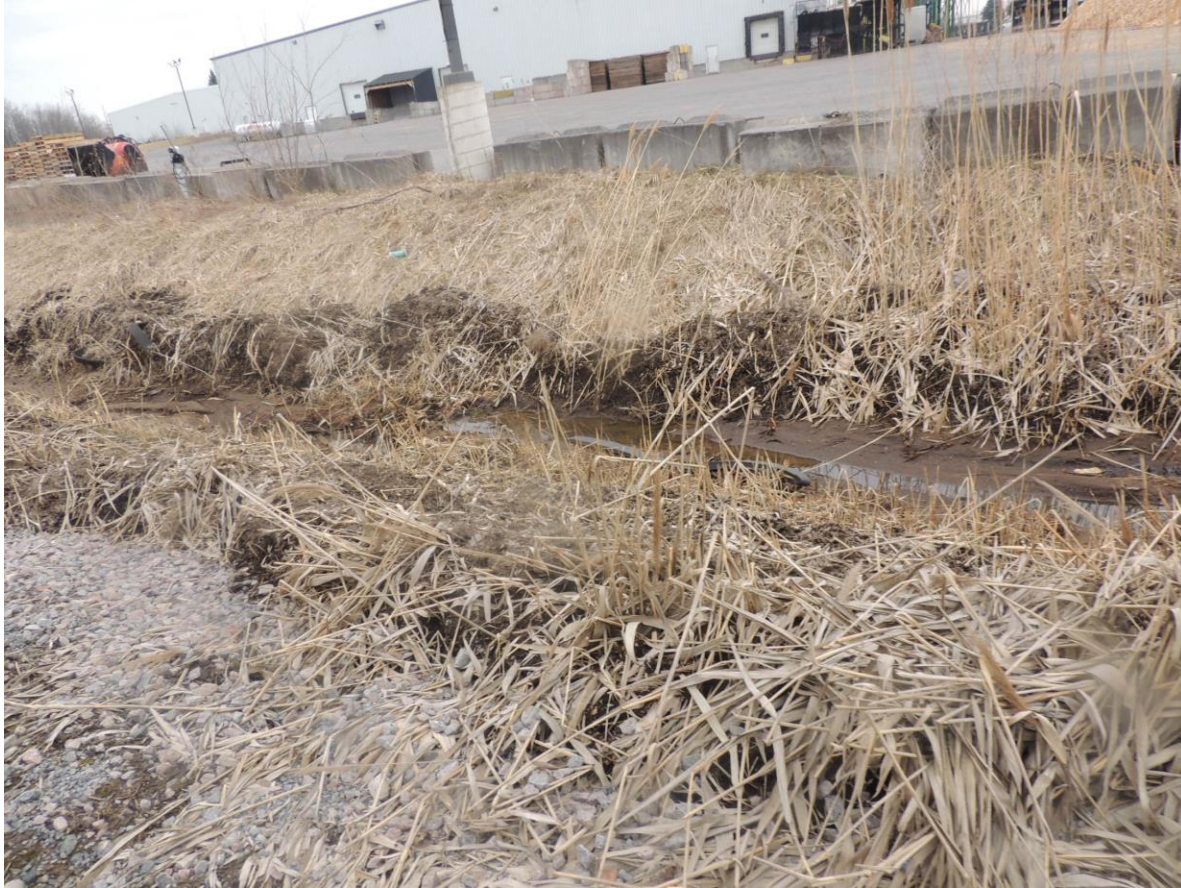
DSCN3998 – Storm channel along the western edge of Site

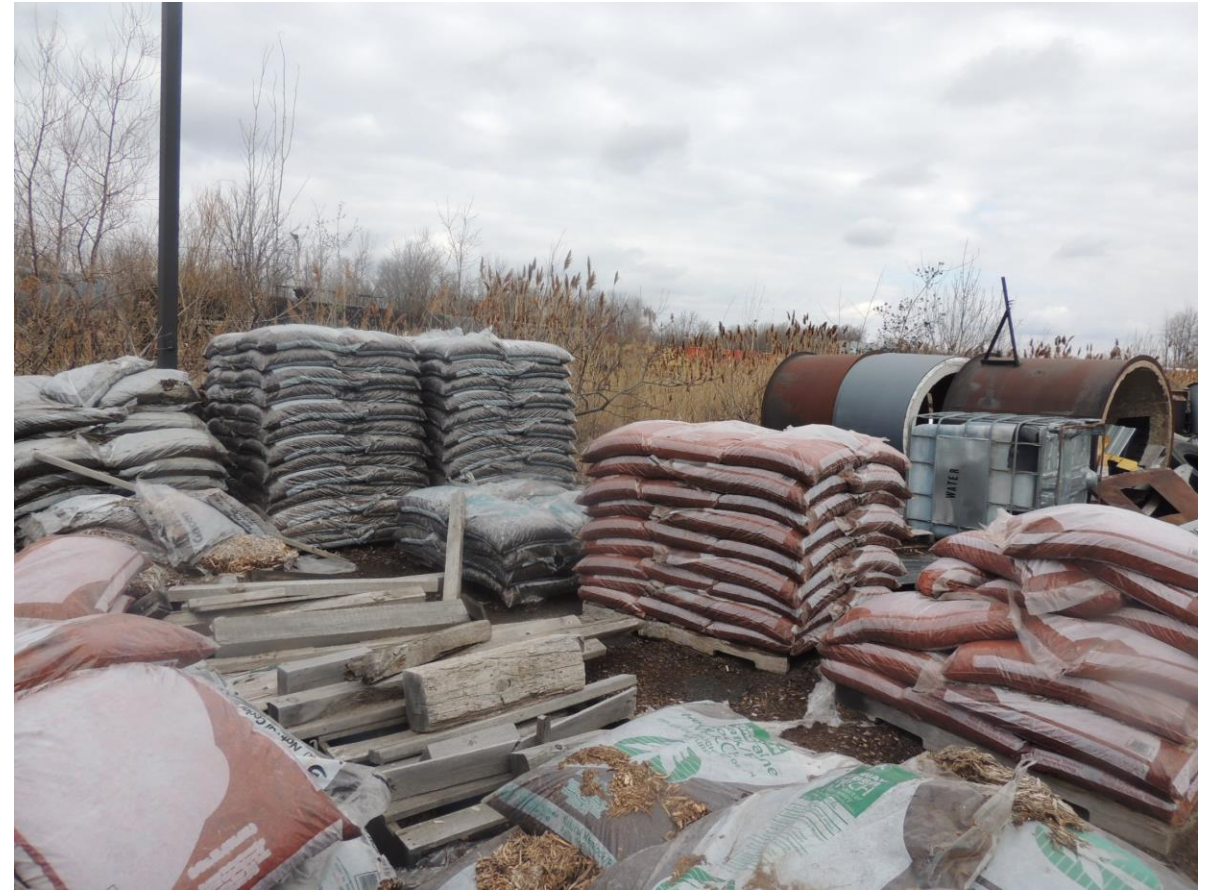
DSCN4003 – Mulch storage, outdoors, some bags open on western portion of Site

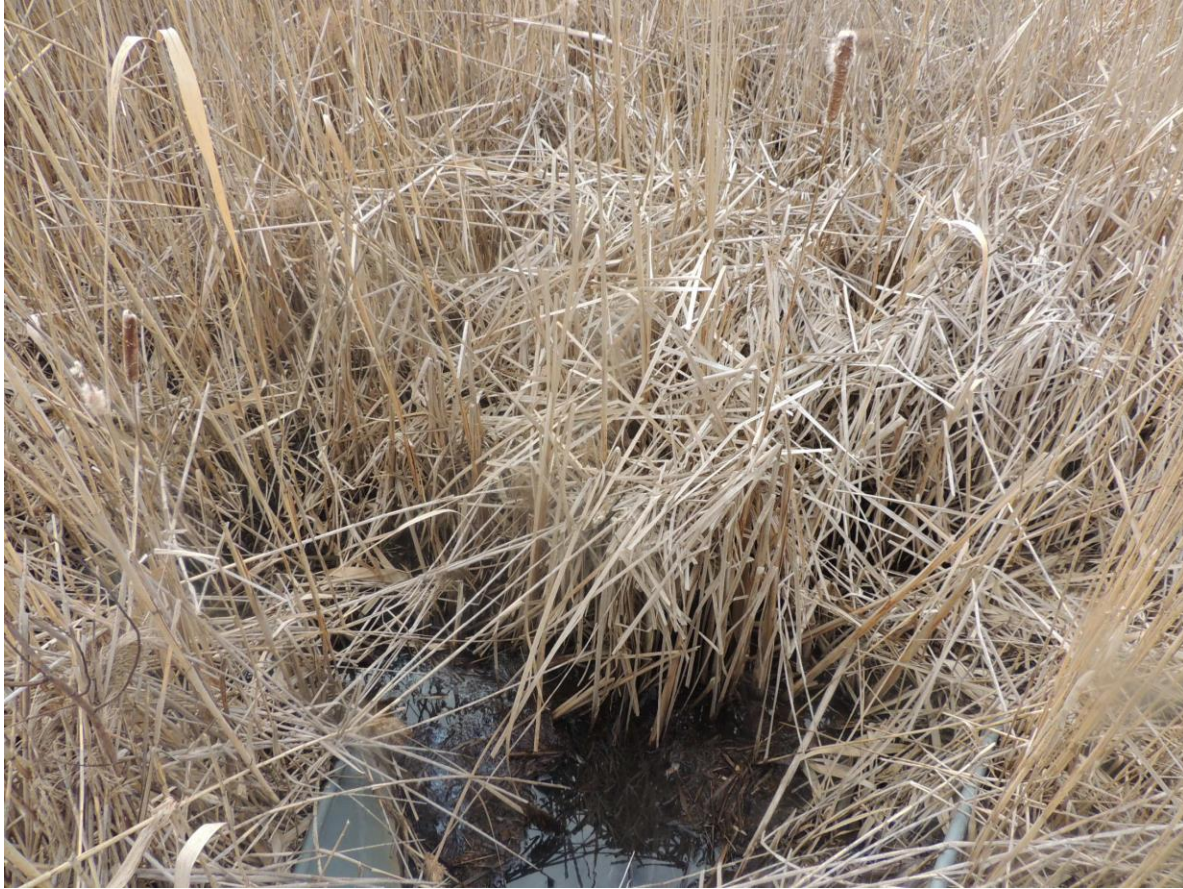
DSCN4015 – Stormwater culvert/channel western portion of Site at or around CSX rail line

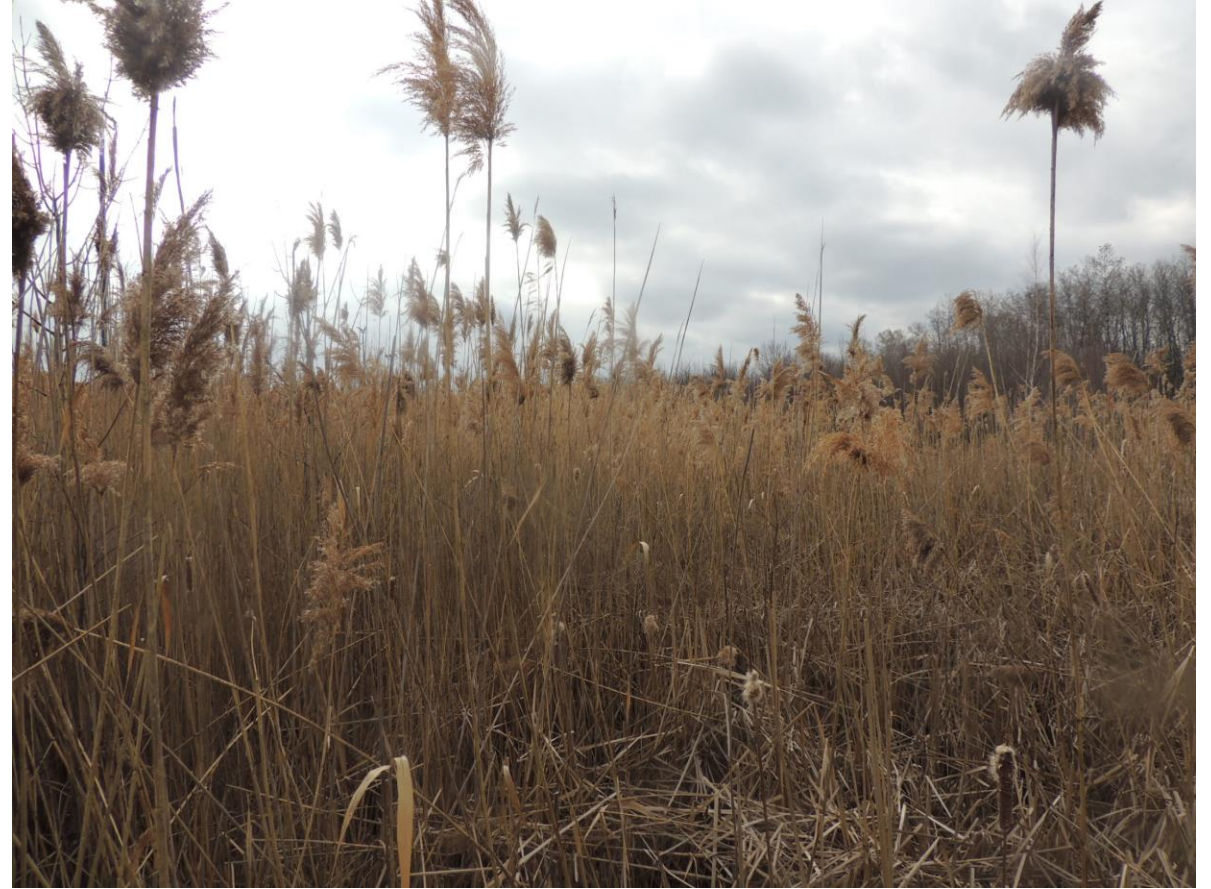
DSCN4016 – drainage with water in it between railway and southwest portion of the Curran Site

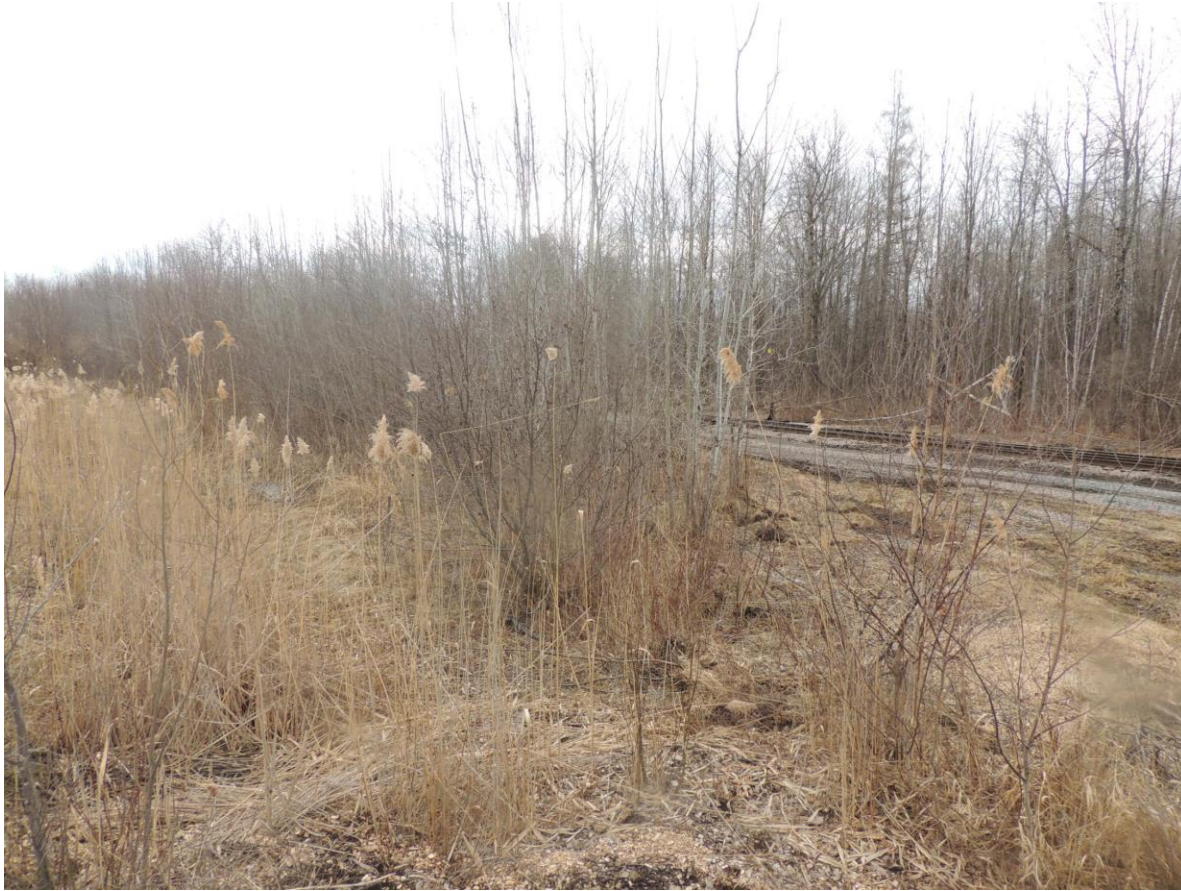
DSCN4021 – Wooded area downslope from southwest portion of the Site

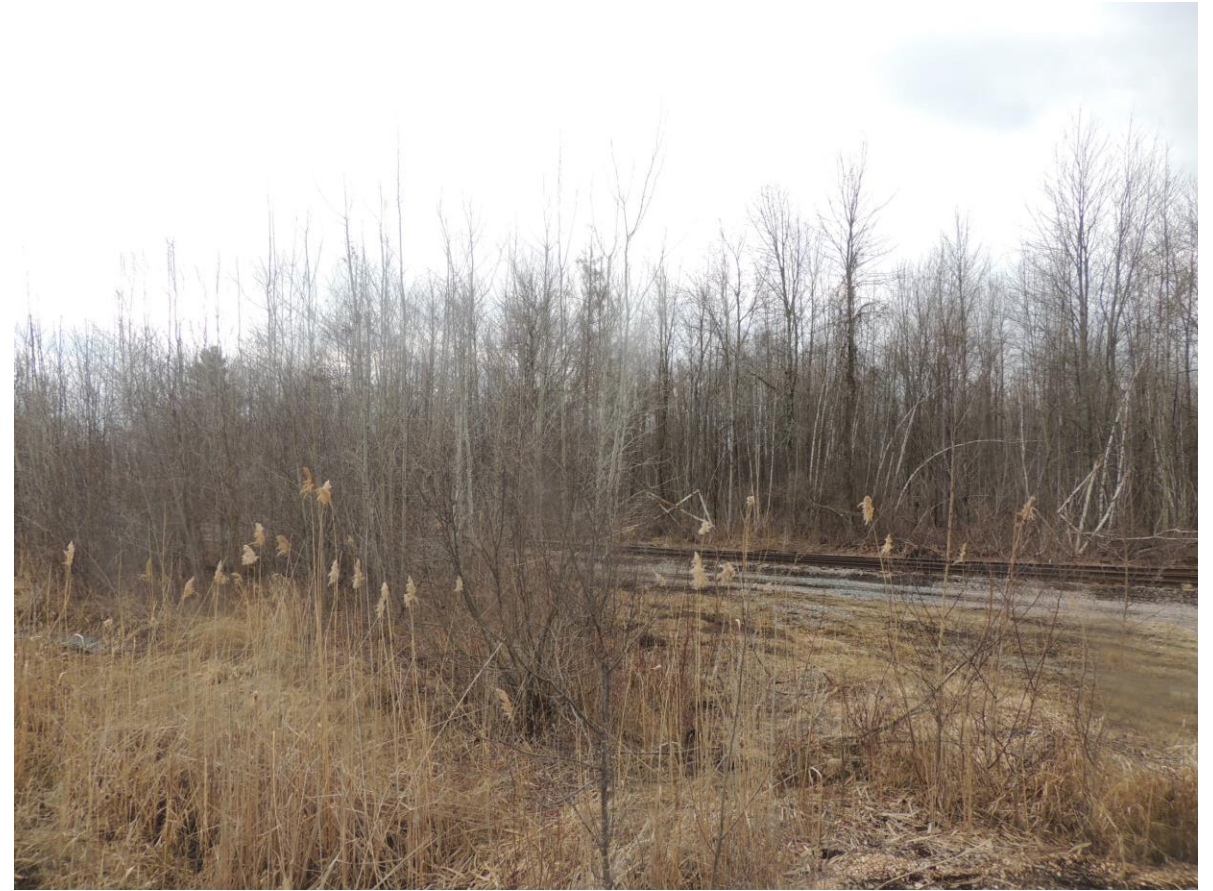
DSCN4022 – Vegetated area/potential drainage on the southwest portion of the Site

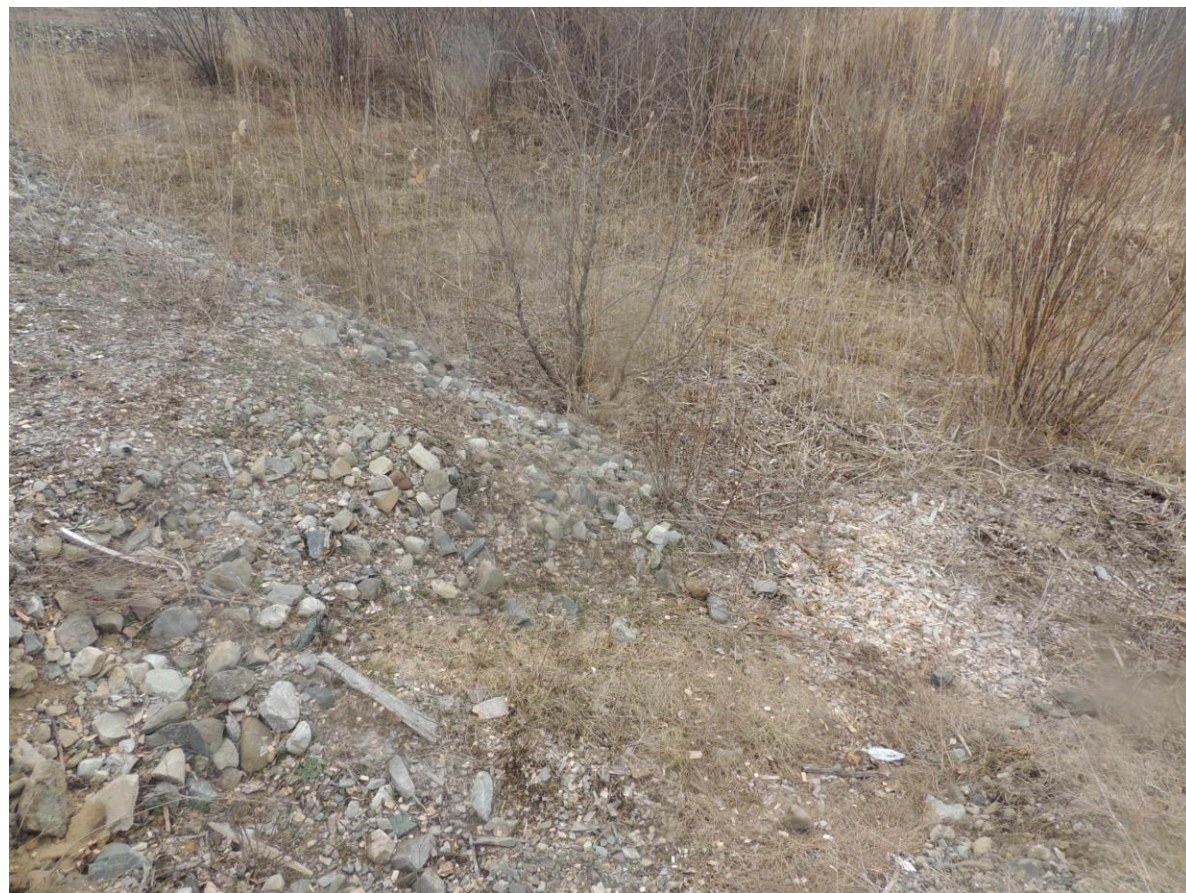
DSCN4024 – Outside of block walls south of the Curran Site

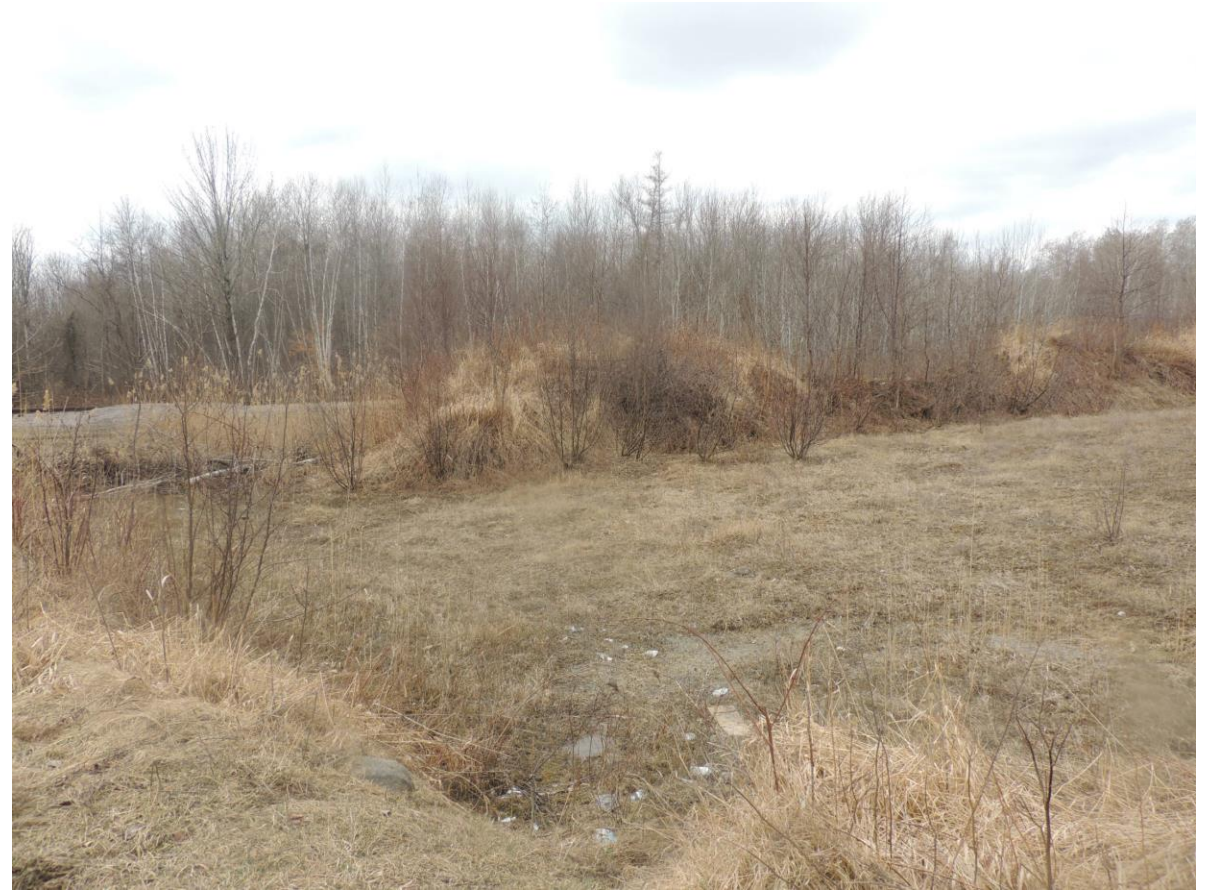
DSCN4053 - Wet area/drainage in vicinity of boiler ash piles

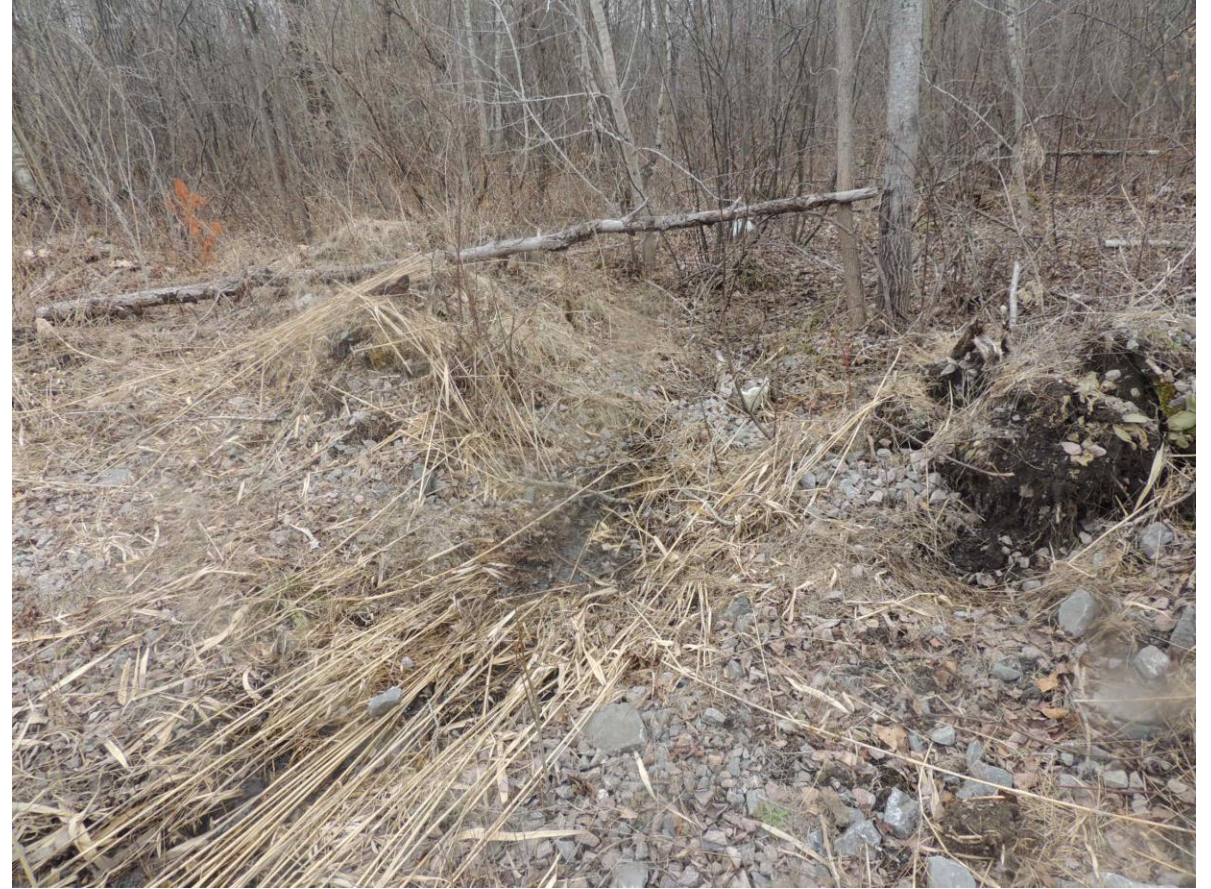
DSCN4057 - Drainage between rail line and southern portion of Facility

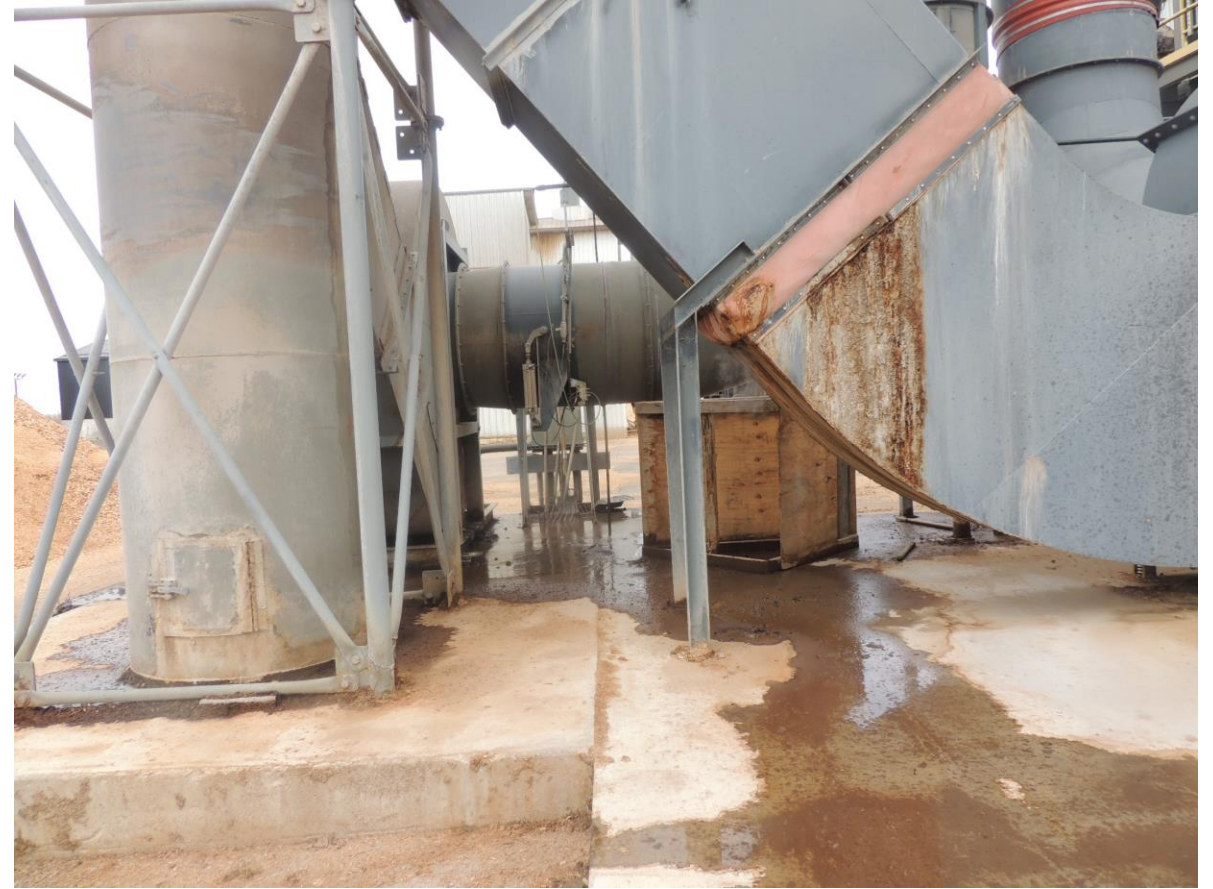
DSCN4059 - Wet area/flow path near southern part of the Facility
