## MULTI-SECTOR GENERAL PERMIT NON-FILER INSPECTION CHECKLIST

| <b>Inspection Date(s):</b> | 2/7/2023 | |
| <b>Operator Name:</b> | Dutchland, Inc. | |

Stormwater Inspection Date: February 7, 2023

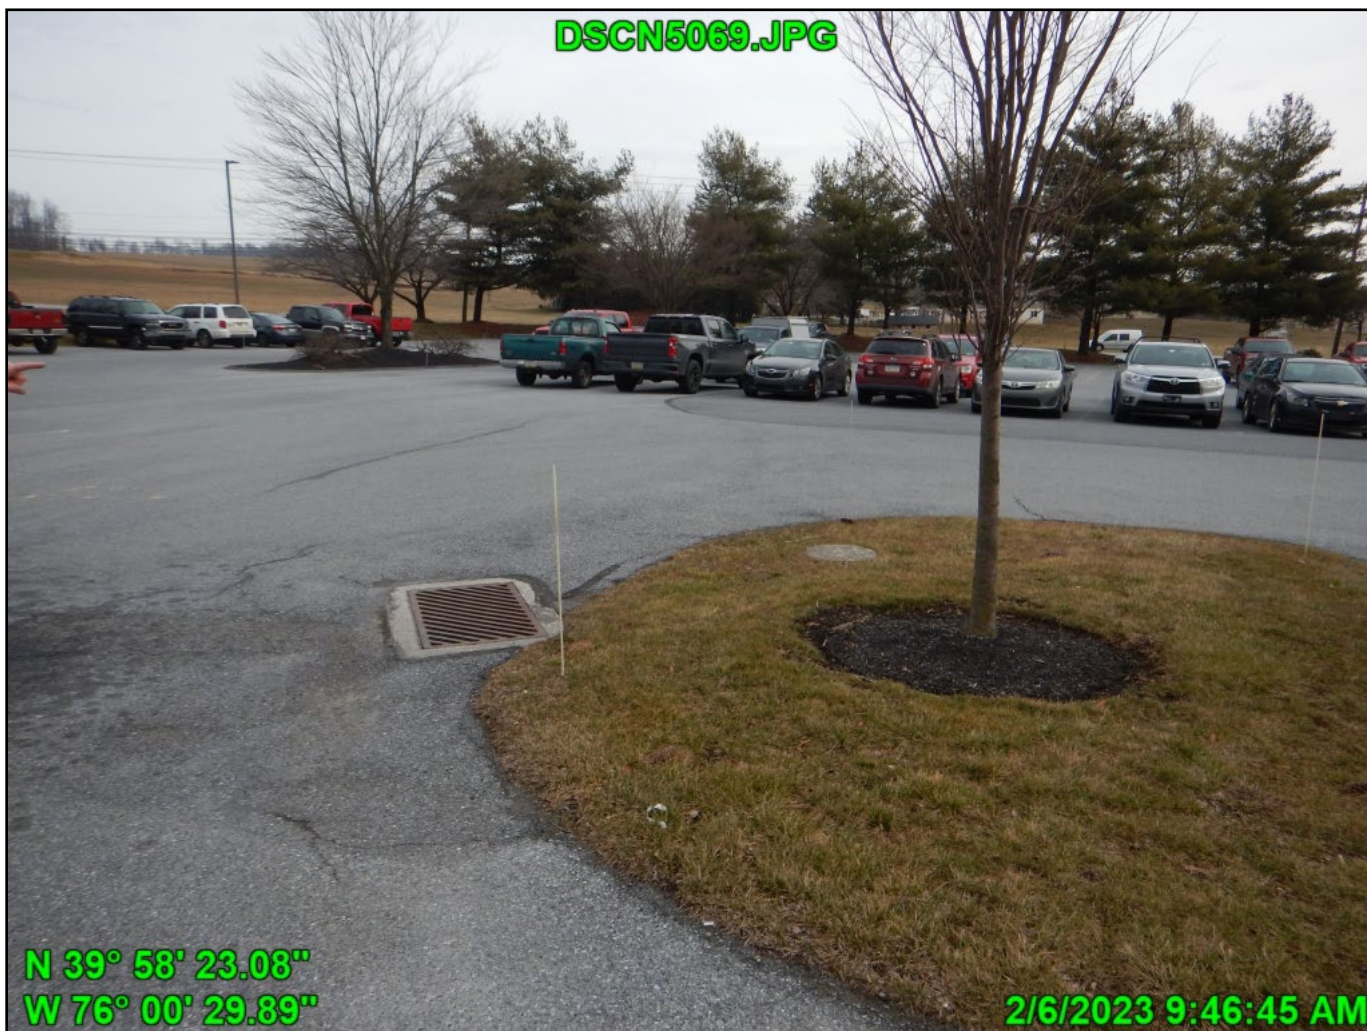
| Description | Catch basin in the Facility parking lot that eventually discharges stormwater offsite. This area receives stormwater sheet flow from the parking lot. |

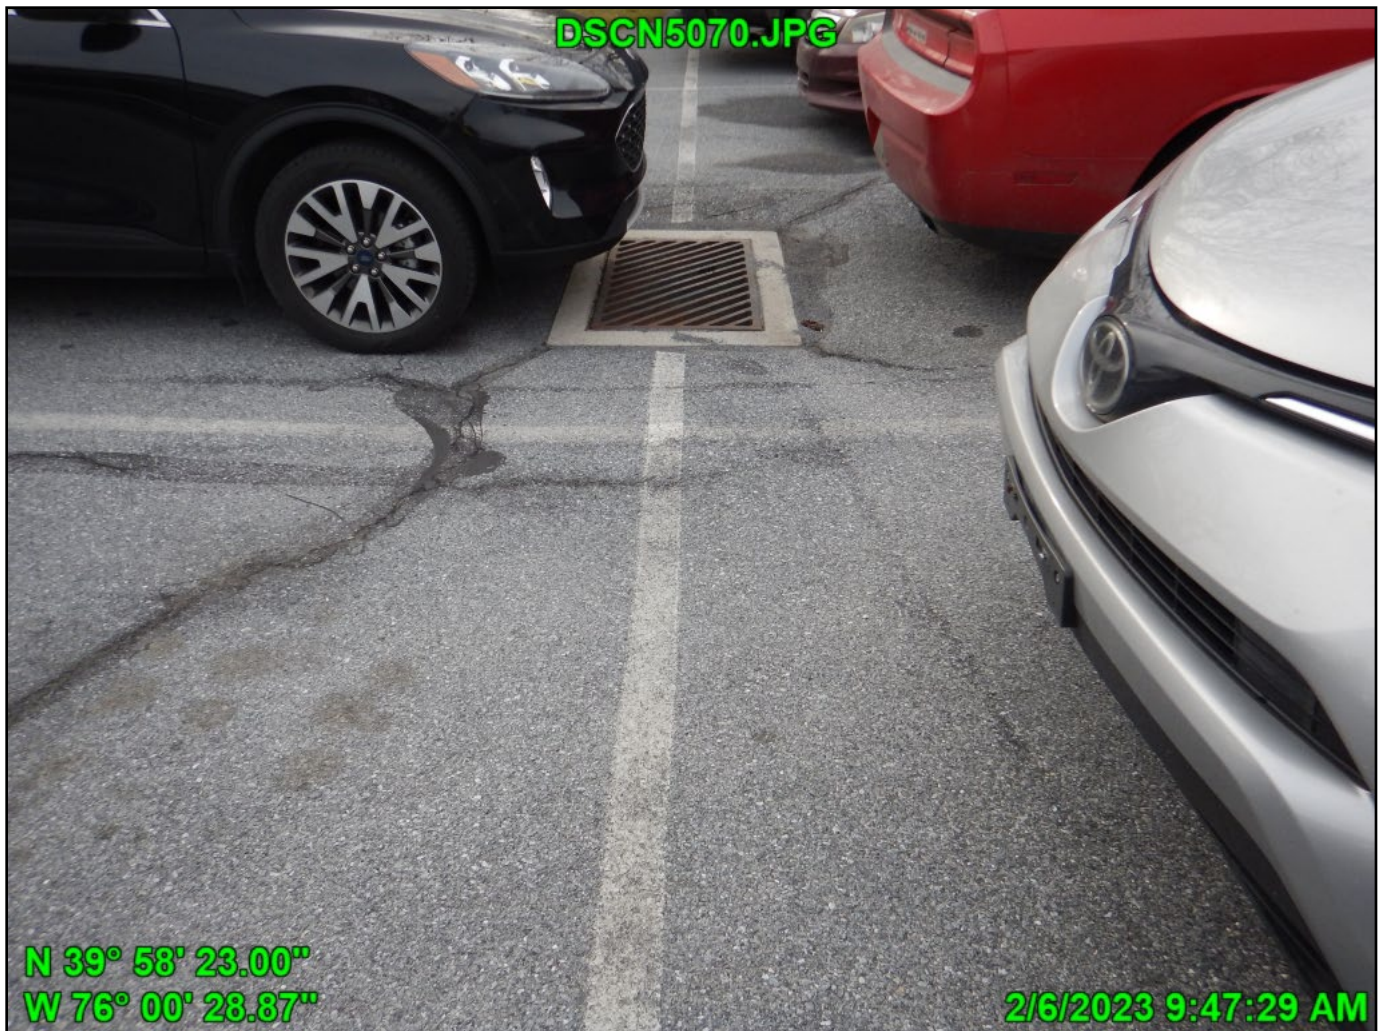
| Description | Another catch basin in the Facility parking lot that eventually discharges stormwater offsite. |

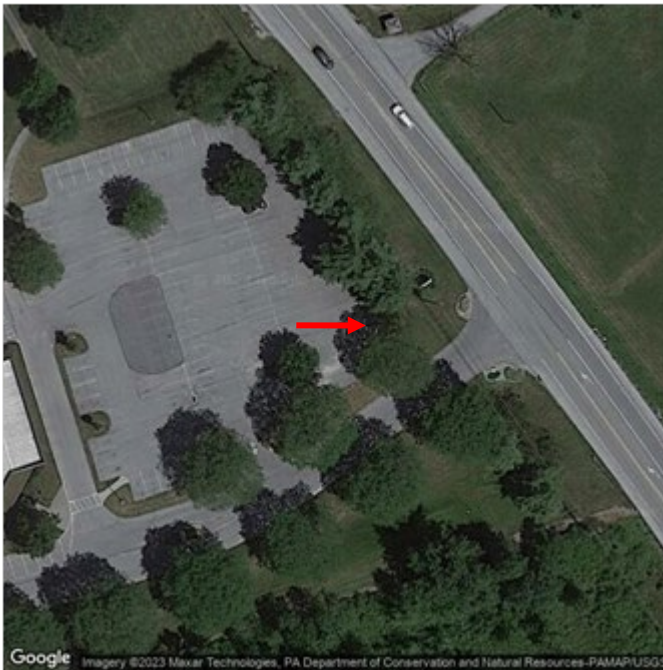
Estimated direction of stormwater flow from the parking lot towards a catch basin. View looking east.

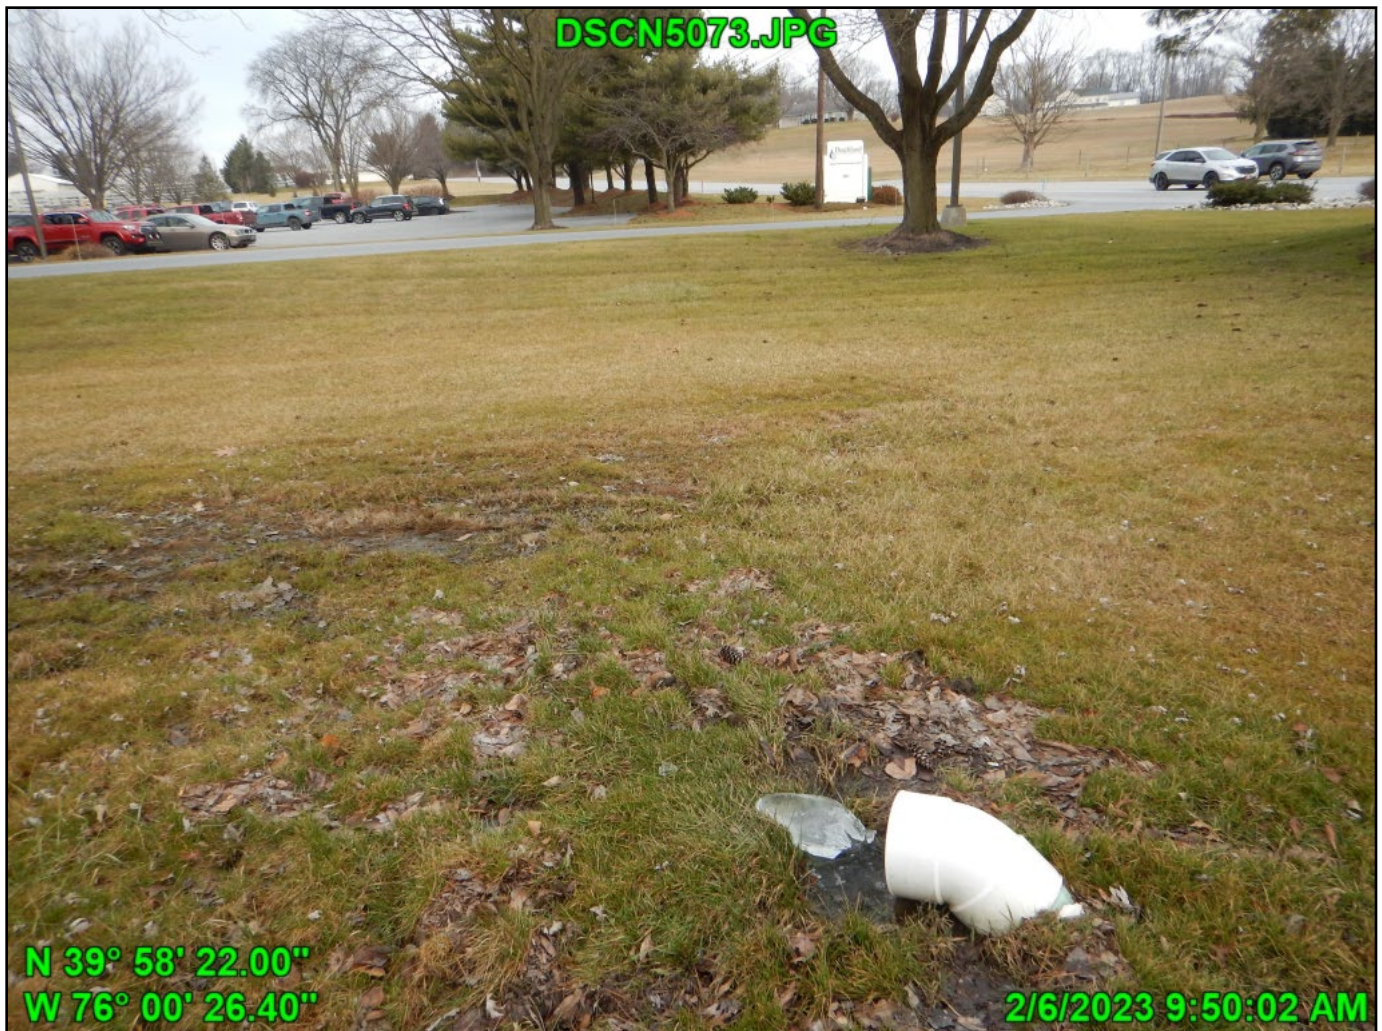
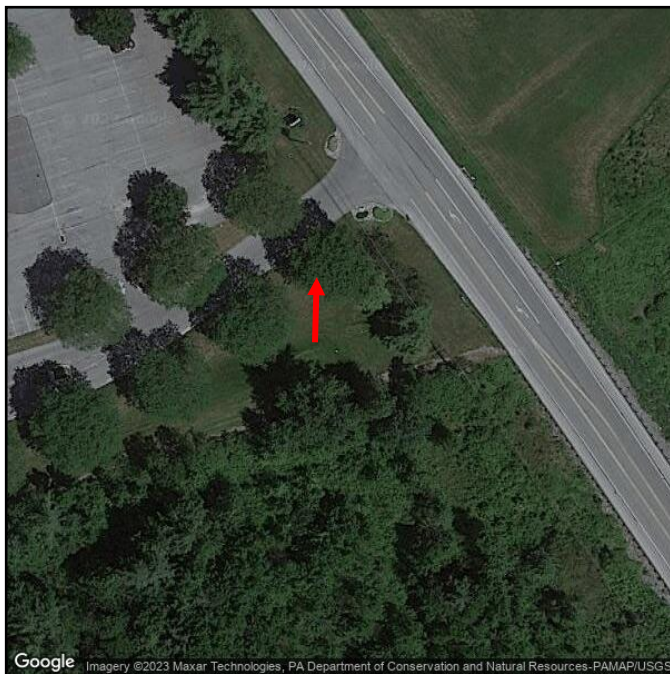
View of a polyvinyl chloride (PVC) pipe/vent sticking out of the ground. The Facility representative was unsure if this was connected to the catch basins in the previous photographs.

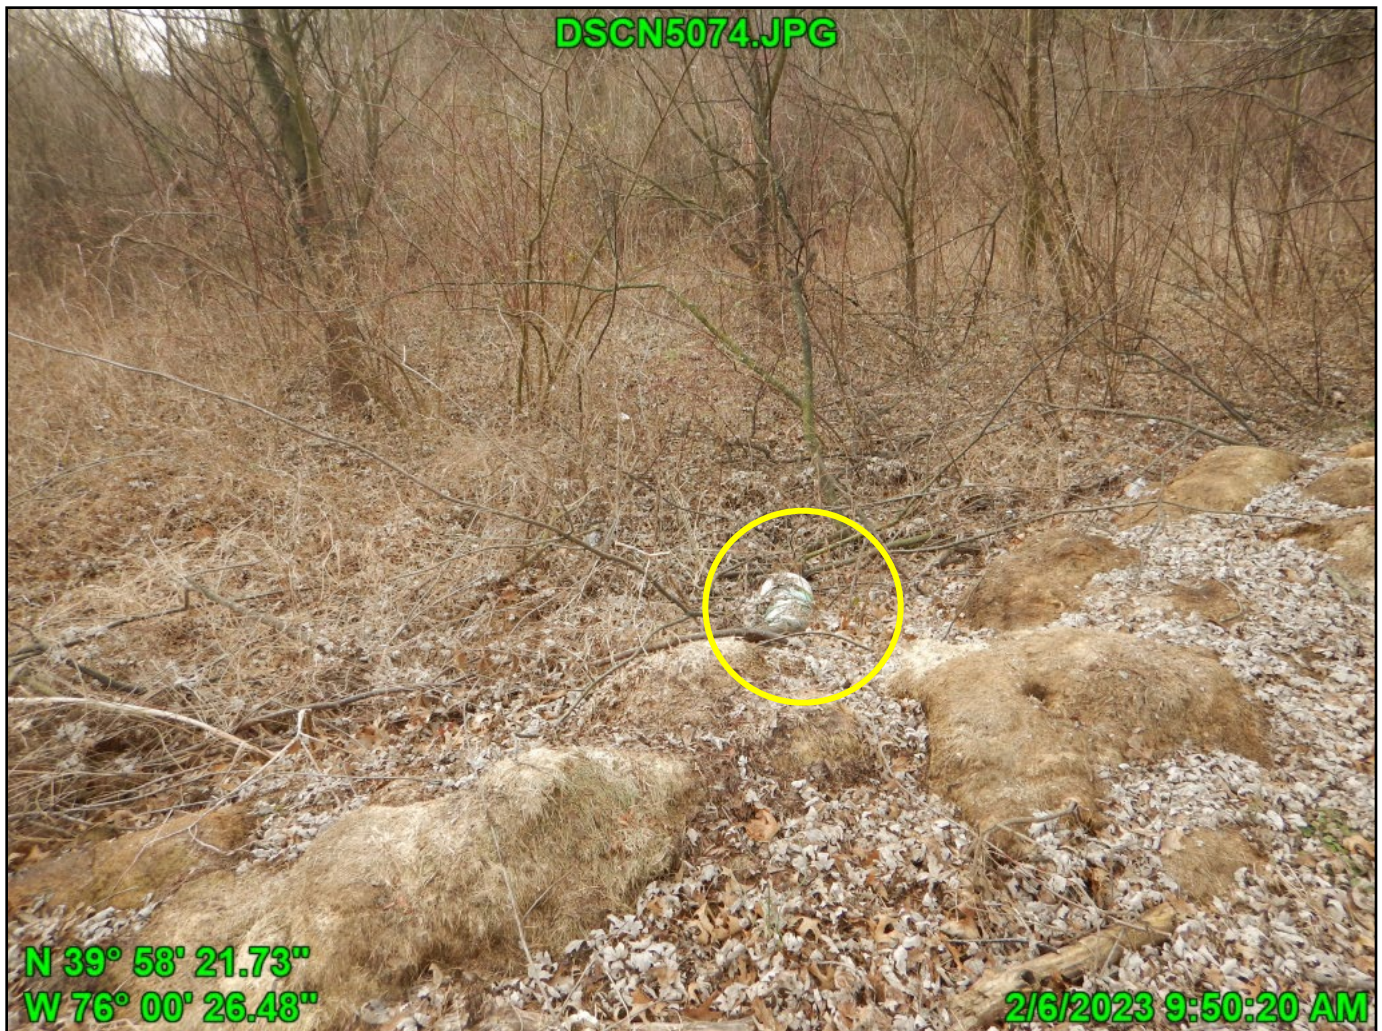
| Description | Stormwater outfall that, according to the Facility representative, discharges stormwater collected from the catch basins in the employee parking lot in Photographs DSCN5069, DSCN5070, and DSCN5072. |

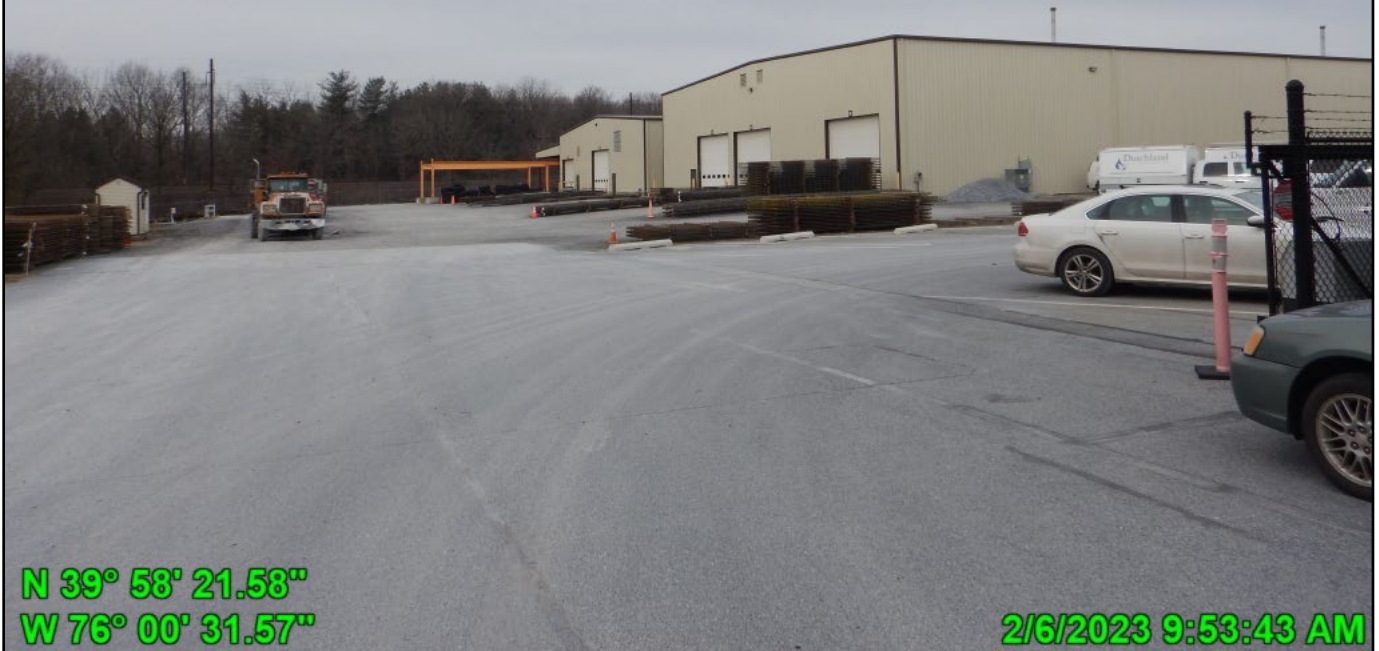
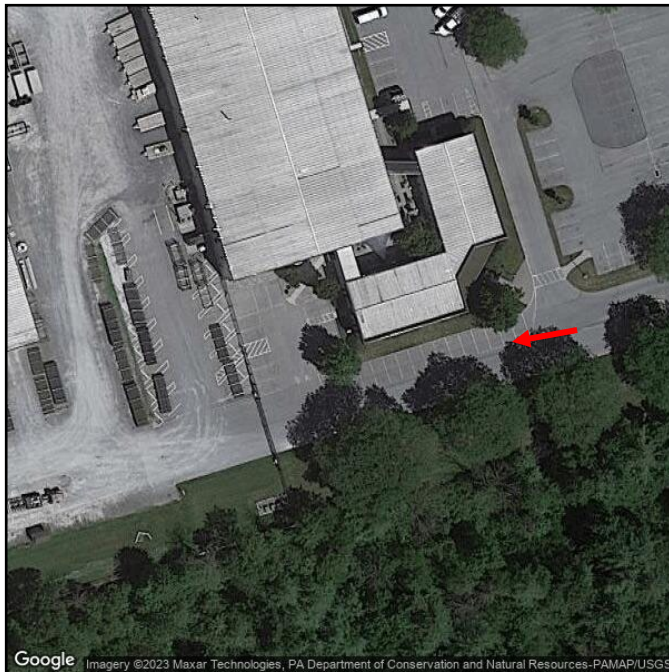
DSCN5076.JPG

| Description | Southwest portion of the Facility where loading/unloading operations take place. |

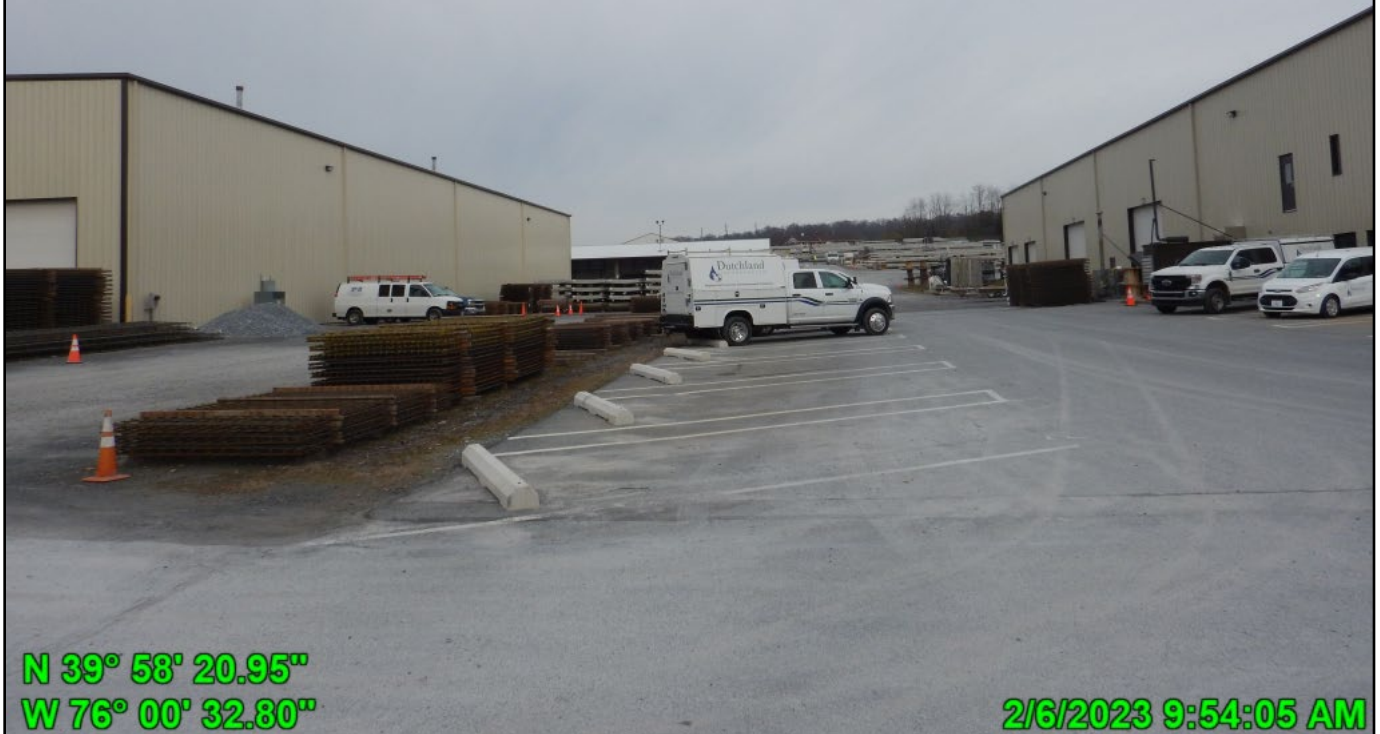
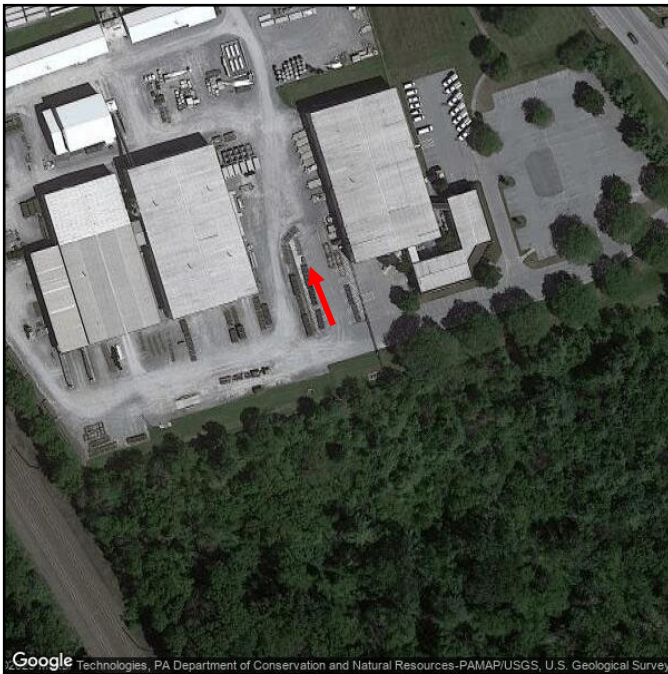
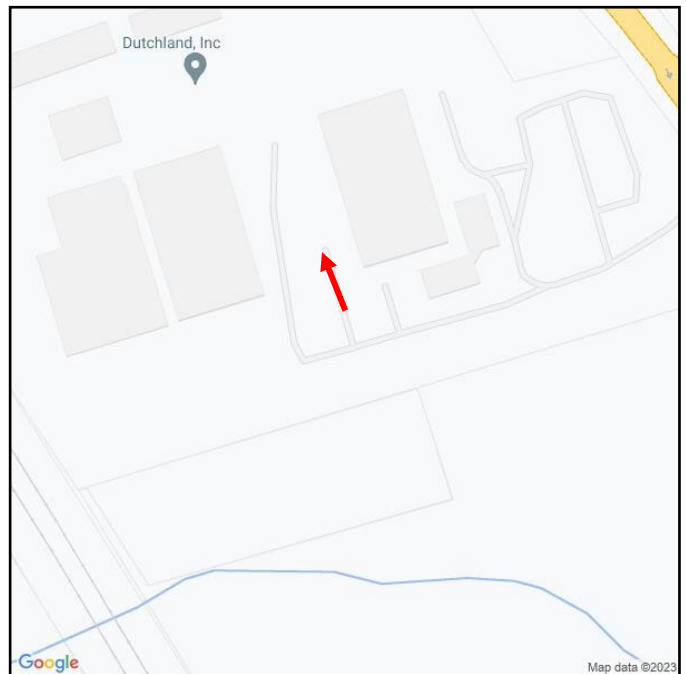
DSCN5077.JPG

| Description | Facility-owned vehicles were parked outside between two Facility manufacturing buildings. |

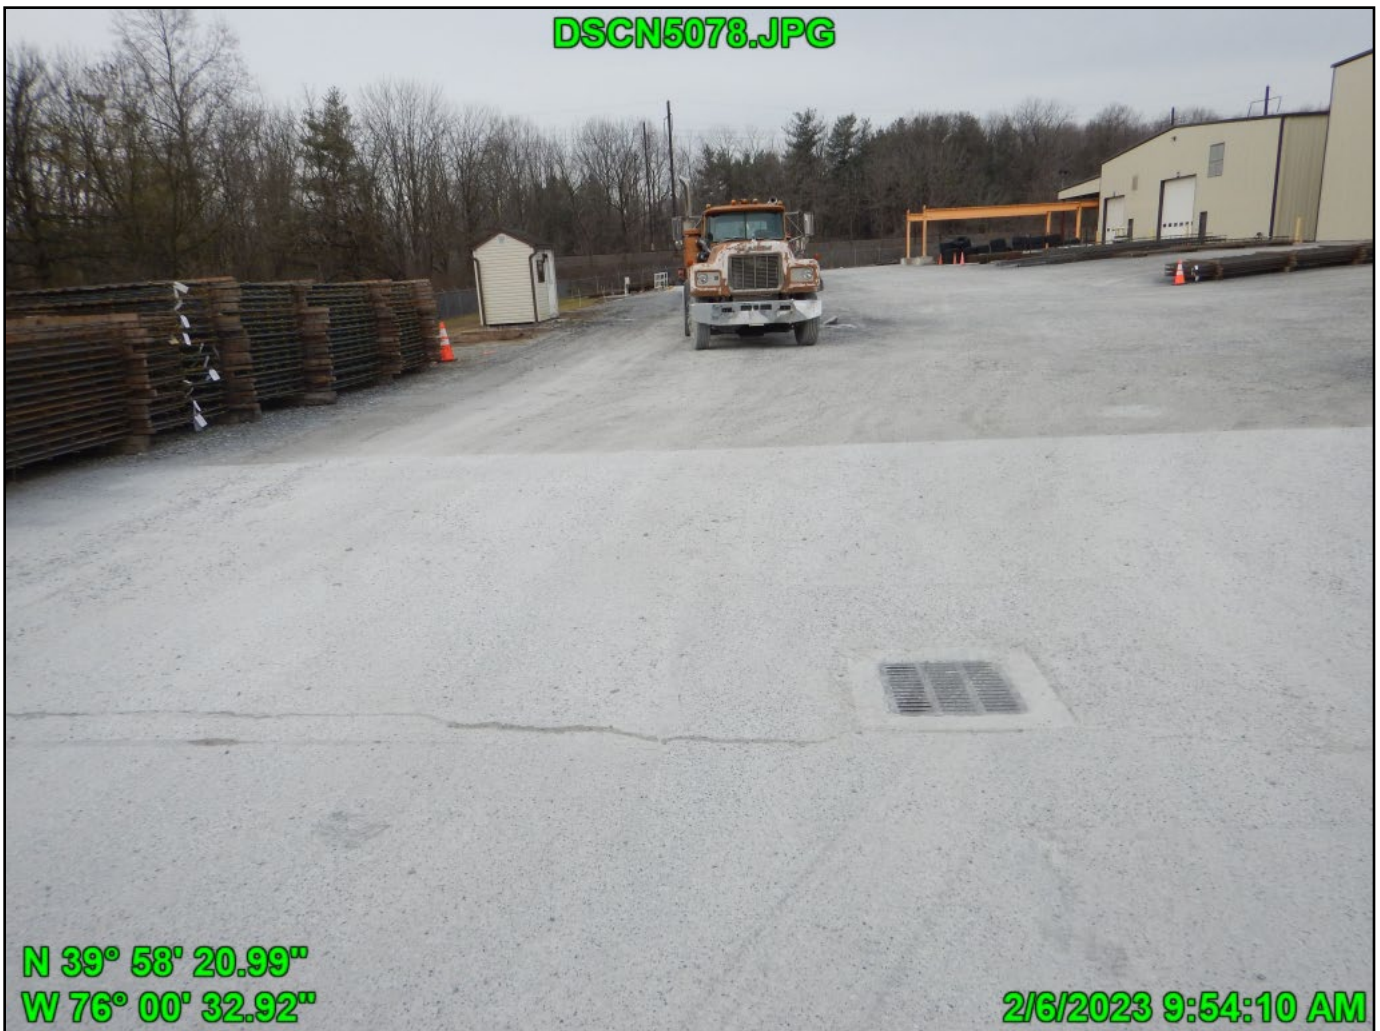
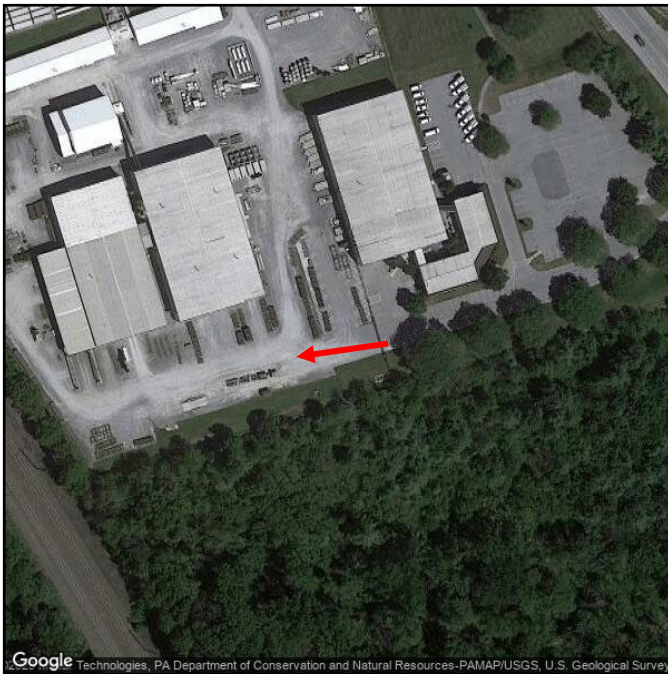
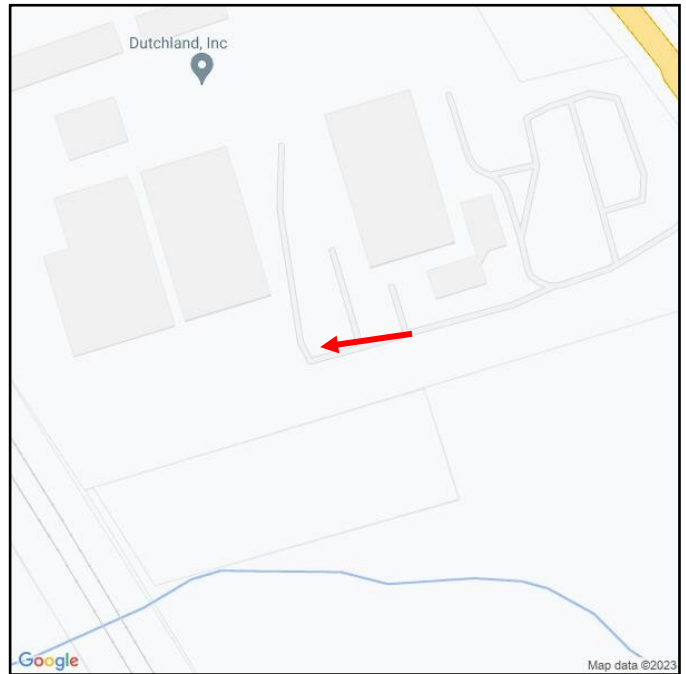
| Description | Catch basin that connects to a drainage swale to the south, prior to discharging offsite. |

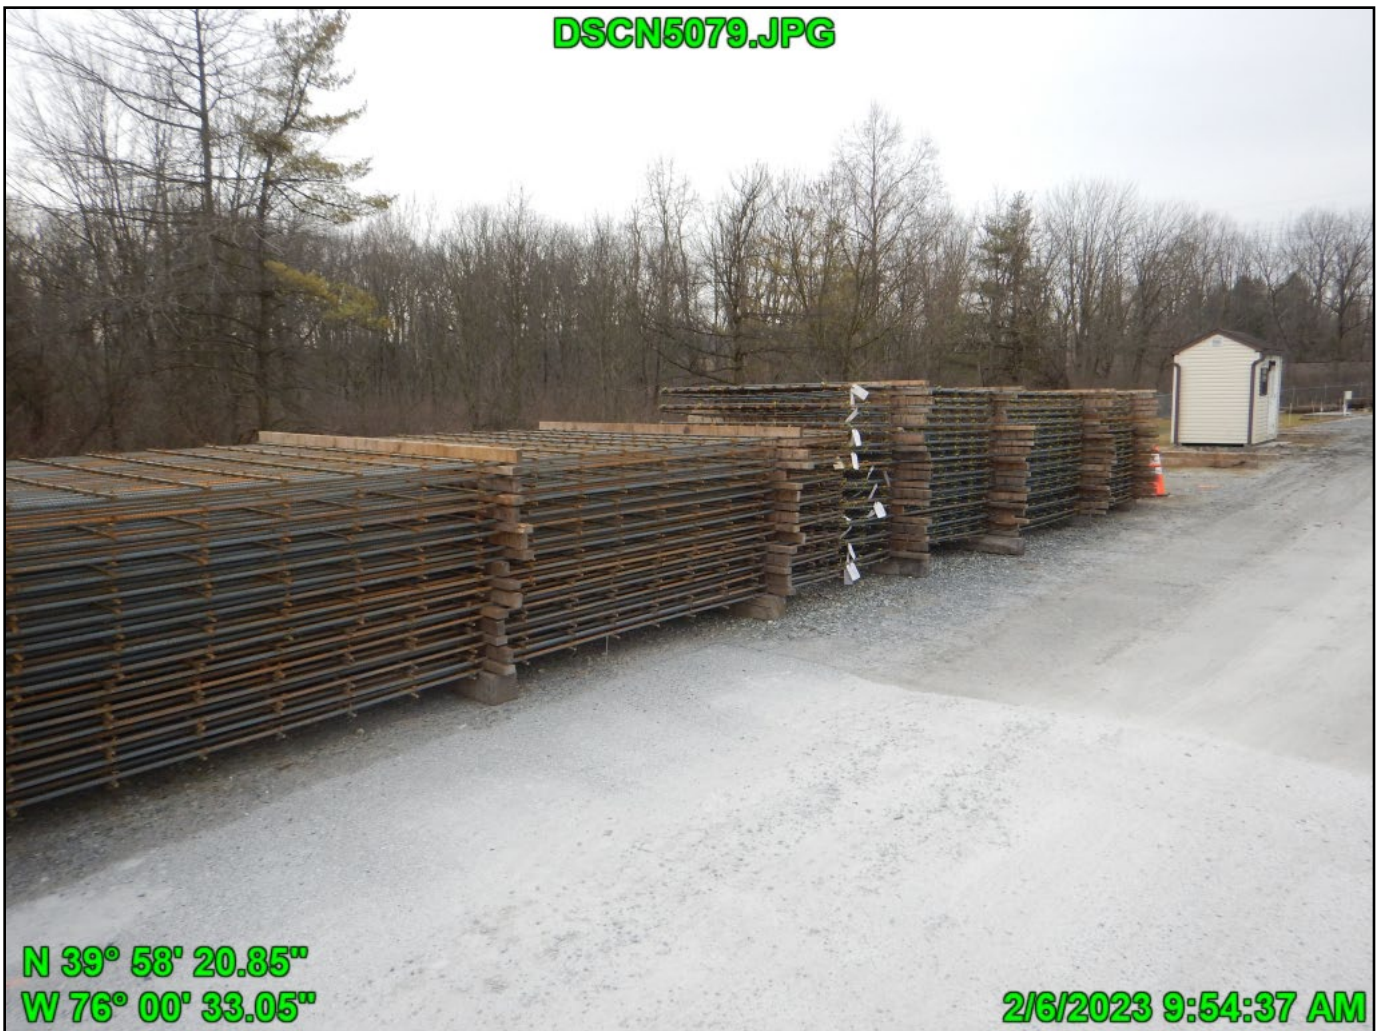
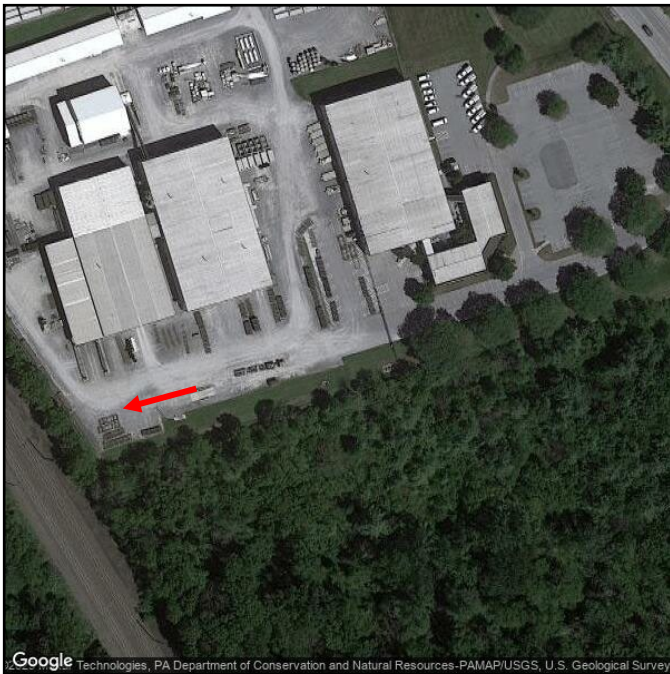
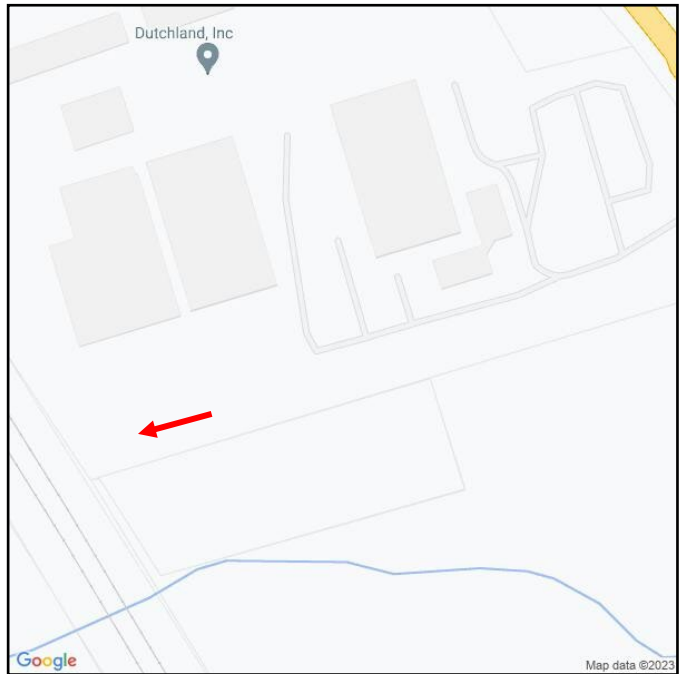
| <b>Pollutant Sources</b> | <b>Observations</b> |
|---|---|
| <b>Storage of Industrial Materials or Products</b> | The EPA Inspection Team observed covered and uncovered storage areas for industrial materials (e.g., wood, steel rebar, metal casing), (refer to <u>Appendix B, Photographs DSCN5079, DSCN5091, DSCN5118, DSCN5138, DSCN5147, and DSCN5148</u> ). |

| Description | Outdoor steel casings materials storage. |

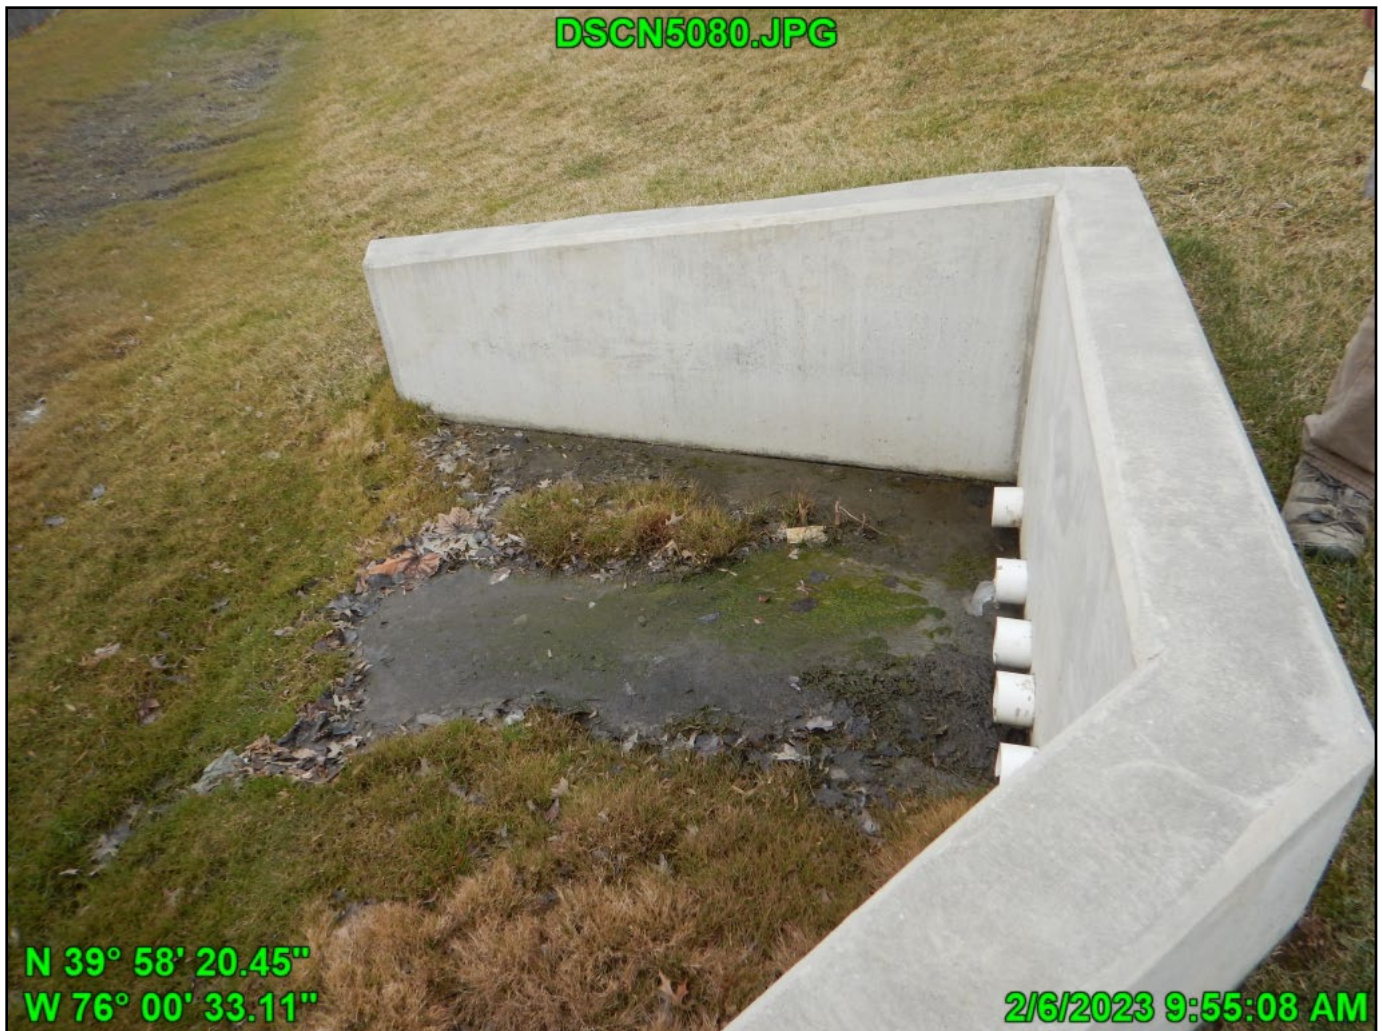
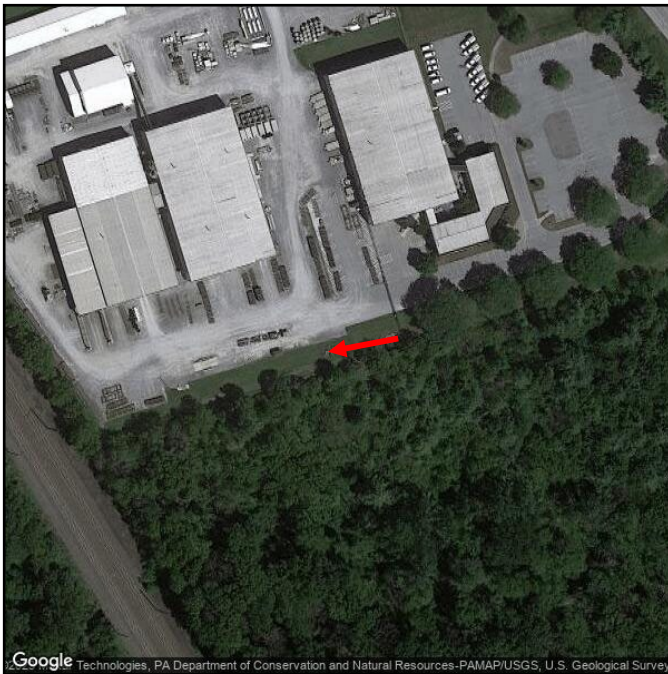
| Description | Headwall and outlet structure that conveys stormwater from onsite catch basins into a drainage swale along the Facility's south boundary. Stormwater is conveyed from upgradient catch basins that are in the loading/unloading area. |

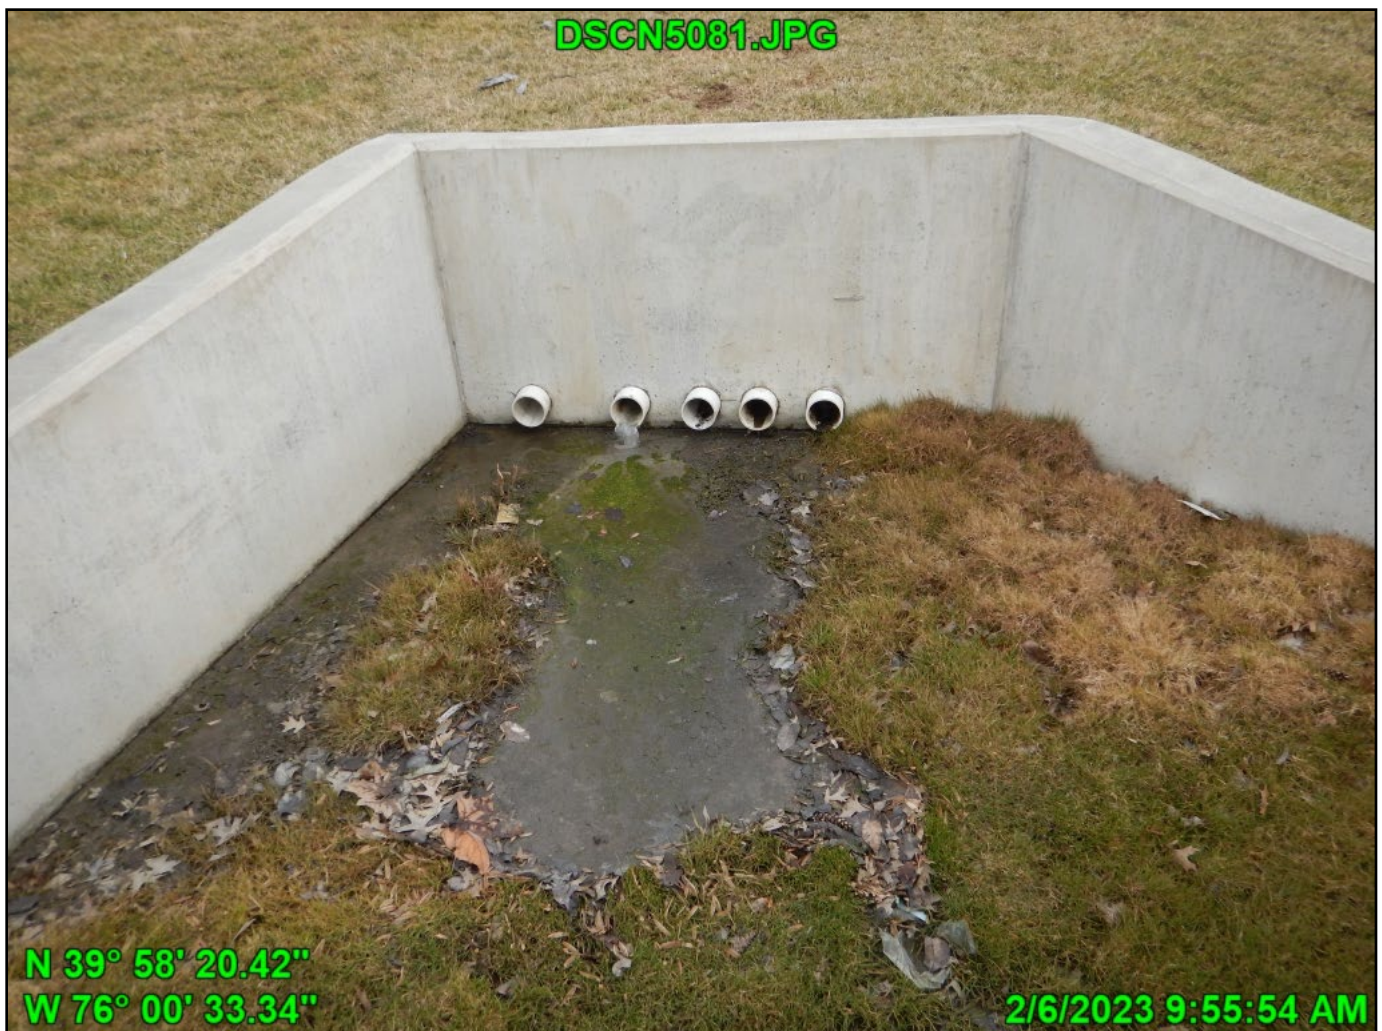
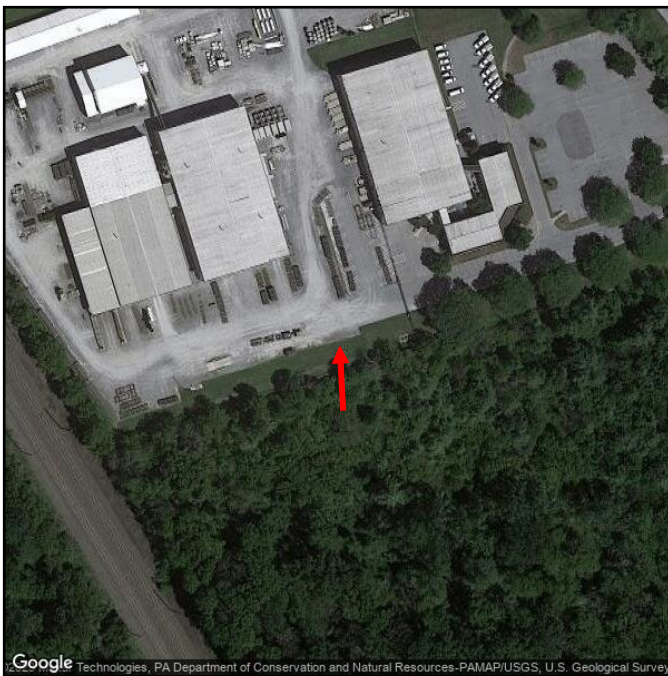
| <b>Description</b> | Additional view of the headwall and outlet structure shown in Photograph DSCN5080. There were no visible pollutants. |

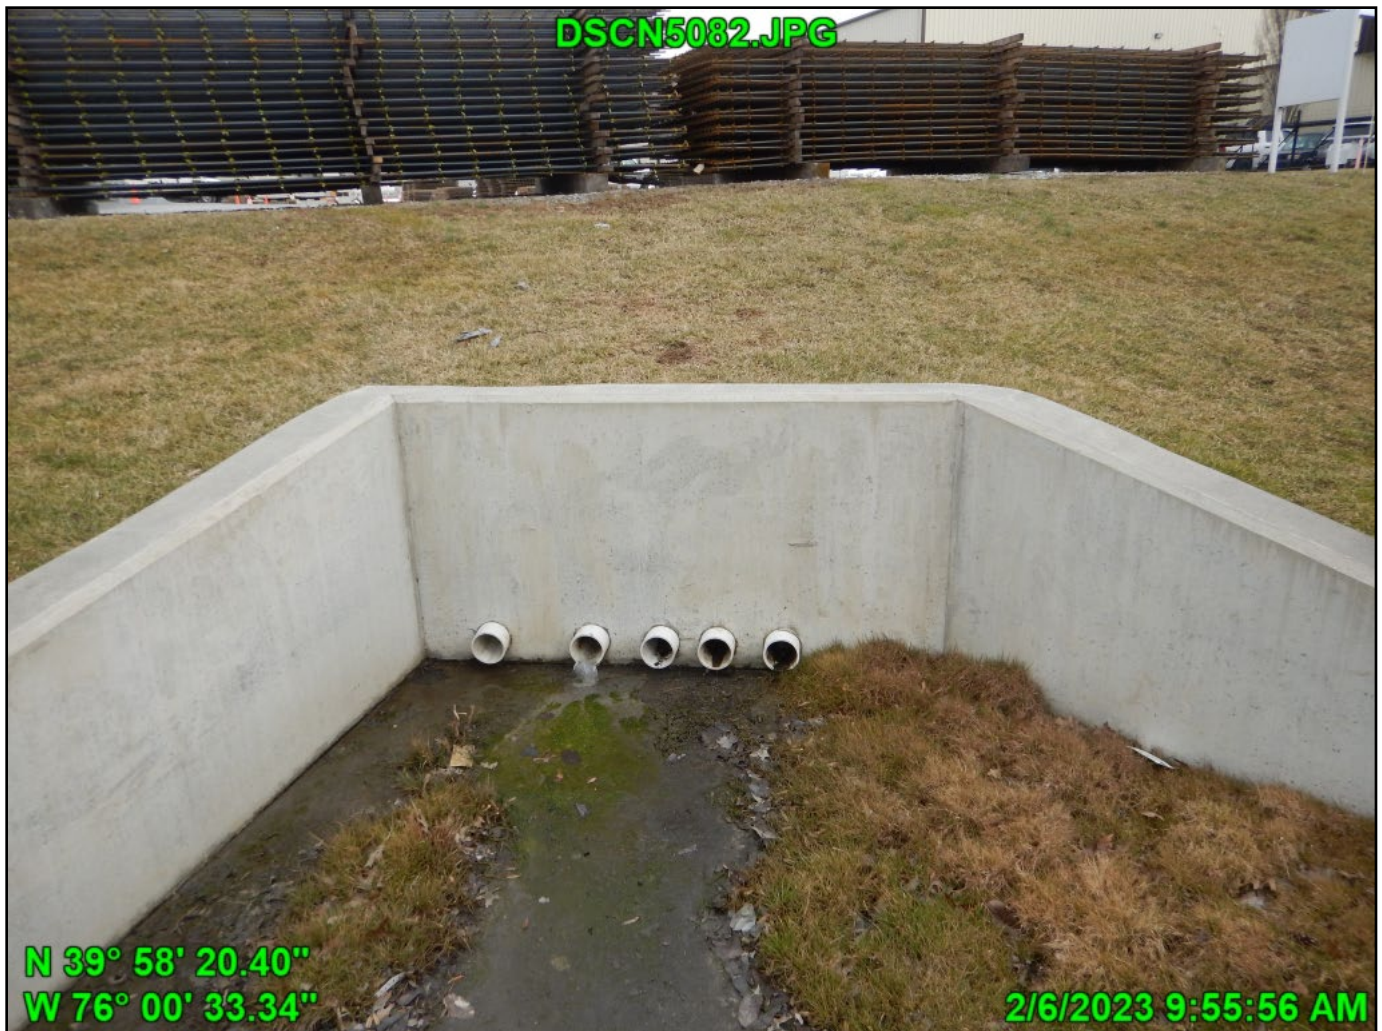
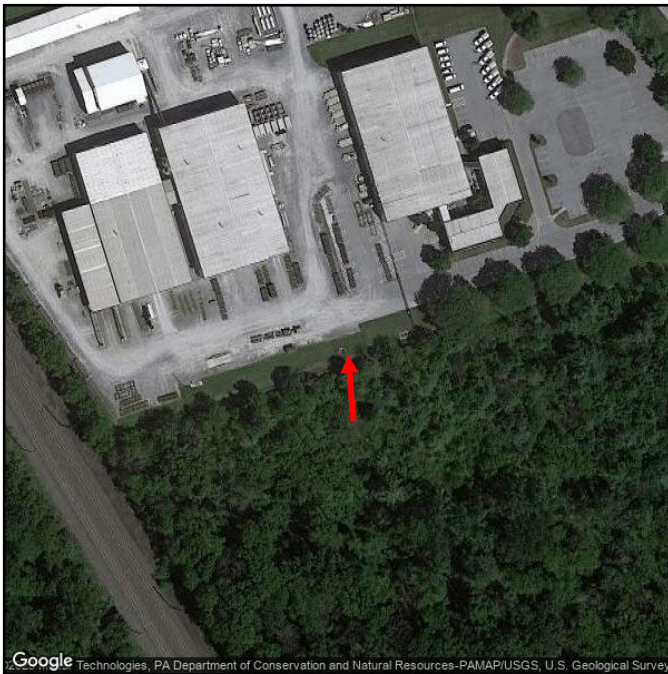
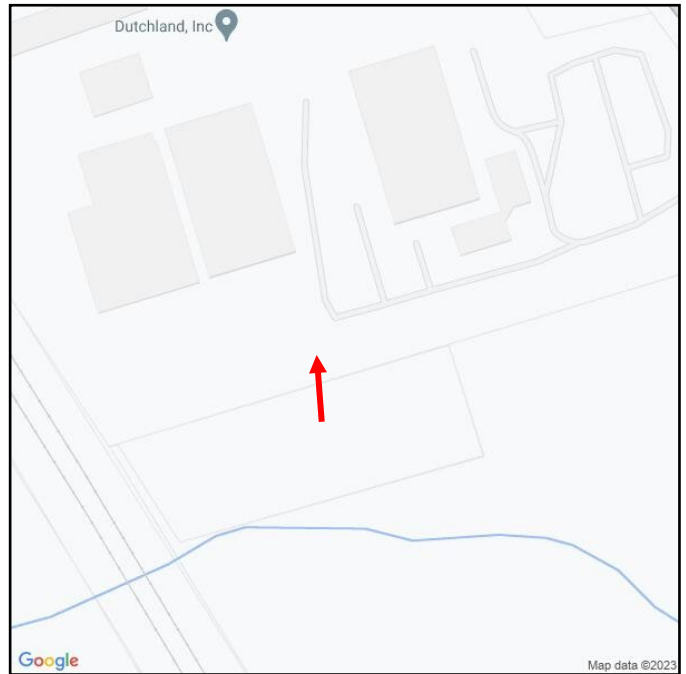
| Description | Additional view of the headwall and outlet structure as shown in Photographs DSCN5080 and DSCN5081. |
