## MULTI-SECTOR GENERAL PERMIT NON-FILER INSPECTION CHECKLIST

| <b>Inspection Date(s):</b> | 2/7/2023 | |
| <b>Operator Name:</b> | Dutchland, Inc. | |

Stormwater Inspection Date: February 7, 2023

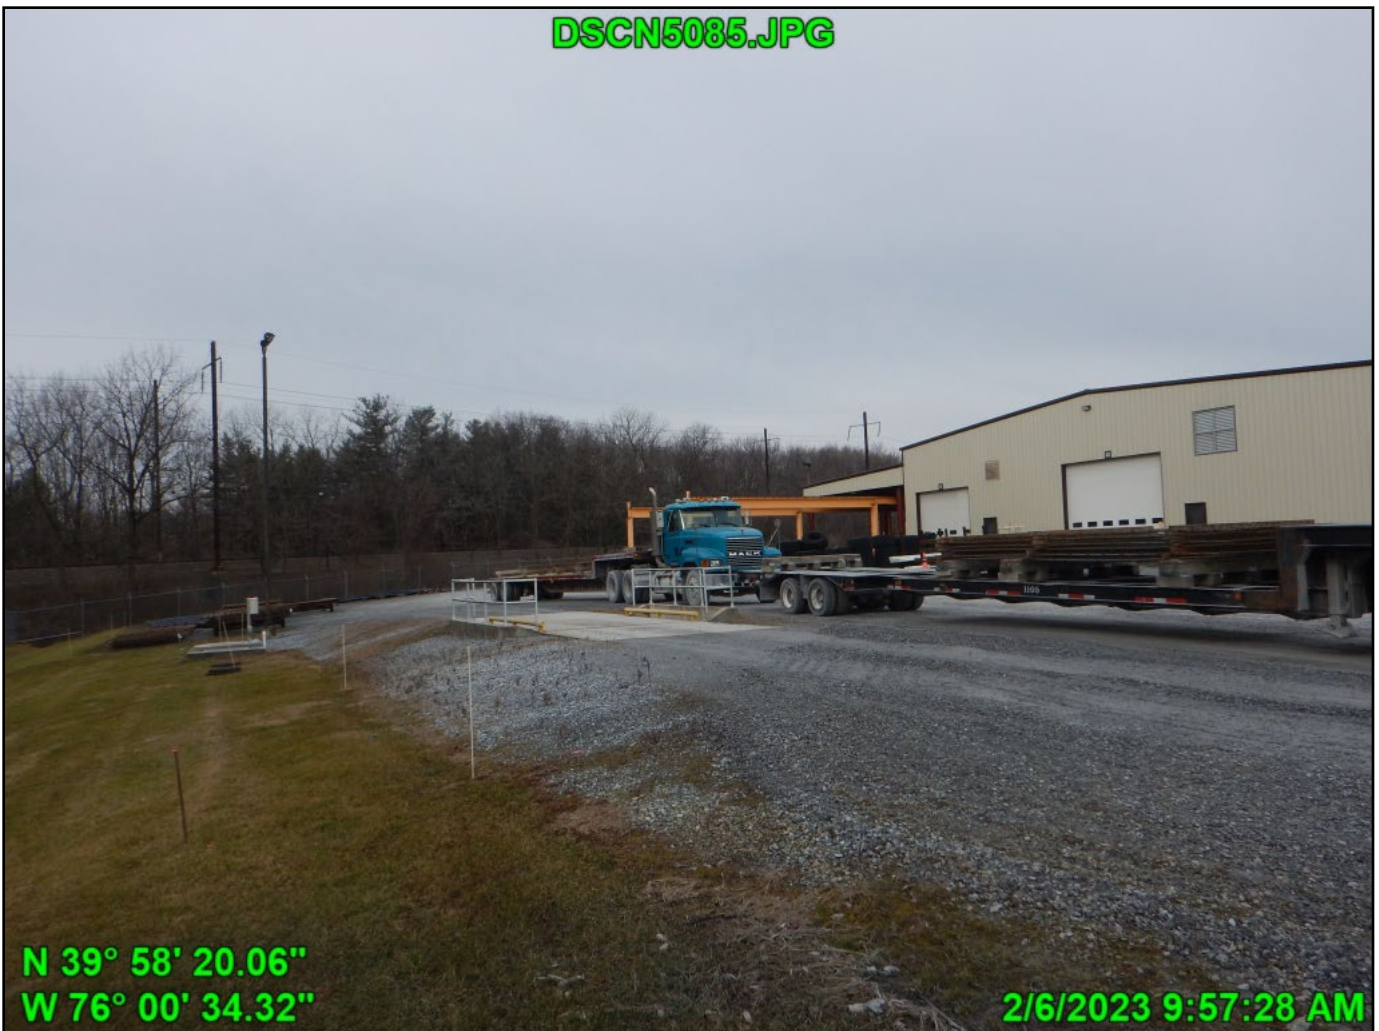
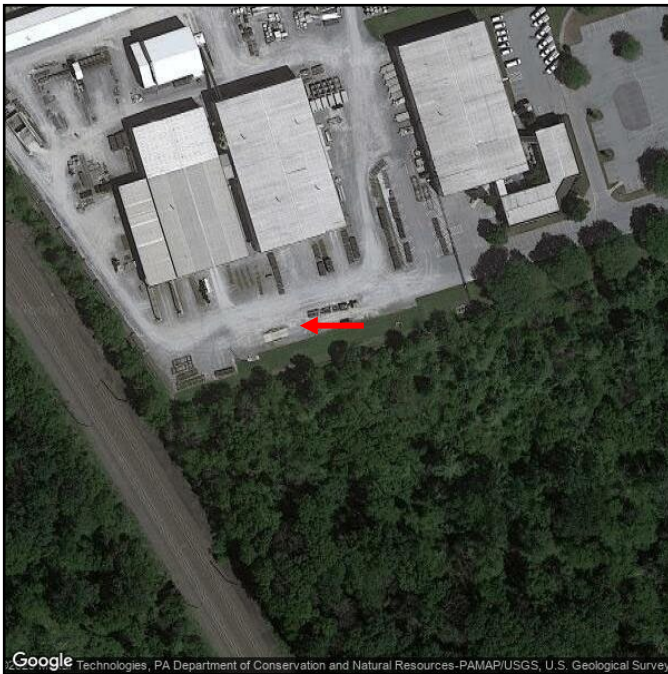
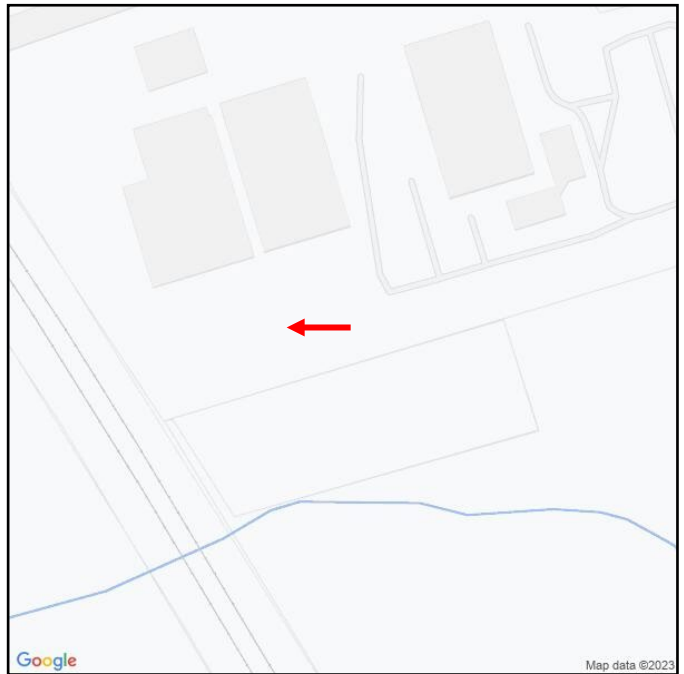
DSCN5085.JPG

| Description | Truck scale in the southwest corner of the Facility. |

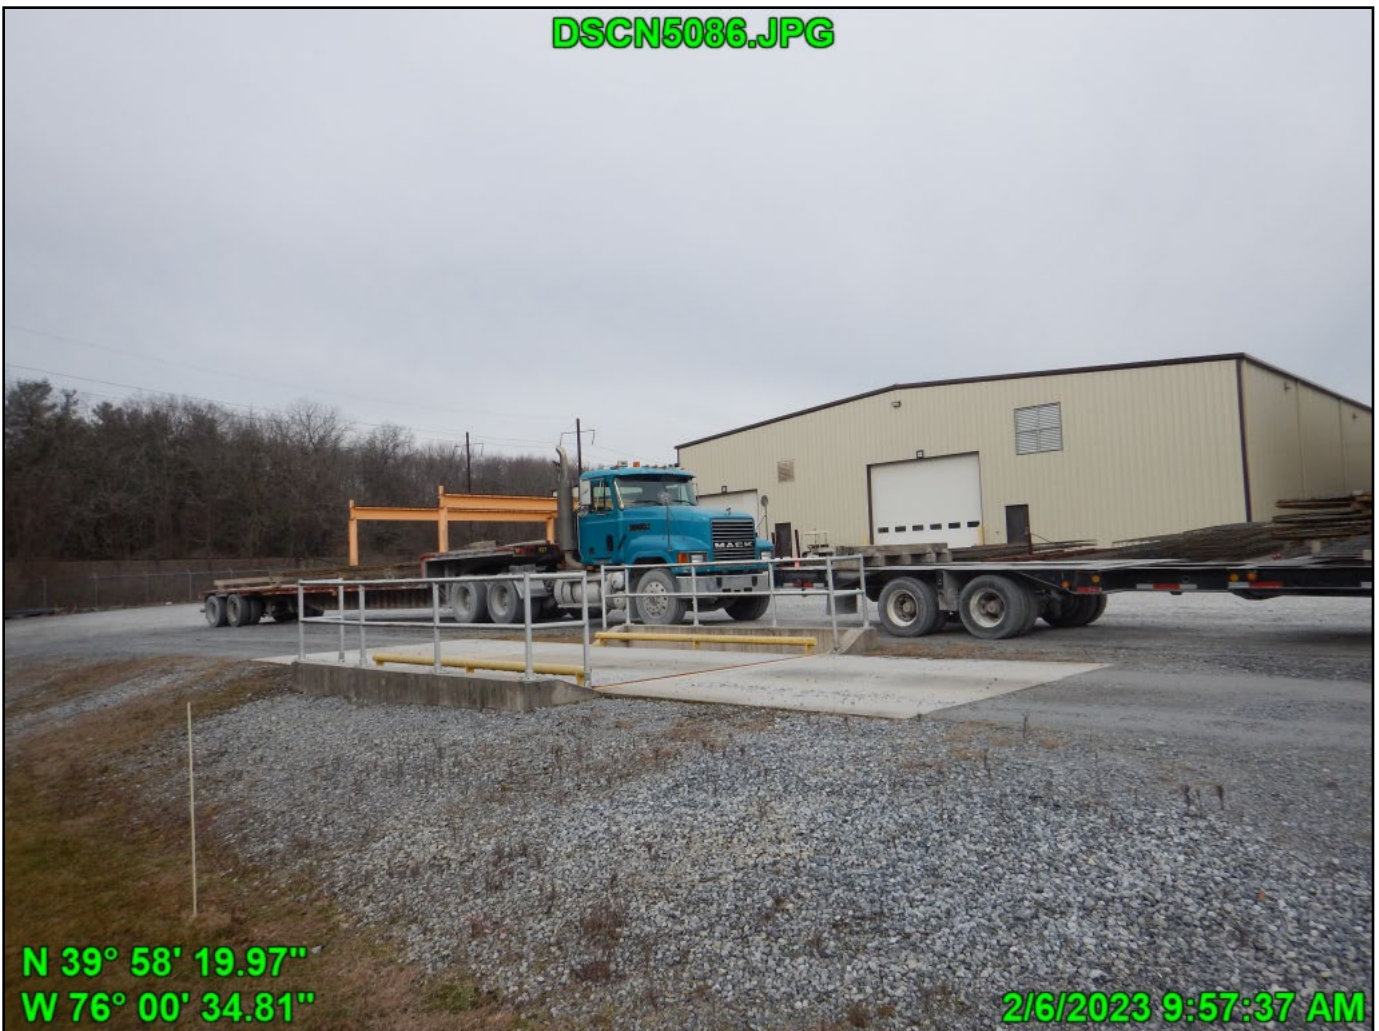
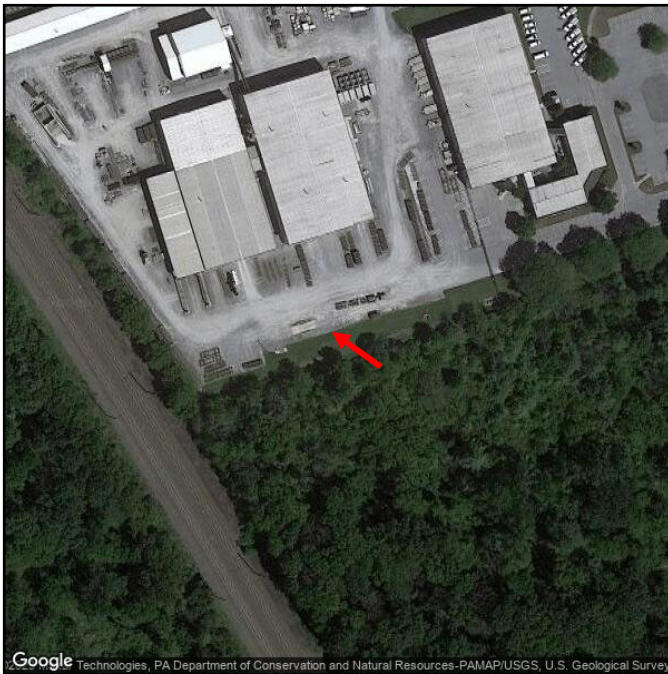
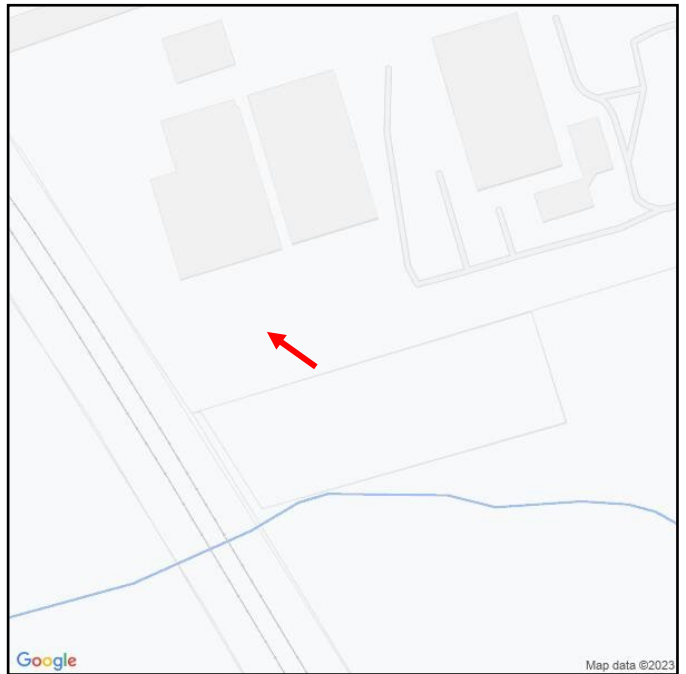
DSCN5086.JPG

| Description | Closer view of the truck scale shown in Photograph DSCN5085. |

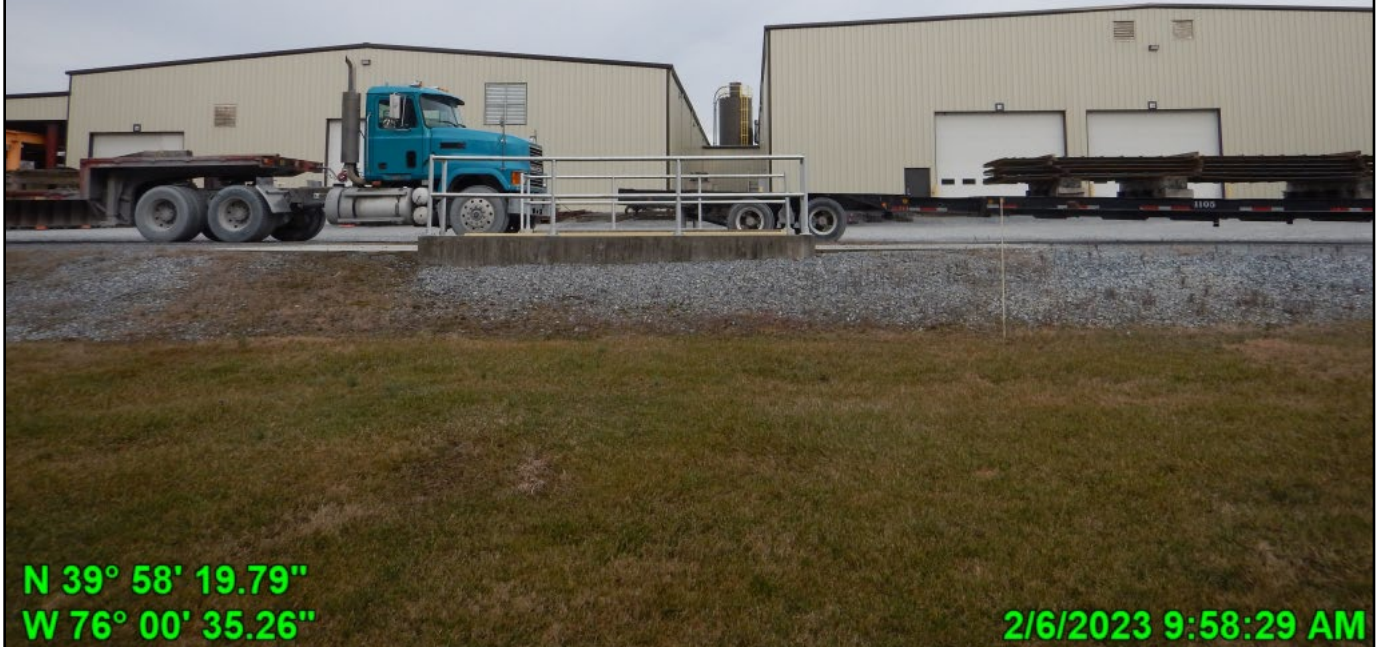
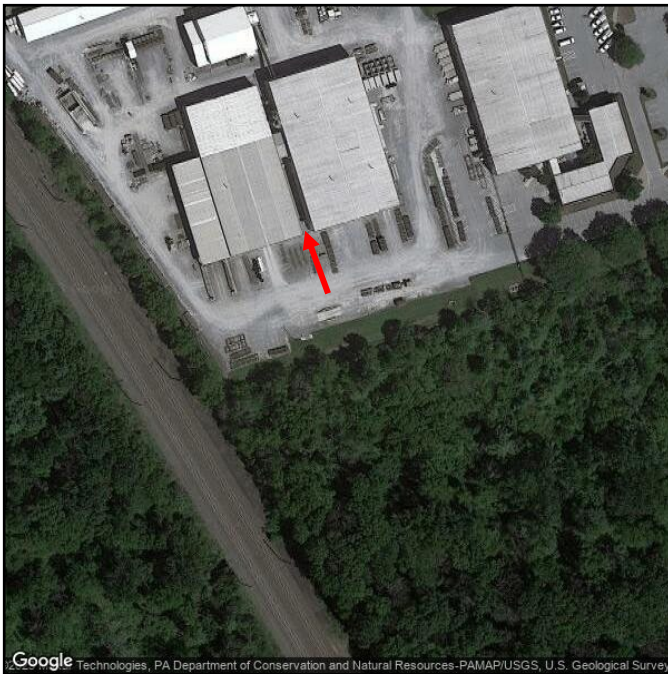
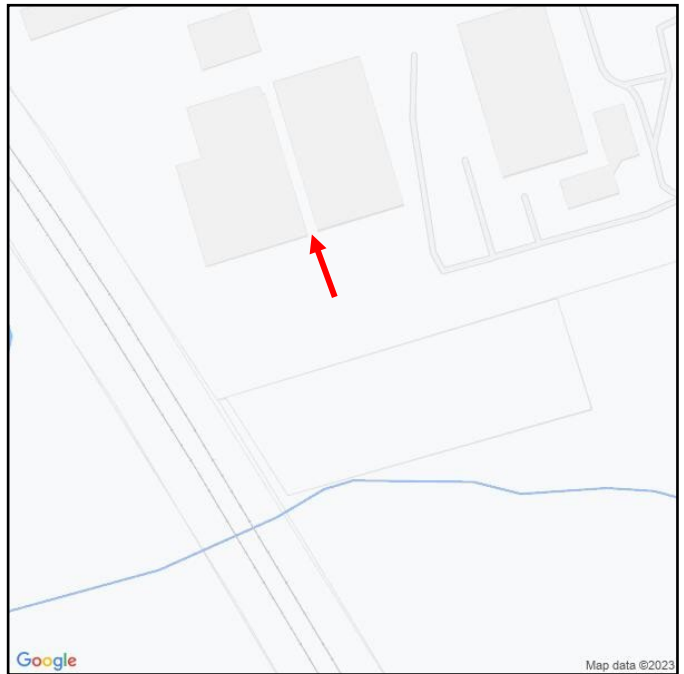
DSCN5087.JPG

| Description |
| Manufacturing buildings in the southwest portion of the Facility. |

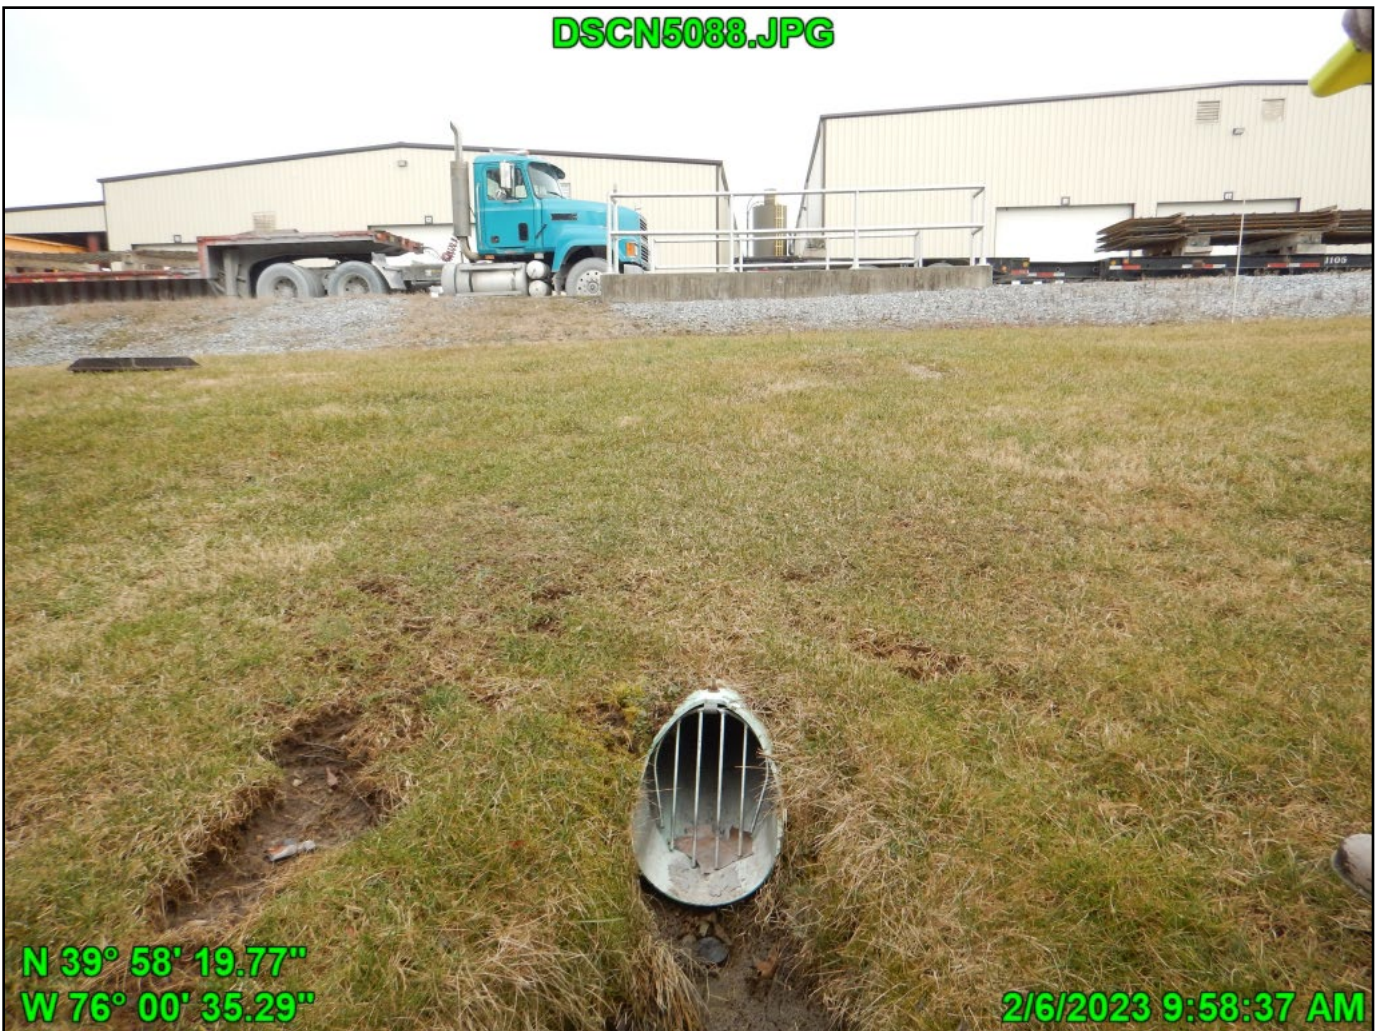
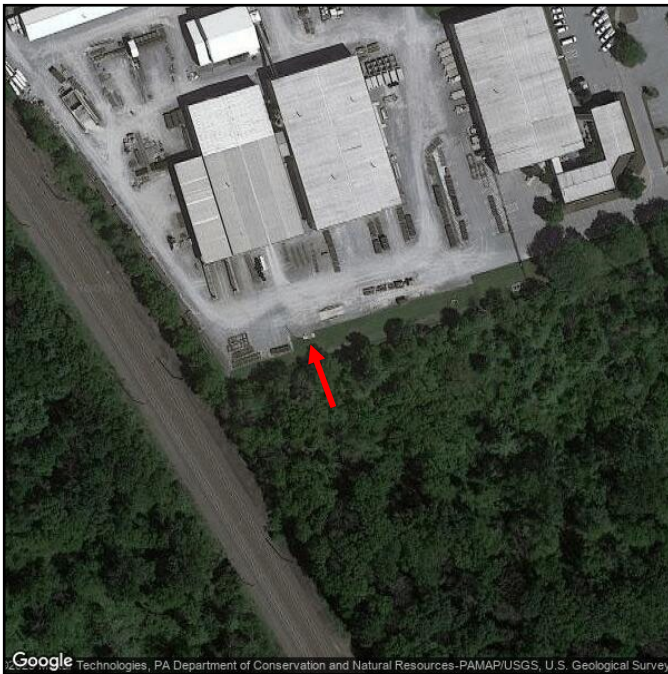
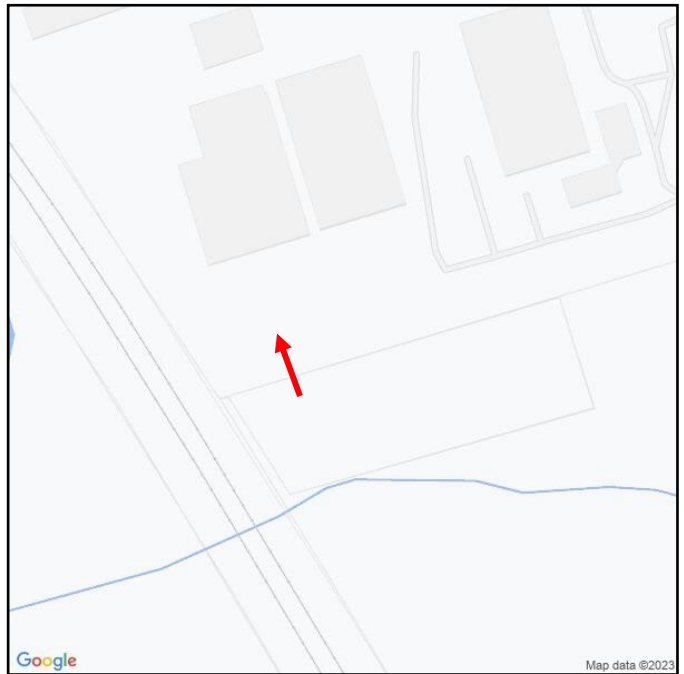
DSCN5088.JPG

| Description | Outlet pipe leading from upgradient catch basins. |

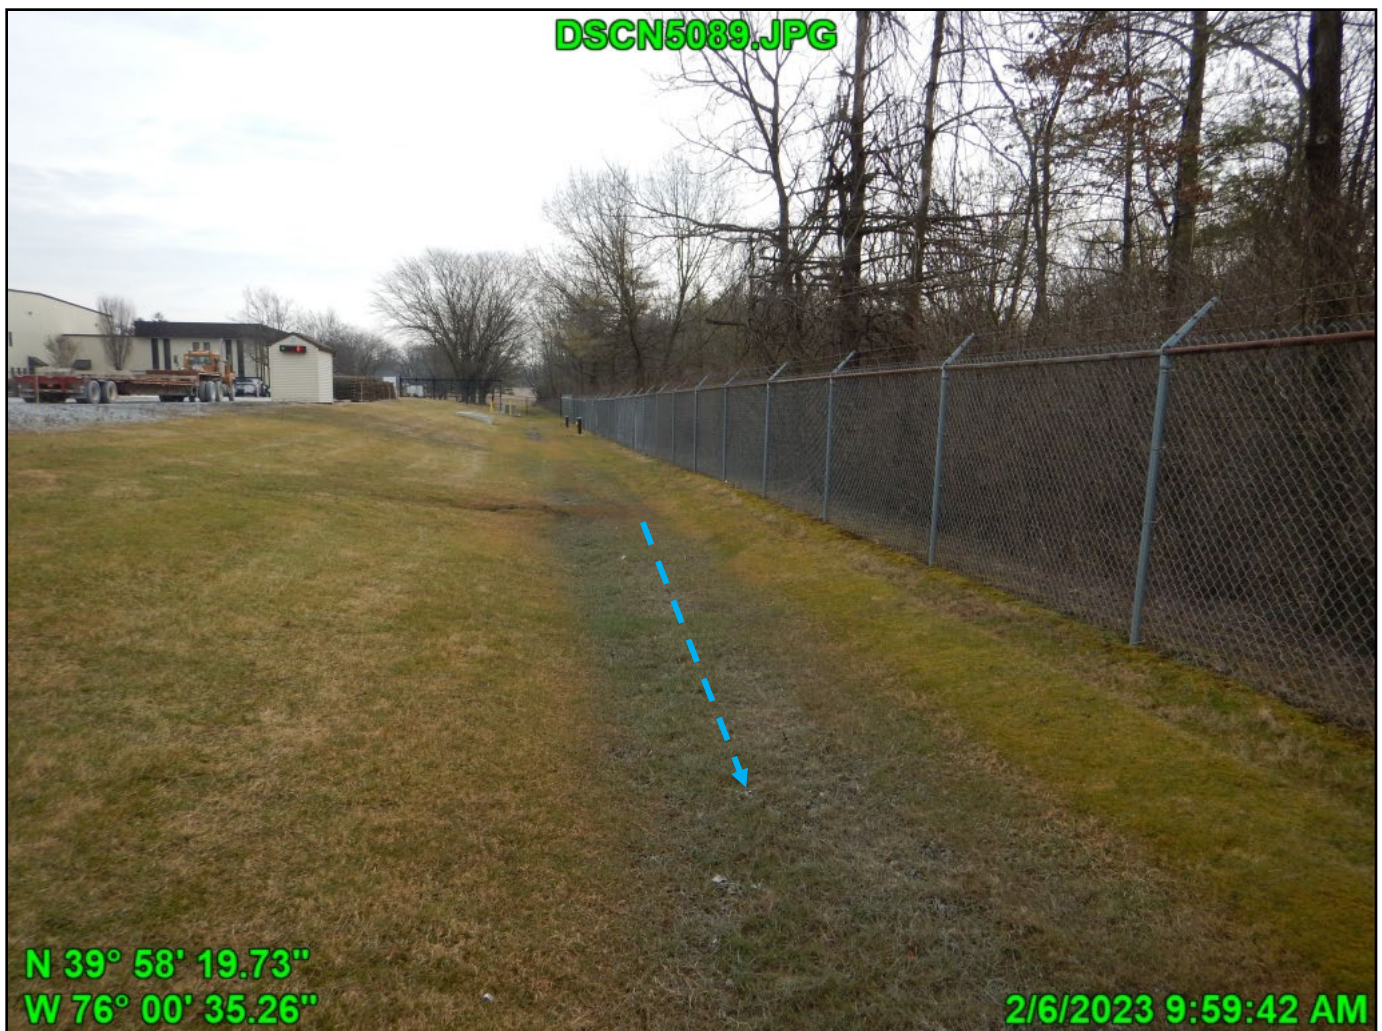
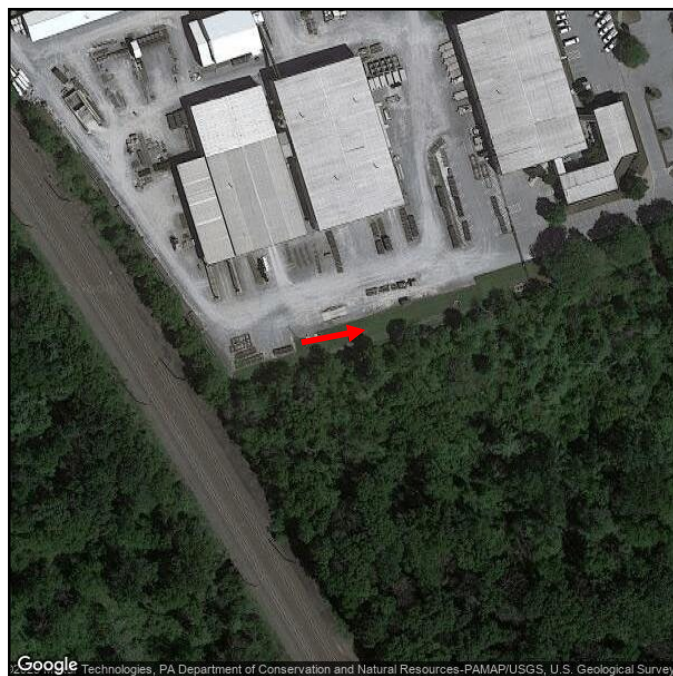
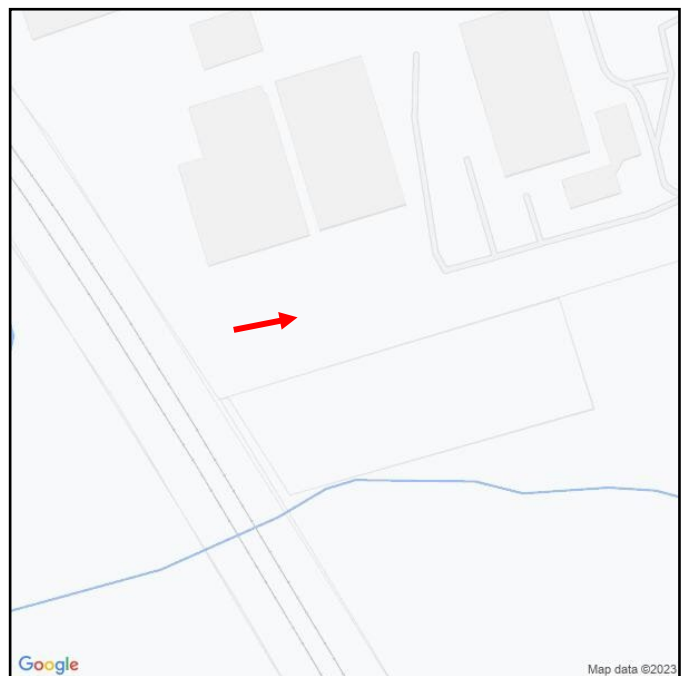
| Description | Upgradient view of the drainage swale along the Facility's south boundary. Note the estimated stormwater flow direction. There appeared to be dark discoloration in the swale. |

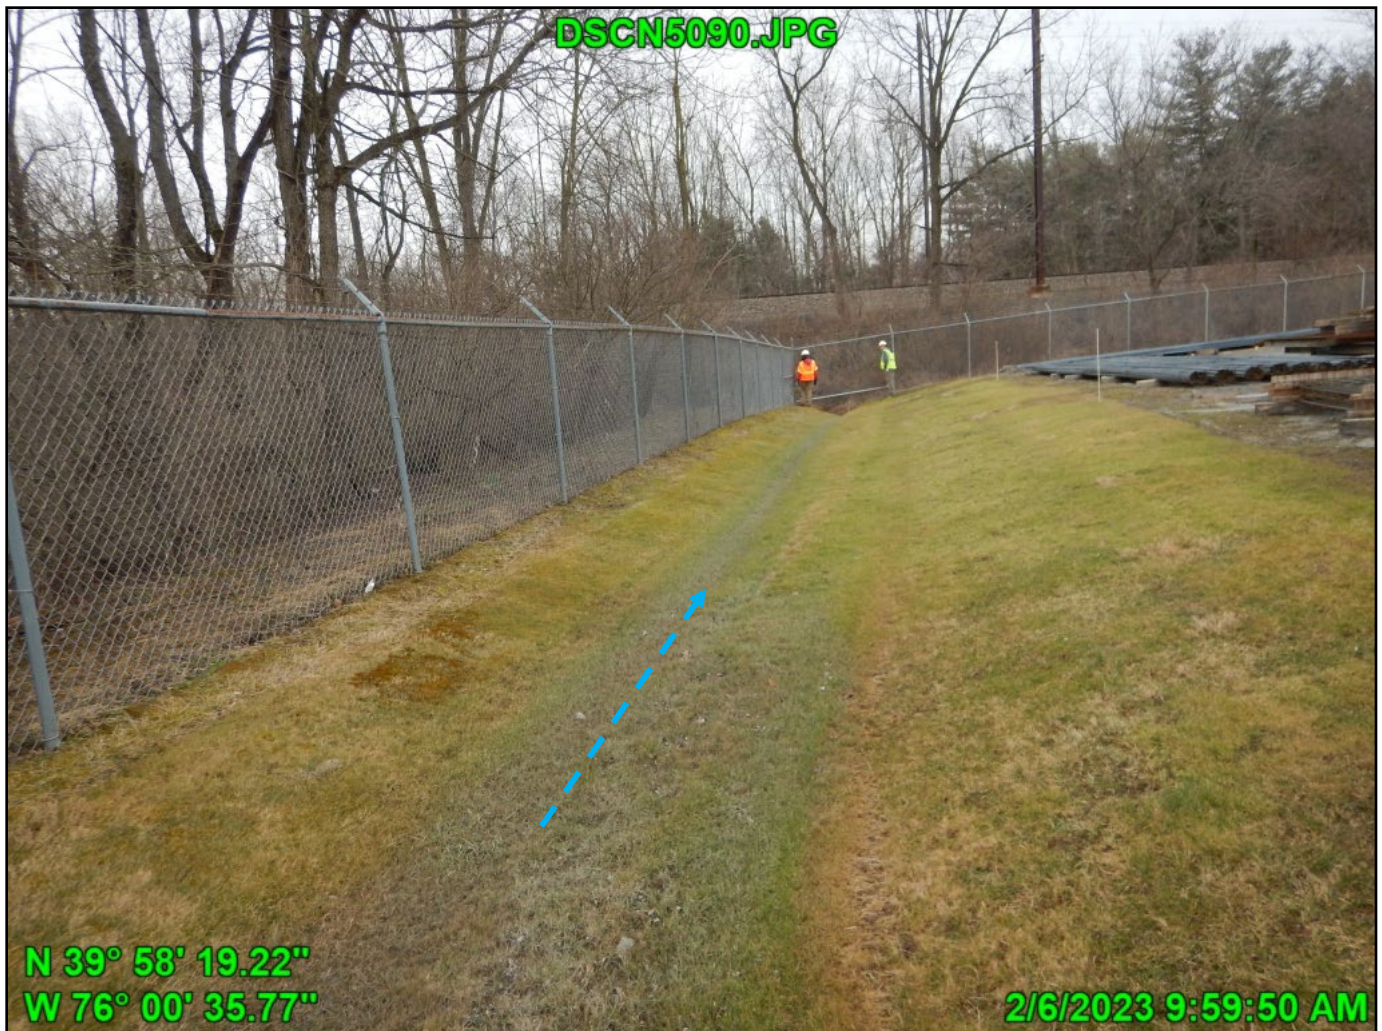
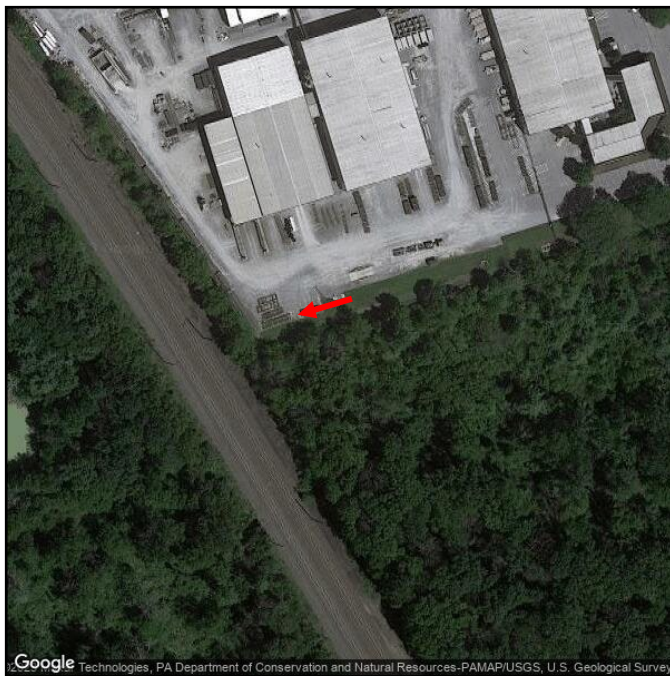
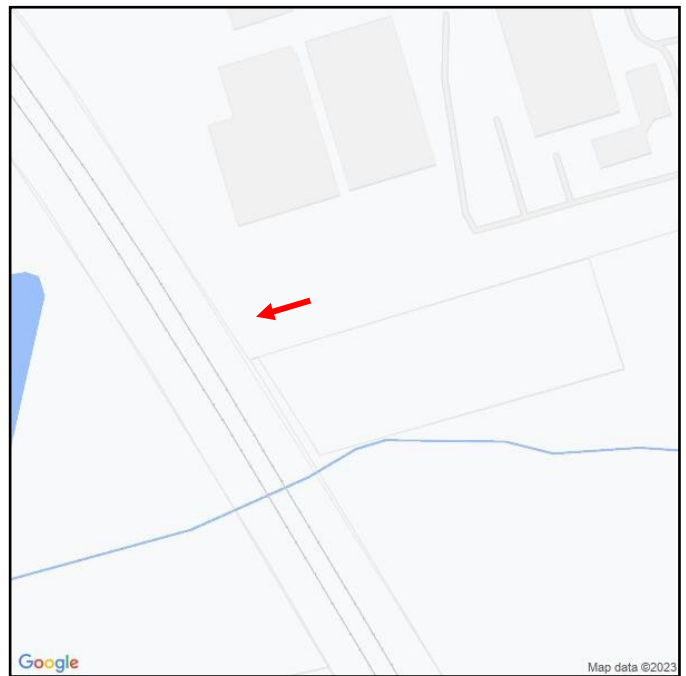
| Description | Downgradient view of the drainage swale along the Facility's south boundary. |

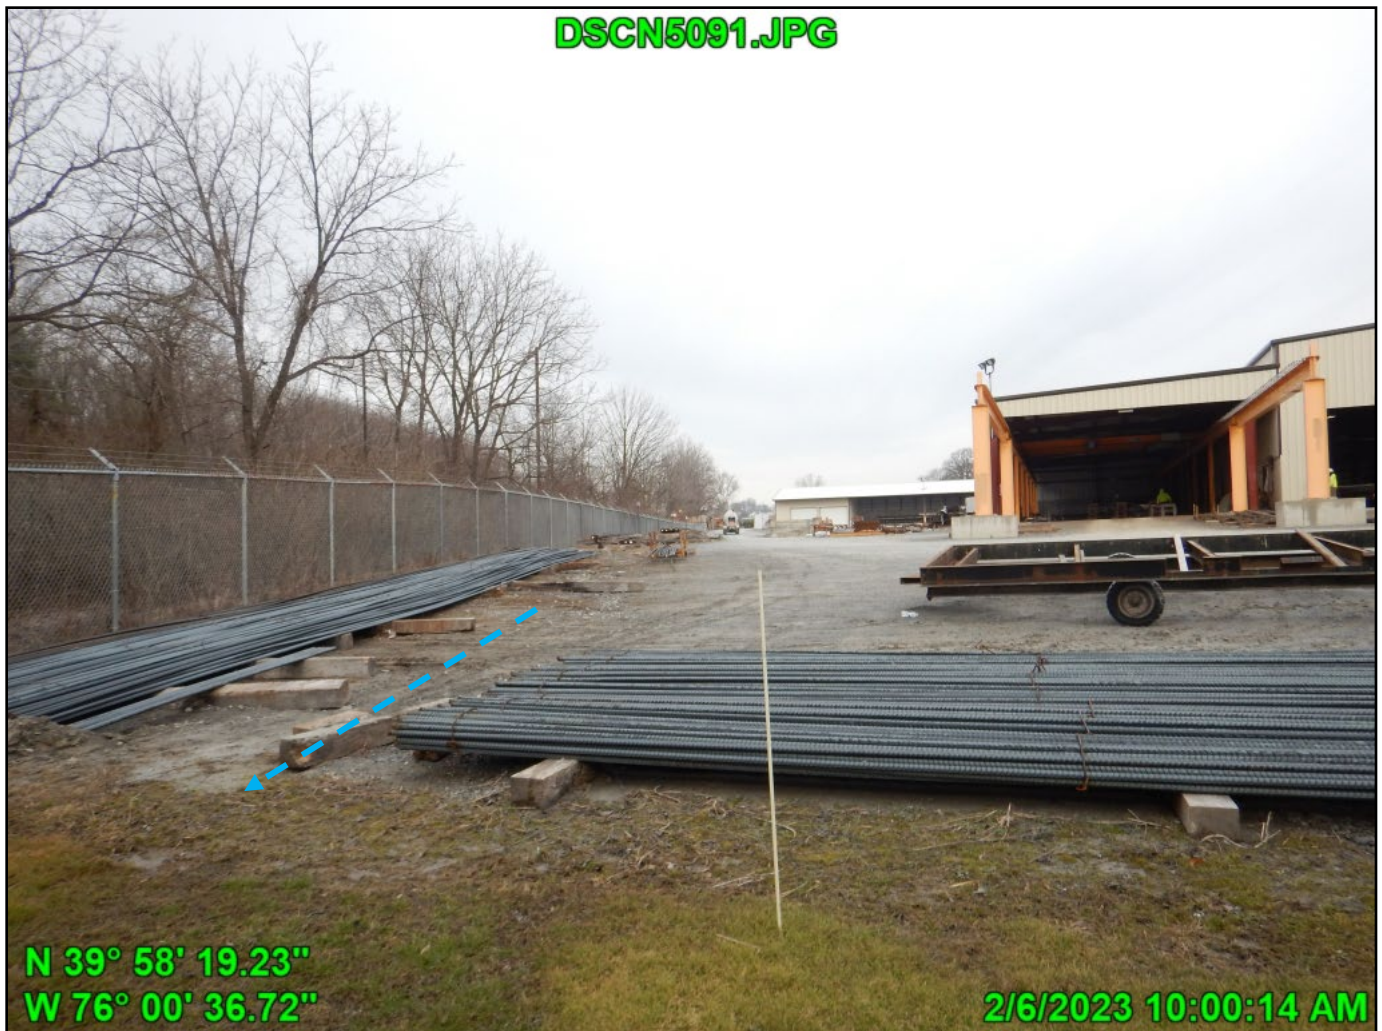
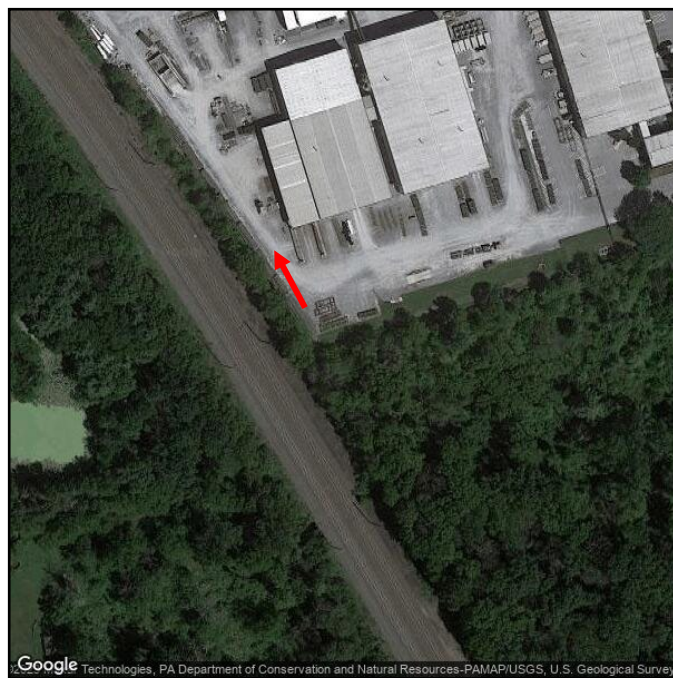
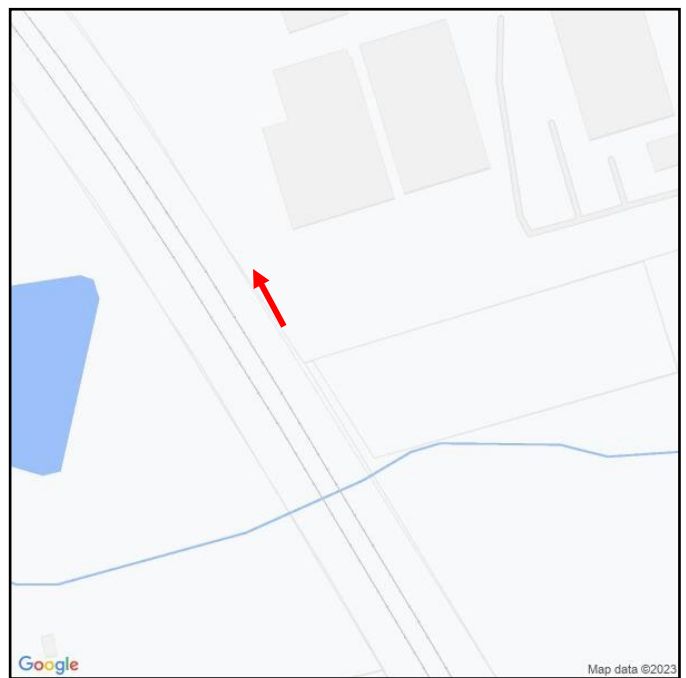
| Description | Upgradient view of steel rebar materials stored outdoors along the Facility's west fence line. Note the estimated stormwater flow direction. |

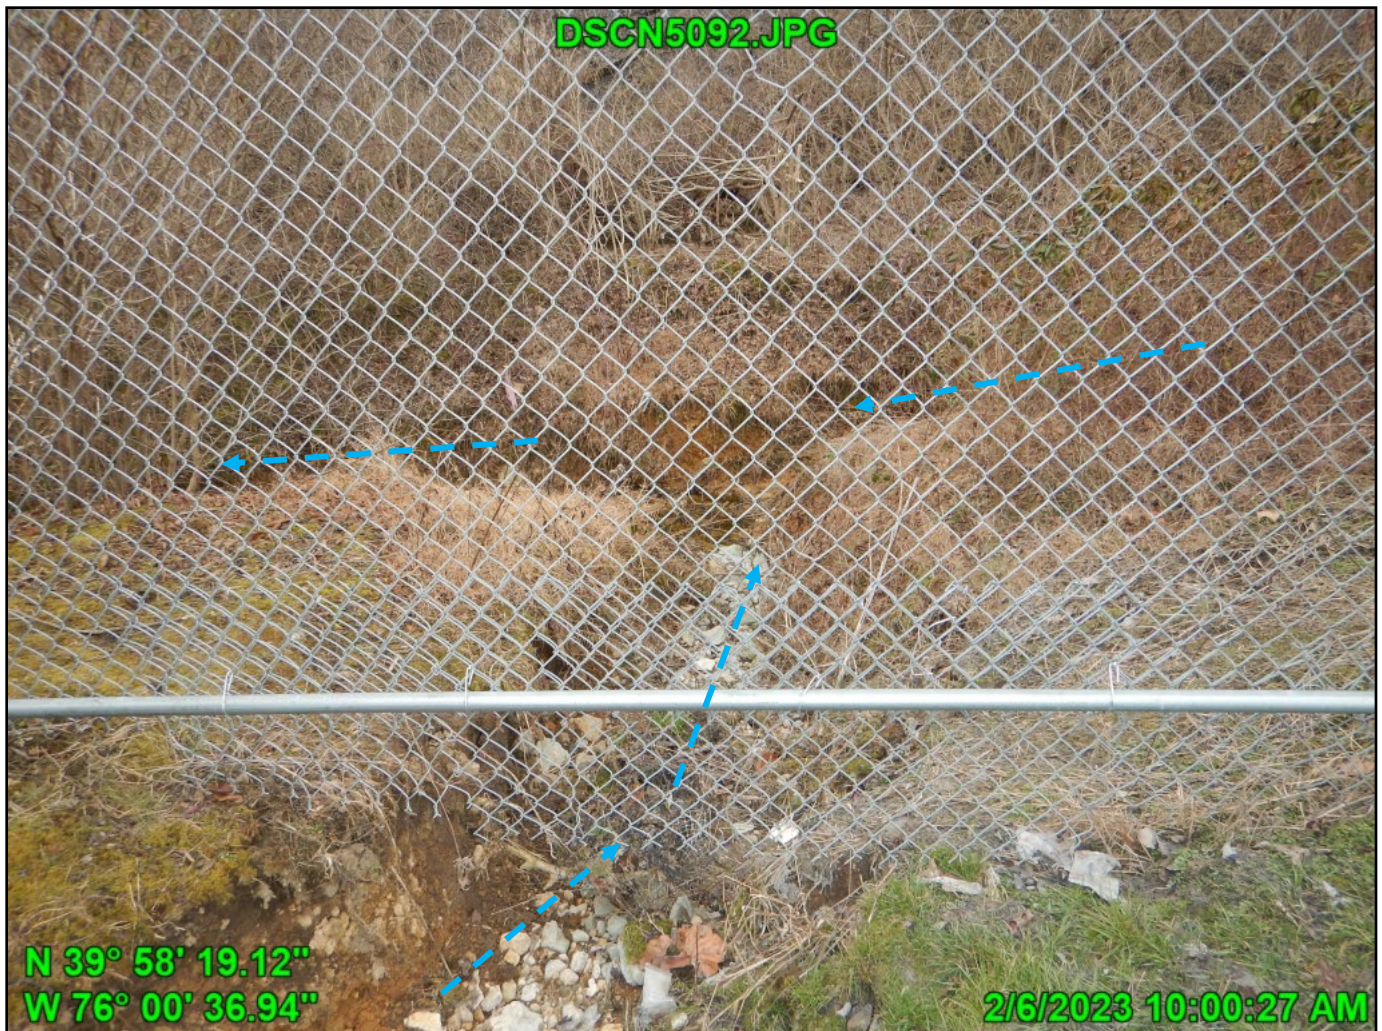
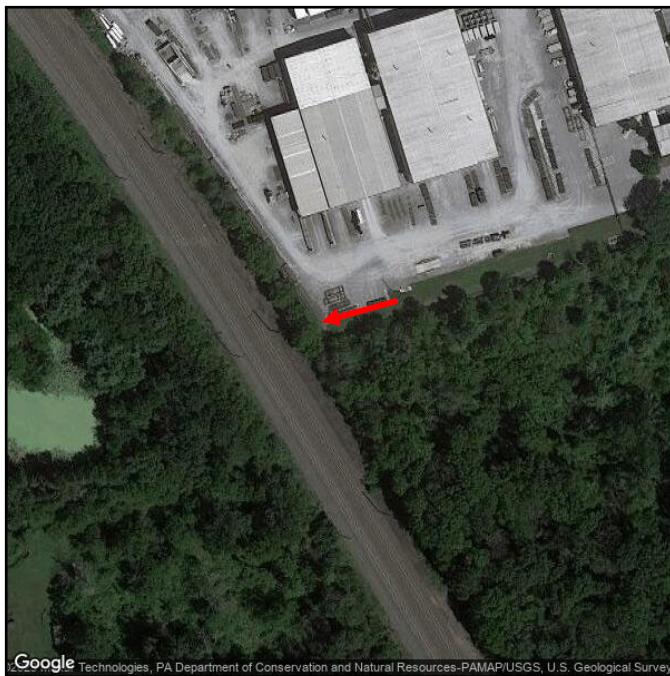
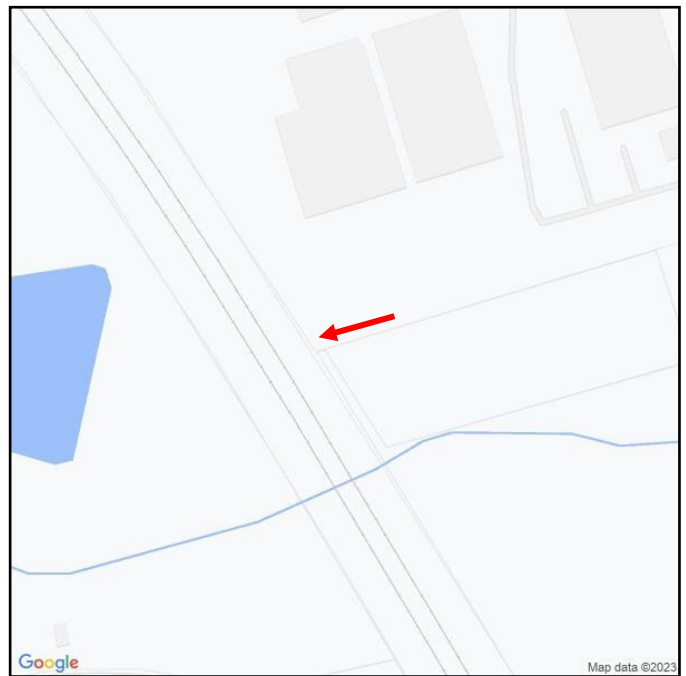
| Description | View of the Facility's southwest corner fence where the drainage swale discharges offsite into a drainage ditch. The drainage ditch connects to an unnamed tributary to Williams Run. |

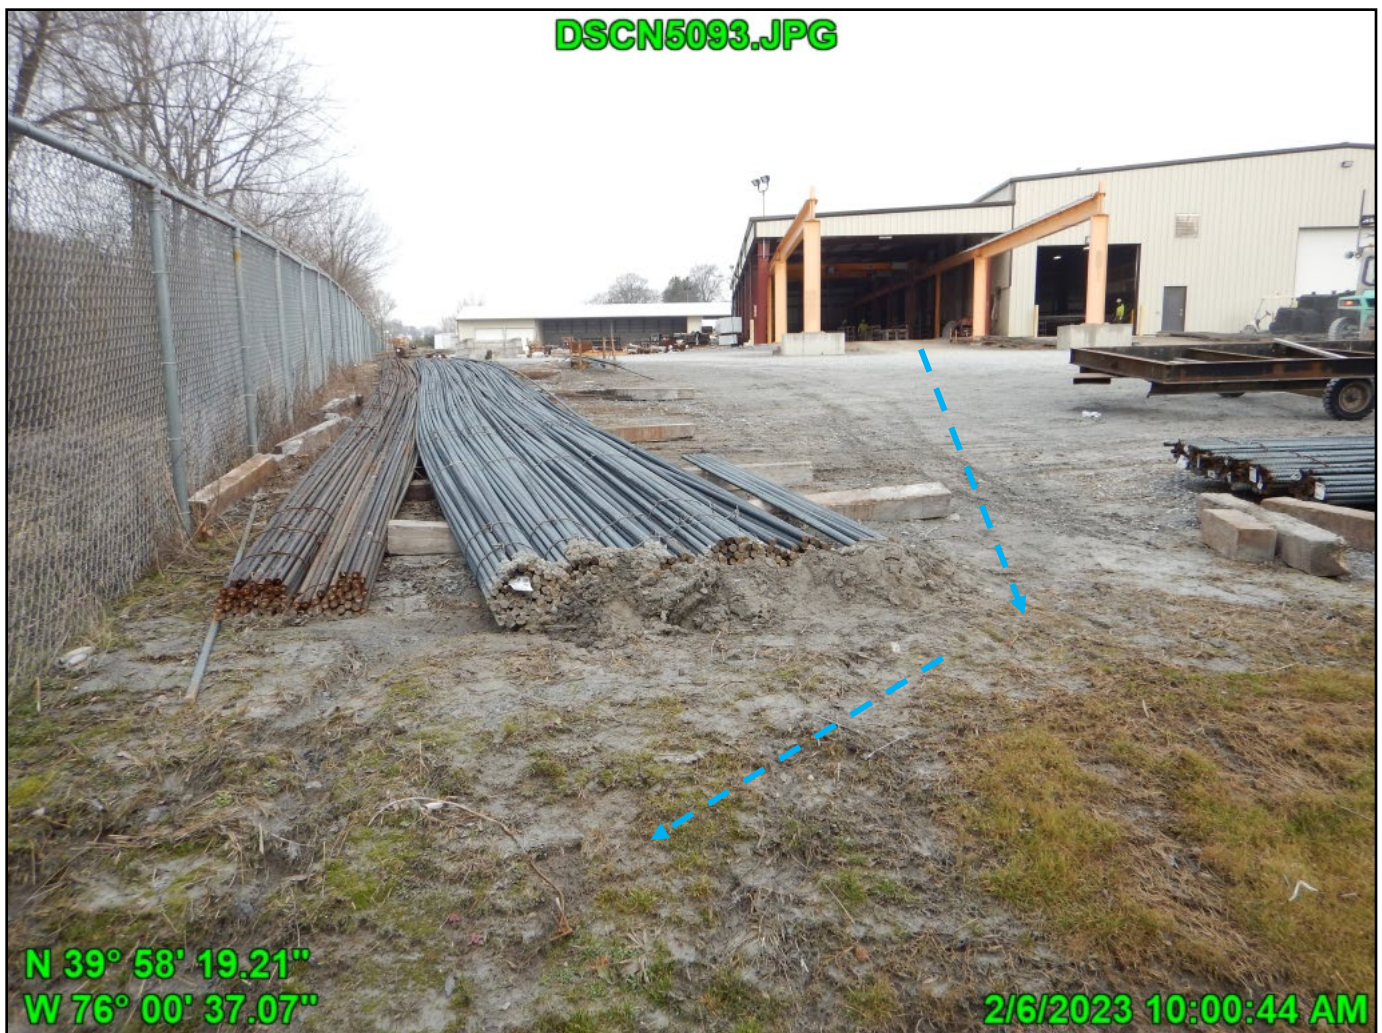
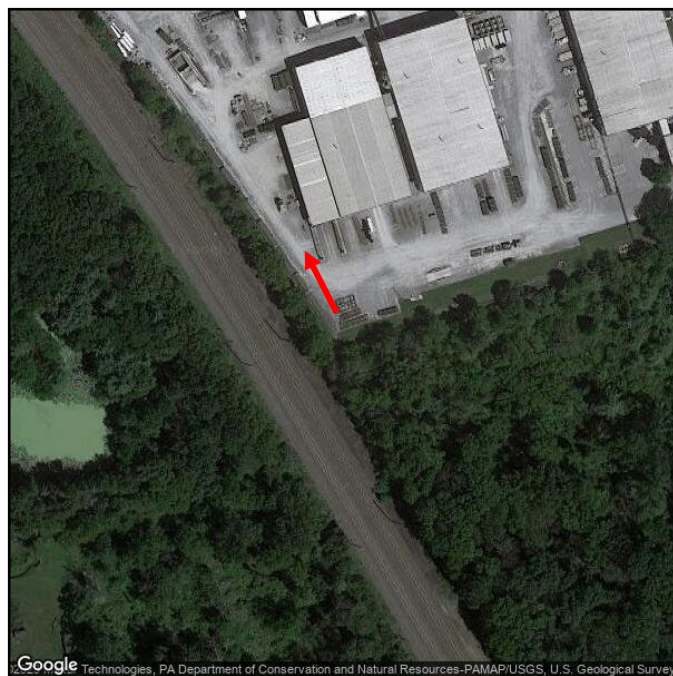
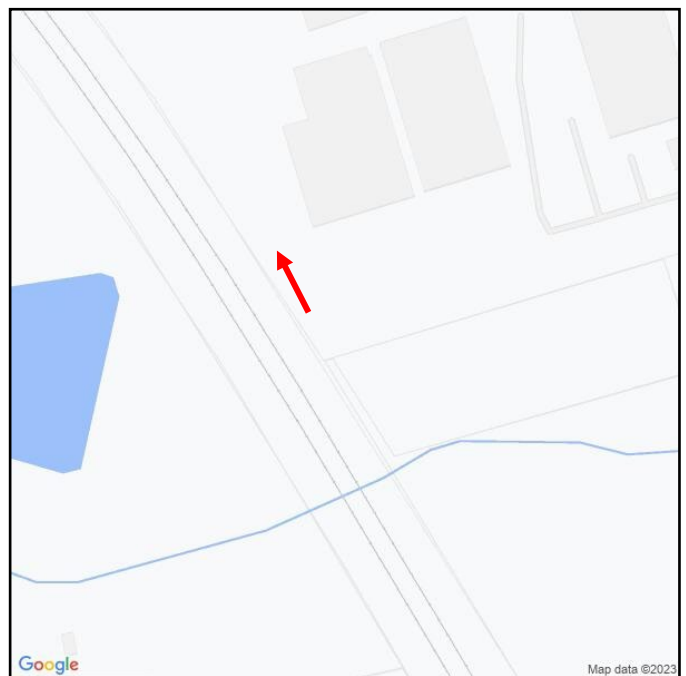
| Description | Upgradient view of steel rebar materials stored outdoors along the Facility's west fence line. Note the estimated stormwater flow direction. |

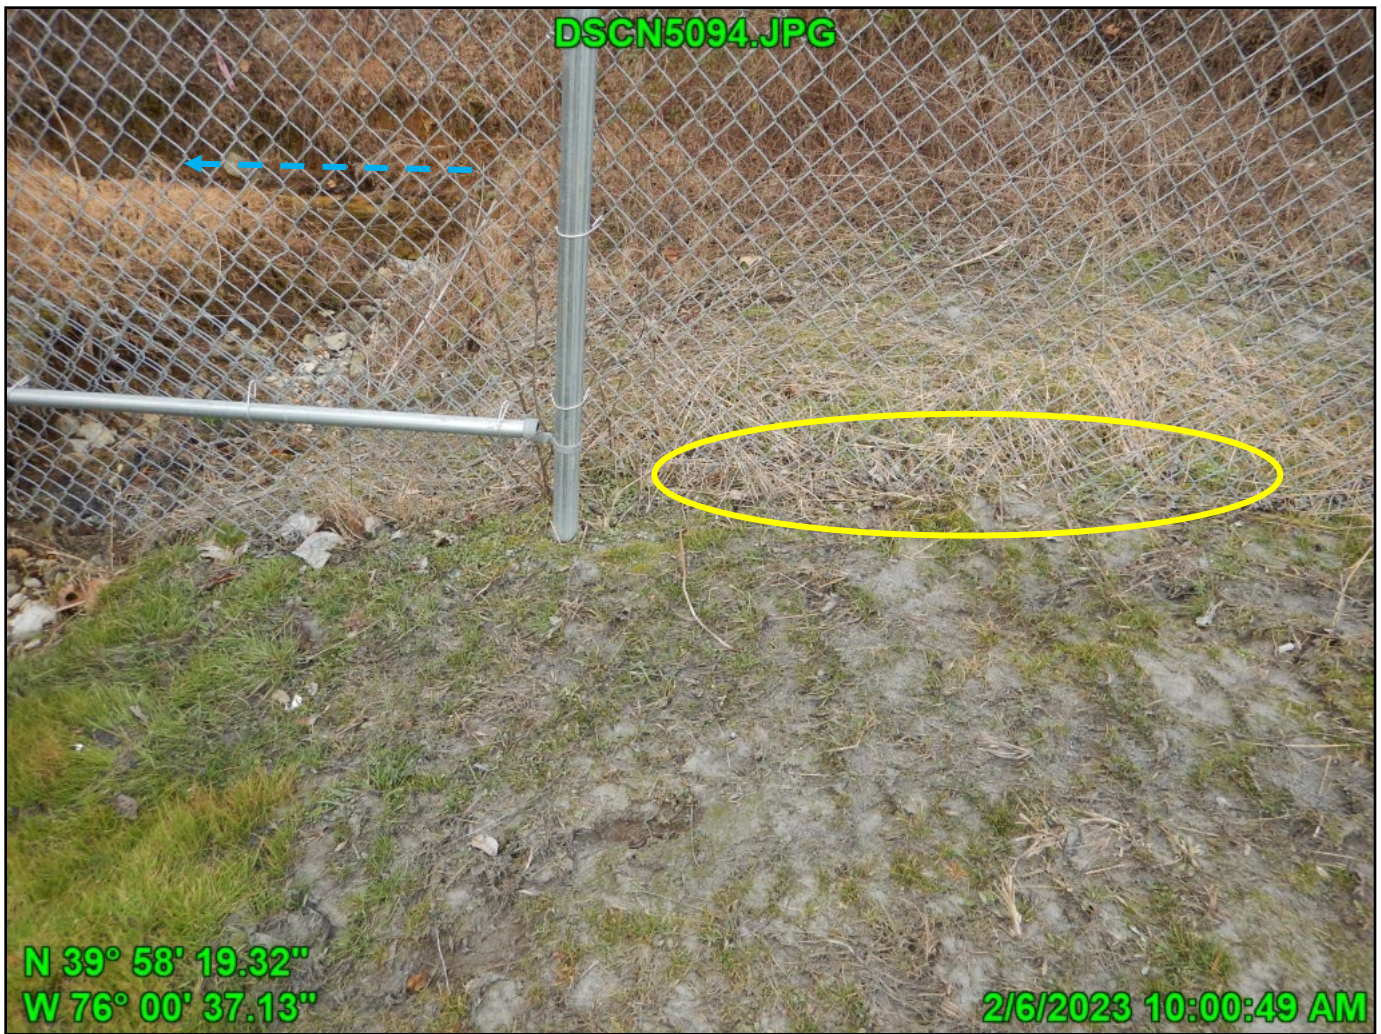
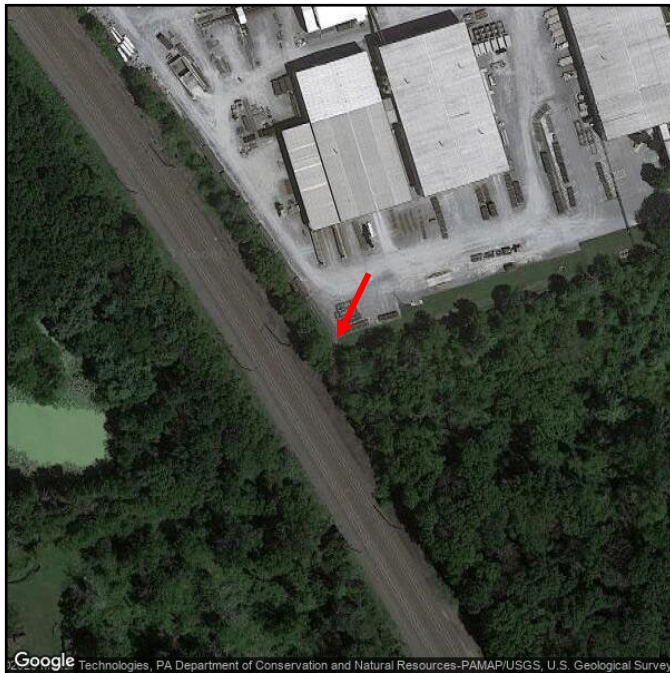
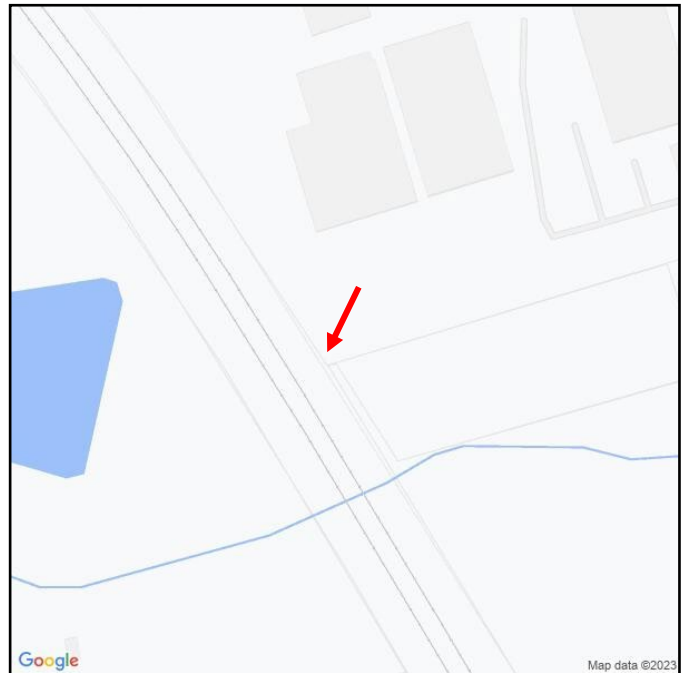
- 3) The EPA Inspection Team observed several locations along the west fence line where sediment and debris had migrated through the chain link fence and towards an adjacent drainage ditch that connects to an unnamed tributary of Williams Run (refer to Appendix B, Photographs DSCN5100 and DSCN5101).

| Description | Sediment and debris near the Facility's southwest corner fence line and offsite towards the drainage ditch. The drainage ditch connects to an unnamed tributary to Williams Run. |
