## MULTI-SECTOR GENERAL PERMIT NON-FILER INSPECTION CHECKLIST

| <b>Inspection Date(s):</b> | 2/7/2023 | |
| <b>Operator Name:</b> | Dutchland, Inc. | |

Stormwater Inspection Date: February 7, 2023

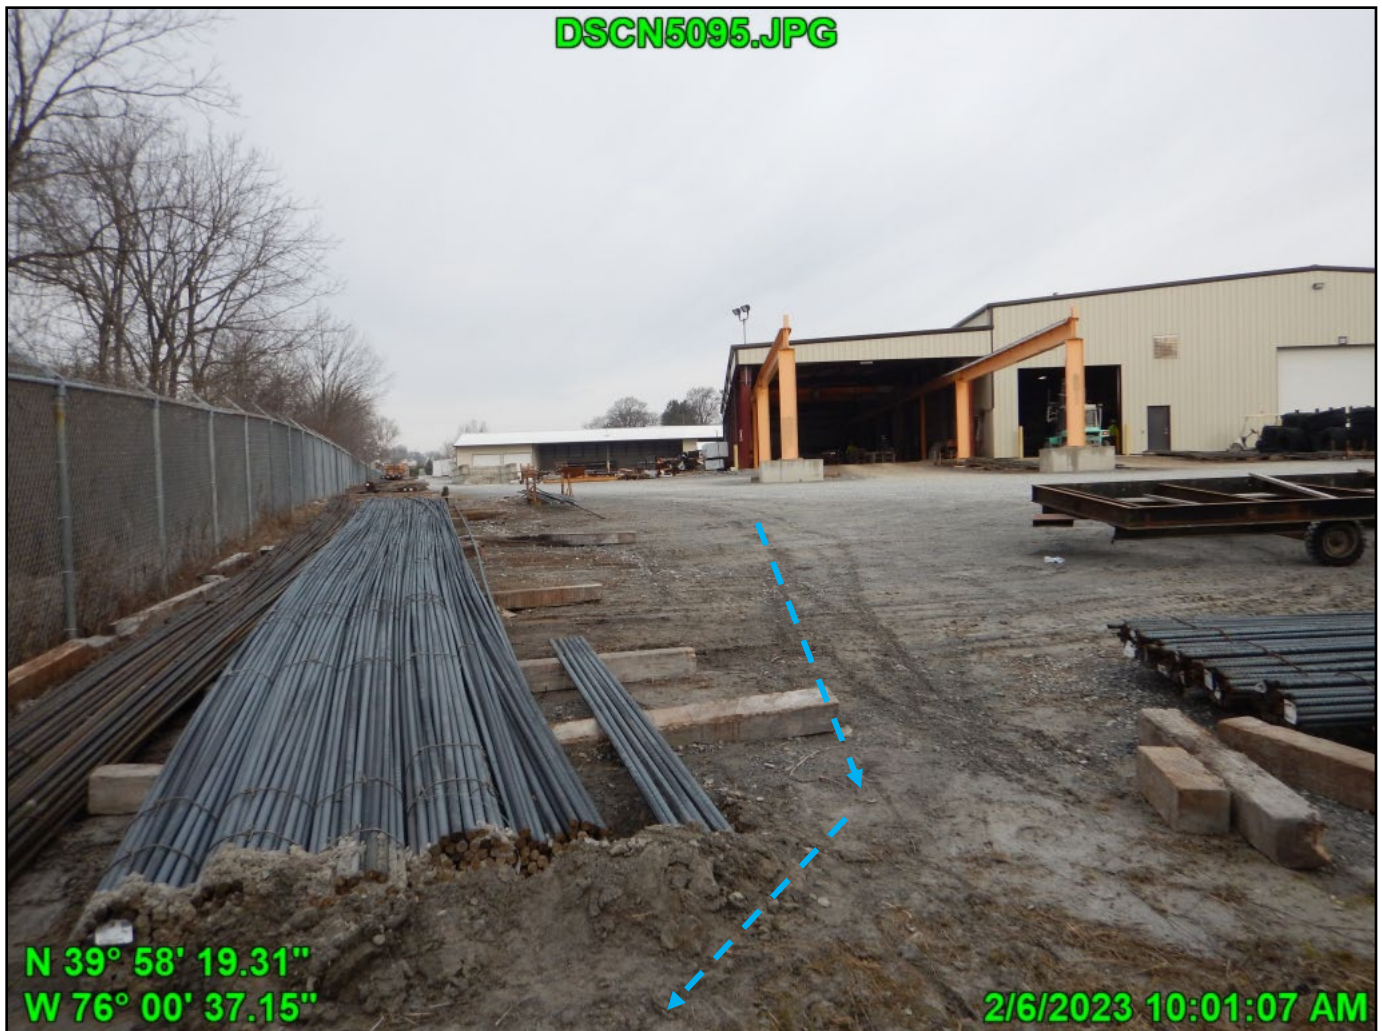
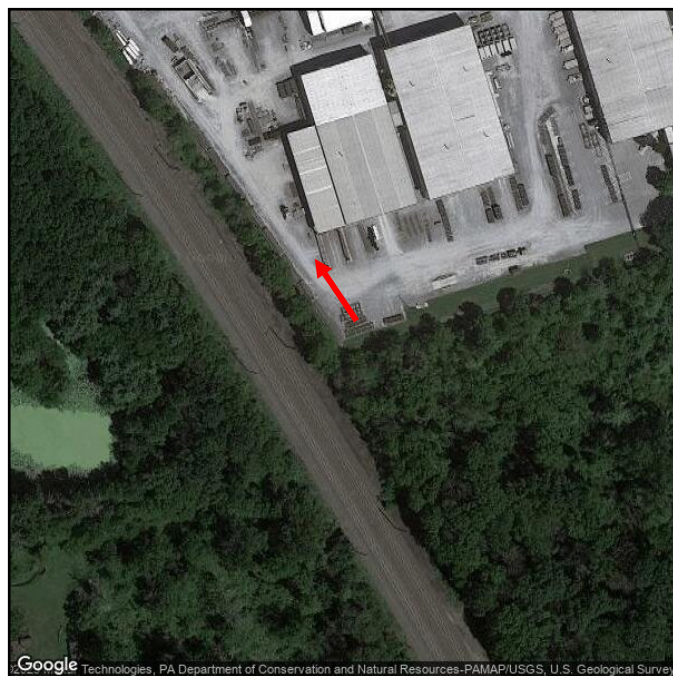
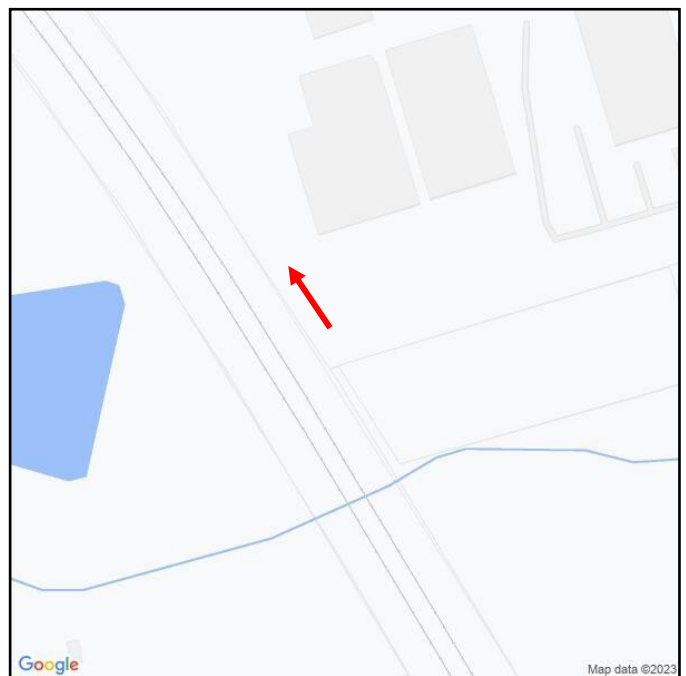
| Description | Upgradient view of outdoor steel rebar materials storage along the Facility's west fence line. Note the estimated stormwater flow direction. |

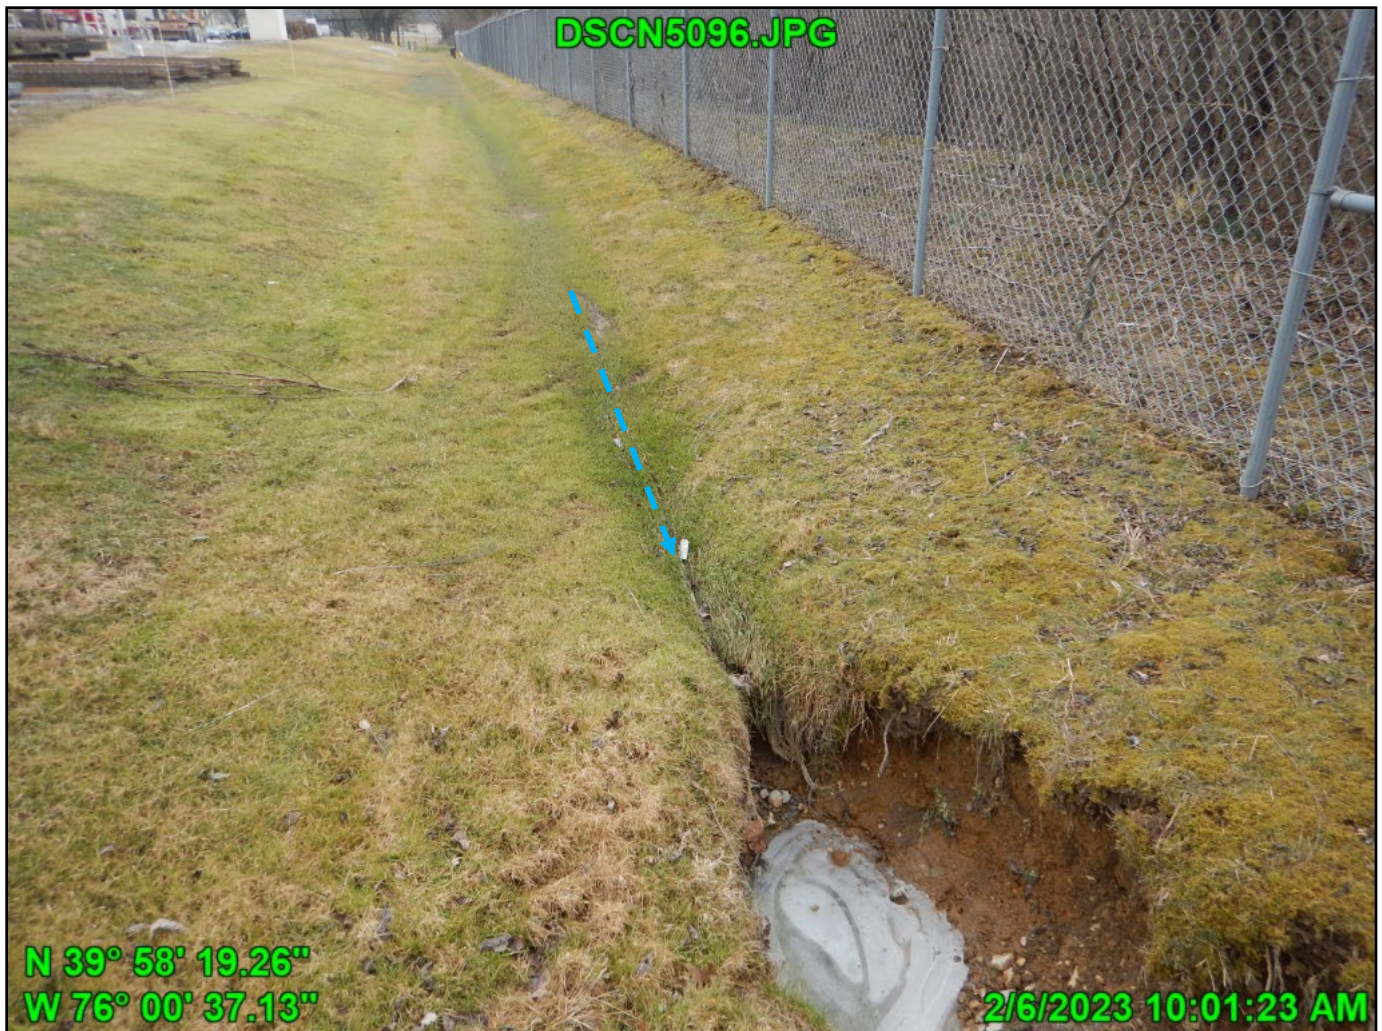
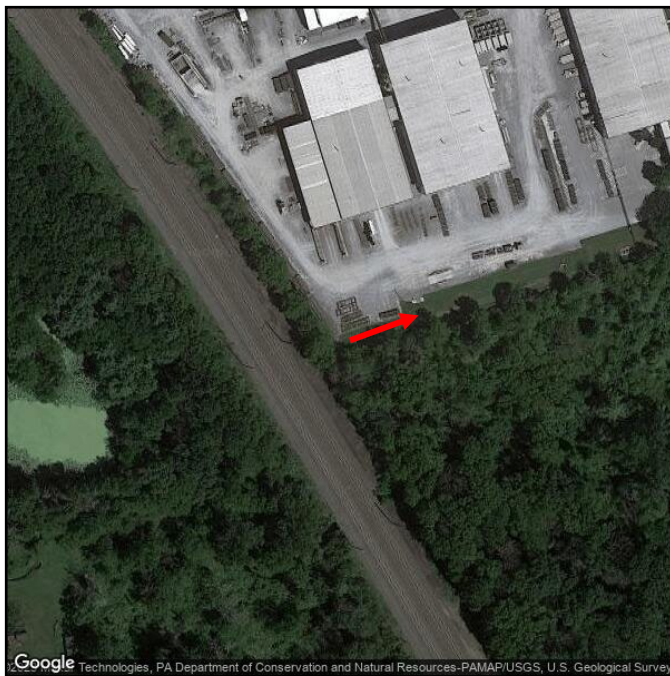
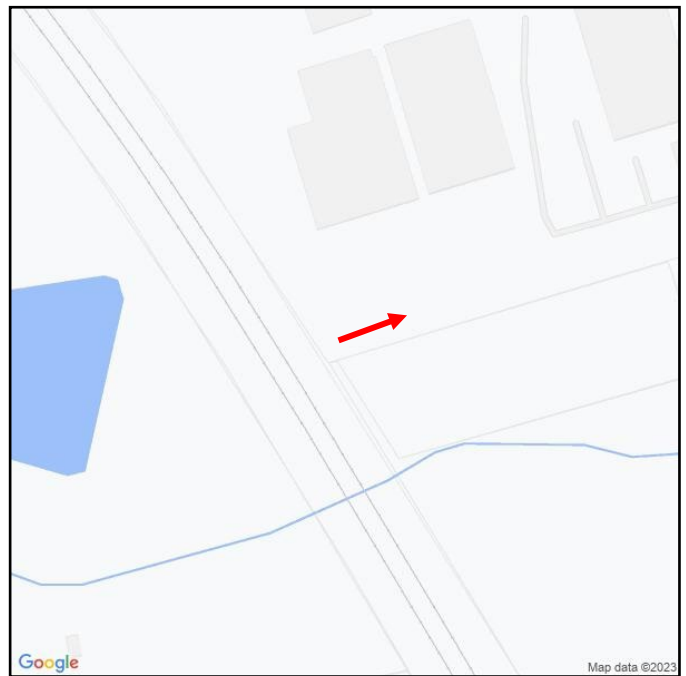
| Description | Upgradient view of the drainage swale along the Facility's south boundary. A head cut was forming at the swale's western end. |

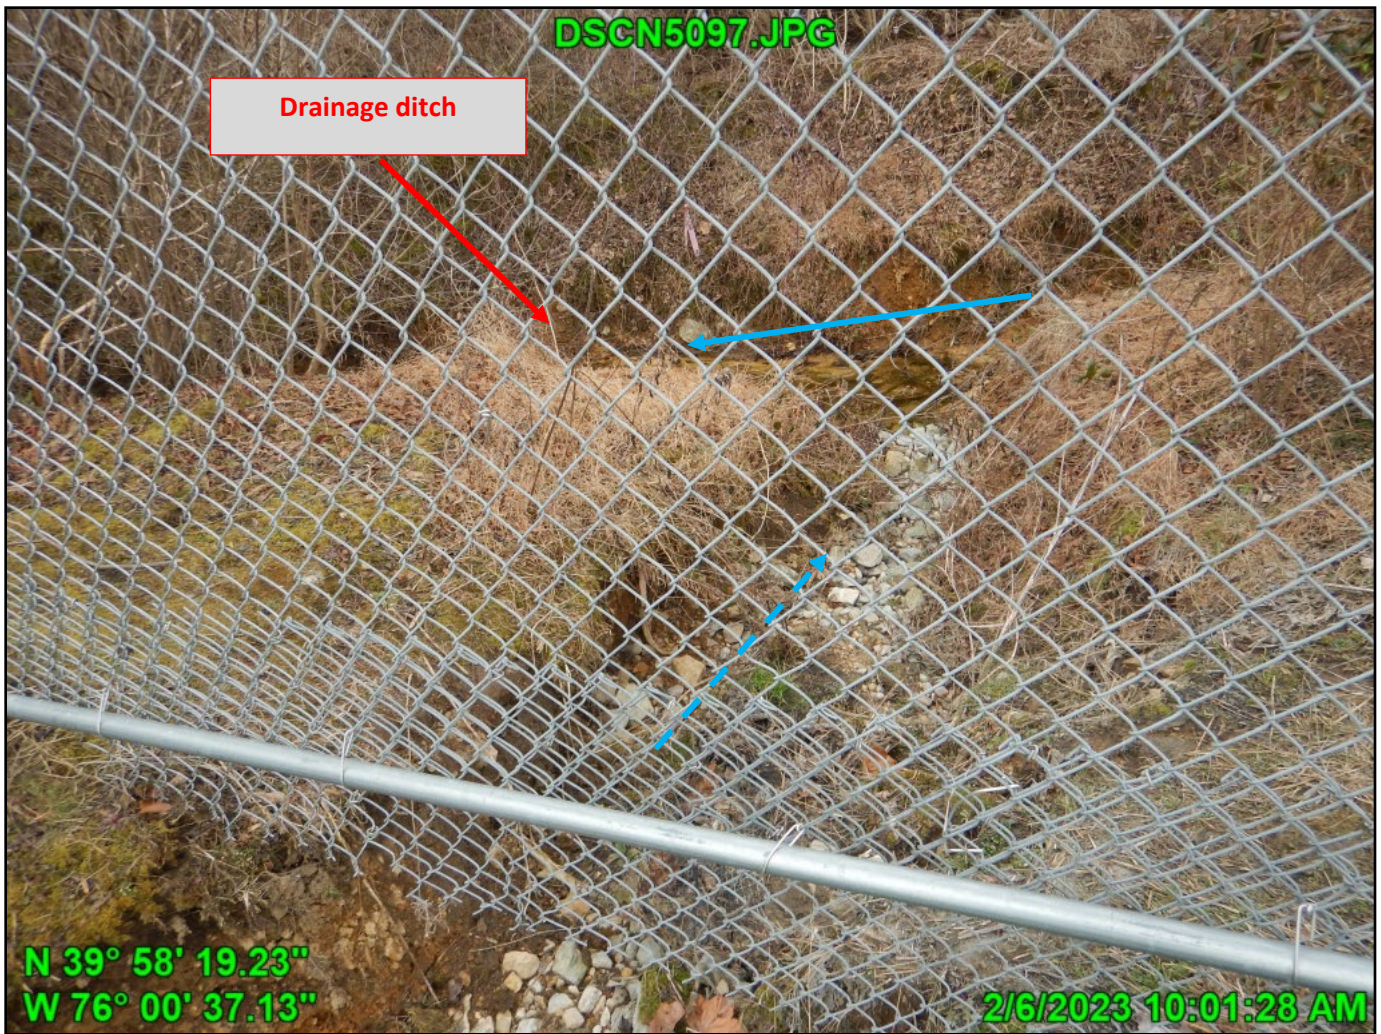
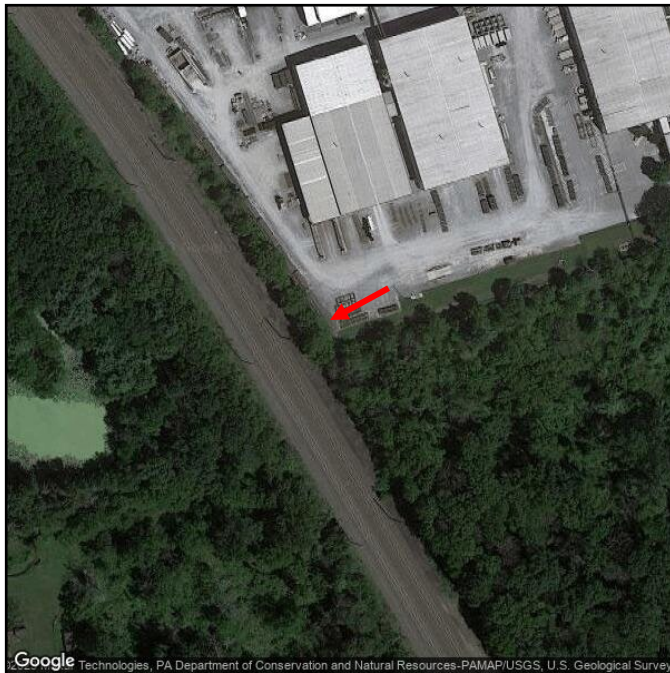
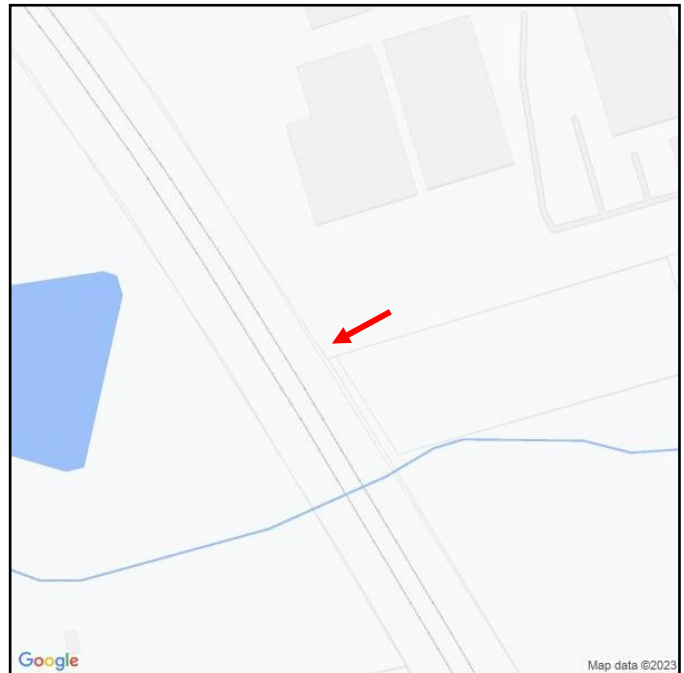
| Description | Channelized area at the southwest corner of the Facility adjacent to the drainage ditch that conveys Facility storm water to an unnamed tributary to Williams Run. Note the dotted lines showing the estimated flow path from the Facility towards the drainage ditch located offsite. |

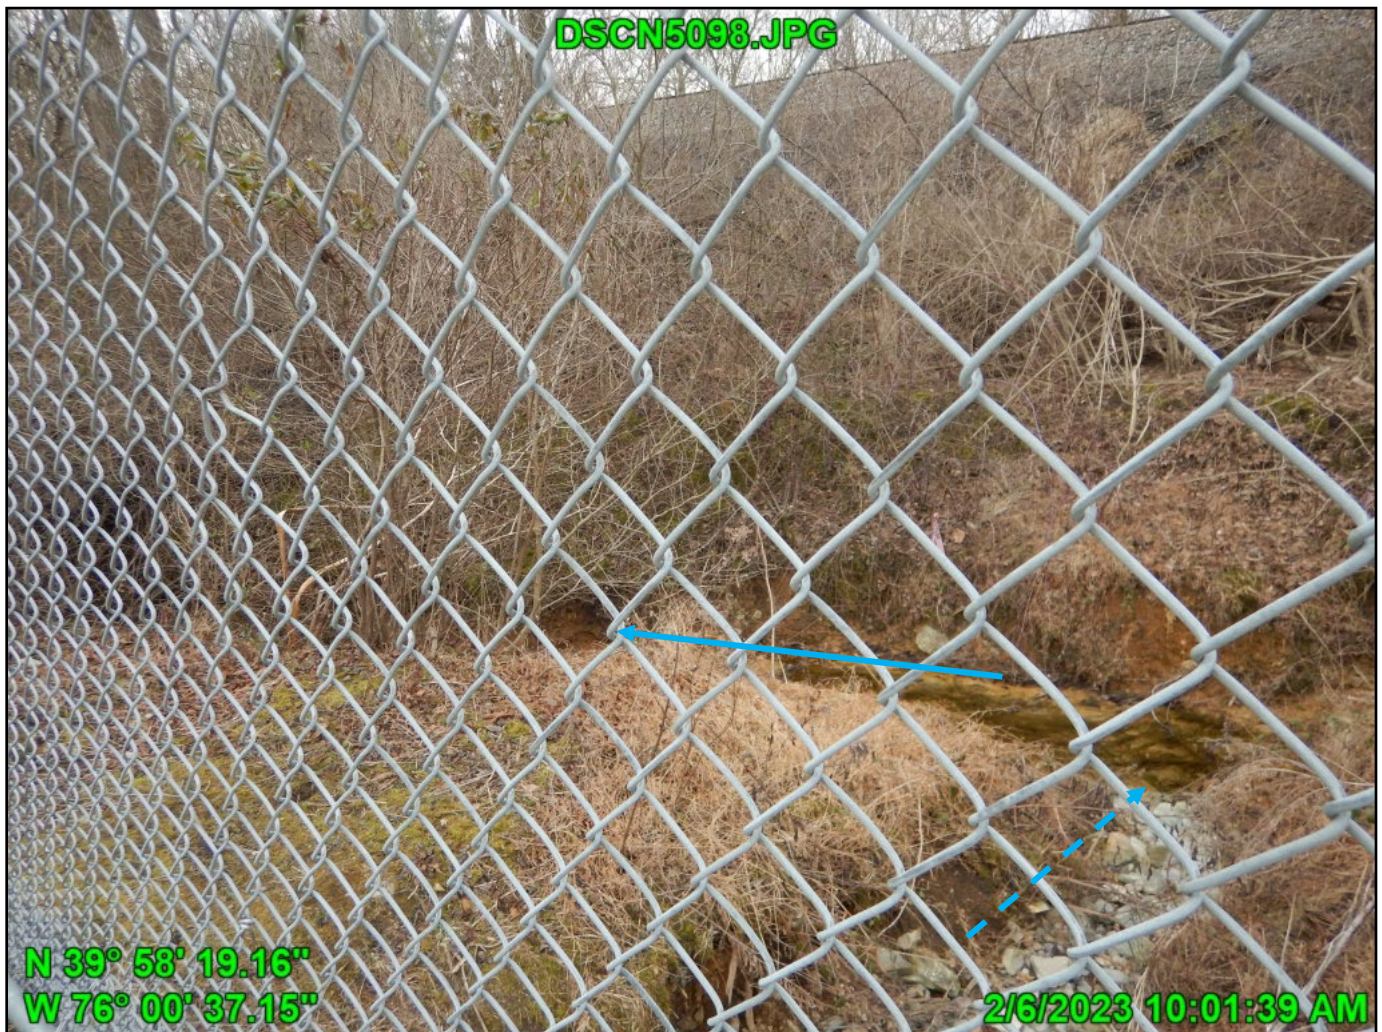
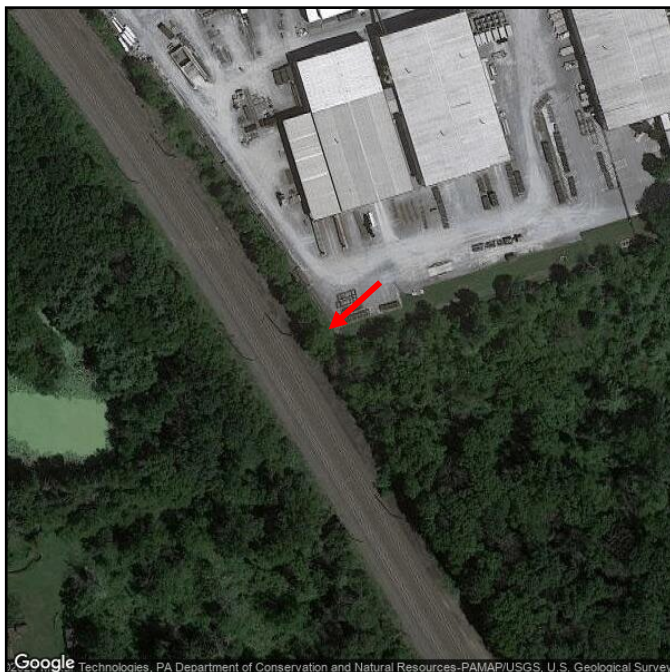
| Description | Channelized area at the southwest corner of the Facility adjacent to the drainage ditch that conveys Facility storm water to an unnamed tributary to Williams Run. Note the dotted lines showing the estimated flow path from the Facility towards the drainage ditch located offsite. |

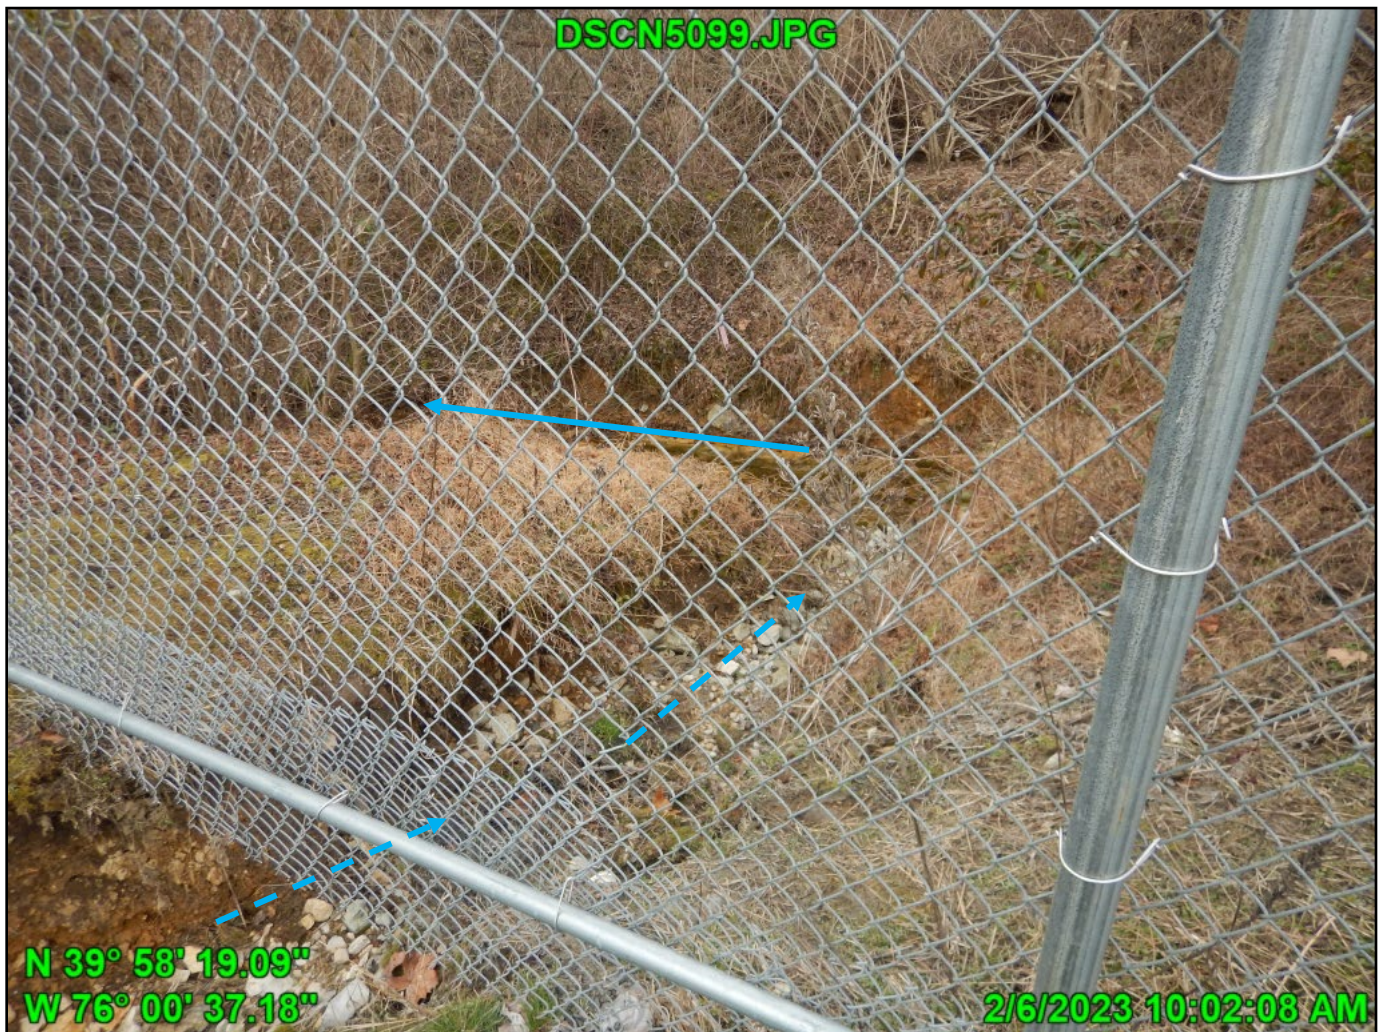
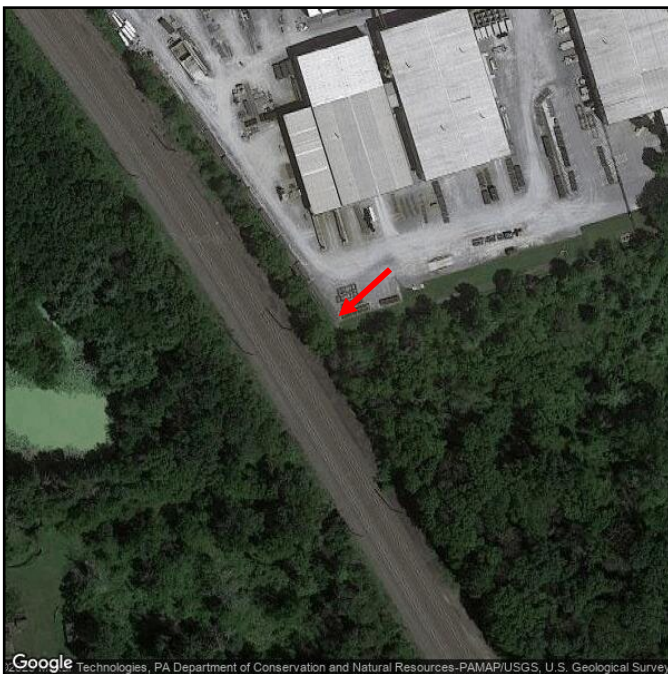
| Description | Channelized area at the southwest corner of the Facility adjacent to the drainage ditch that conveys Facility storm water to an unnamed tributary to Williams Run. Note the dotted lines showing the estimated flow path from the Facility towards the drainage ditch located offsite. |

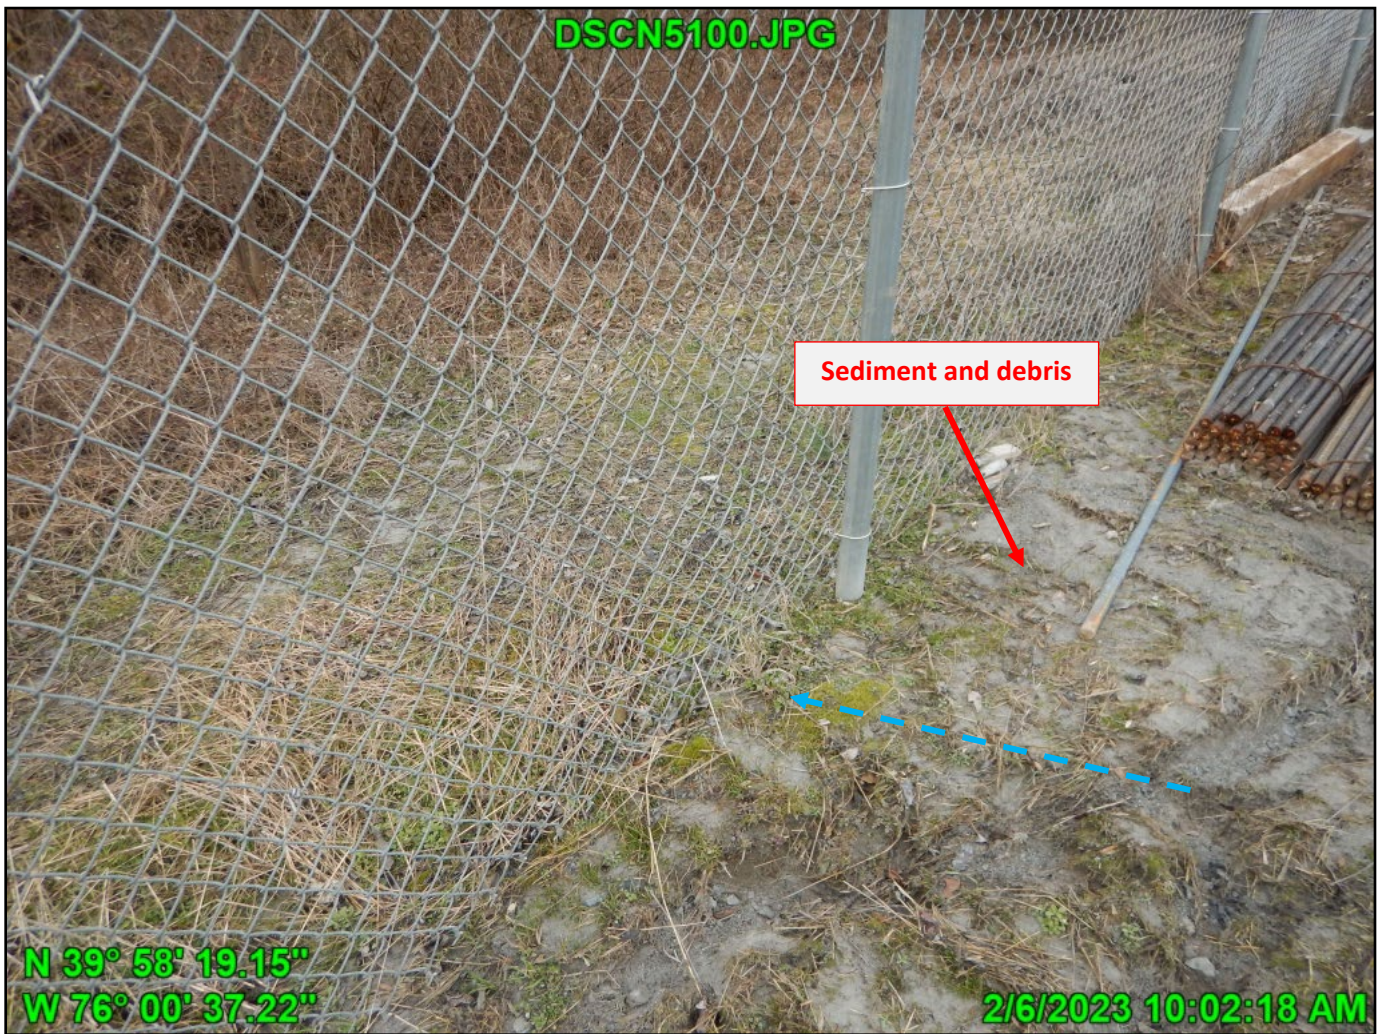
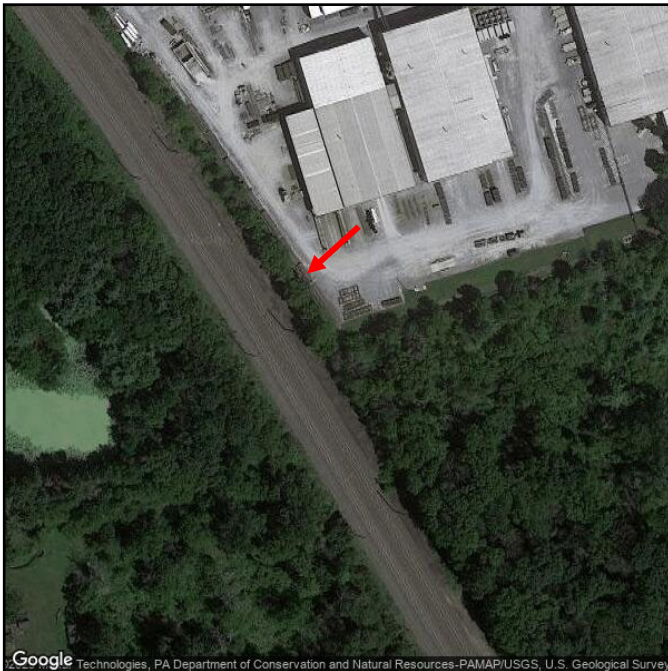
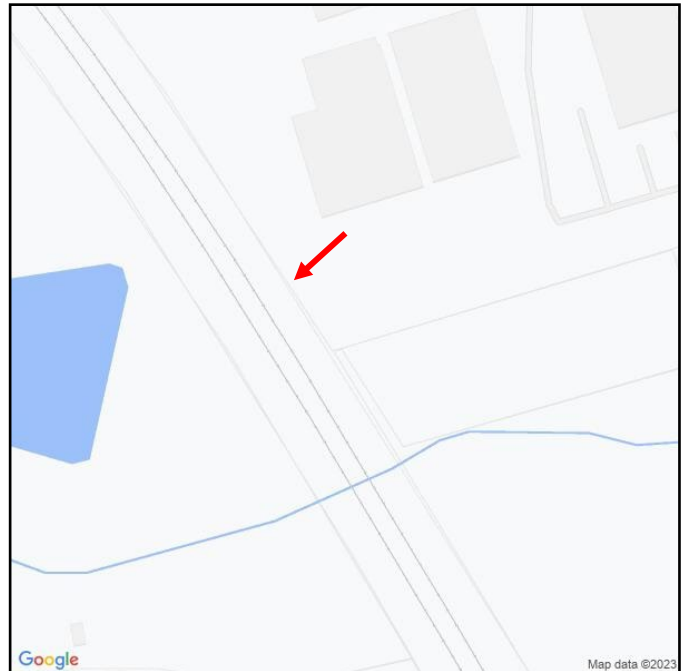
| Description | Sediment and debris near the Facility's southwest corner fence line and offsite towards the drainage ditch that conveys Facility storm water to an unnamed tributary to Williams Run. |

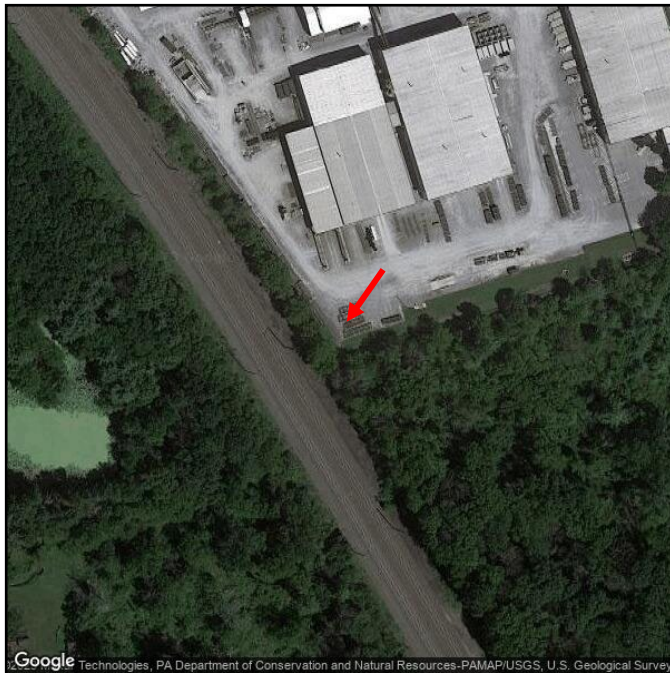
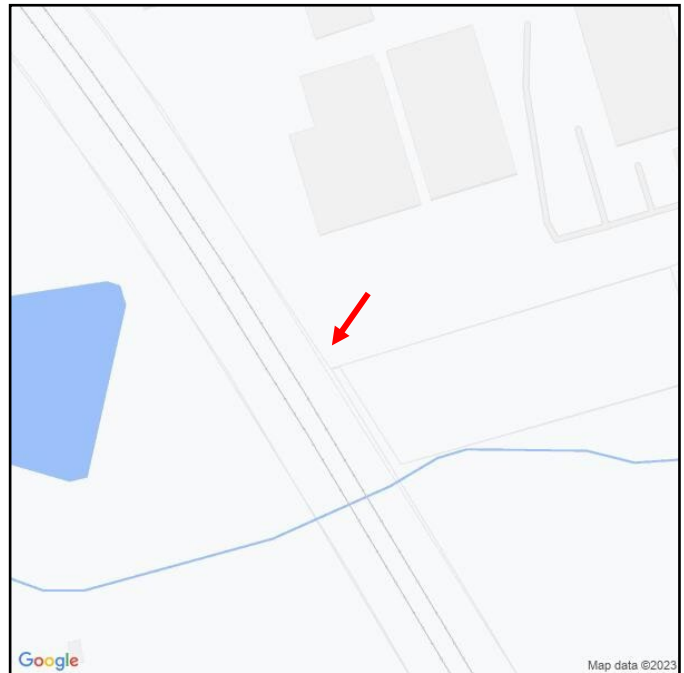
View of the southwest corner of the Facility. Note the sediment and materials (e.g., rebar) near the fence line. Also note the adjacent drainage ditch and the eroded drainage swale.

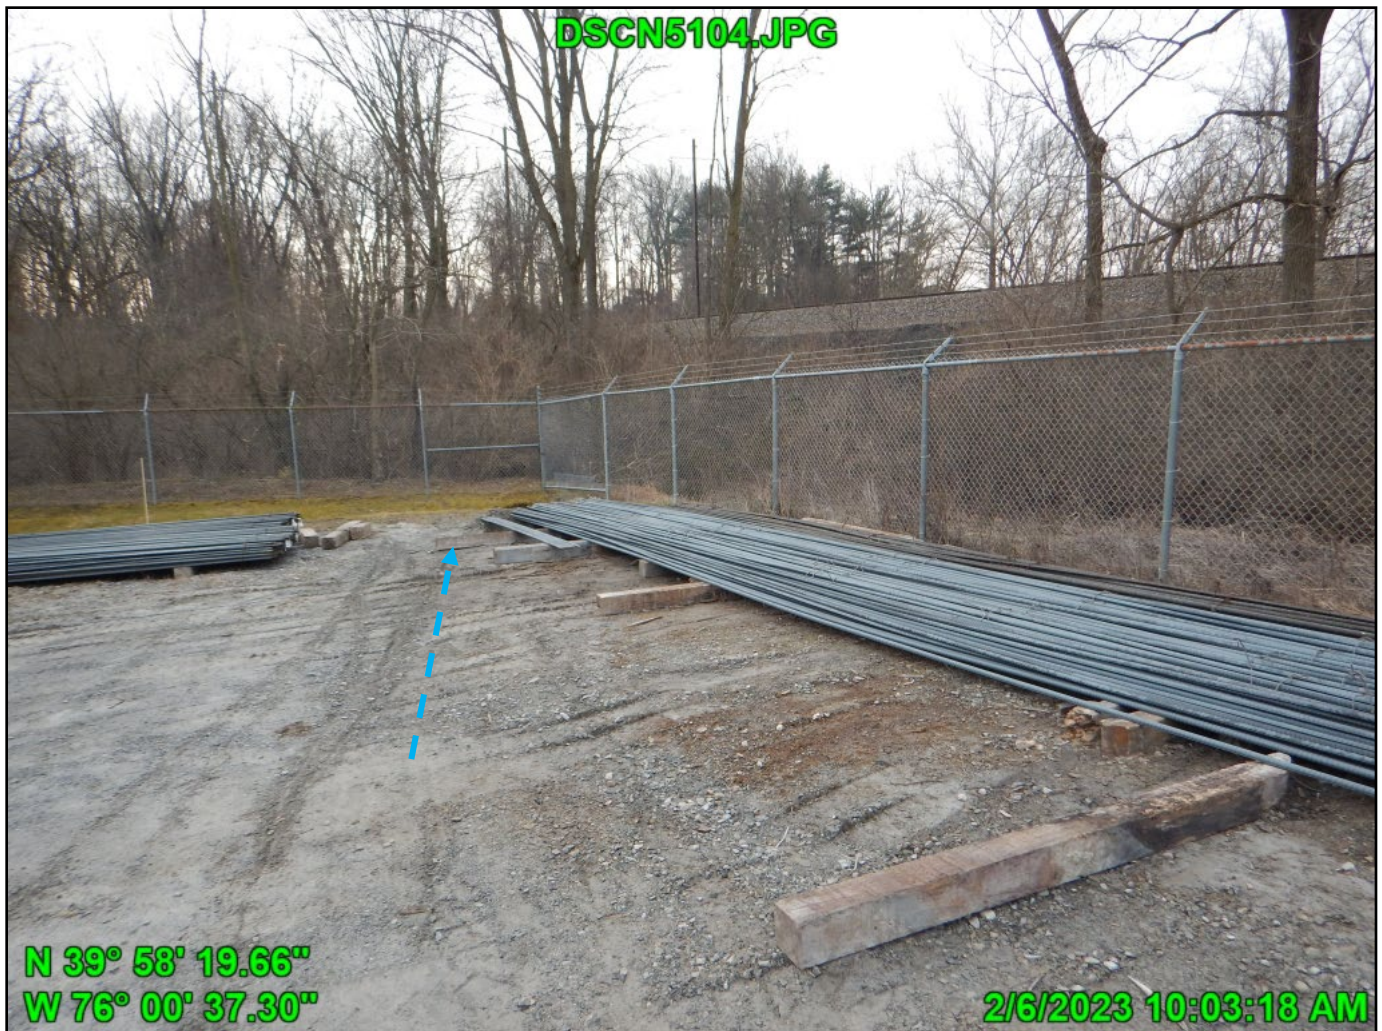
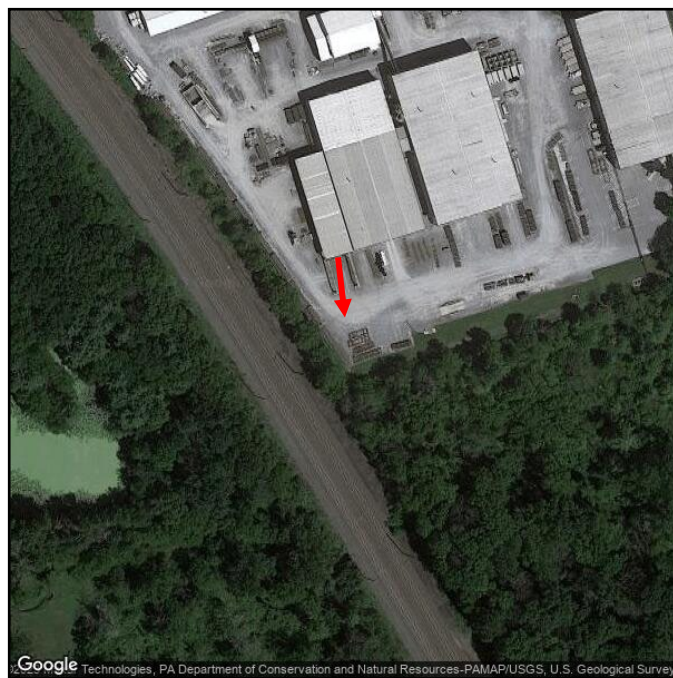
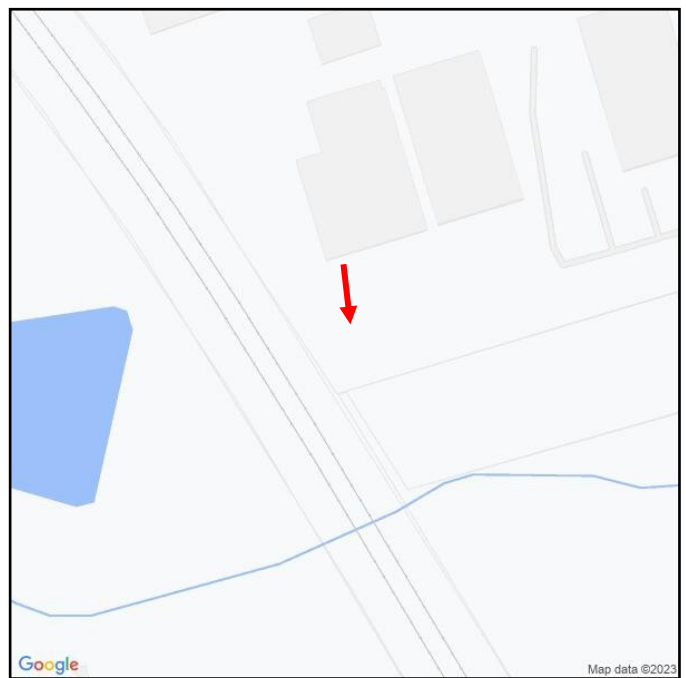
| Description | Downgradient view of steel rebar materials stored outdoors along the Facility's west fence line. Note the estimated stormwater flow direction. |

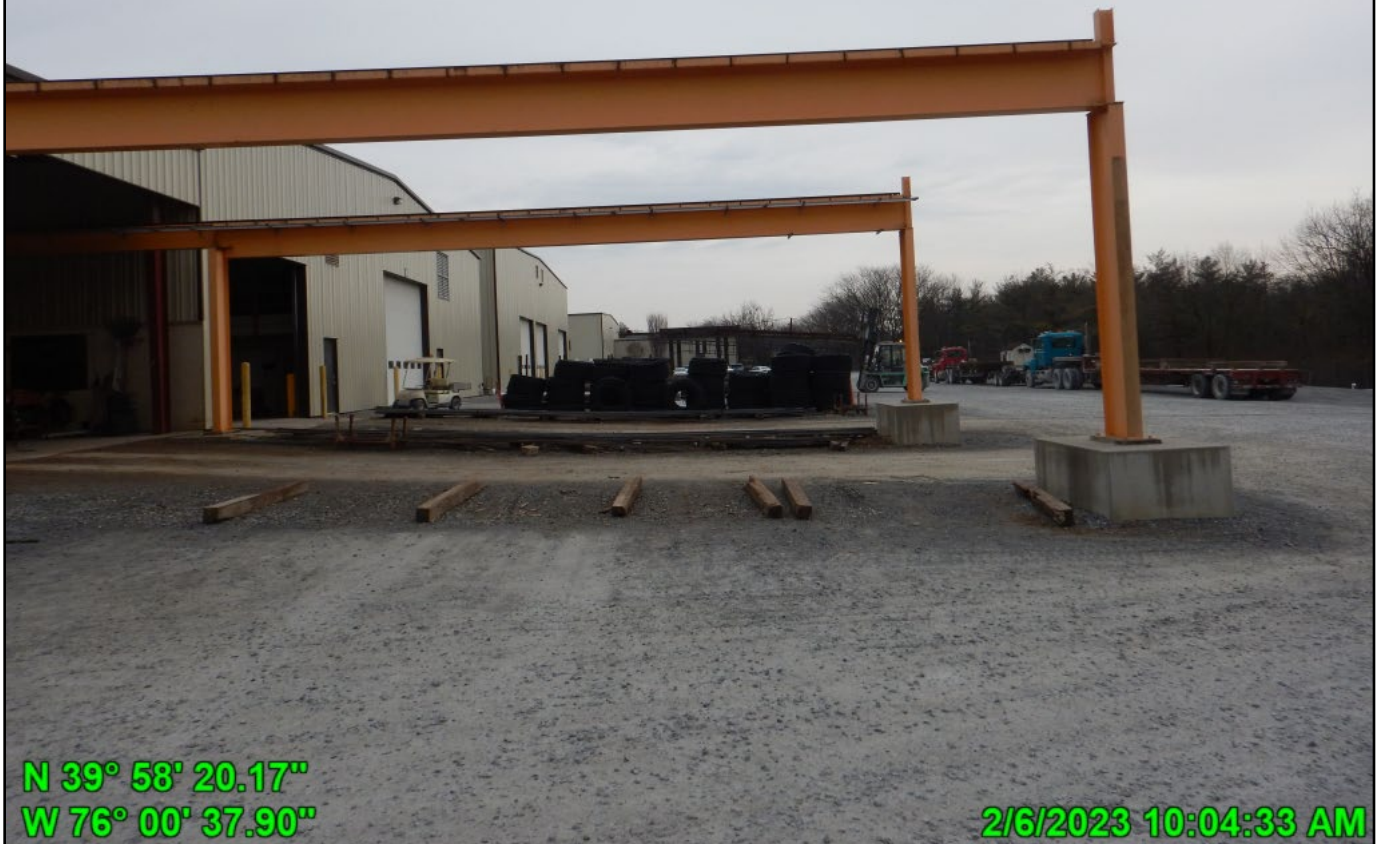
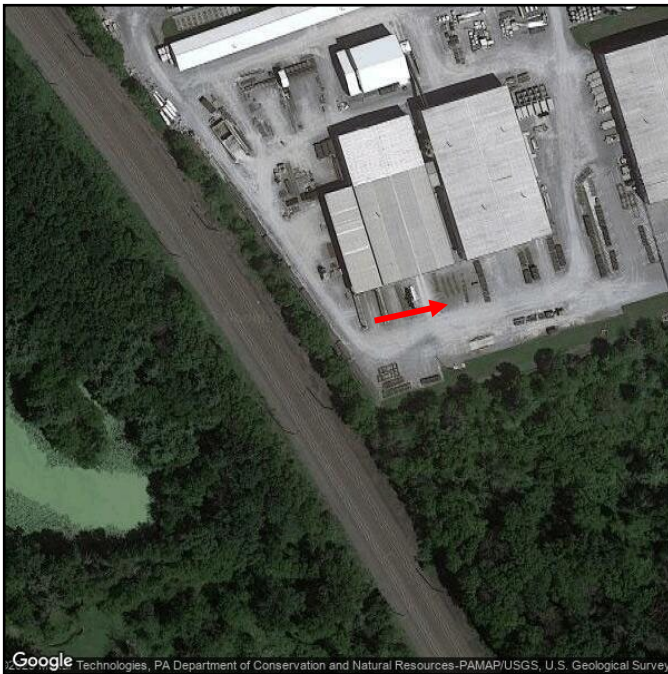
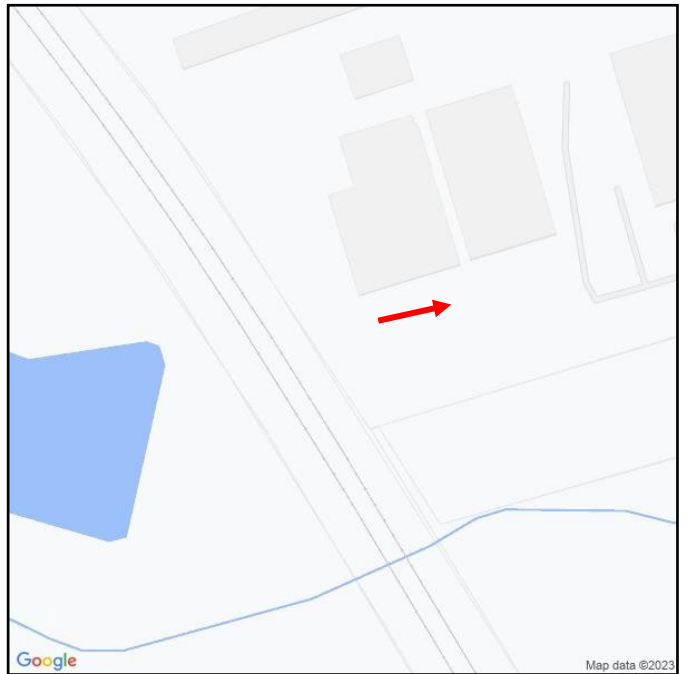
DSCN5107.JPG

| Description | View of the Facility's west boundary fence line. Note the drainage ditch offsite to the west. |

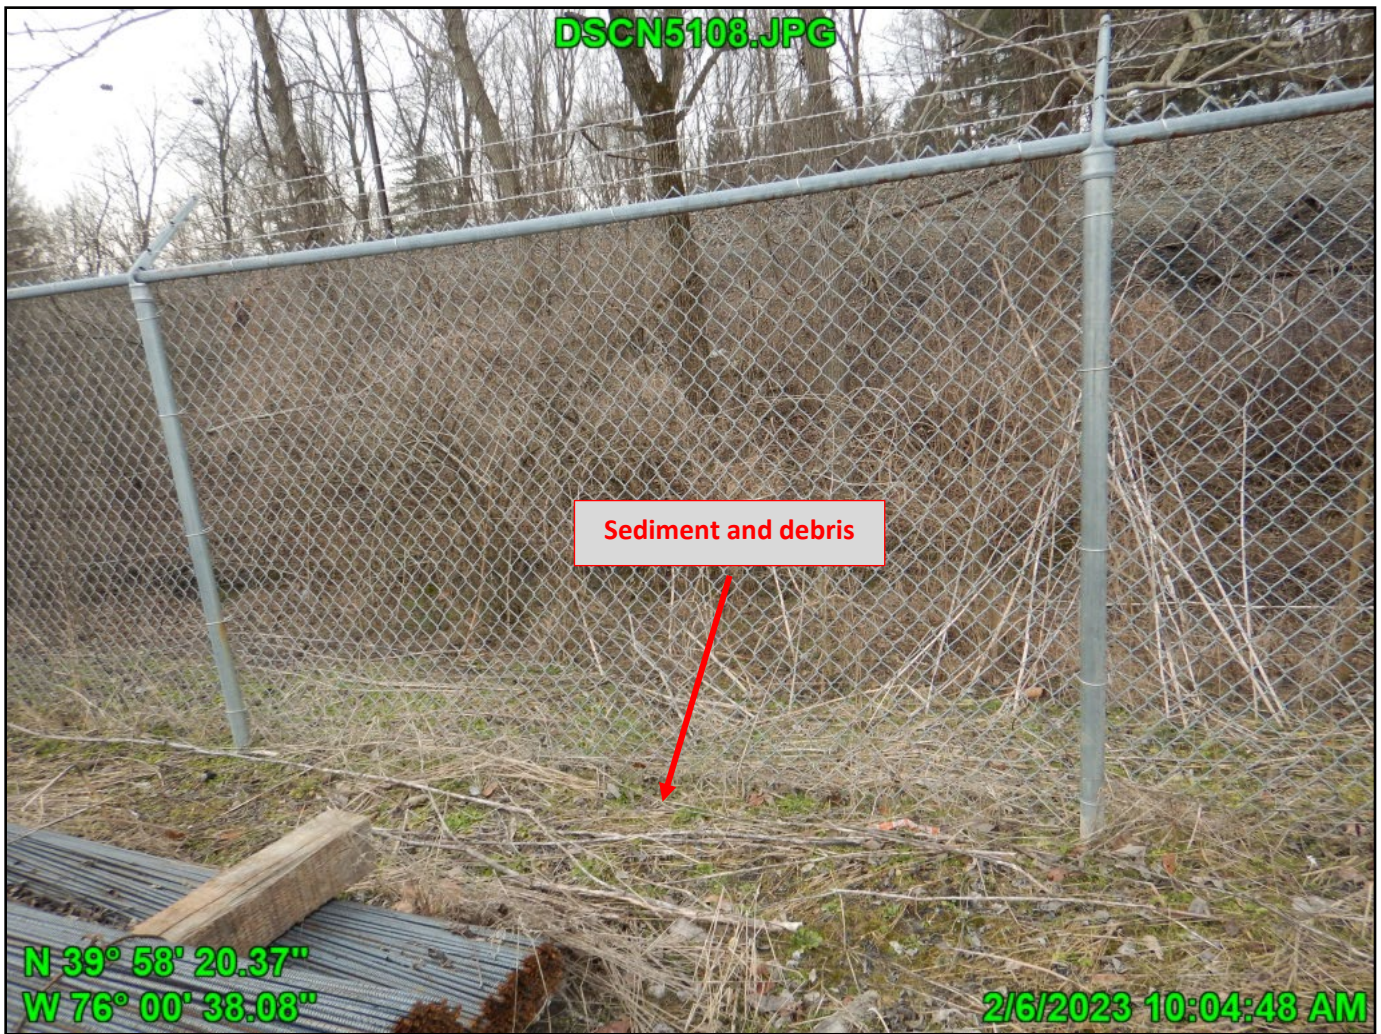
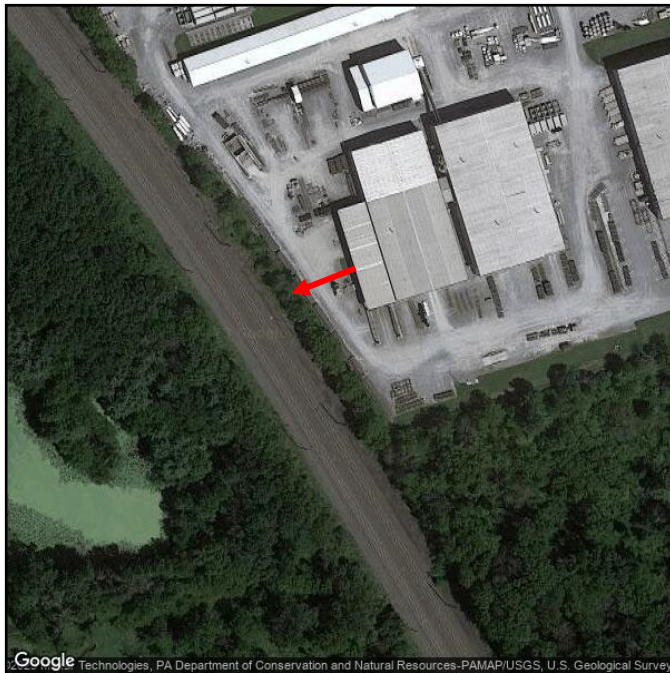
| Description | View of evidence of previous flow by the Facility's west boundary fence line. |

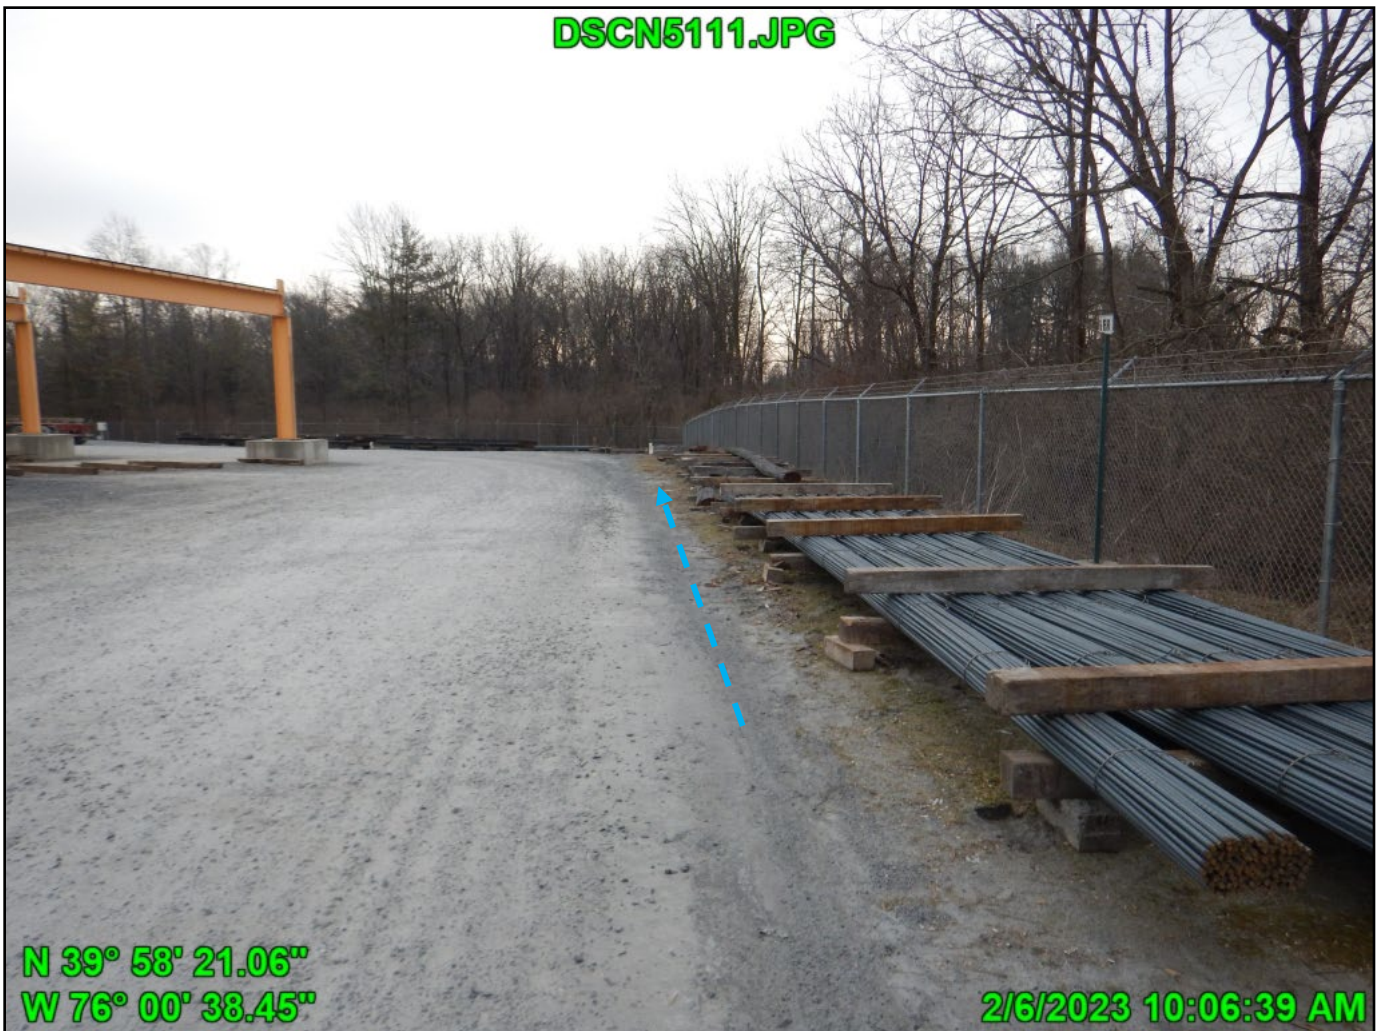
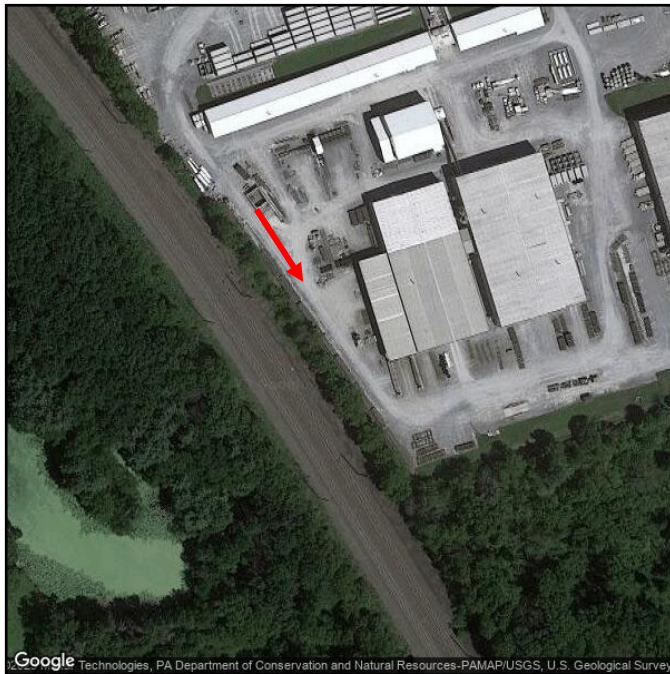
DSCN5111.JPG

View of a metal materials storage area in the east area of the Facility. Note some of the materials are stored outside the overhead cover.
