## MULTI-SECTOR GENERAL PERMIT NON-FILER INSPECTION CHECKLIST

| <b>Inspection Date(s):</b> | 2/7/2023 | |
| <b>Operator Name:</b> | Dutchland, Inc. | |

Stormwater Inspection Date: February 7, 2023

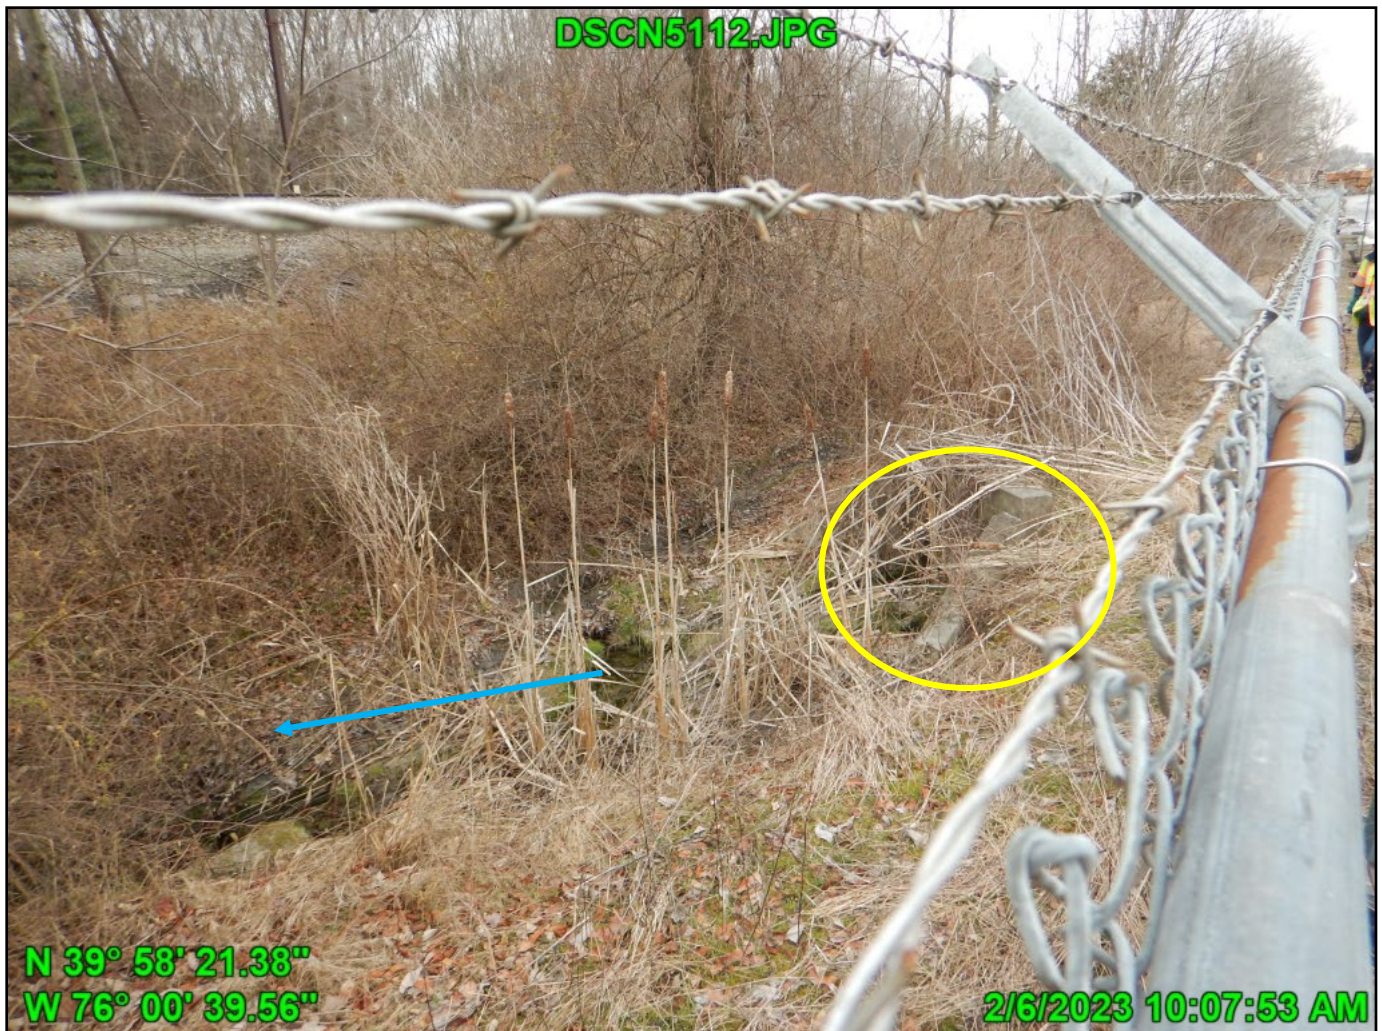
| Description | Headwall outlet structure and drainage ditch. This structure conveys stormwater from onsite catch basins in Photograph DSCN5120 and DSCN5121. |

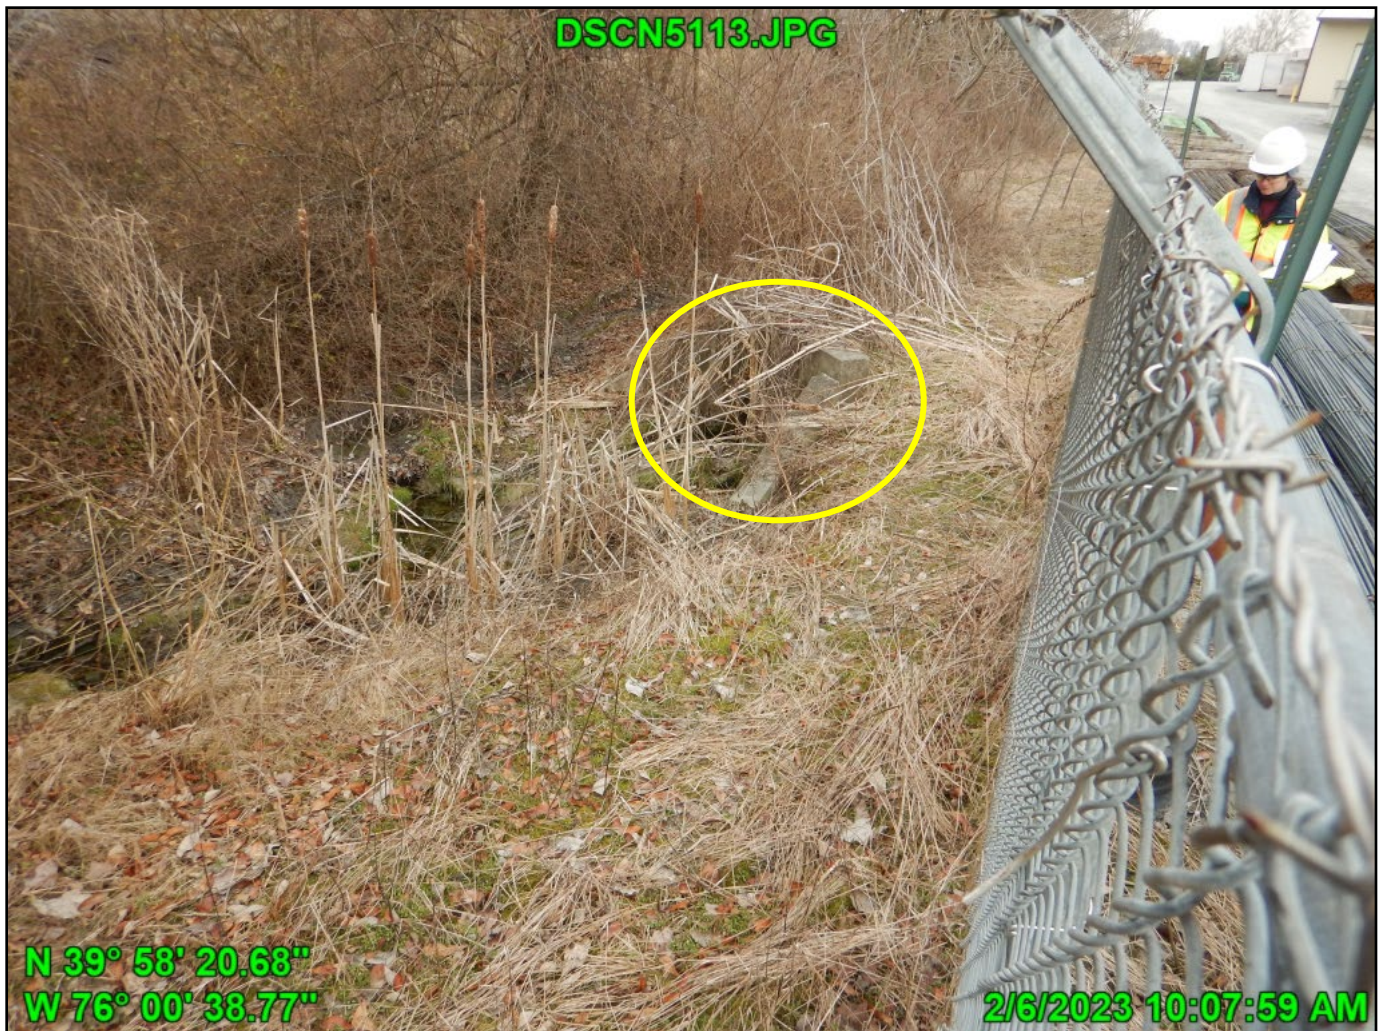
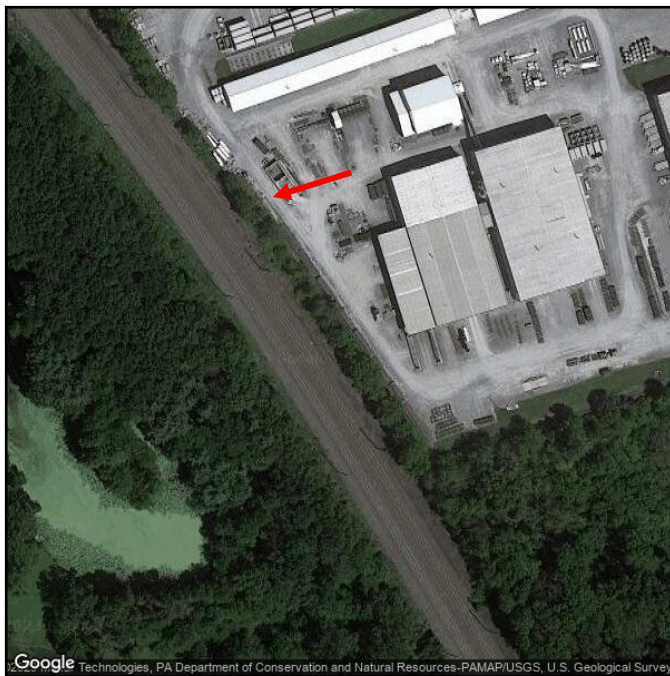
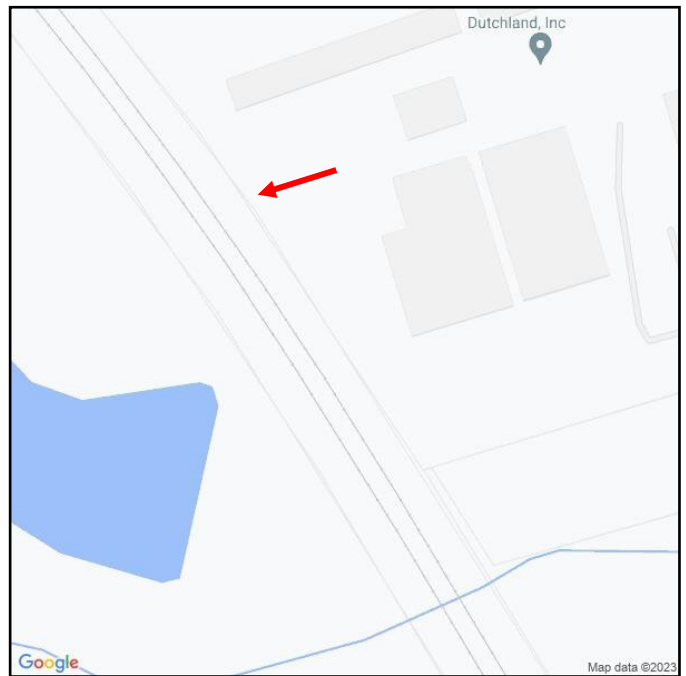
| Description | Headwall outlet structure and drainage ditch shown in Photograph DSCN5112. |

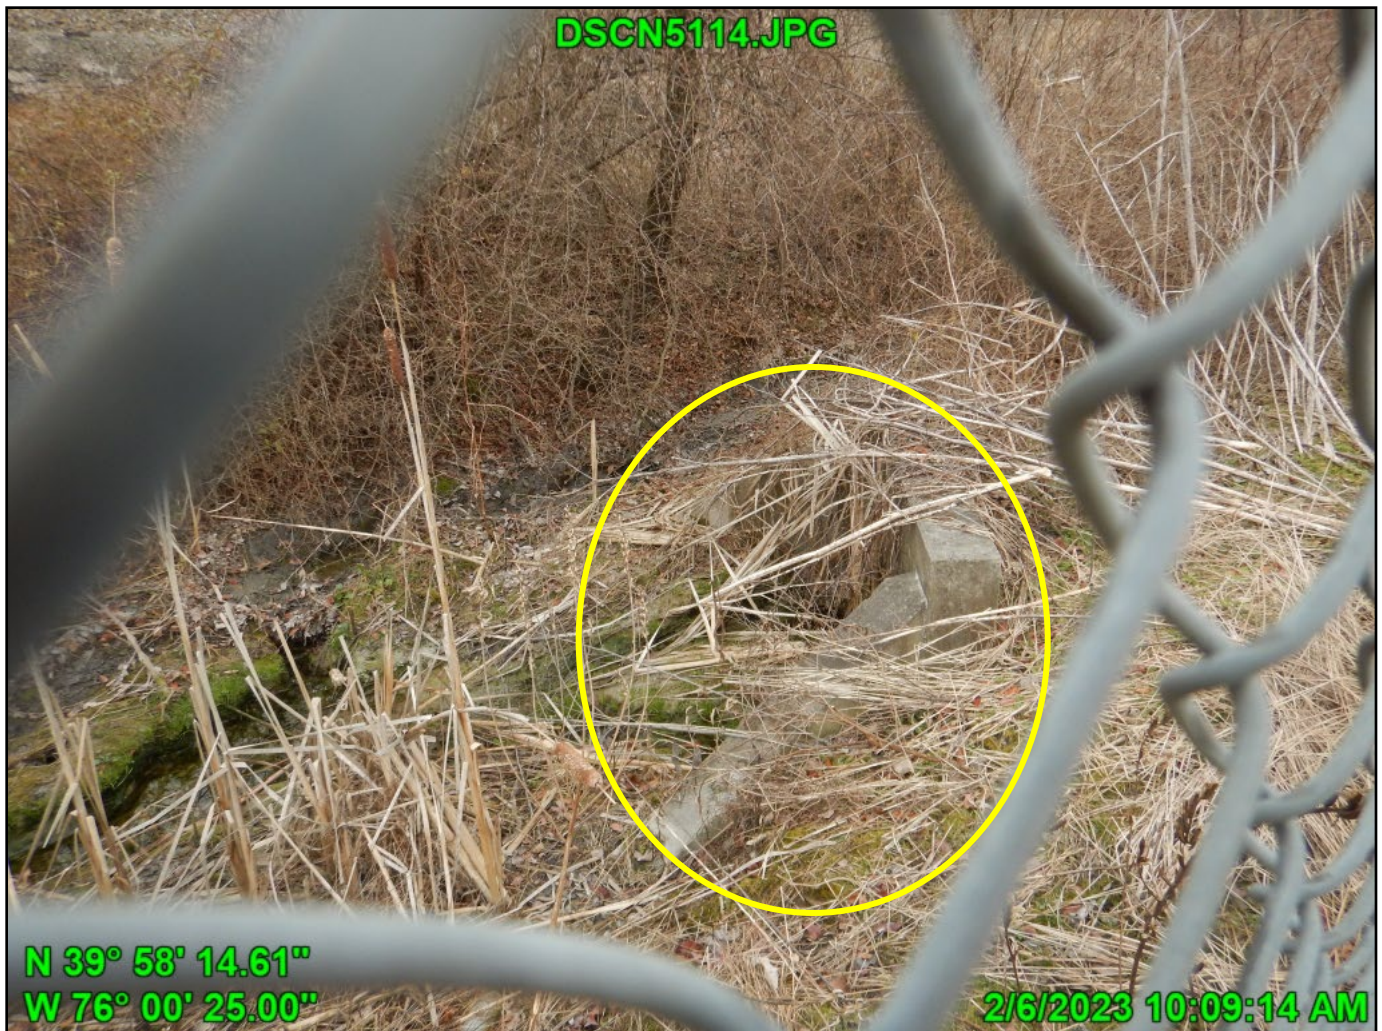
| Description | Closer view of the headwall outlet structure and drainage ditch shown in Photographs DSCN5112 and DSCN5113. |

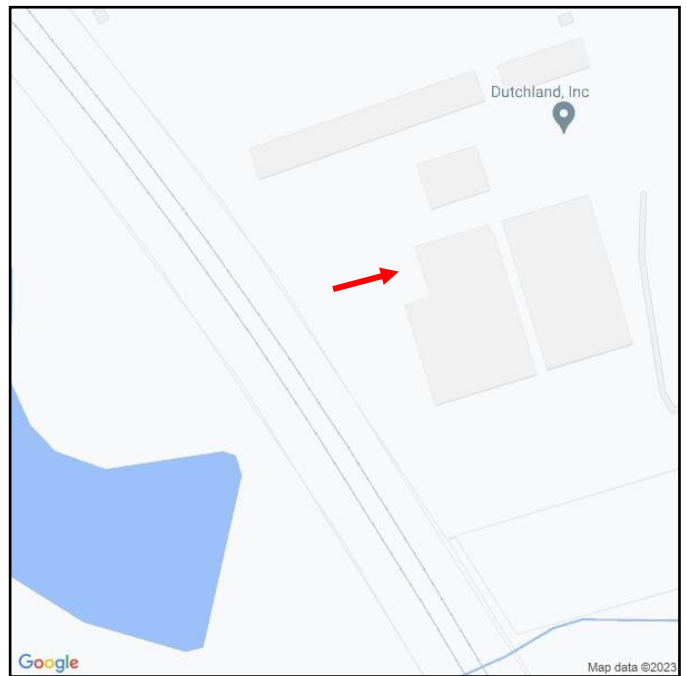
| Description | Outdoor uncovered steel and steel rebar materials storage area in the west portion of the Facility. |

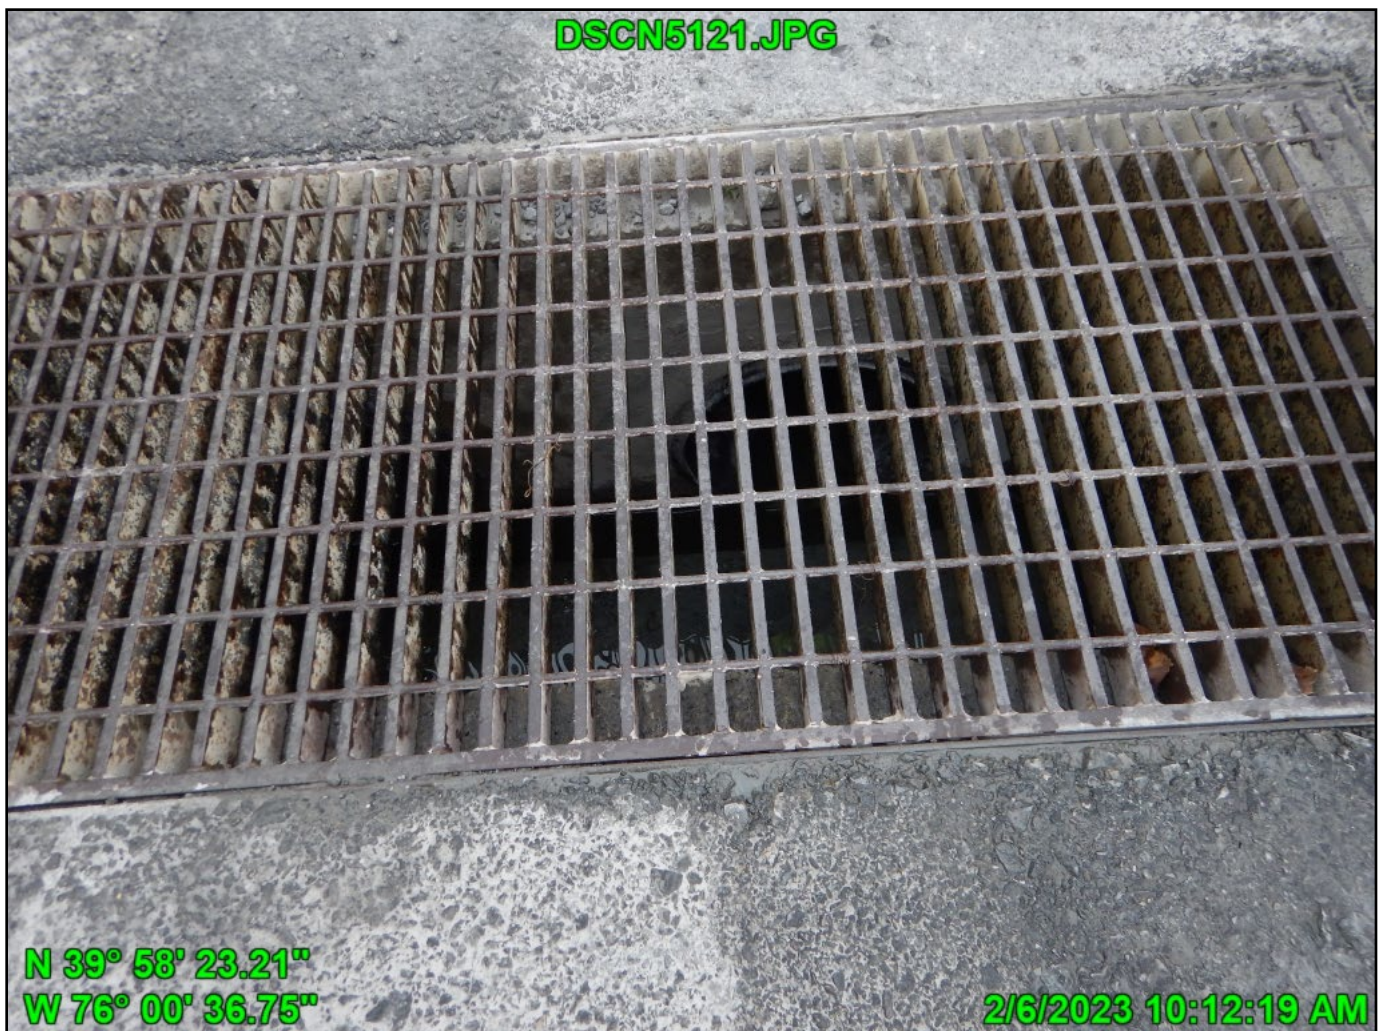
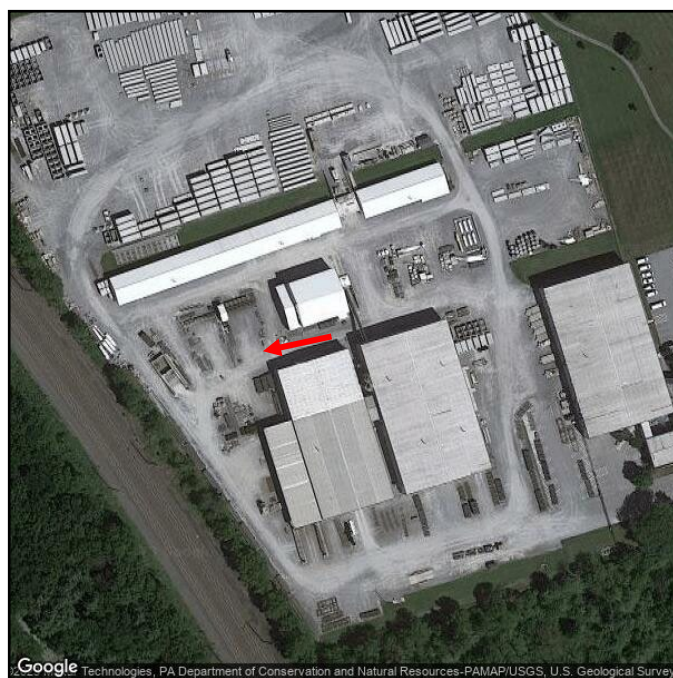
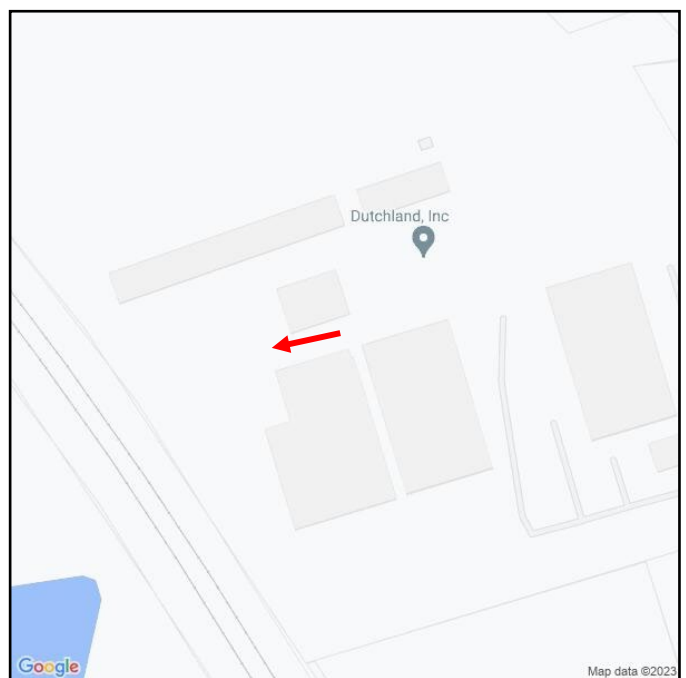
| Description | An additional catch basin, different from the one in Photograph DSCN5120, that according to the Facility representative, conveys stormwater towards the headwall as shown in Photograph DSCN5114. |

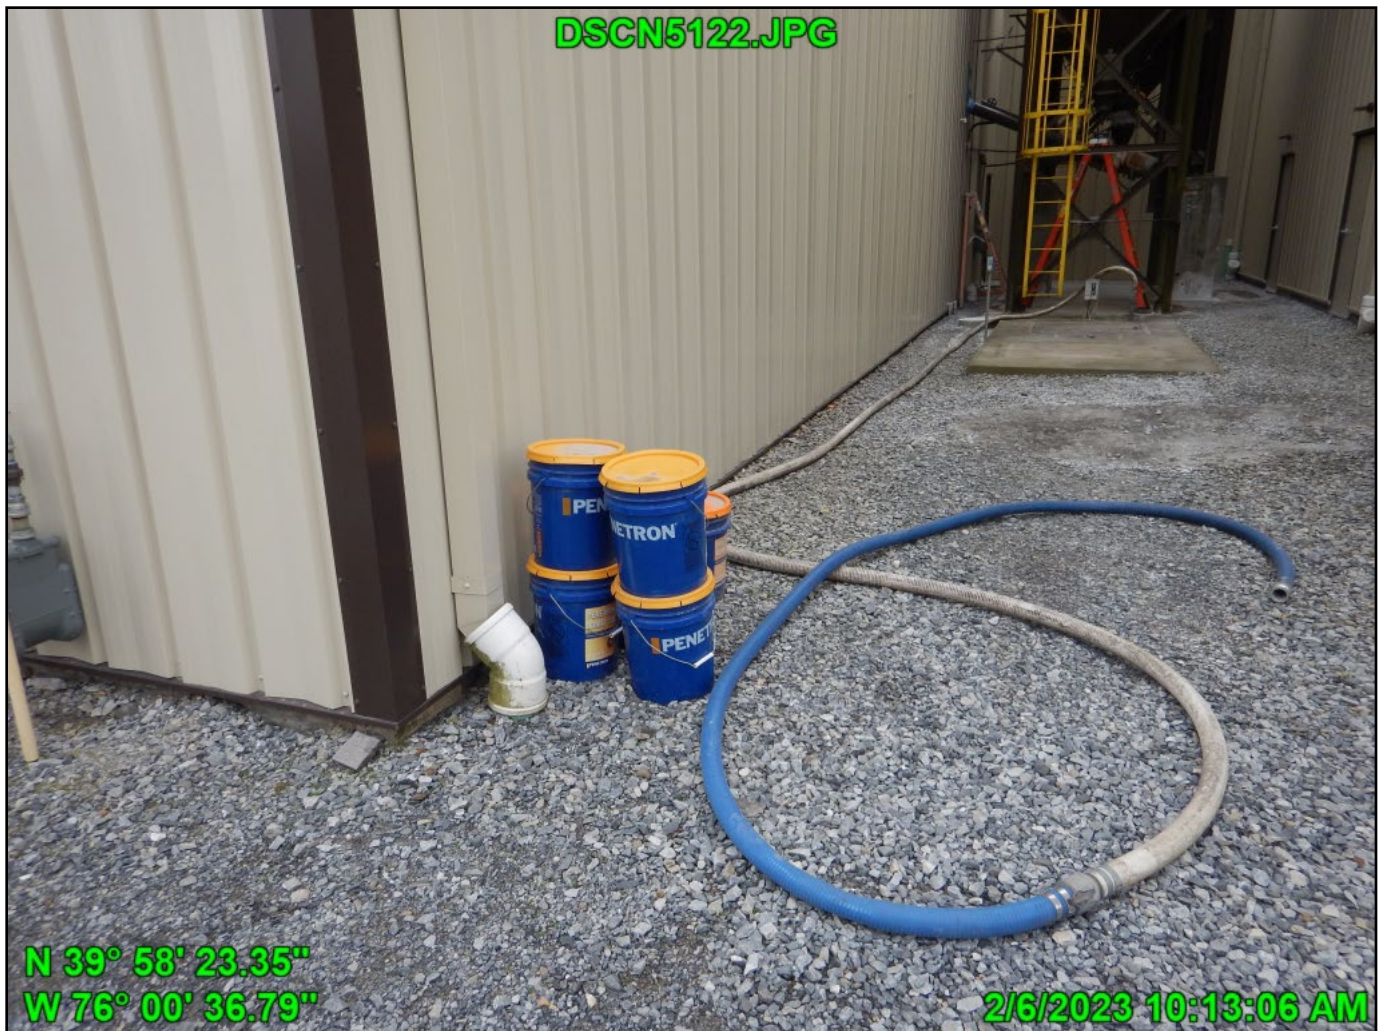
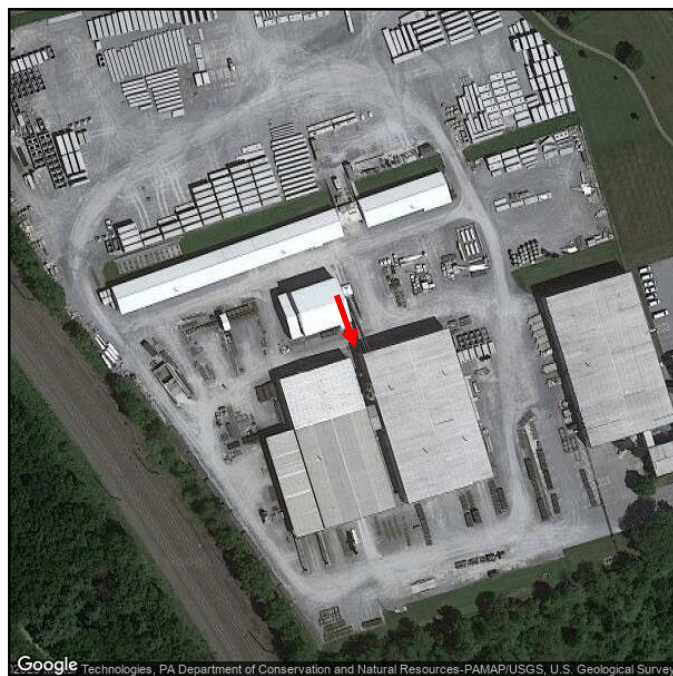
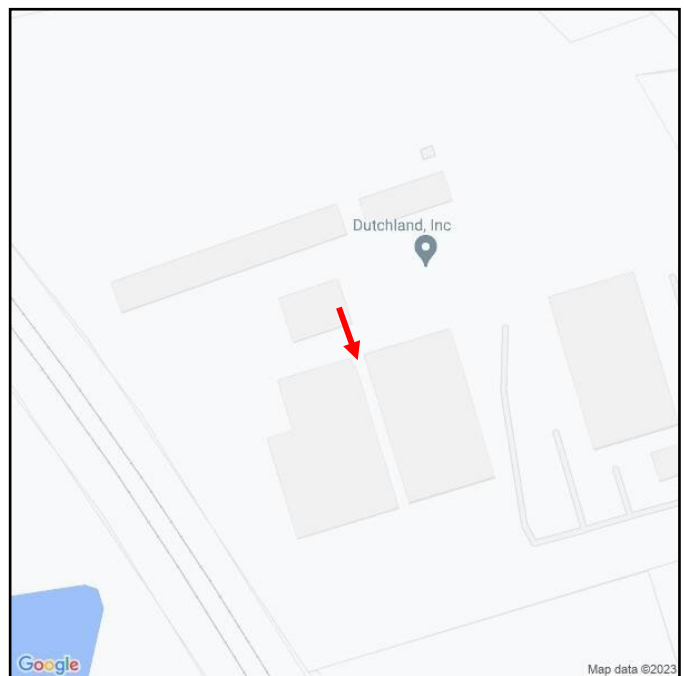
| Description | Five (5) penetron admix buckets stored outside without cover or containment. Penetron is added during concrete batching to protect the concrete against water penetration. |

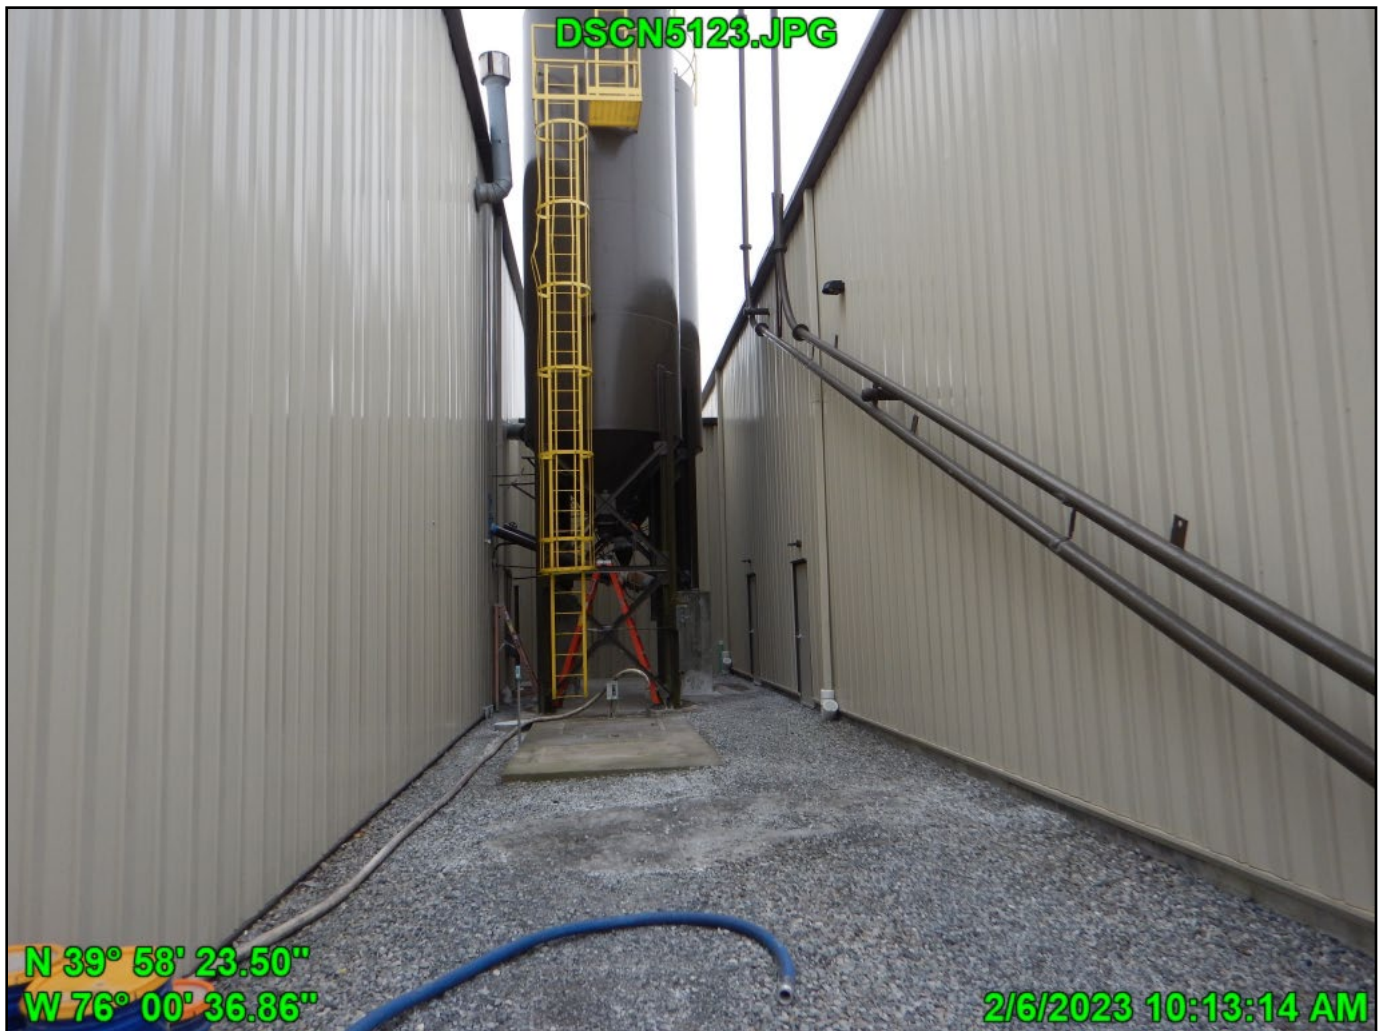
| Description | Area between two of the manufacturing buildings. It was not clear what was contained in the silos. |

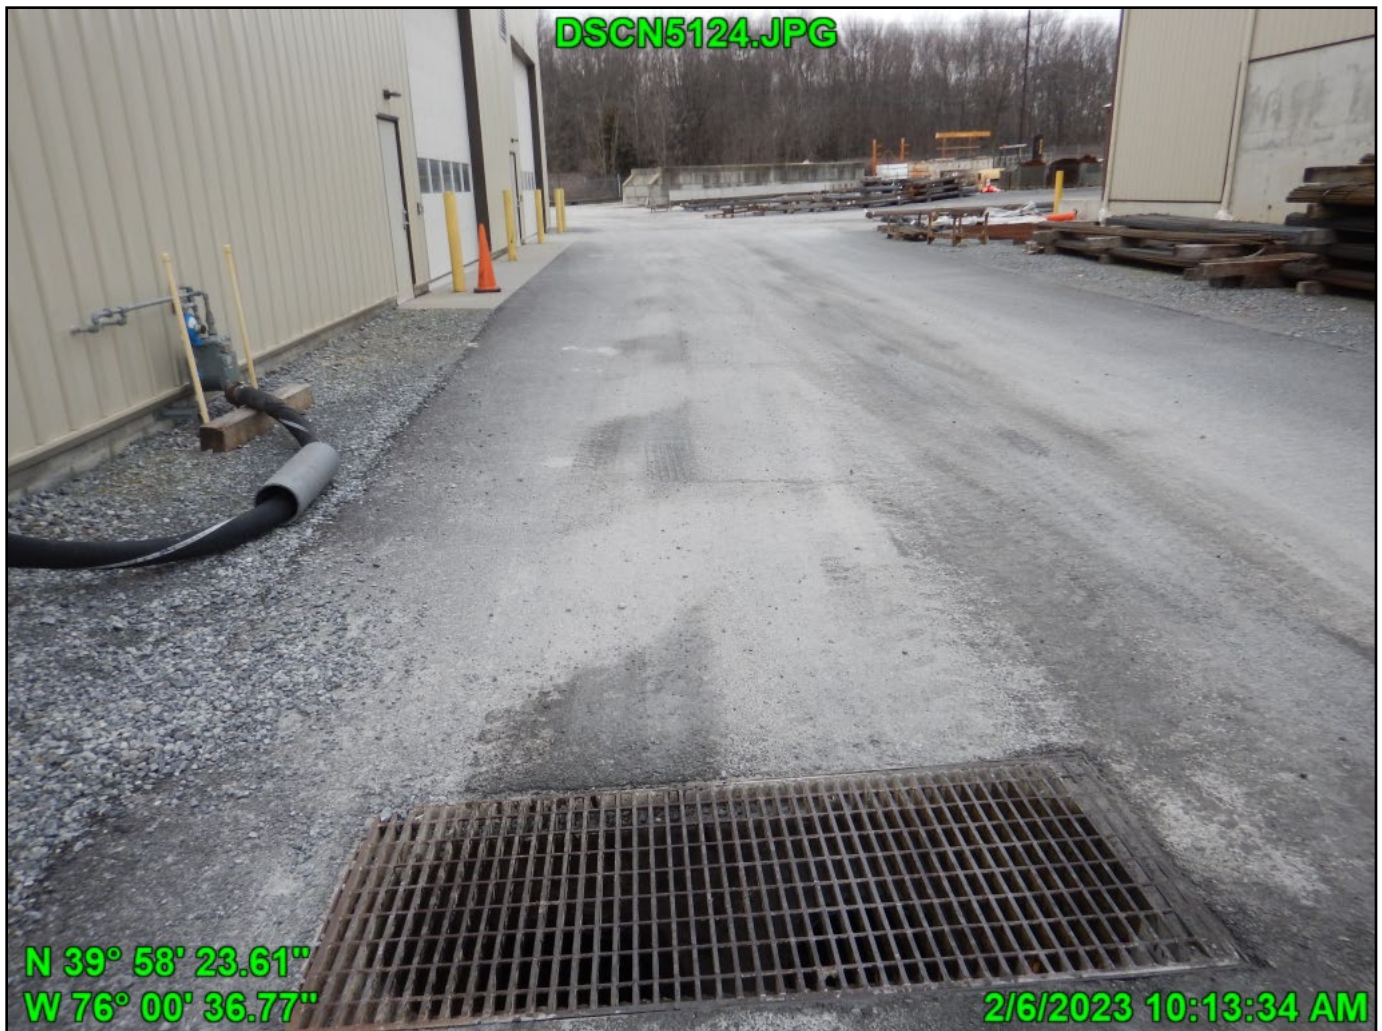
| Description | Catch basin upgradient to those in Photographs DSCN5120 and DSCN5121. |

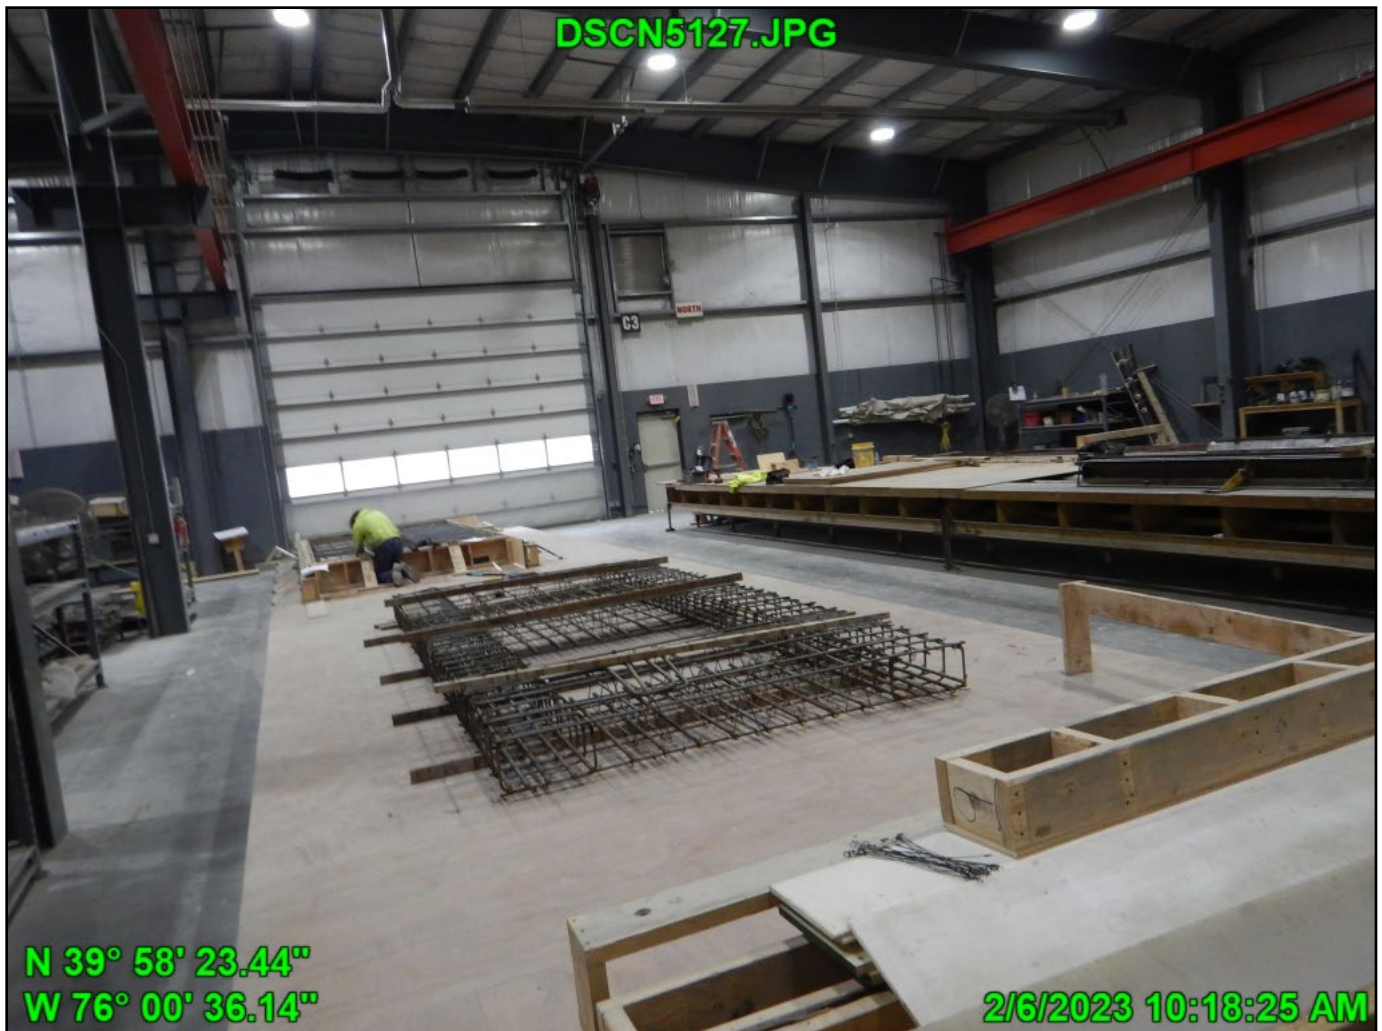
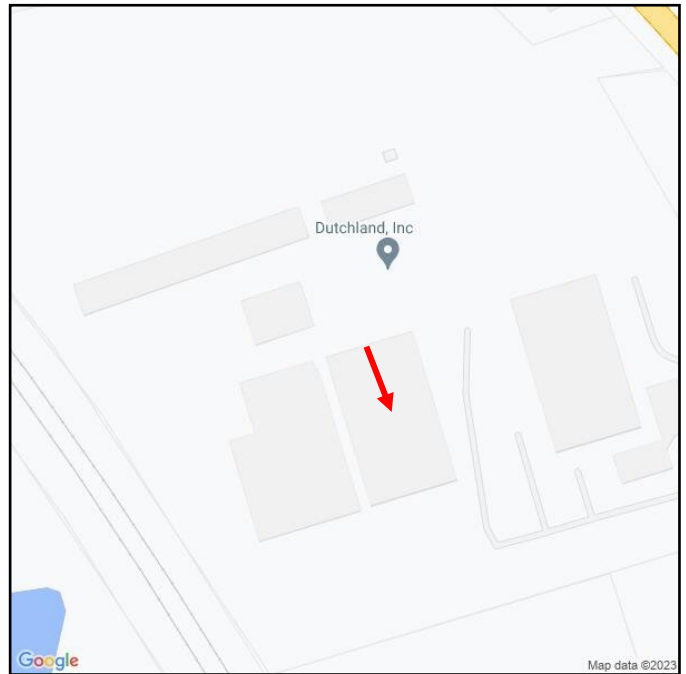
| Description | Inside one of the Facility's manufacturing buildings. |

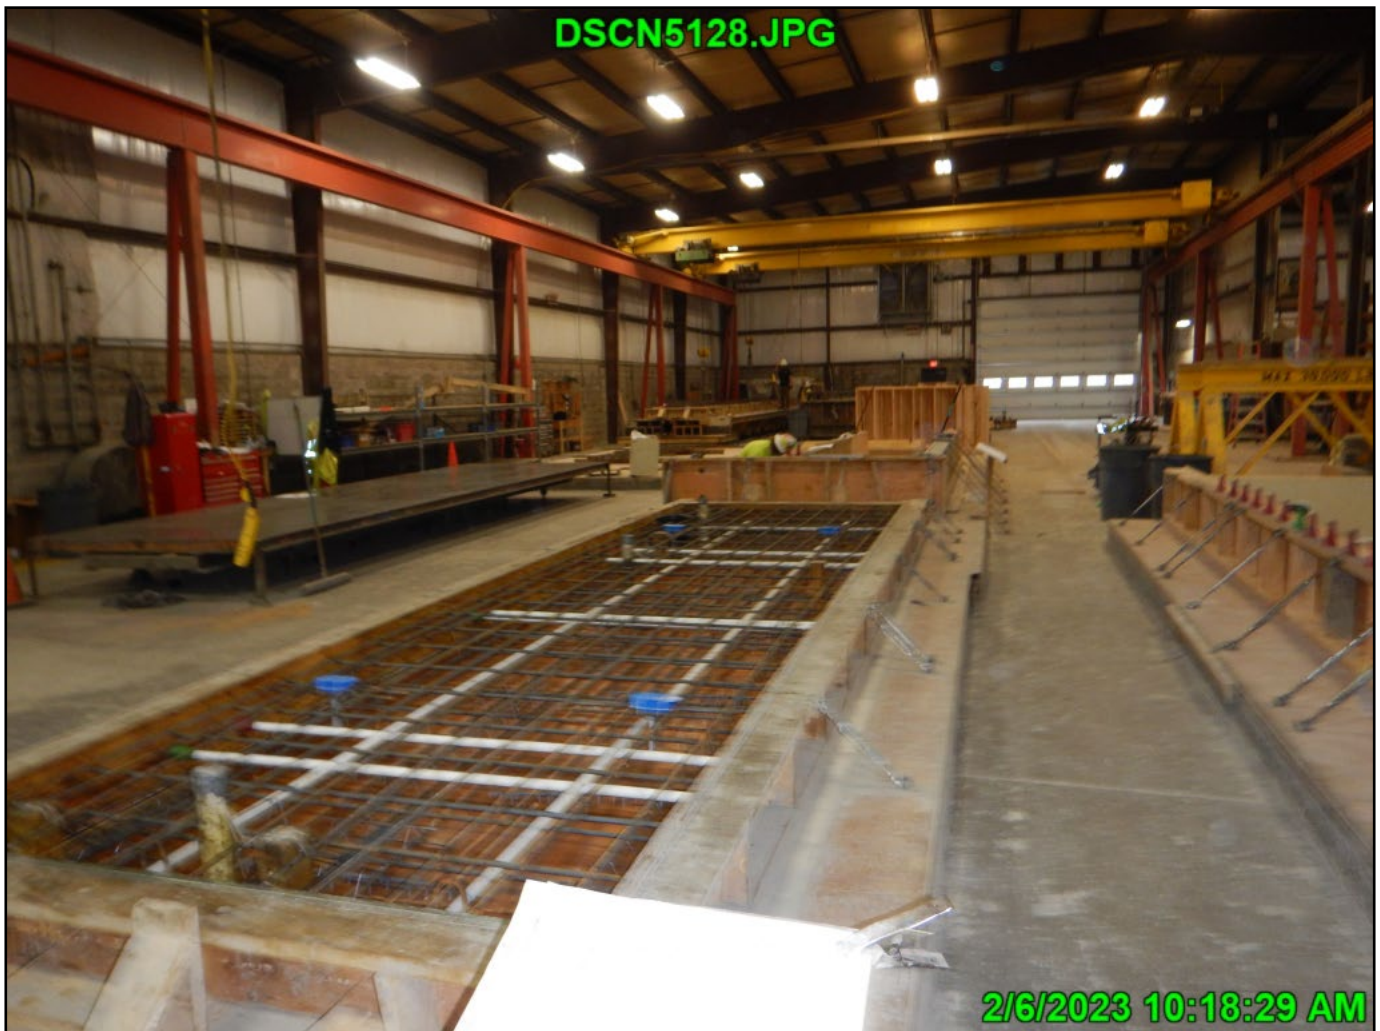
| Description | Inside one of the Facility's manufacturing buildings. |

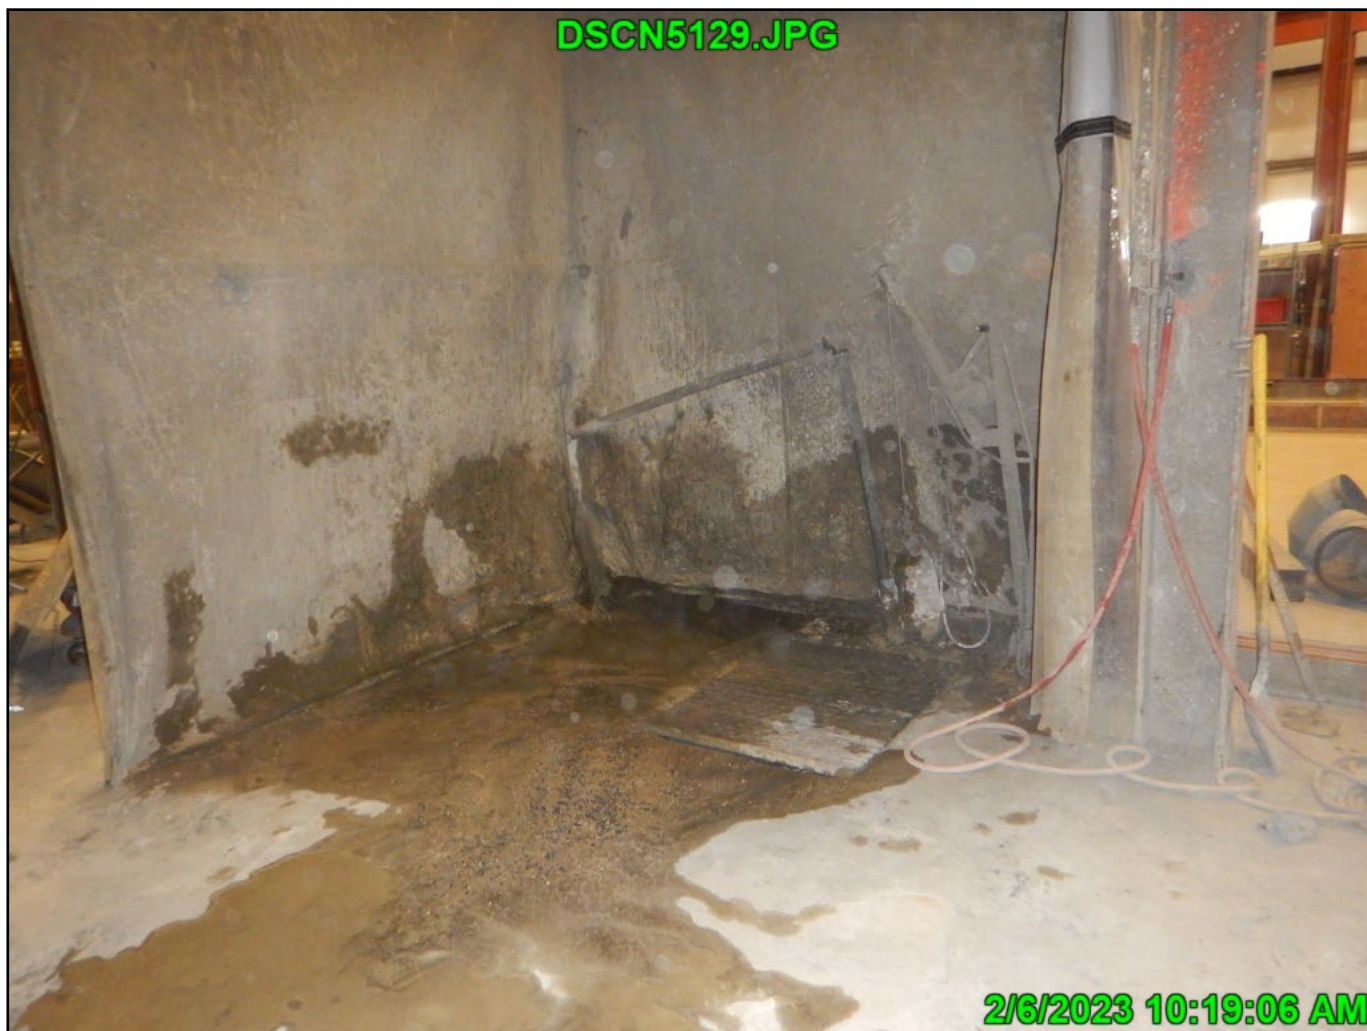
| Description | Wash area with a drain inside one of the manufacturing buildings. The Facility representative stated the drain is connected to an underground storage basin that is pumped out regularly by a contractor. |

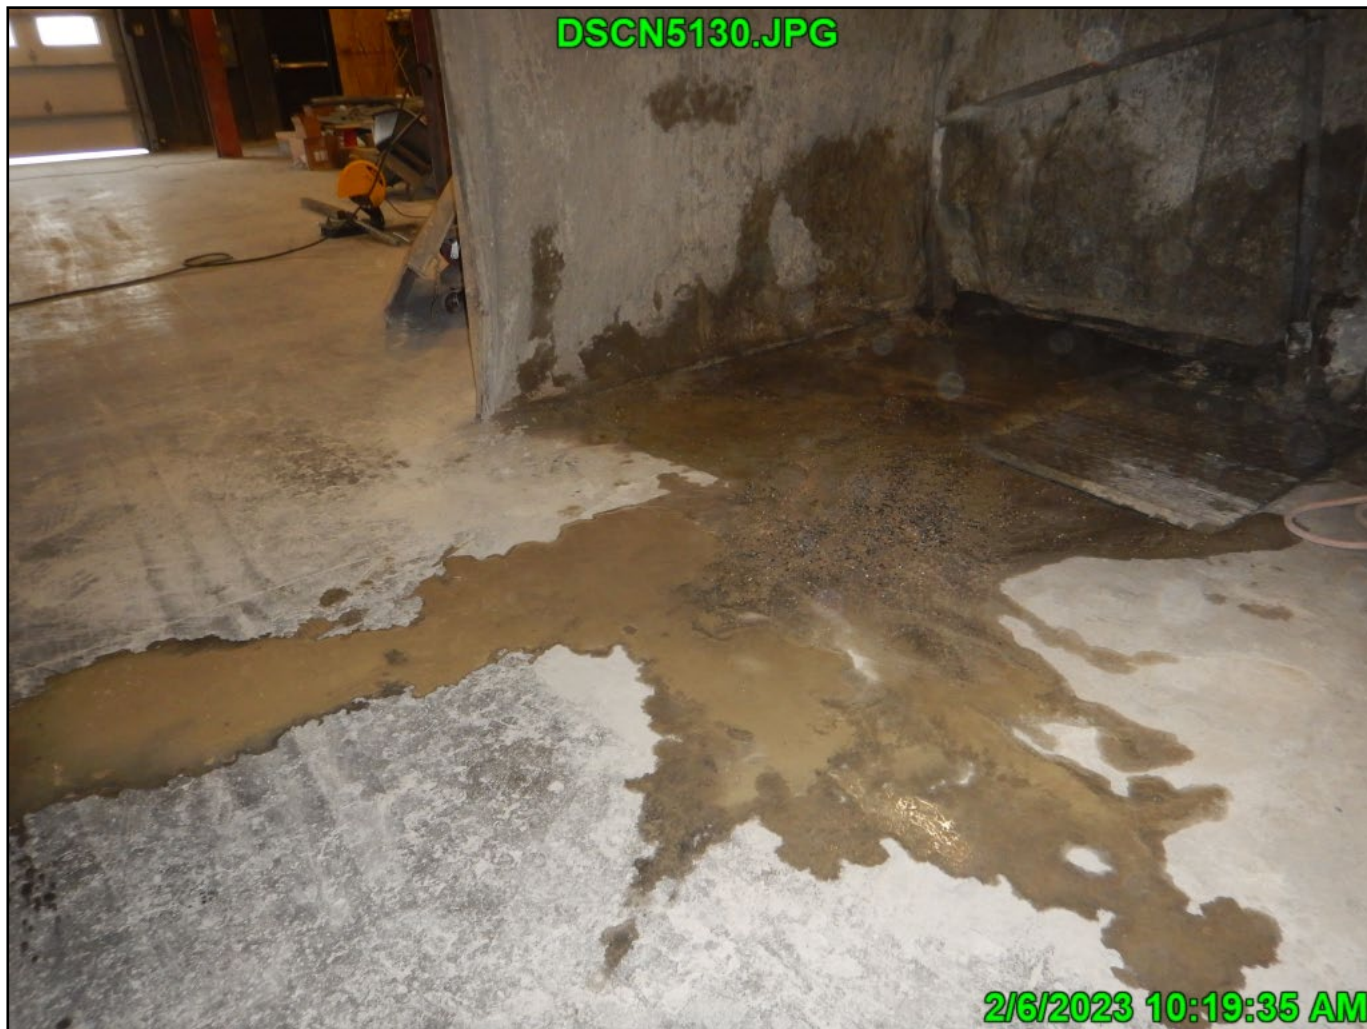
| Description | Wash area inside one of the manufacturing buildings as shown in Photograph DSCN5129. |

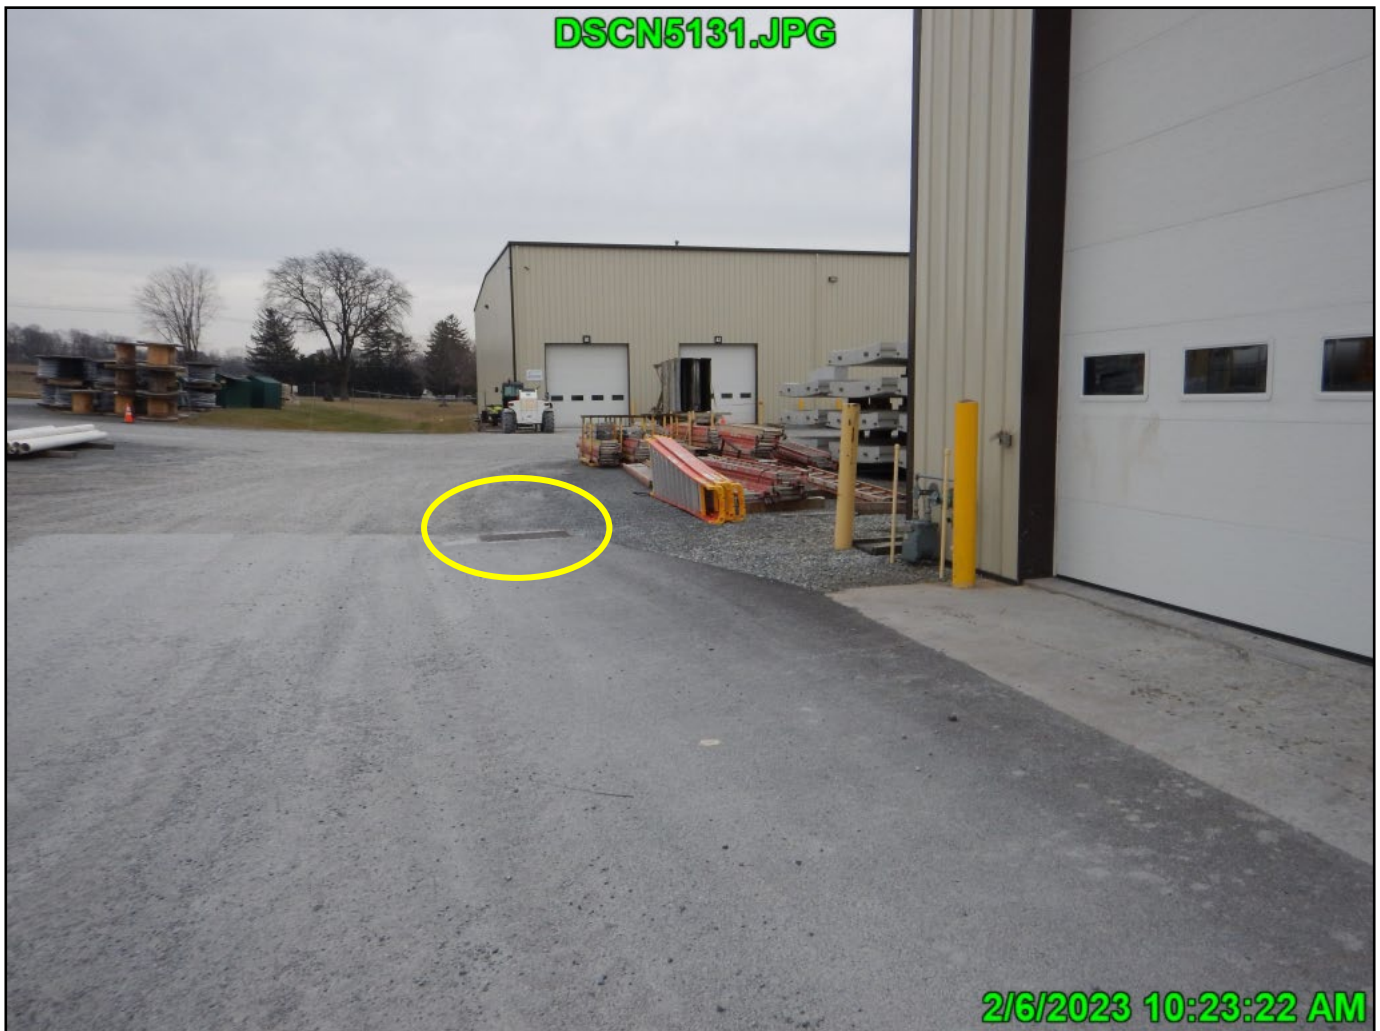
| Description | Catch basin that conveys stormwater to an adjacent drainage swale. |

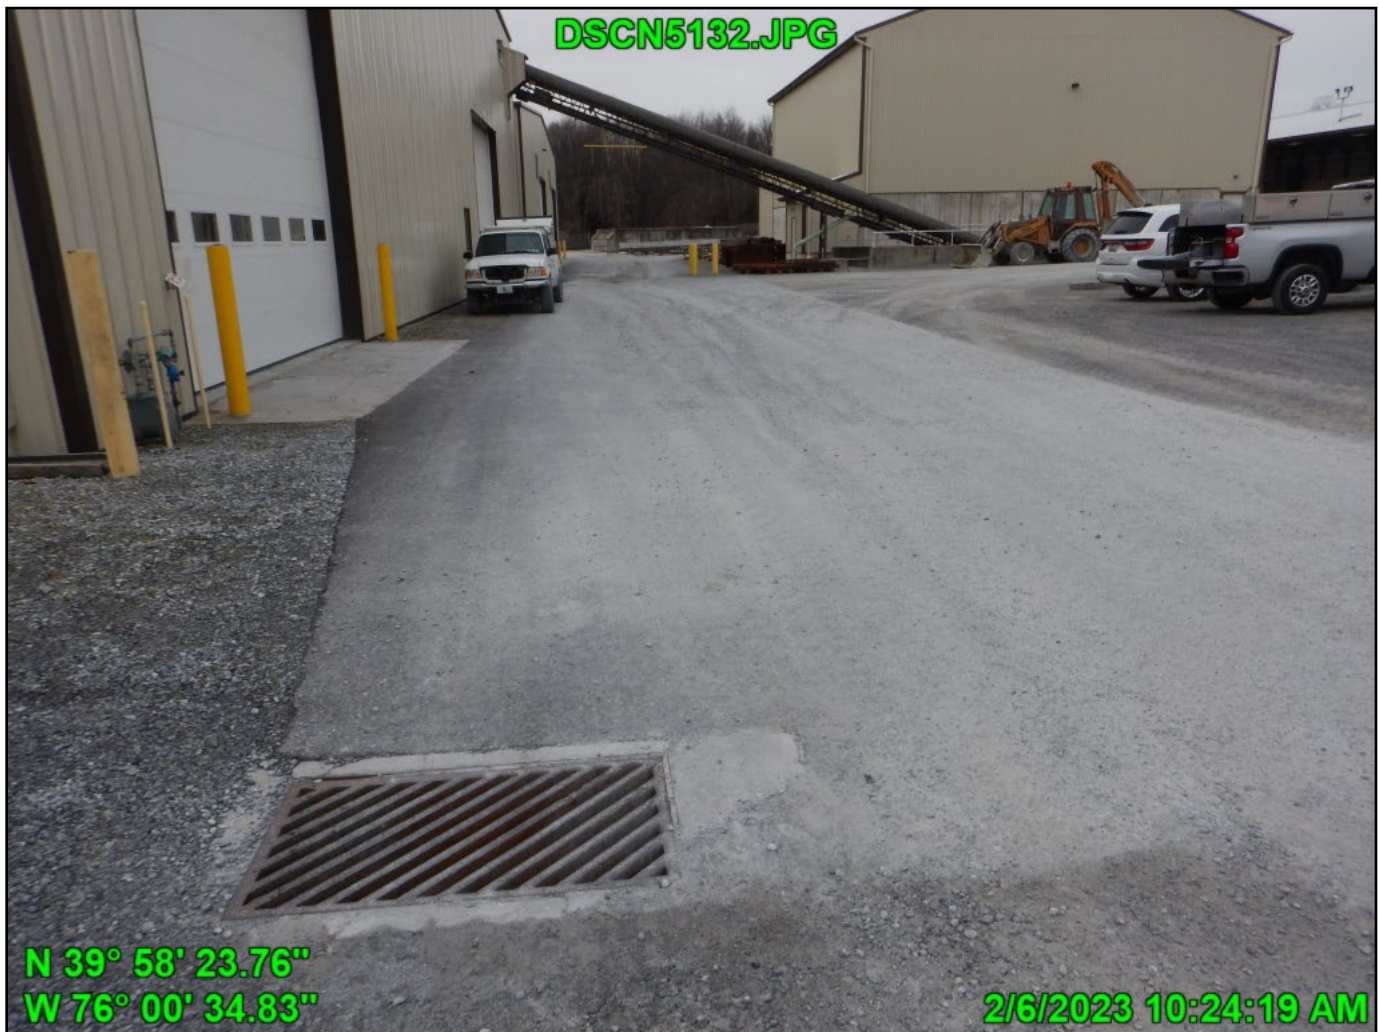
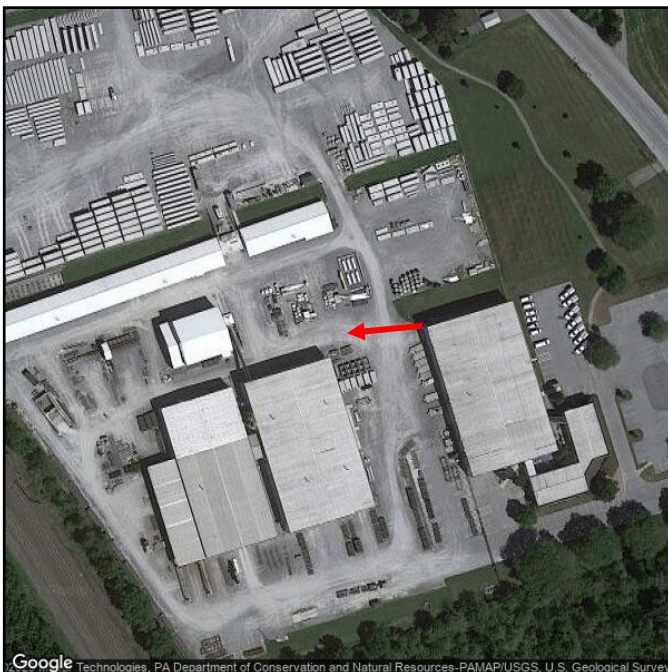
| <b>Description</b> | Catch basin shown in Photograph DSCN5131. |
