## MULTI-SECTOR GENERAL PERMIT NON-FILER INSPECTION CHECKLIST

| <b>Inspection Date(s):</b> | 2/7/2023 | |
| <b>Operator Name:</b> | Dutchland, Inc. | |

Stormwater Inspection Date: February 7, 2023

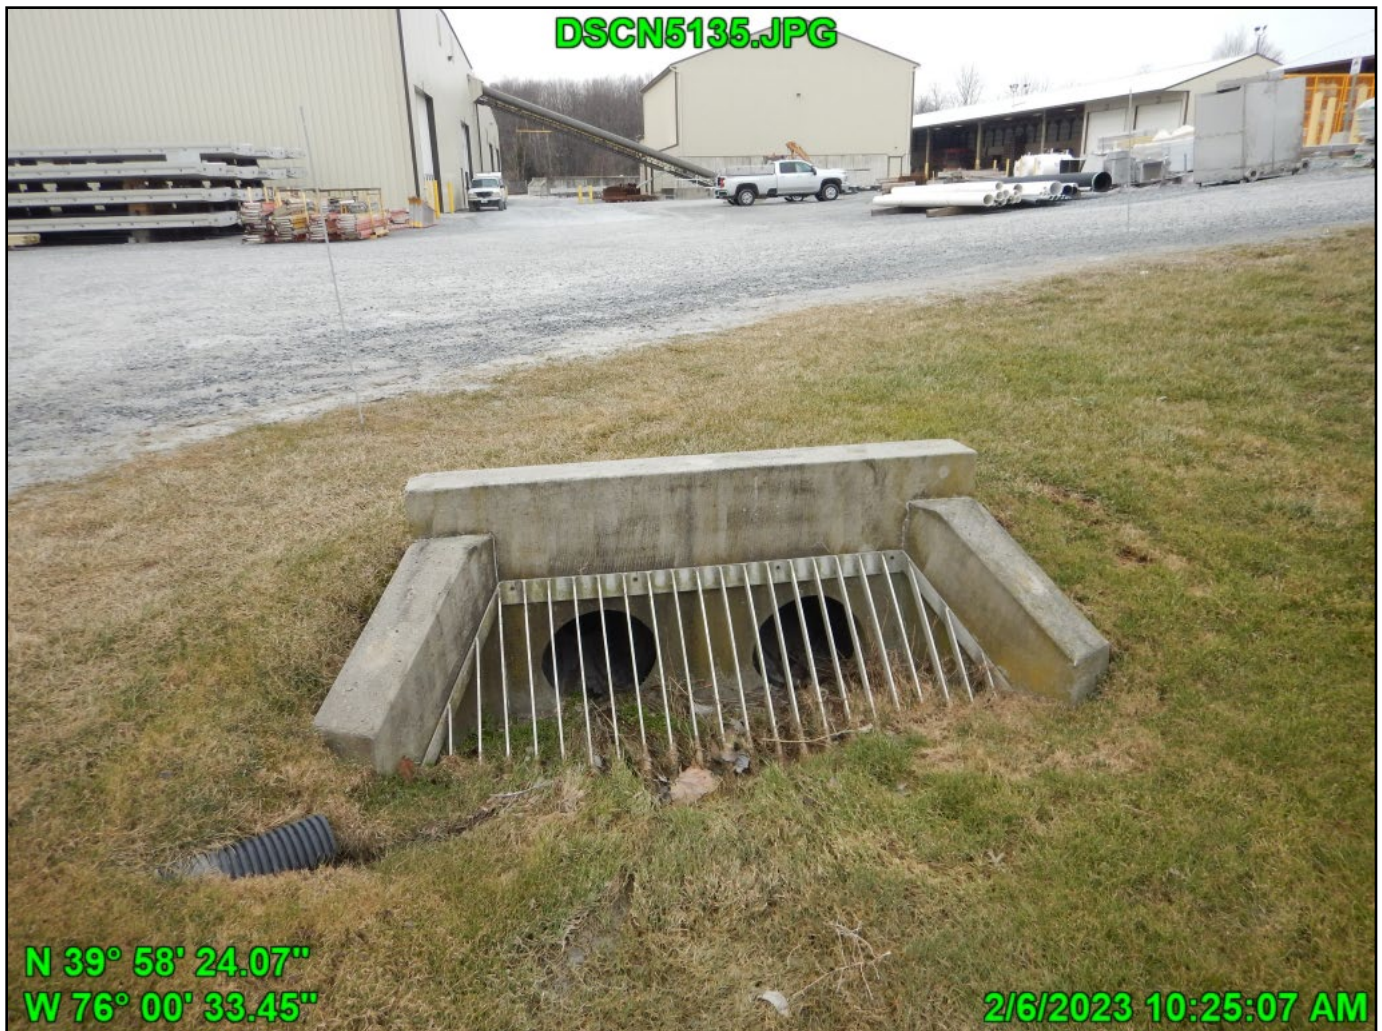
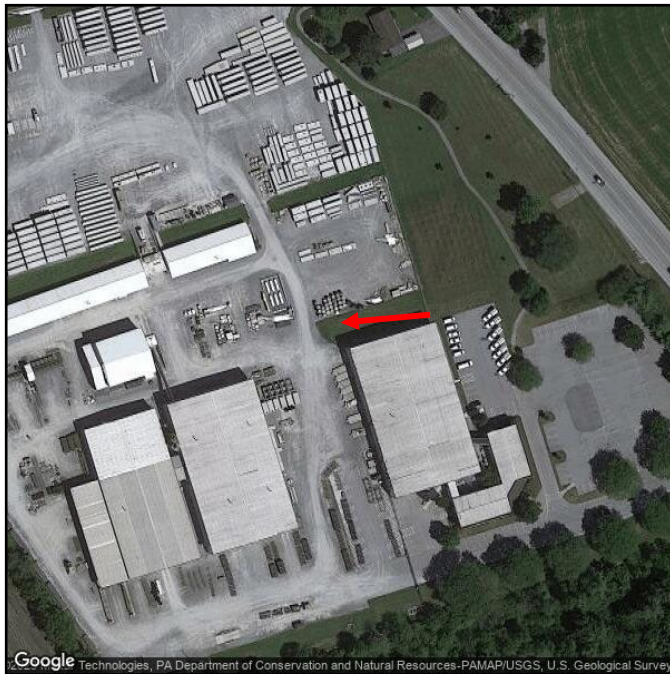
| Description | Headwall outlet structure to the drainage swale shown in Photograph DSCN5133. The black corrugated plastic pipe is connected to the adjacent building's roof drain. |

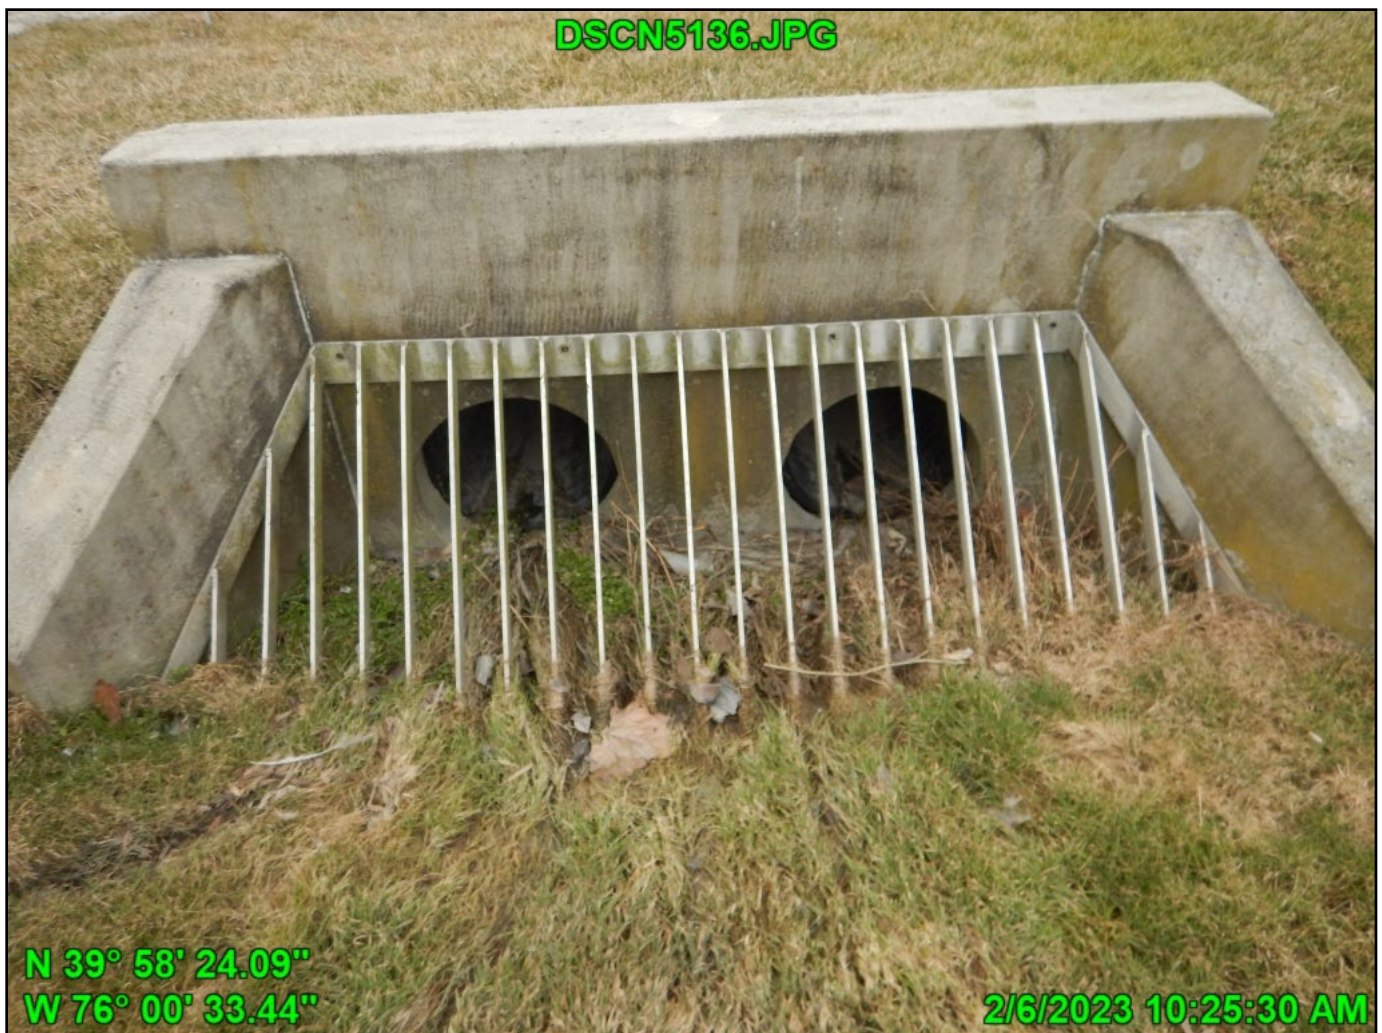
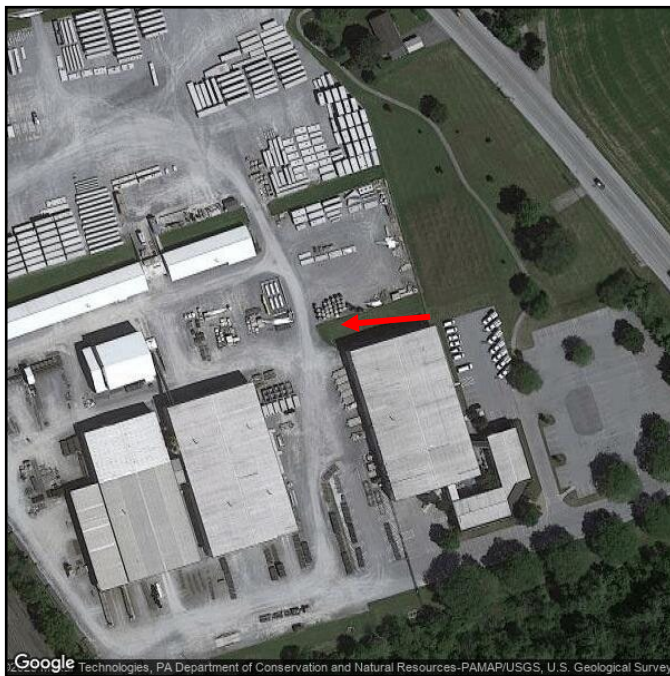
**Description**

Closer view of the headwall outlet structure to the drainage swale shown in Photographs DSCN5133 and DSCN5135.

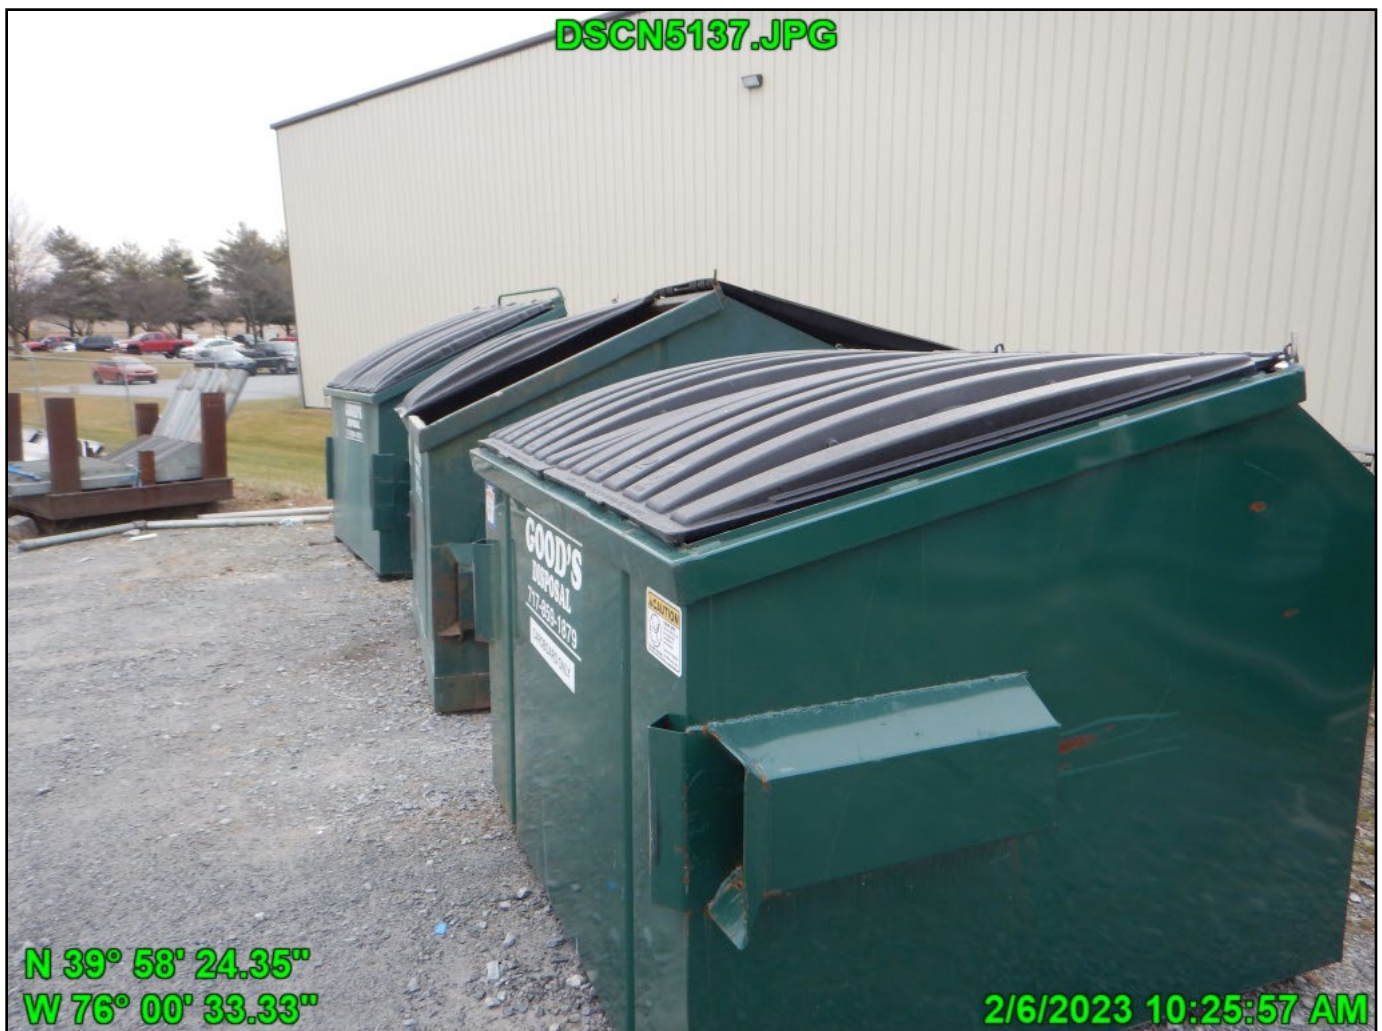
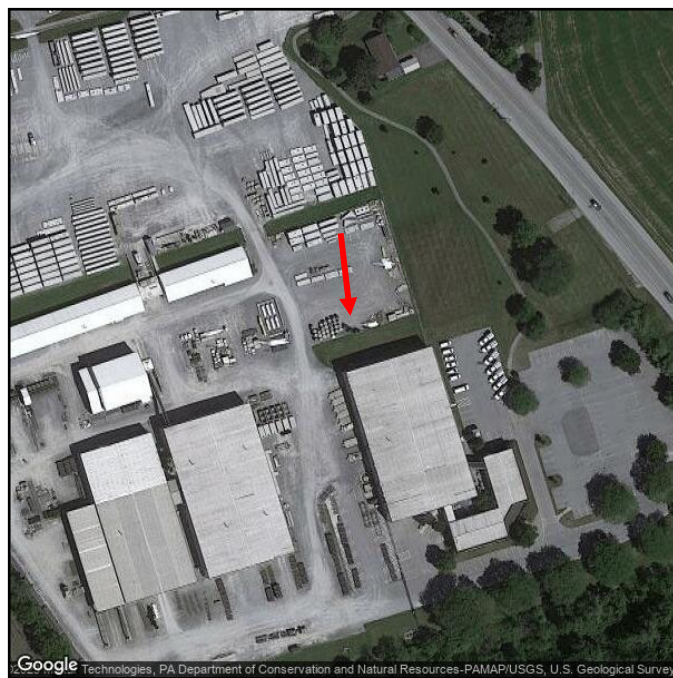
| Description | Three (3) covered trash dumpsters in the middle area of the Facility. |

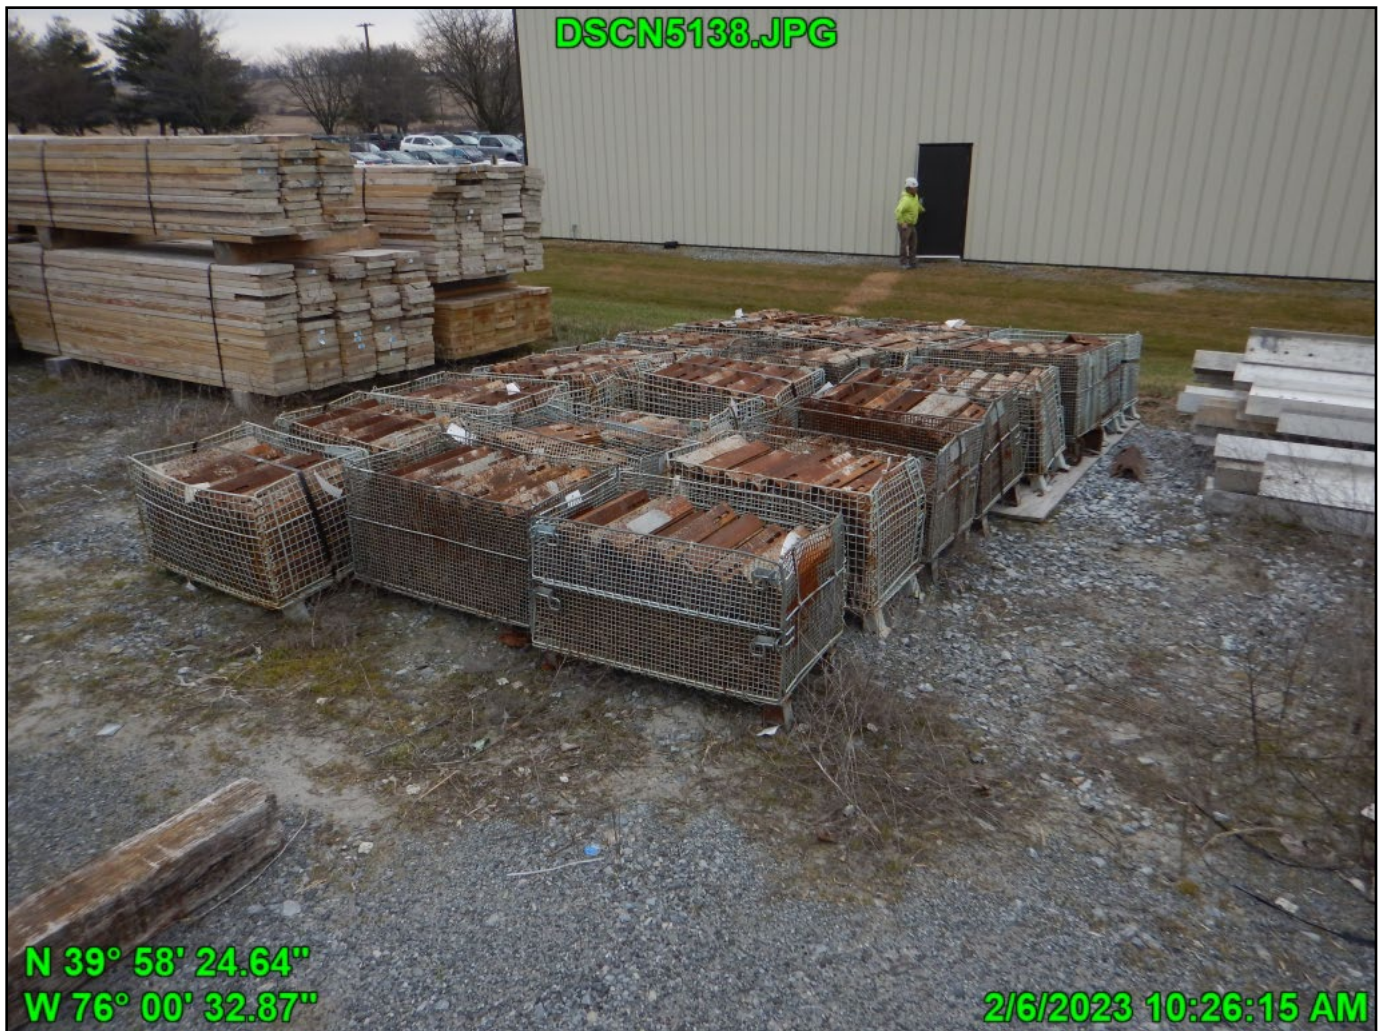
| Description | Wood and unknown metal materials stored outside in the middle area of the Facility. |

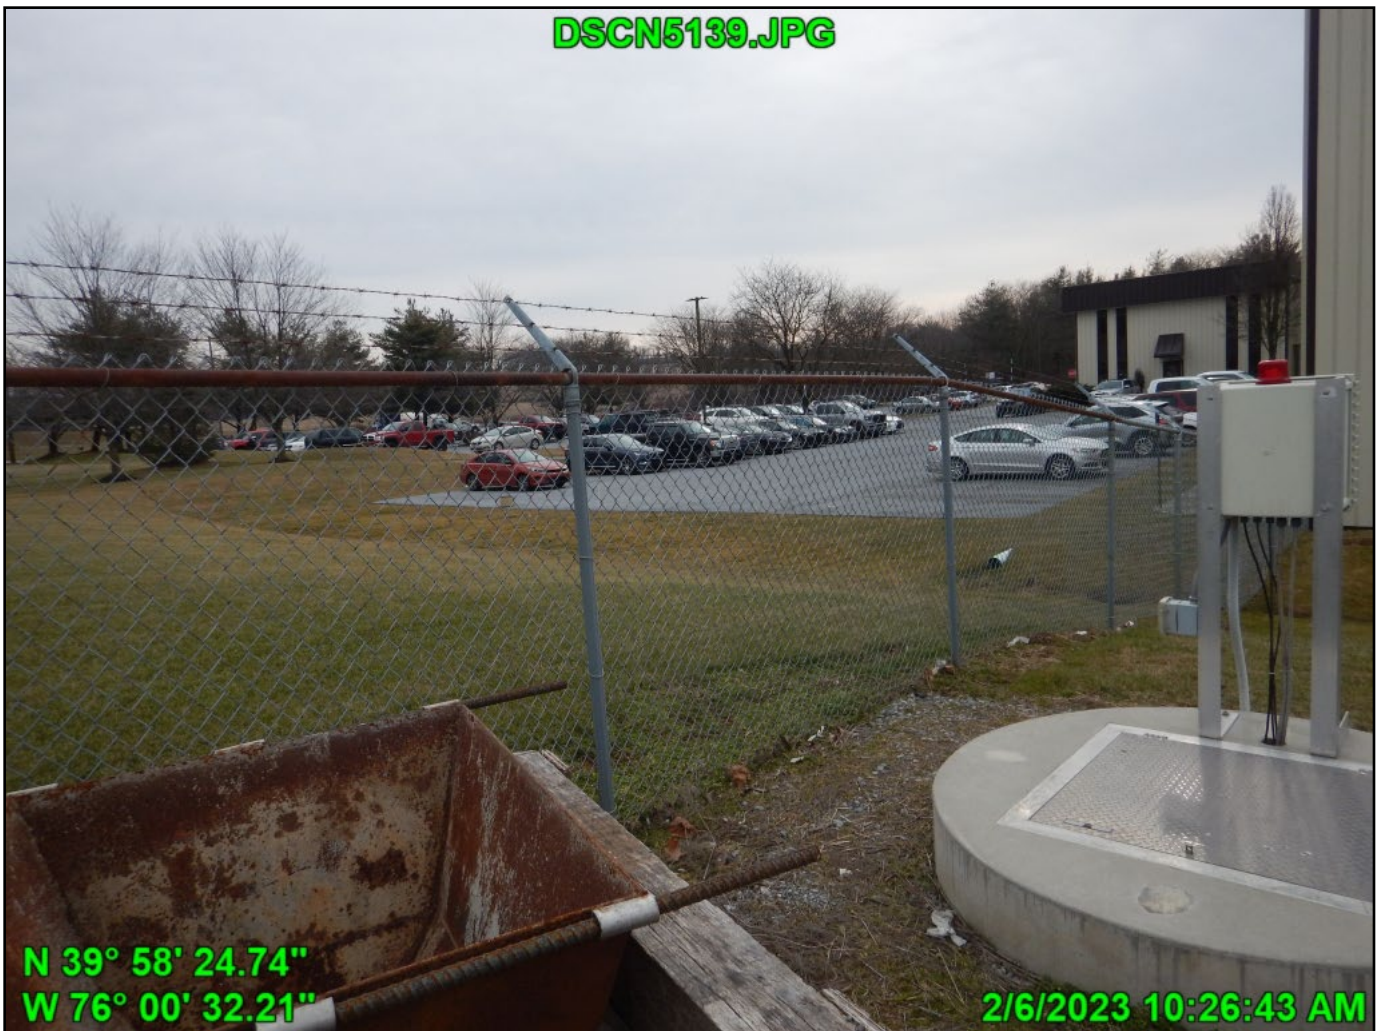
| Description | Continuation of the onsite drainage swale shown in Photograph DSCN5134. |

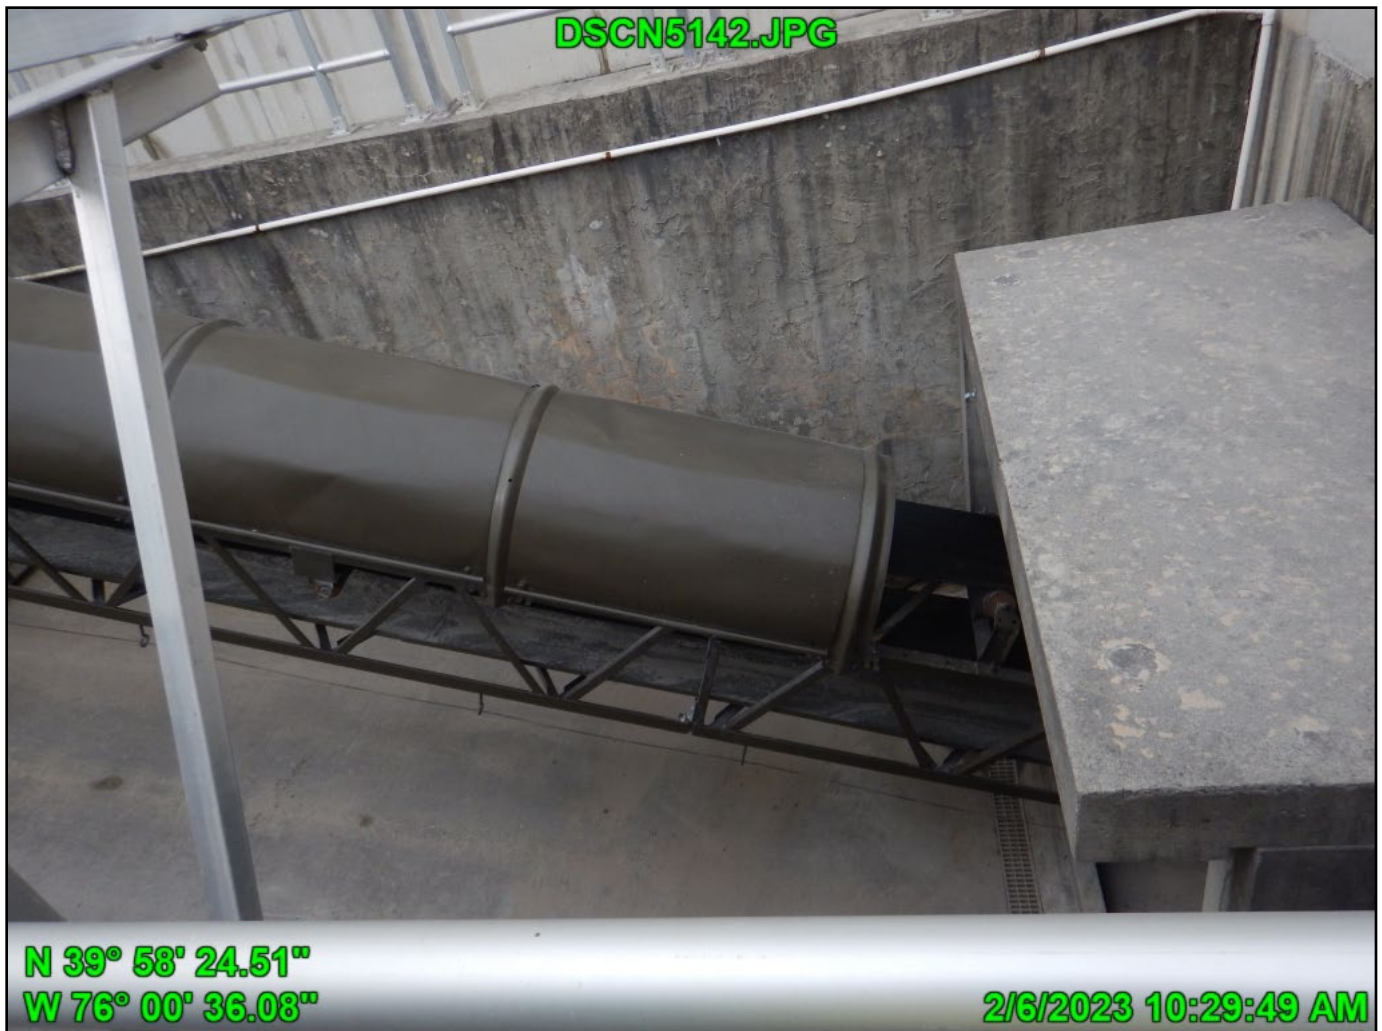
| Description | View of the Facility's conveyor that transfers well water from a sump for manufacturing. |

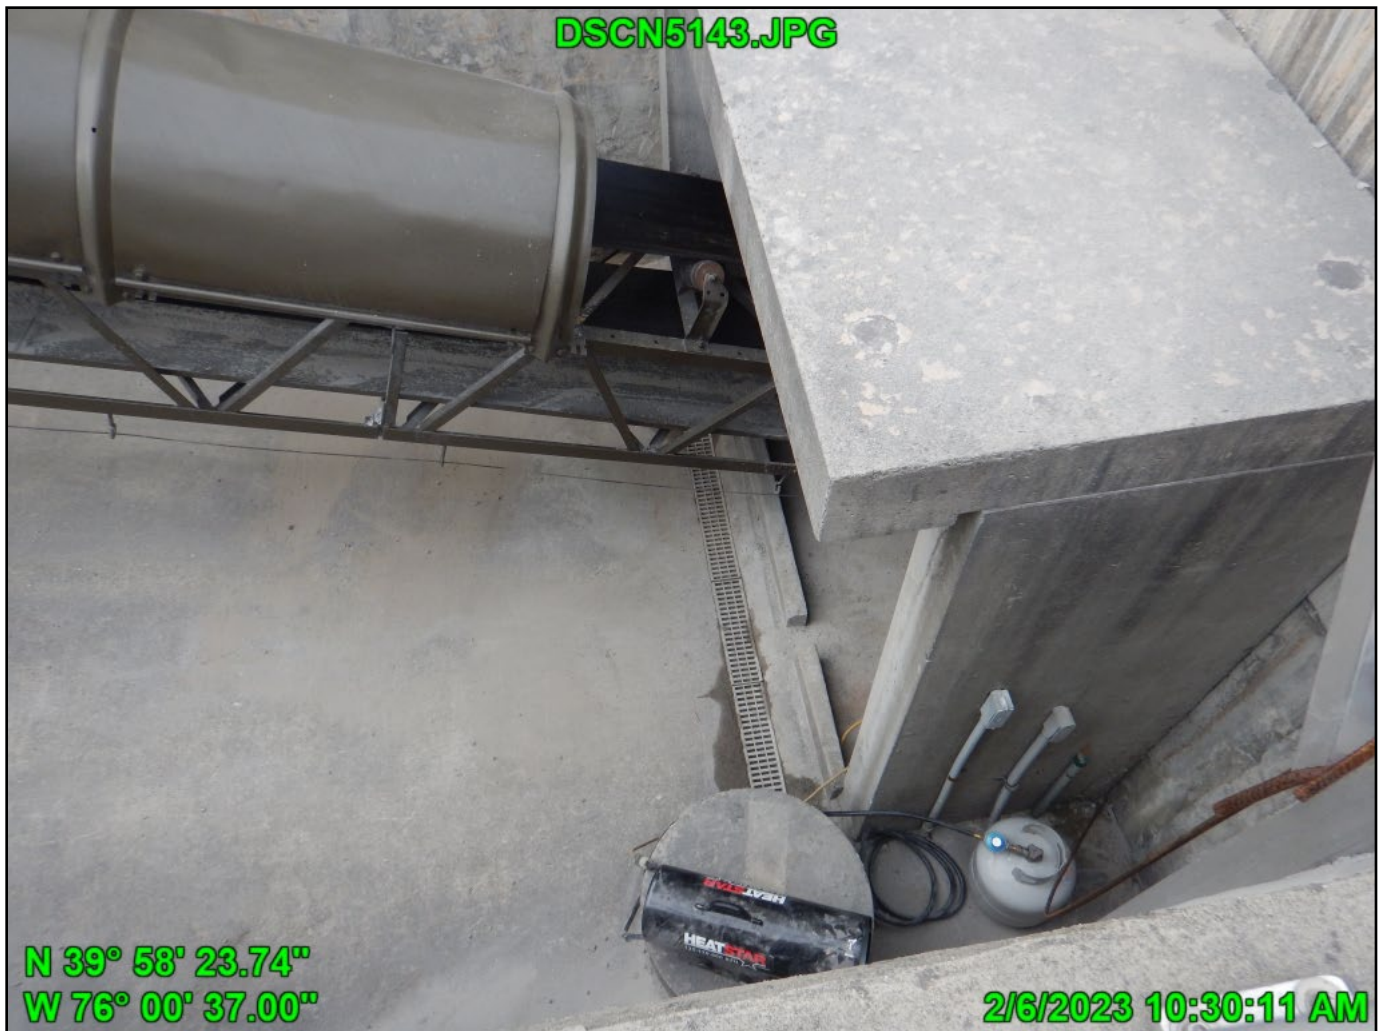
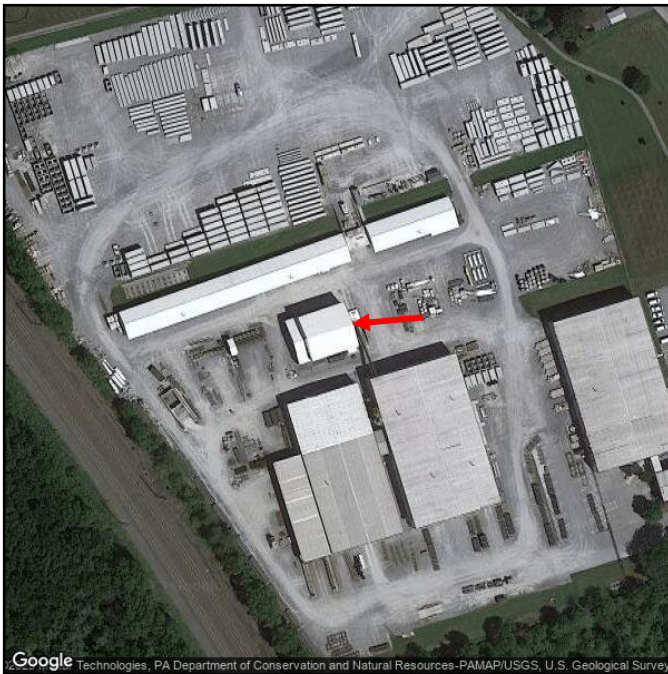
| Description | Additional view of the Facility's conveyor shown in Photograph DSCN5142. |

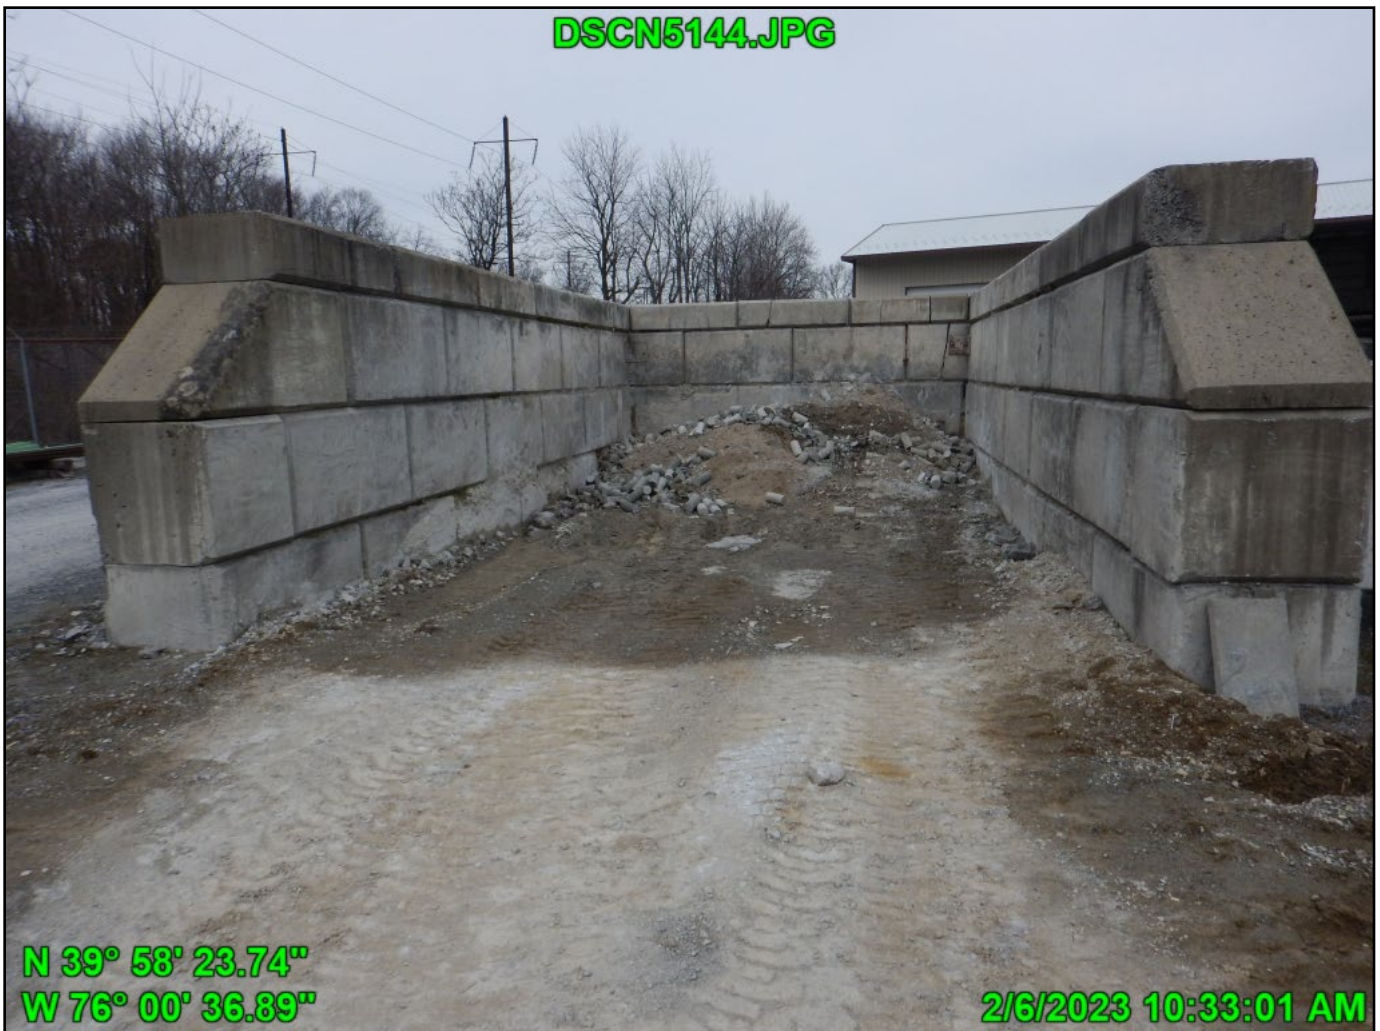
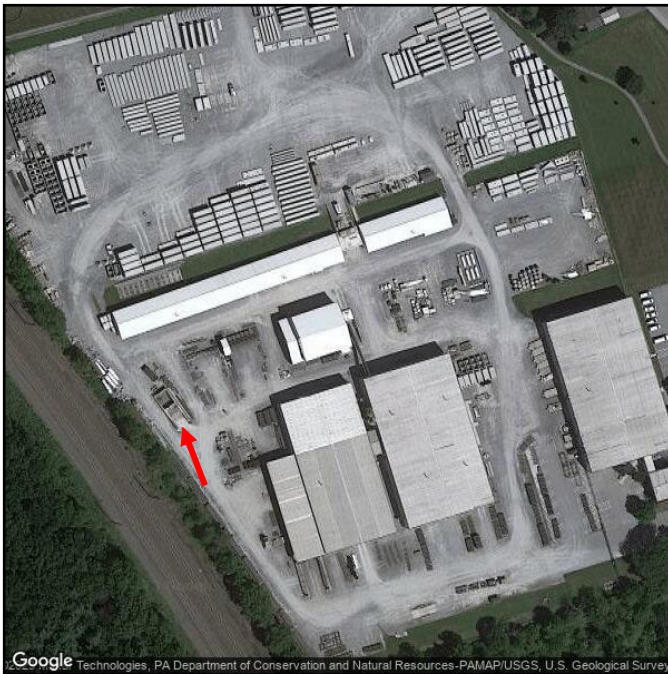
| Description | Concrete waste storage area in the west area of the Facility. |

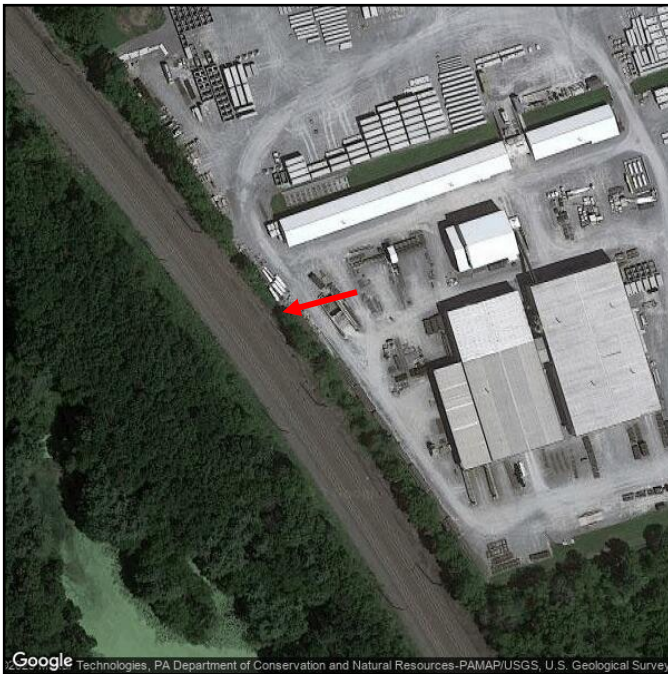
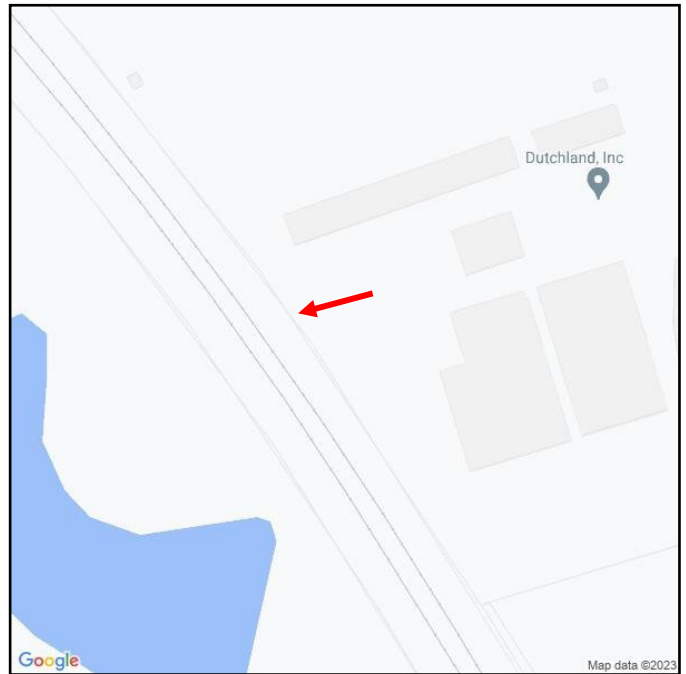
| Description | Stormwater flow path containing debris and sediment towards the Facility's west boundary fence line and drainage ditch. Though unconfirmed, it appeared that concrete had once been washed out in this area and left to dry. |

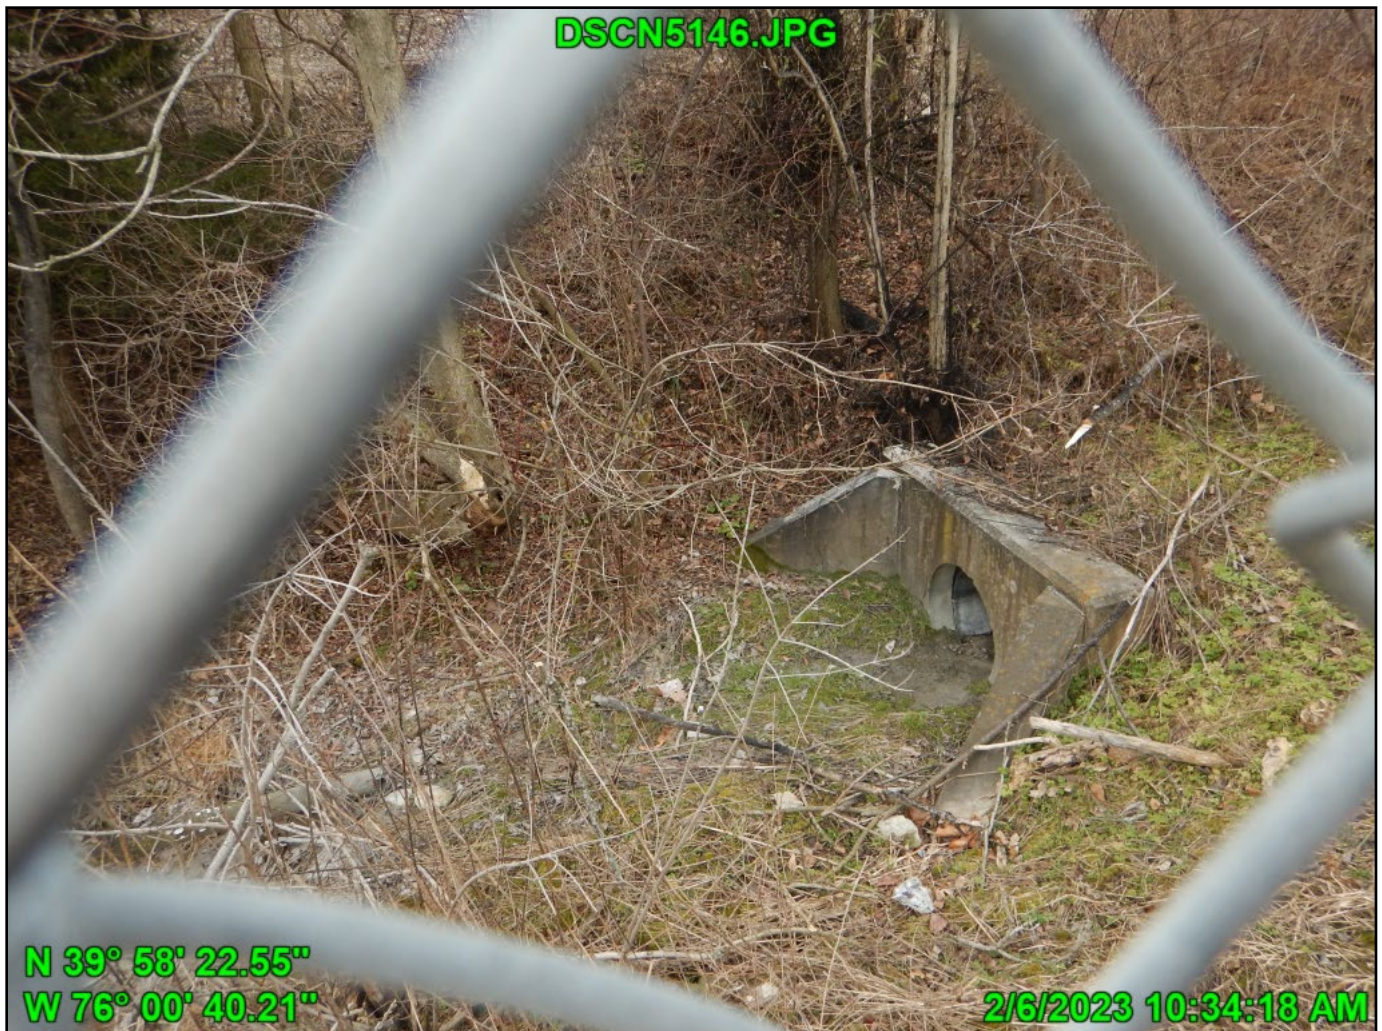
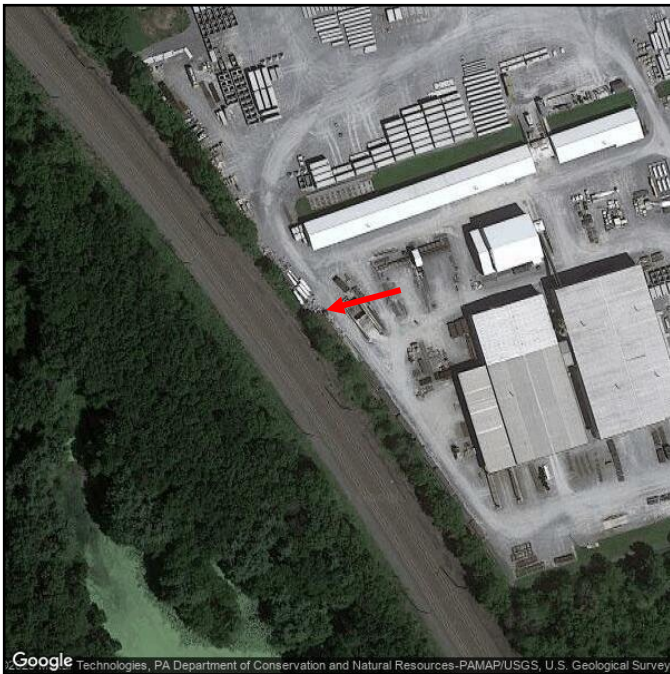
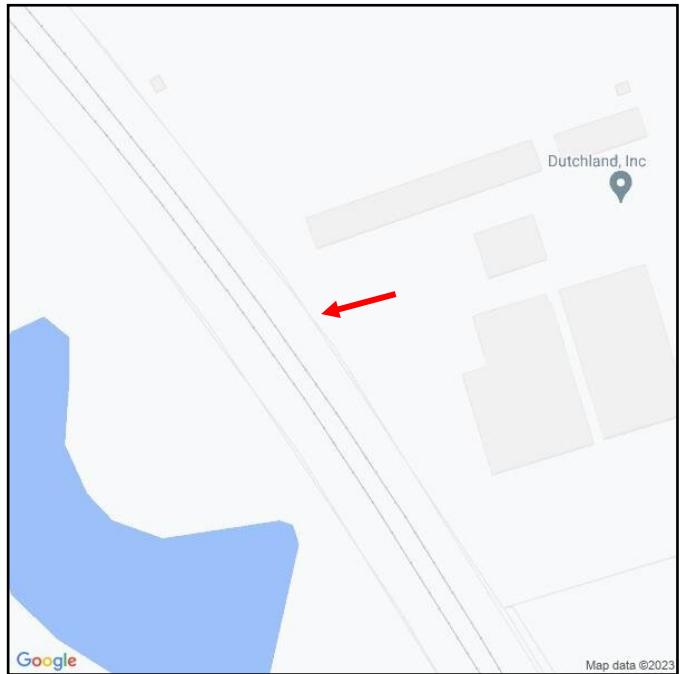
| Description | Closer view of the headwall shown in Photograph DSCN5146. |

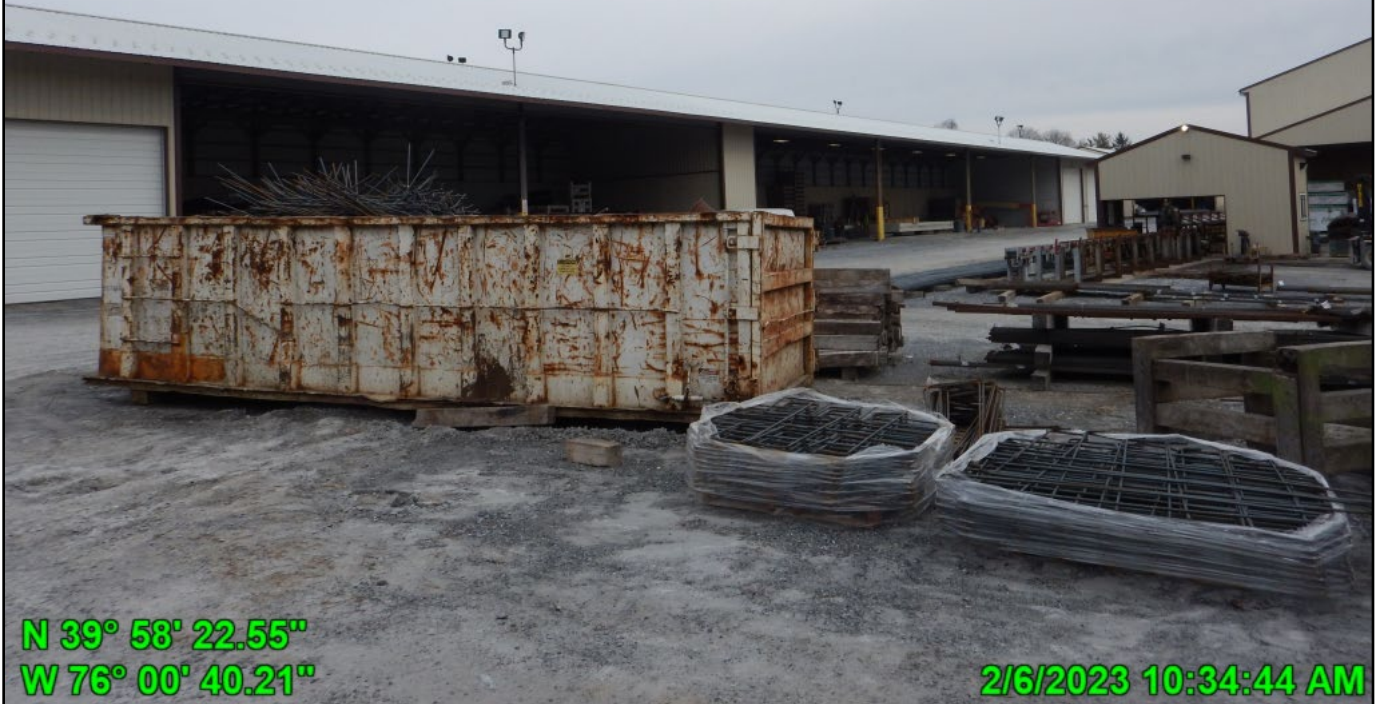
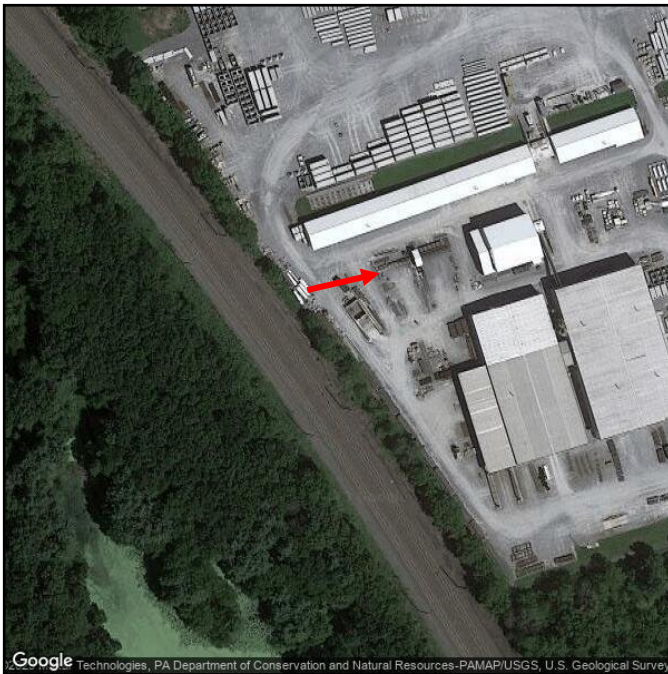
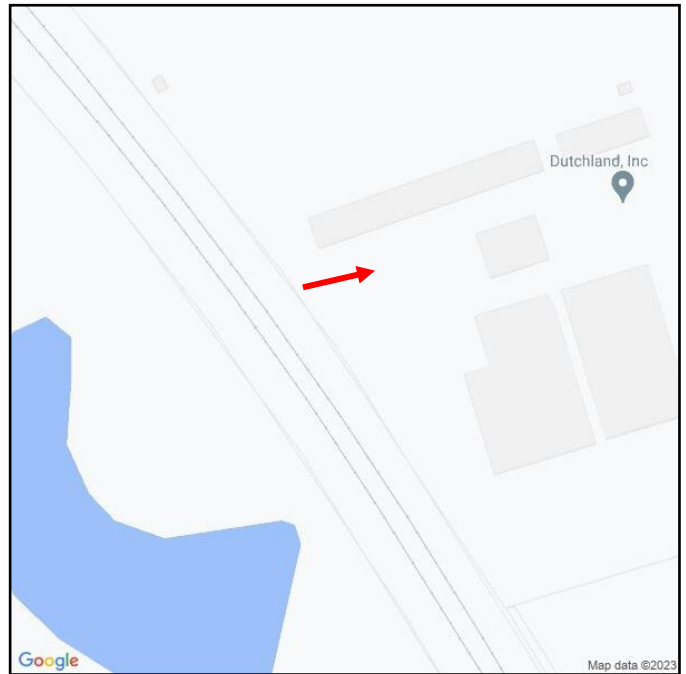
DSCN5147.JPG

Concrete forms and a dumpster stored outside in the west area of the Facility. Forms were stacked on pallets to minimize contact with stormwater.

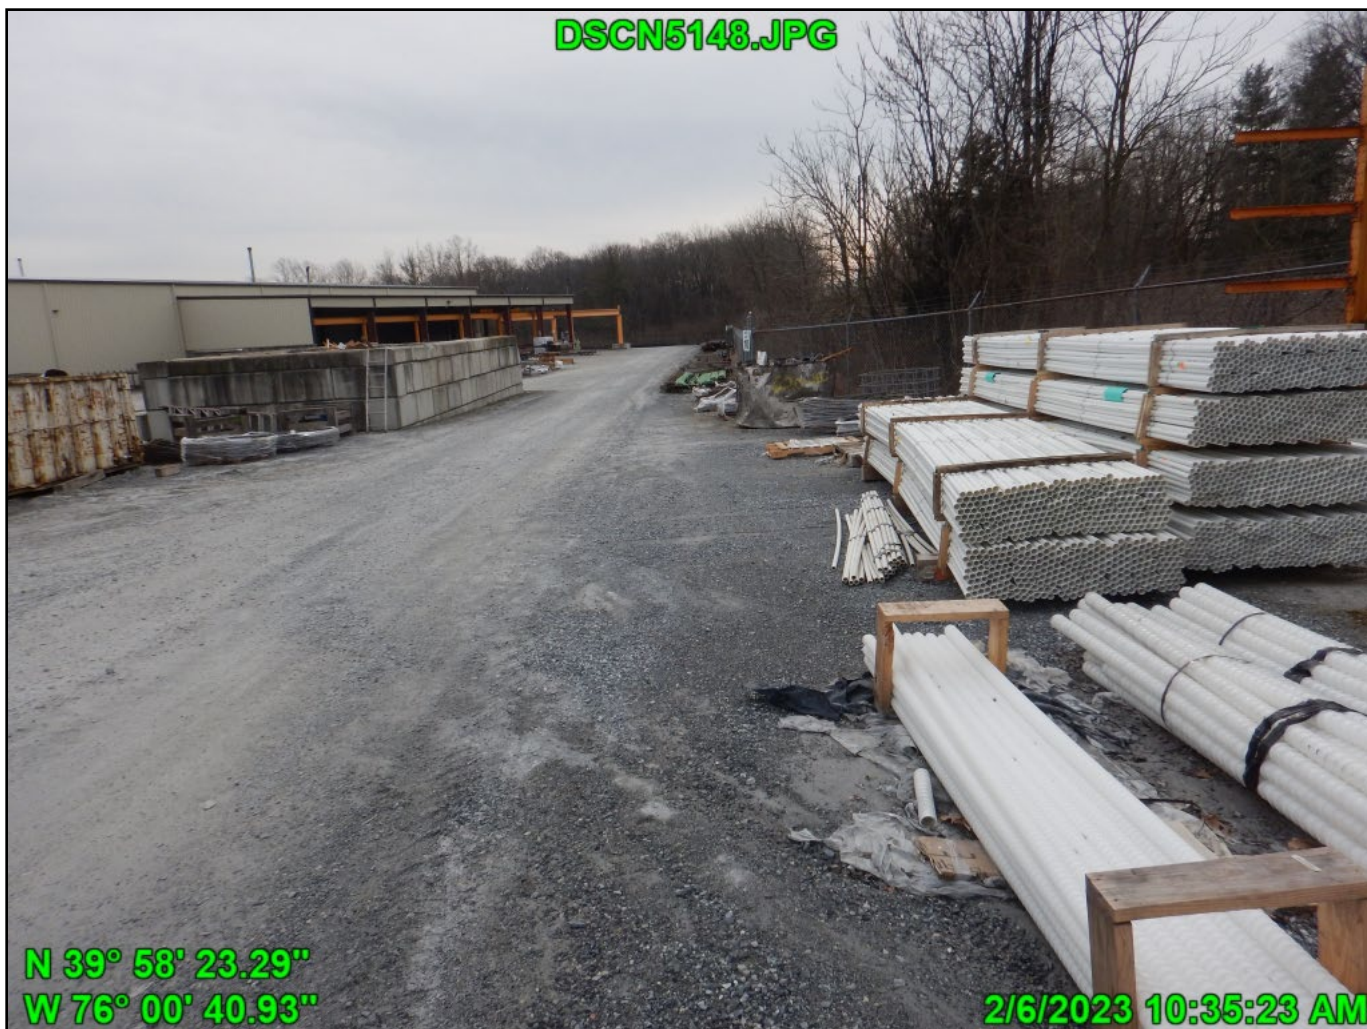
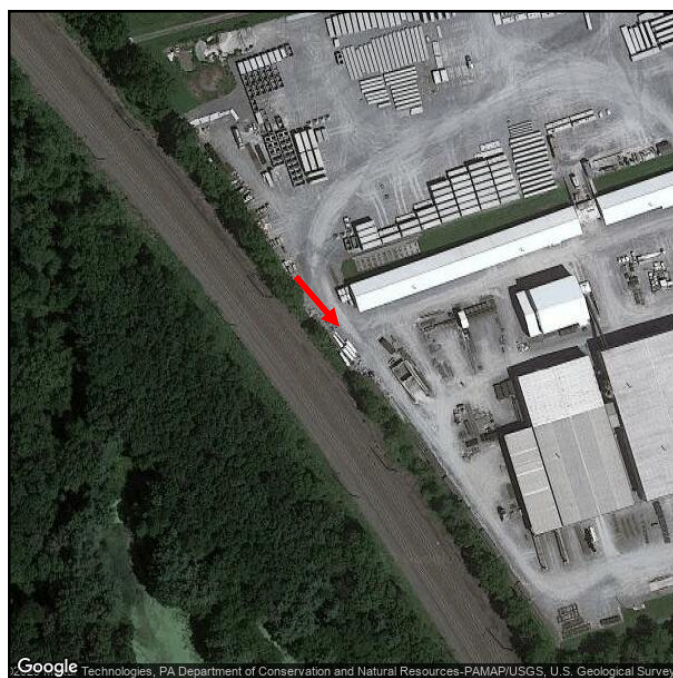
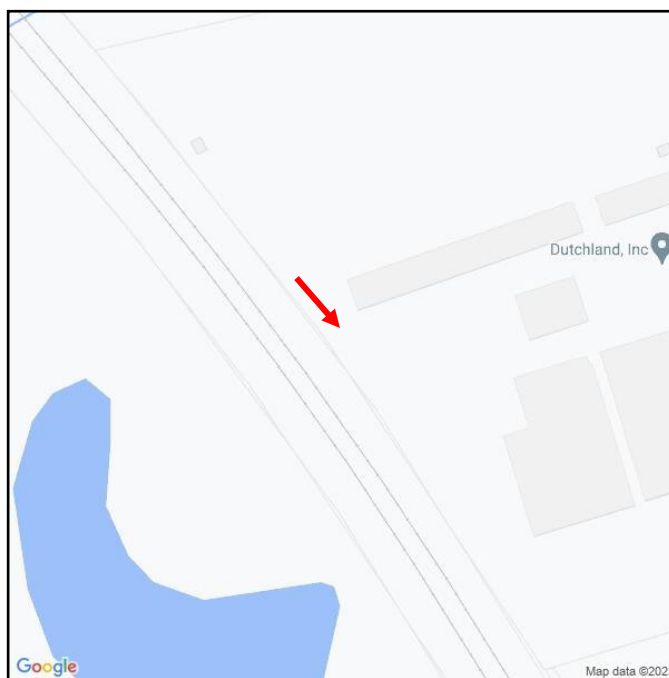
| Description | PVC pipe materials stored outside in the west area of the Facility. |
