## MULTI-SECTOR GENERAL PERMIT NON-FILER INSPECTION CHECKLIST

| <b>Inspection Date(s):</b> | 2/7/2023 | |
| <b>Operator Name:</b> | Dutchland, Inc. | |

Stormwater Inspection Date: February 7, 2023

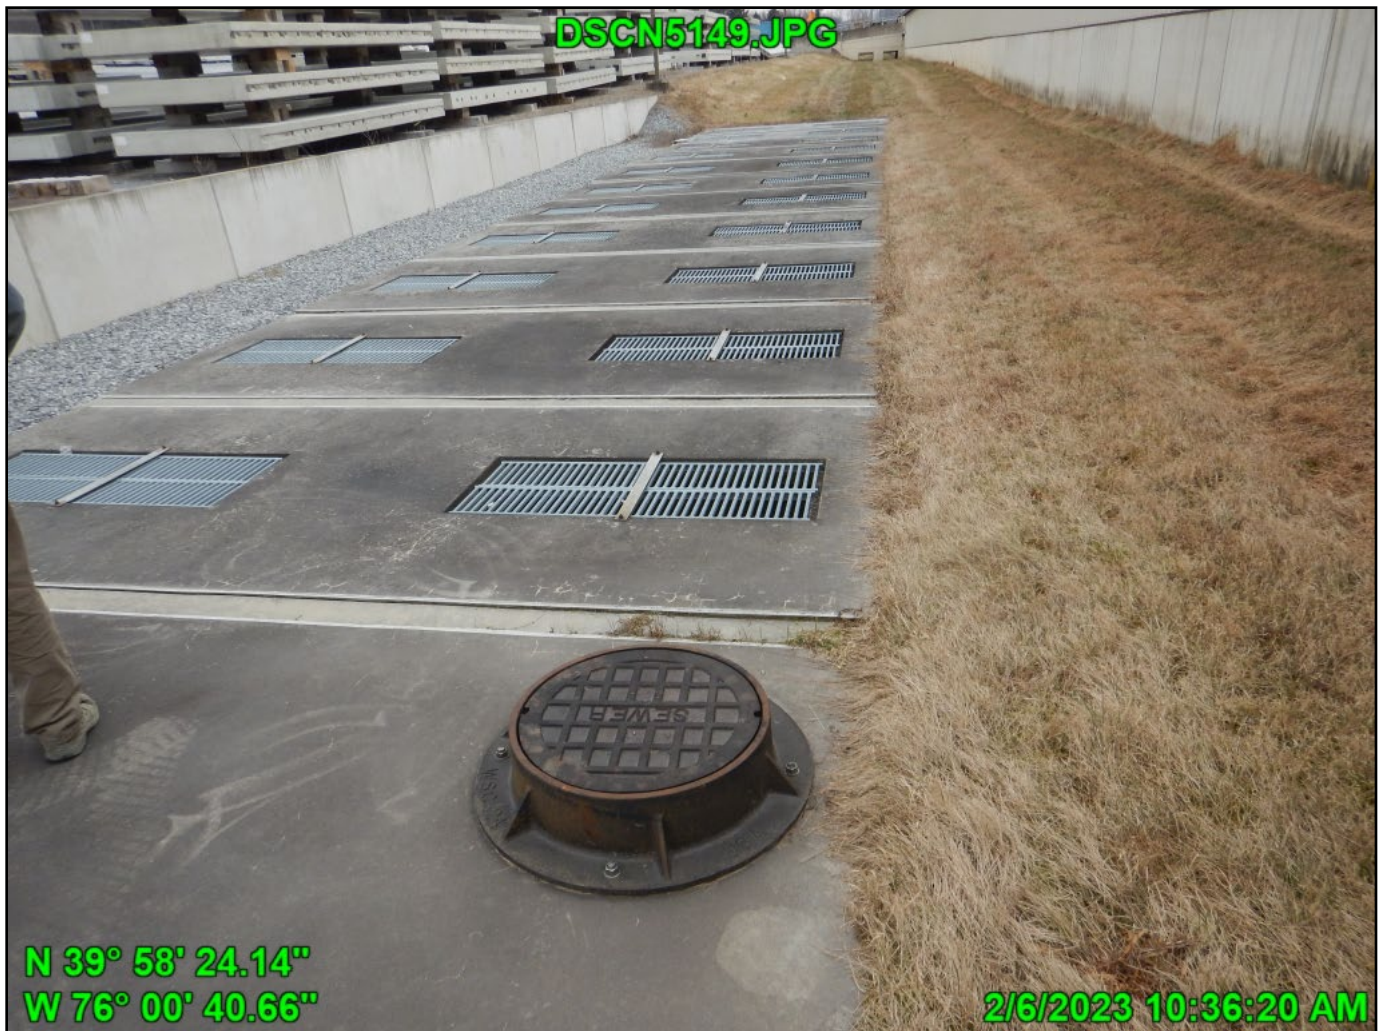
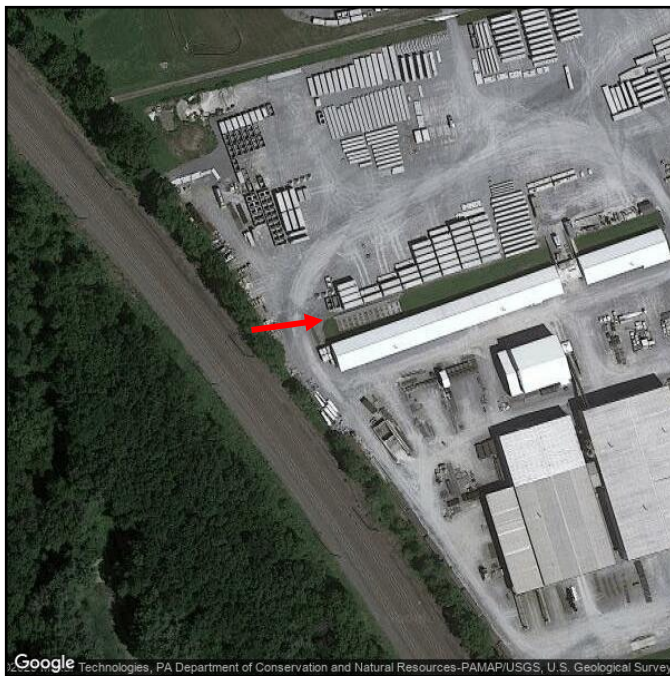
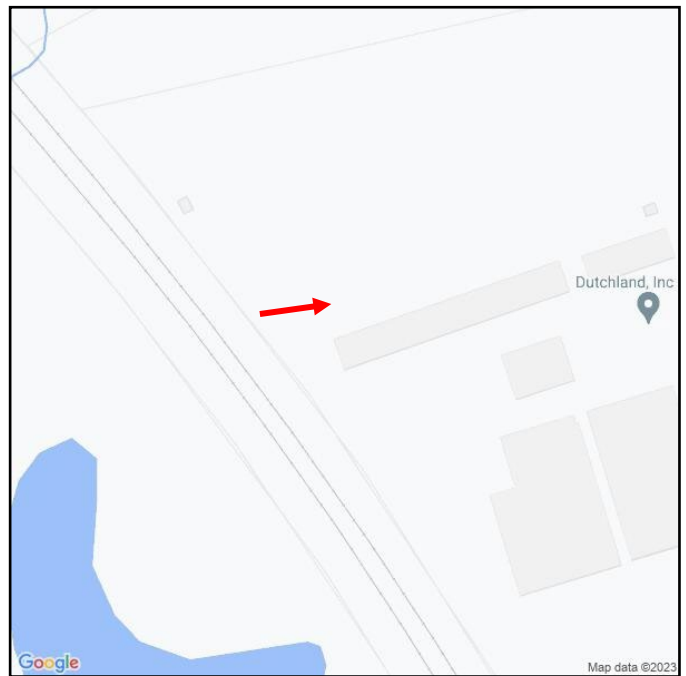
| Description | Facility's French drain system to capture stormwater runoff from the adjacent areas. The Facility representative did not know if this connected to the local sewer system. |

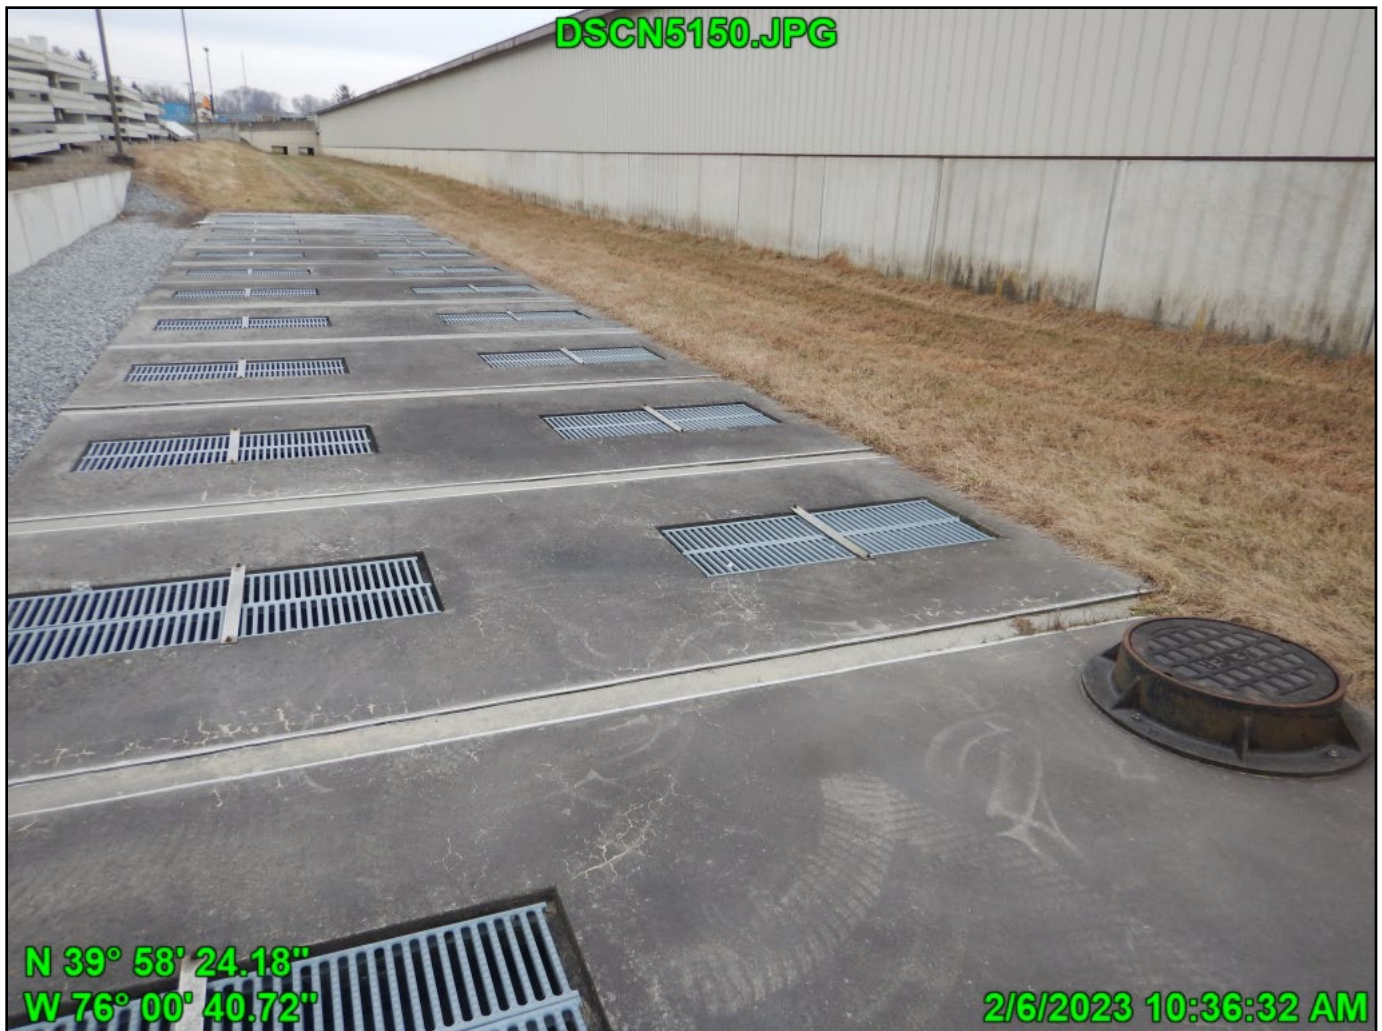
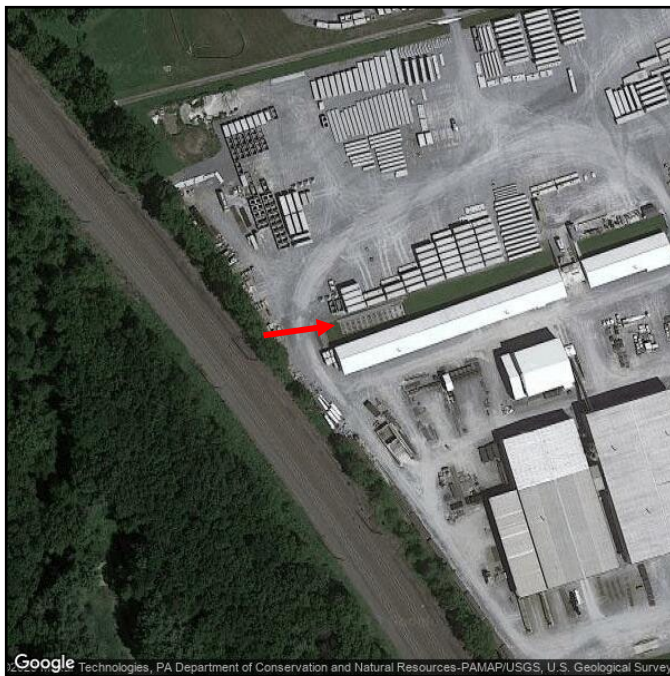
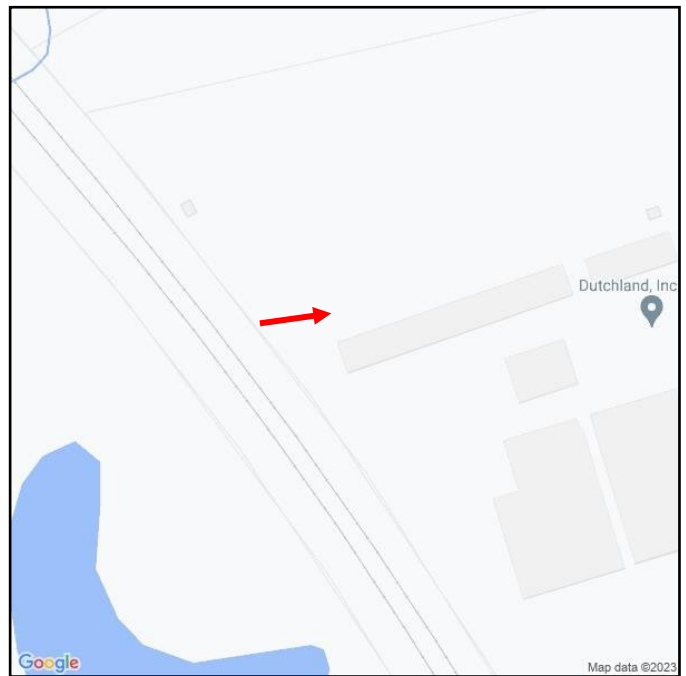
| Description | Facility's French drain system to capture stormwater runoff from the adjacent areas. |

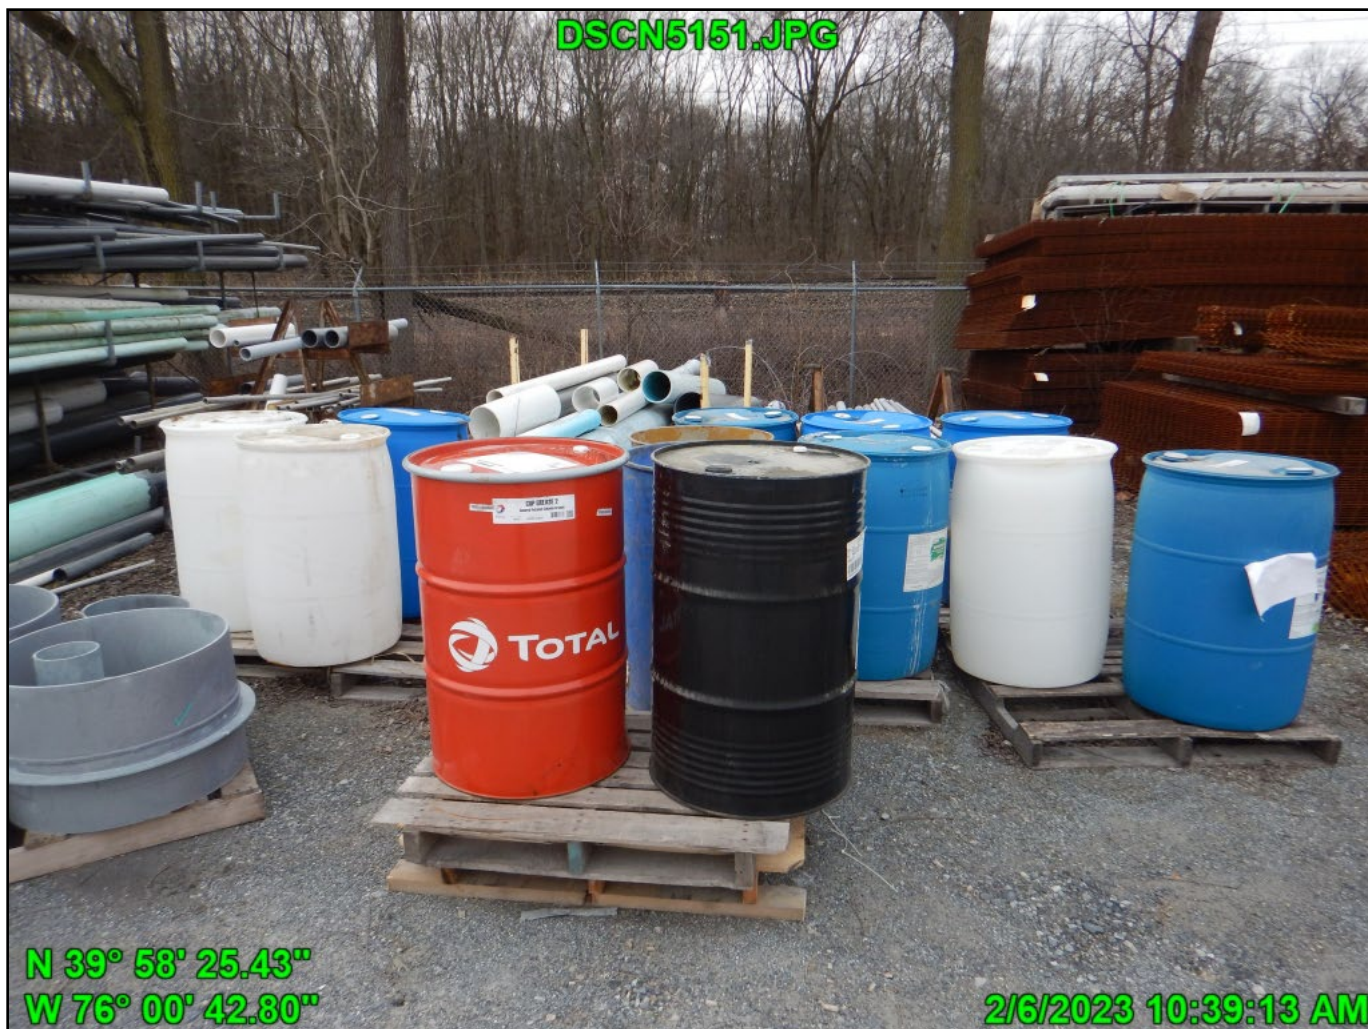
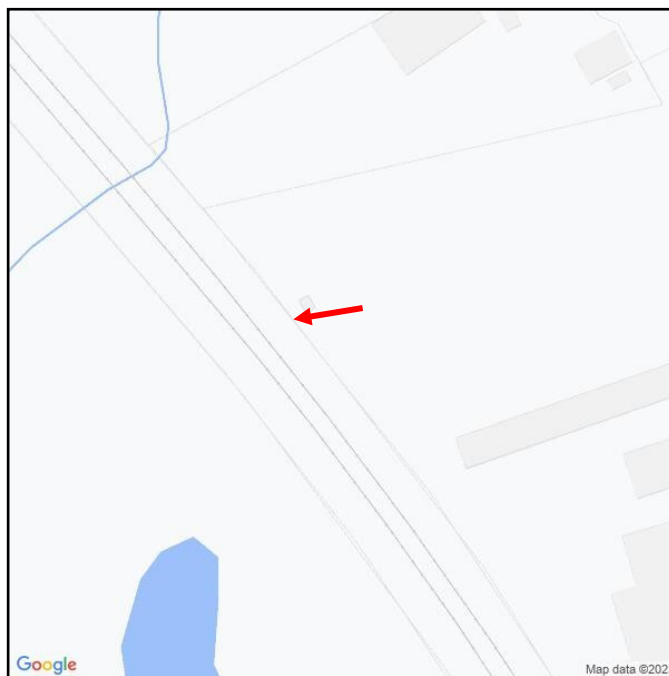
| Description | Used, empty 55-gallon drums stored on pallets in the west area of the Facility. |

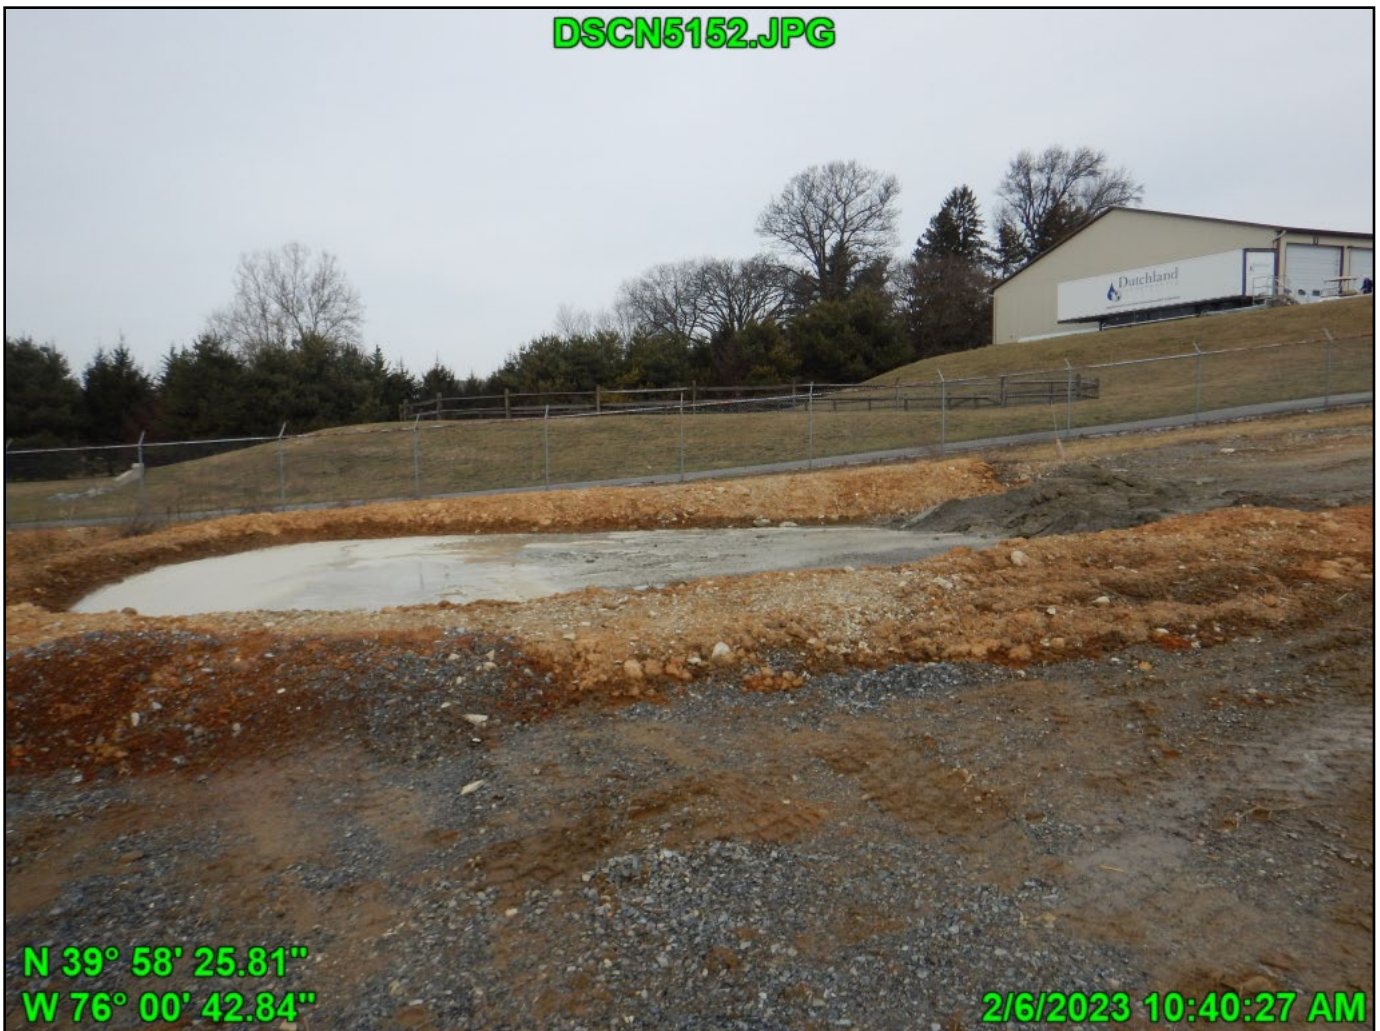
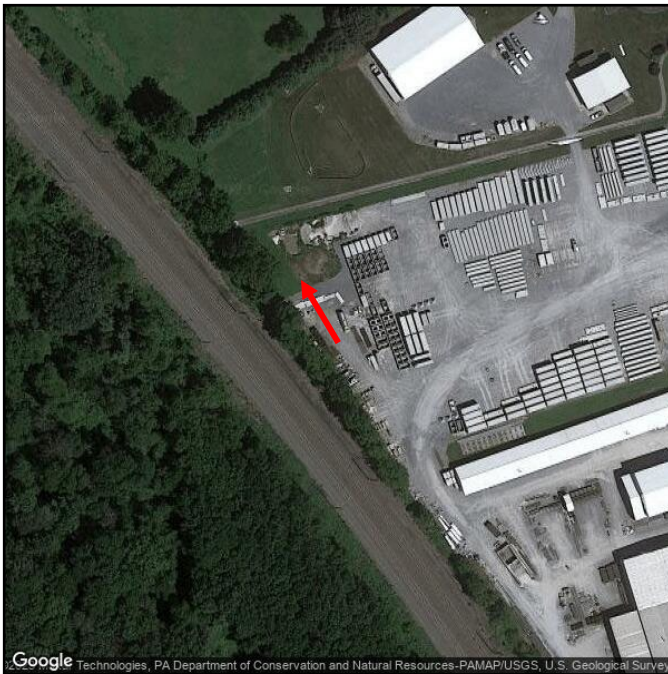
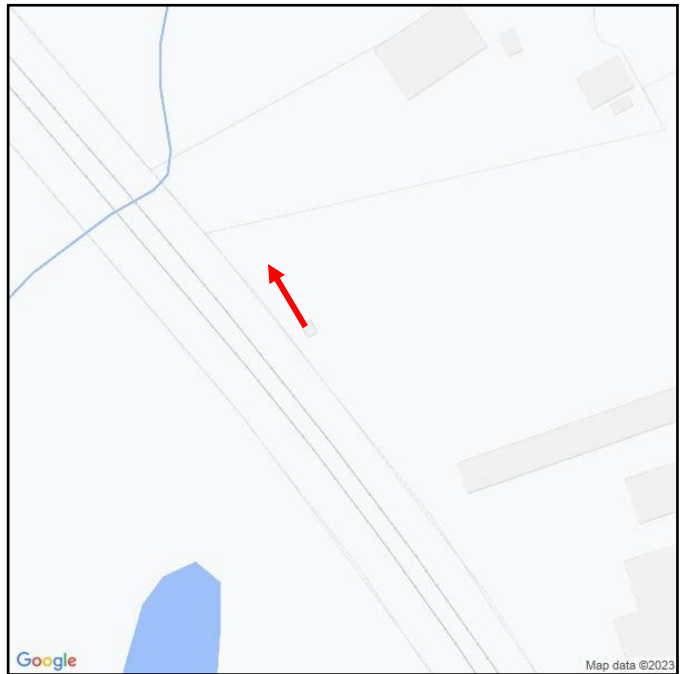
DSCN5152.JPG

| Description | Three (3)-tiered earthen concrete washout area. |

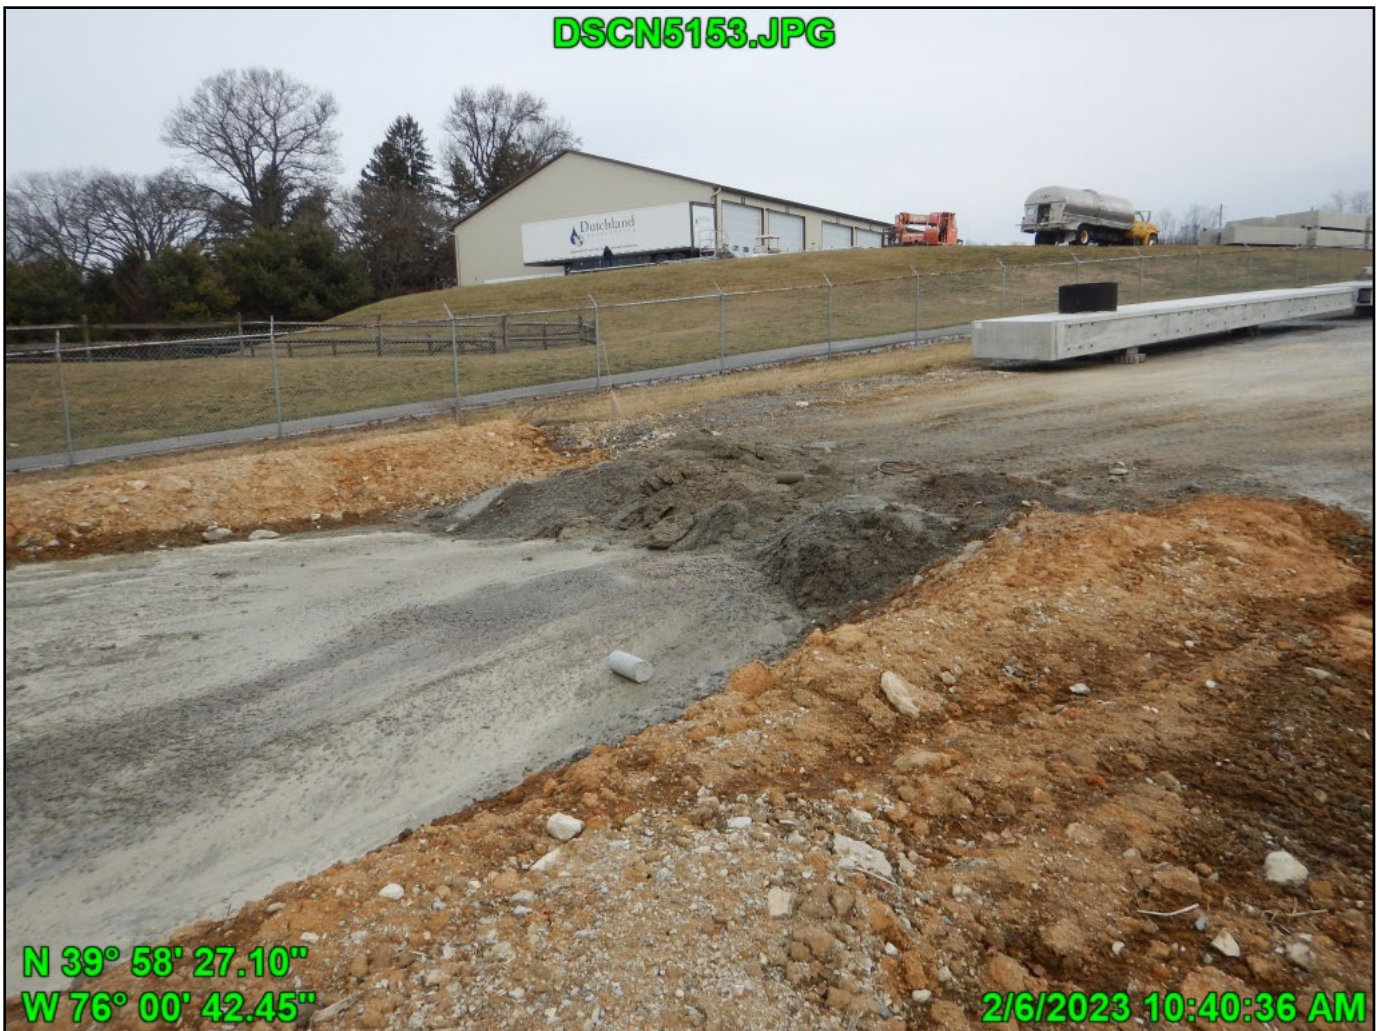
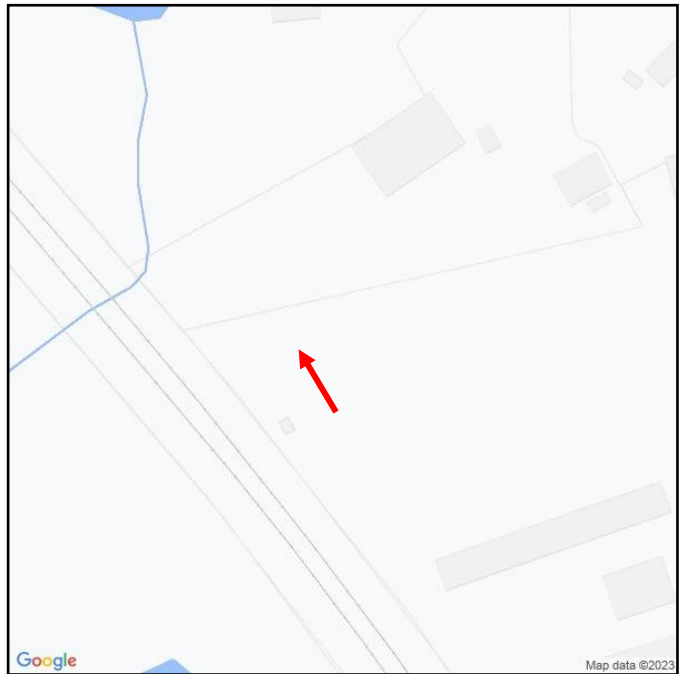
DSCN5153.JPG

| Description | Three (3)-tiered earthen concrete washout area. |

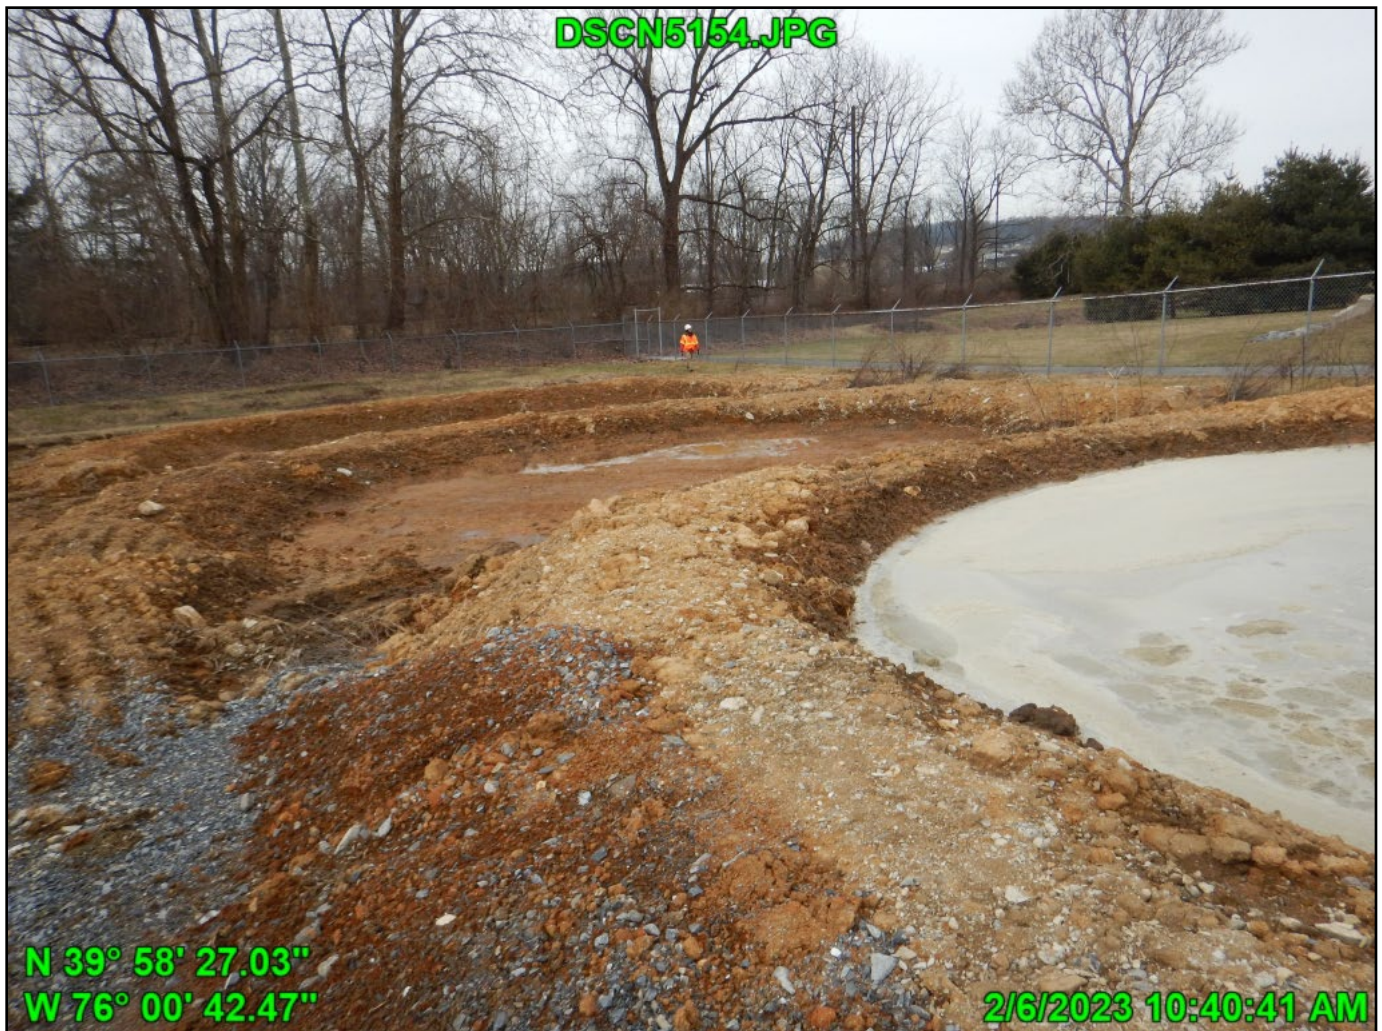
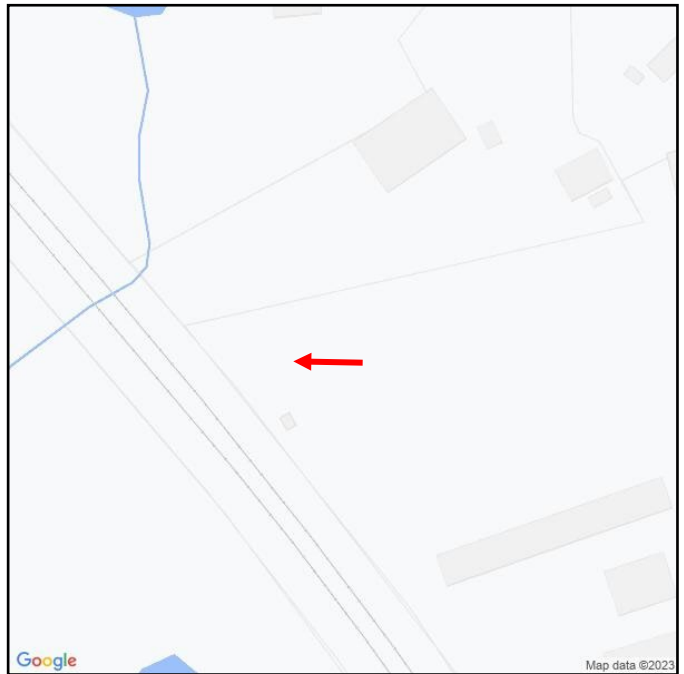
| Description | Three (3)-tiered earthen concrete washout area. Once the lowest tier fills, the Facility will dig out the washout materials and dispose offsite. |

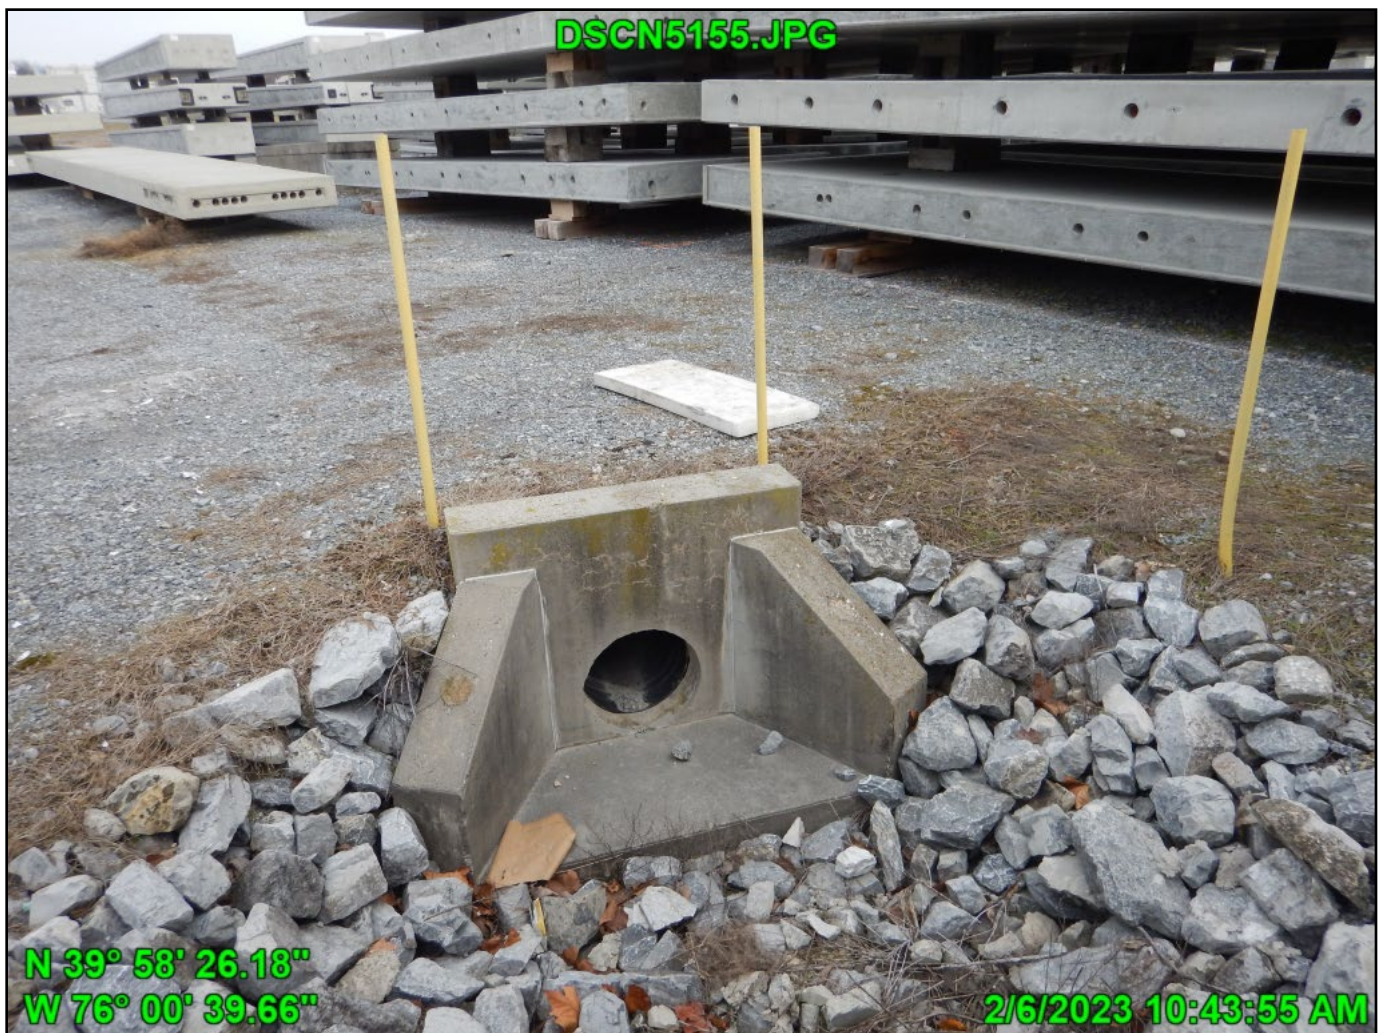
Headwall outlet structure in the north area of the Facility. The Facility representative was unsure where stormwater was conveyed from.

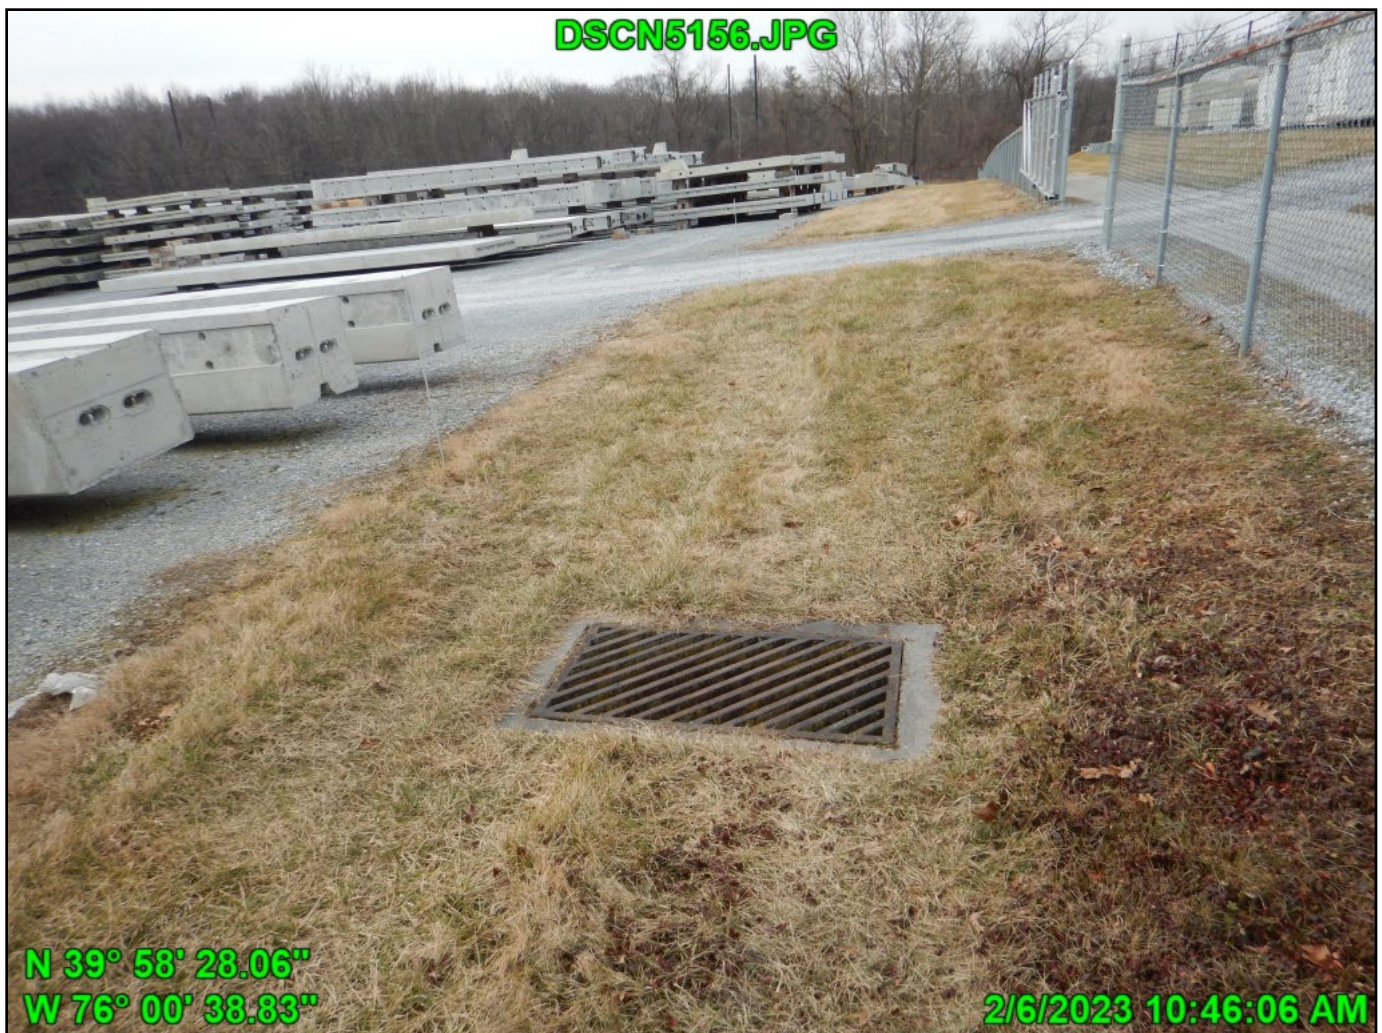
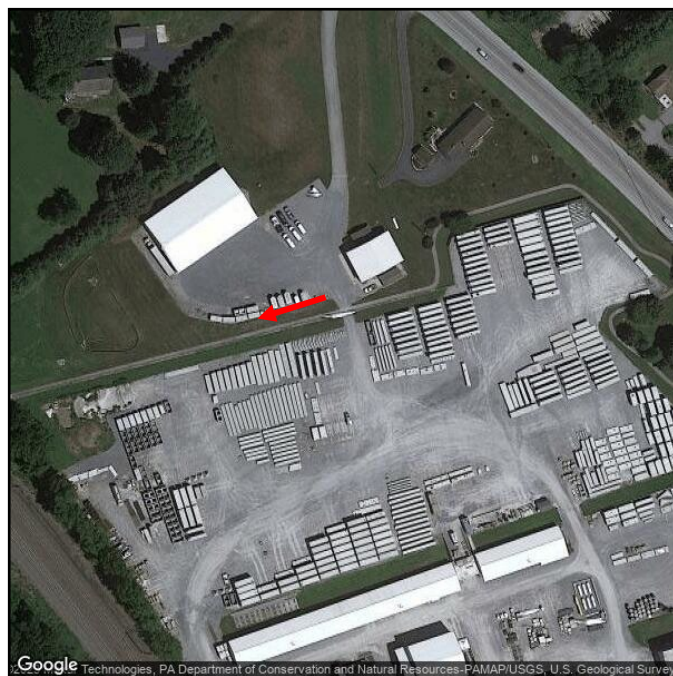
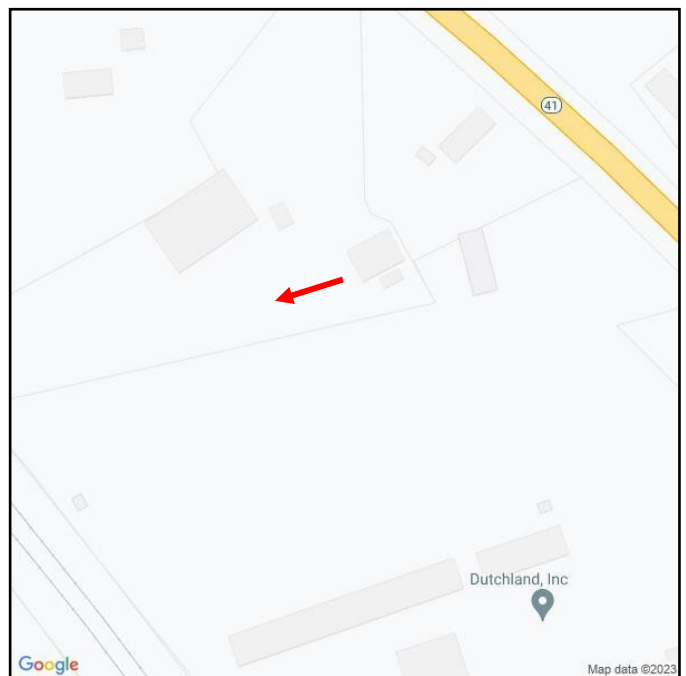
| Description | Catch basin in the north area of the Facility. It was unclear where this connected. |

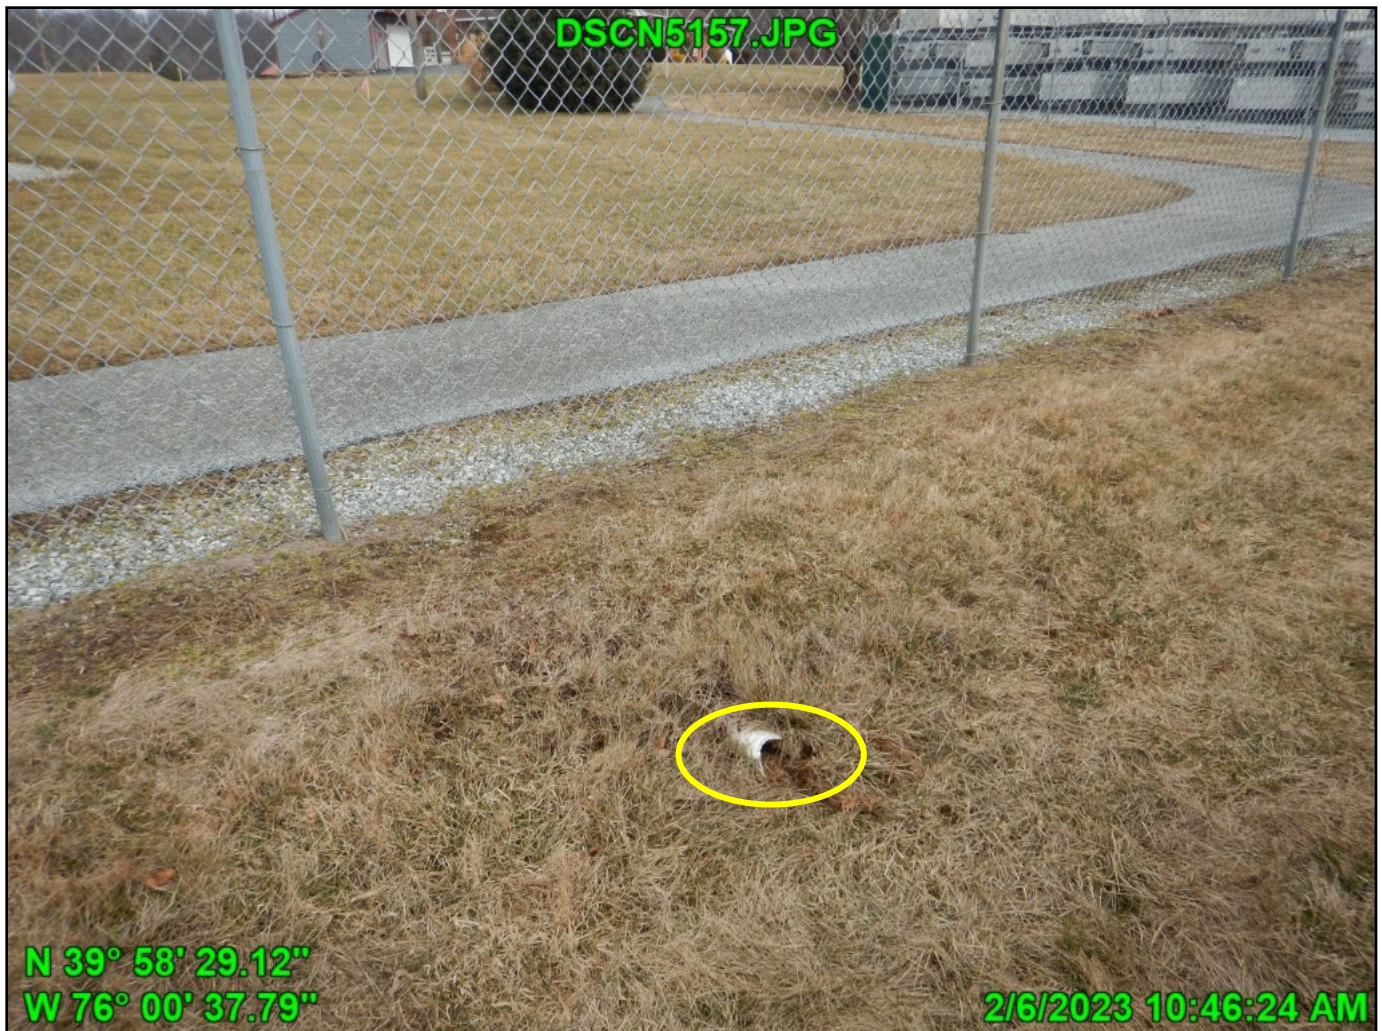
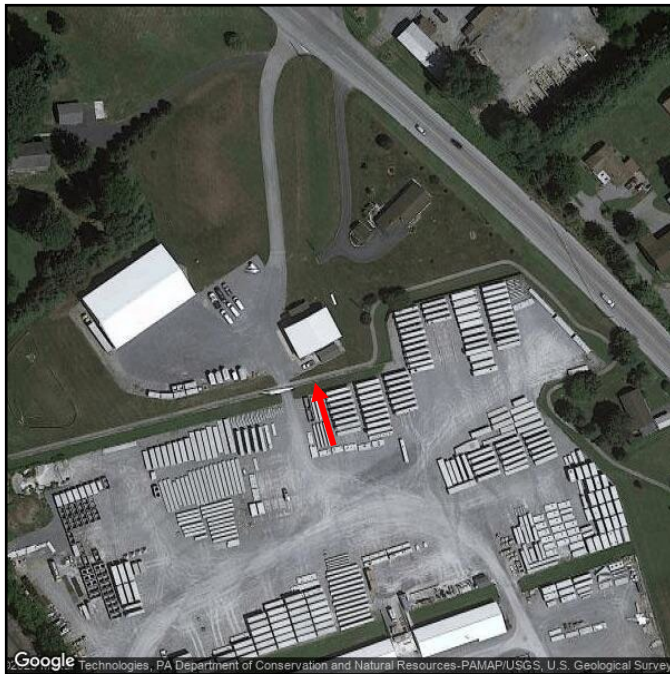
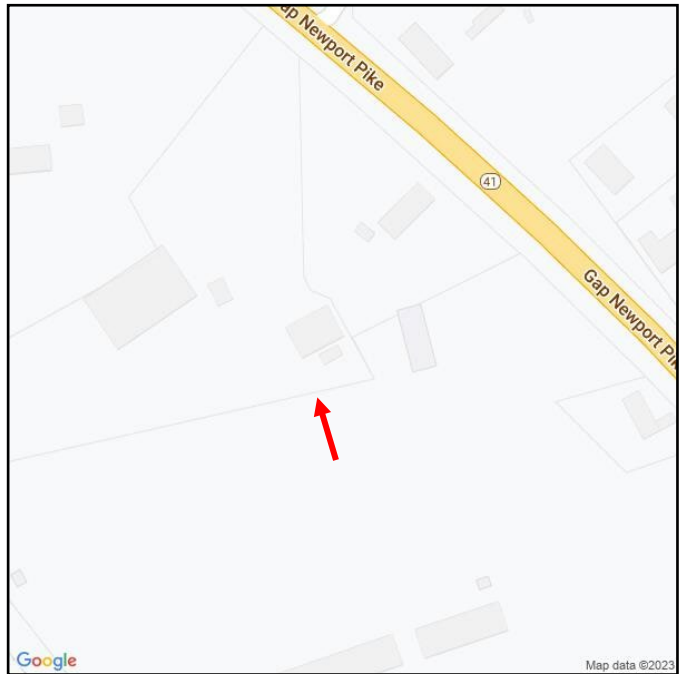
| Description | PVC pipe that had an unknown connection. |

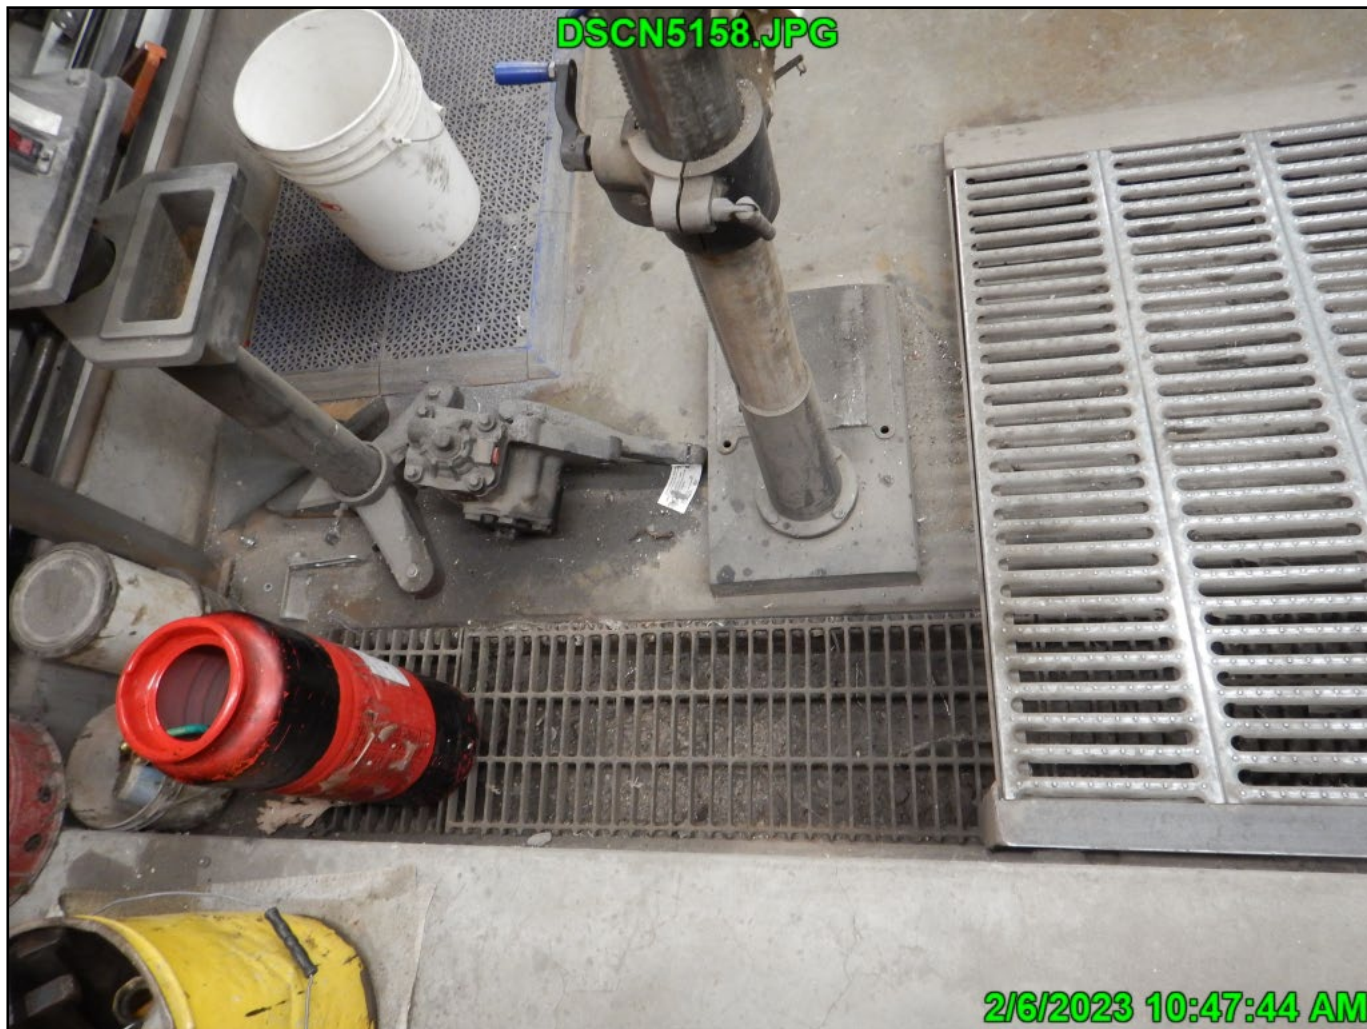
| Description | Floor drains inside the fleet maintenance shop. |

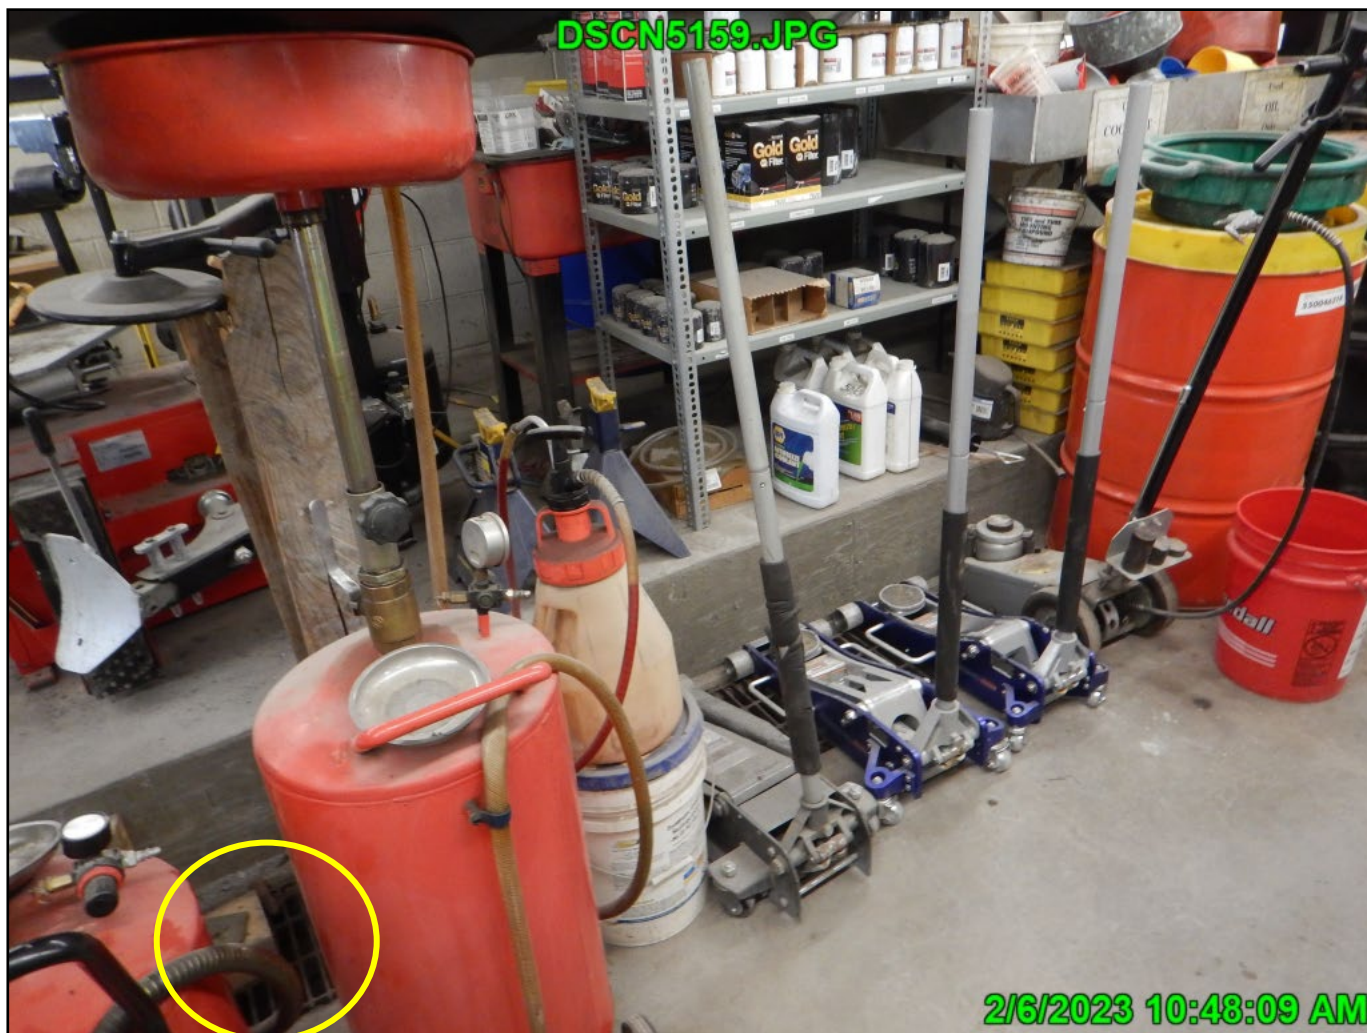
| Description | Waste oil containers being stored on top of the floor drains in fleet maintenance shop. |
