## MULTI-SECTOR GENERAL PERMIT NON-FILER INSPECTION CHECKLIST

| <b>Inspection Date(s):</b> | 2/7/2023 | |
| <b>Operator Name:</b> | Dutchland, Inc. | |

Stormwater Inspection Date: February 7, 2023

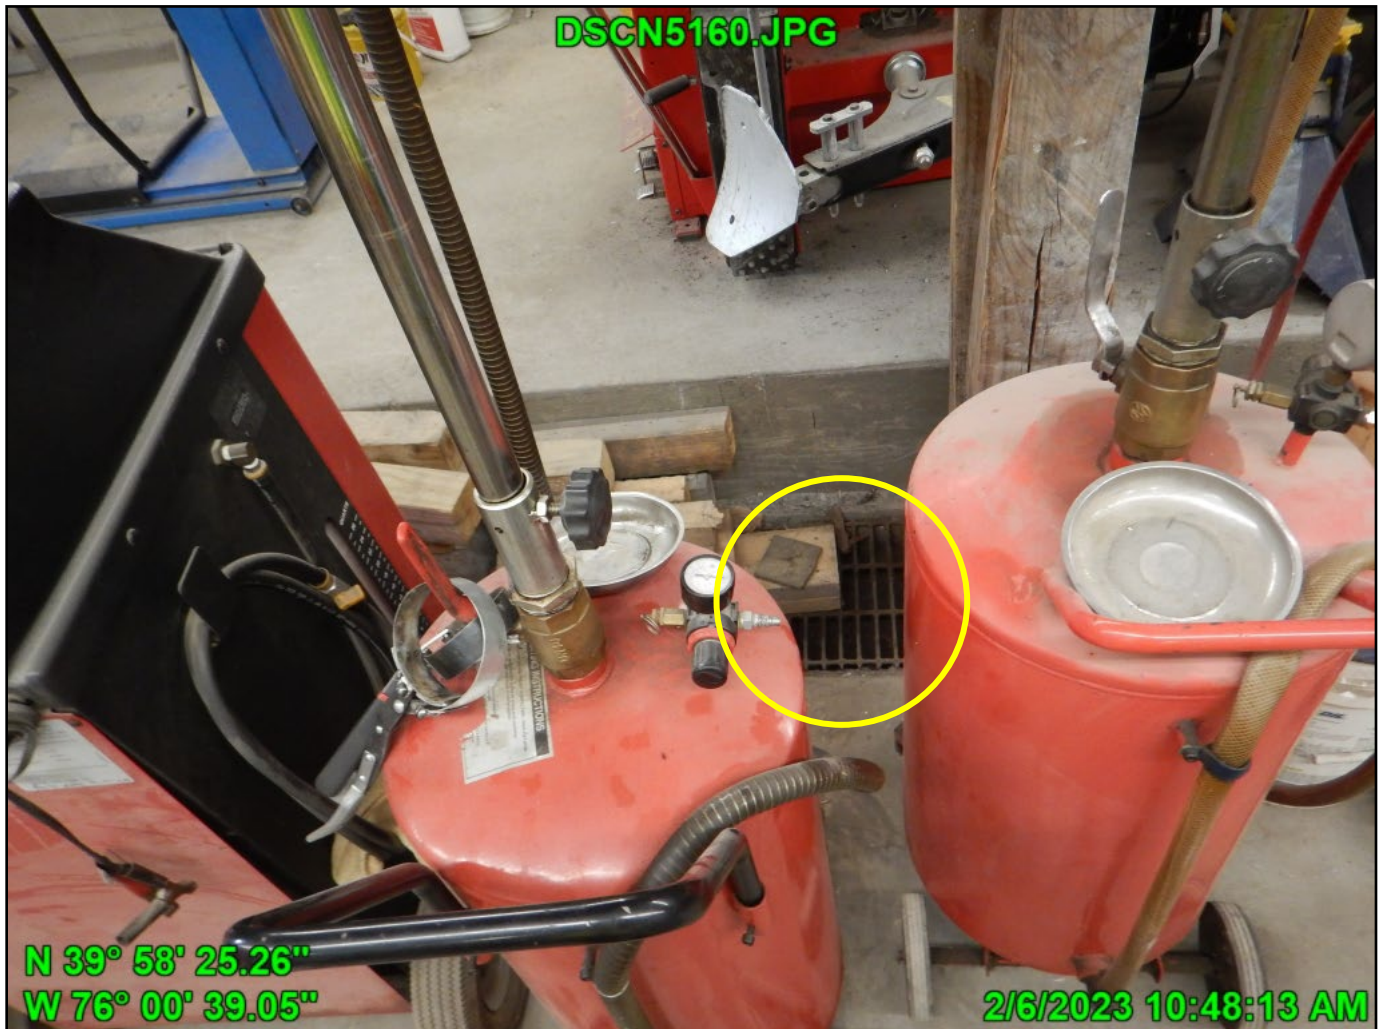
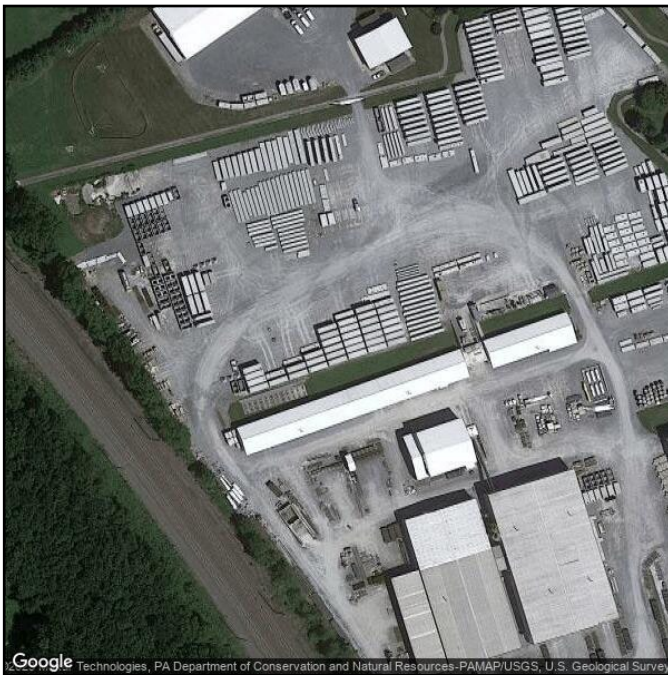
| Description | Waste oil containers being stored on top of the floor drains in fleet maintenance shop. |

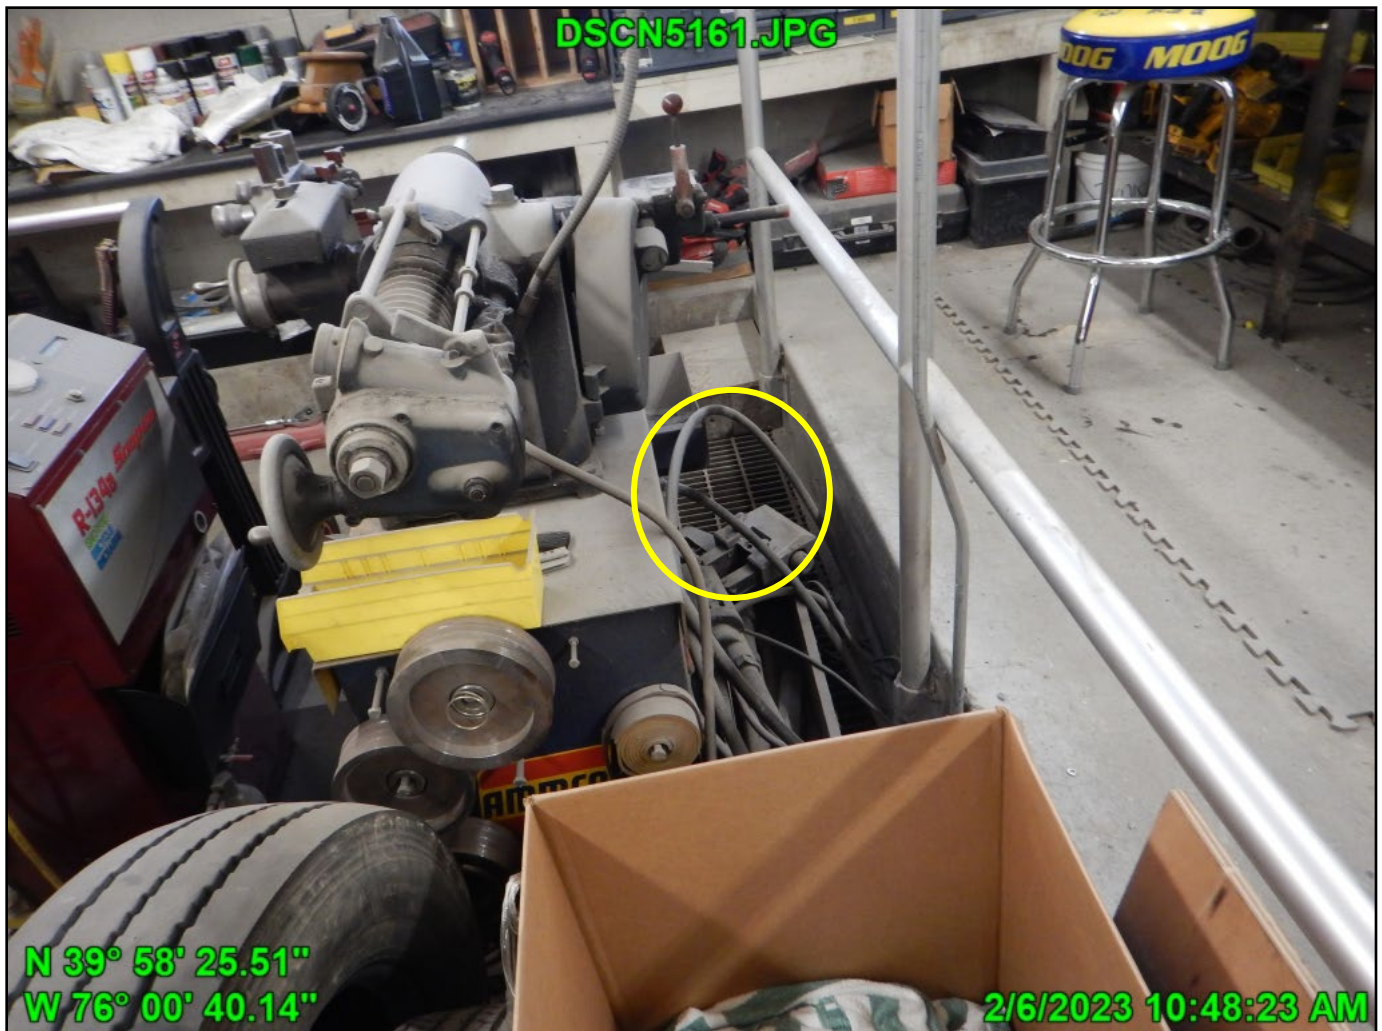
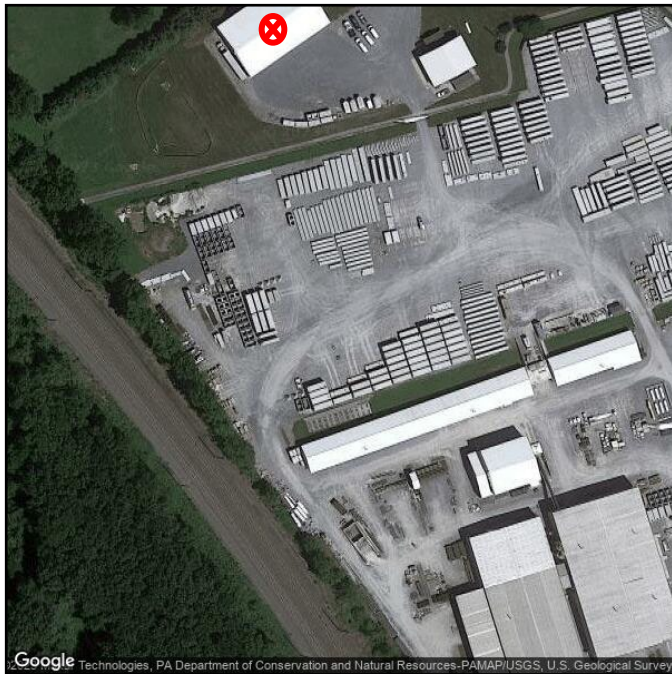
| Description | Materials being stored on top of the floor drains in fleet maintenance shop. |

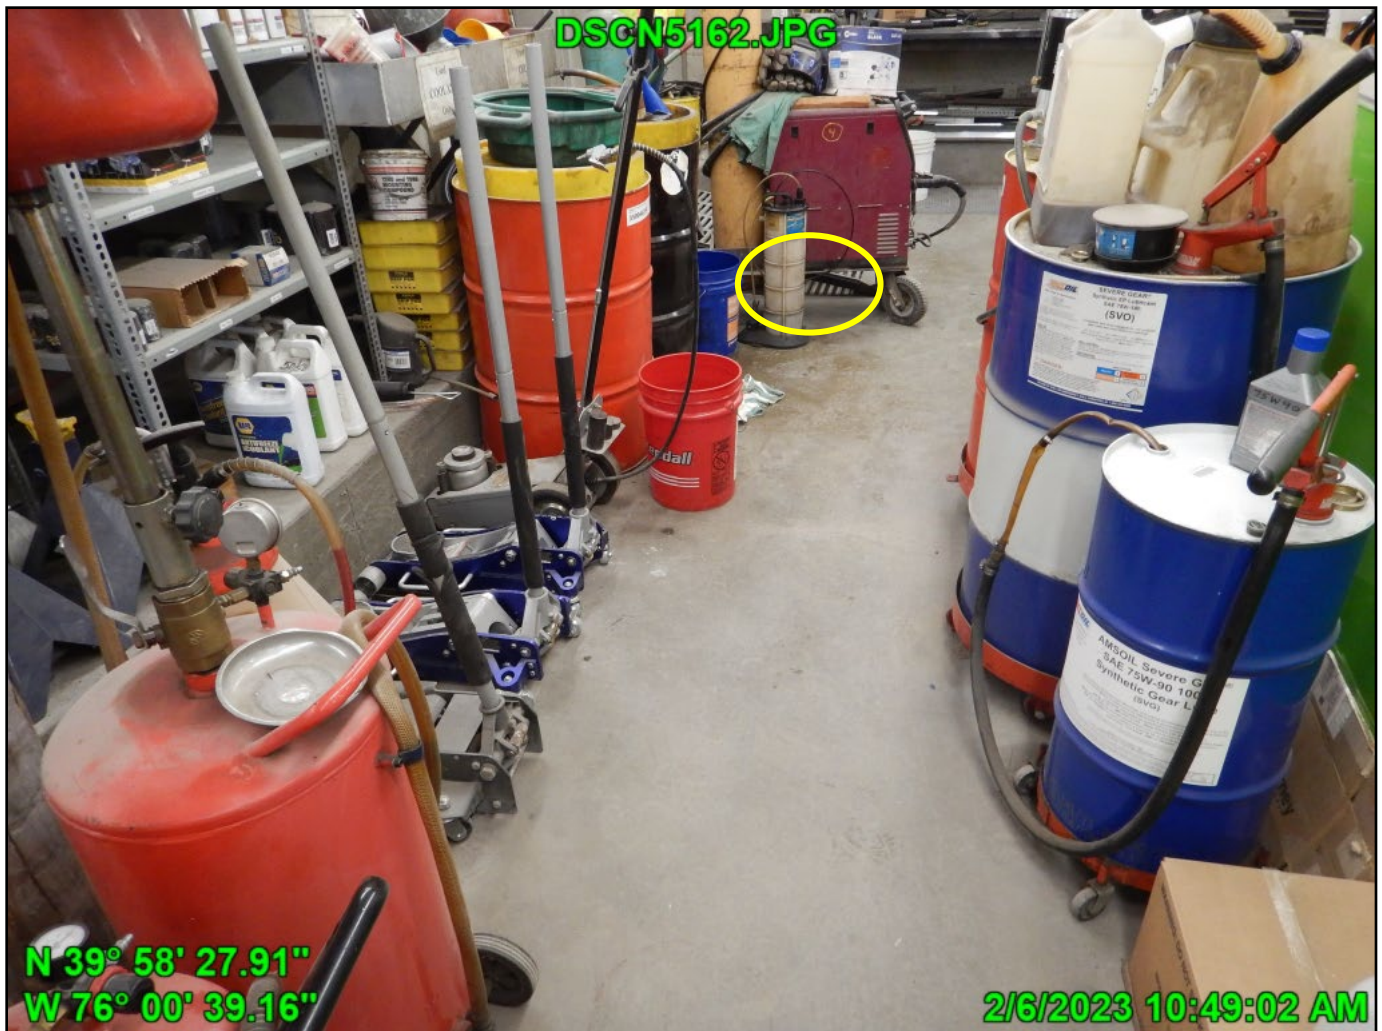
| Description | Waste oil containers being stored on top of the floor drains in the fleet maintenance shop. |

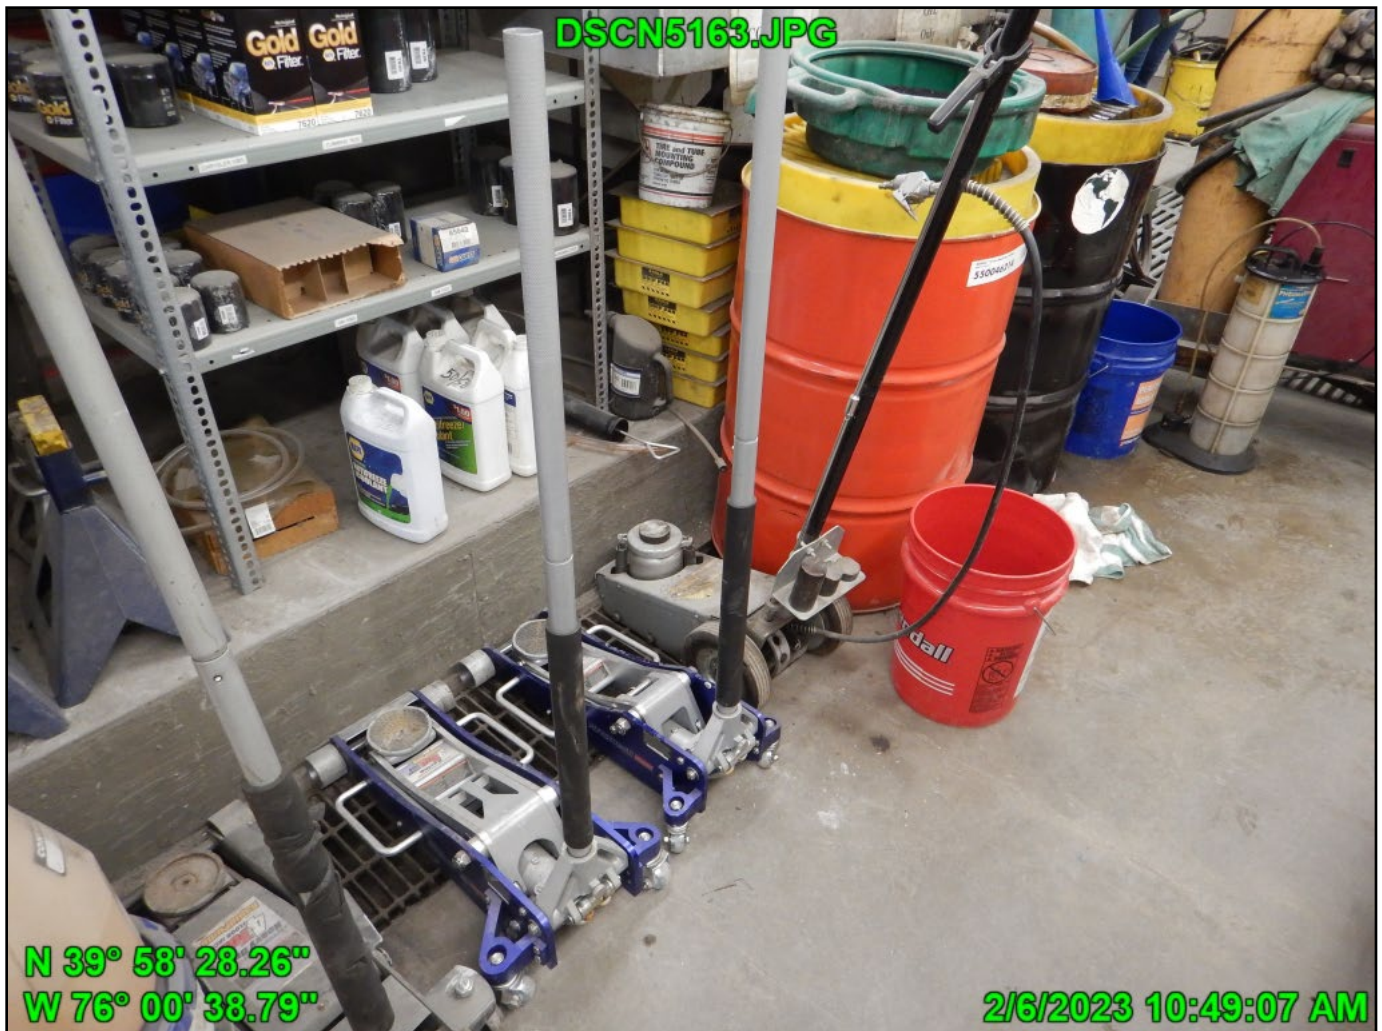
| Description | Waste oil containers being stored on top of the floor drains in fleet maintenance shop. |

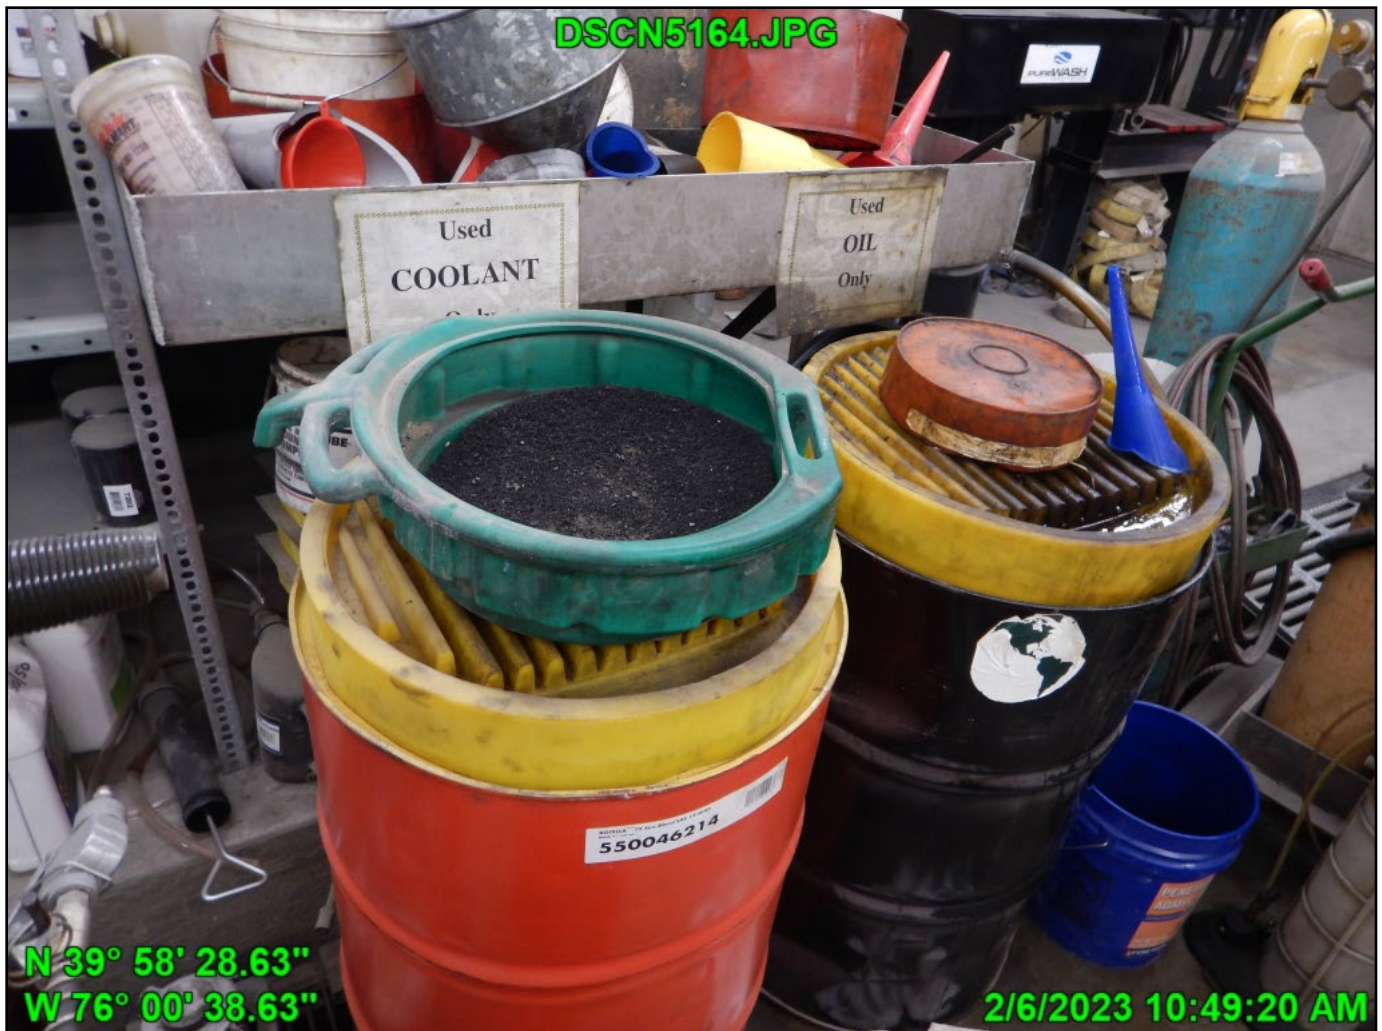
| Description | Waste oil and coolant containers stored on top of the floor drains in fleet maintenance shop without secondary containment. |

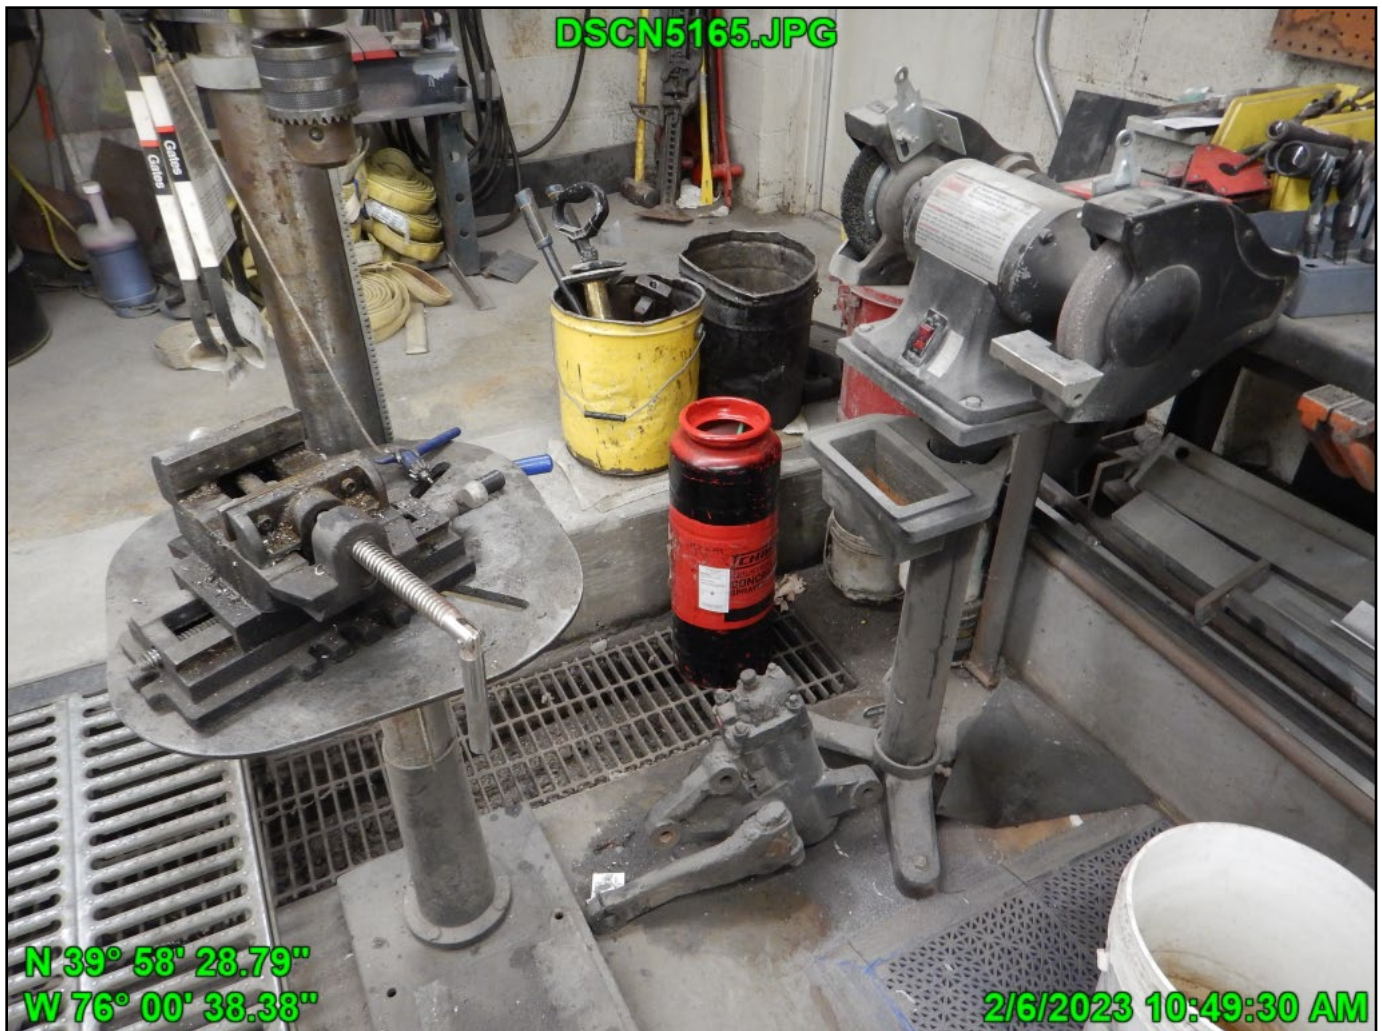
| Description | Unlabeled and unidentified canister placed over a floor drain in the fleet maintenance shop. |

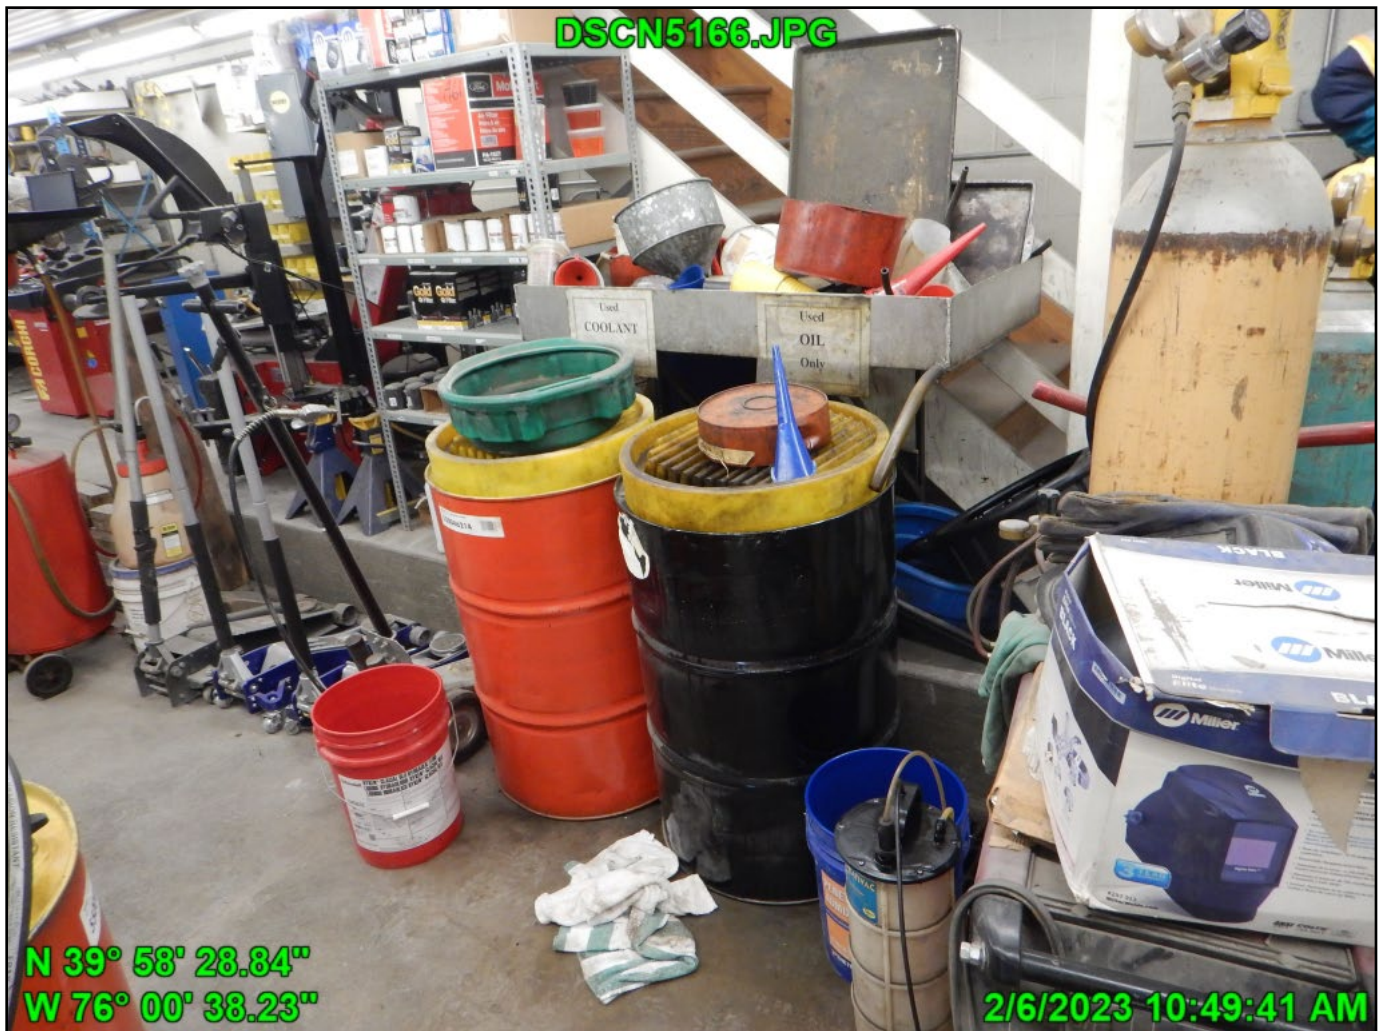
| Description | Waste oil and coolant containers stored on top of the floor drains in fleet maintenance shop. |

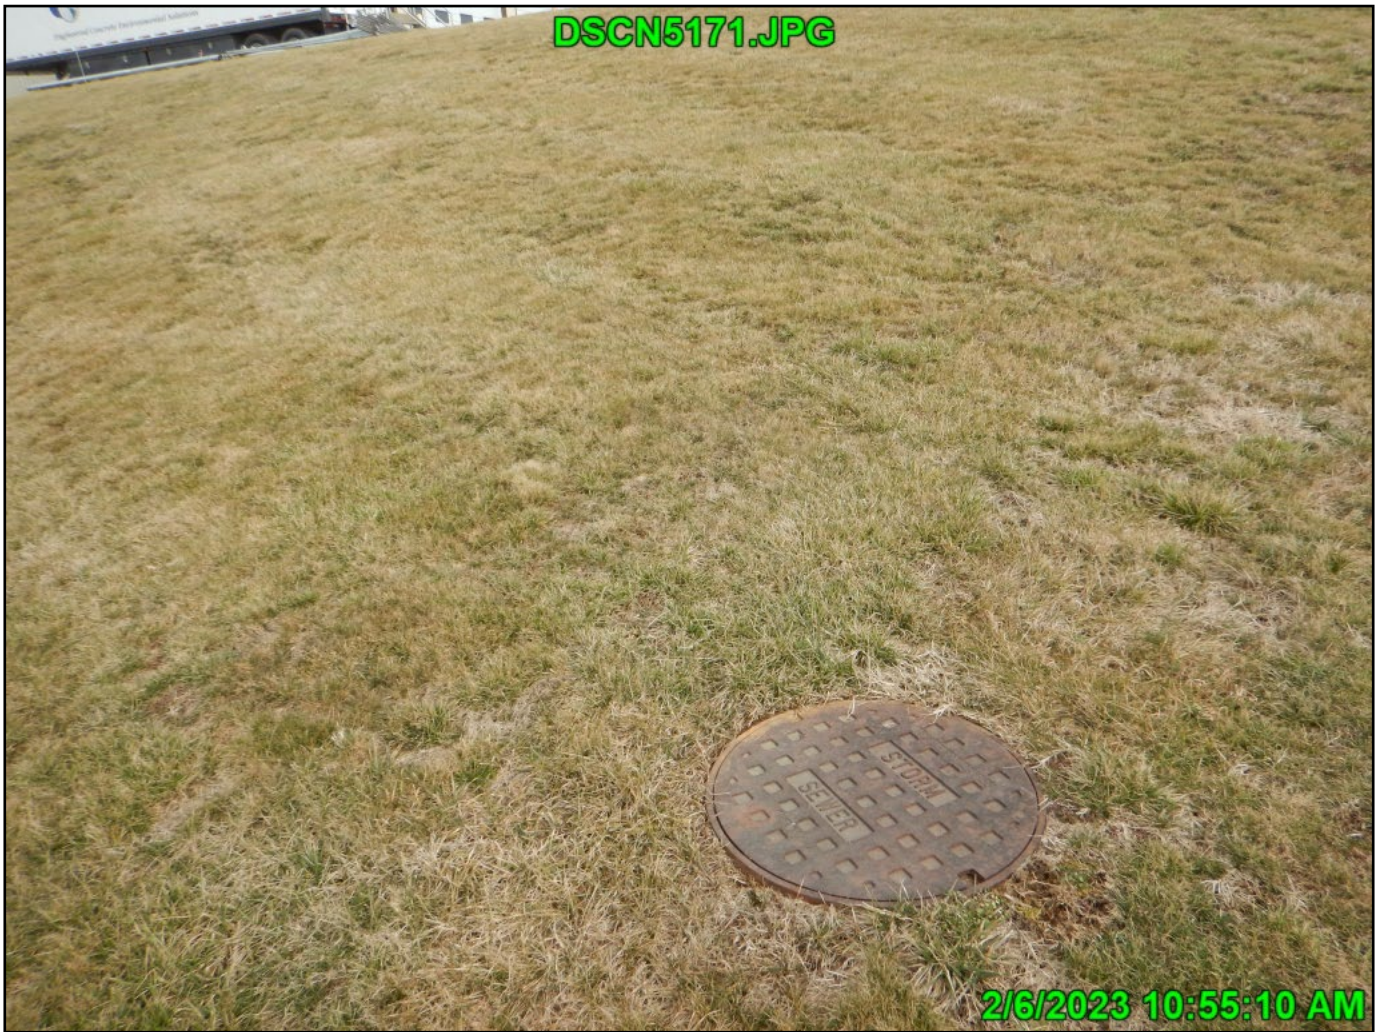
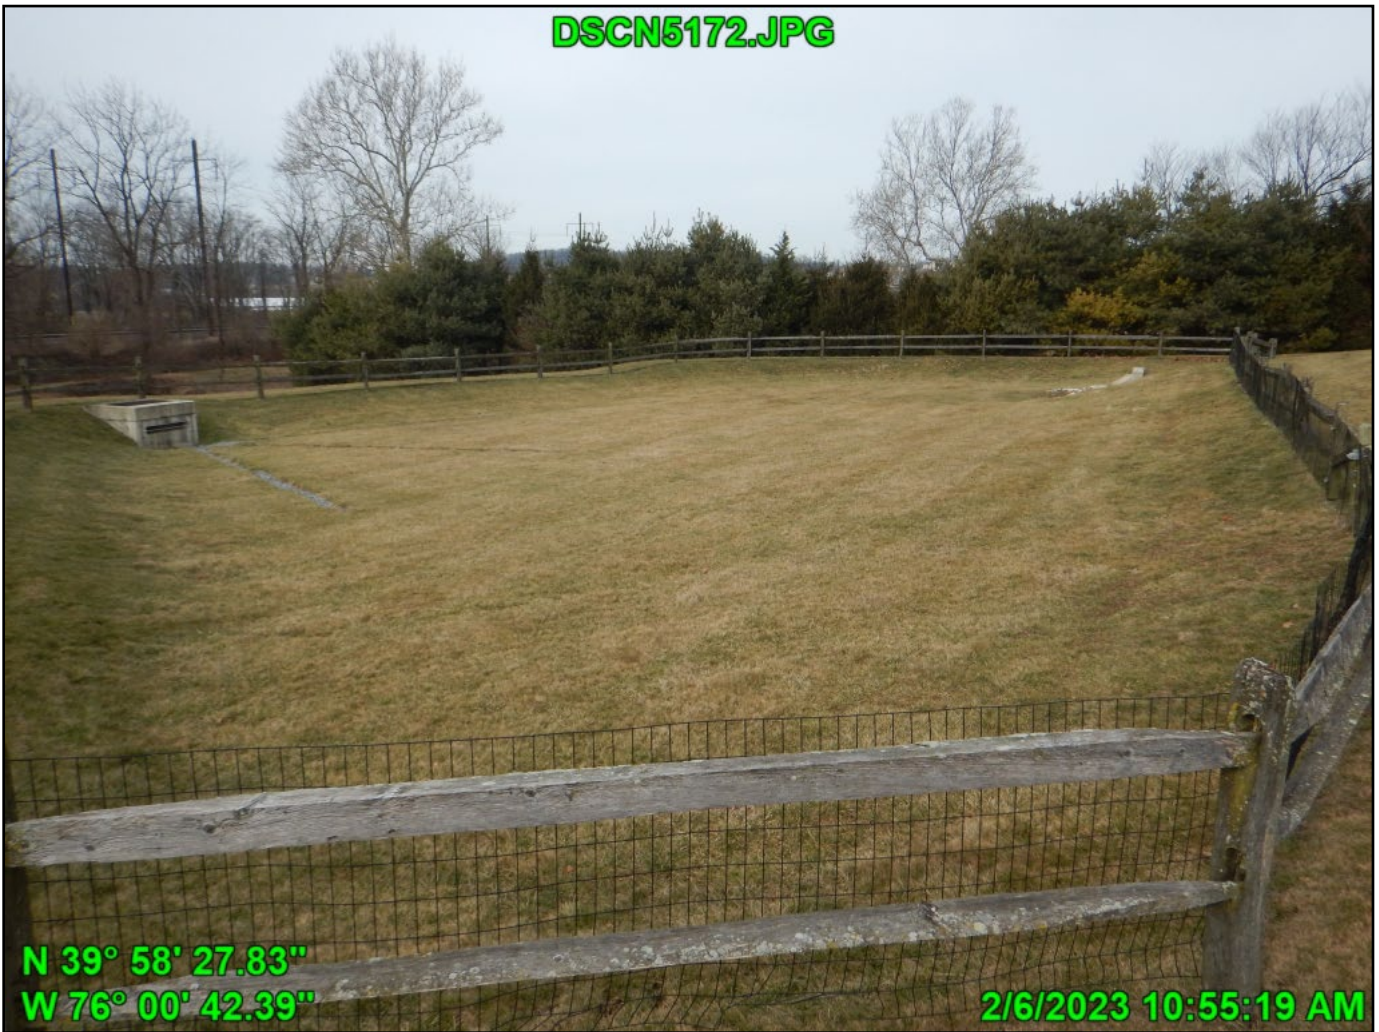
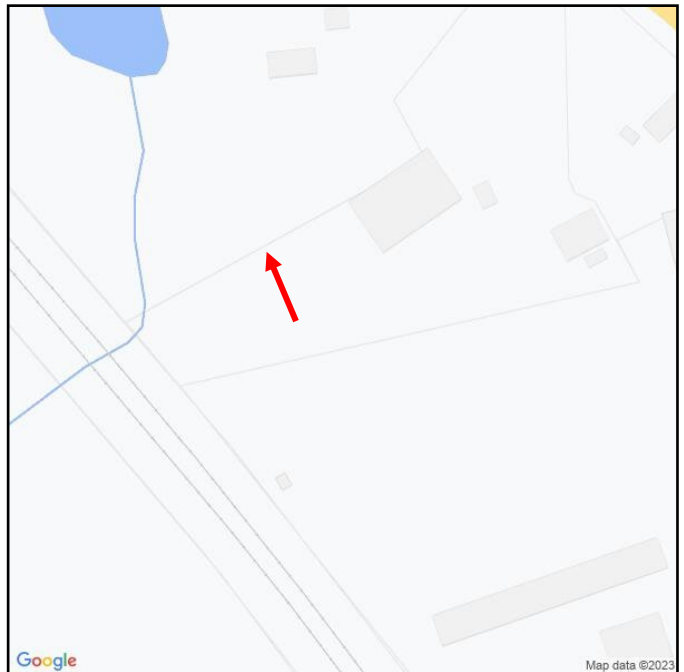
DSCN5172.JPG

| Description | Storm sewer manhole in the north area of the Facility. |

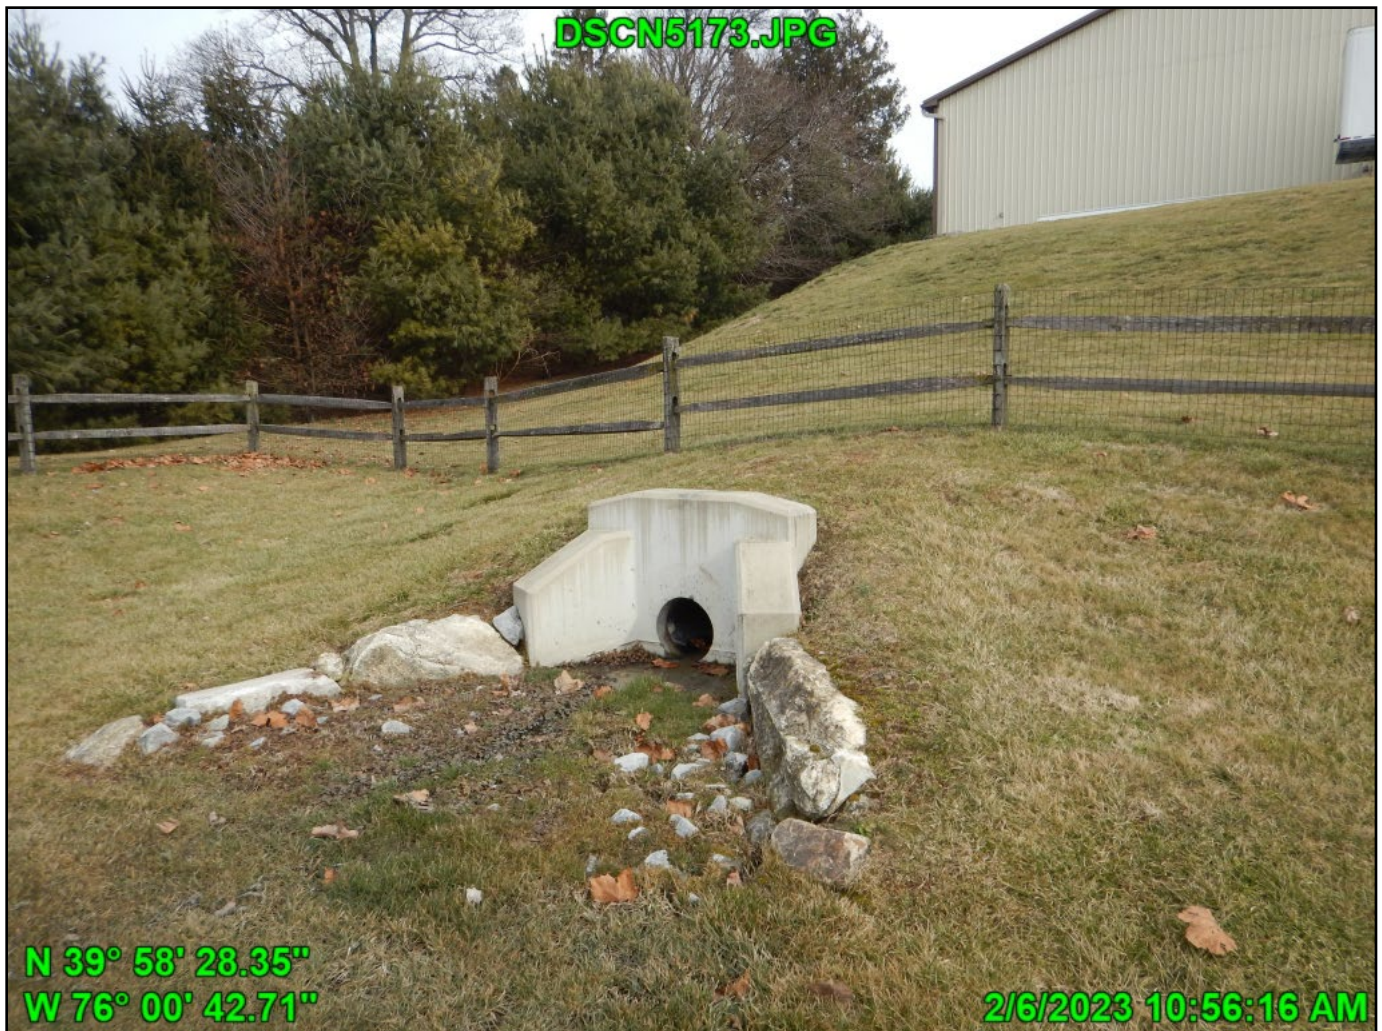
| Description | Headwall inlet structure in the detention basin shown in Photograph DSCN5172. Note the sparse riprap. |

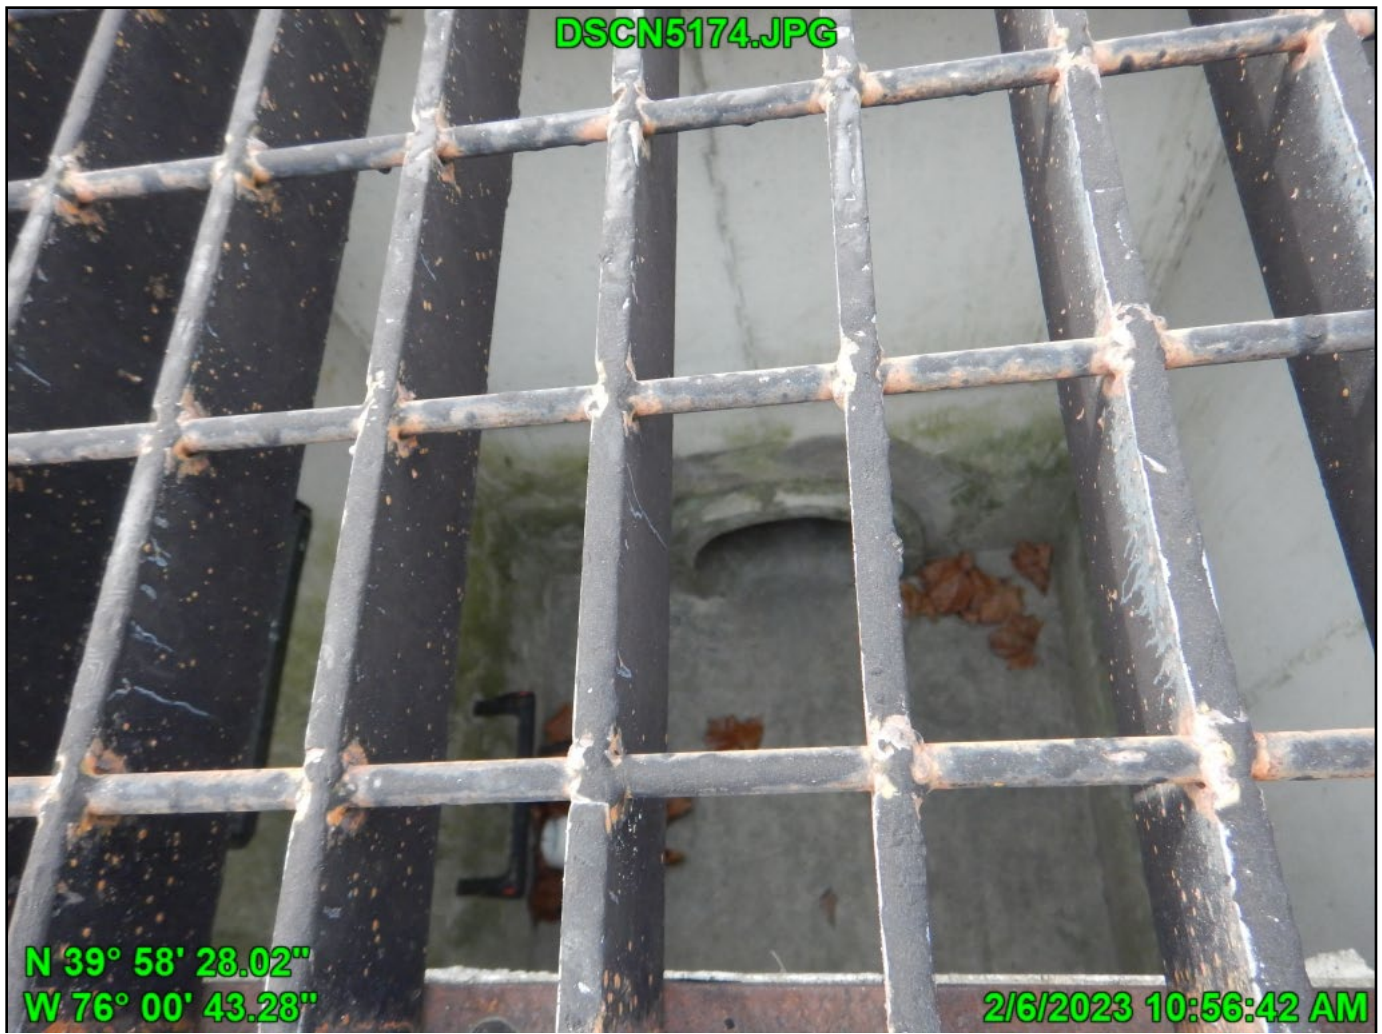
| Description | Inside the concrete riser structure located in the detention basin shown in Photograph DSCN5172. |

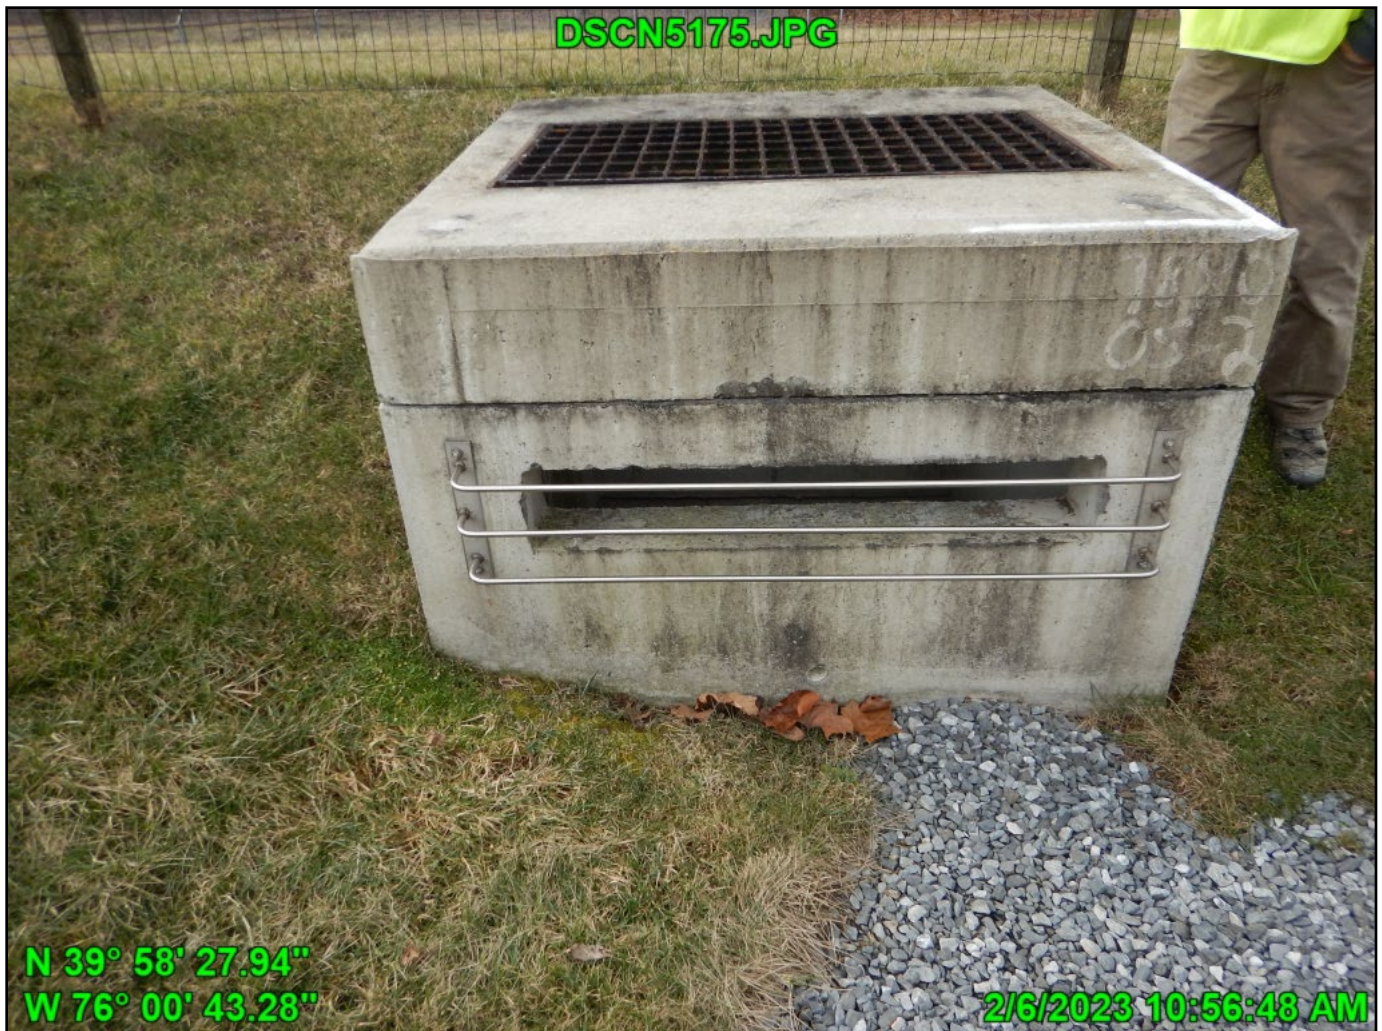
| Description | Concrete riser structure located in the detention basin shown in Photograph DSCN5174. |

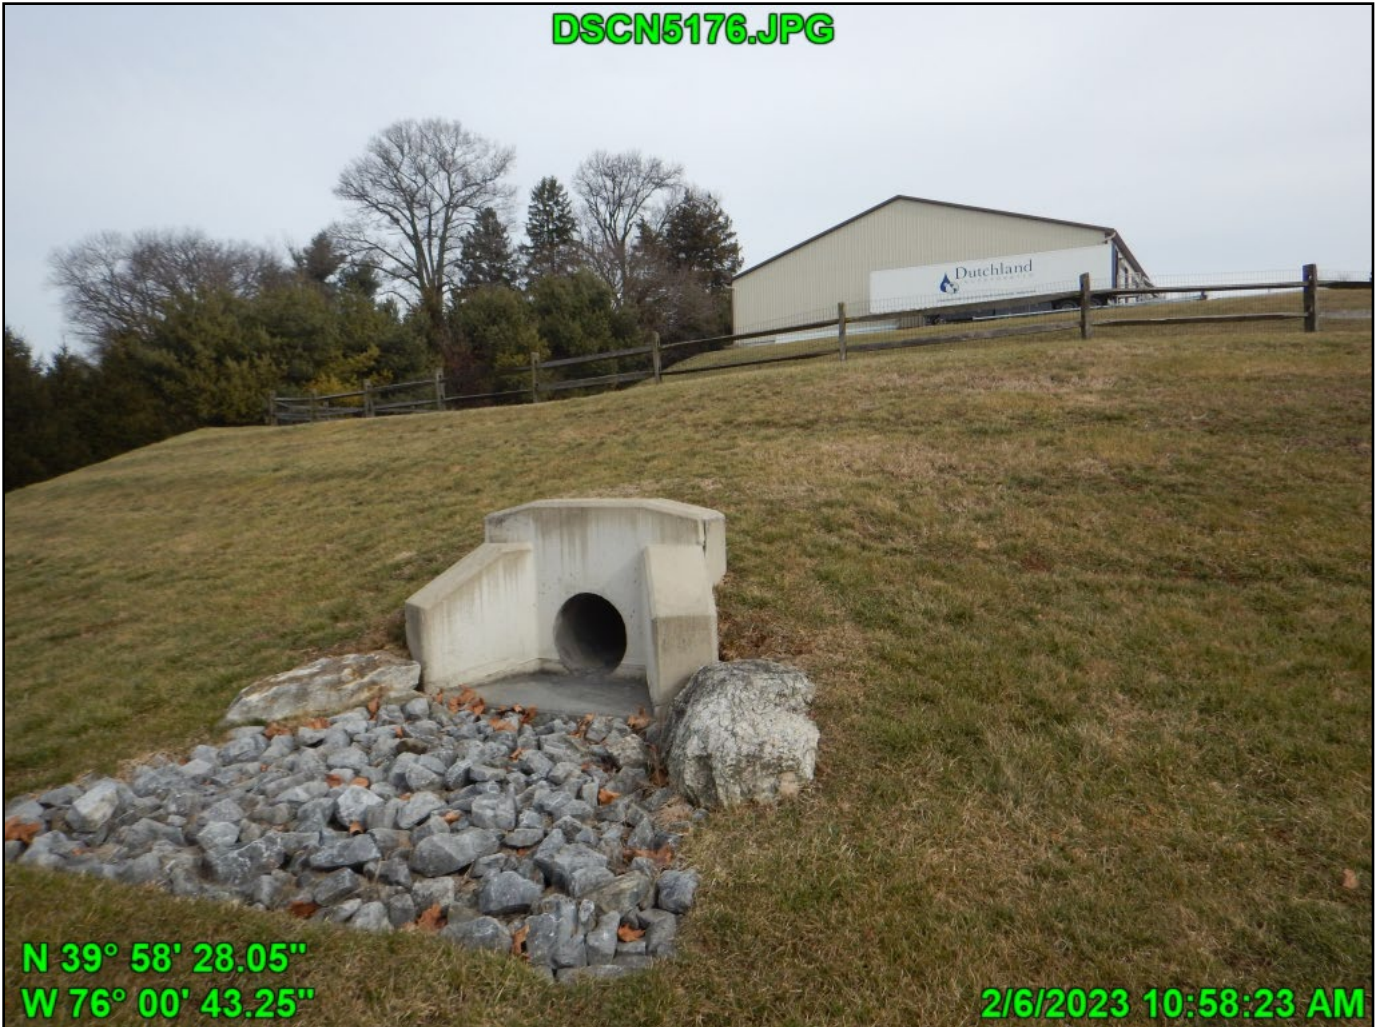
DSCN5176.JPG

Headwall outlet structure that conveys stormwater runoff from the adjacent building roofs and areas. This area receives stormwater overflow through the concrete riser from the upgradient basin.

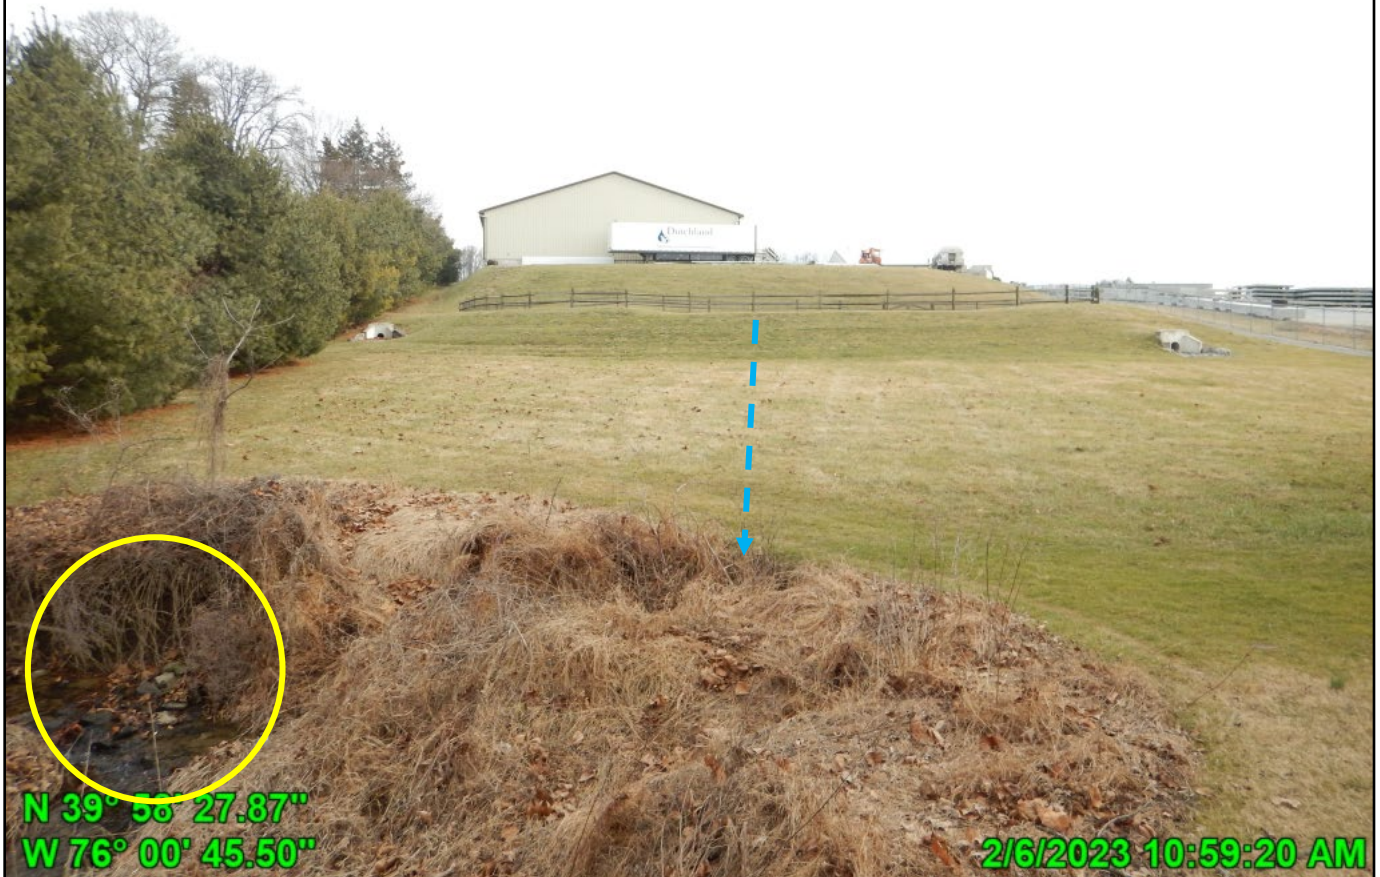
DSCN5179.JPG

Upgradient view of the detention basin in the northwest area of the Facility adjacent to the unnamed tributary to Williams Run.

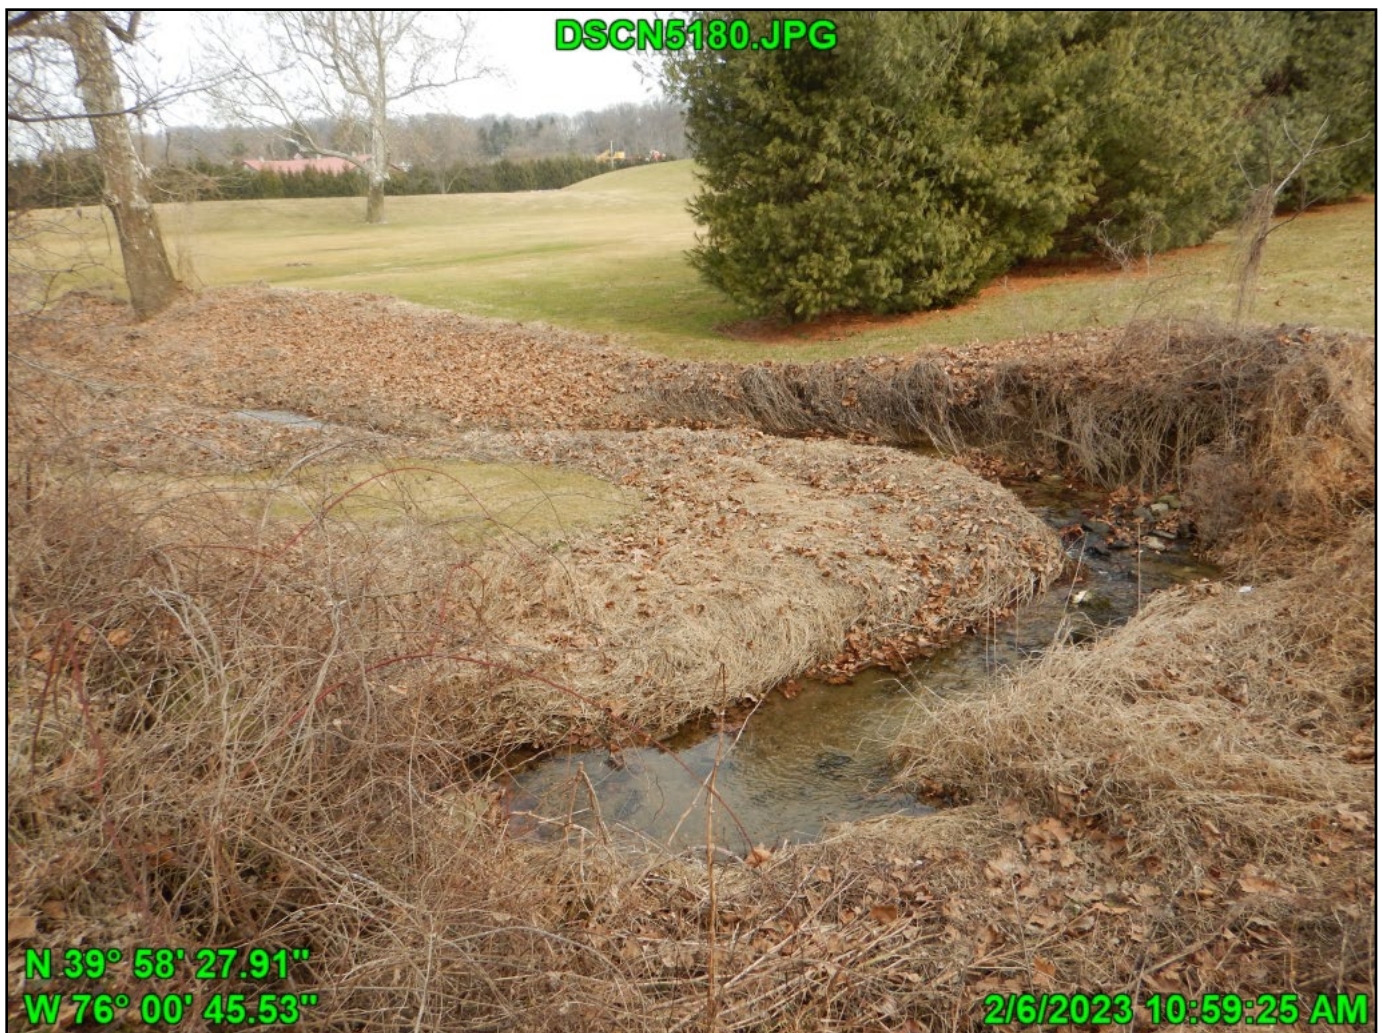
| Description | Unnamed tributary to Williams Run adjacent to the Facility, shown in Photograph DSCN5177. |
