## MULTI-SECTOR GENERAL PERMIT NON-FILER INSPECTION CHECKLIST

| <b>Inspection Date(s):</b> | 2/7/2023 | |
| <b>Operator Name:</b> | Dutchland, Inc. | |

Stormwater Inspection Date: February 7, 2023

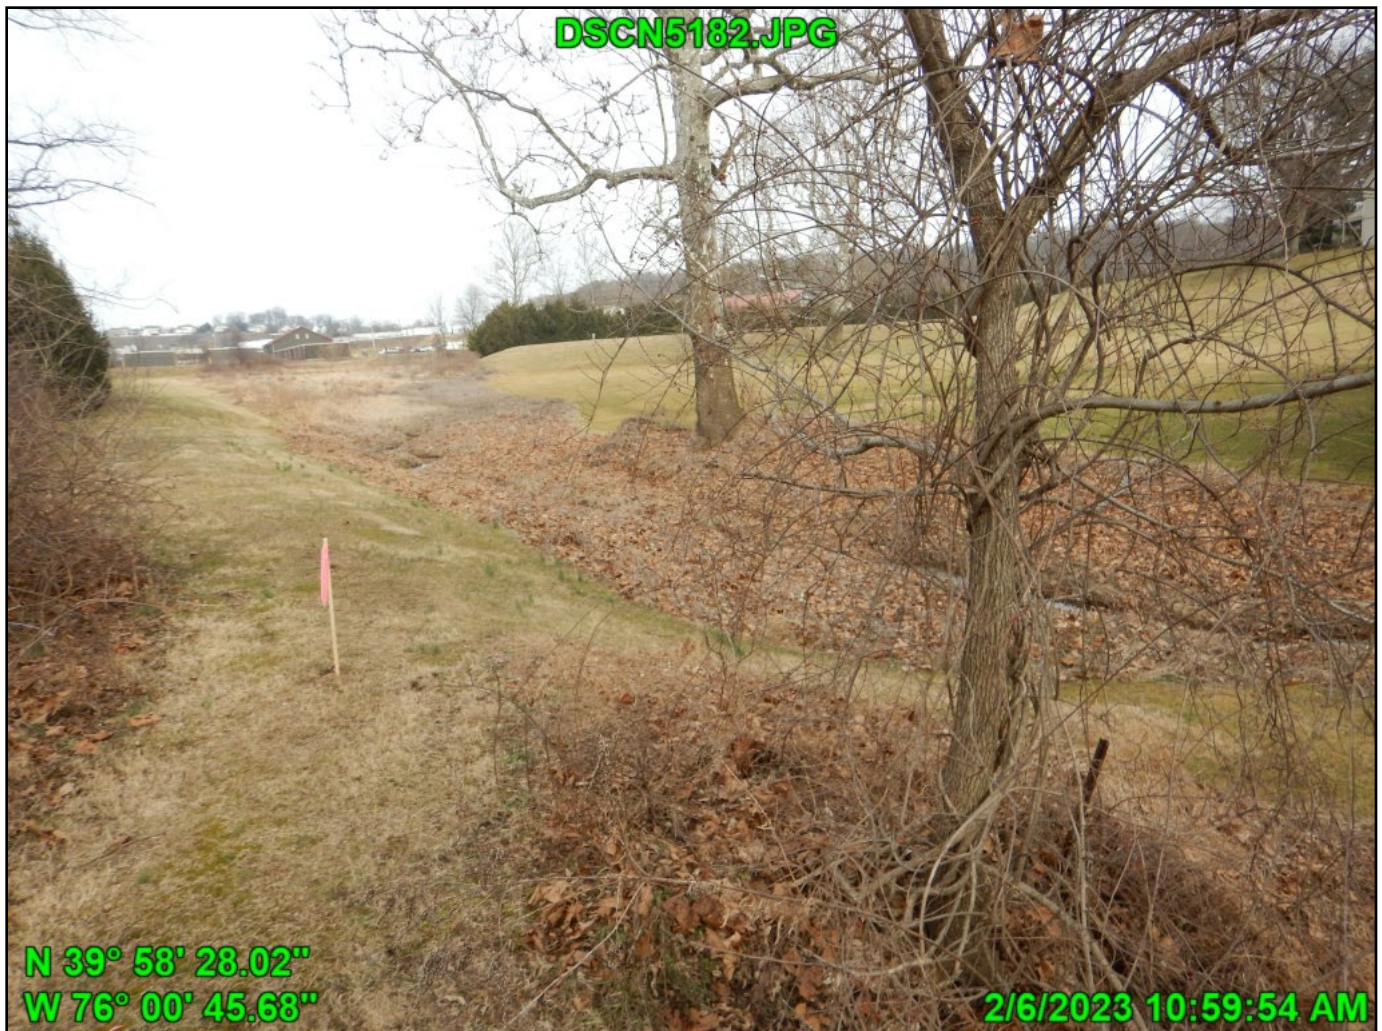
| Description | Unnamed tributary to Williams Run adjacent to the Facility, shown in Photograph DSCN5177. |

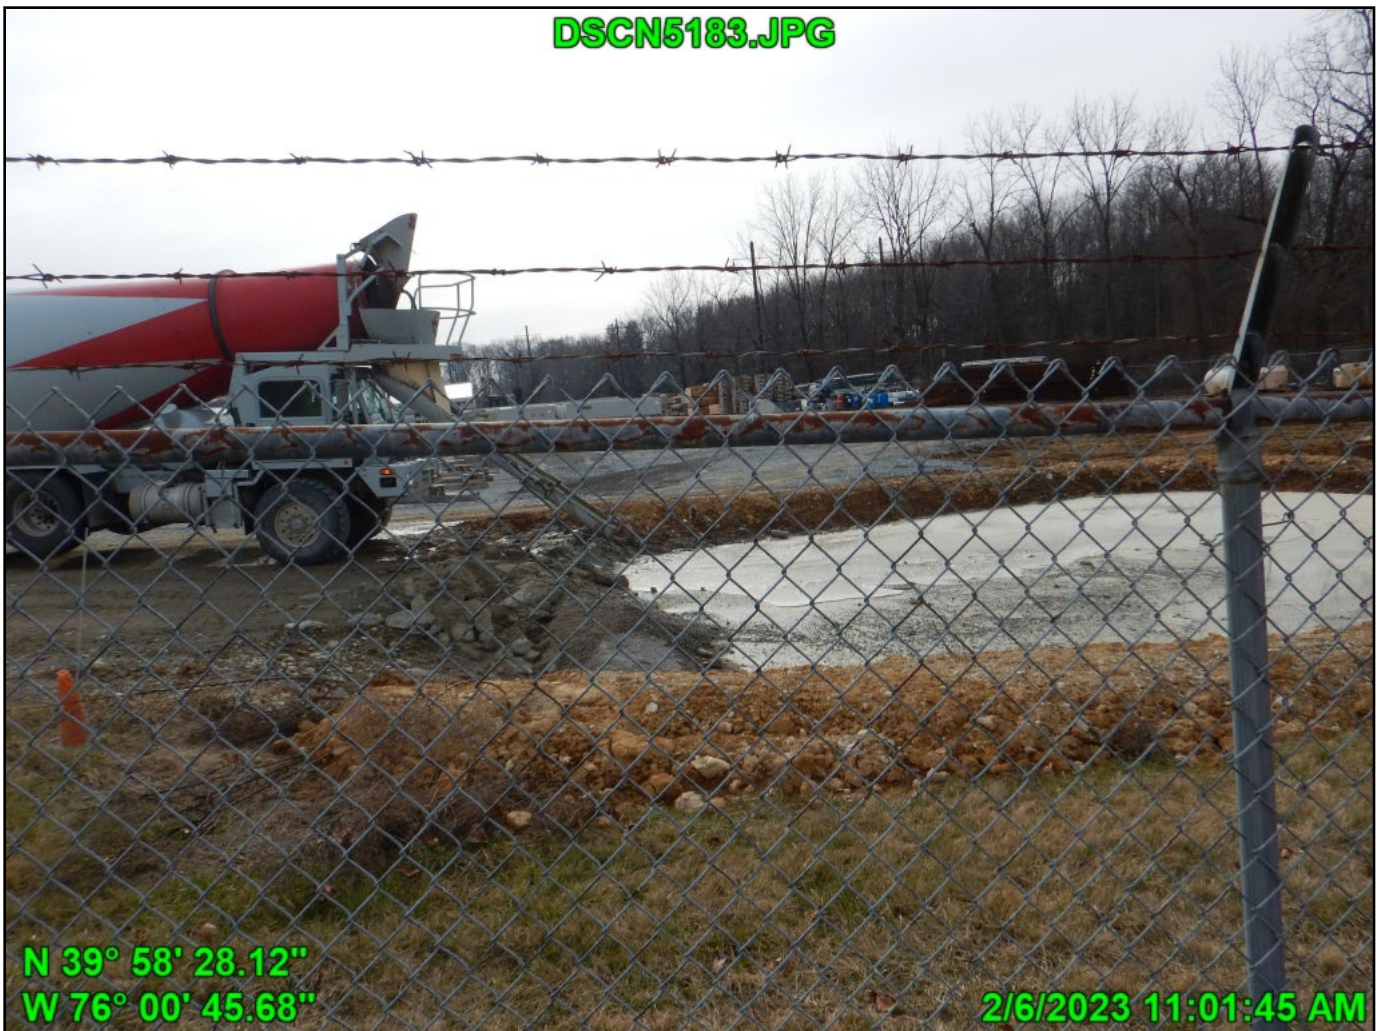
DSCN5183.JPG

| Description | Truck using the concrete washout in the northwest area of the Facility during the inspection. |

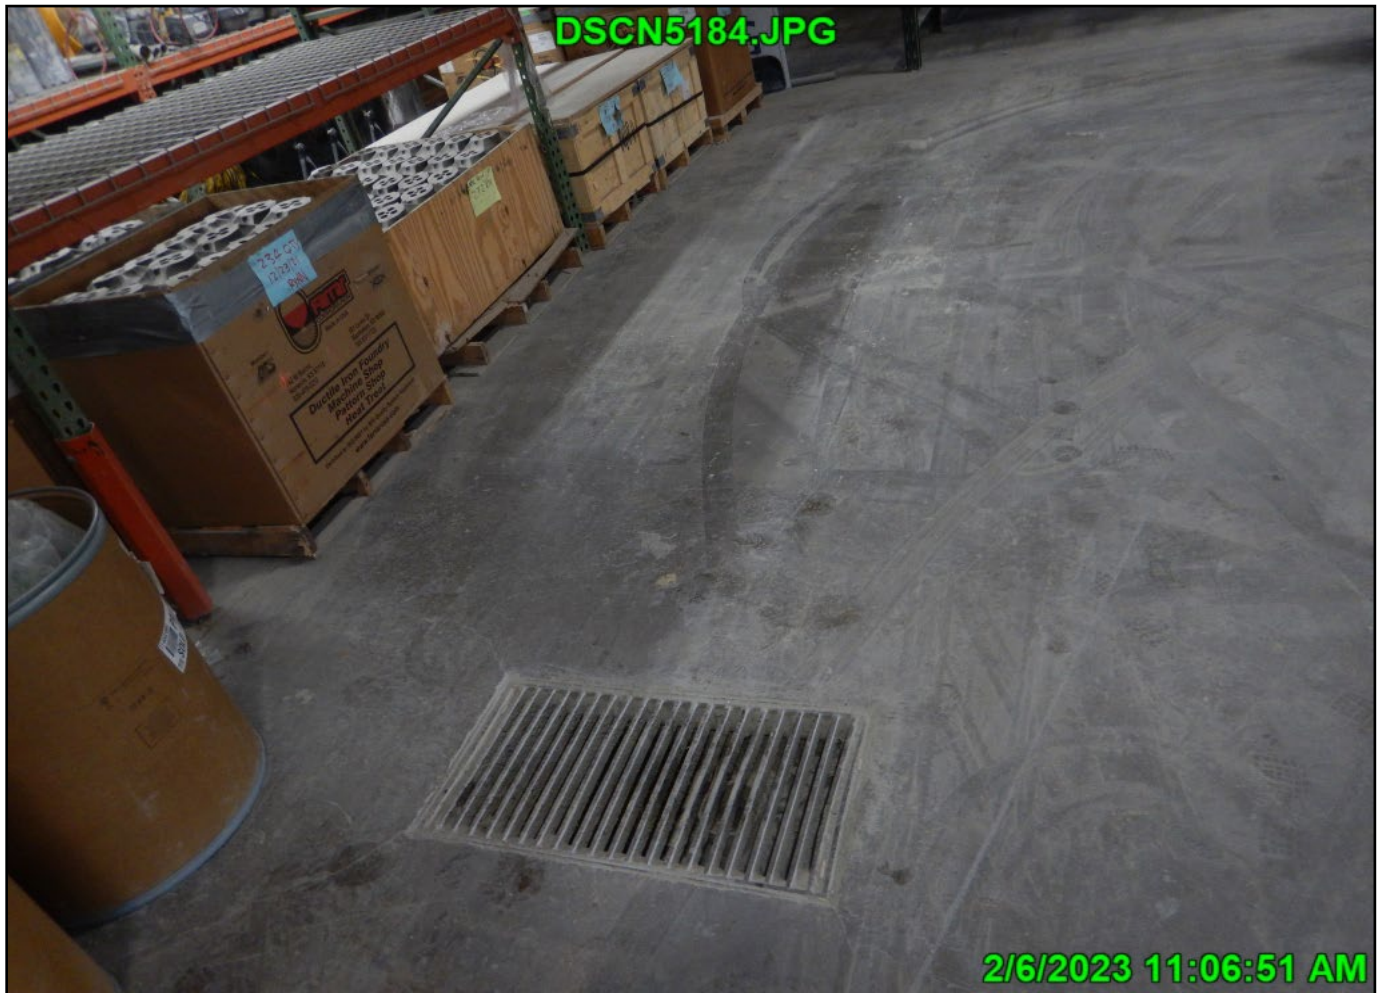
| Description | Floor drain inside a manufacturing building. The Facility representative was unsure where the drain discharged to. |

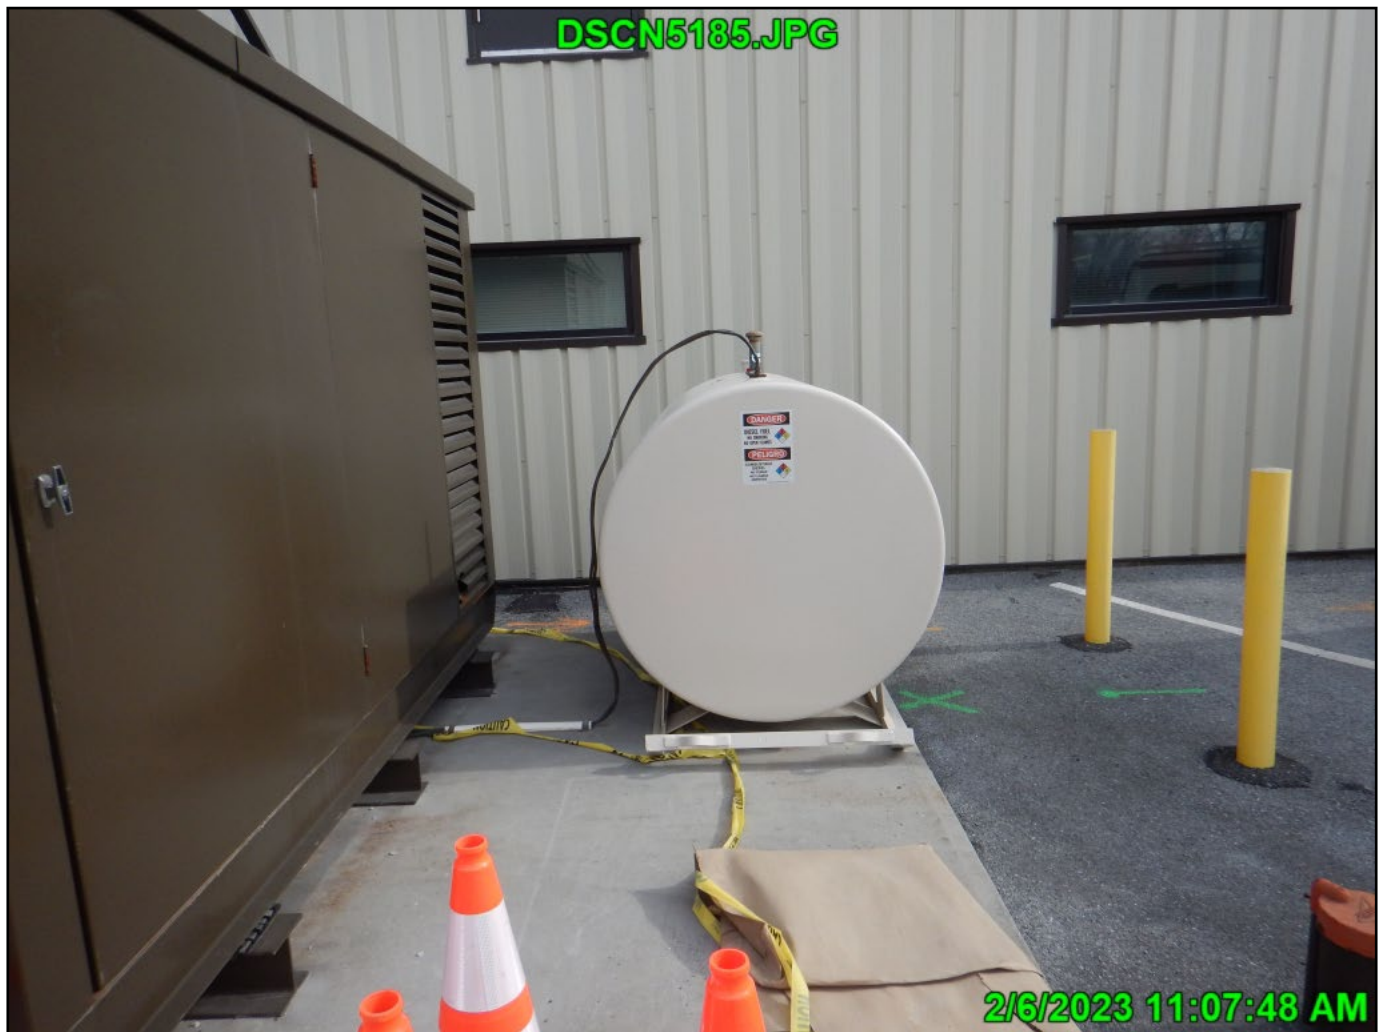
| Description | Diesel tank for an onsite generator (unknown quantity). It was unclear if the diesel tank was double walled. Note the lack of secondary containment or spill kit nearby. |
