## Clean Water Act Section 404: Site Visit/Case Development

| Site Name | South Alabama Materials, Inc., Sardine Pit | | | | |

**ATTACHMENT D**  
**South Alabama Materials, Inc.**

Sardine Pit  
Photographic Log  
Escambia County, Alabama  
January 30-31, 2024

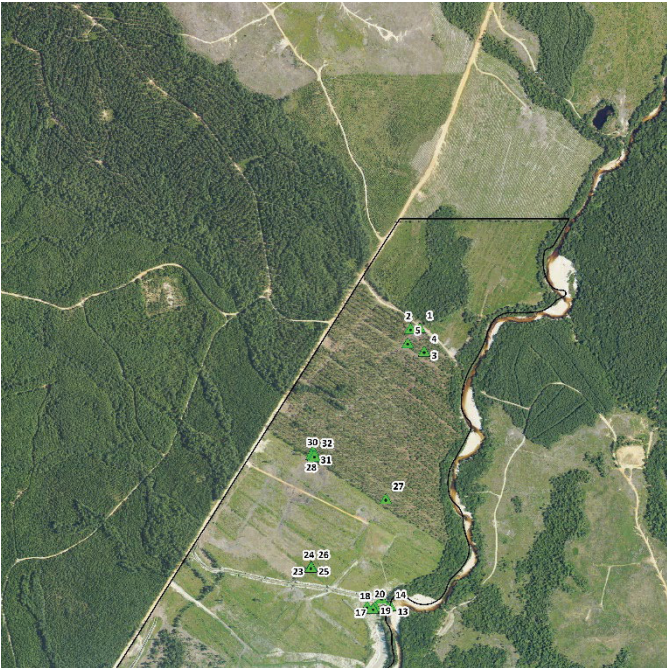
PHOTO 1

| Description | Soil profile at Data Point A1. |

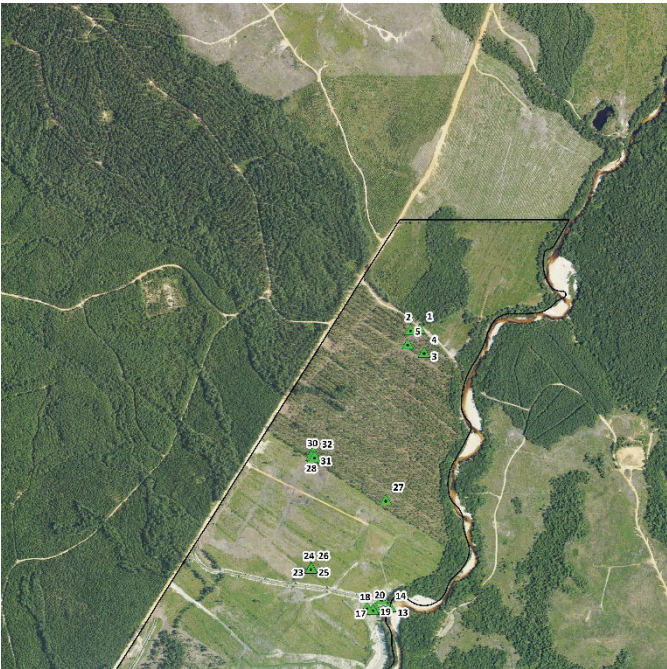
PHOTO 2

| Description | Soil profile at Data Point A1. |

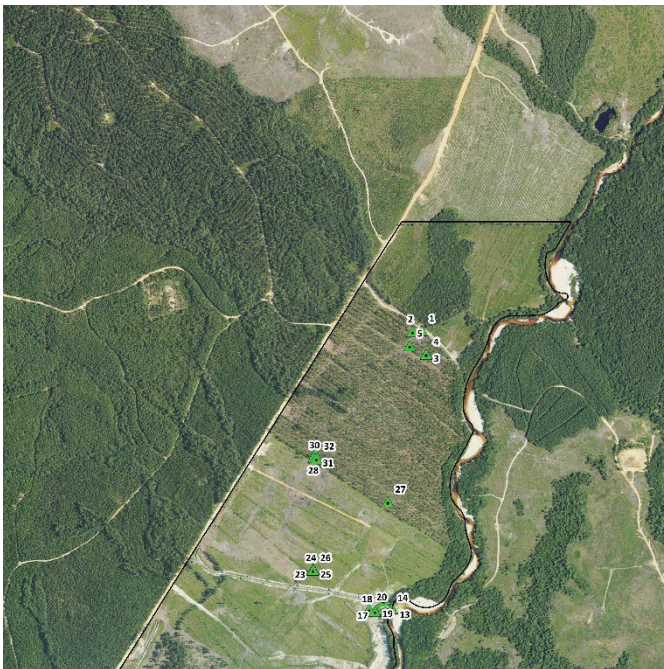
PHOTO 3

| Description | Striking south over Data Point A1. |

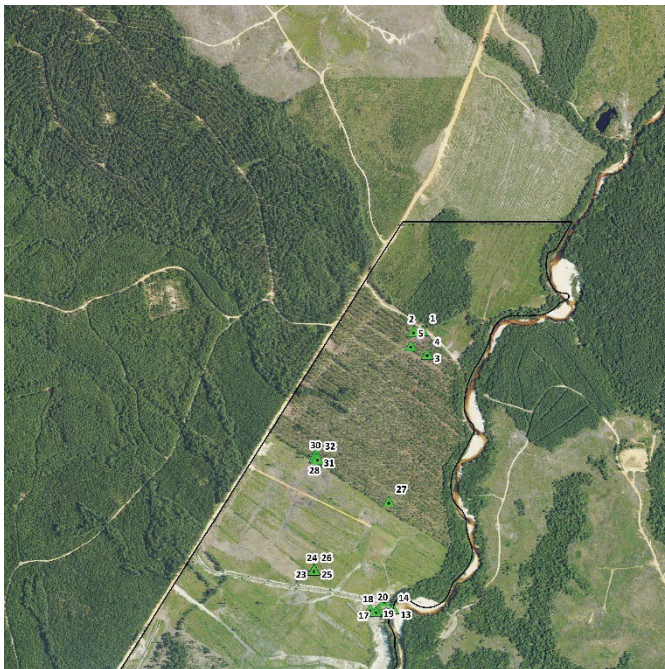
# PHOTO 4

| Description | Striking east over Data Point A1. |

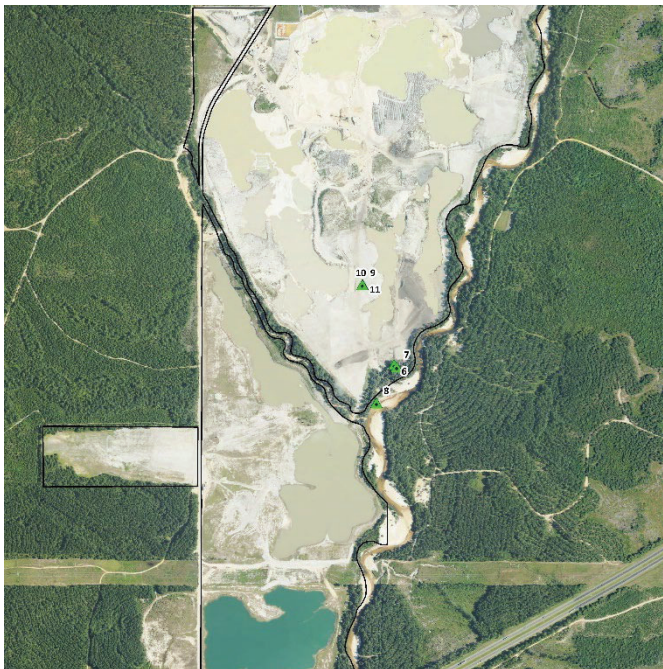
# PHOTO 6

| Description | Striking downstream, unnamed tributary (UT) east of berm, just upstream of the UT's confluence with Big Escambia Creek. Red arrow indicates direction of flow. |

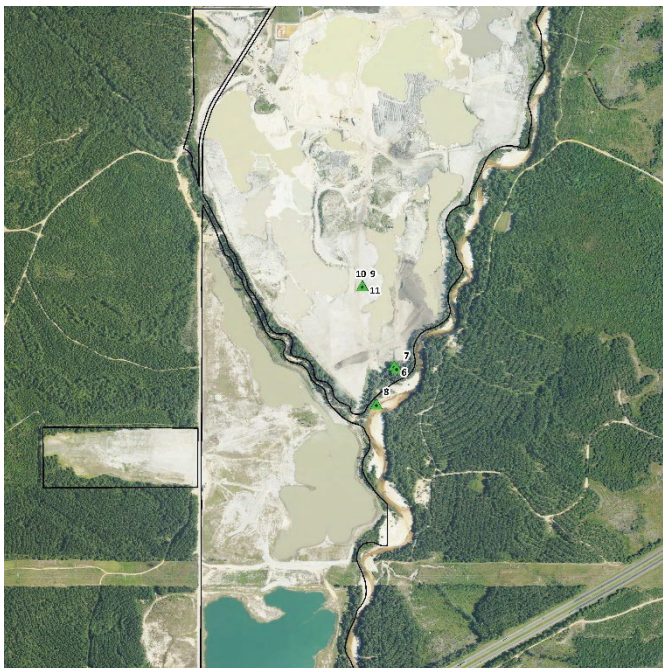
PHOTO 7

| Description | Striking northwest from same location as Photo 6 in UT channel, Big Escambia Creek's natural levee. |

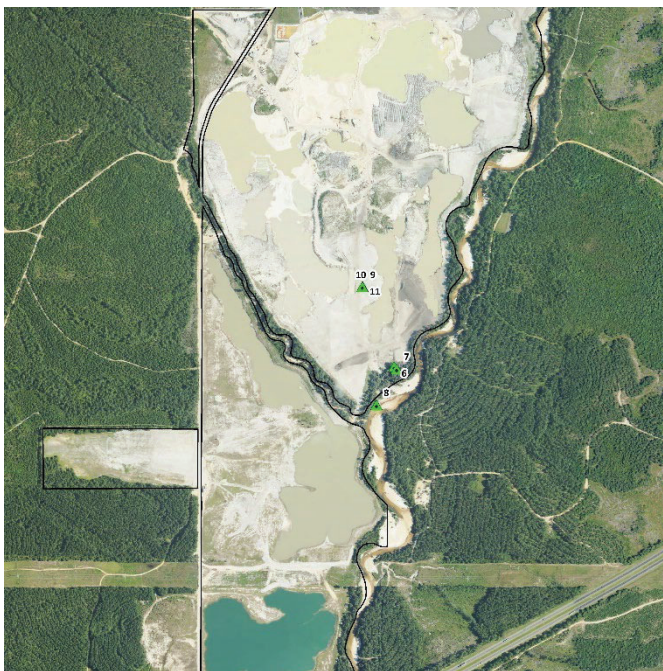
# PHOTO 8

| Description | Striking downstream, unnamed tributary (UT) east of berm, at the UT's confluence with Big Escambia Creek. Red arrow indicates direction of flow. |

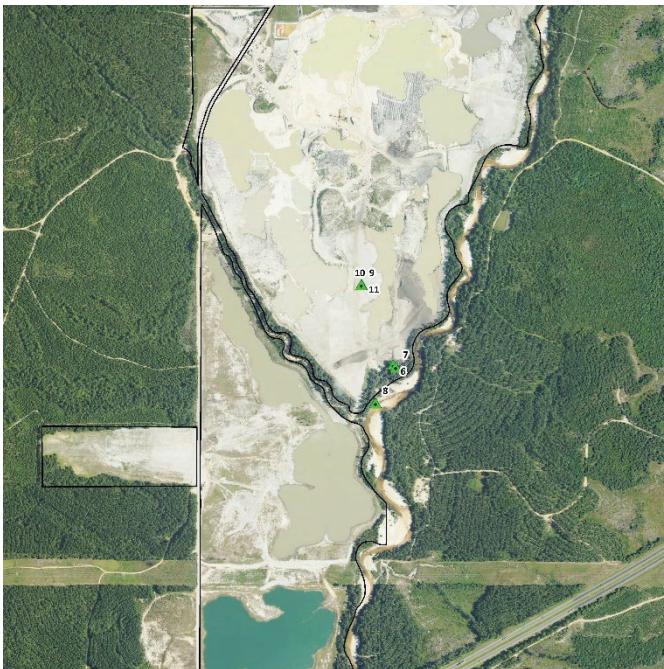
PHOTO 9

| Description | Striking northeast from interior of mine, spoil pile in background. |

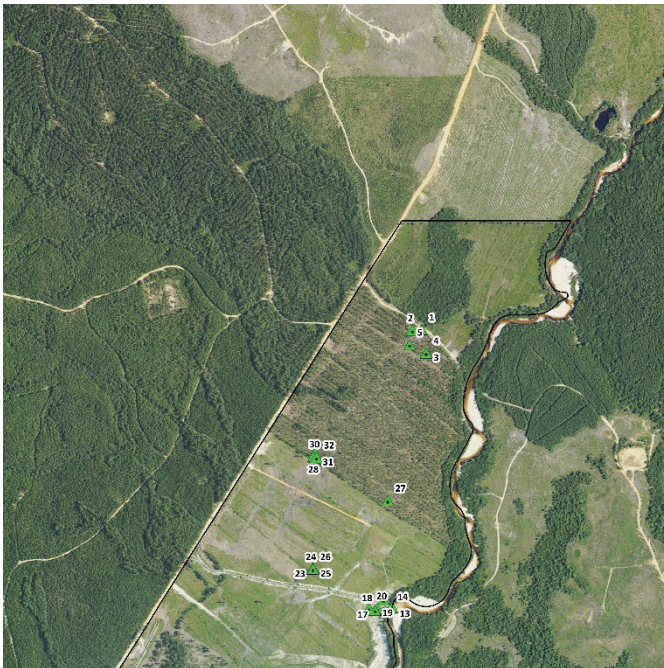
PHOTO 16

| Description | Striking south of fill material. |
