## **RCRA Inspection Report**

Cymer-Dayton LLC  
411 Manufacturers Road  
Dayton, Tennessee 37321  
Rhea County

EPA ID: TND981023674  
NAICS: 325199 - All Other Basic Organic Chemical  
Manufacturing

May 7, 2024, at 9:30 a.m. EDT

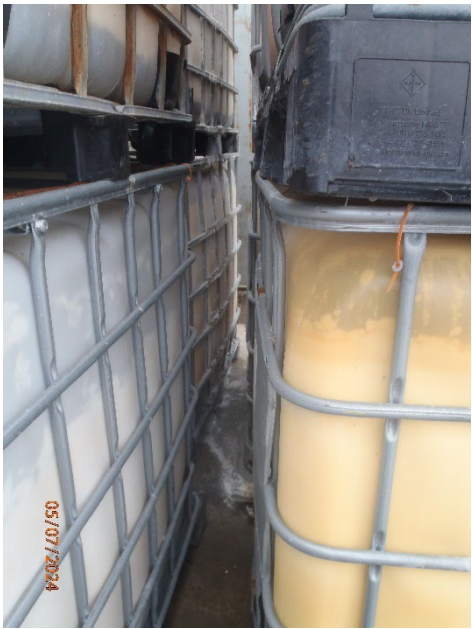
narrow, and the inspectors observed a white substance released to the ground between the totes (Pictures 19-20). One of the totes were observed to be contracting in on itself (Pictures 21-22). Another tote was observed to be bulging (Picture 23).

Picture 19 – Fatty Acid Tote Storage release to ground

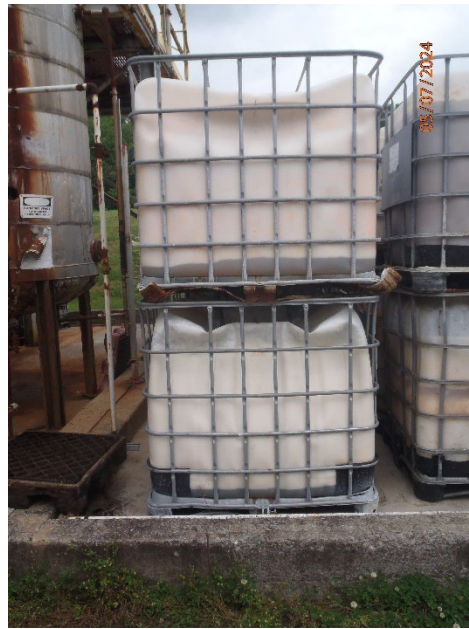
Picture 21 – Fatty Acid Tote contracting in

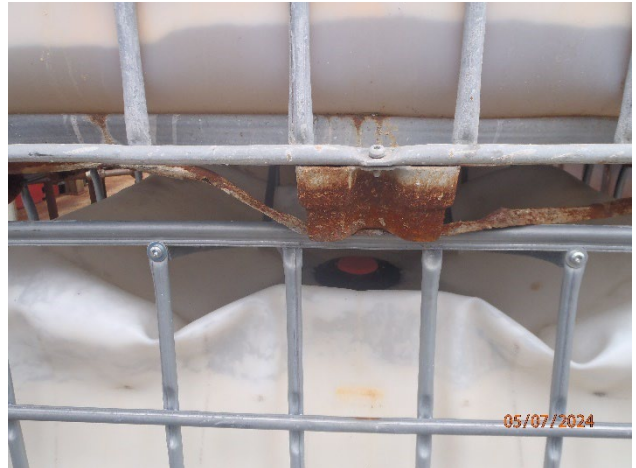
Picture 22 – Fatty Acid Tote contracting in

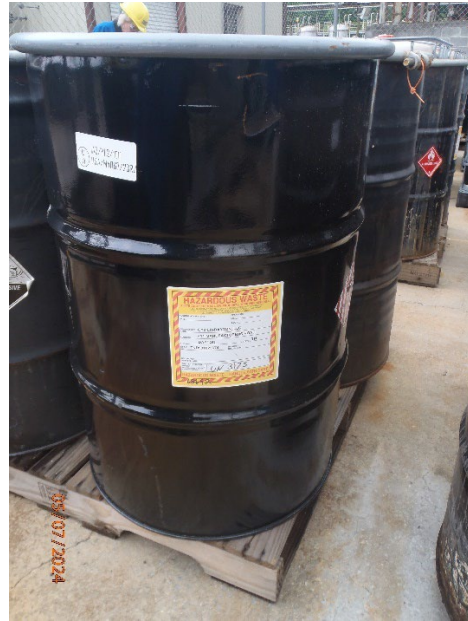
Inside the CAA, there were 98 total containers: thirty-four 55-gallon containers of non-hazardous waste (Picture 35) and sixty-four 55-gallon container of hazardous waste. Of the 64 hazardous waste containers, two of the containers did not have start accumulation dates (Pictures 26, 27, 30, 33). These containers were marked with the waste profile number 68692, Waste Solid Containing Flammable Liquids, and Waste Flammable Solid, D001, F003, F005. Mr. Linn pointed out that the container with the curled label did have an accumulation start date of March 23, 2024, but the ink had been washed off (Pictures 30, 33).

Picture 26 – HWCAA

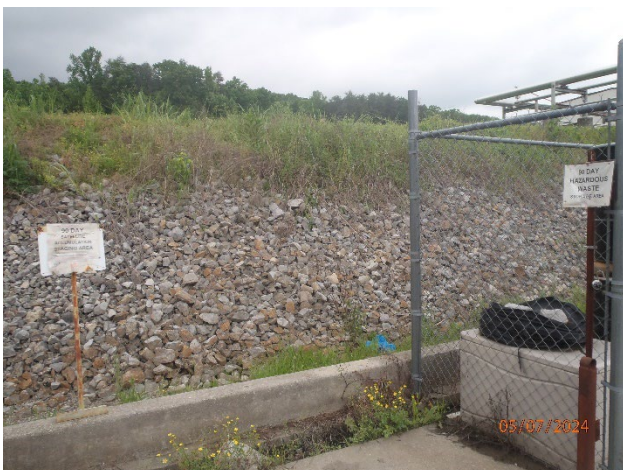
The central accumulation area (CAA) is a fenced in area with a locked gate (Pictures 10-12, 44). There is a ‘90 Day Hazardous Waste Storage Area’ sign near the gate (Picture 25). However, there were no ‘No Smoking’ signs posted along the fence. This is an area of concern.

Picture 25 – HWCAA signs

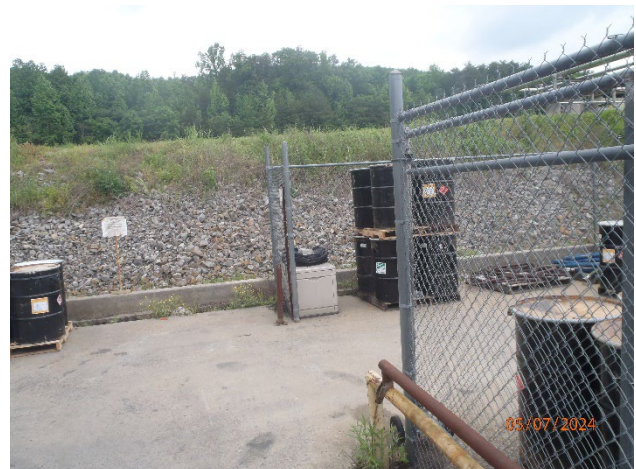
Near the CAA entrance was a square container that had coiled hoses with rocks on top. Mr. Matt Riley, EHS Technician, stated the container was a spill kit (Picture 45), however there were wasps and/or bees inside the container that needed to be removed, thus the spill kit was unavailable. This is an area of concern.

Picture 45 – HWCAA spill kit

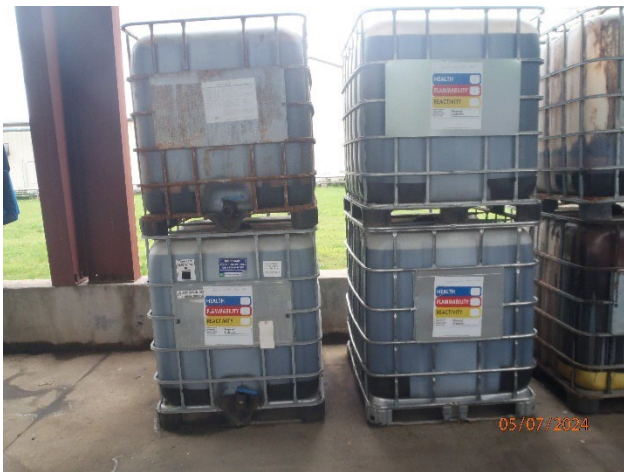
Across from the resin solution containers the inspectors observed ten closed, undated 275-gallon IBC totes. Three of the 275-gallon IBC totes were labeled or marked as Hexanol and Water Organic Waste (Picture 46, 47, 50). The remaining seven totes were not properly marked or labeled with words identifying the contents. It was unknown whether the contents were a spent material or a by-product exhibiting a characteristic of hazardous waste. Mr. Linn was unaware of ten 275-gallon IBC totes waste being stored in the flammable storage area, and contacted Mr. Shaun McMillin, Operations Manager for additional information. Mr. McMillin arrived and explained that the totes were to be distilled to reclaim hexanol. After recovery the hexanol would be stored in a 10,000-gallon bulk product tank. The wastewater would be sent off-site to Aqua Treat.

Picture 46 – Flammable Storage totes to be distilled

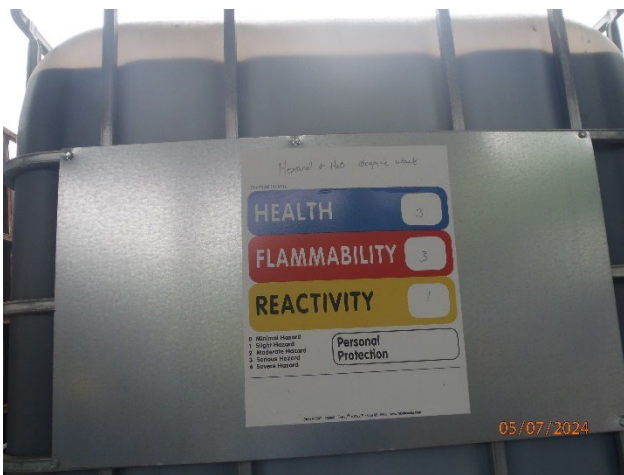
Picture 47 – Flammable Storage totes to be distilled

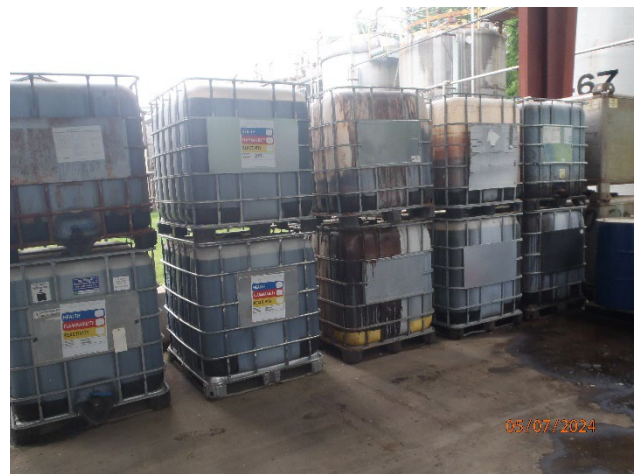
Picture 50 – Flammable Storage totes to be distilled

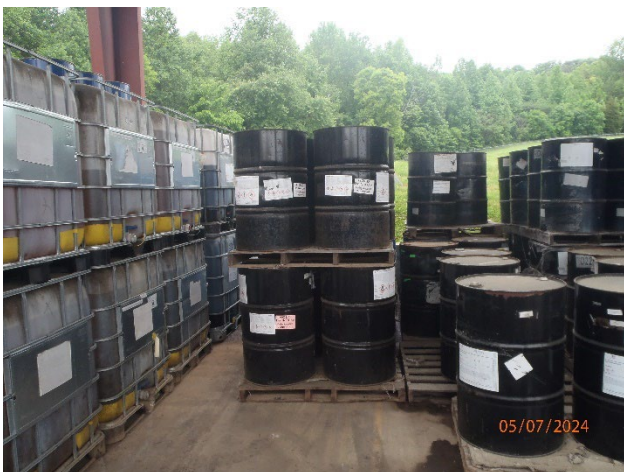
Next to the CAA was the flammable storage area (Picture 51). Facility representatives explained that product and raw material are stored in this area. The inspectors observed eight 55-gallon containers of black dye/toulene/Hexion E-70 resin solution (Pictures 48-49). On at least one of the containers, the inspectors observed a "REV. DATE 26-OCT-2017." Mr. Linn explained that the contents were off specification for the previous customer, but still viable. The containers of resin solution were marked as on 'Hold Do Not Use, Pending Management Approval'. Mr. Linn stated that the facility was currently negotiating with an auto racing company to purchase the resin solution. The condition of the containers and labels, in addition to the 10/26/2017 date, raises concerns about the length of time the containers have been stored. The inspectors

Picture 48 – Flammable Storage black dye/toluene resin solution

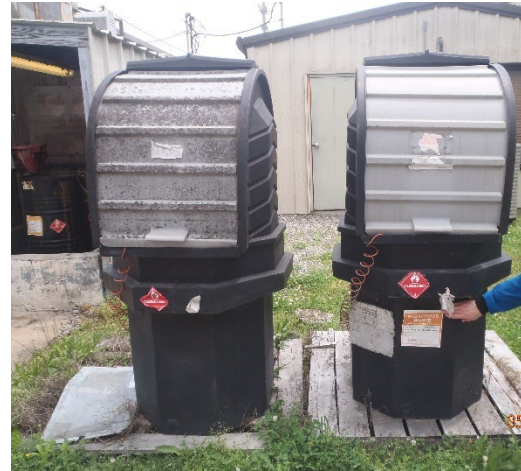
Picture 62 – Lab SAA not at or near generation point

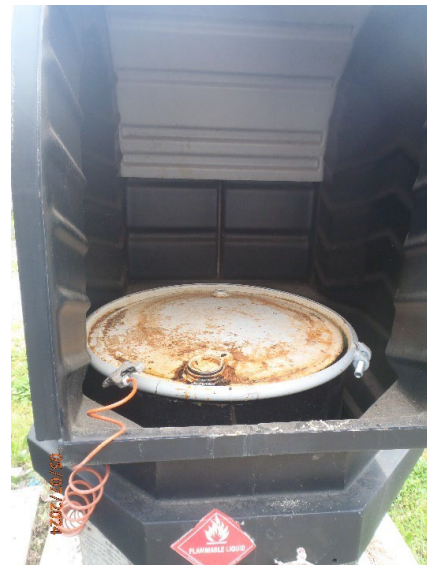
Picture 63 – Lab SAA not at or near generation point

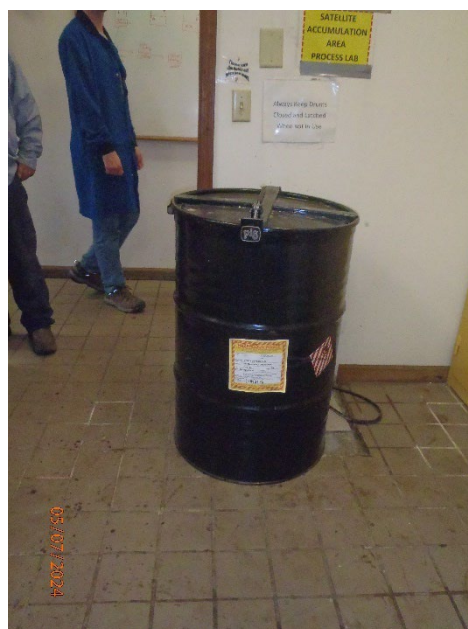
Picture 66 – Lab SAA for PPE/debris/rags

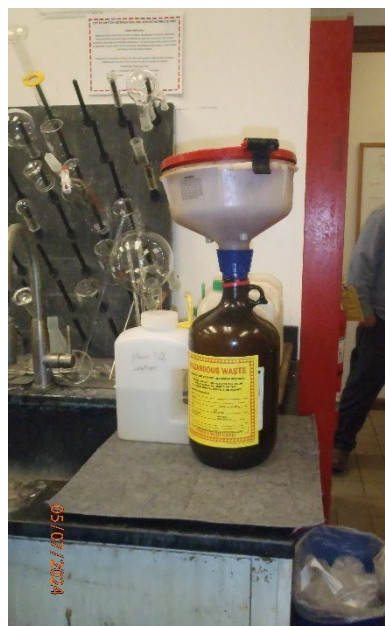
Picture 67 – Lab SAA container w/funnel

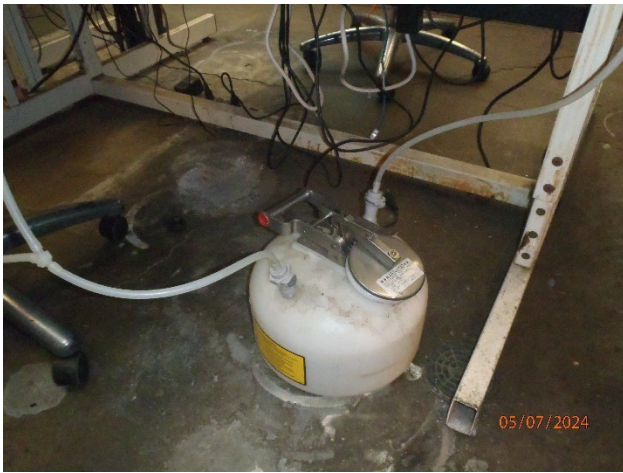
Picture 68 – Lab HPLC SAA

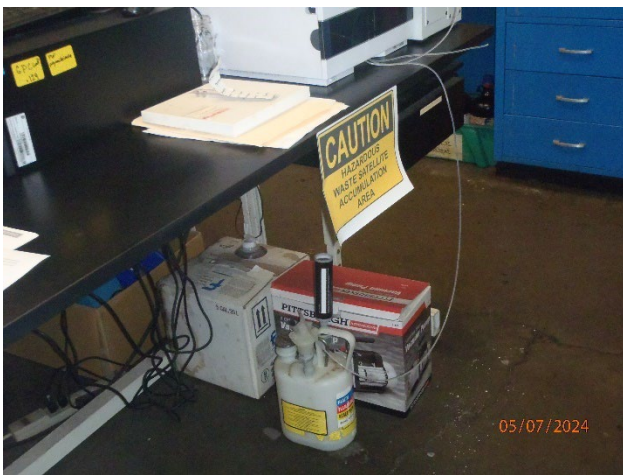
Picture 69 – Lab HPLC SAA

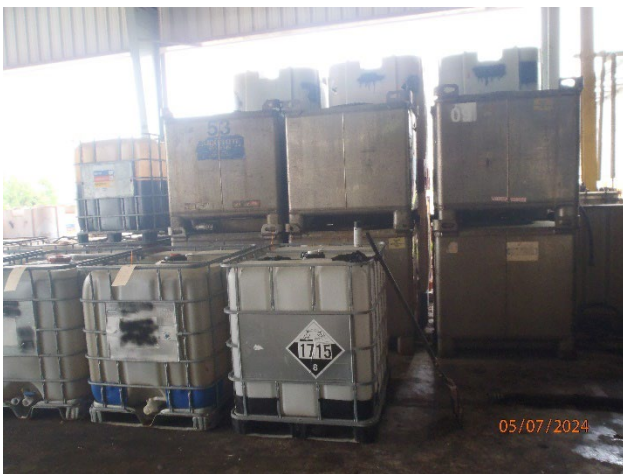
The inspectors also observed approximately twenty-five 275-gallon IBC totes stored in this area (Picture 87). Mr. Linn explained that the totes contained material from hazardous waste tank T-60 that needed to be distilled. However, the inspectors expressed concern about containers not being marked or labeled with words 'hazardous waste' and indication of hazard, the length of time the containers had been stored on site, and when the material would be distilled. Mr. Linn had been in his current position for over a year, and the material had been on site prior to him becoming EHS Manager. The totes have been stored for over a year. This is an area of concern.

Picture 87 – Building 6 totes needing to be distilled

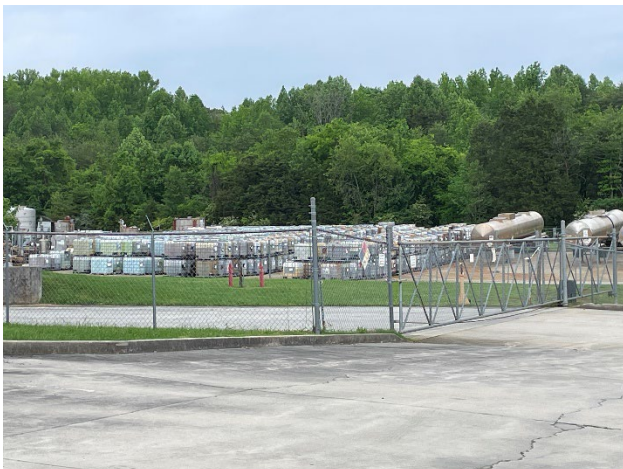
Picture 88 – Tanker Lot

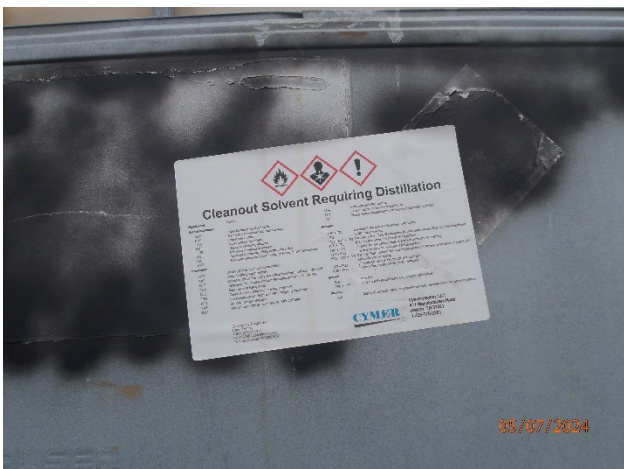
Picture 94 – Tanker Lot tote of cleanout solvent to be distilled

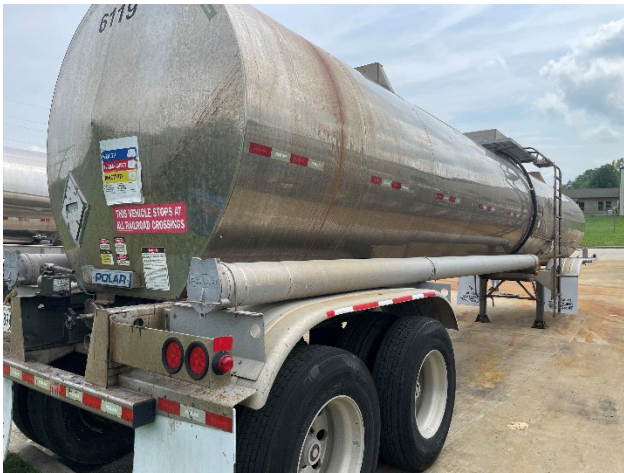
Picture 97 – HW Tanker 6119 not labeled or dated
