## RCRA COMPLIANCE EVALUATION INSPECTION REPORT

TAV Holdings, Inc.  
3311 Empire Boulevard SW  
Atlanta, Georgia 30354  
EPA ID # GAD033537663

October 6, 2021

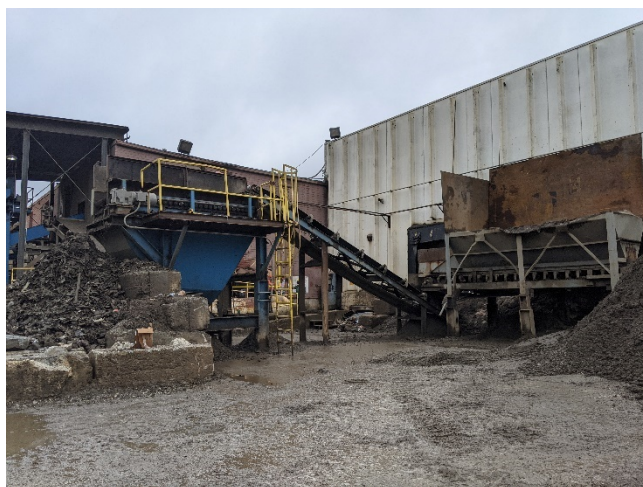
The facility tour began in the receiving area. Several piles of ASR, solid waste, were observed in this area (Figures 48 and 49). The solid waste in this area is stored in open piles that are exposed to weather elements. The area had received rainfall in the days prior to the inspection and the solid waste piles were wet. Water contaminated with small particles was observed flowing from the south to the north where the outdoor processing, storage and Receiving Area are located. The water was observed to be pooling in the area immediately east of the Receiving Area (Figures 87 and 88). This area is known as the Jig Storage.

*Figure 49: PXL\_20211006\_140801482.jpg –  
Receiving Area*
