Re: U.S. EPA-Region 1 Inspection Report of Solvay, September 7, 2022

RCRA Compliance Inspection of:

Solvay
1937 West Main Street
Stamford, CT 06902

RCRA HAZARDOUS WASTE INSPECTION REPORT

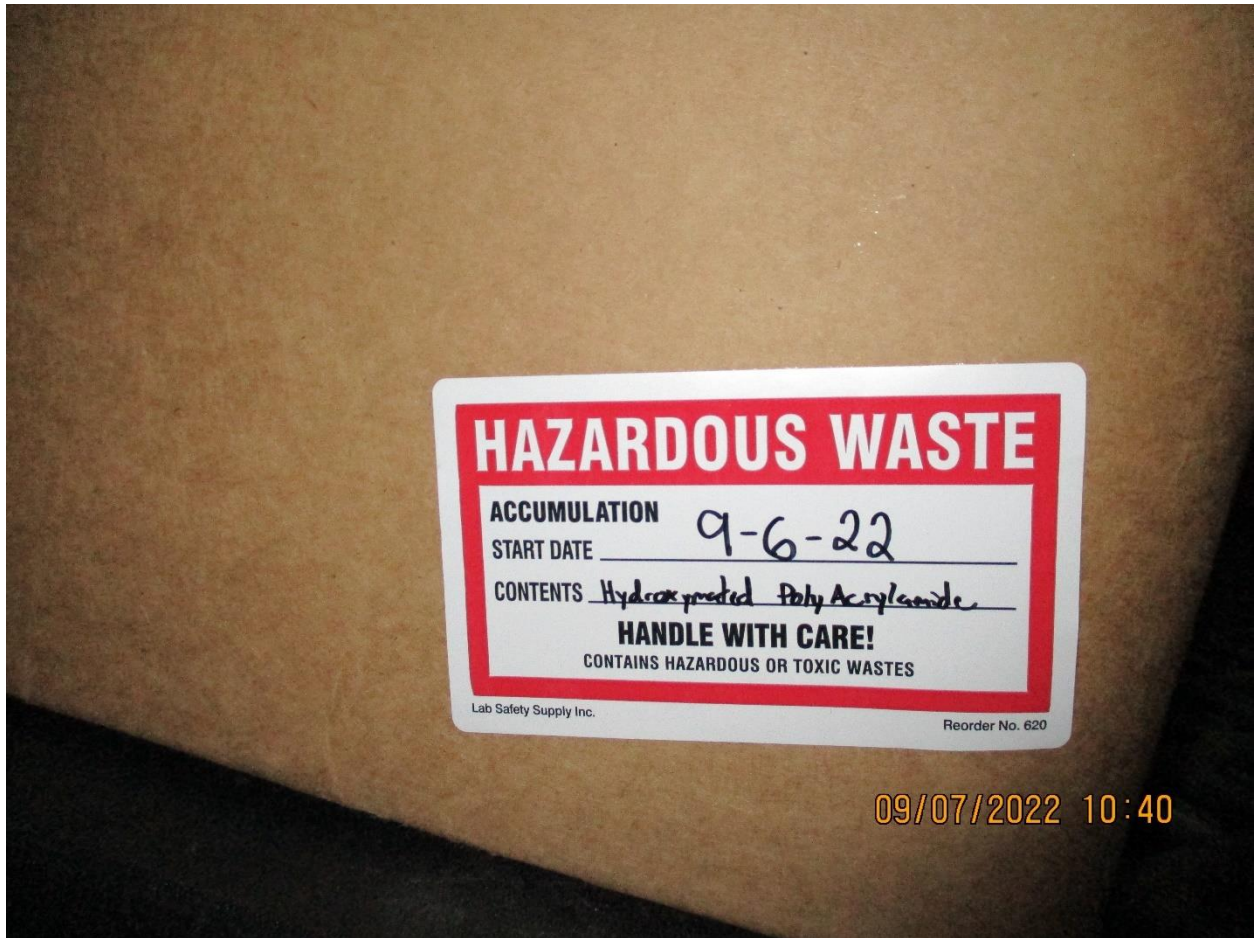
Photo 43

Skid 4. Four hazardous waste cardboard boxes, and two red lab pack boxes (*See attachment 1, Photo #34 and #43-46*).

HW label on container on skid 4, in center back of 90-Day HWSA, located in the Maintenance Shop

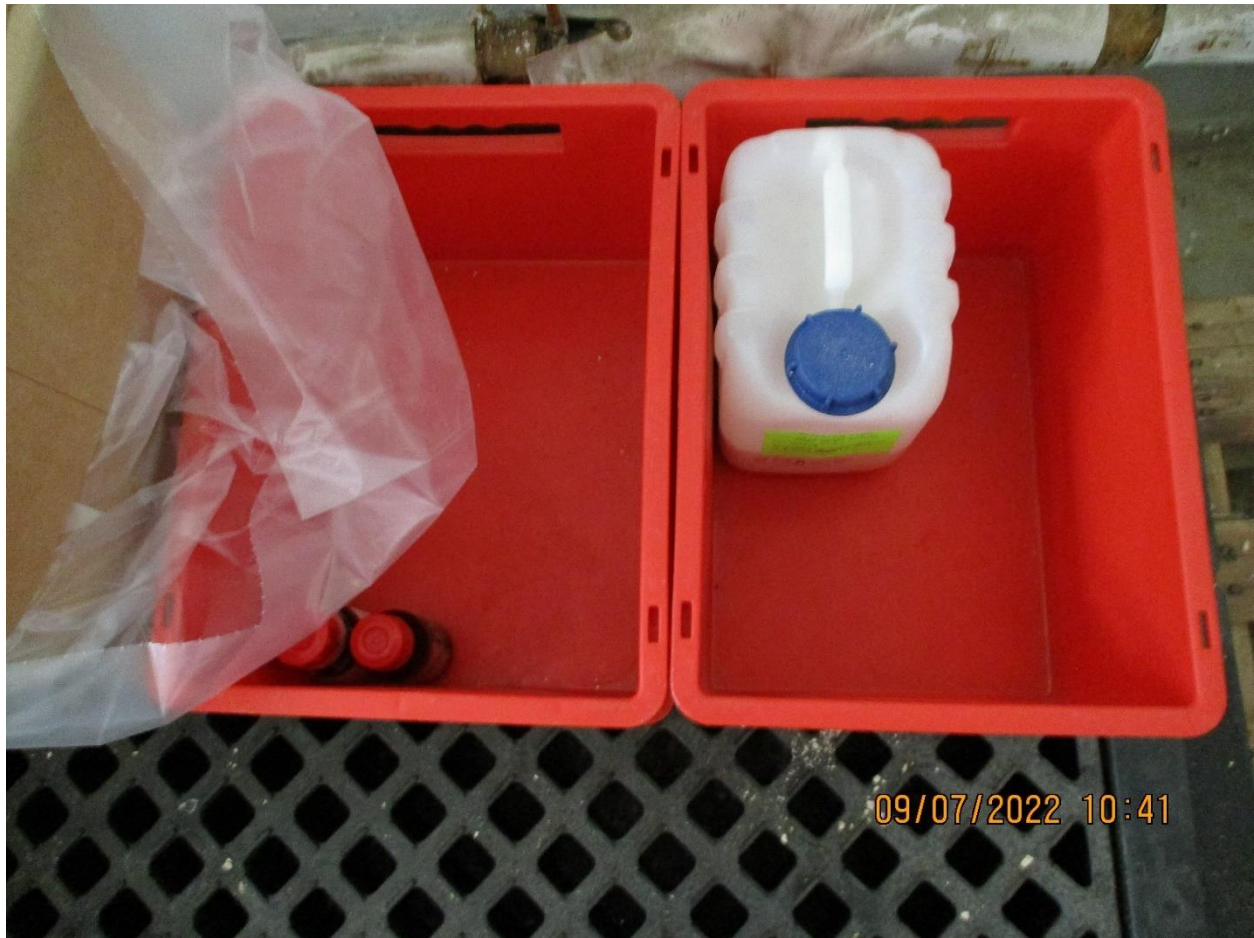
Photo 45

Contents inside HW container for lab pack on skid 4, in center back of 90-Day HWSA, located in the Maintenance Shop

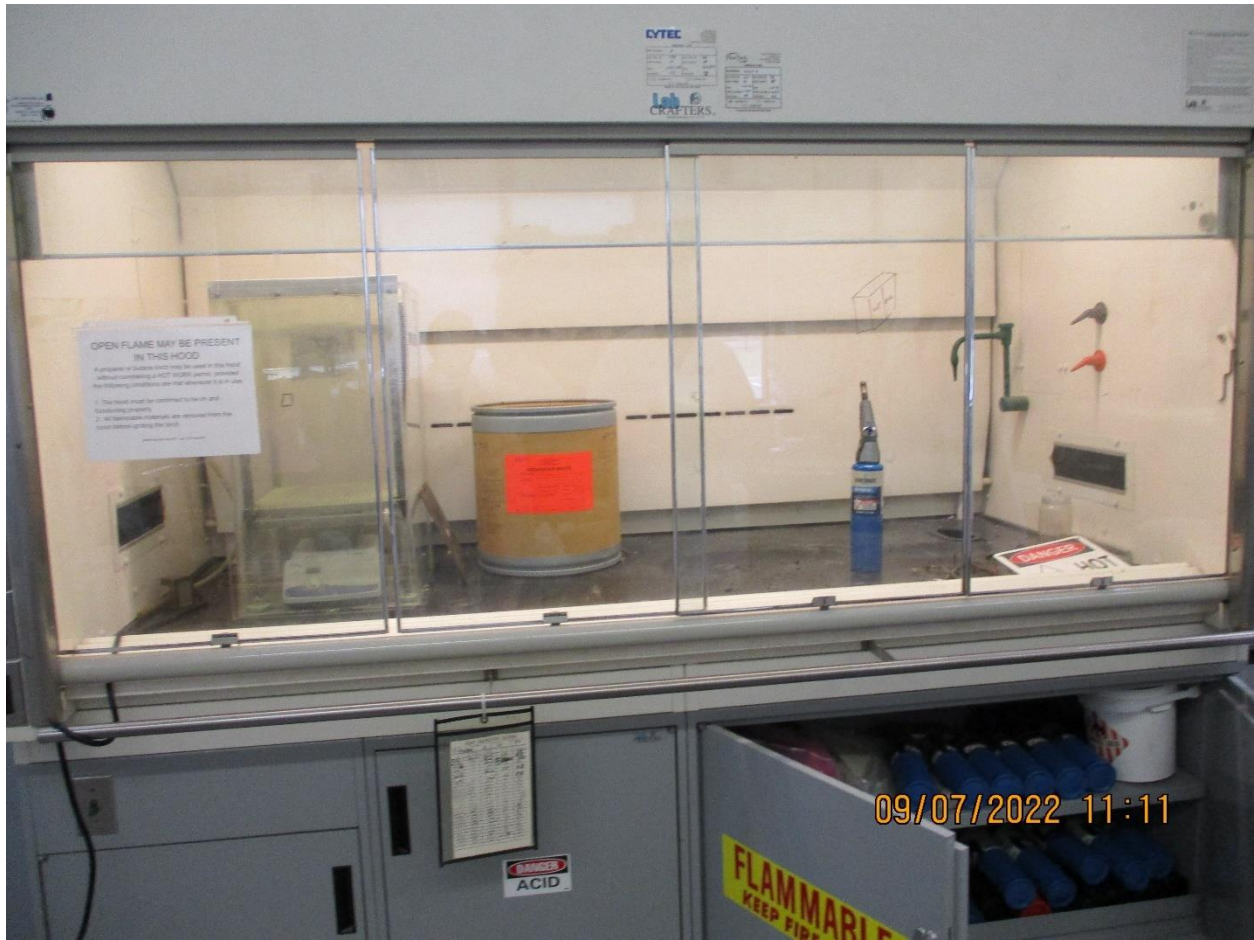
Photo 53

High Bay area, where heavy equipment is located. In the back of this area there was a SAA for hazardous waste in a lab hood. There was one 5 to 10-gallon cardboard container with a hazardous waste label that described the waste as "Sulfur" and had flammable checked off on the label. Mr. Hannah and Mr. Wagner explained that this waste is solid sulfur waste. Sulfur is used to fumigate the plastics by heating it up, and this is where the waste sulfur is collected. The container was closed (*See attachment 1, Photo #53-#55*).

HW SAA container in lab hood, located in Building 13, High Bay area

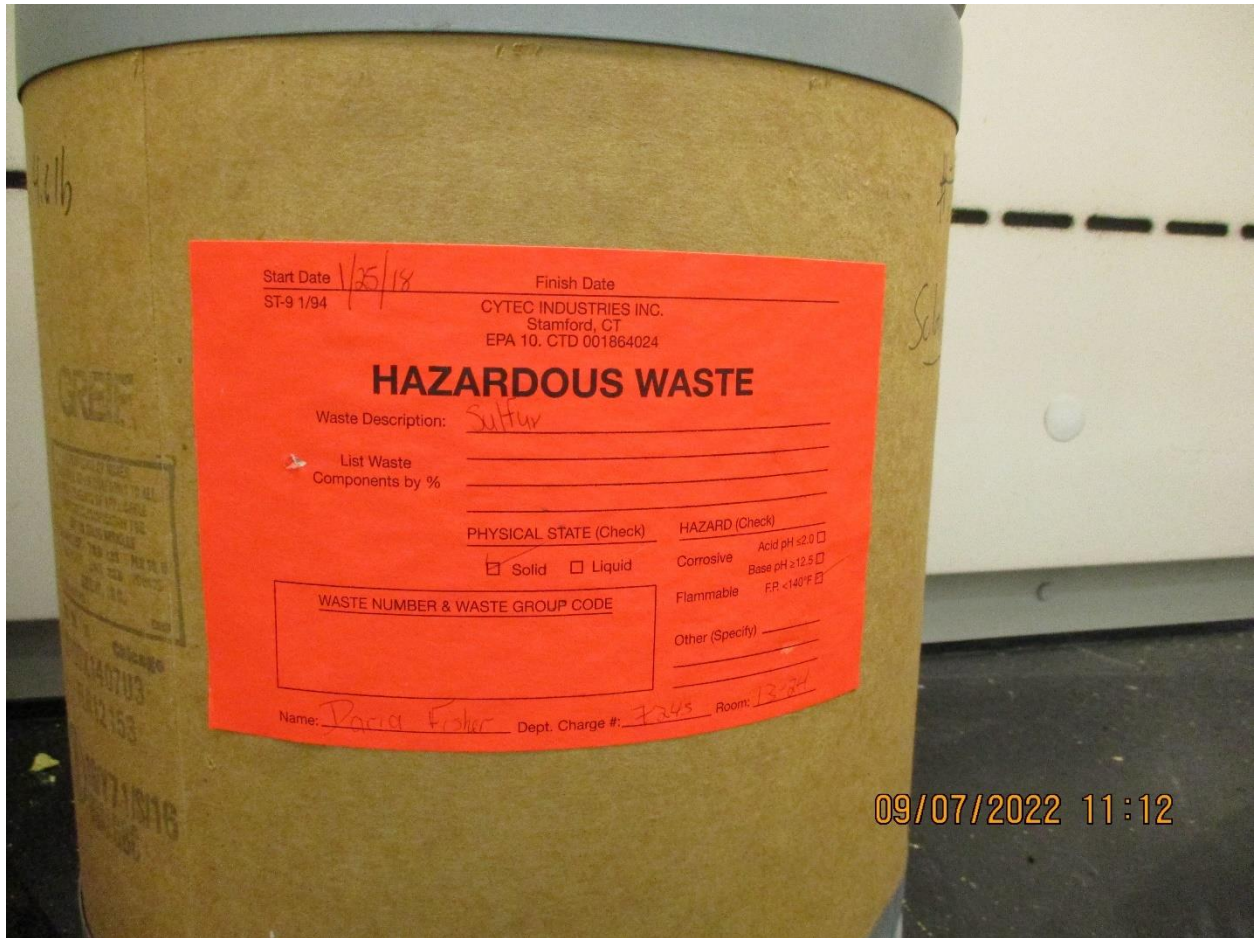
Photo 54

Label on HW SAA container in lab hood, located in Building 13, High Bay area

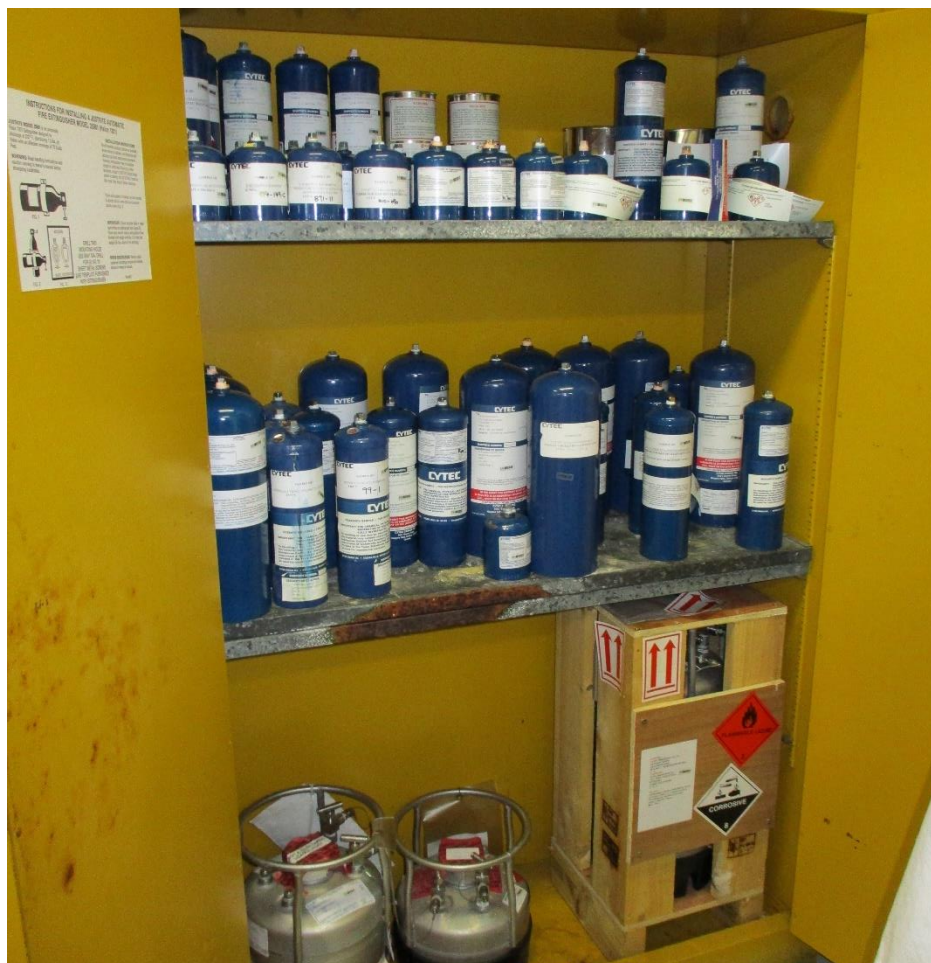
Photo 57

Prep Lab, Room 4.4. This is where larger volume chemistry takes place, greater than 500 milliliters. There is a cabinet in this area which holds pyrophoric virgin material. The sign on the left cabinet door states, "No Flammables", on the right door it states, "FLAMMABLE" and inside the cabinet there is a box containing flammable liquid. The cabinet does not have grounding (*See attachment 1, Photo #57-#60*).

Contents inside Pyrophoric Storage cabinet, located in Building 13, Prep Lab
Room 4.4

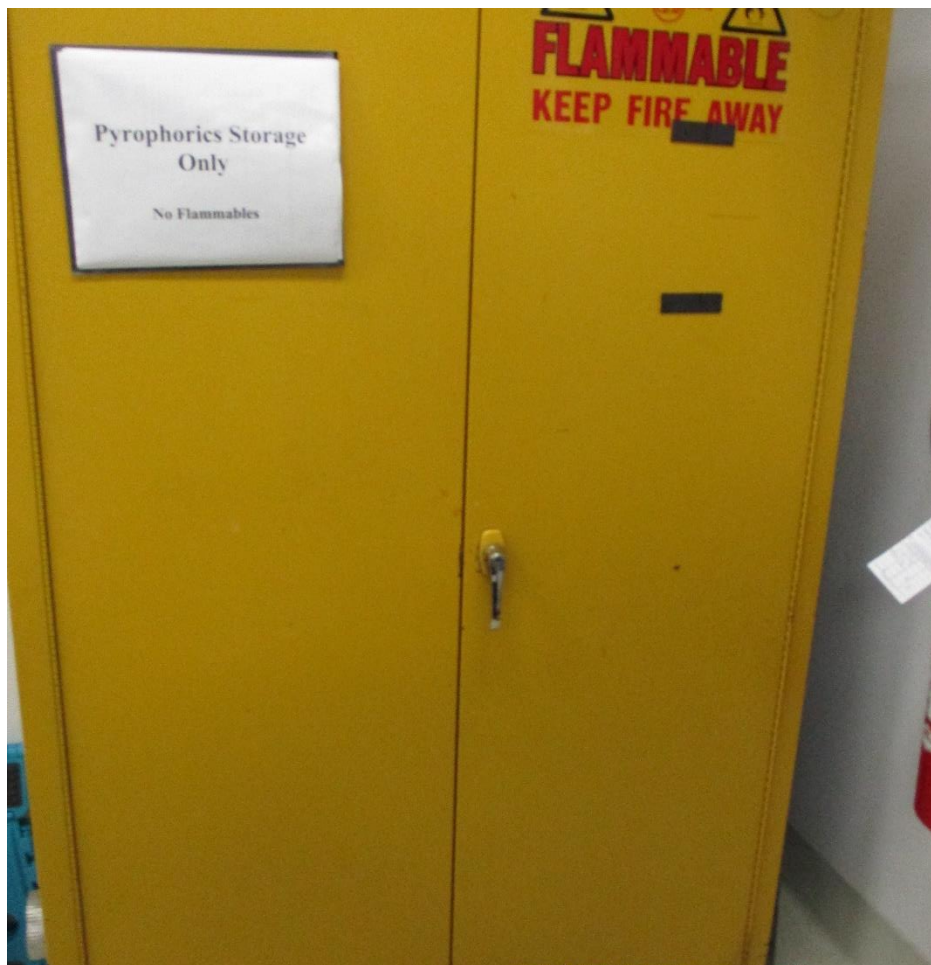
Photo 58

Pyrophoric Storage cabinet, located in Building 13, Prep Lab Room 4.4

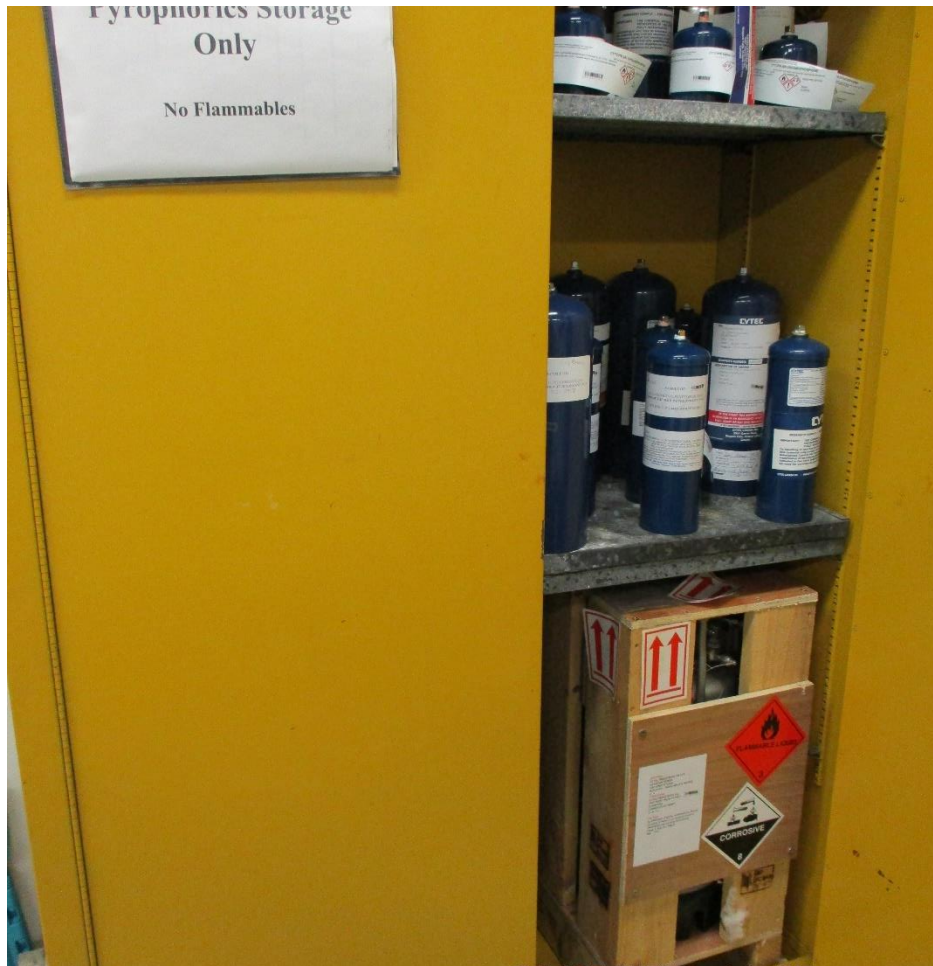
Photo 59

Flammable and Corrosive material located inside Pyrophoric Storage cabinet,
located in Building 13, Prep Lab Room 4.4

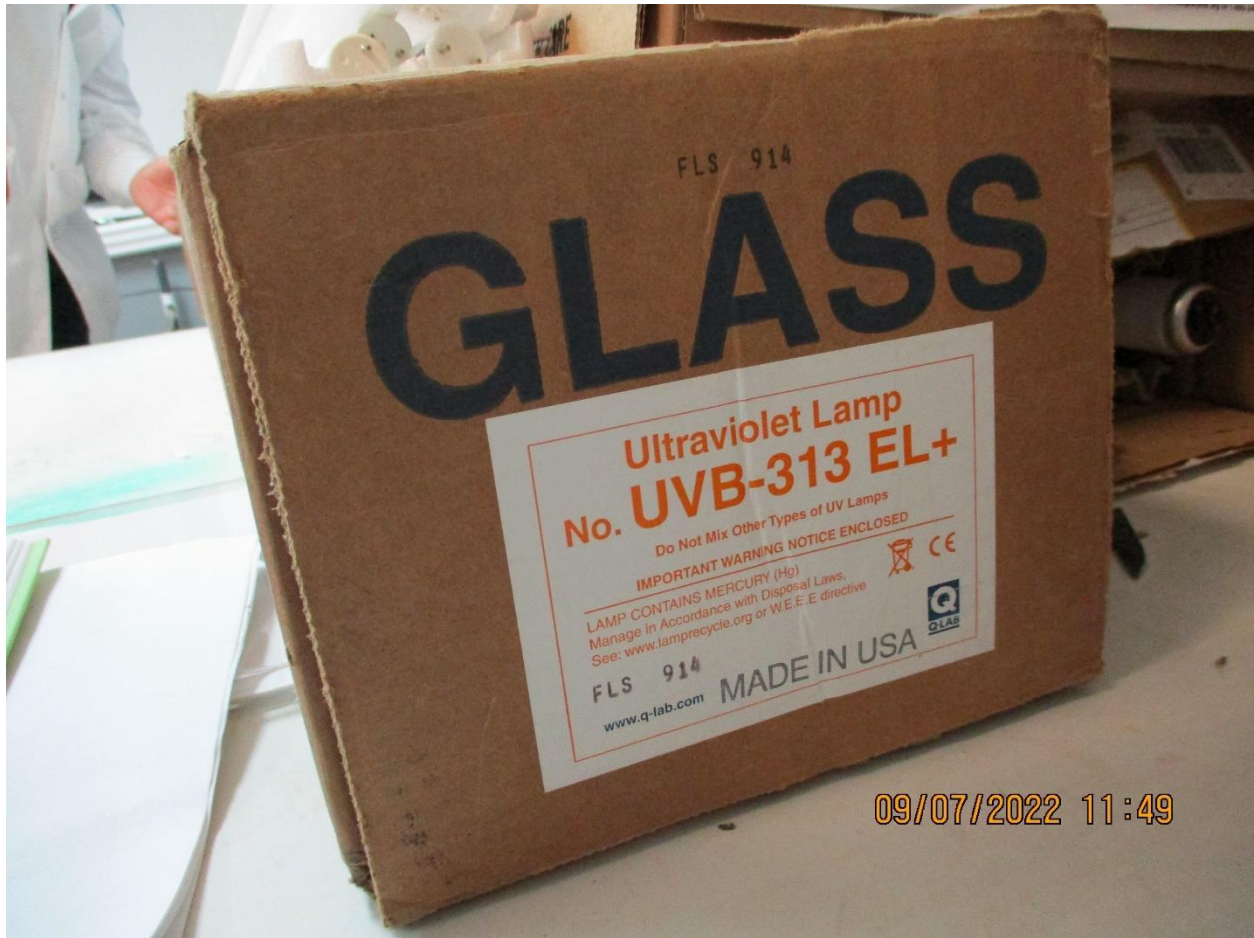
Photo 66

Signage for Universal Waste Fluorescent Bulbs area, located in Building 13, QUV Lab

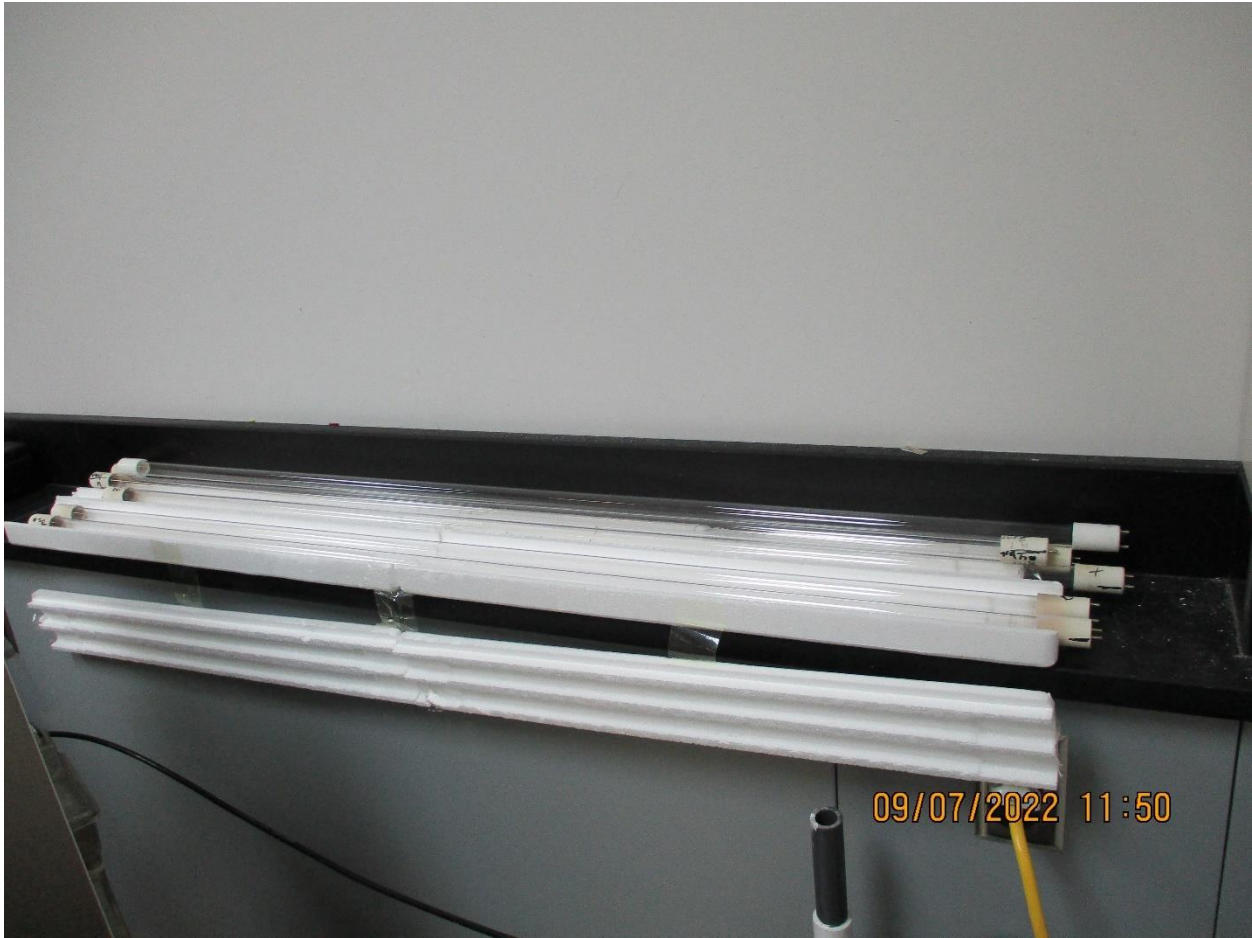
Photo 67

Label on new fluorescent bulb box, located in Building 13, QUV Lab

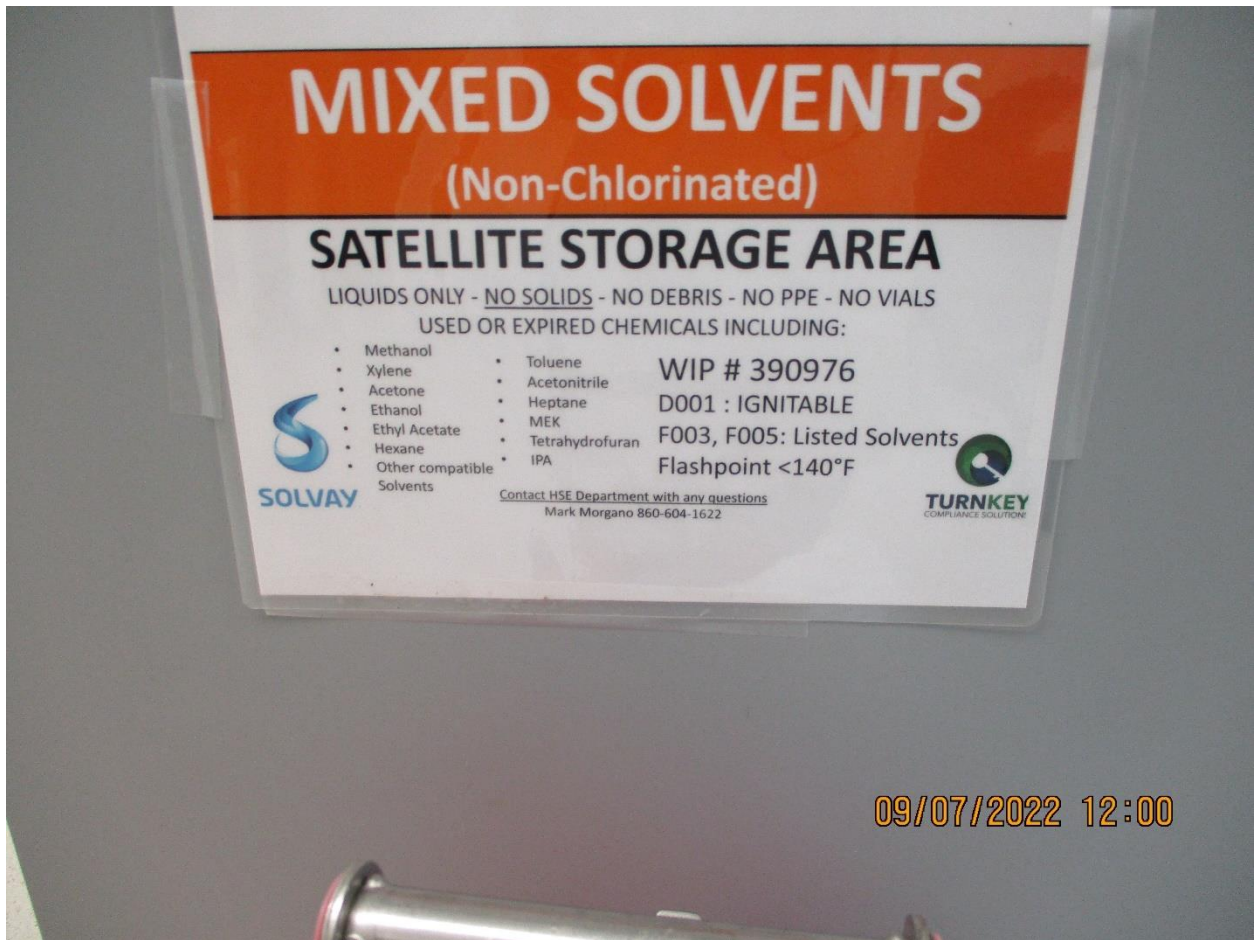
Photo 69

SAA located in Building 13, Instrument Lab

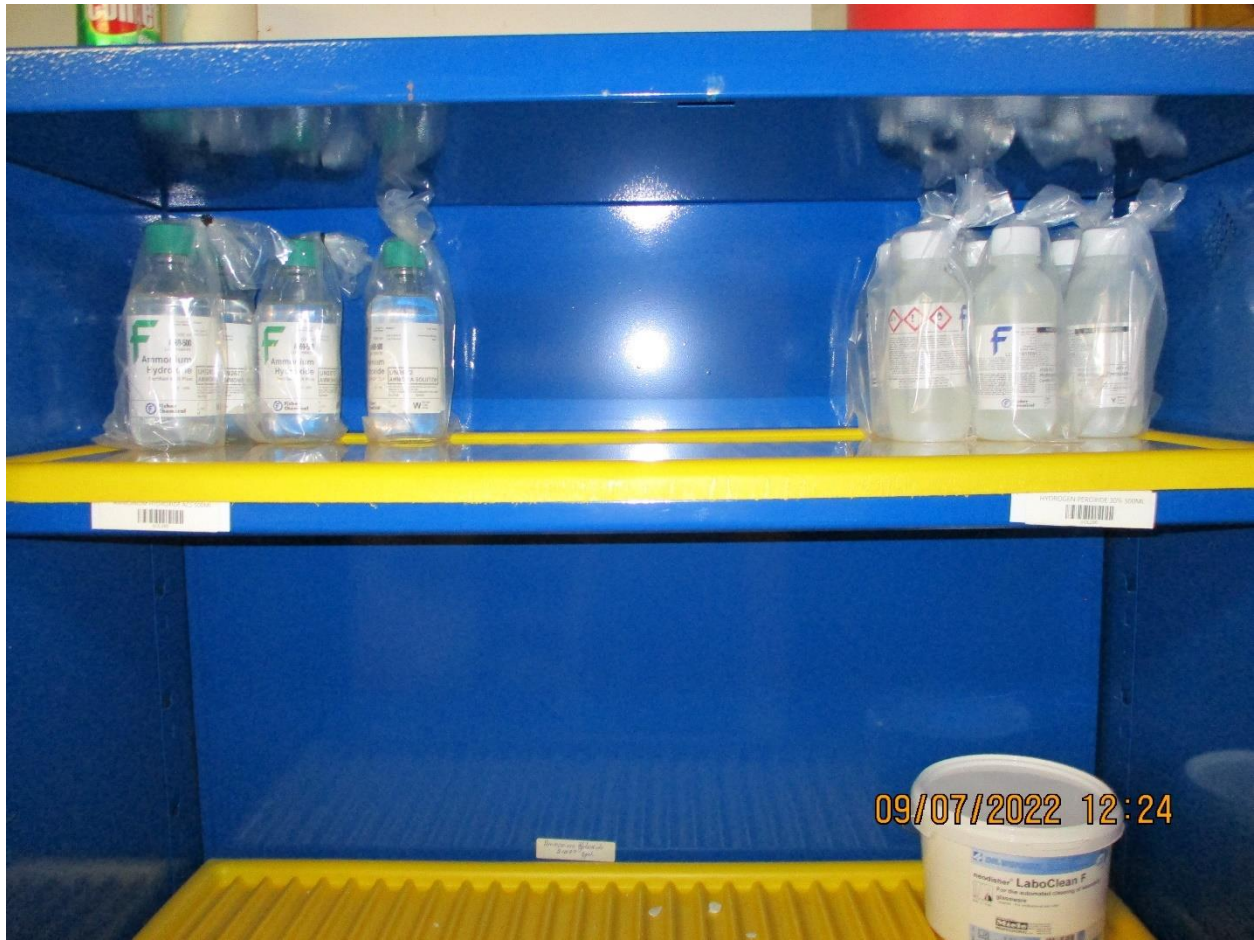
Photo 88

The inspection team followed Mr. Hannah and Mr. Wagner out of Building 13, and to the Wastewater Treatment Room. There is no hazardous waste generated in this area. Next, the inspection team observed the loading dock, and Shipping and Receiving area. There was a blue cabinet for virgin peroxide storage and ammonium hydroxide (*See attachment 1, Photo #88-#91*).

Contents inside blue corrosive storage cabinets, located in Shipping and Receiving Area on Floor 1

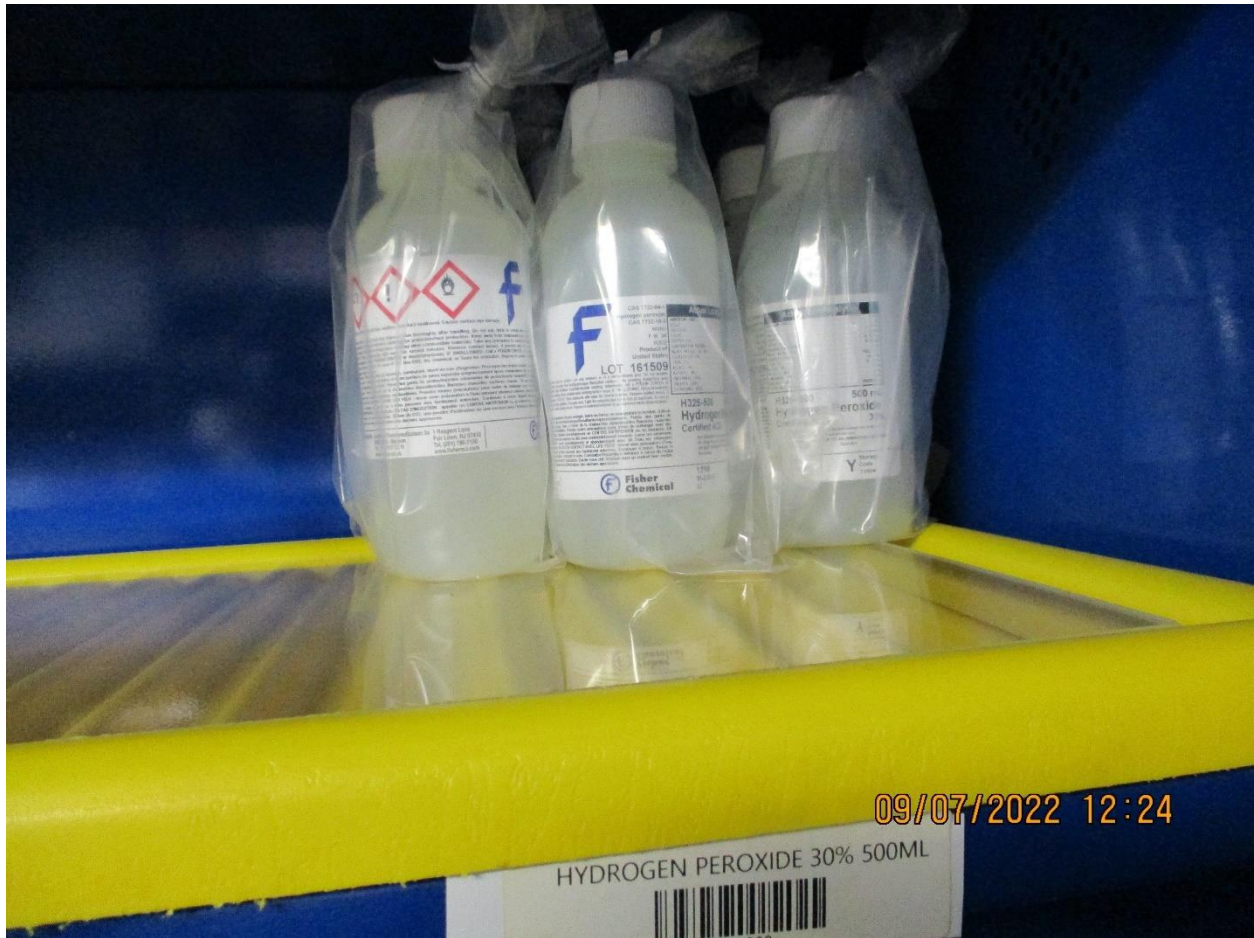
Photo 89

Contents inside blue corrosive storage cabinets, located in Shipping and Receiving Area on Floor 1

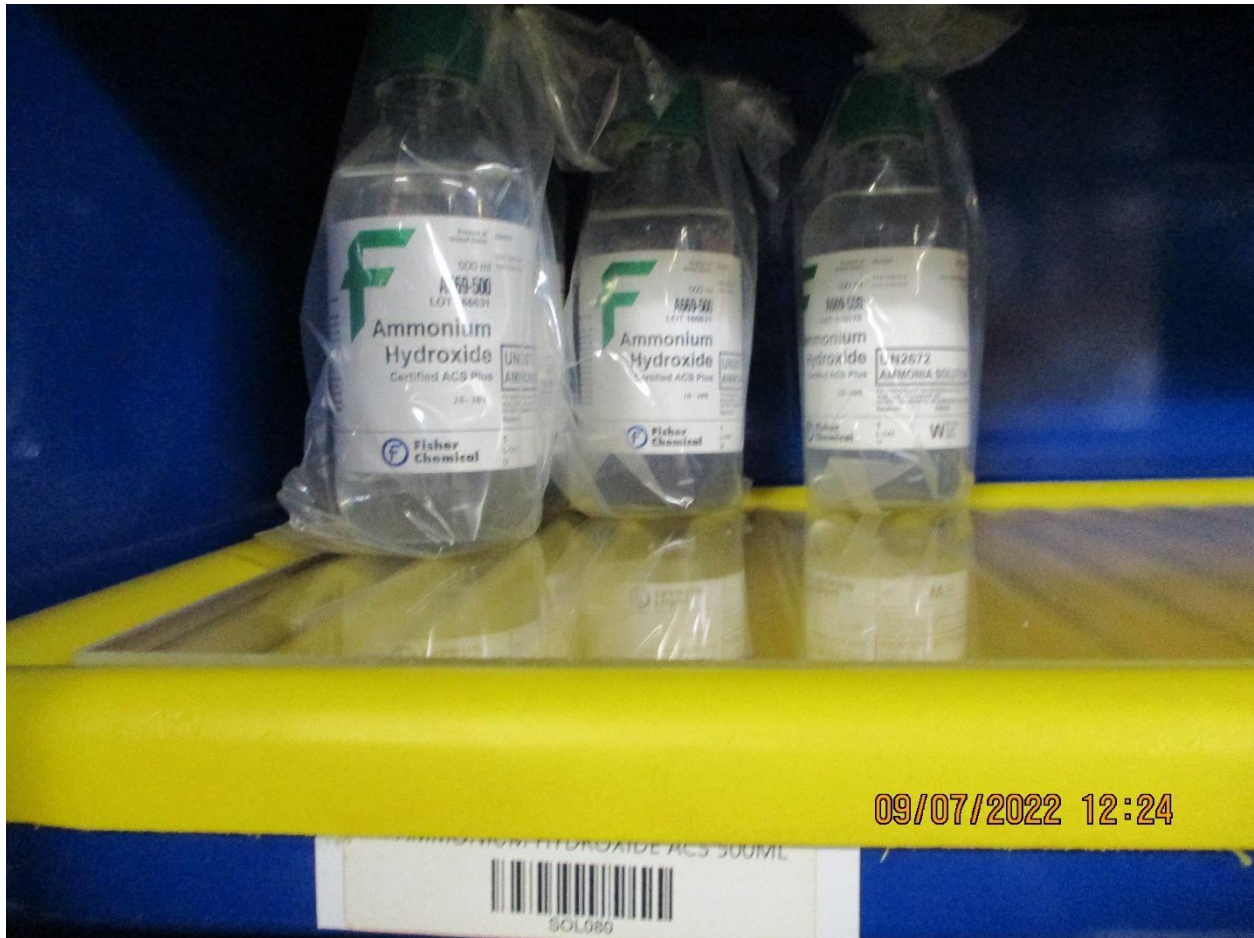
Photo 90

Contents inside blue corrosive storage cabinets, located in Shipping and Receiving Area on Floor 1

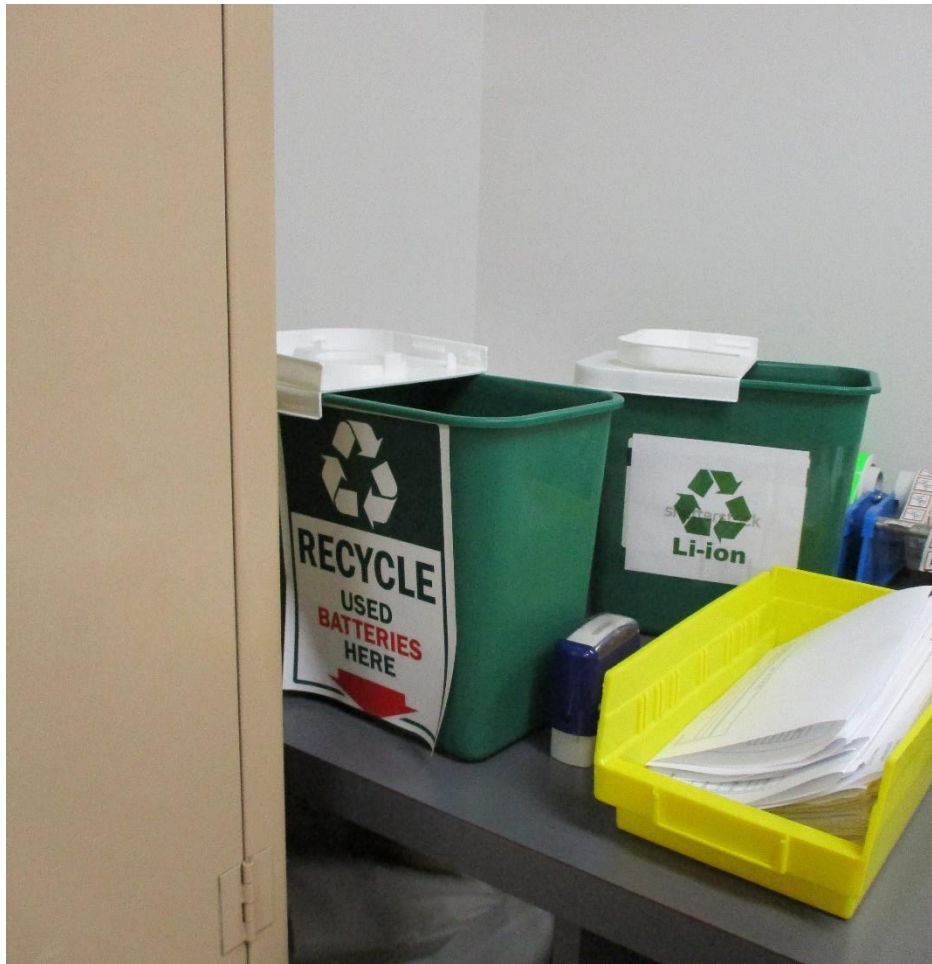
Photo 92

There were two small green plastic bins for waste batteries on a work bench in the shipping and receiving area. One green bin was labelled, "RECYCLE USED BATTERIES HERE" and contained AA and AAA batteries. The other green bin was labelled, "Li-ion" and used Li-ion batteries were inside the box. Both containers were open, neither was dated, and there was no sign stating Universal Waste Batteries (*See attachment 1, Photo #92-#97*).

Two containers for waste batteries, one "Li-ion" and one "USED BATTERIES", located in Shipping and Receiving Area on Floor 1

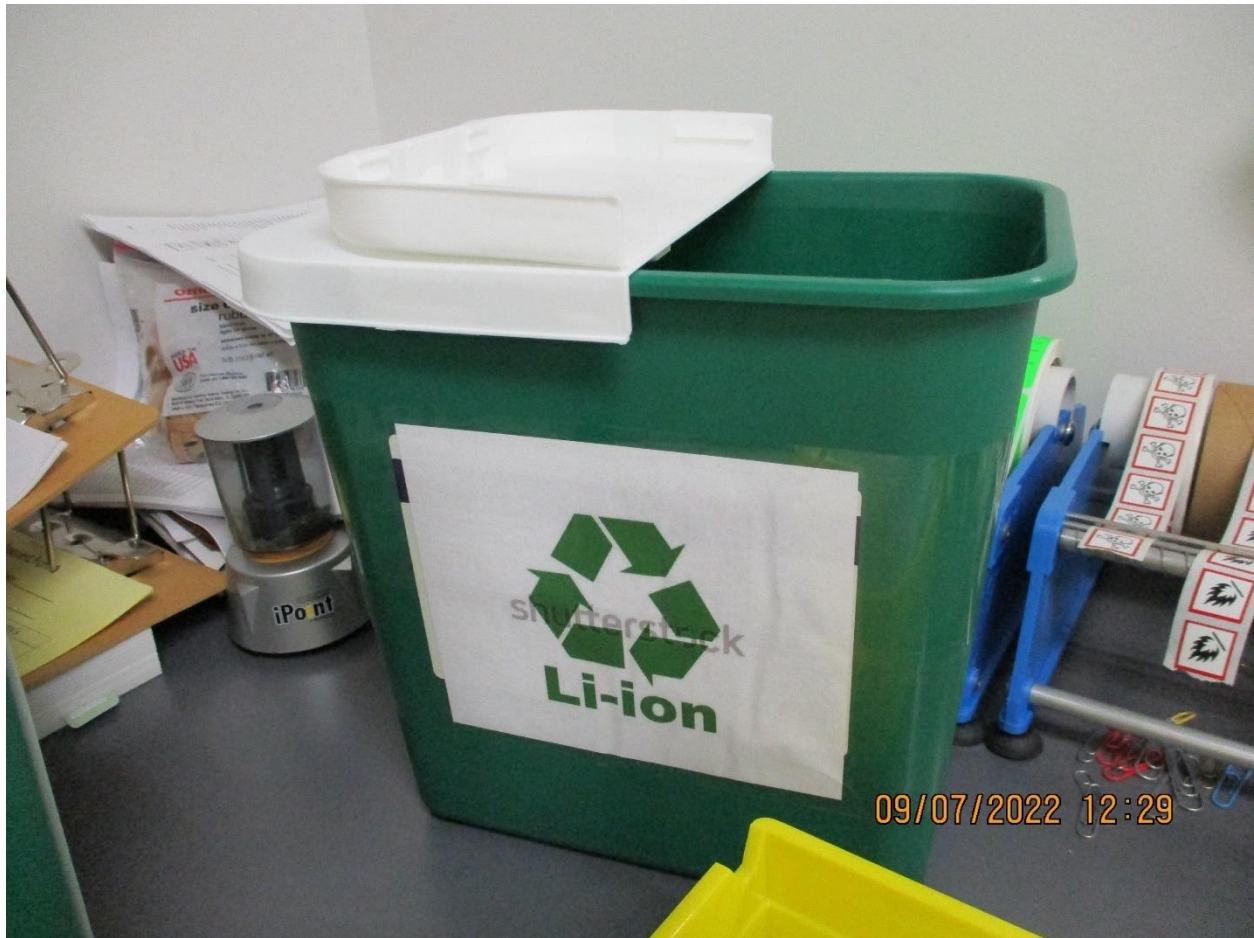
Photo 93

Two containers for waste batteries, one "Li-ion" and one "USED BATTERIES", located in Shipping and Receiving Area on Floor 1

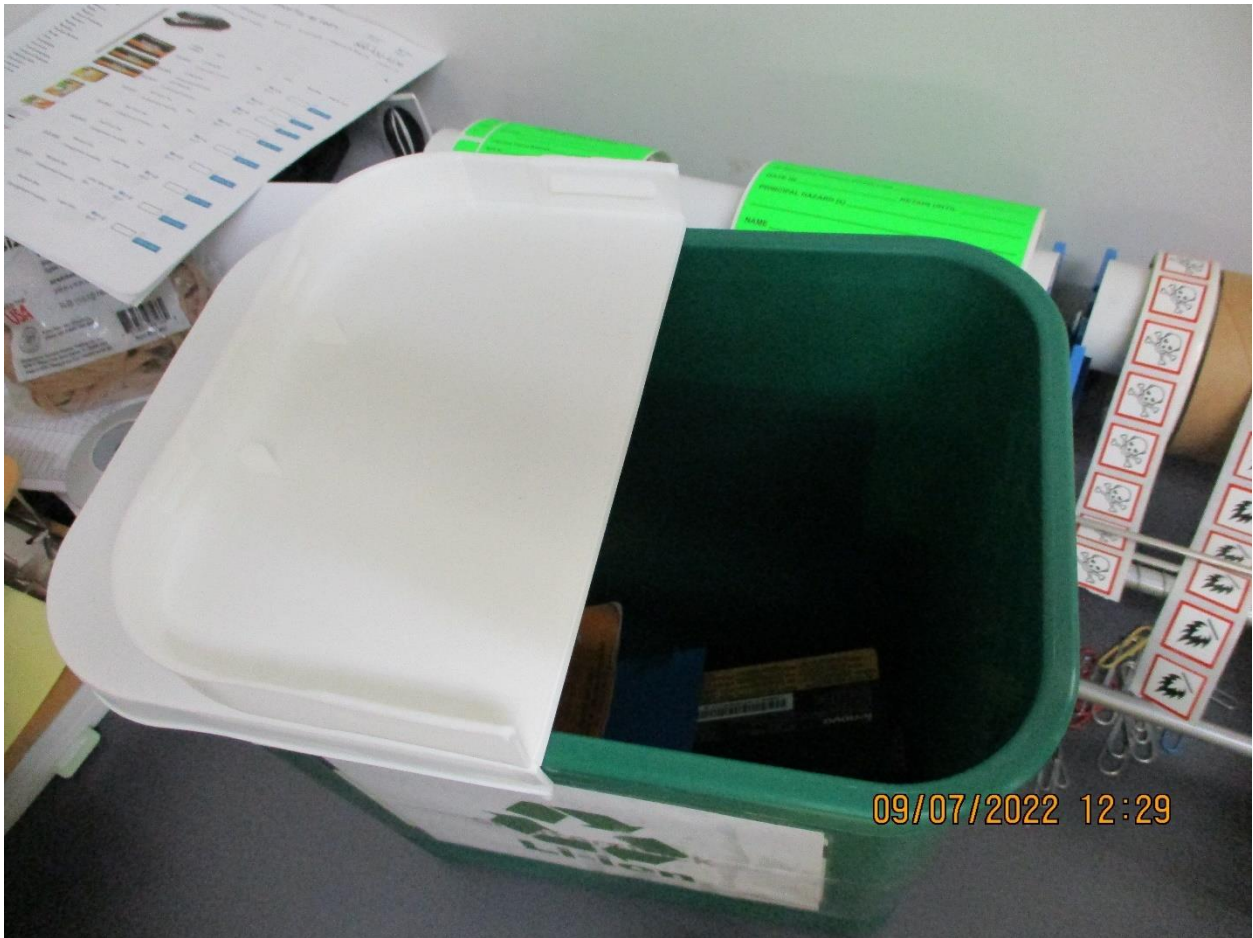
Photo 94

Container for waste "Li-ion" batteries, located in Shipping and Receiving Area on Floor 1

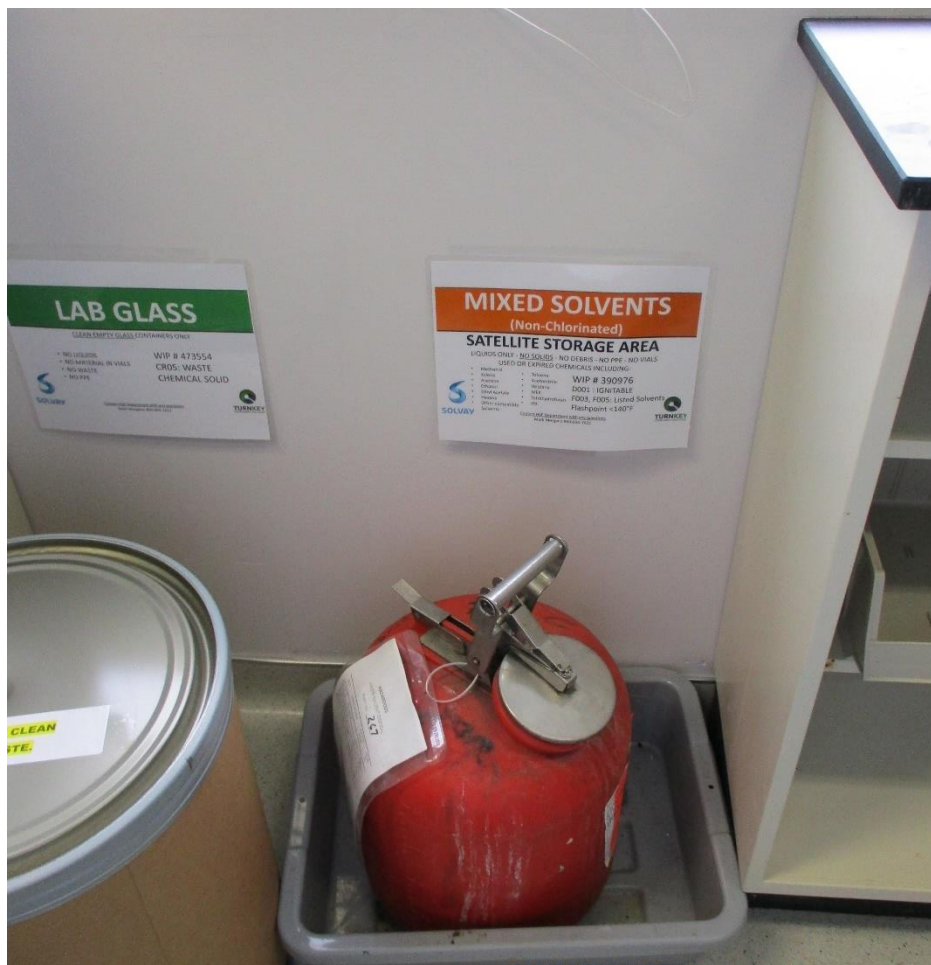
Photo 100

Lab 238, Analytical Lab X-Ray Fluorescence and Rheology. One SAA with hazardous waste sign on wall at area. The sign stated the waste stream was “ACIDIC LIQUID”. There was one SAA container in secondary containment that was empty at the time of the inspection. The container had a hazardous waste label on it. The container was closed (*See attachment 1, Photo #98-#100*).

Signage at SAA, located in Analytical Lab, Lab 238, on Floor 2

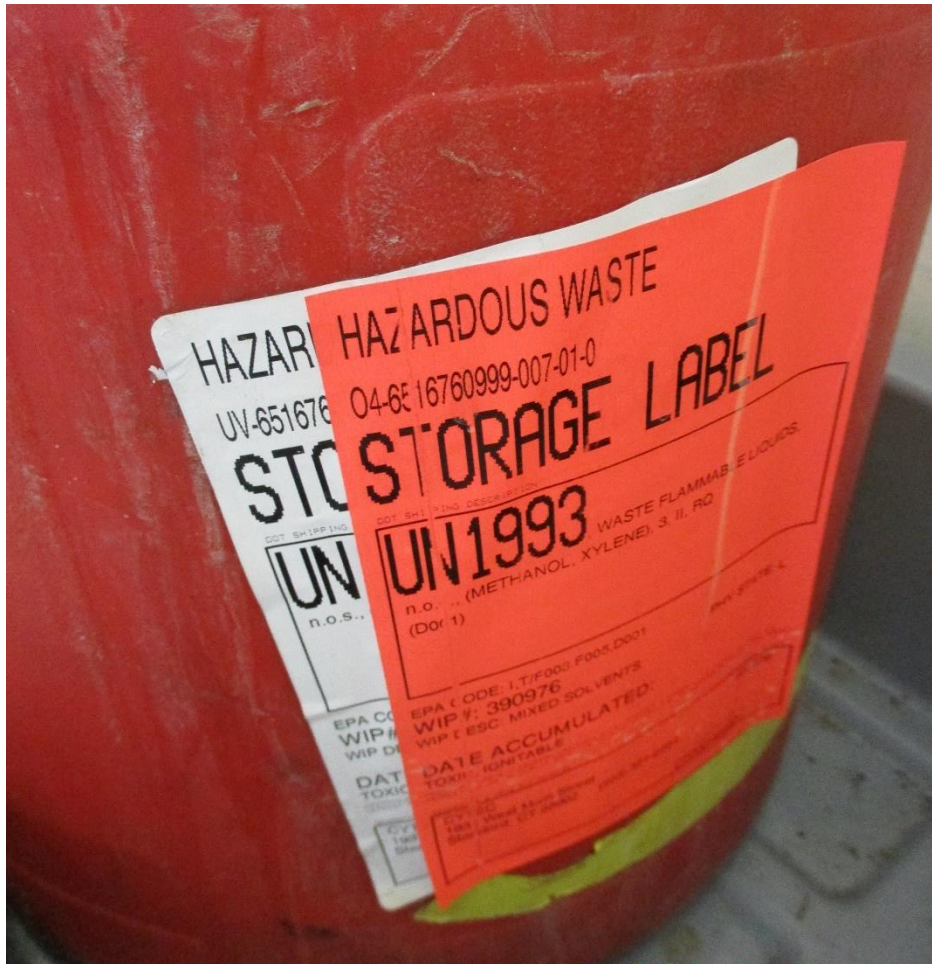
Photo 101

Titration and Classical Analysis Lab, there was one SAA with a red SAA container in secondary containment with a hazardous waste solvent disposal sheet attached to the top of it and a hazardous waste label on the container. There was a hazardous waste SAA sign on the wall at the area which stated, “MIXED SOLVENTS (Non-Chlorinated). The container was closed (*See attachment 1, Photo #101-#103*).

SAA, located in Titrations and Classical Analysis Lab, on Floor 2

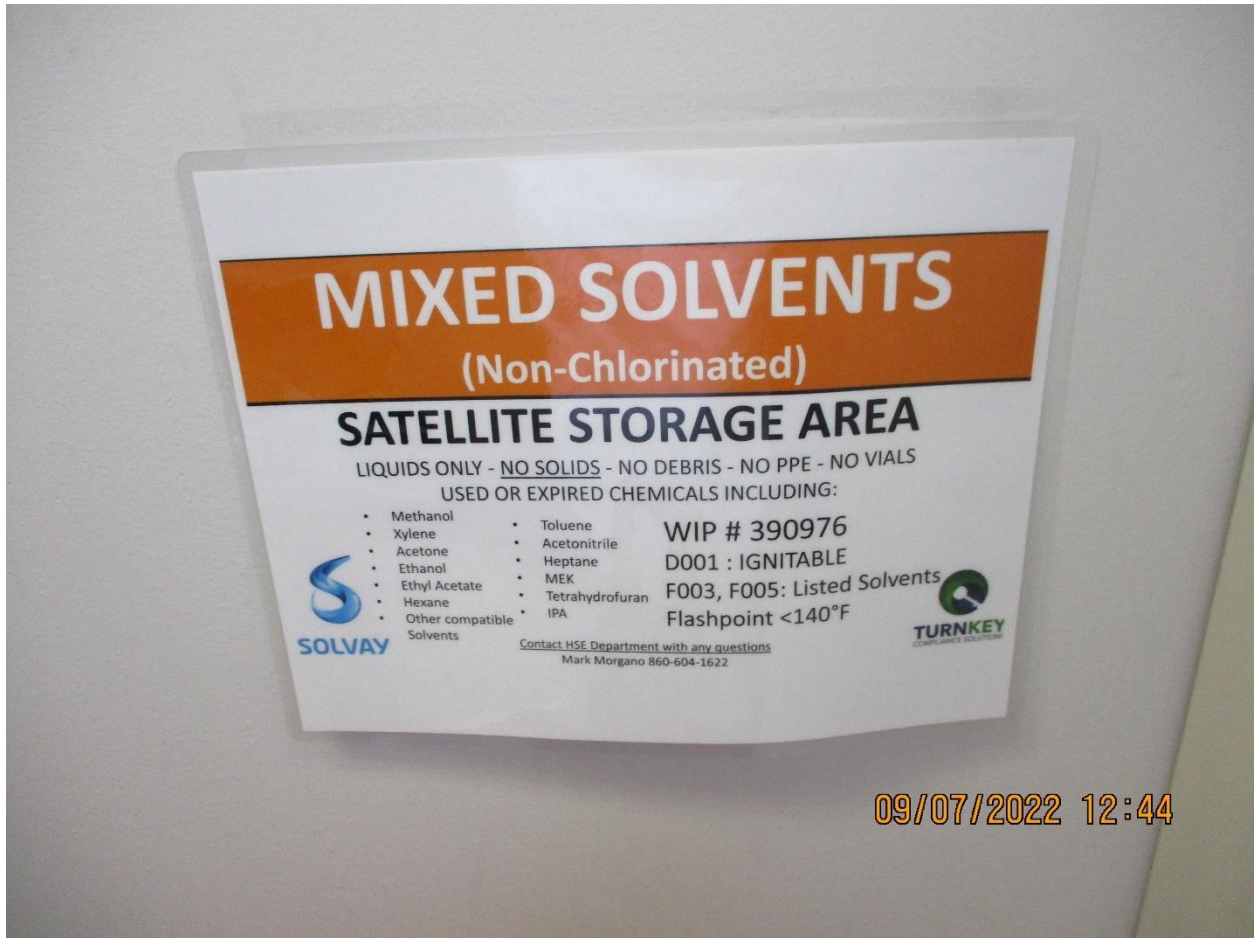
Photo 102

Label on HW container in SAA, located in Titrations and Classical Analysis Lab,
on Floor 2

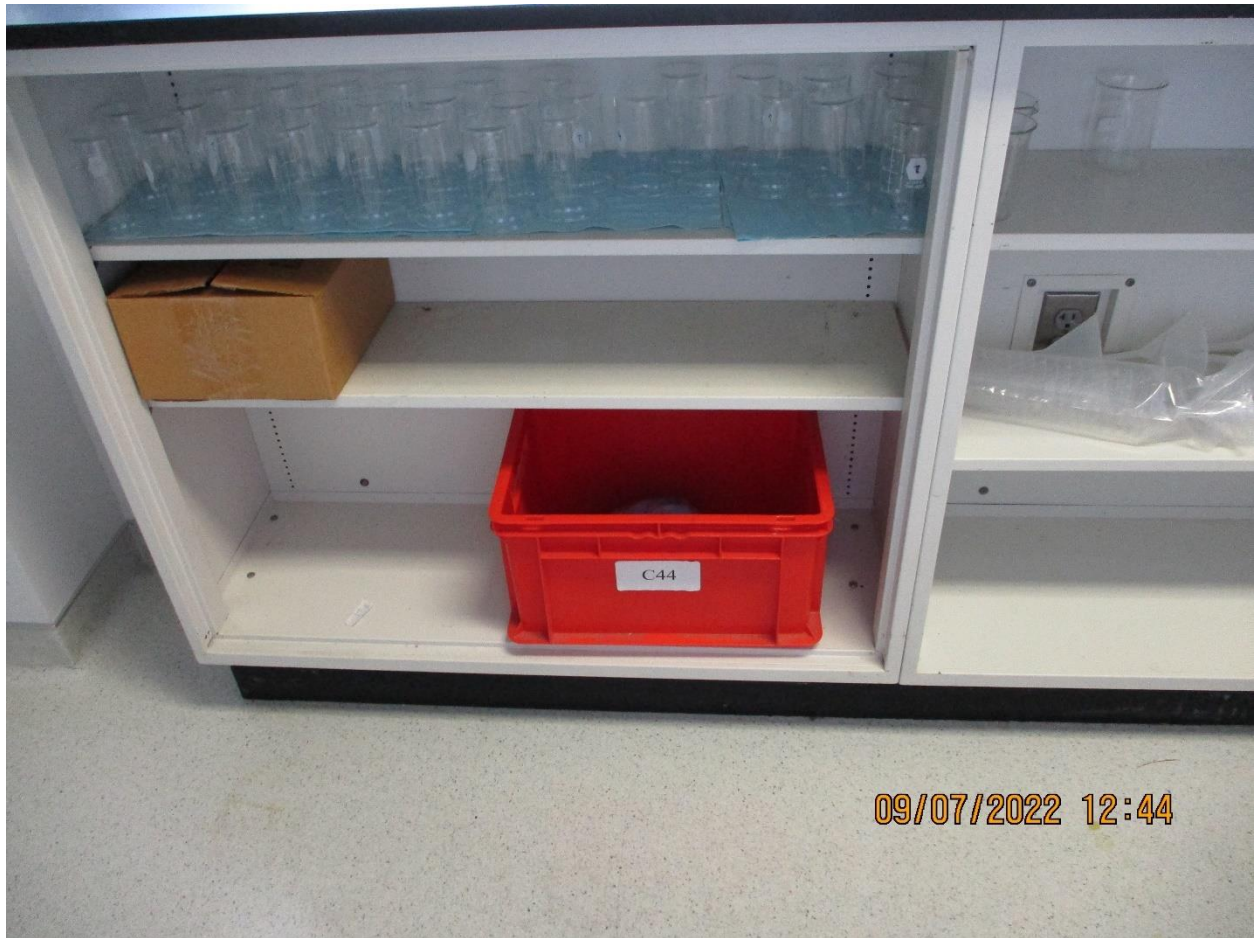
Photo 103

Signage at SAA, located in Titrations and Classical Analysis Lab, on Floor 2
