Re: U.S. EPA-Region 1 Inspection Report of Solvay, September 7, 2022

RCRA Compliance Inspection of:

Solvay
1937 West Main Street
Stamford, CT 06902

RCRA HAZARDOUS WASTE INSPECTION REPORT

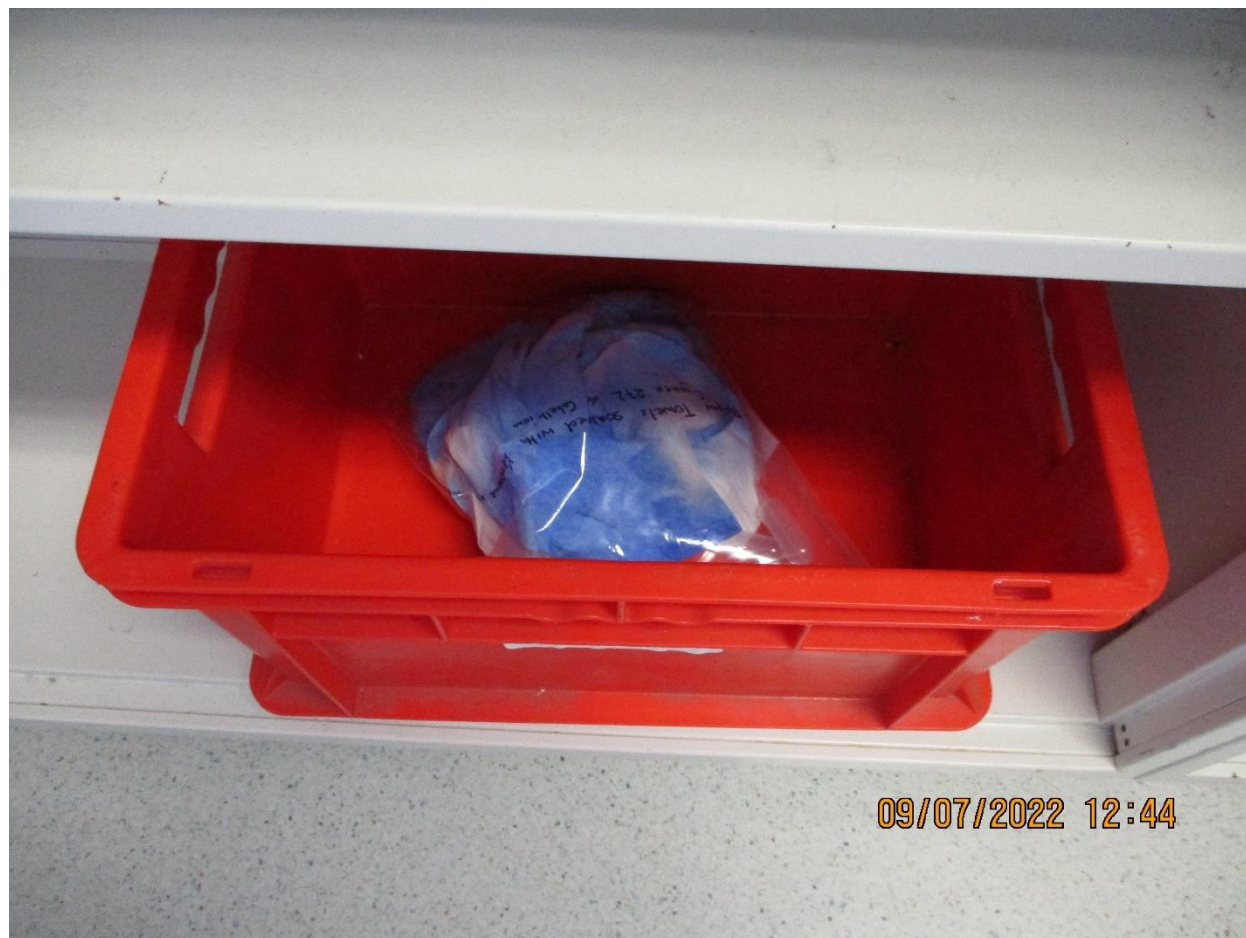
Photo 104

There was a red lab pack box on the bottom of a shelf in the room. There was a bag in the box that had a description on it. The description could not all be read. The words that could be read were, ... Towels soaked with Kerosene, ... 272... Cobalt ion. There was no inventory sheet in the box and the box had no hazardous waste label, or date (*See attachment 1, Photo #104-#105*).

Red lab pack container on shelf located in Titrations and Classical Analysis Lab,
on Floor 2

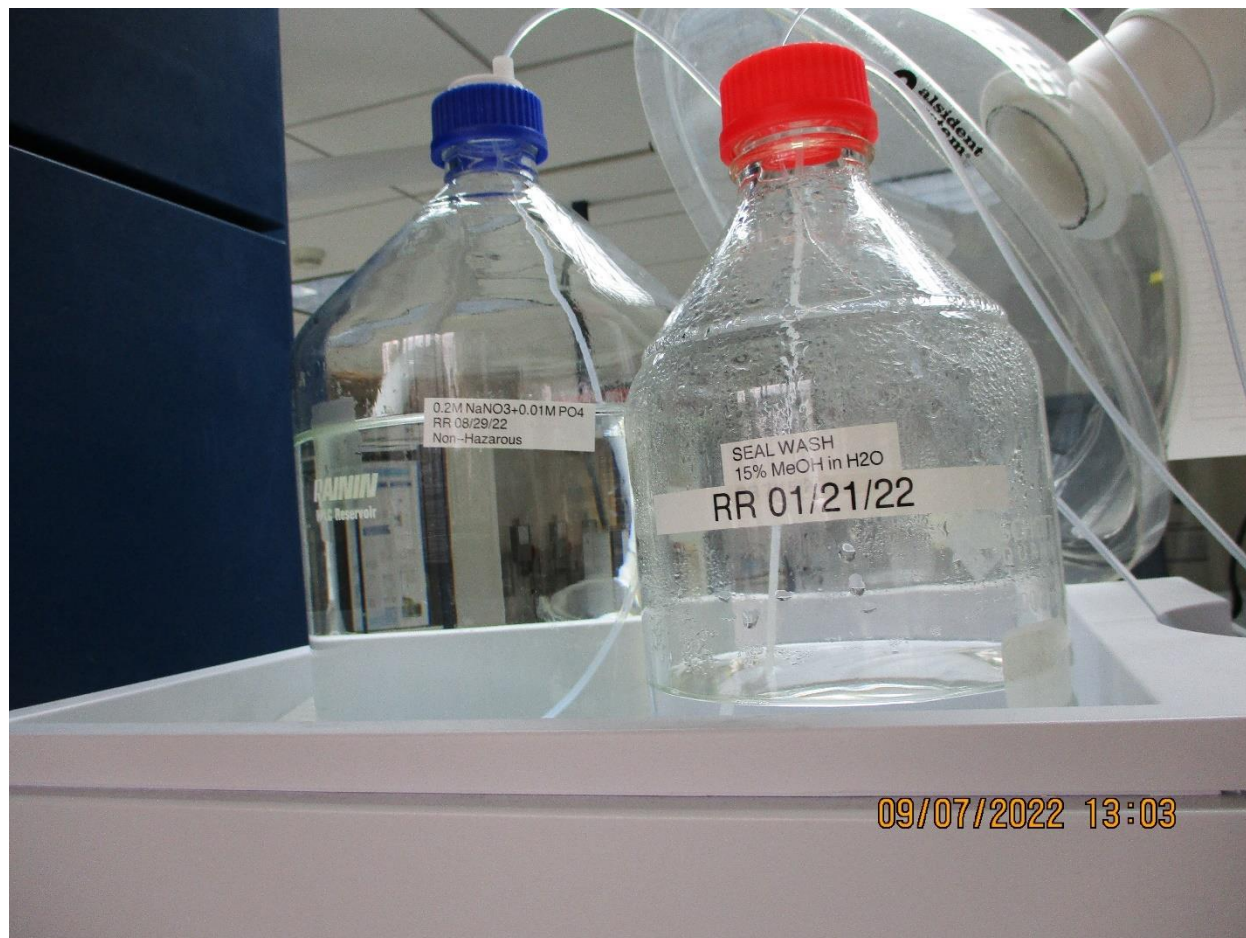
Photo 121

mostly aqueous waste. She explained that they review their waste profiles each year to determine if the waste is hazardous (*See attachment 1, Photo #121-#124*).

Feed containers, feeding Size Exclusion Chromatography instrument, located in Analytical Separations Lab, Lab 234, on Floor 2

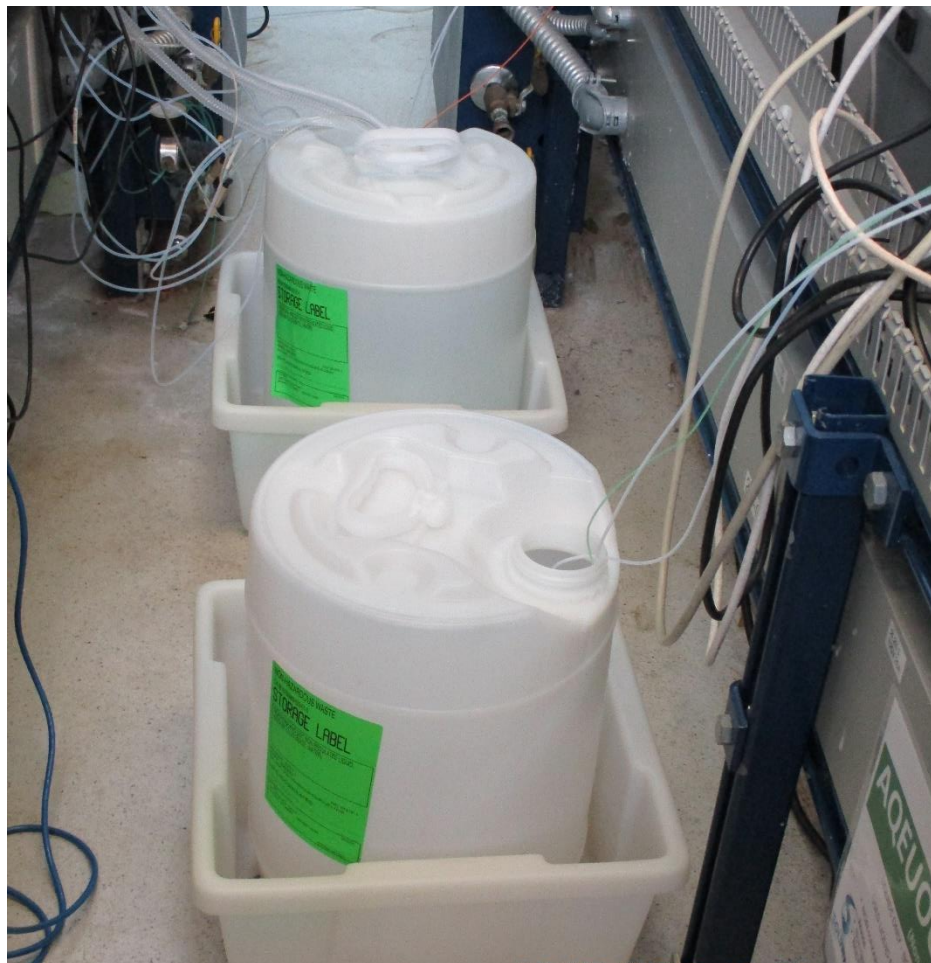
Photo 122

Feed containers, feeding Size Exclusion Chromatography instrument, located in Analytical Separations Lab, Lab 234, on Floor 2

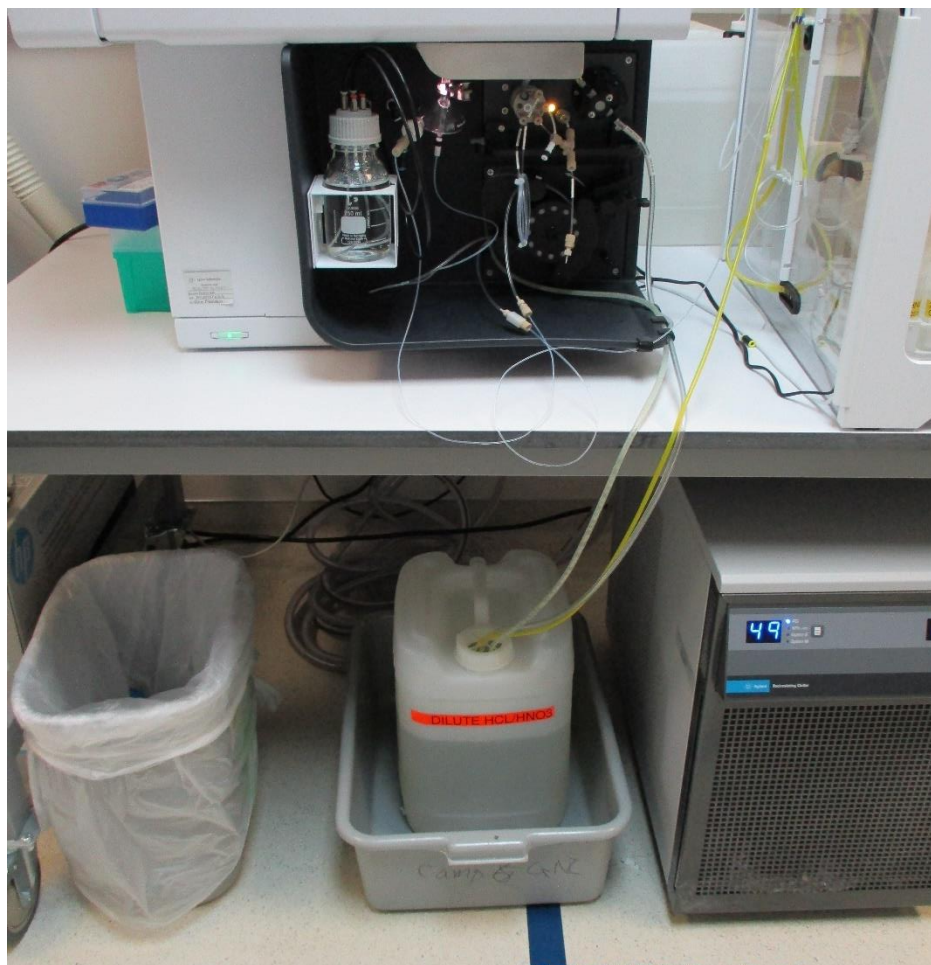
Photo 137

Label on HW container on floor, dated "09/03/22" awaiting moving to 90-HWSA,
located in Separations Prep Lab, Lab 232, on Floor 2

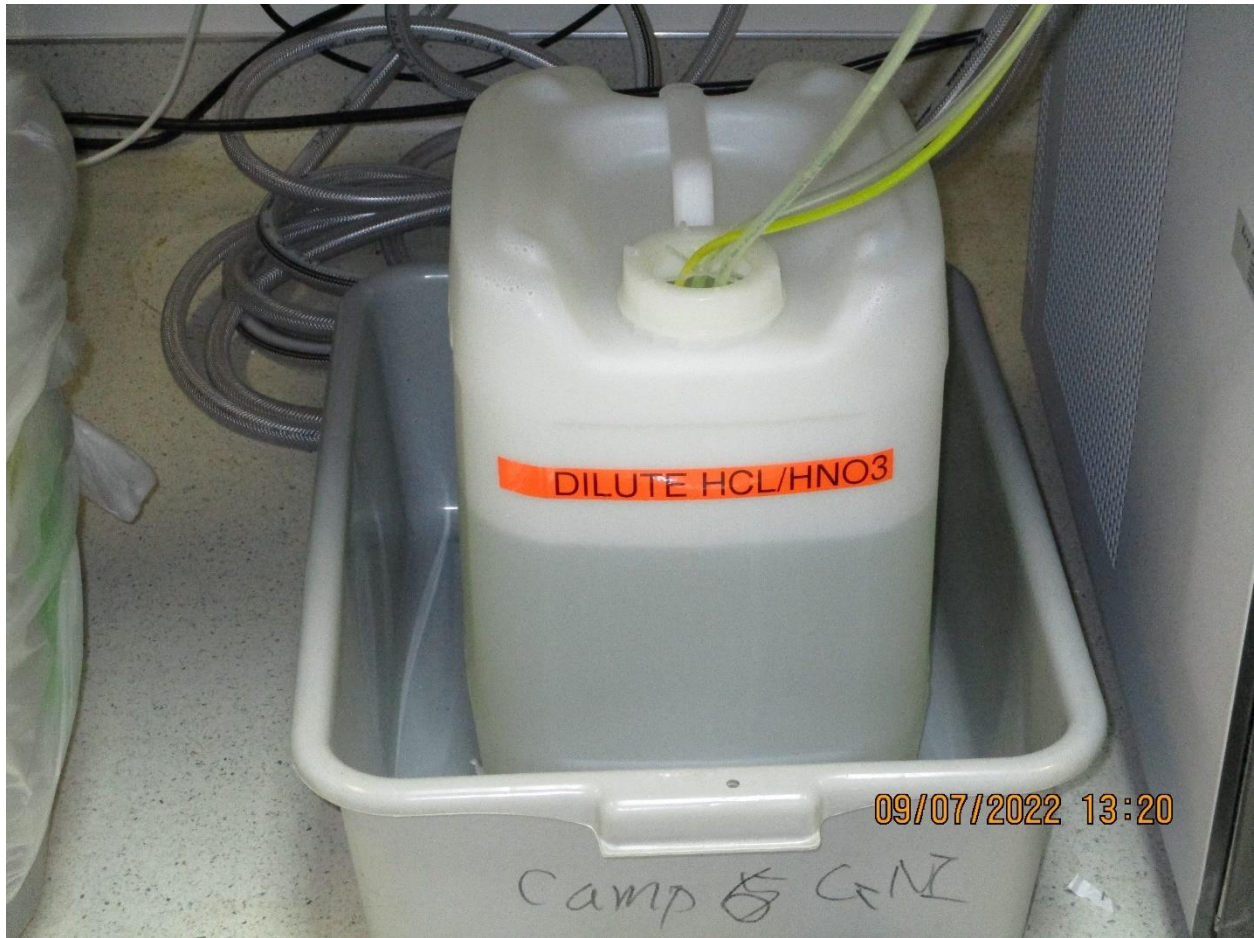
Photo 138

Room 230, there was one container located under a work bench that was actively collecting waste from an Inductively Coupled Plasma Optical Emission Spectroscopy (ICP-OES) instrument. The container was in secondary containment, it was open and had a label on it that read, "DILUTE HCL/HNO₃". There was no hazardous waste label on the container, and there was no SAA signage nearby (*See attachment 1, Photo #138-#139*).

Container collecting "DILUTE HCL/HNO₃" waste from ICP-OES instrument,
located in Room 203, on Floor 2

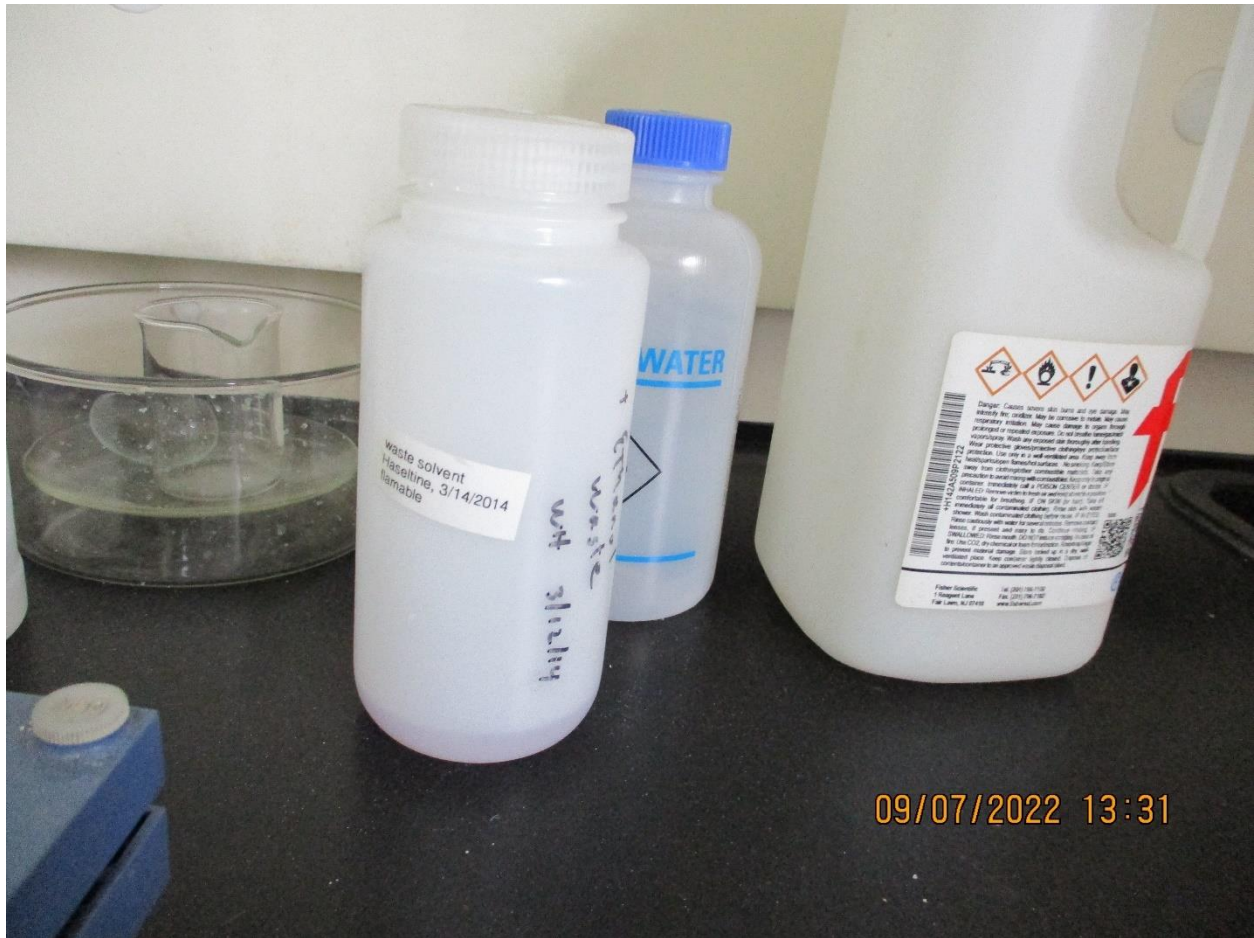
Photo 144

Scanning Electron Microscopy Prep, Room 224, there was one white plastic jar in a hood that had a sticker on it that read, “waste solvent Haseltine, 3/14/2014 flammable”. There was SAA signage at the area, and the container did not have a hazardous waste label on it. The container was closed (*See attachment 1, Photo #144-#145*).

Plastic bottle in hood labelled, "waste solvent Haseltine, 3/14/2014, flammable", located in Scanning Electron Microscope, Room 224, on Floor 2

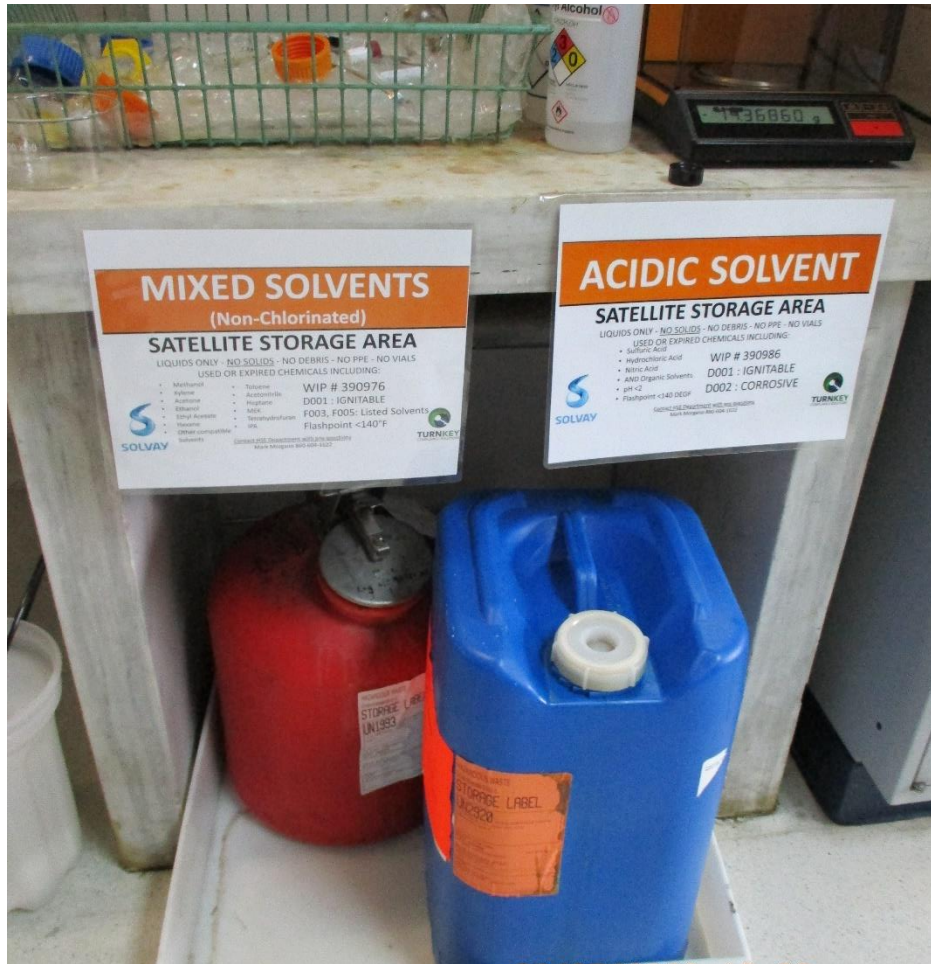
Photo 145

Plastic bottle in hood labelled, "waste solvent Haseltine, 3/14/2014, flammable", located in Scanning Electron Microscope, Room 224, on Floor 2

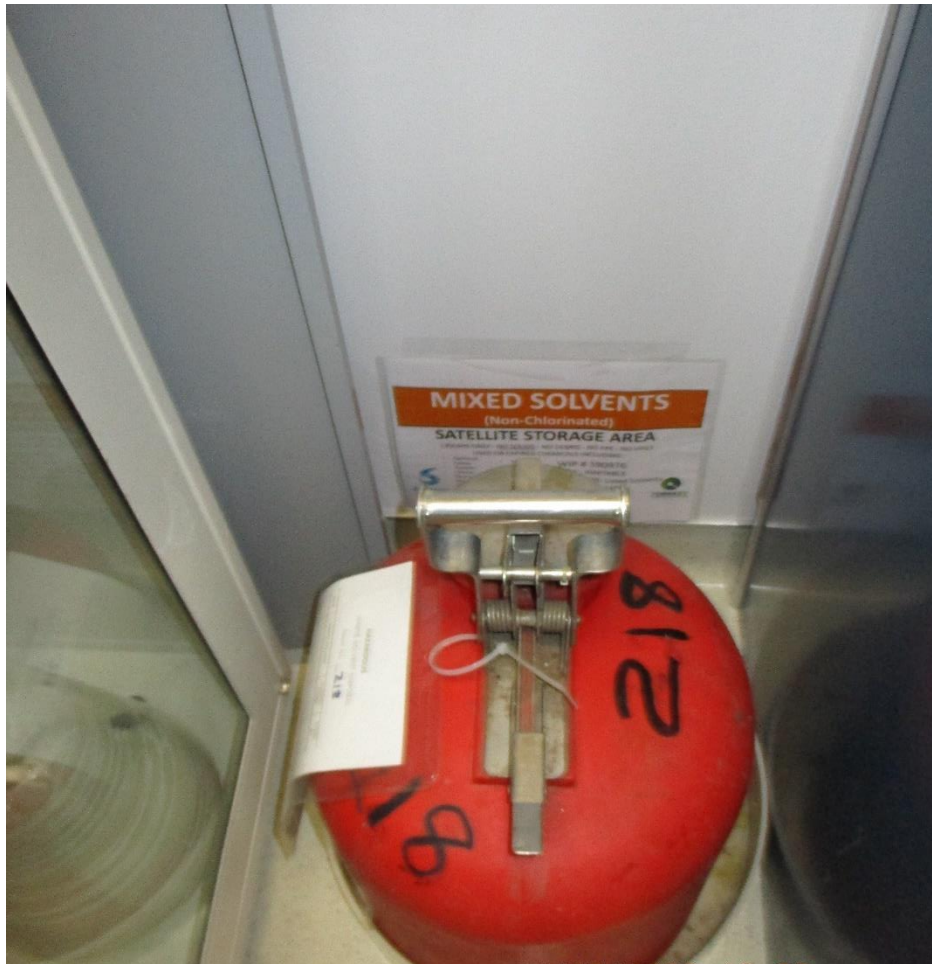
Photo 149

HW Label on blue container in SAA, located in Room 222, on Floor 2

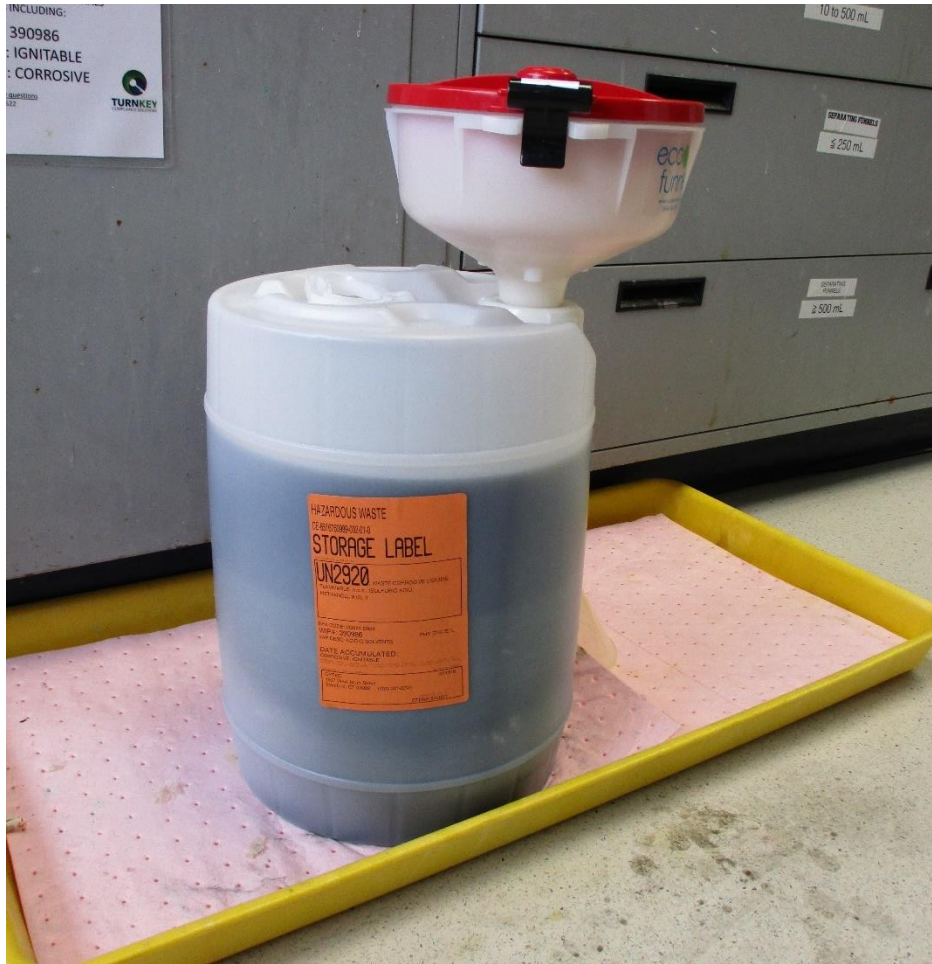
Photo 151

HW container in hood, located in Room 218, on Floor 2

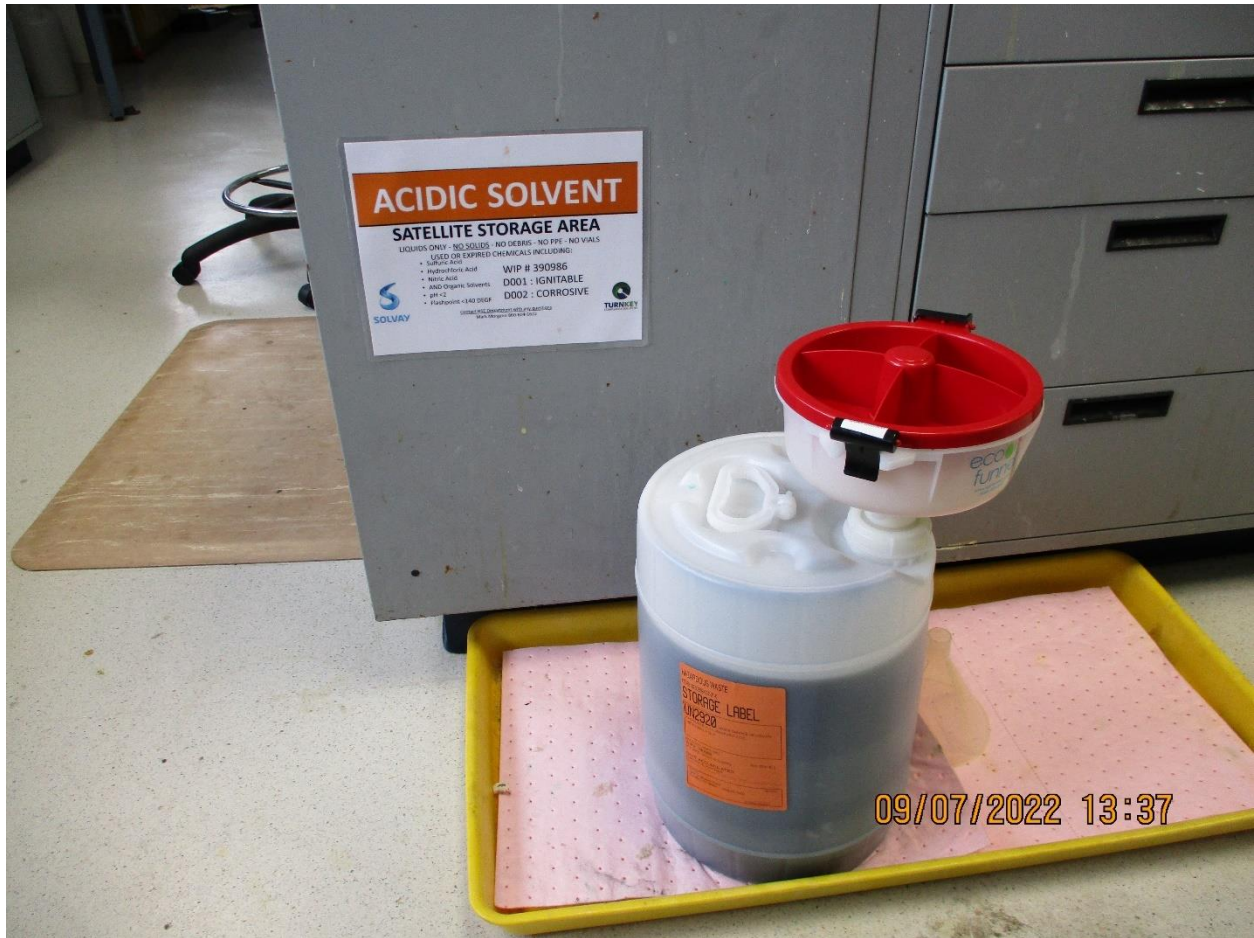
Photo 152

SAA located in Room 218, on Floor 2

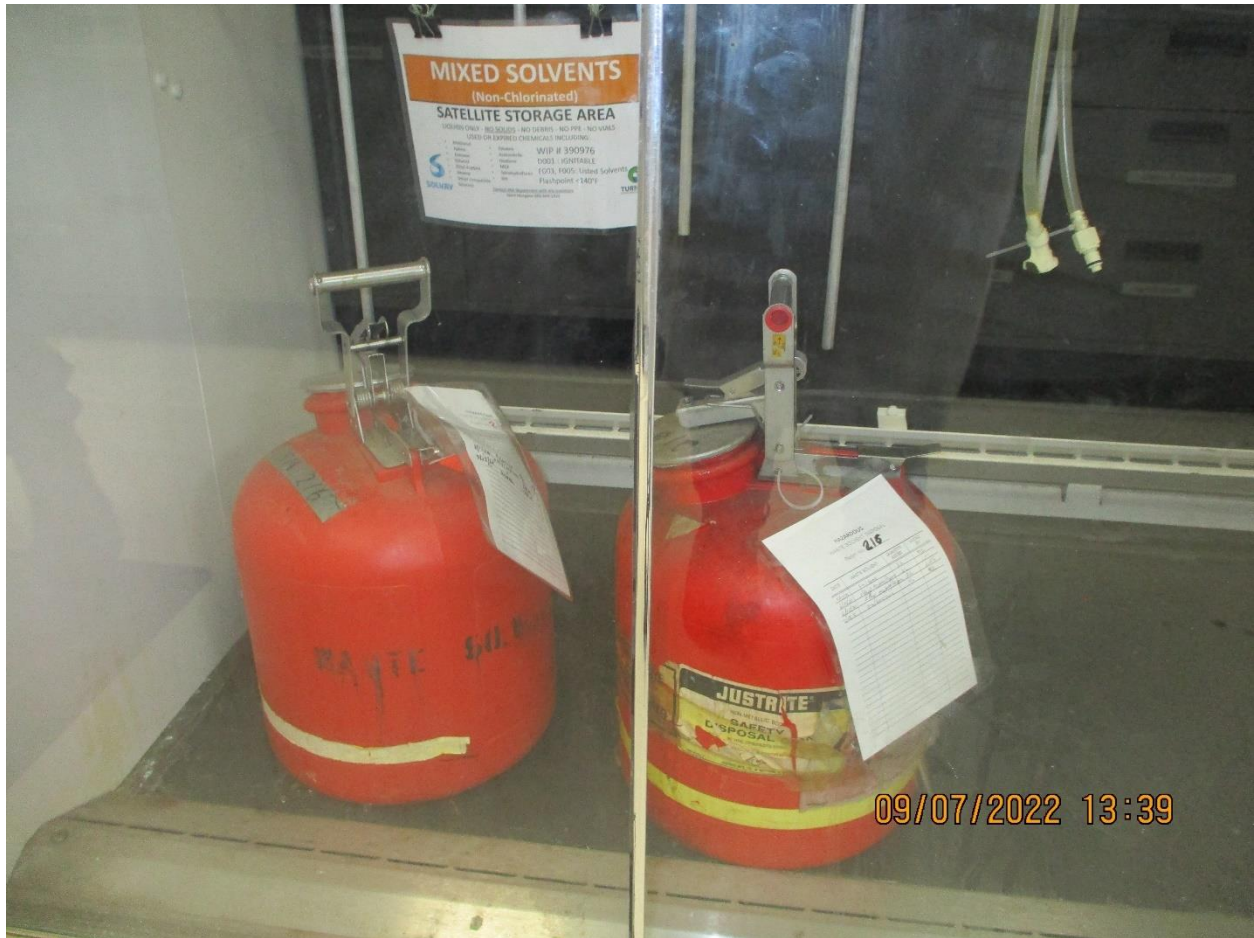
Photo 153

SAA located in Room 218, on Floor 2

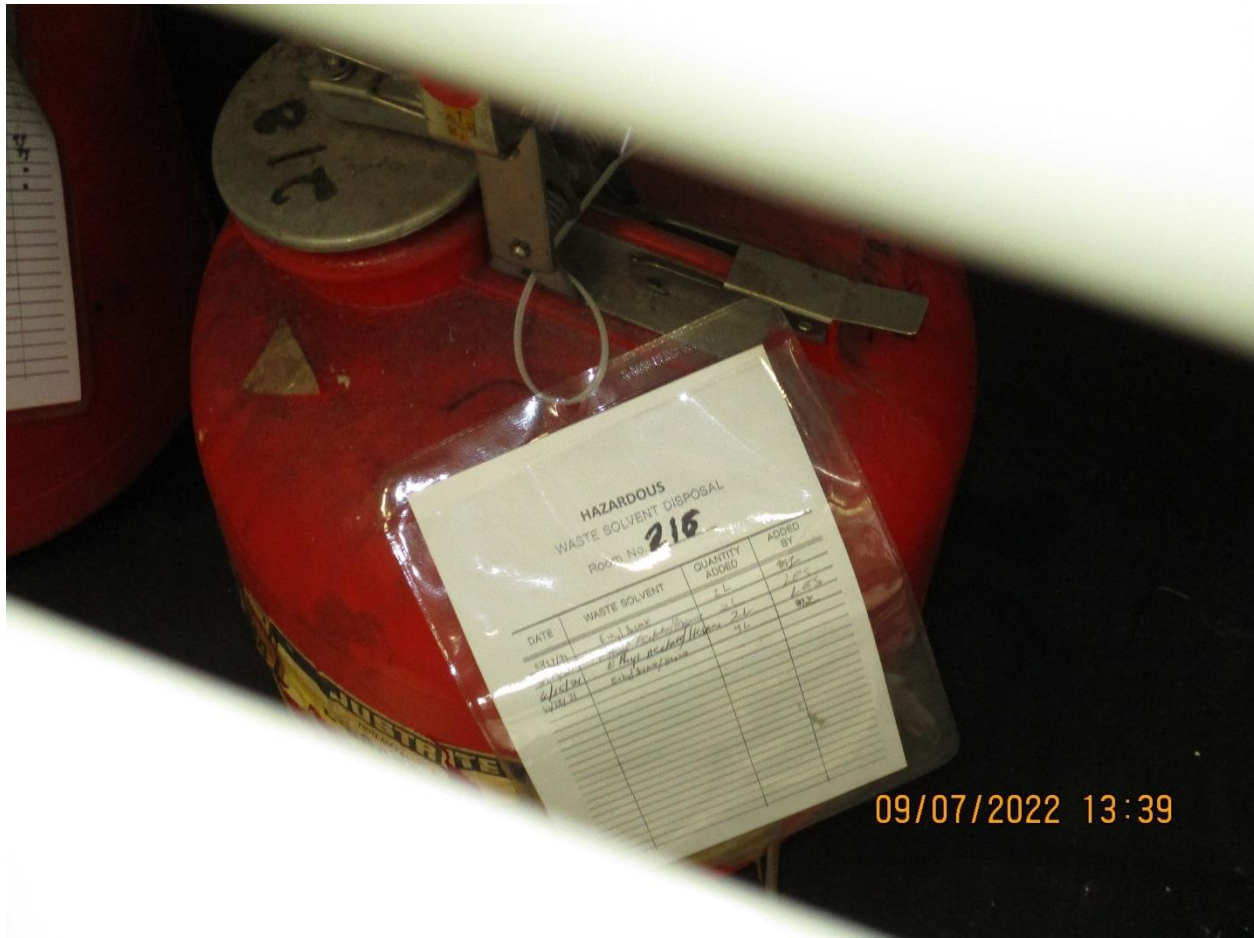
Photo 154

SAA located in hood in Room 216, on Floor 2

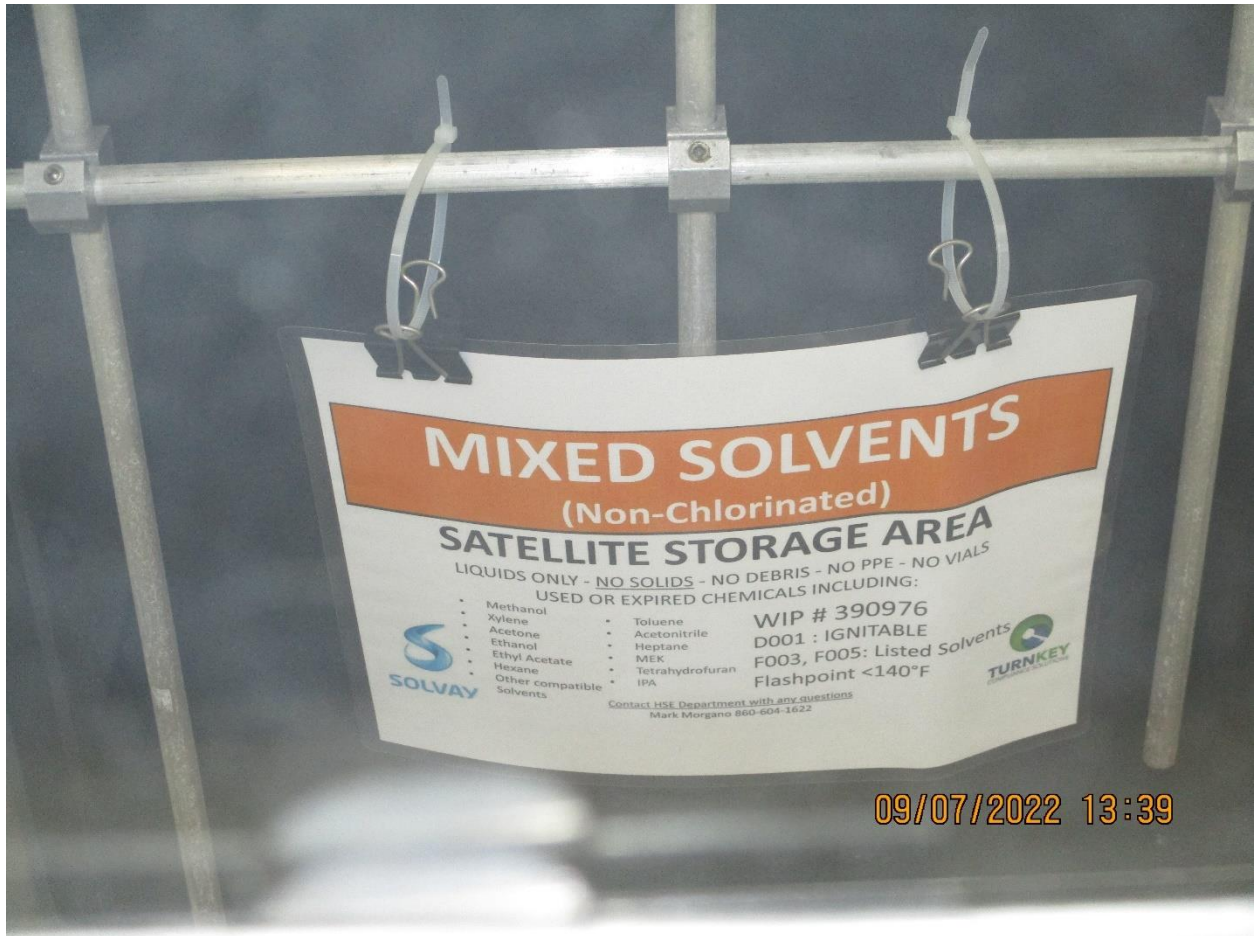
Photo 155

HW container with inventory log, located in hood in Room 216, on Floor 2

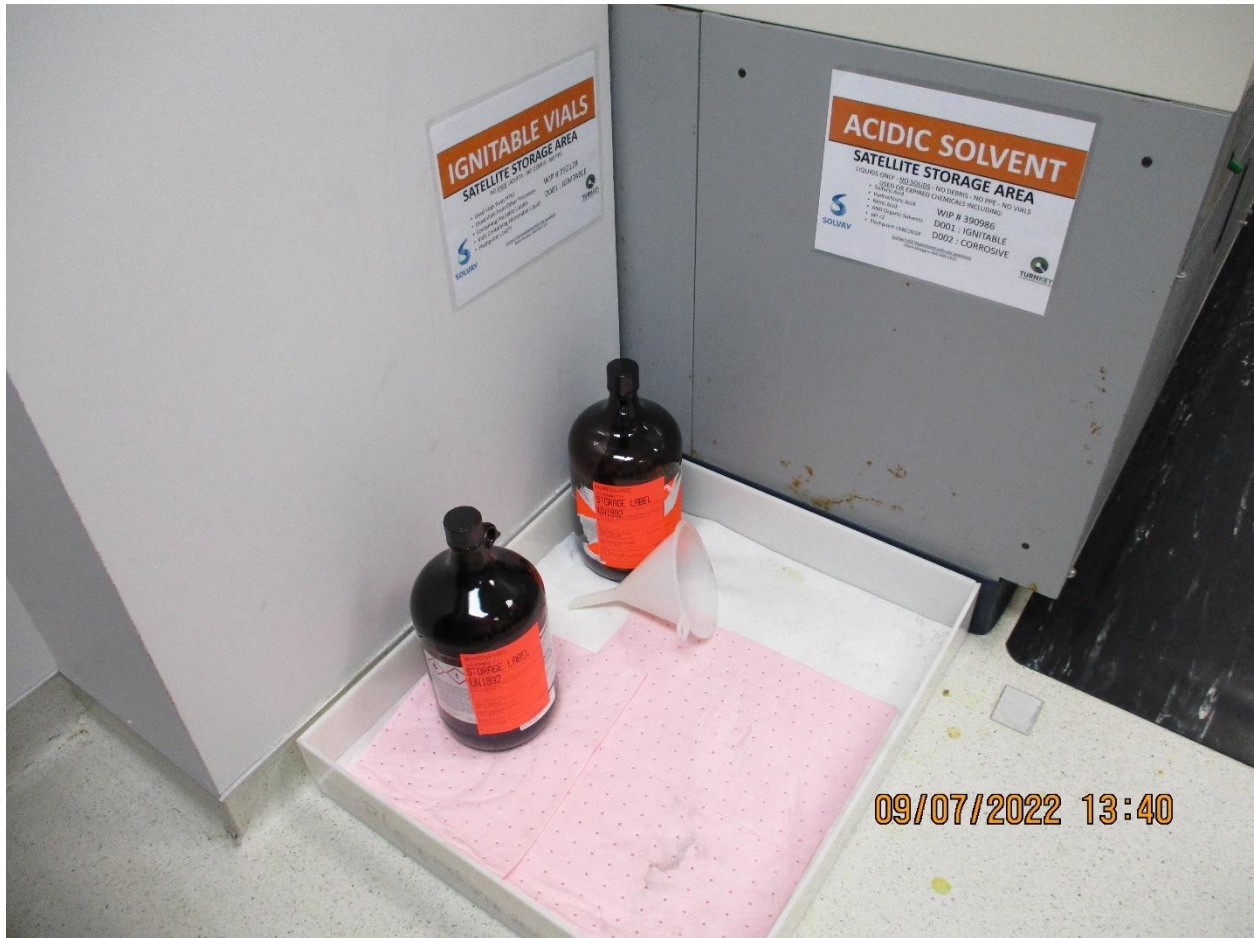
Photo 157

HW container in hood, located in Room 216, on Floor 2

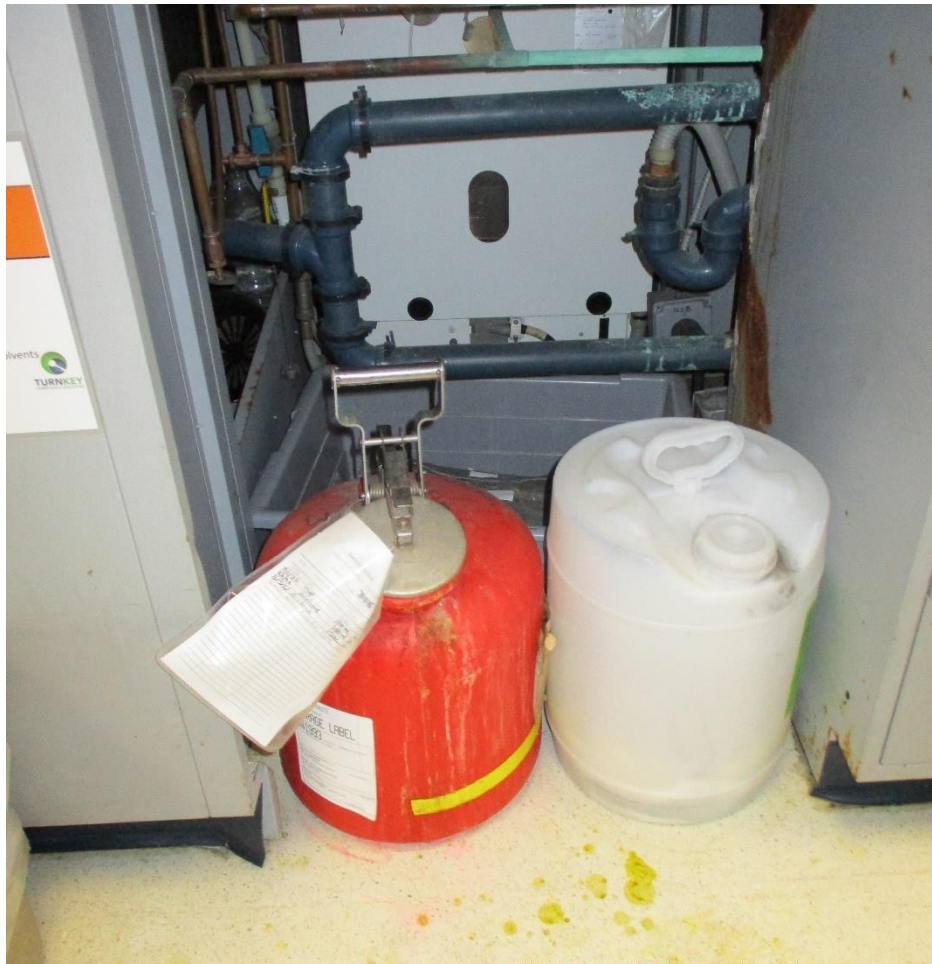
Photo 160

Label on two of two containers in SAA, located in Room 216, on Floor 2

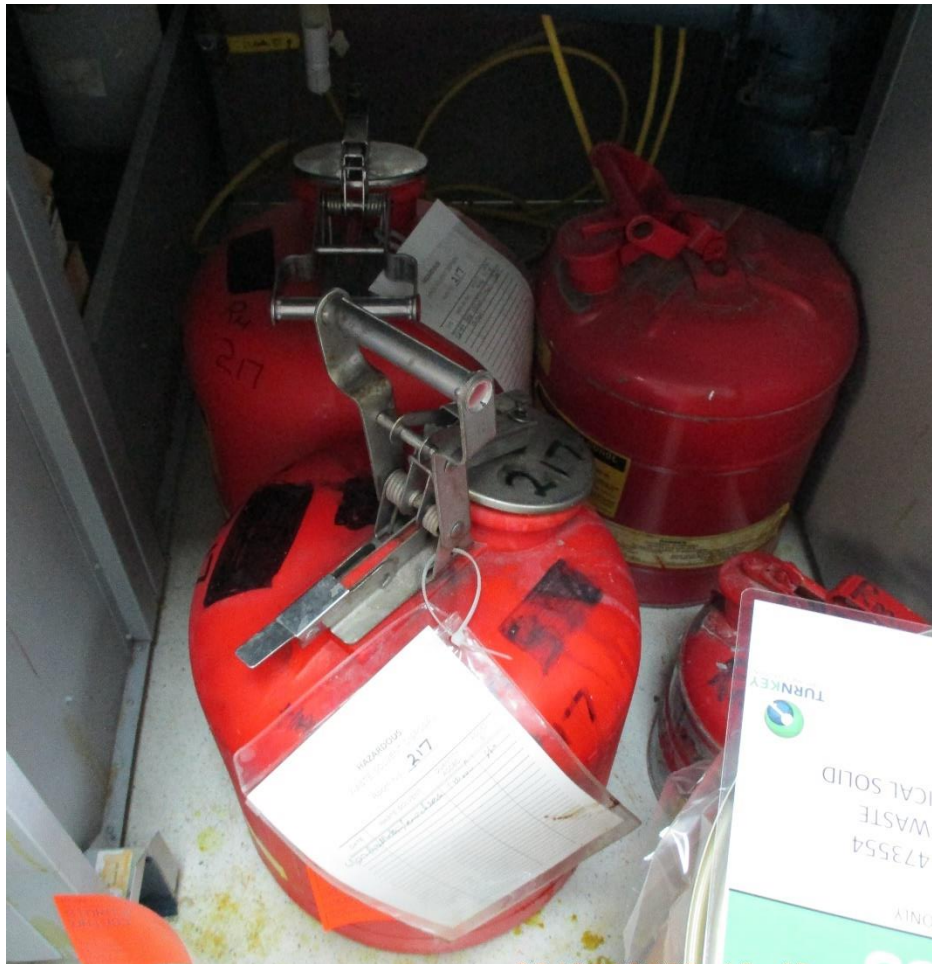
Photo 164

Located on a lab bench there was a container collecting waste from an analytical instrument. The container was in secondary containment, had a hazardous waste label which described the waste as, "THF, Acetonitrile". The container was closed (*See attachment 1, Photo #163-#164*).

Label on HW container collecting waste from instrument, located in Room 215, on Floor 2

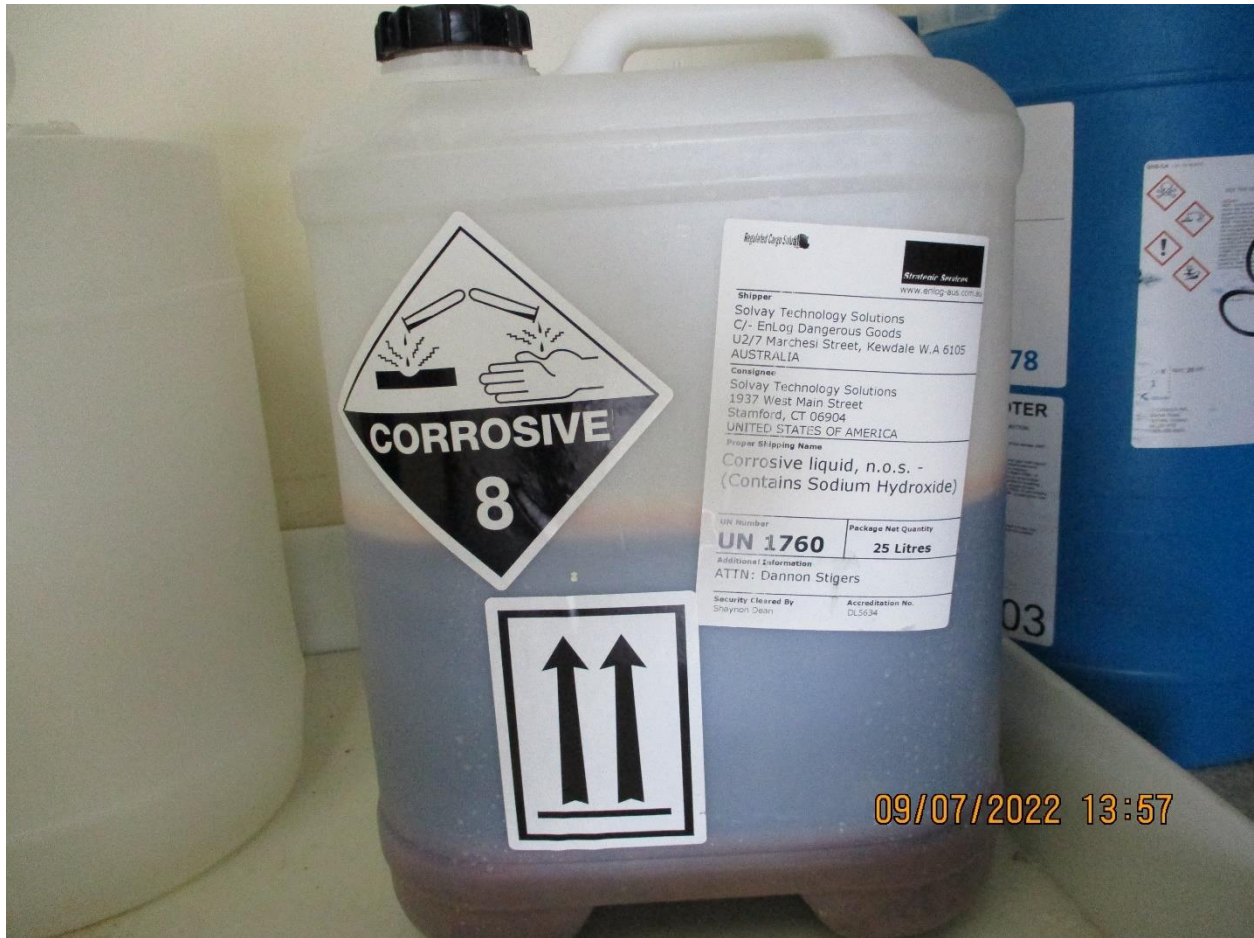
Photo 168

Room 318, there was one SAA with two white hazardous waste containers sitting in secondary containment. One container had a hazardous waste label. One had a corrosive sticker, and a label with a waste description that stated, "Corrosive liquid, n.o.s., (Contains Sodium Hydroxide)", but did not state the words hazardous waste. There were two SAA signs that stated, "MIXED SOLVENTS (Non-Chlorinated)" and "BAYER LIQUOR". Both containers were closed (*See attachment 1, Photo #168-#170*).

SAA located in room 318, on Floor 3

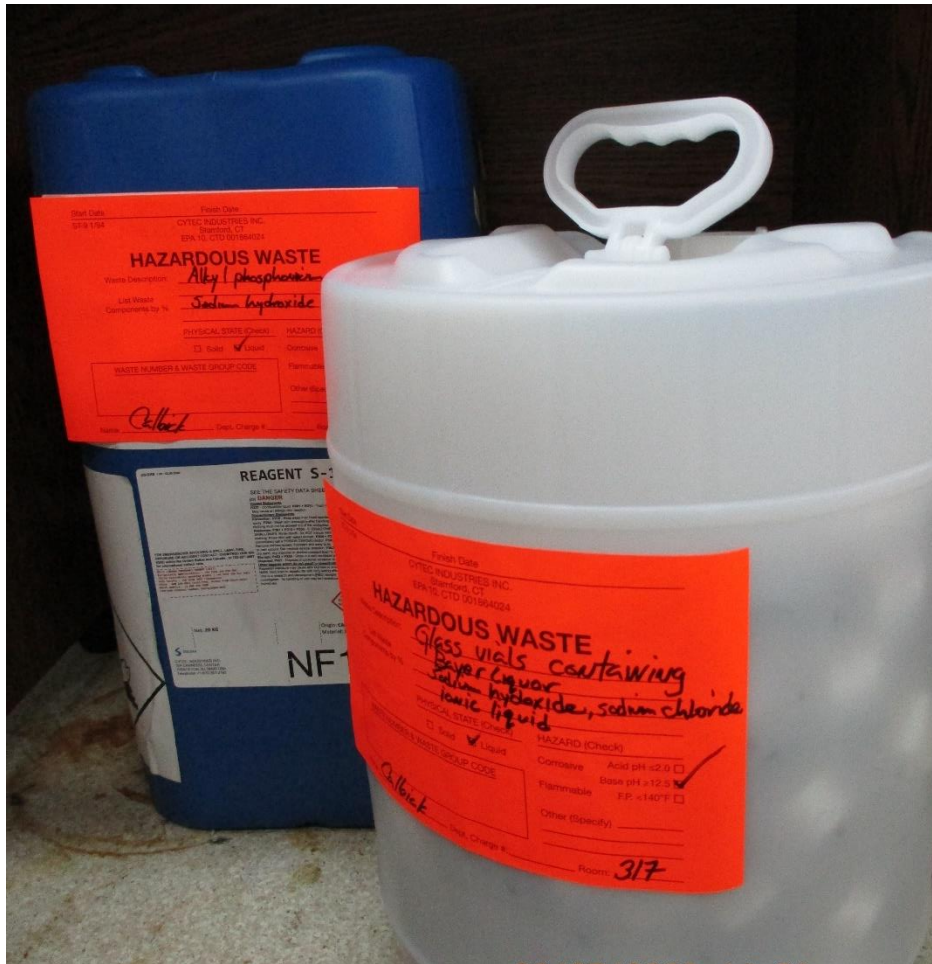
Photo 171

phosphonium salt”. There was one SAA sign nearby that stated, “CAUSTIC VIALS”. Both containers were closed (*See attachment 1, Photo #171-#174*).

SAA under table, located in Room 317, on Floor 3

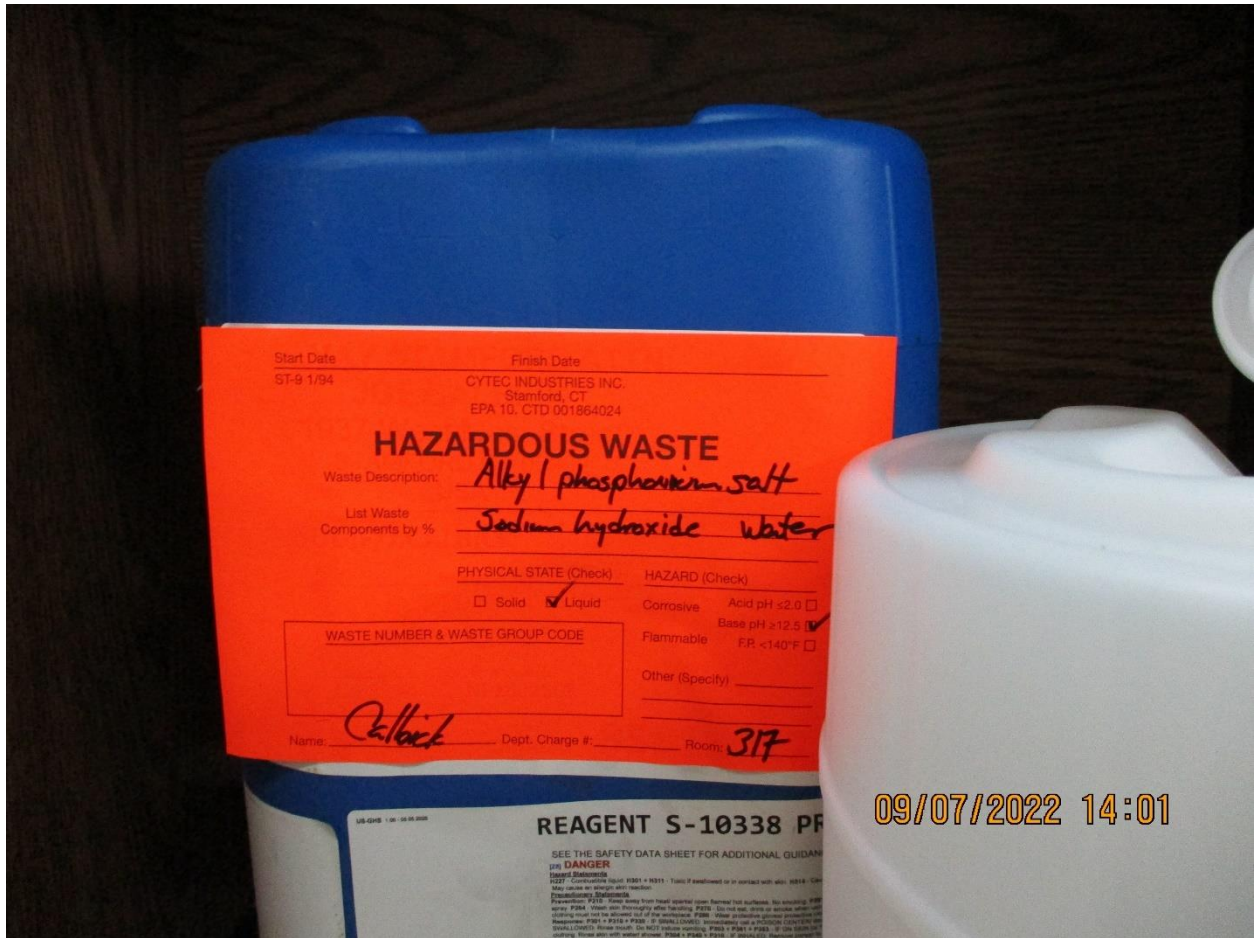
Photo 173

HW label on one container in SAA under table, located in Room 317, on Floor 3

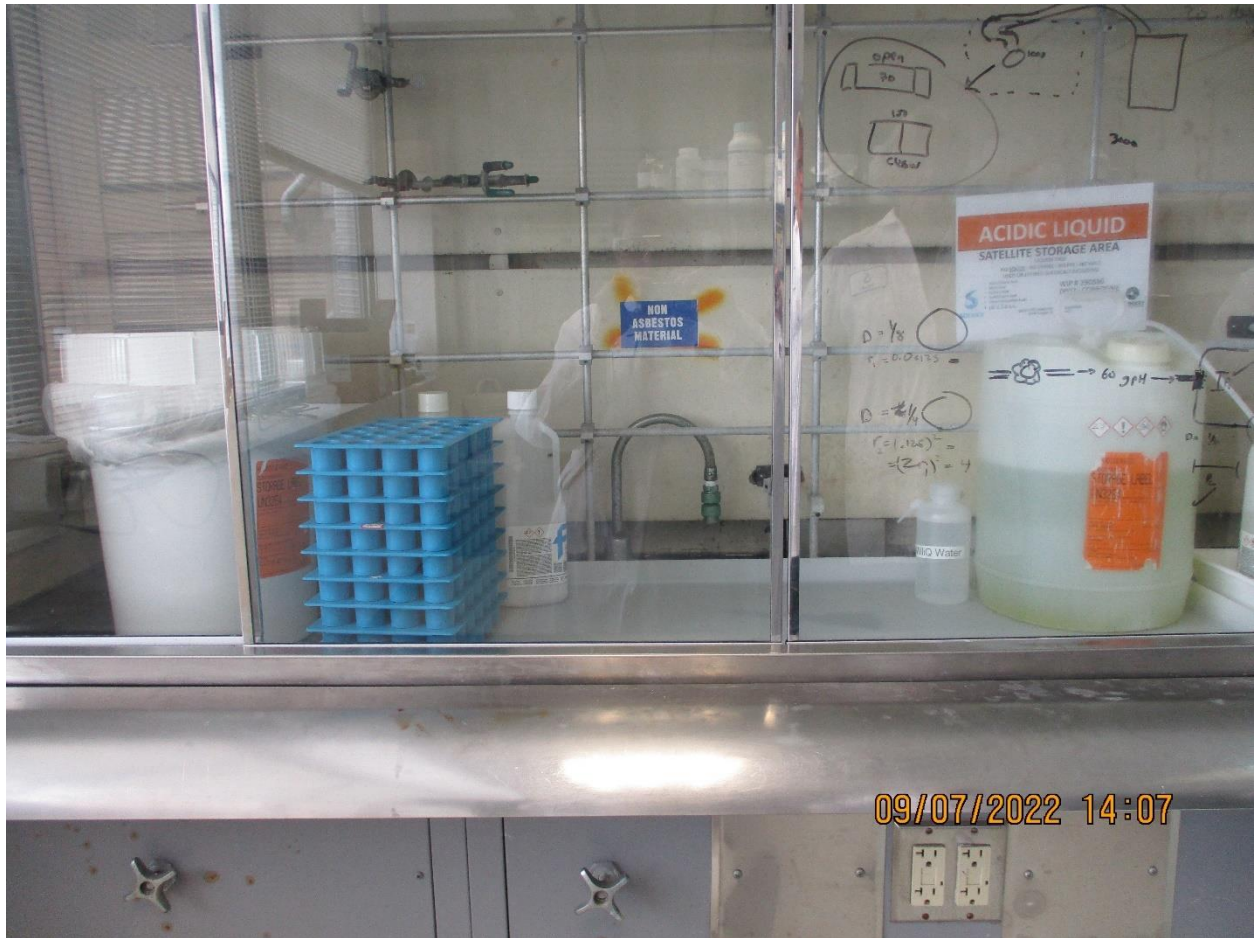
Photo 175

Room 330.2, there was one SAA in a lab hood with two white hazardous waste containers. One SAA hazardous waste container was collecting waste from an analytical instrument. The other had a hazardous waste label that described the waste as, “WASTE CORROSIVE LIQUID, ACIDIC, INORGANIC, n.o.s., (SULFURIC ACID SOLUTION), 8, II. Both containers had hazardous waste labels and were closed. There was a SAA sign that stated, “ACIDIC LIQUID” (*See attachment 1, Photo #175-#178*).

SAA in hood, located in Room 330.2, on Floor 3
