Re: U.S. EPA-Region 1 Inspection Report of Solvay, September 7, 2022

RCRA Compliance Inspection of:

Solvay
1937 West Main Street
Stamford, CT 06902

RCRA HAZARDOUS WASTE INSPECTION REPORT

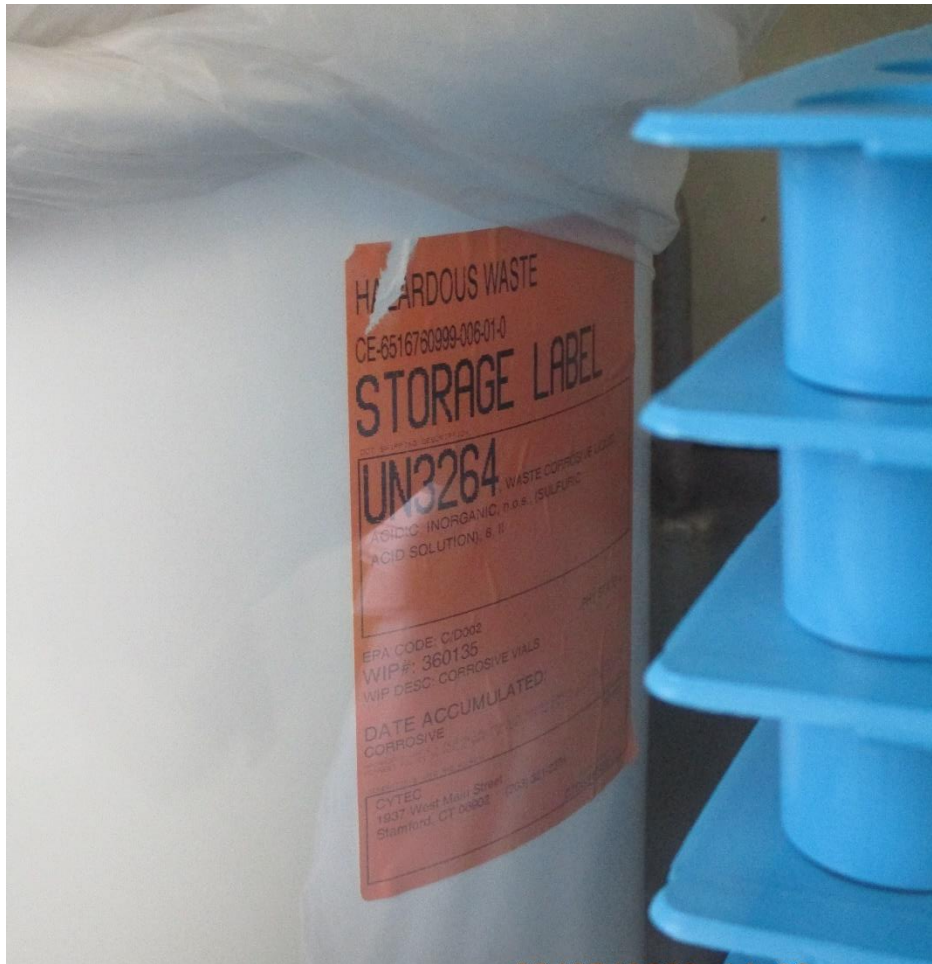
Photo 177

Room 330.2, there was one SAA in a lab hood with two white hazardous waste containers. One SAA hazardous waste container was collecting waste from an analytical instrument. The other had a hazardous waste label that described the waste as, “WASTE CORROSIVE LIQUID, ACIDIC, INORGANIC, n.o.s., (SULFURIC ACID SOLUTION), 8, II. Both containers had hazardous waste labels and were closed. There was a SAA sign that stated, “ACIDIC LIQUID” (*See attachment 1, Photo #175-#178*).

Label on SAA HW container on right side of hood, located in Room 330.2, on
Floor 3

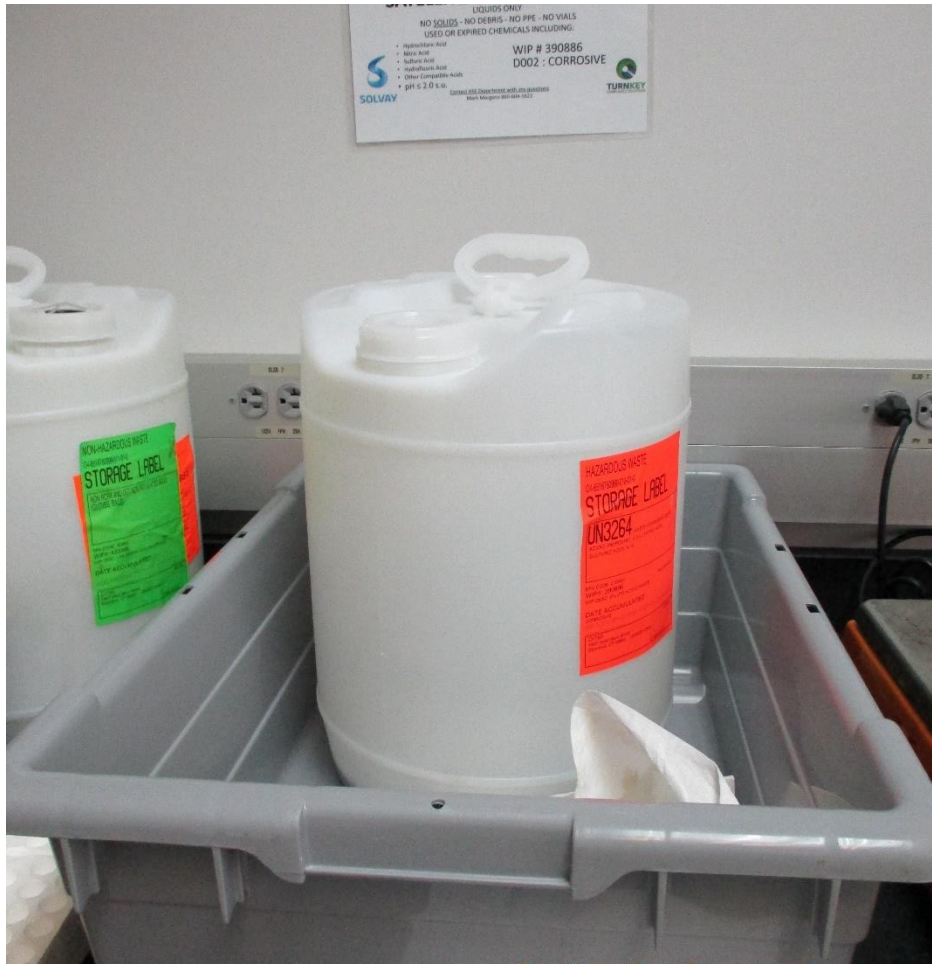
Photo 178

Label on SAA HW container on left side of hood, located in Room 330.2, on Floor

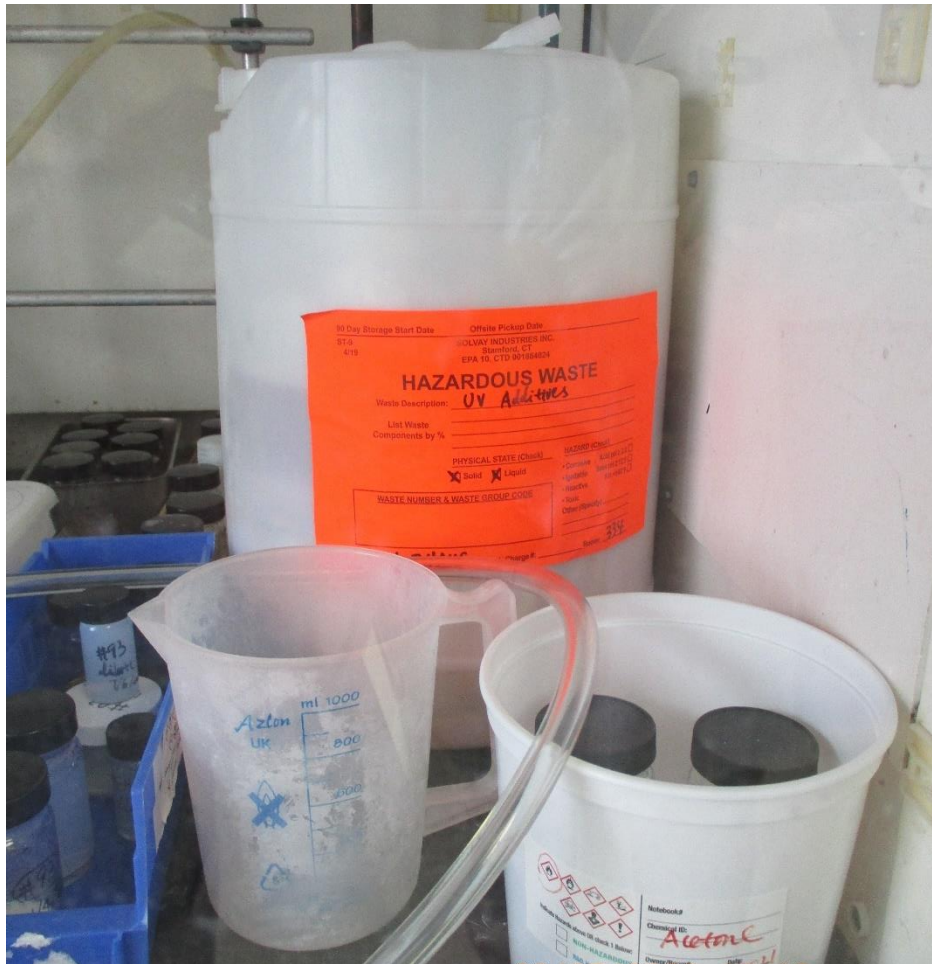
Photo 180

There was one SAA on a bench top, with one white hazardous waste container in secondary containment. The sign at the SAA stated, “ACIDIC LIQUID”. The container had a hazardous waste label and was closed (*See attachment 1, Photo #179-#180*).

Label on HW container in SAA on bench, located in Room 330.2, on Floor 3

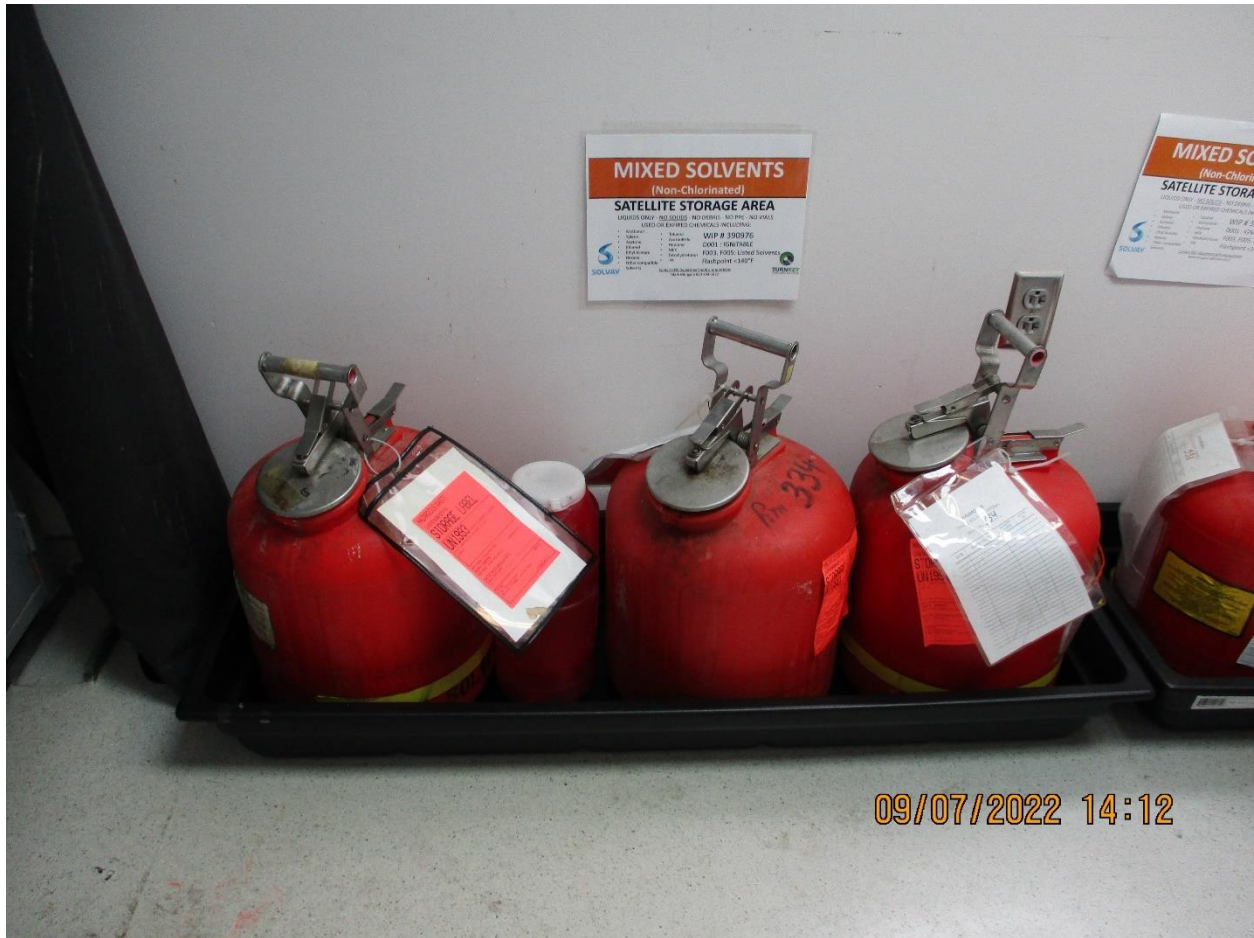
Photo 182

There was one SAA on the floor that had four different waste streams, and 6 hazardous waste containers. 5 of the containers were red, one was white. All 5 red containers had the Hazardous Waste Solvent Disposal sheet attached to the top of them. All 6 containers had a hazardous waste label, were closed and were sitting in secondary containment. The signs at the SAA stated the waste streams were, “MIXED SOLVENTS (Non-Chlorinated)”, “ACIDIC LIQUID”, and “HALOGENATED SOLVENTS”. (*See attachment 1, Photo #182-#190*).

SAA on floor, located in Room 332, on Floor 3

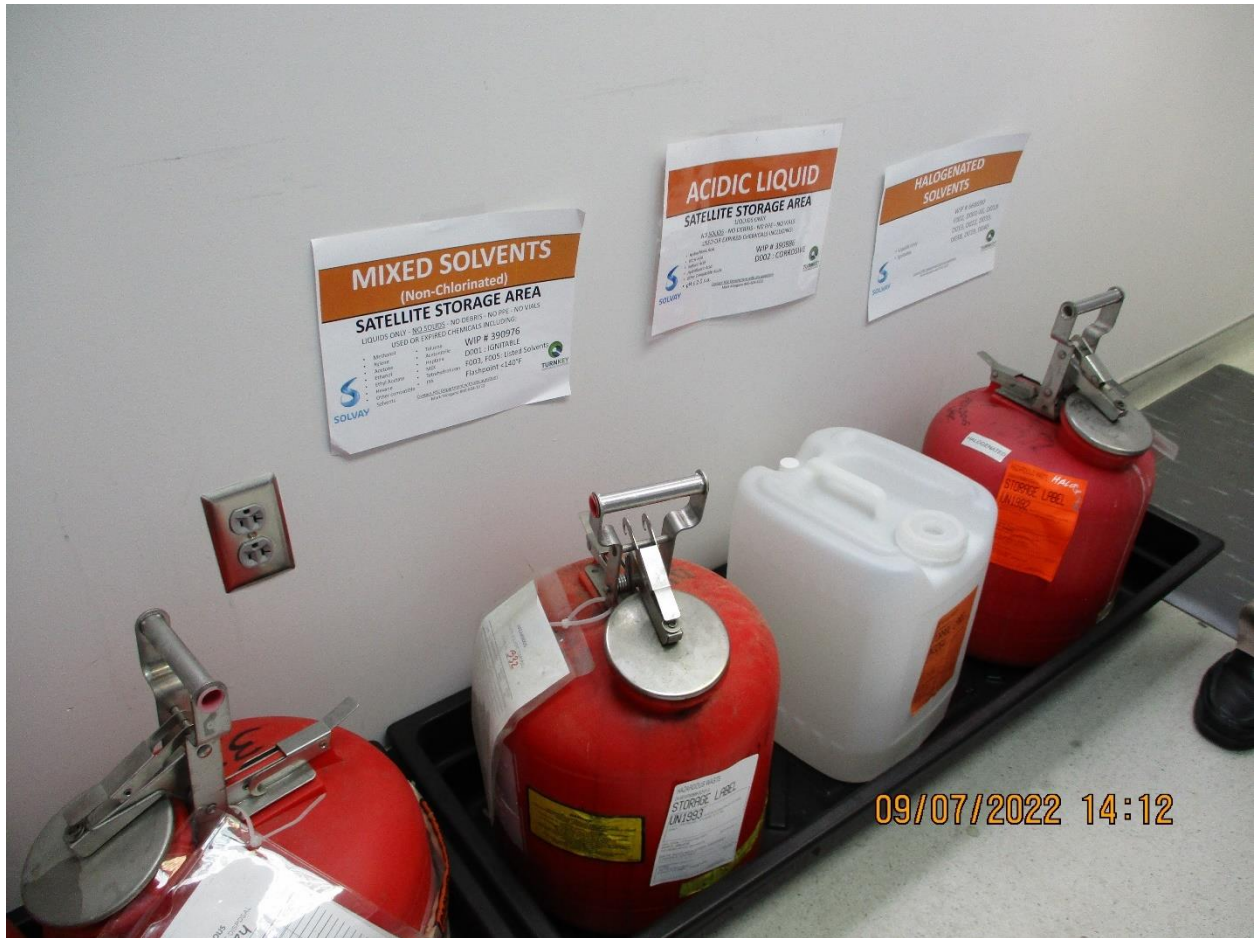
Photo 183

HW containers and signage in SAA on floor, located in Room 332, on Floor 3

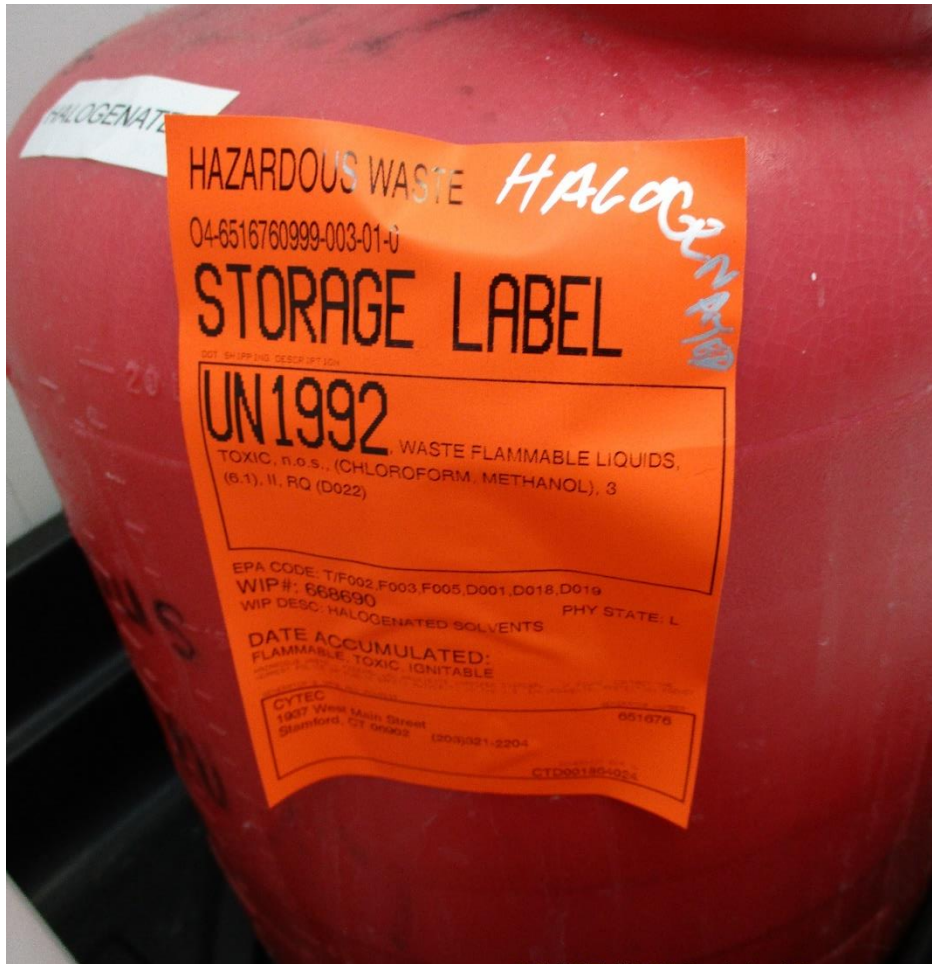
Photo 188

HW label on HW container in SAA on floor, located in Room 332, on Floor 3

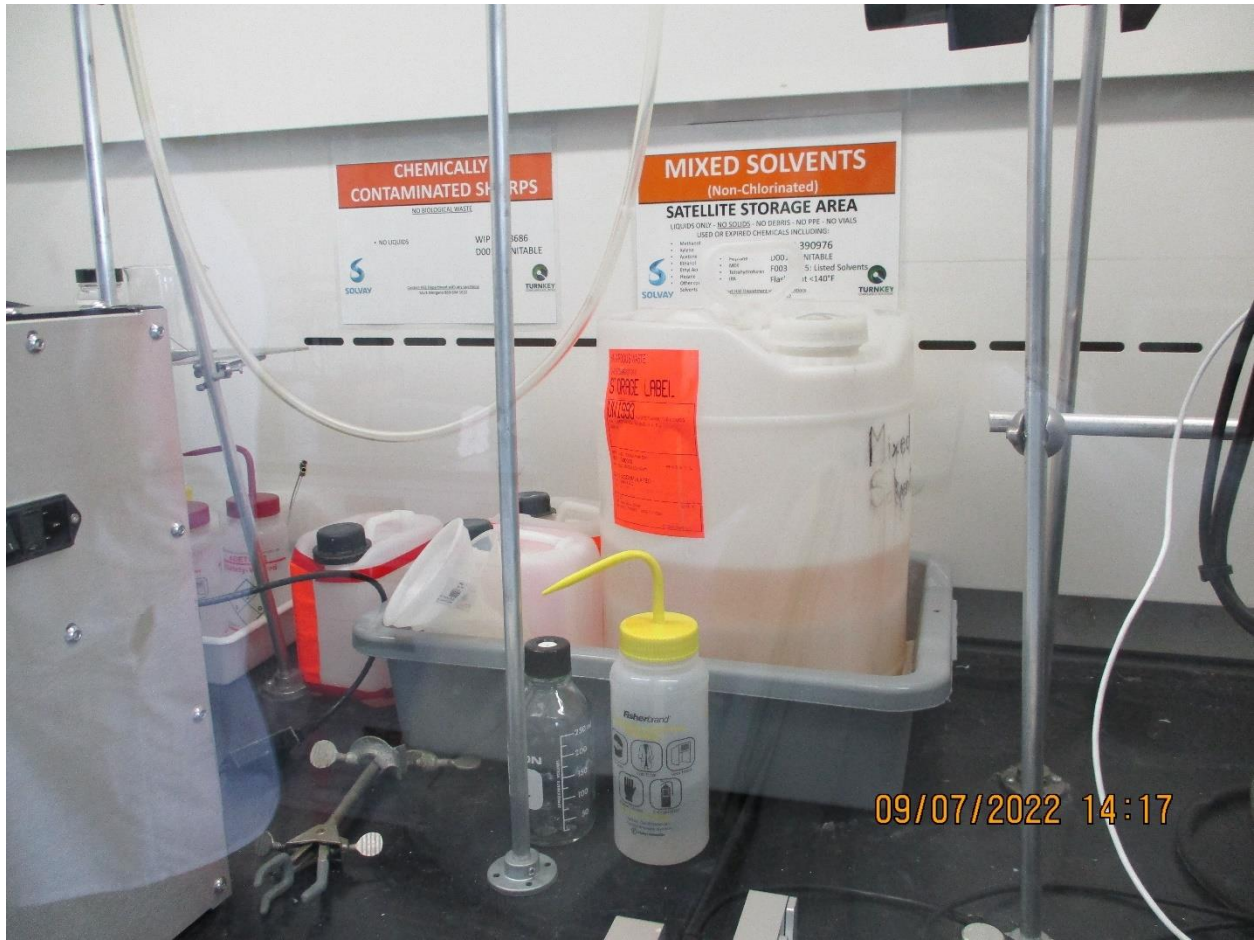
Photo 191

Robotics and Automation, Room 333, there was one SAA with 4 hazardous waste containers. Three of the containers were in secondary containment, one was not. Three of the containers had hazardous waste labels, one is undetermined, it was not visible through the glass on the hood. All four containers were closed. There were two SAA signs, that stated the waste streams as, “CHEMICALLY CONTAMINATED SHARPS” and “MIXED SOLVENTS (Non-Chlorinated)” (*See attachment 1, Photo #191-#193*).

SAA in hood, located in Room 333, Robotics and Automation Lab on Floor 3

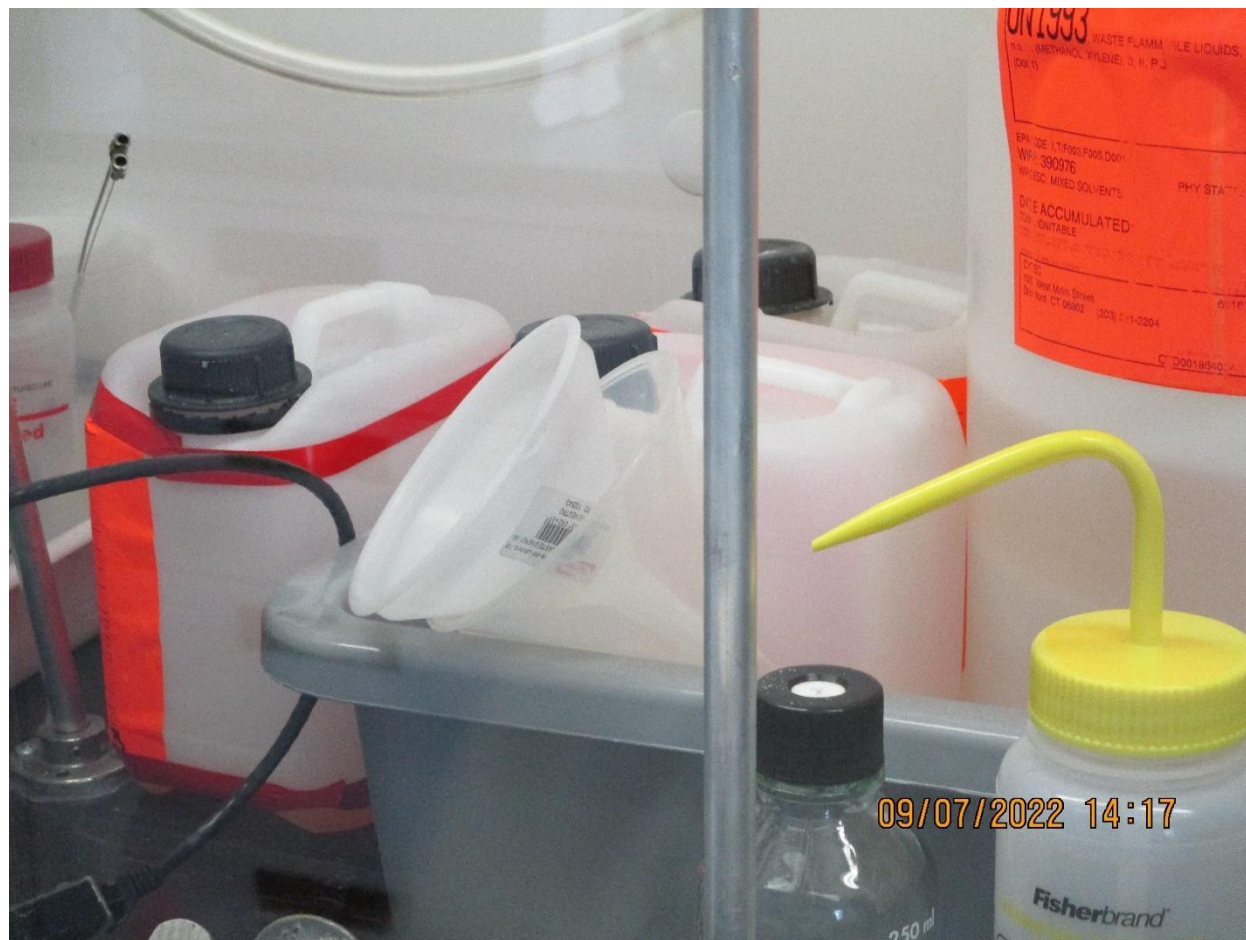
Photo 192

Containers in SAA in hood, located in Room 333, Robotics and Automation Lab
on Floor 3

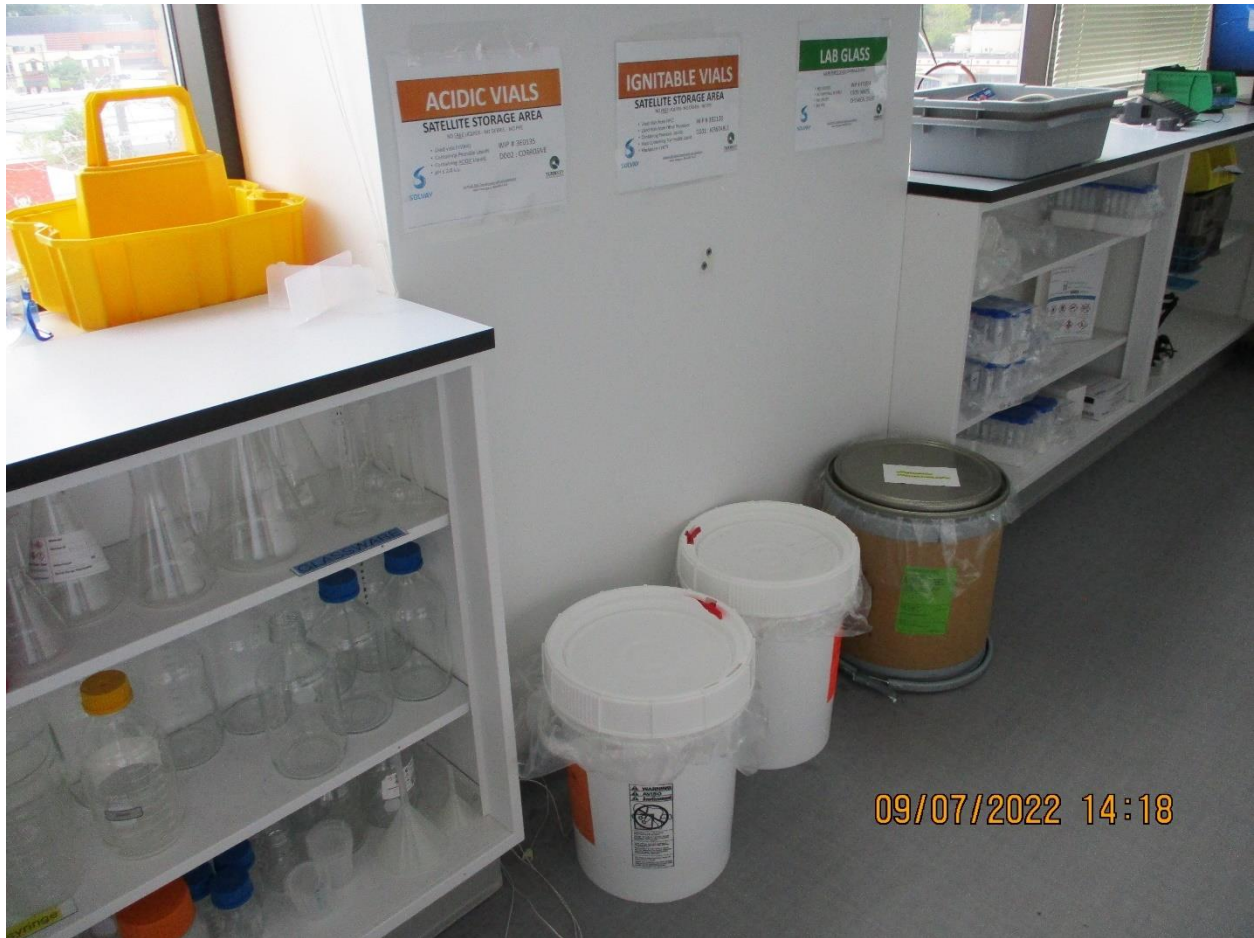
Photo 194

There was one SAA on the floor with two hazardous waste containers. Both containers were not in secondary containment, they both had hazardous waste labels on them, and they were both closed. The SAA signs at the area stated the waste streams as, “ACIDIC VIALS” and “IGNITABLE VIALS” (*See attachment 1, Photo #194-#196*).

SAA on floor, located in Room 333, Robotics and Automation Lab, on Floor 3

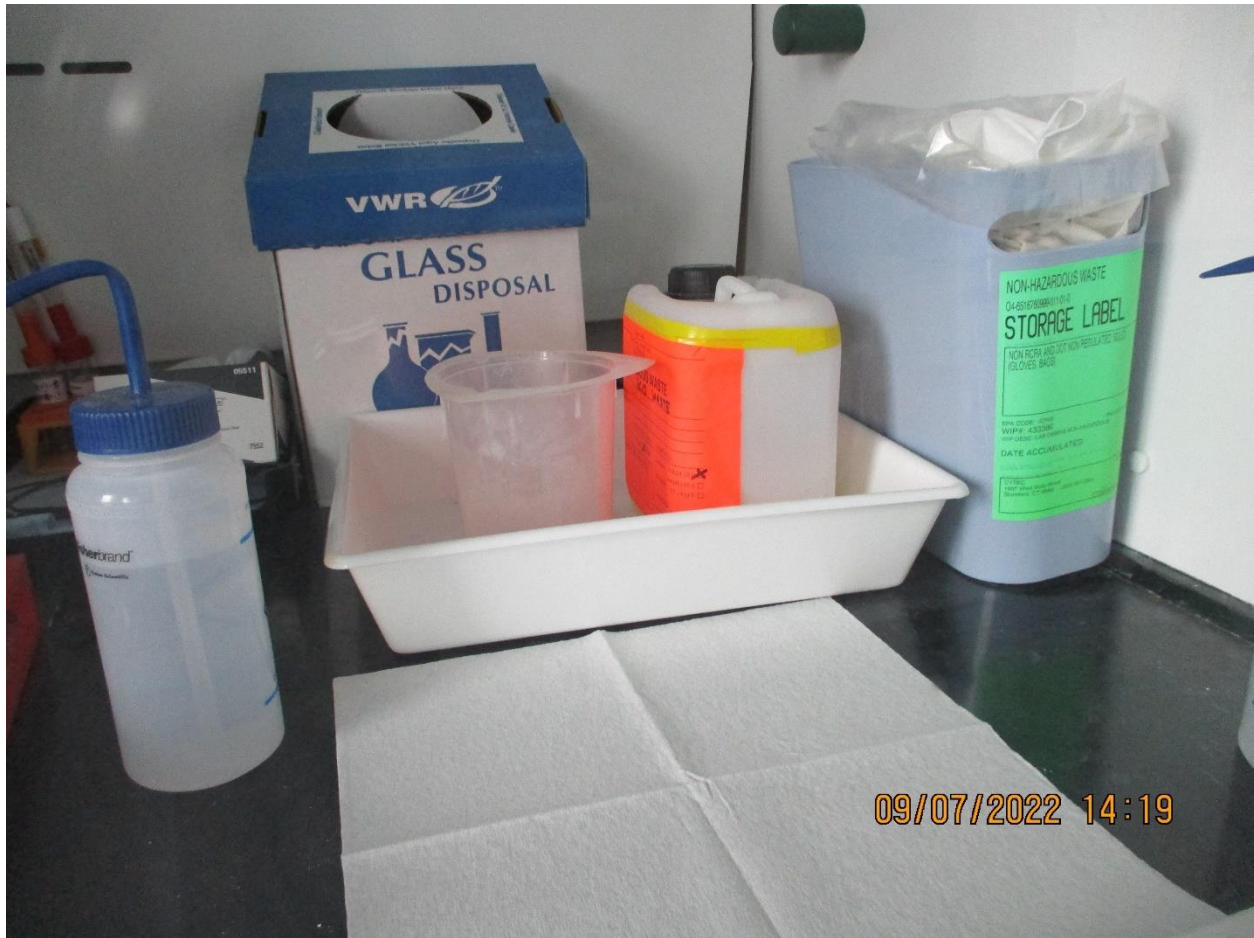
Photo 197

There was one hazardous waste container in a lab hood, in secondary containment. The container had a hazardous waste label that described the waste as, “ACID WASTE”, the container was closed (*See attachment 1, Photo #197-#198*).

HW container in hood, located in Room 333, Robotics and Automation Lab, on
Floor 3

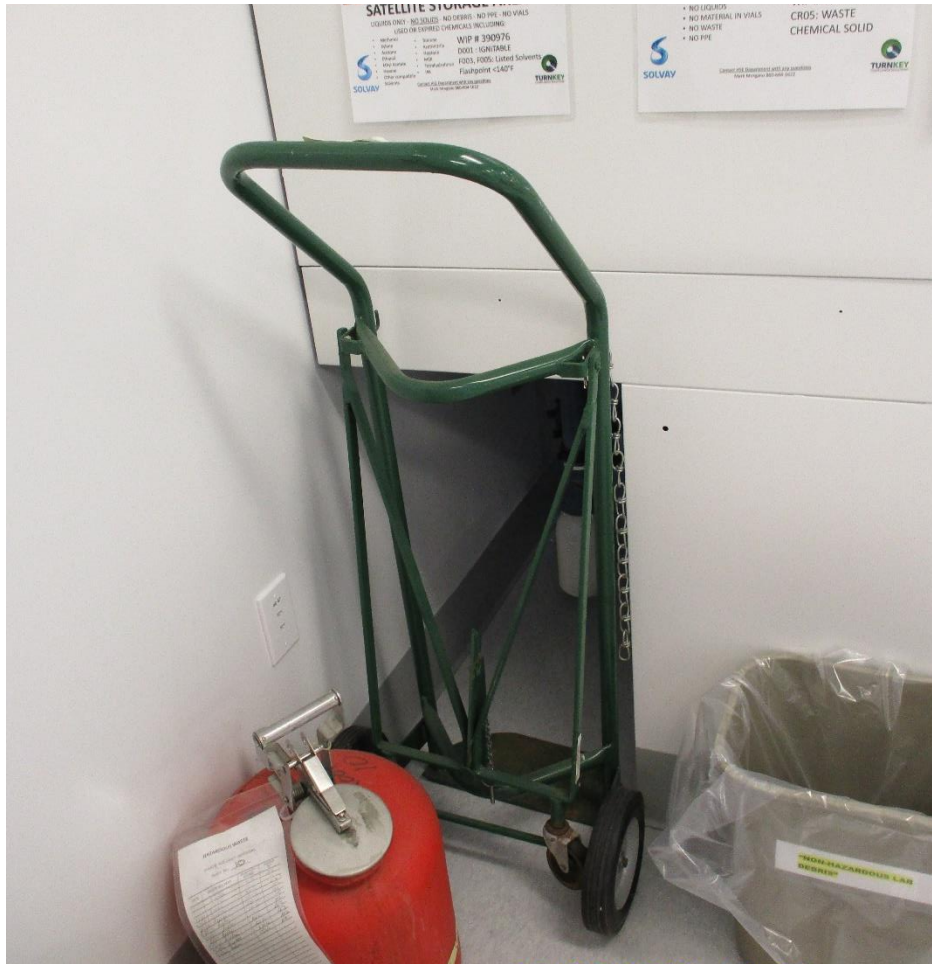
Photo 199

stated the waste as, “MIXED SOLVENTS (Non-Chlorinated)”. The container did not have a hazardous waste label on it (*See attachment 1, Photo #199*).

SAA on floor, located in Room 335, HEL Lab, on Floor 3

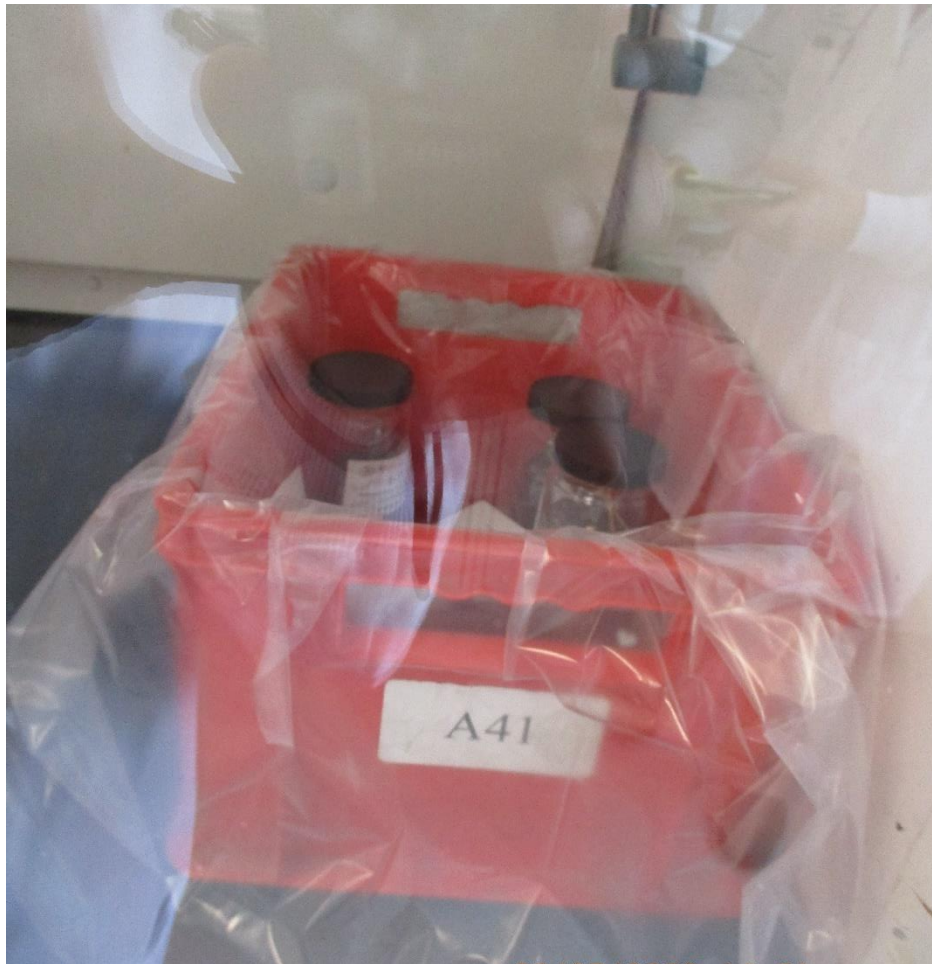
Photo 200

There was one red lab pack box in a hood which had small glass jars in it, along with a Waste Material Inventory sheet. The box did not have a hazardous waste label on it and was not dated. There was also a glass jar containing spent assorted batteries (*See attachment 1, Photo #200-#202*).

Red lab pack container in hood, located in Room 335, HEL Lab, on Floor 3

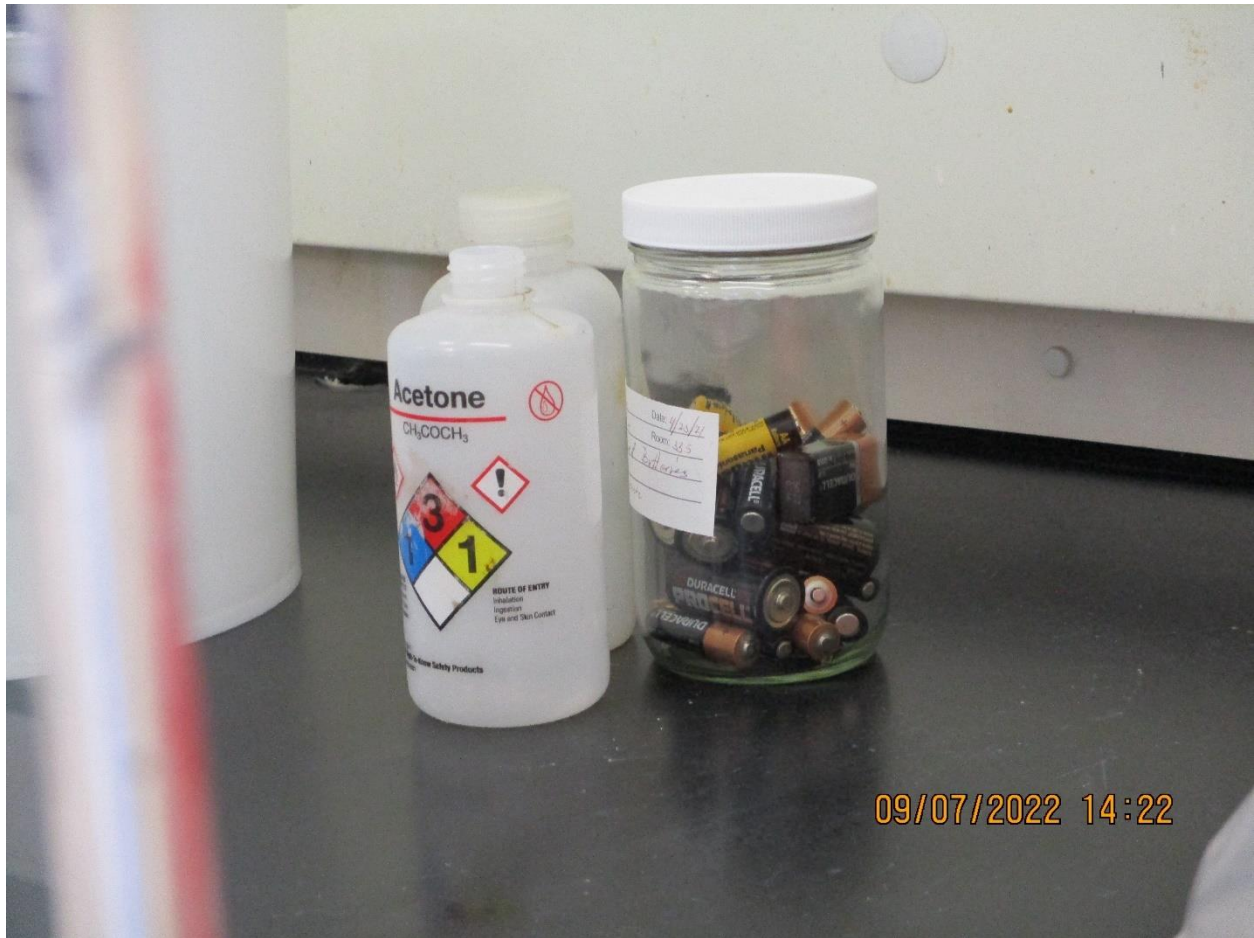
Photo 201

Waste batteries container in hood, located in Room 335, HEL Lab, on Floor 3

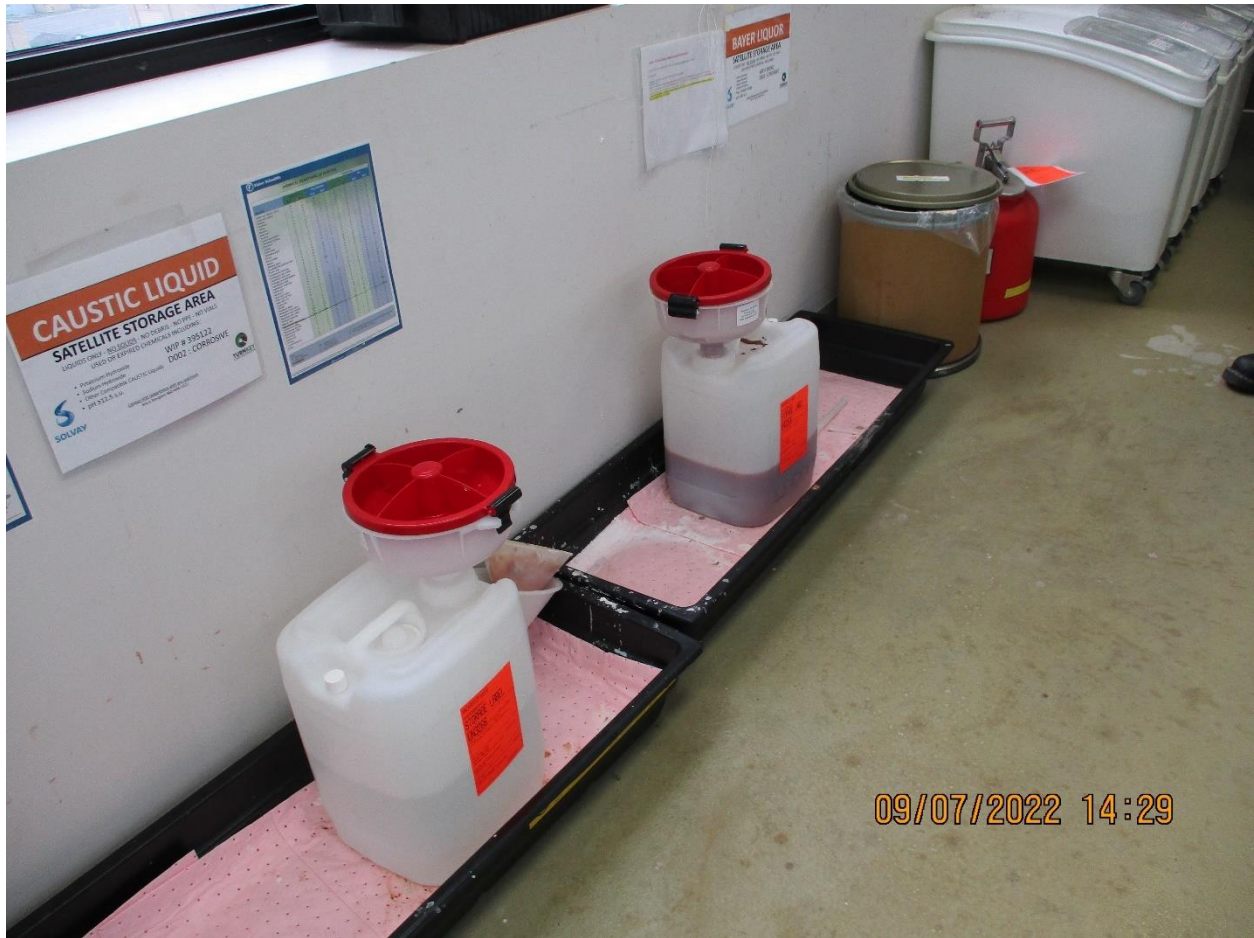
Photo 203

Alumina Separation, Room 440, there was one SAA on the floor with three hazardous waste containers, two white and one red. The two white containers were in secondary containment and were equipped with funnels. The one red container had the Waste Solvent Disposal sheet attached to the top of it. All three containers had hazardous waste labels. One of the white containers equipped with a funnel did not have the funnel closed tightly. The waste stream for that container was described as, “WASTE CORROSIVE LIQUID, BASIC, INORGANIC, n.o.s., (SODIUM HYDROXIDE, SODIUM ALUMINATE) 8, II. There were two SAA signs at the area which described the waste streams as, “CAUSTIC LIQUID” and “BAYER LIQUOR” (*See attachment 1, Photo #203-#209*).

SAA on floor, located in Room 440, Alumina Separation Lab, on Floor 4

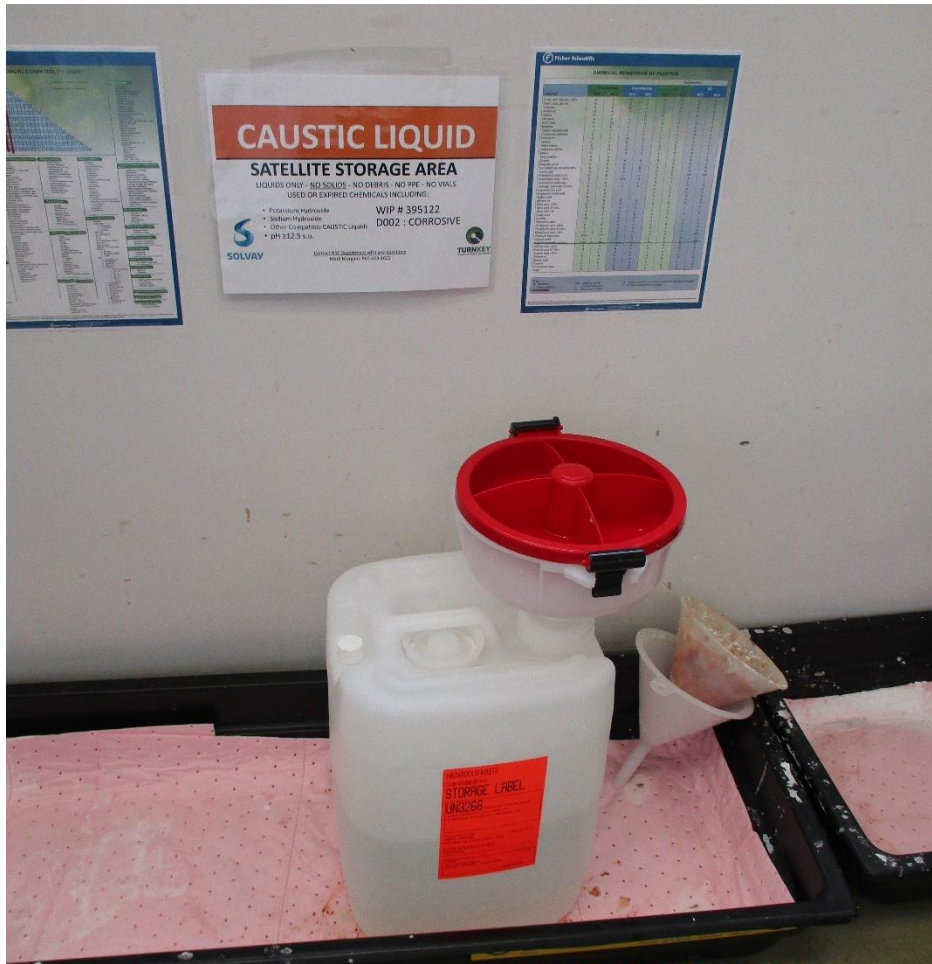
Photo 204

Container and signage at SAA on floor, located in Room 440, Alumina Separation Lab, on Floor 4

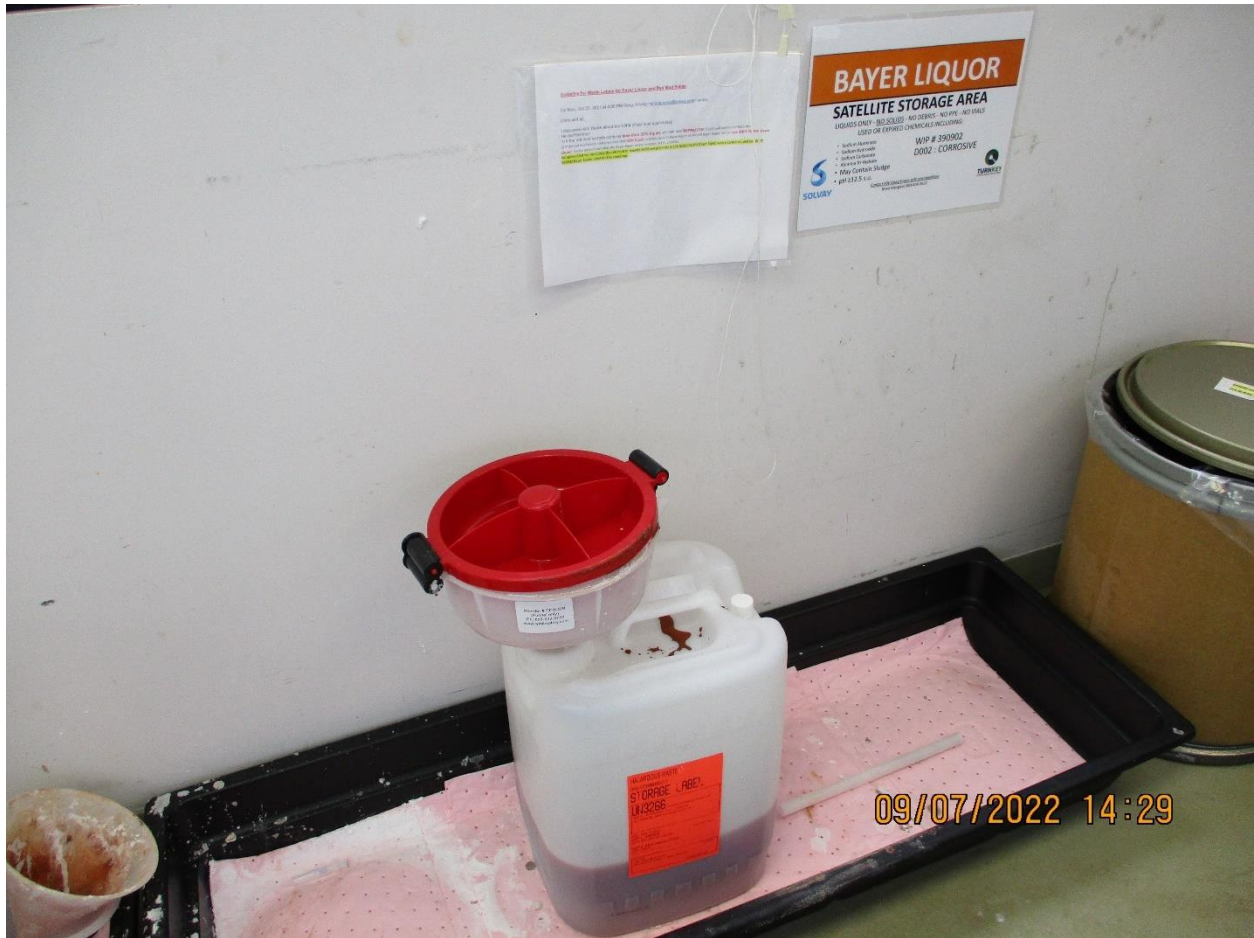
Photo 205

Container and signage at SAA on floor, located in Room 440, Alumina Separation Lab, on Floor 4

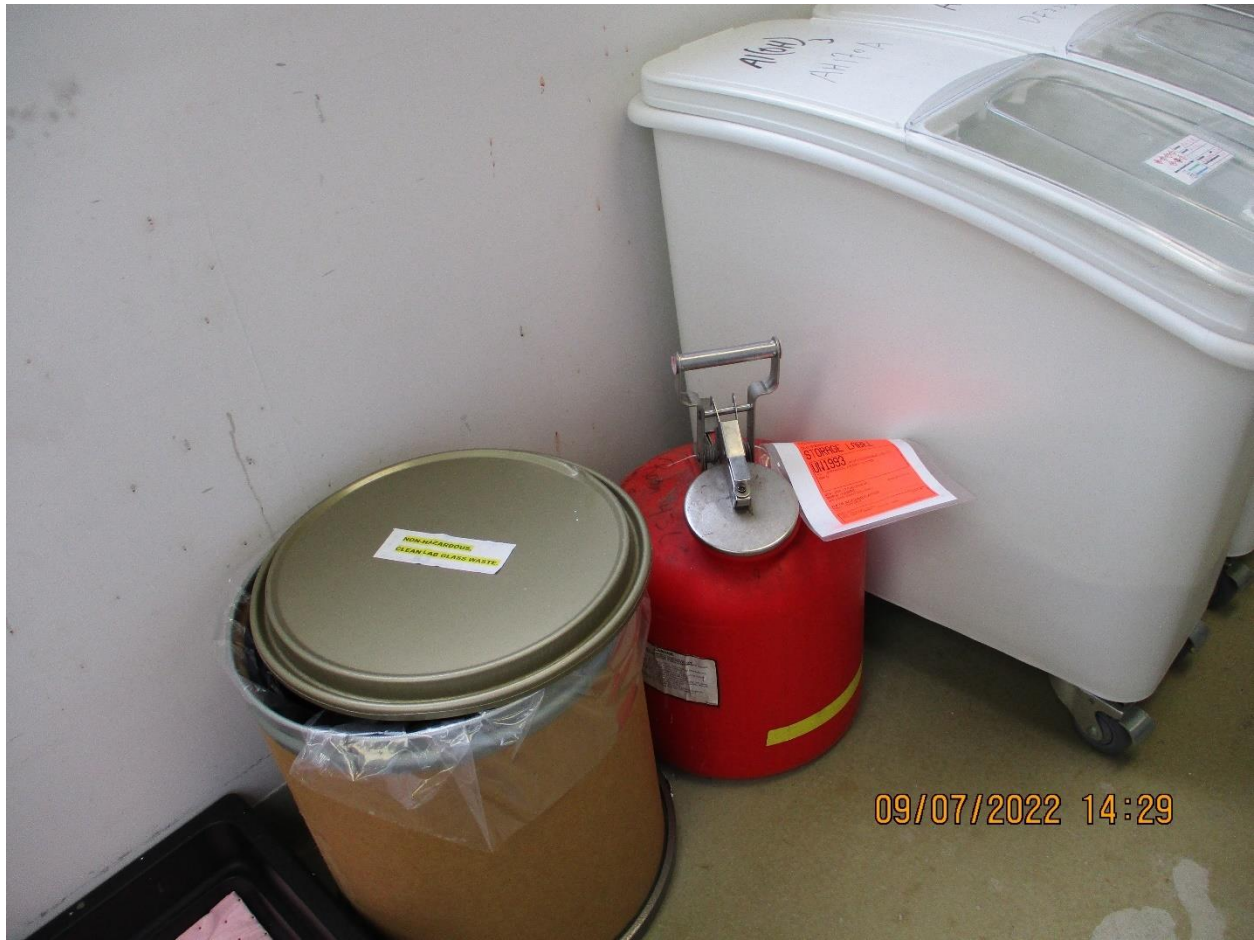
Photo 206

HW container on floor, at SAA located in Room 440, Alumina Separation

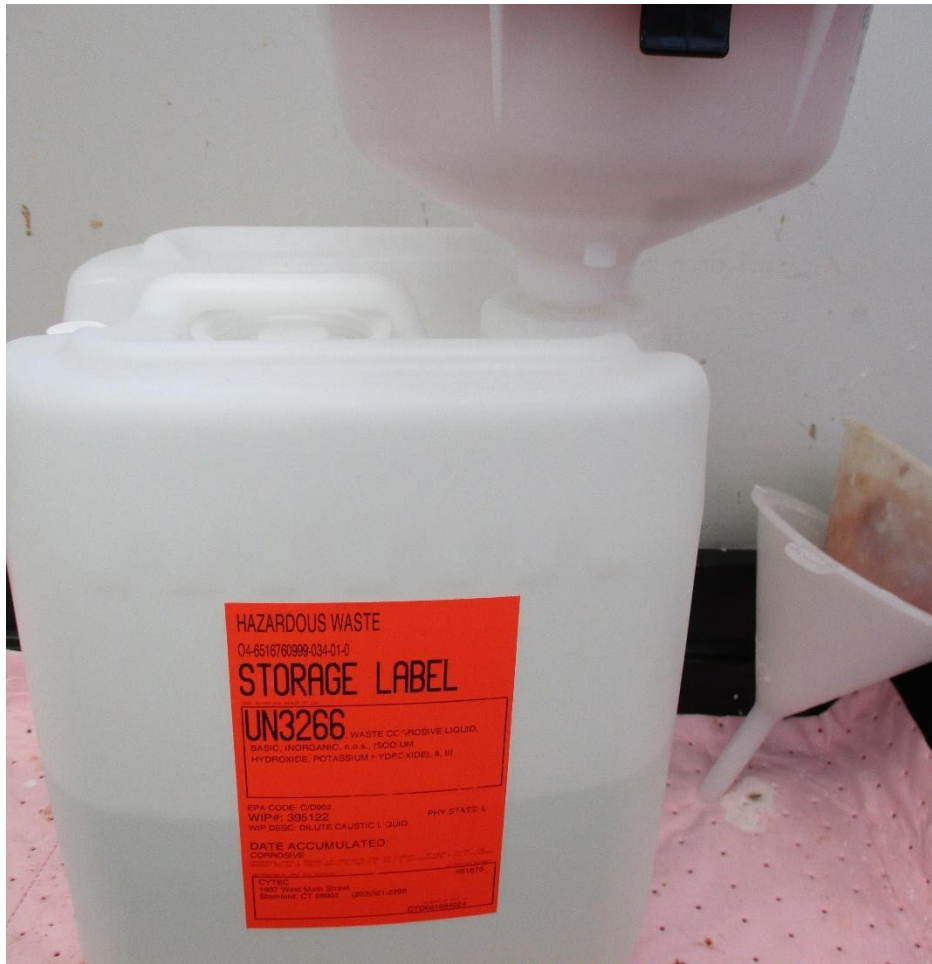
Photo 207

Label on SAA container at SAA on floor, located in Room 440, Alumina Separation Lab, on Floor 4

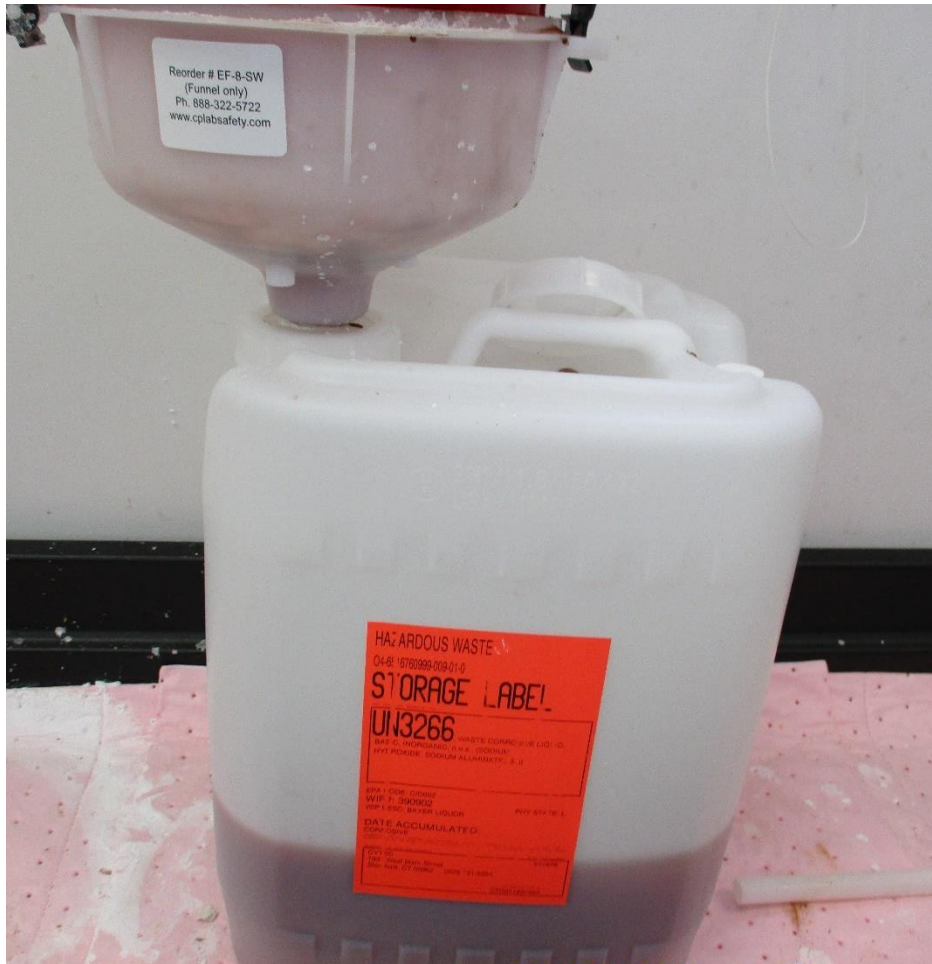
Photo 208

Label on SAA container at SAA on floor, located in Room 440, Alumina Separation Lab, on Floor 4

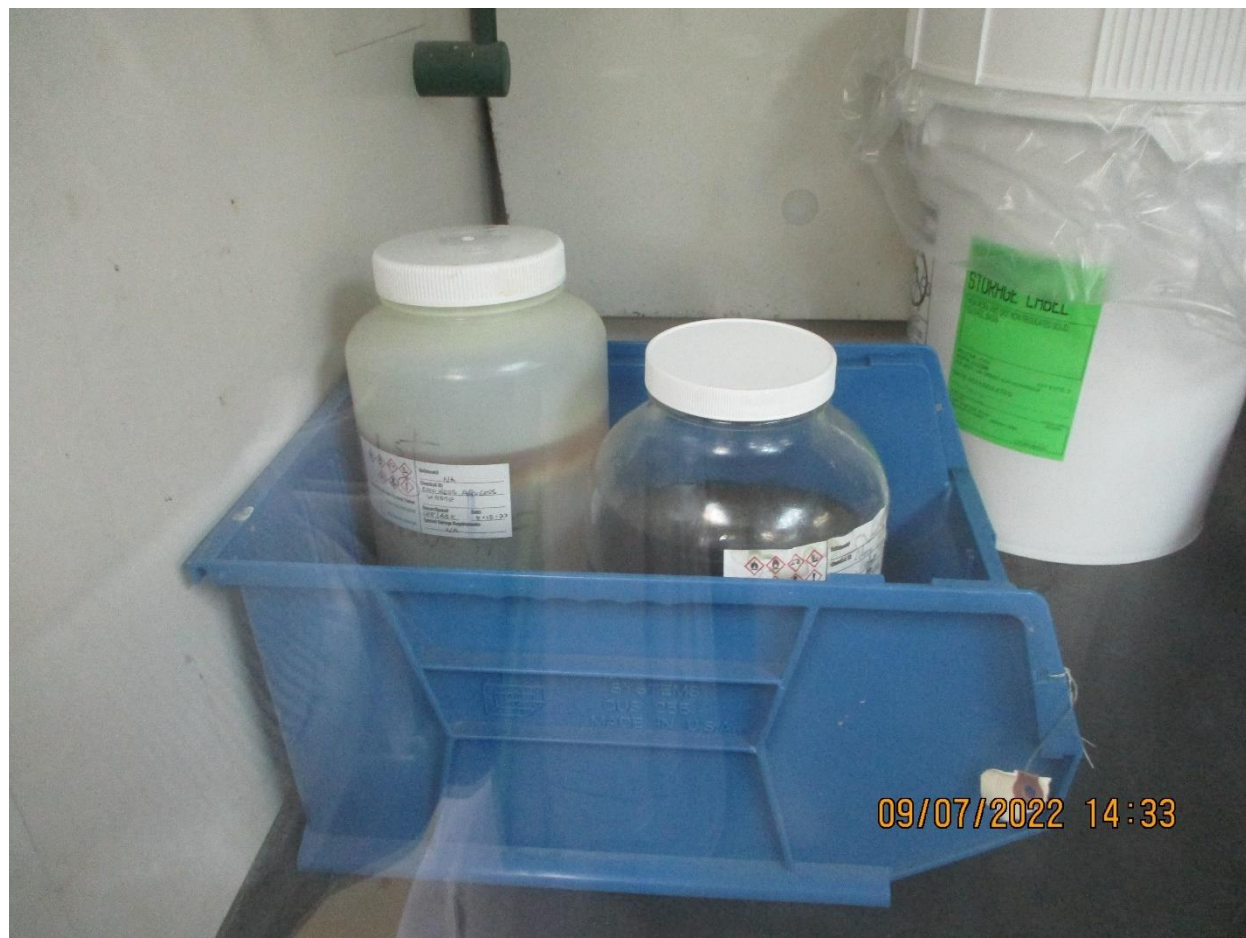
Photo 210

Minerals Metallurgical, Room 430, there was one blue box in a lab hood holding two containers. One was a glass jar, and the other was a plastic jar. The glass jar had “Odorous Waste” written on a label on the outside of the jar. The other container had “ODOROUS AQUEOUS WASTE” written on a label on the outside of the jar. Both containers did not have hazardous waste labels. Mr. Hannah and Mr. Wagner did not know if this was hazardous waste at the time of the inspection. Both containers were closed. There was no SAA signage at the area (*See attachment 1, Photo #210-#211*).

Two containers, one storing odorous aqueous waste and one storing odorous organic waste in hood, located in Room 430, Minerals Metallurgy Lab, on Floor 4
