Re: U.S. EPA-Region 1 Inspection Report of Solvay, September 7, 2022

RCRA Compliance Inspection of:

Solvay
1937 West Main Street
Stamford, CT 06902

RCRA HAZARDOUS WASTE INSPECTION REPORT

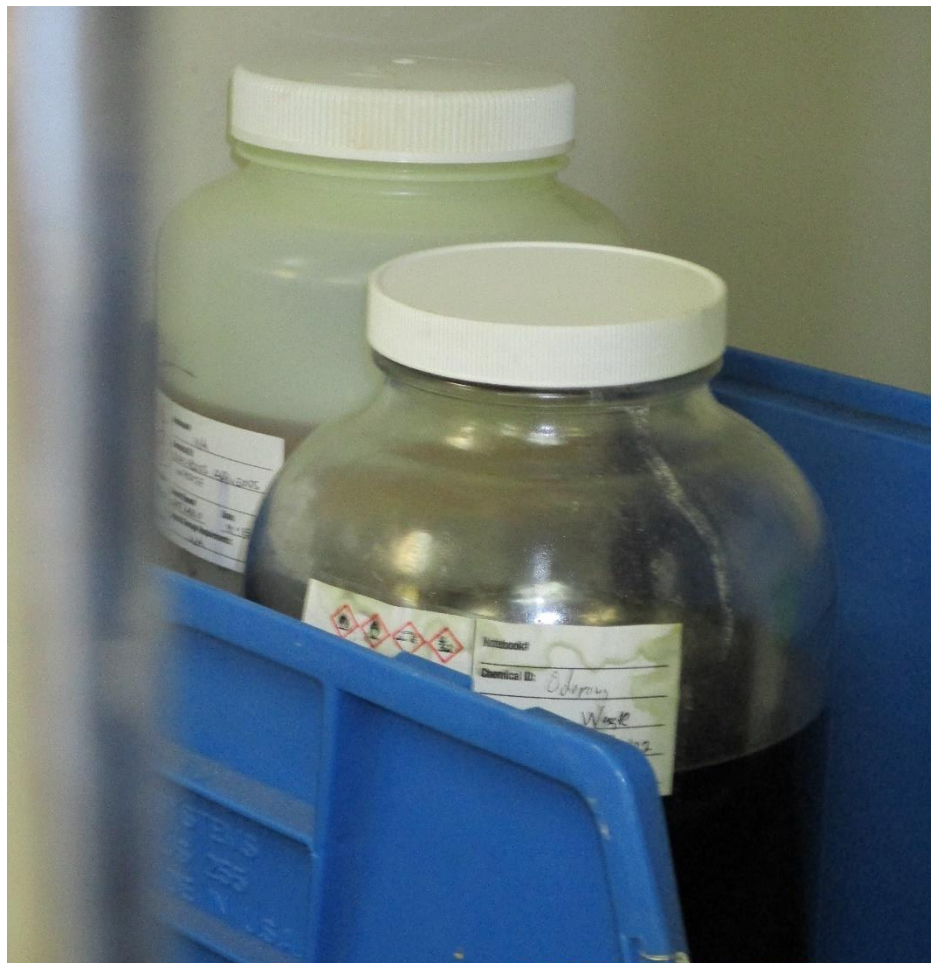
Photo 211

Minerals Metallurgical, Room 430, there was one blue box in a lab hood holding two containers. One was a glass jar, and the other was a plastic jar. The glass jar had “Odorous Waste” written on a label on the outside of the jar. The other container had “ODOROUS AQUEOUS WASTE” written on a label on the outside of the jar. Both containers did not have hazardous waste labels. Mr. Hannah and Mr. Wagner did not know if this was hazardous waste at the time of the inspection. Both containers were closed. There was no SAA signage at the area (*See attachment 1, Photo #210-#211*).

Two containers, one storing odorous aqueous waste and one storing odorous organic waste in hood, located in Room 430, Minerals Metallurgy Lab, on Floor 4

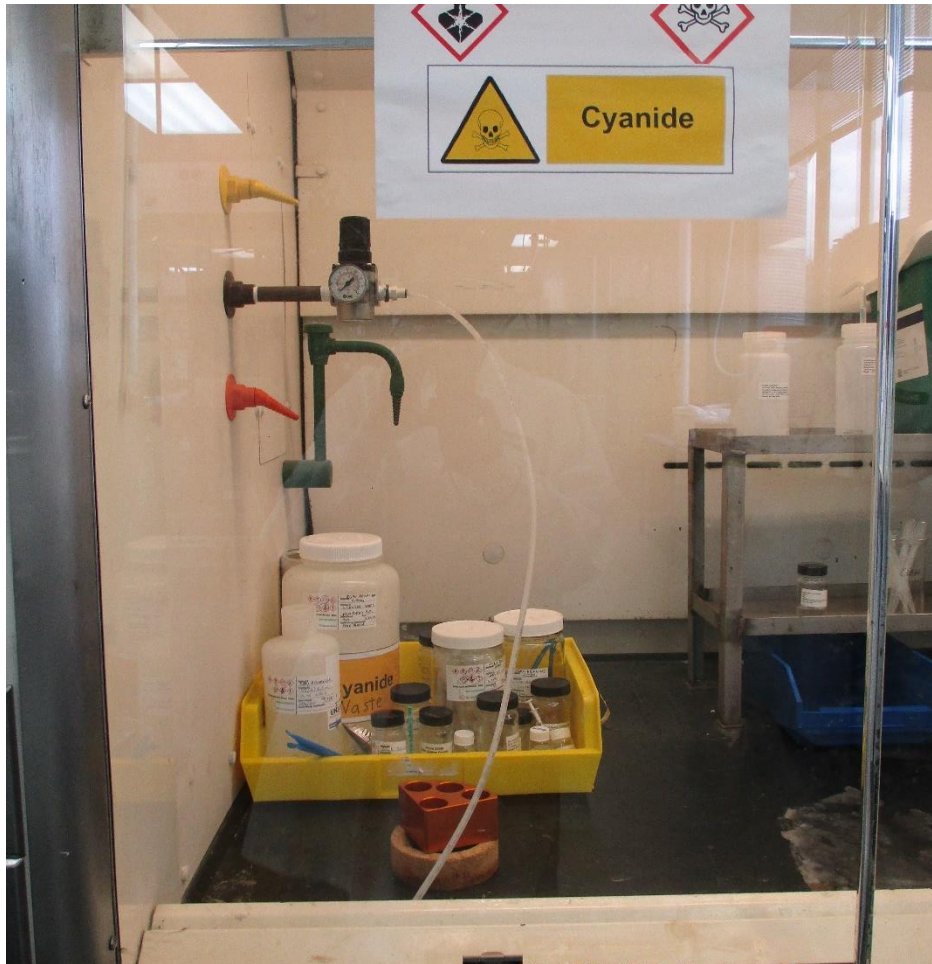
Photo 212

There was one yellow box inside a lab hood holding approximately 14 small containers. On the glass outside of the lab hood, there was a sign which read, “Caution: Cyanide use in Hood No Acids!” Not all labels on the small containers could be read through the hood glass door. The inspectors observed some containers which stated “waste” on their labels. The following containers that stated waste were observed, “10% ... Sodium Cyanide WASTE” with a date of 4/29/22. One container stated, “CYANIDE WASTE” and had a date of 3/26/19. One container stated, “CYANIDE... WASTE”. It was unknown if the other containers were waste or not. None of the containers had hazardous waste labels. The containers were not at a designated SAA. All of the containers were closed. (*See attachment 1, Photo #212-#215*).

Yellow container holding small containers, some waste cyanide in hood, located in Room 430, Minerals Metallurgy Lab, on Floor 4

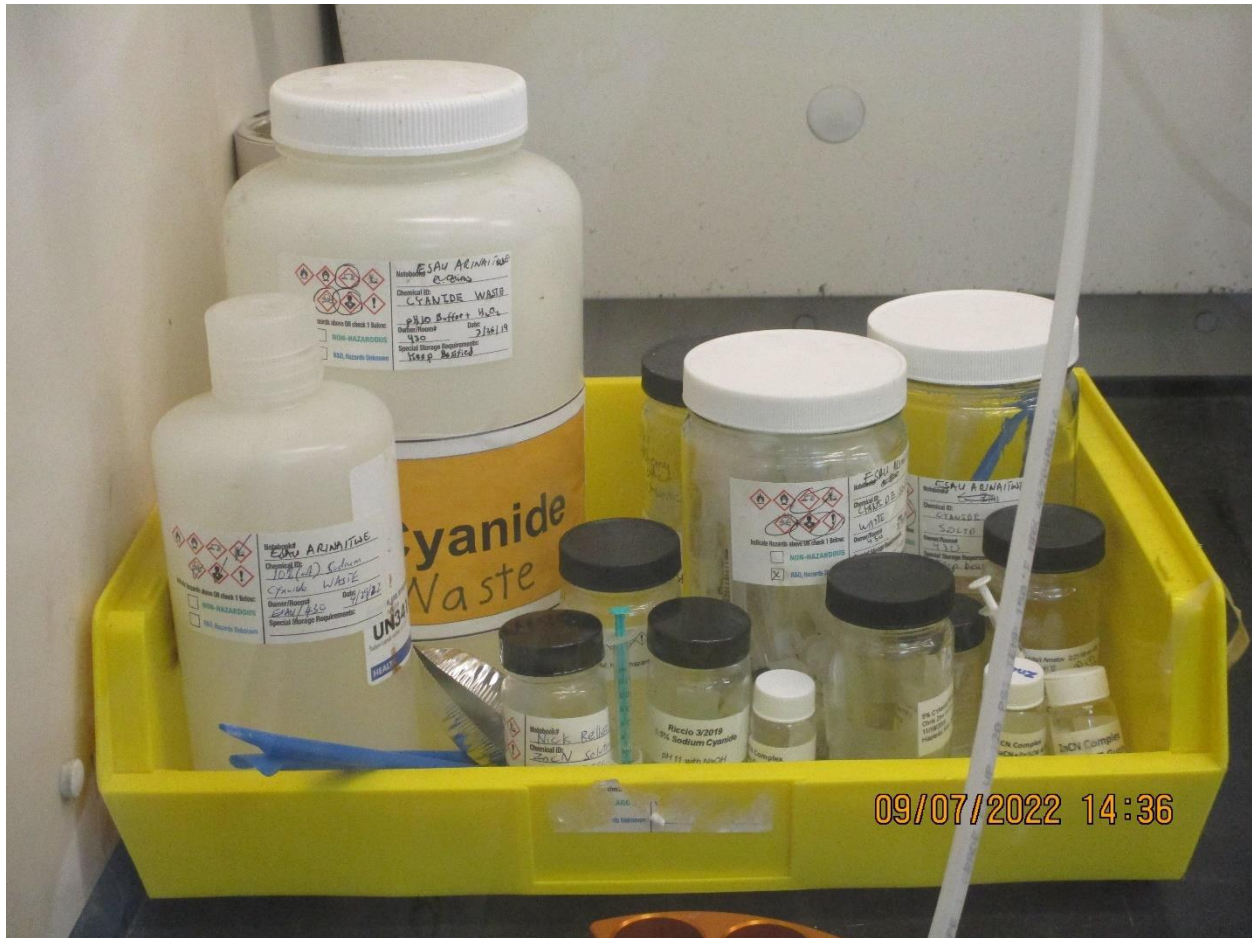
Photo 213

Yellow container holding small containers, some waste cyanide in hood, located in Room 430, Minerals Metallurgy Lab, on Floor 4

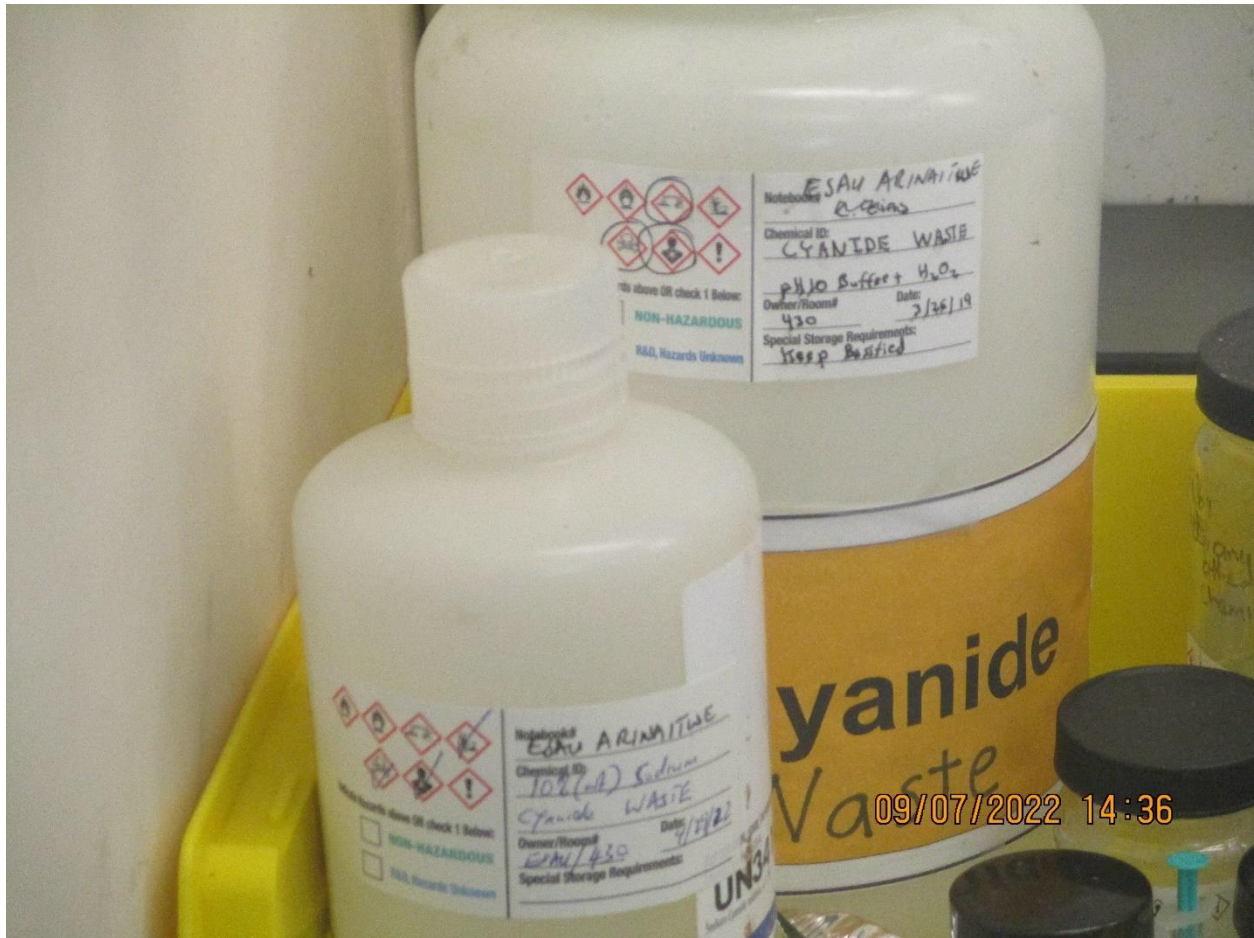
Photo 214

Some containers inside yellow container holding small containers, some waste cyanide in hood, located in Room 430, Minerals Metallurgy Lab, on Floor 4

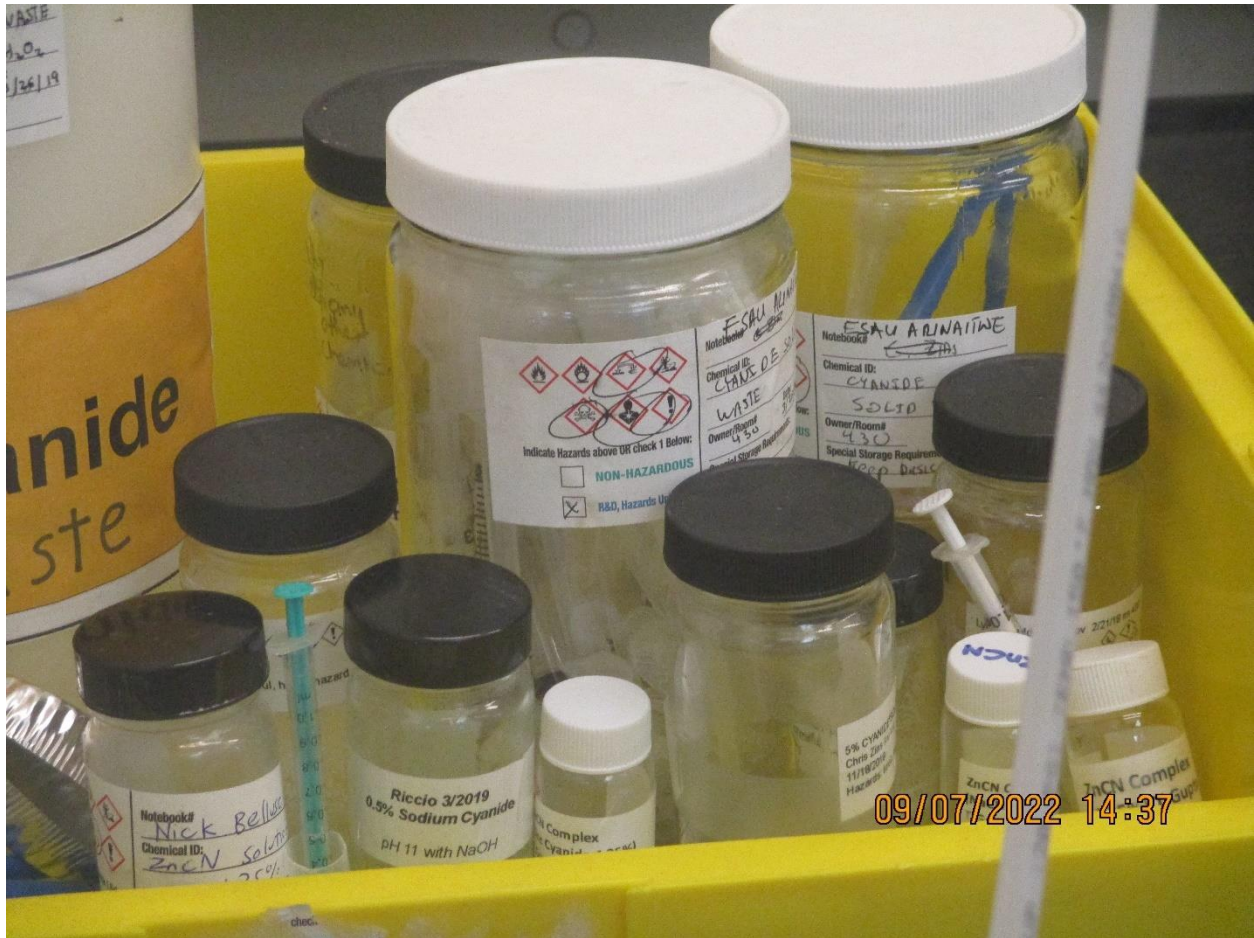
Photo 215

Some containers inside yellow container holding small containers, some waste cyanide in hood, located in Room 430, Minerals Metallurgy Lab, on Floor 4

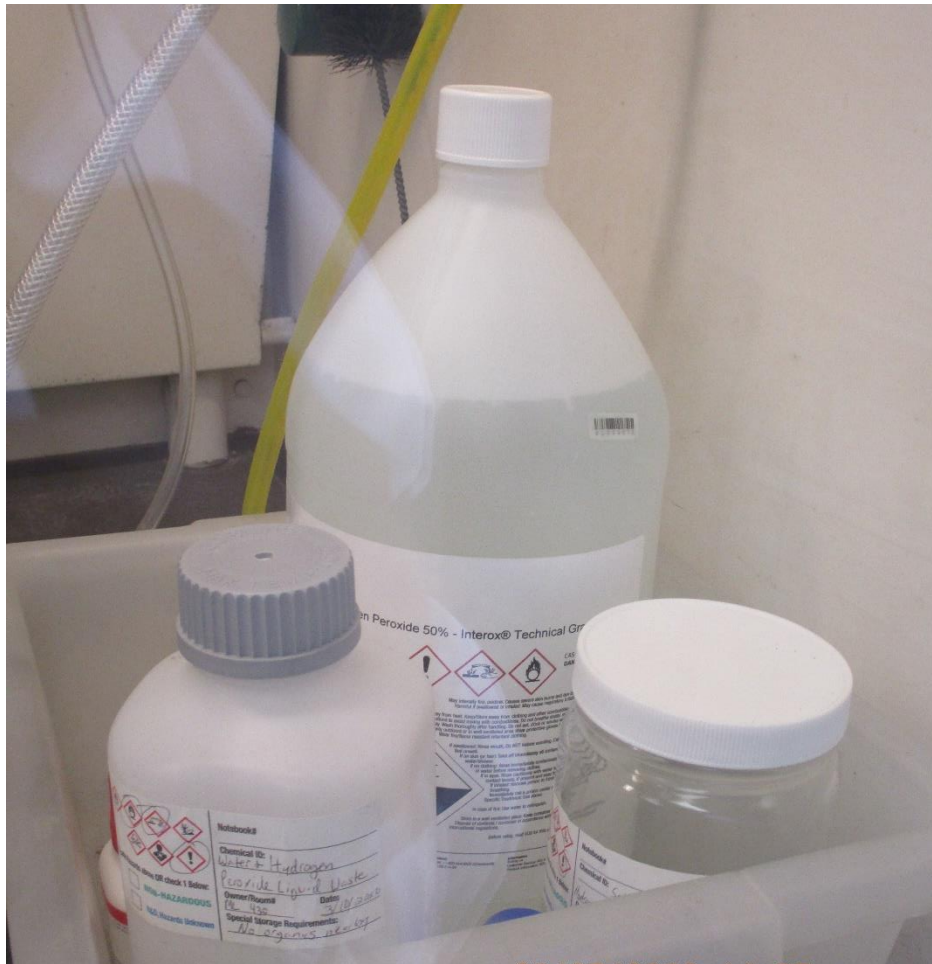
Photo 216

hazardous waste labels. There was no SAA sign at the area (*See attachment 1, Photo #216*).

White container holding containers, one waste hydrogen peroxide in hood, located in Room 430, Minerals Metallurgy Lab, on Floor 4
