## RCRA COMPLIANCE EVALUATION INSPECTION REPORT

TAV Holdings, Inc.  
3311 Empire Boulevard SW  
Atlanta, Georgia 30354  
EPA ID # GAD033537663

October 6, 2021

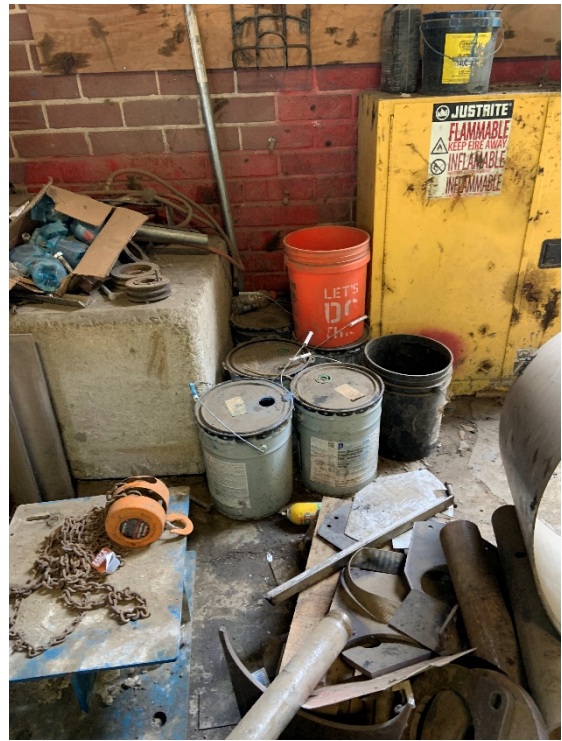
*Figure 9: IMG\_3078.jpg – Paint bucket with liquid in it in the Fabrication Building*

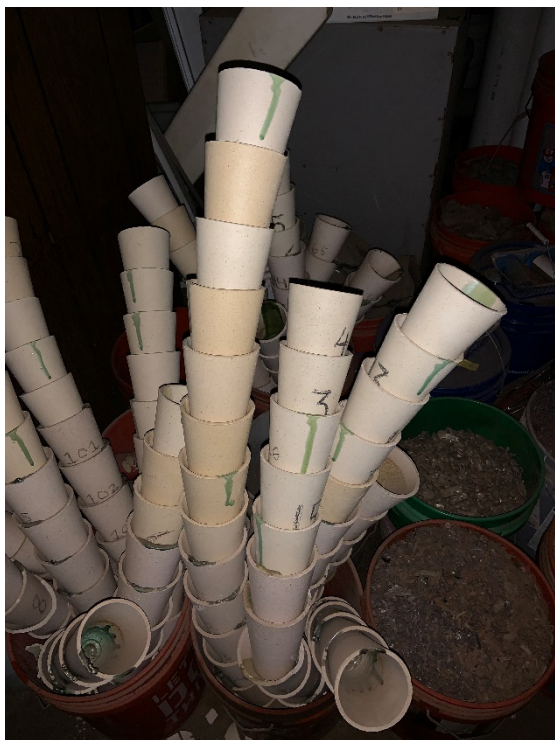
*Figure 41: IMG\_3110.jpg- Containers of unknown waste in the Keebler Building*

*Figure 42: IMG\_3111.jpg- Containers of unknown waste in the Keebler Building*

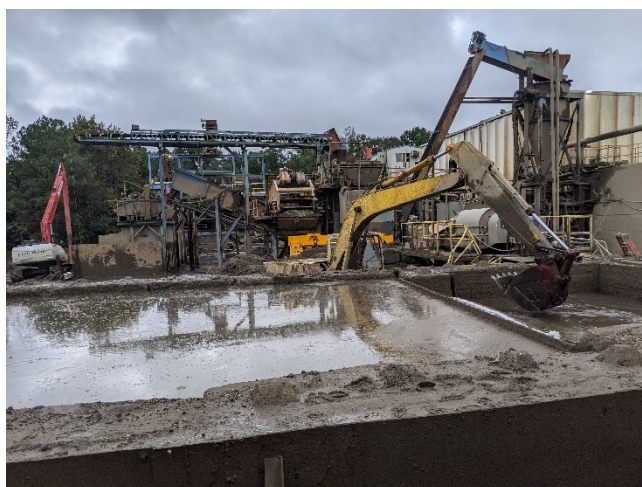
The area to the northwest of the WWT Area is used to store this material. The facility claims that the solid waste material continues to contain recoverable metals. However, the inspectors observed that the material is being allowed to wash offsite with stormwater. The facility has failed to manage the material as a commodity.

*Figure 60: PXL\_20211006\_145602623.jpg – Solid Waste stored near the Wastewater Treatment area*

*Figure 61: PXL\_20211006\_145612675.MP.jpg – Solid Waste stored near the Waste Water Treatment area*

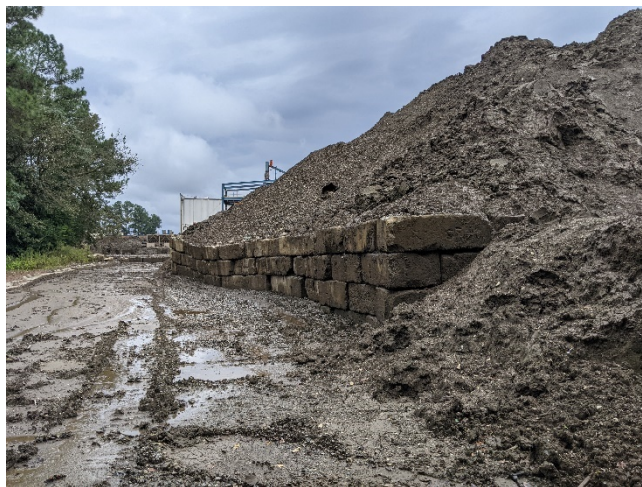
*Figure 97: PXL\_20211006\_181046518.jpg –  
Rear side of solid waste pile near Outfall 3*

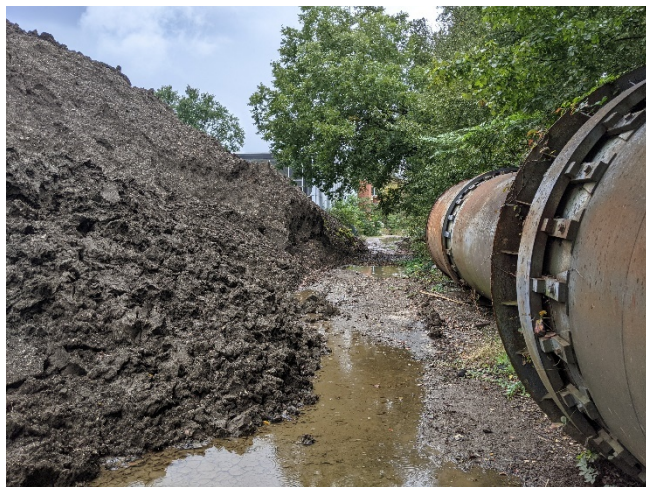
*Figure 98: PXL\_20211006\_181114686.jpg –  
Rear side of solid waste pile near Outfall 3*
