INSPECTION REPORT

| Type of Inspection | Compliance Evaluation Inspection (CEI) | | |
| Company Name | PACCAR, Inc. | | |
| Facility or Site Name | Kenworth Truck Co Renton | | |

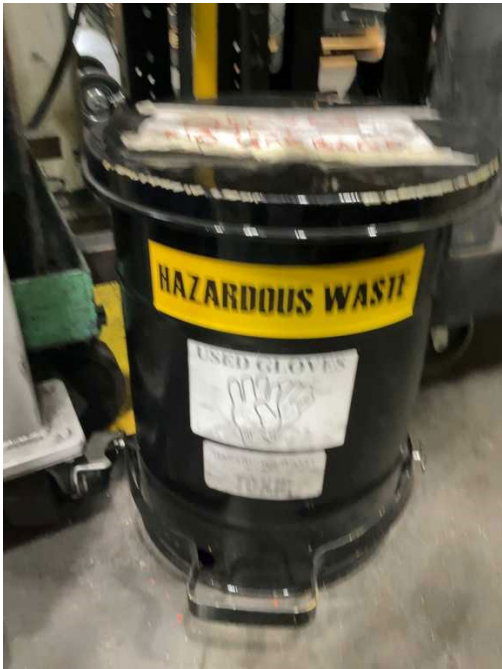
| Assembly Building /Frame Floor | | | 47.49398241, -122.19867392 |

| A close-up view of the same five-gallon SAA container, showing that the waste glove is preventing the lid from closing completely. | | | |

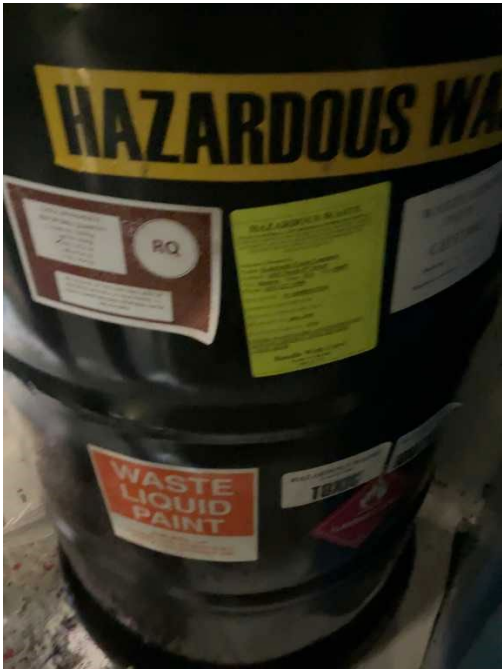
| 55-gallon SAA container of waste liquid paint is not closed. Small bung plug was missing, and bung hole was open and not closed. | <b>Regulation:</b> | <b>Sections:</b> |

| Another view of the same 55-gallon SAA container of waste liquid paint, looking down into the funnel, showing that the container was not closed. | | | |

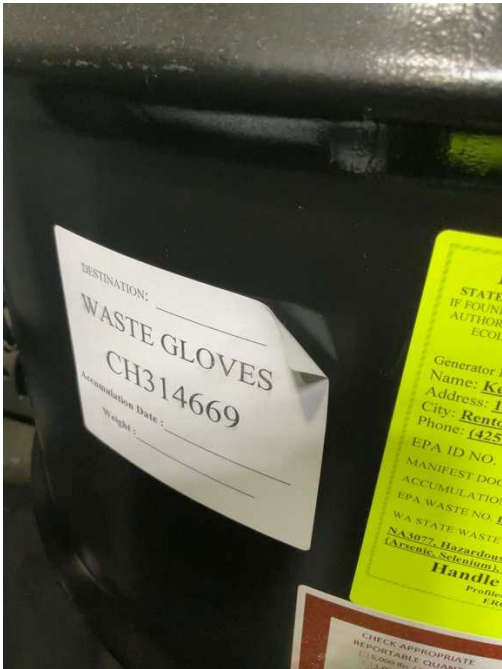
| Close-up view of 55-gallon accumulation container of waste gloves, on the south side of chassis oven, showing it is not marked with an accumulation start date. | | | |

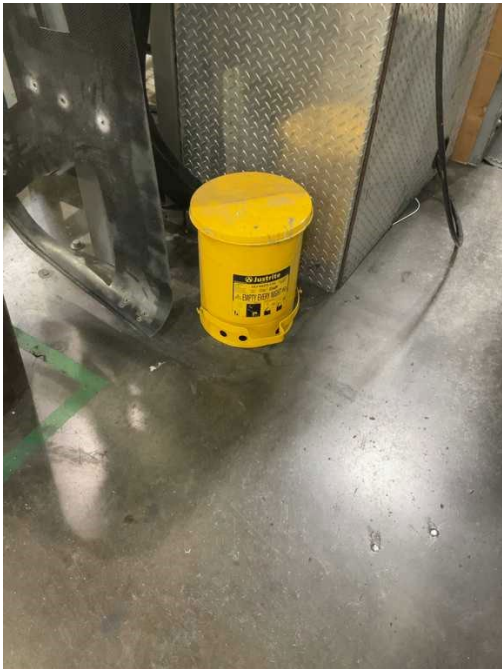
| Close-up view of five-gallon SAA step-can container, holding waste shop towels, that is not closed. | | | |

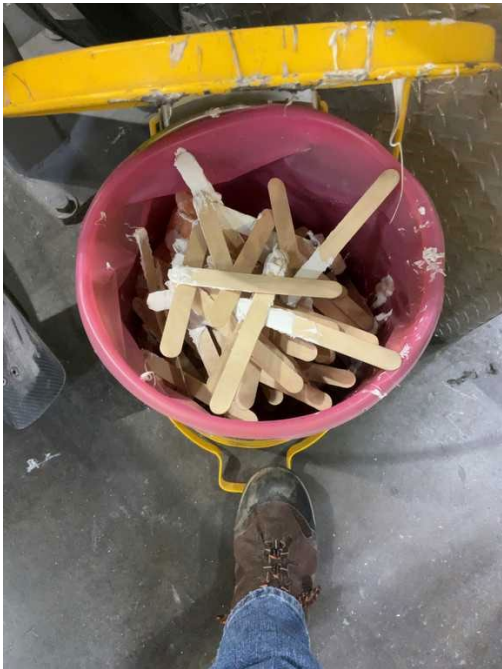
| Close-up view of a five-gallon step-can containing a WA State only waste that is being managed as “Special Waste.” | | | |

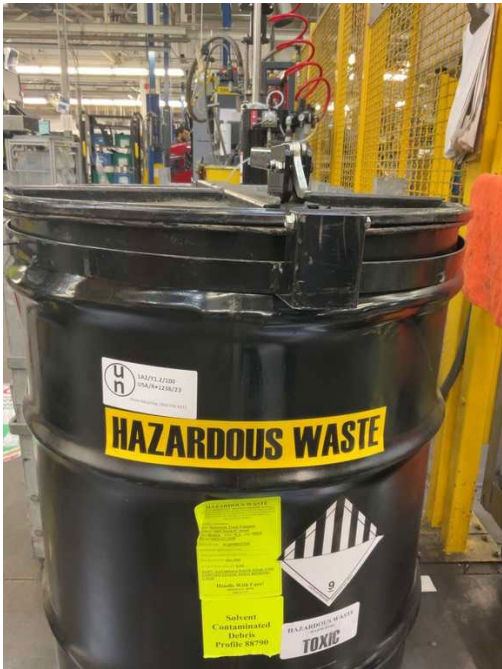
| View of 55-gallon SAA container of waste solvent contaminated debris that is not closed. | | | |

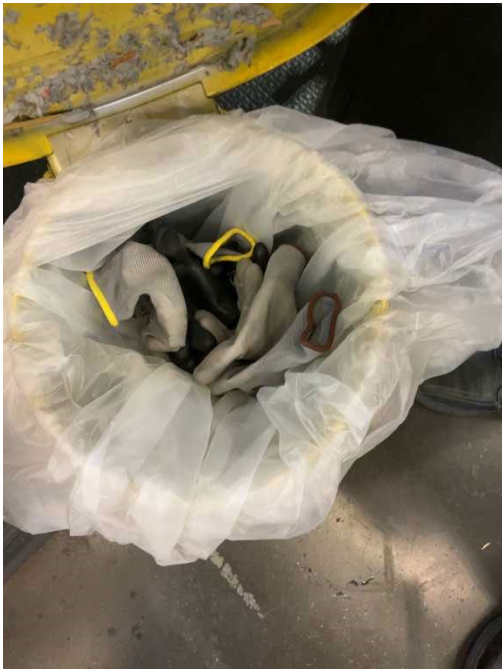
| Close-up view of yellow, SAA step-can for waste solvent contaminated debris, but containing waste gloves, and not closed. | | | |

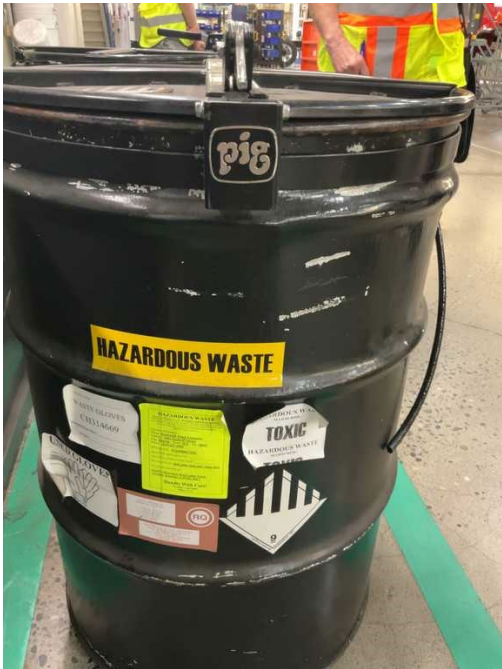
| View of 55-gallon waste glove accumulation container, seen here without an ASD and not closed. | | | |

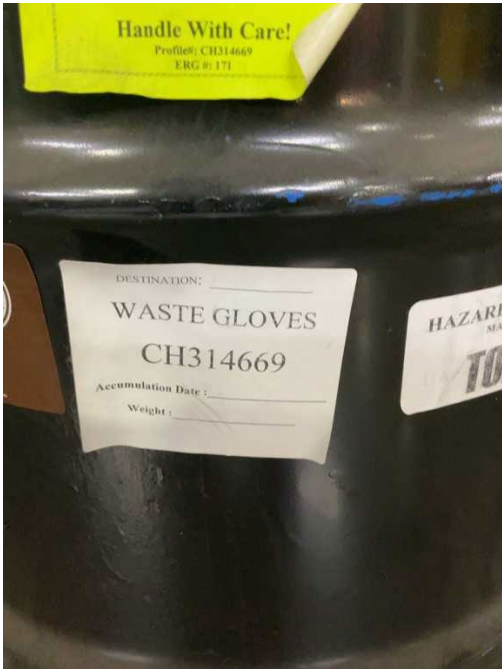
| Close-up view of 55-gallon waste glove accumulation container that is not marked with an ASD and not being inspected weekly. | | | |

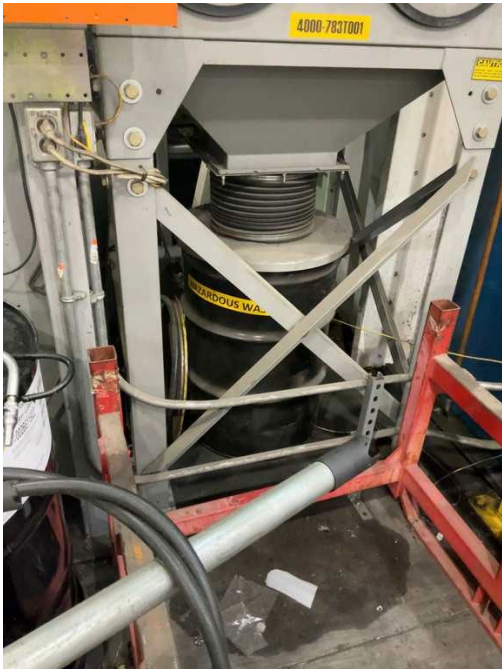
| View of used oil collection container, seen here not closed. | | | |

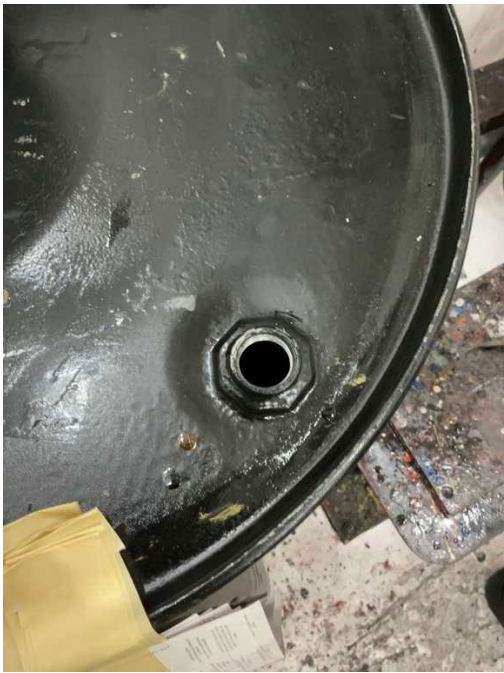
| View of 55-gallon SAA container for waste liquid paint, seen here not closed with small bung wide open. | | | |

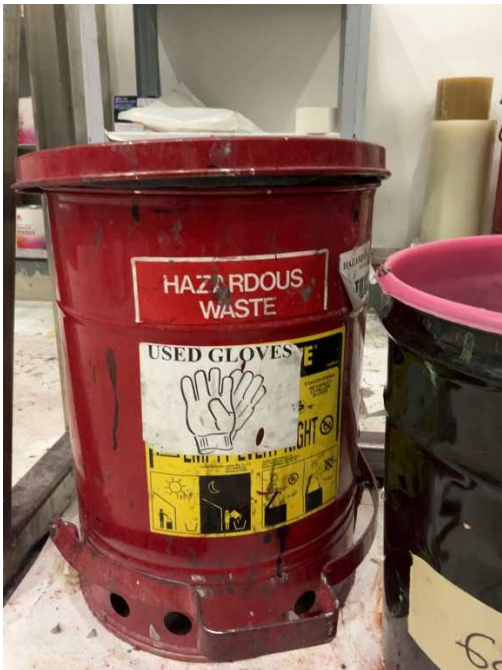
| View of SAA step-can (Red), for waste gloves, that is not closed. | | | |

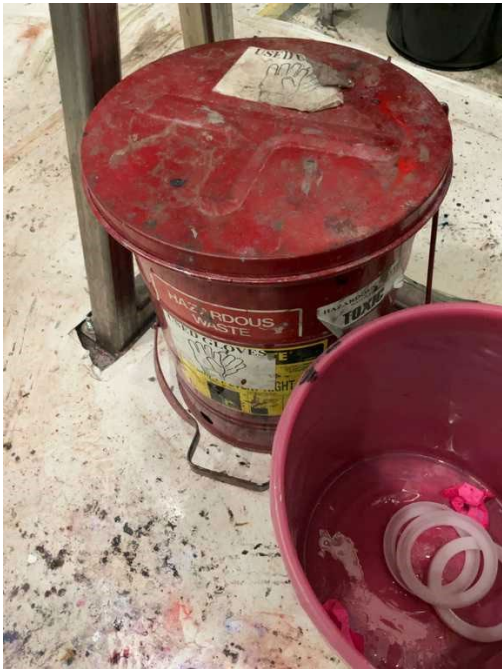
| Another view of SAA step-can (Red), for waste gloves, that is not closed. | | | |

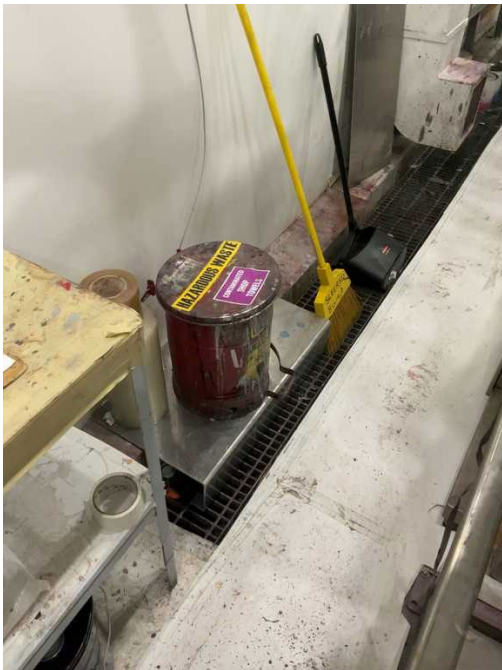
| Another view of SAA step-can (Red), for waste gloves, that is not closed. | | | |

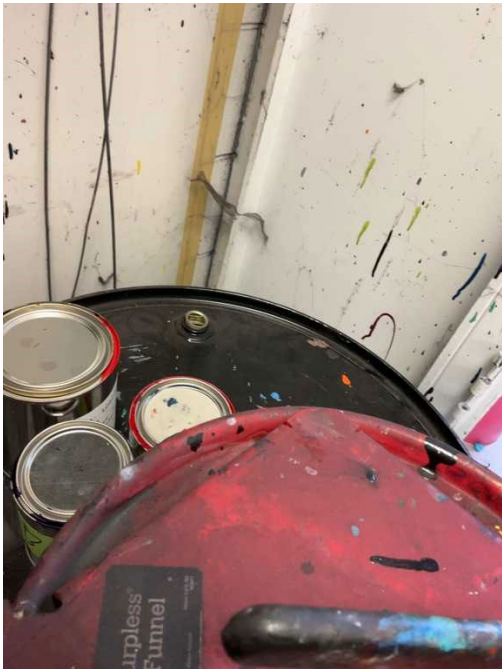
| Close-up view of 55-gallon SAA container for waste liquid paint, seen here with funnel not closed. | | | |

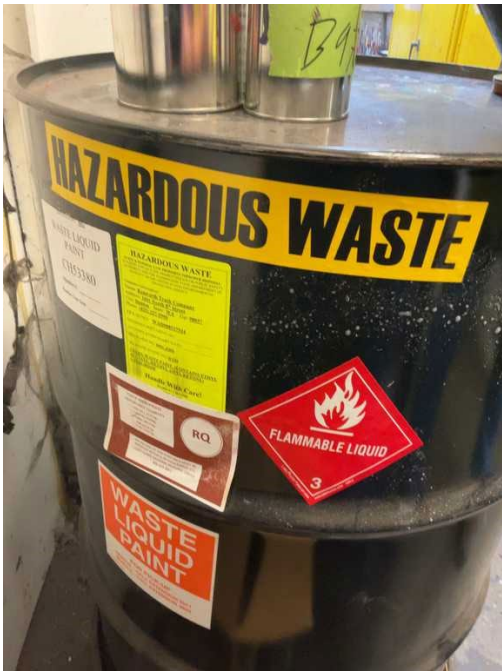
| Another close-up view of 55-gallon SAA container for waste liquid paint, seen here with small bung not closed, due to bung plug being mis threaded. | | | |

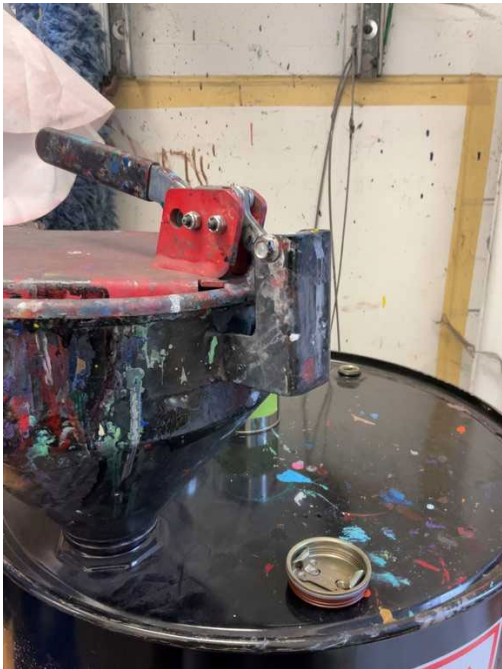
| Close-up view of labeling on 55-gallon SAA container for waste liquid paint. | | | |

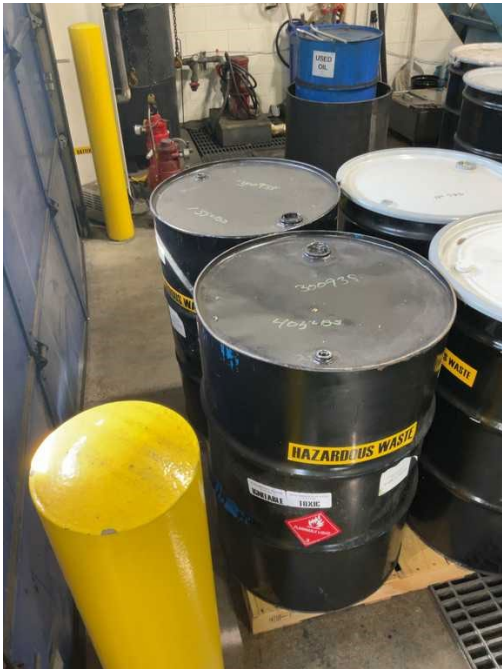
| A pallet with four, 55-gallon hazardous waste accumulation containers was straddling the containment drain and two of the four waste containers were situated between the drain and a roll up door and not actually within the area of containment. | <b>Regulation:</b> | <b>Sections:</b> |

| Another view of pallet with four hazardous waste containers seen here with two of the four containers outside of the containment area. | | | |

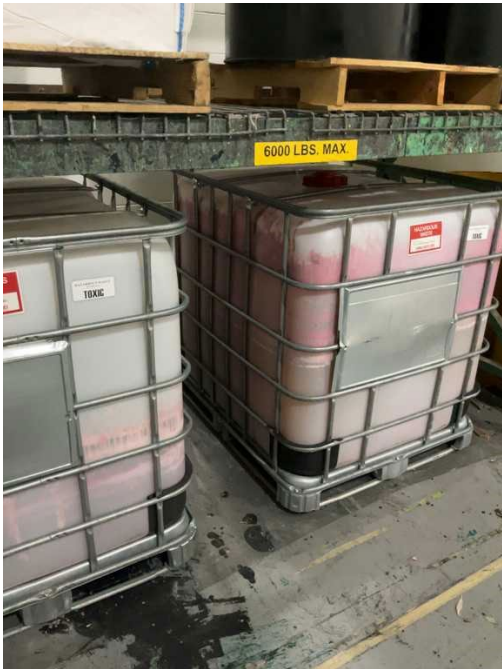
| Close-up view of the labeling on 275-gallon waste tote. | | | |

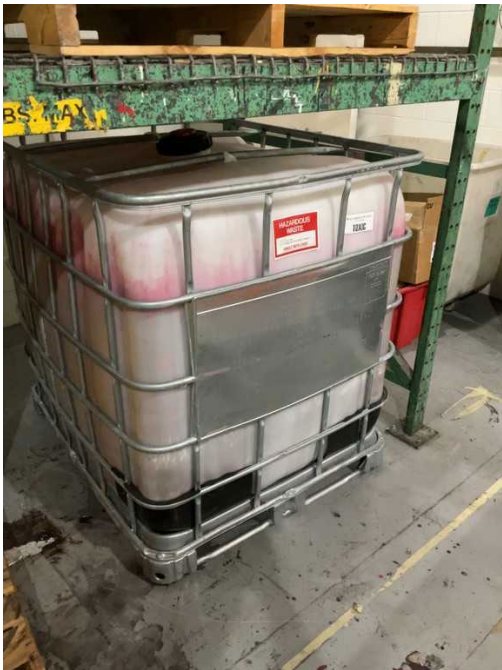
| View of two of the three 275-gallon waste totes seen here after being labeled with the hazard/risk indicator. | | | |
