U.S. Environmental Protection Agency Region 5

Purpose: Industrial User Pretreatment Compliance Inspection

Facility: Manasek Acquisition Company, LLC d/b/a Warner Bodies
11700 North SR37
Elwood, Indiana 46036

Inspection Date: April 14 and 15, 2021

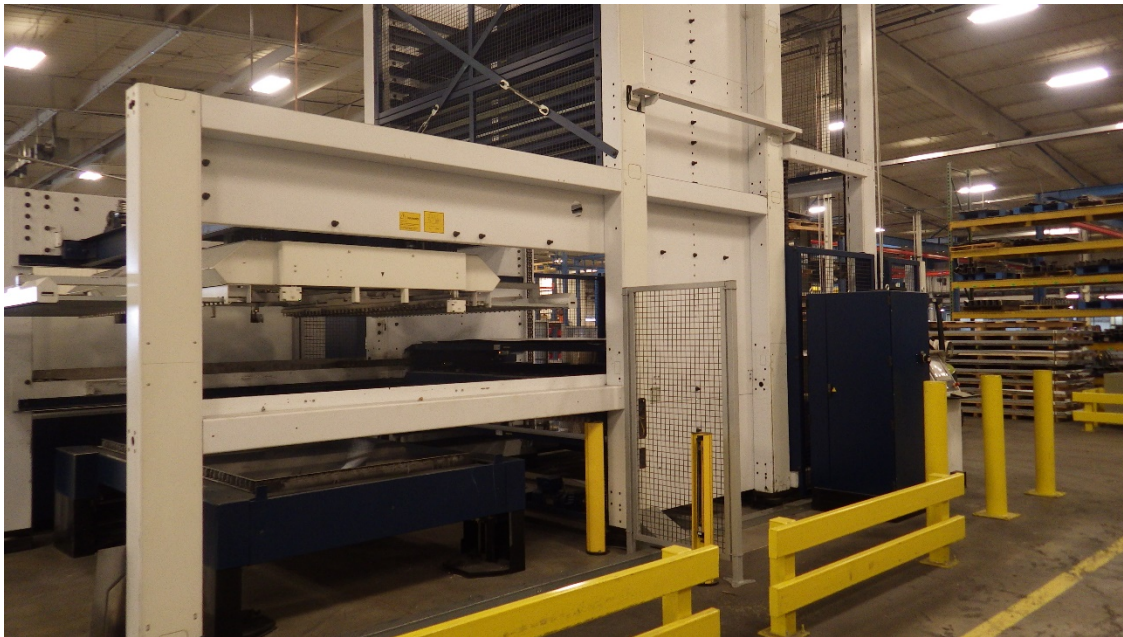
3: RIMG0003

Description: Laser cutting machine with an automatic feeder.

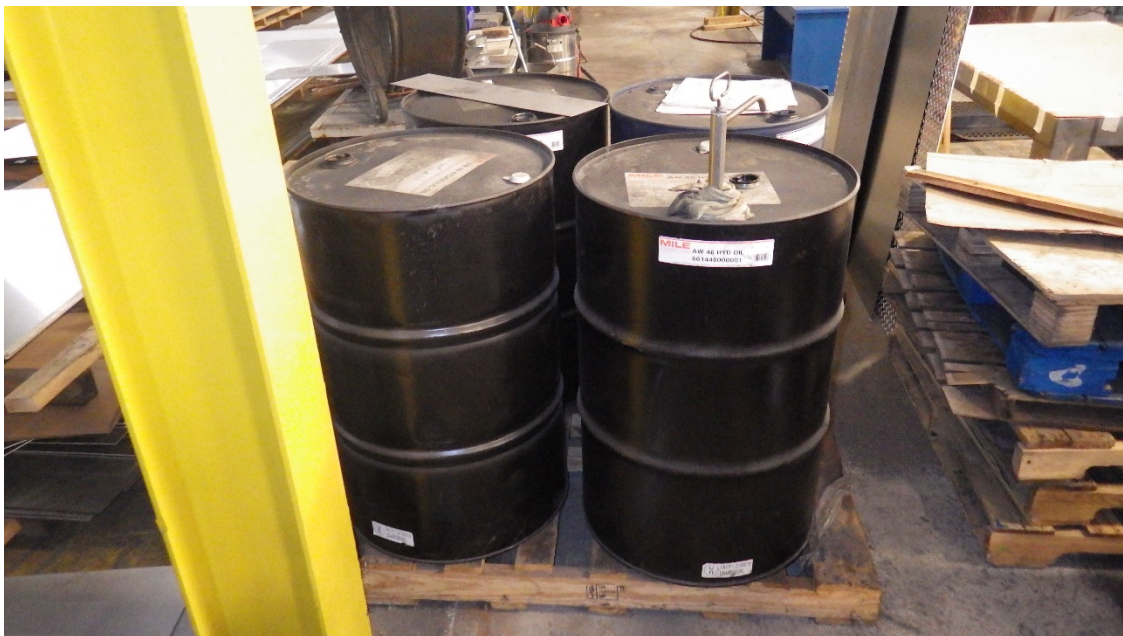
4: RIMG0004

Description: Hyrdraulic Oil in 55 gallon drums.

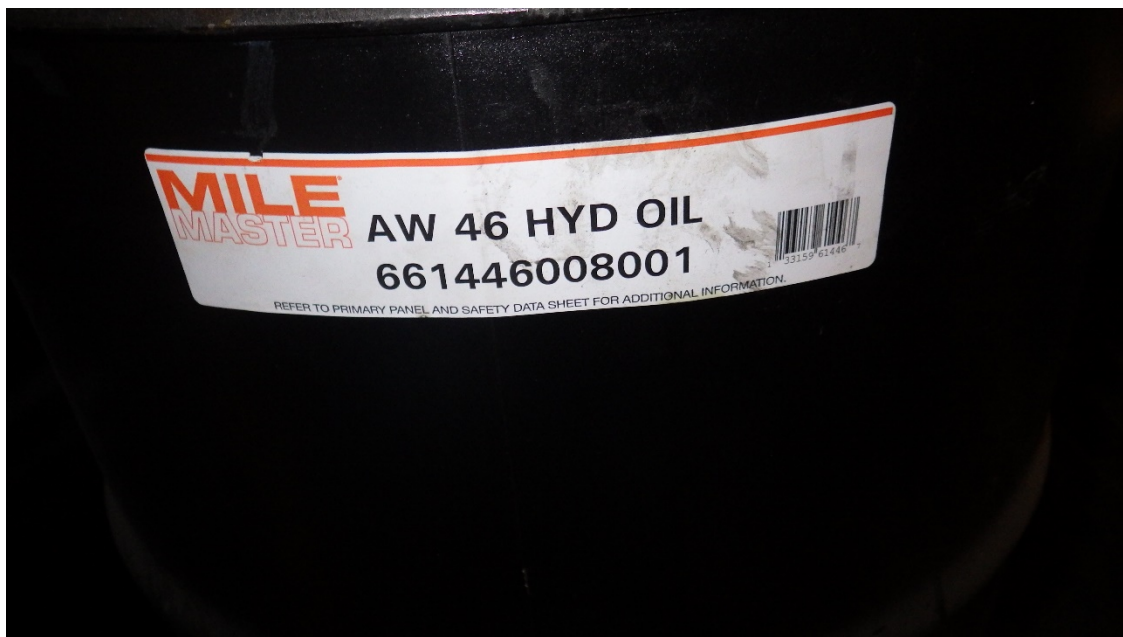
5: RIMG0005

Description: Hyrdraulic Oil in 55 gallon drums.

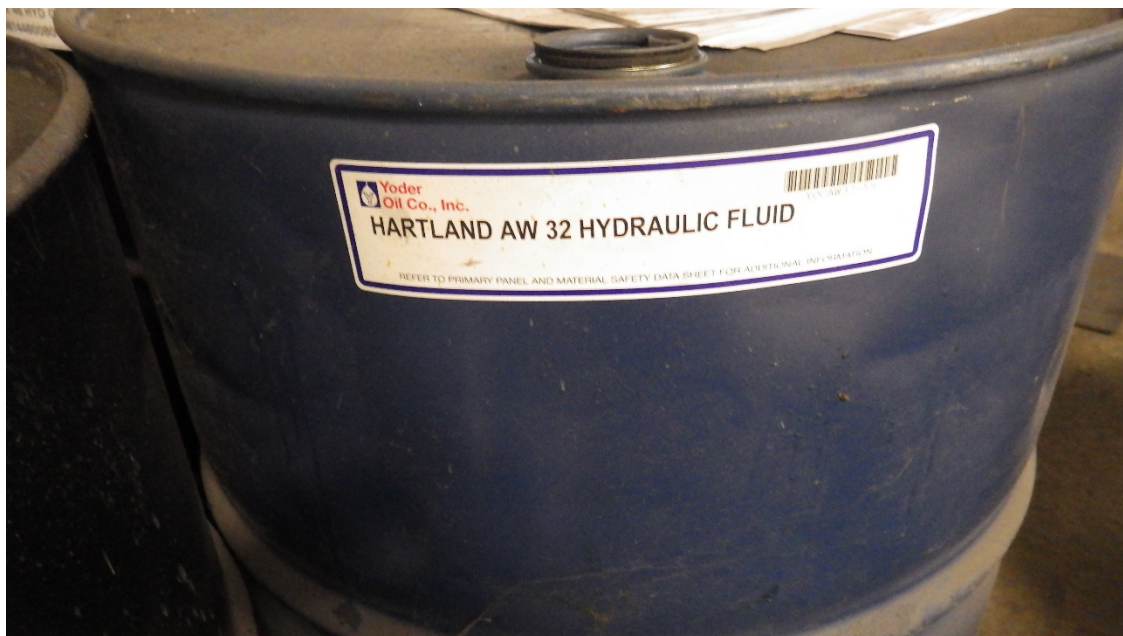
6: RIMG0006

Description: Hyrdraulic Oil in 55 gallon drums.

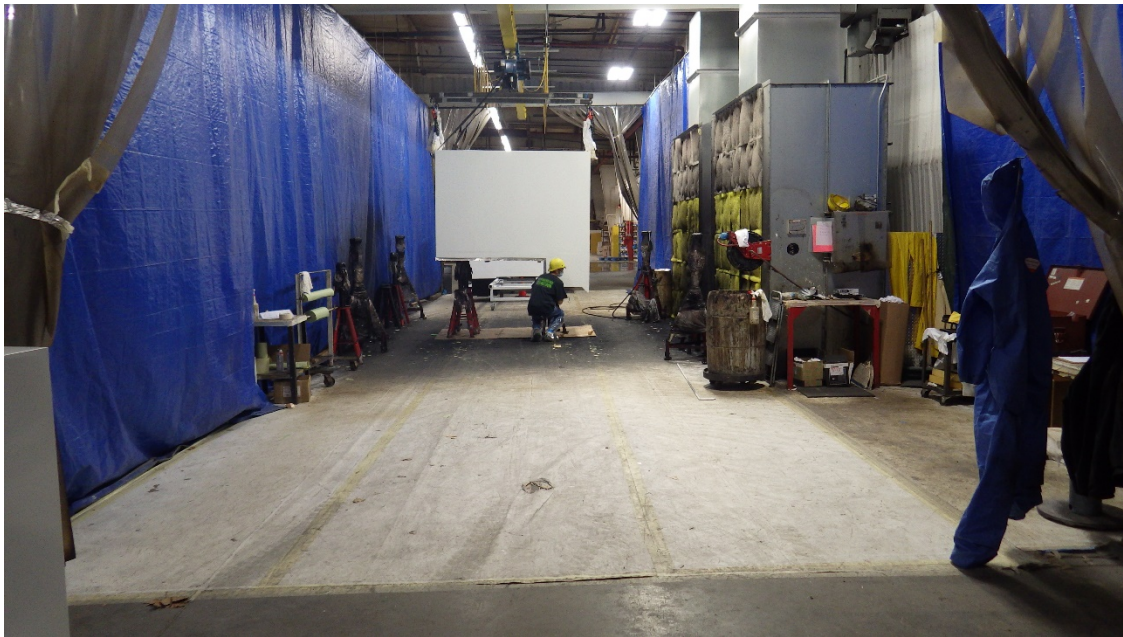
17: RIMG0017

Description: Undercoating area.

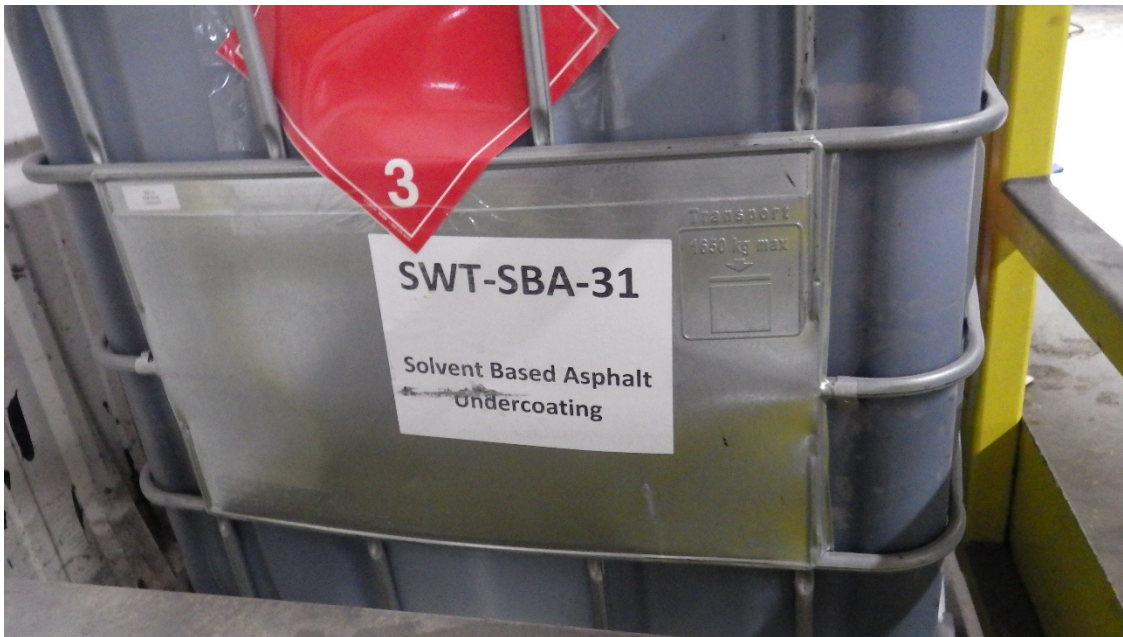
23: RIMG0023

Description: Asphalt based undercoating.

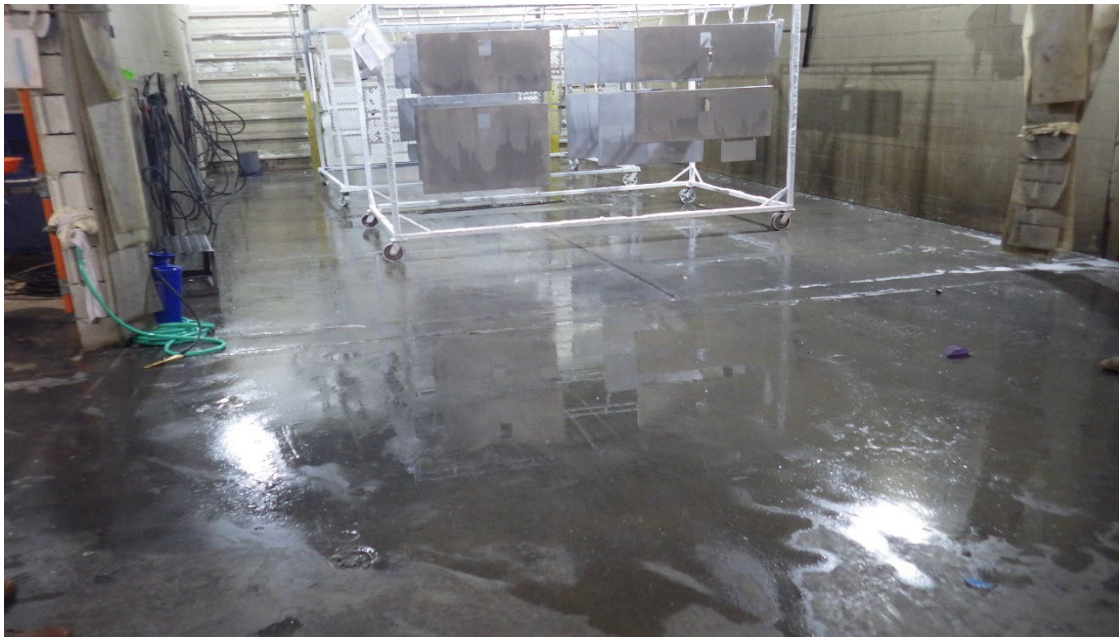
26: RIMG0026

Description: Parts wash area.

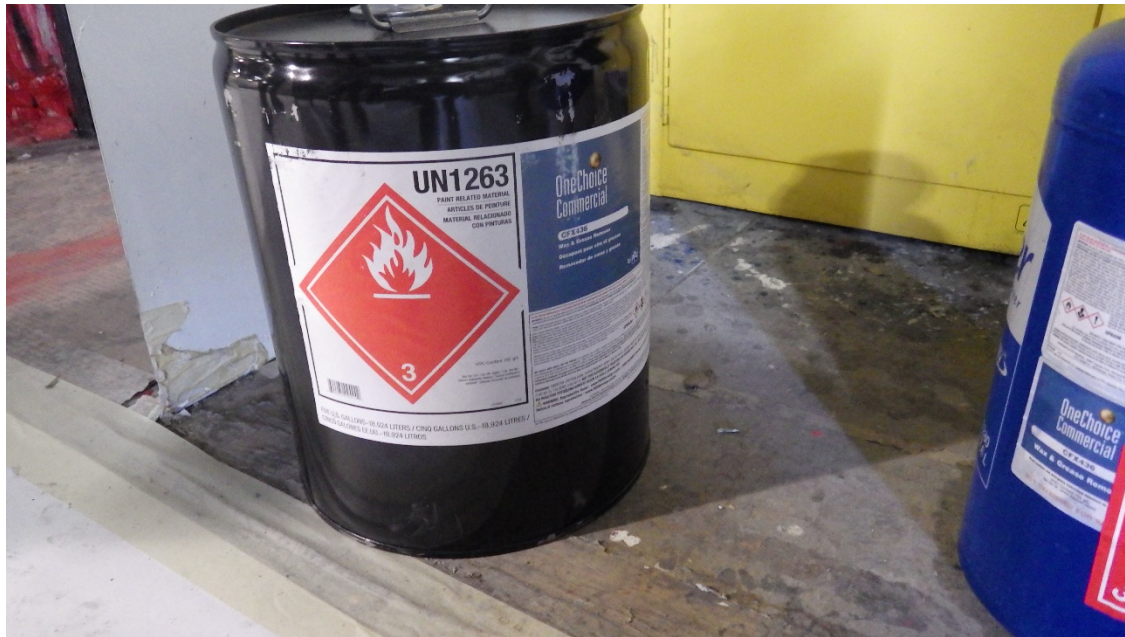
35: RIMG0035

We continued the tour to inspect the materials used for the washing operation. The washing area staff first applies the degreaser with the use of a blue tank sprayer (photo 34) on the body parts brought into the wash area, followed by etching/wash conditioner (photo 33) and ending with water rinse and applying the conversion coating spray (photo 32). The coil conditioner and coating chemicals are stored in white 55-gallon plastic drums on a large (yellow) spill-containment tote (photo 31) that can store four such drums. Mr. Henley mentioned that the degreaser could be the single largest source of “toluene” causing the facility’s TTO exceedances. He stated that he is looking into alternative degreasers without the toluene as an ingredient.

Description: Wash chemicals – new degreaser.

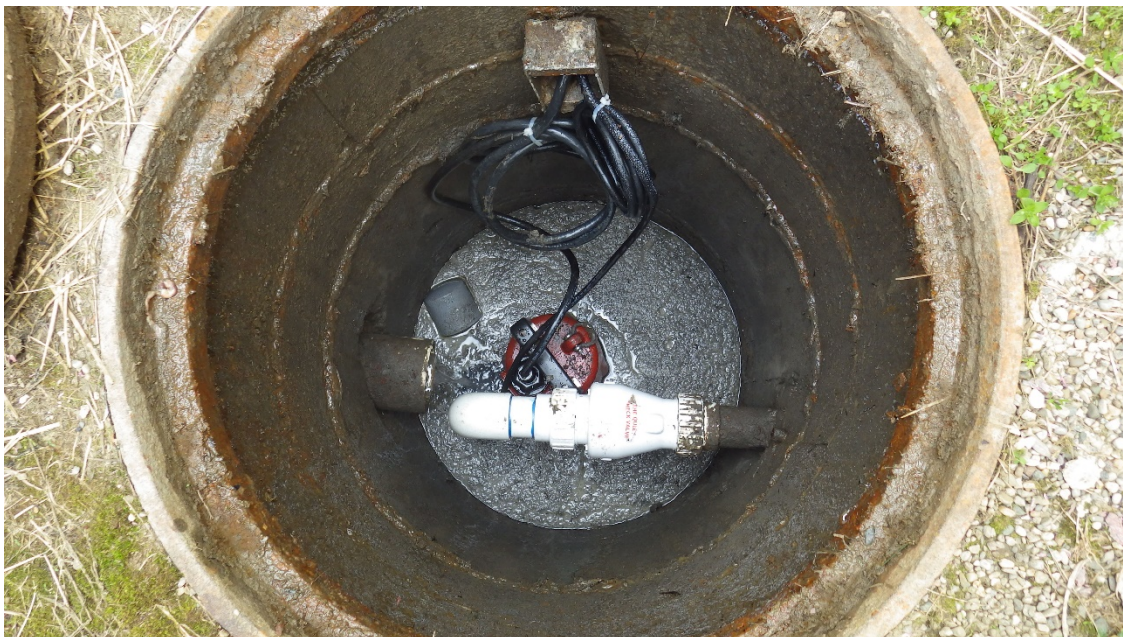
43: RIMG0043

Description: Final stage pretreatment take with pump to discharge pipe.

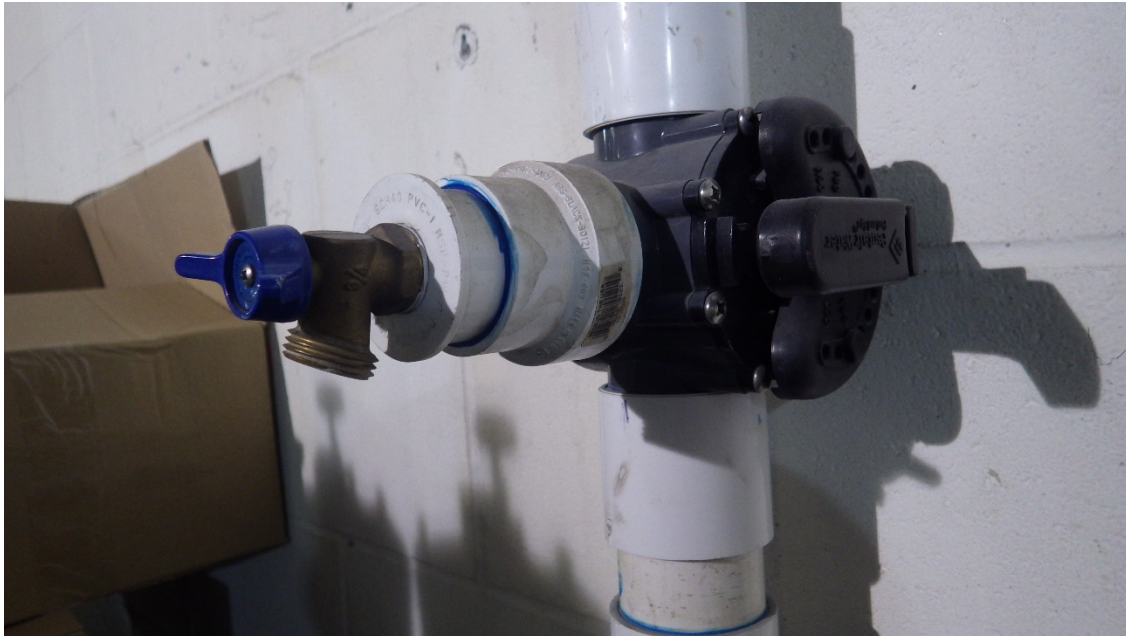
46: RIMG0046

Description: Discharge sampling location above discharge flow meter.

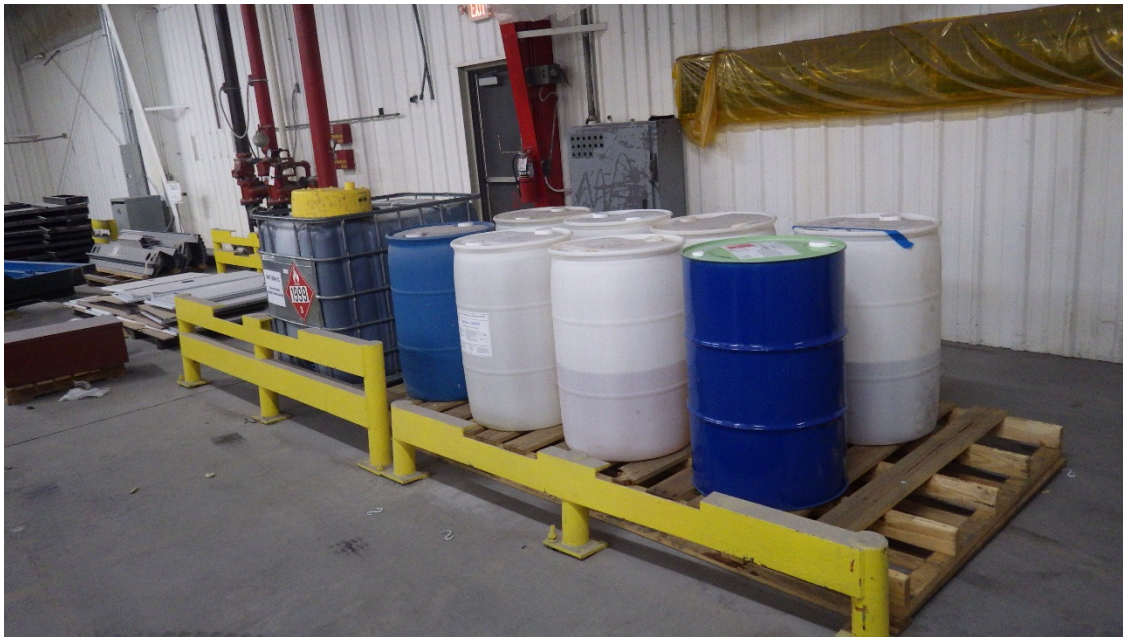
56: RIMG0056

Description: Chemical storage located in northwest corner of western portion of the facility.
Location: Northwest corner of western portion of the facility.

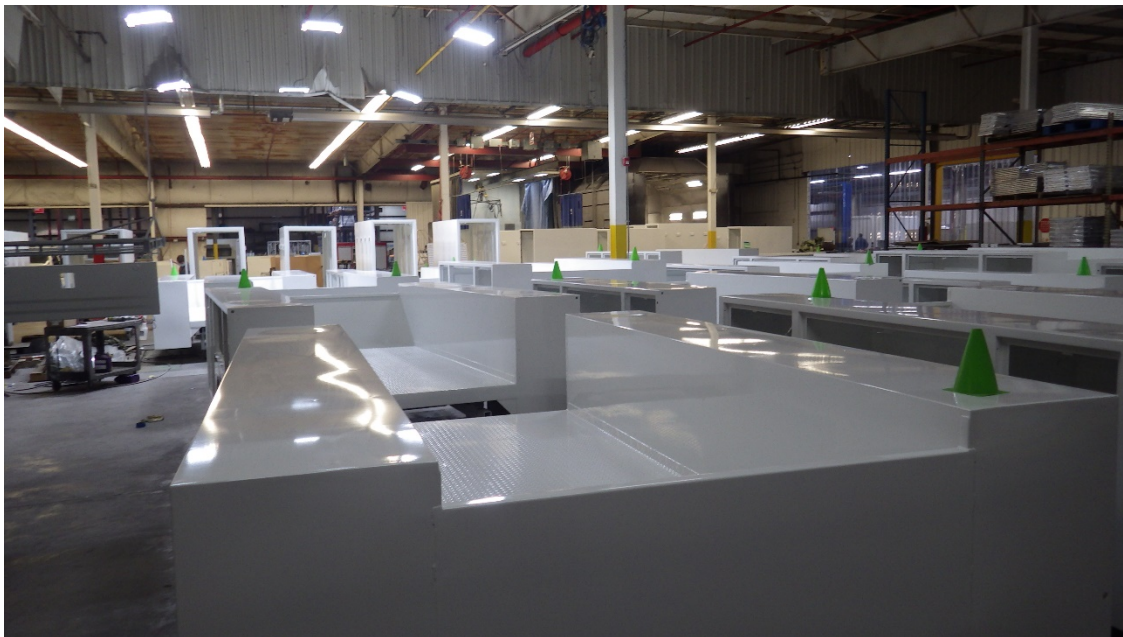
57: RIMG0057

Description: Finished product assembly.

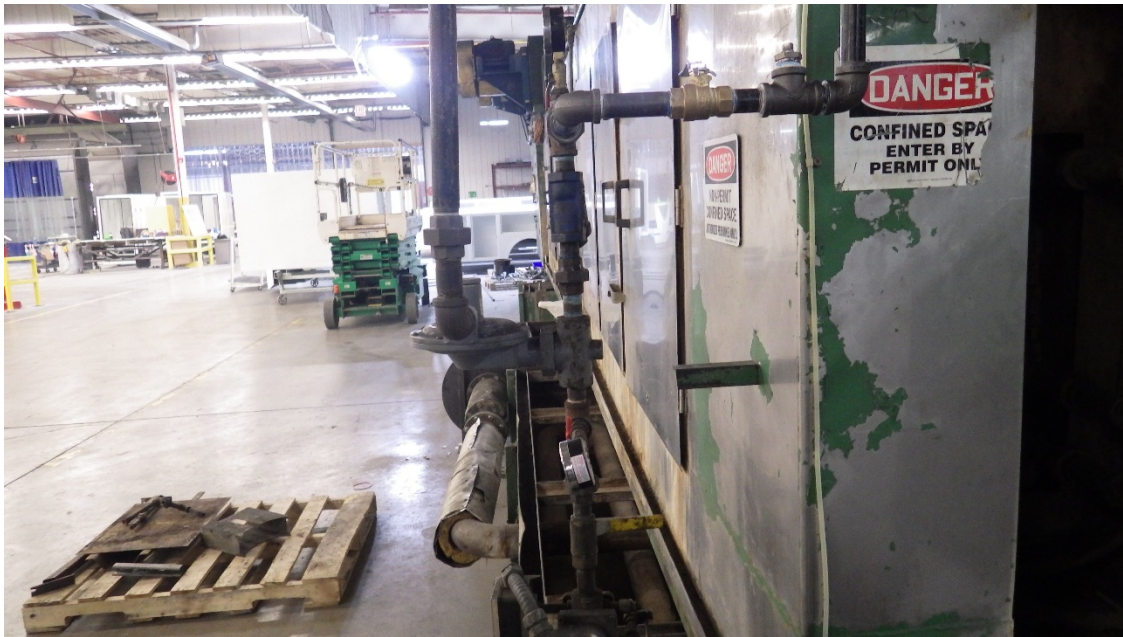
58: RIMG0058

Description: Newly purchased parts washer (not yet installed).

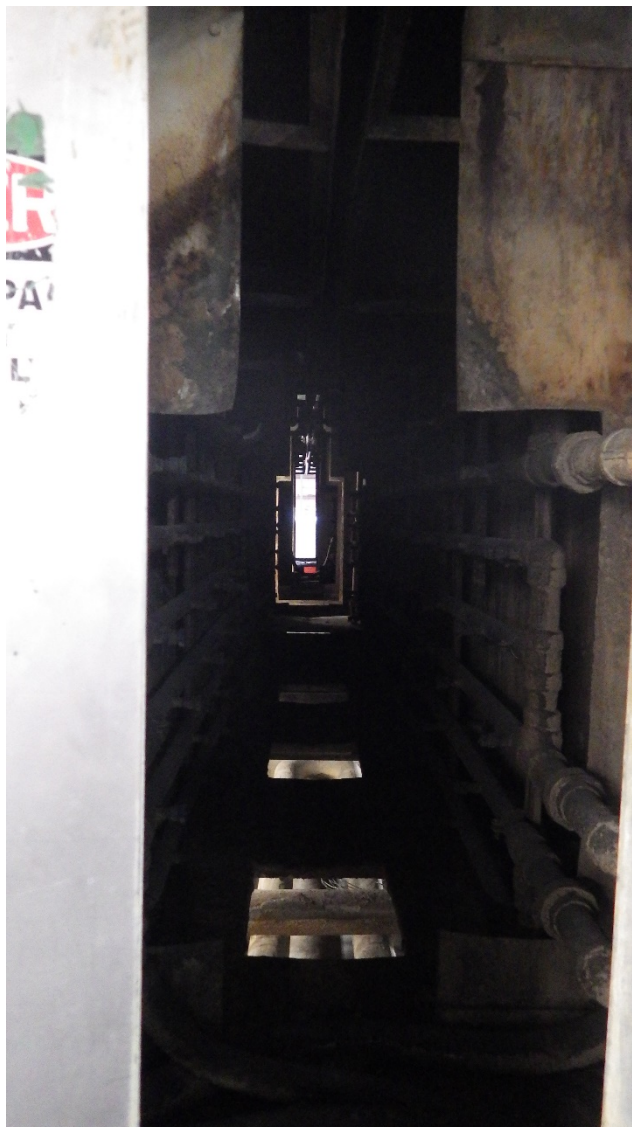
59: RIMG0059

Description: Newly purchased parts washer (not yet installed).

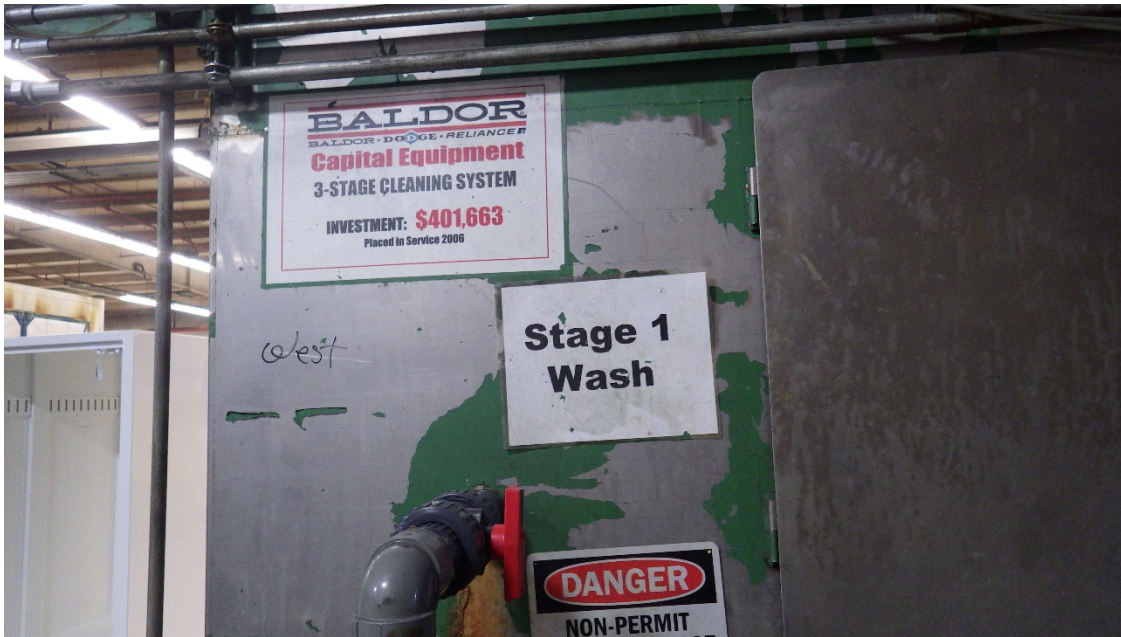
60: RIMG0060

Description: Newly purchased parts washer (not yet installed).

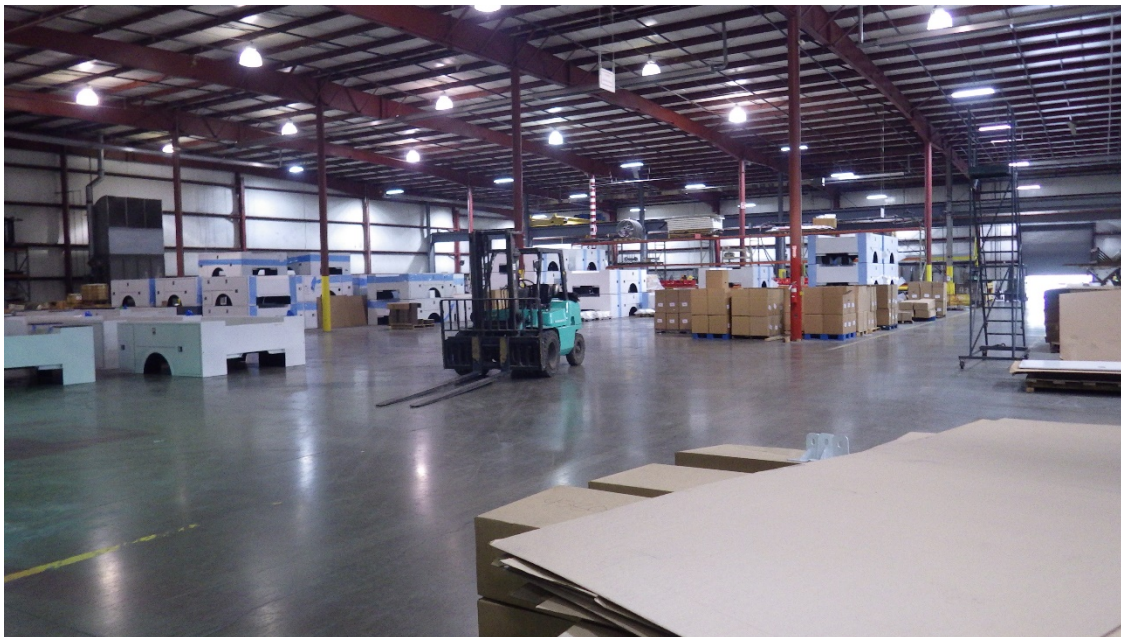
61: RIMG0061

We continued the inspection towards the southwest portion of the facility where we observed the shipping area (photo 61) and custom fire truck bodies assembly area (photo 63). Mr. Manasek escorted us to a small production area dedicated for the assembly of new food processing equipment and to conduct repairs on pulpers, finishers, coils, and other parts of the food processing equipment (photo 62). There are no floor drains in this portion of the building.

Description: Shipping area.

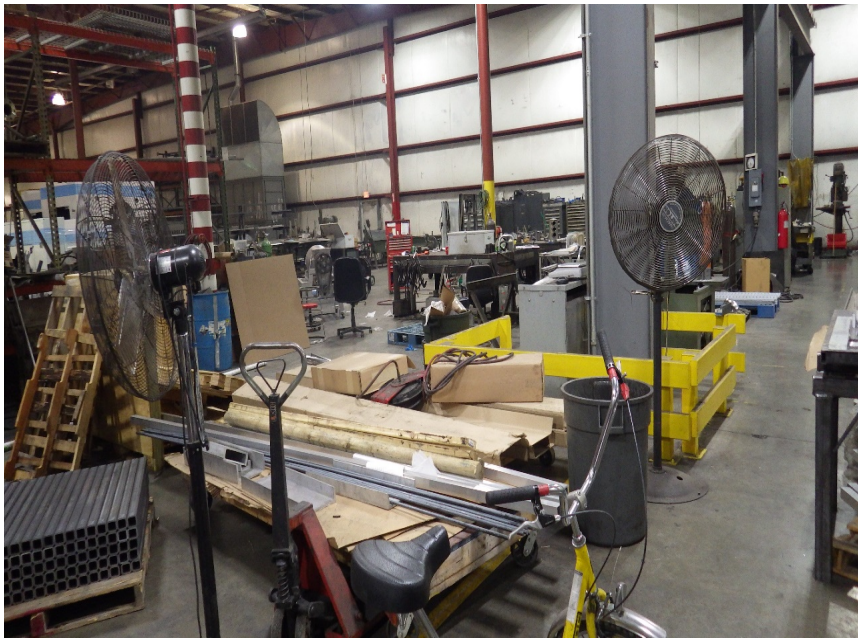
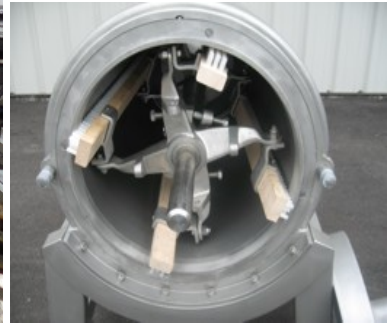
62: RIMG0062

Description: Small sub operation producing large food processors.

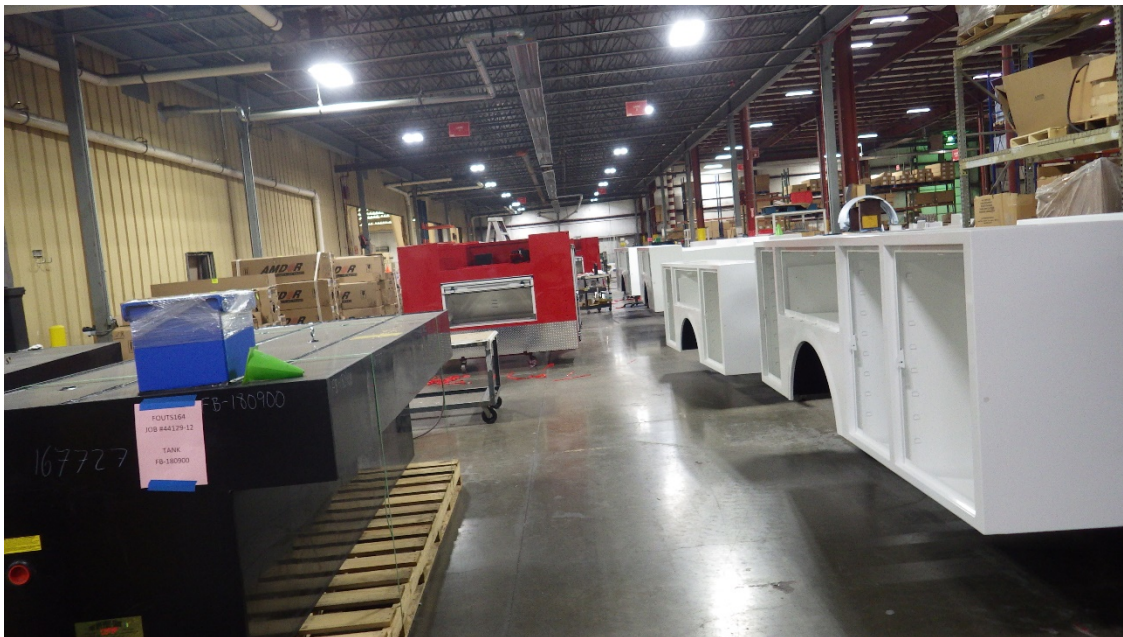
63: RIMG0063

Description: Fire truck bodies being produced.

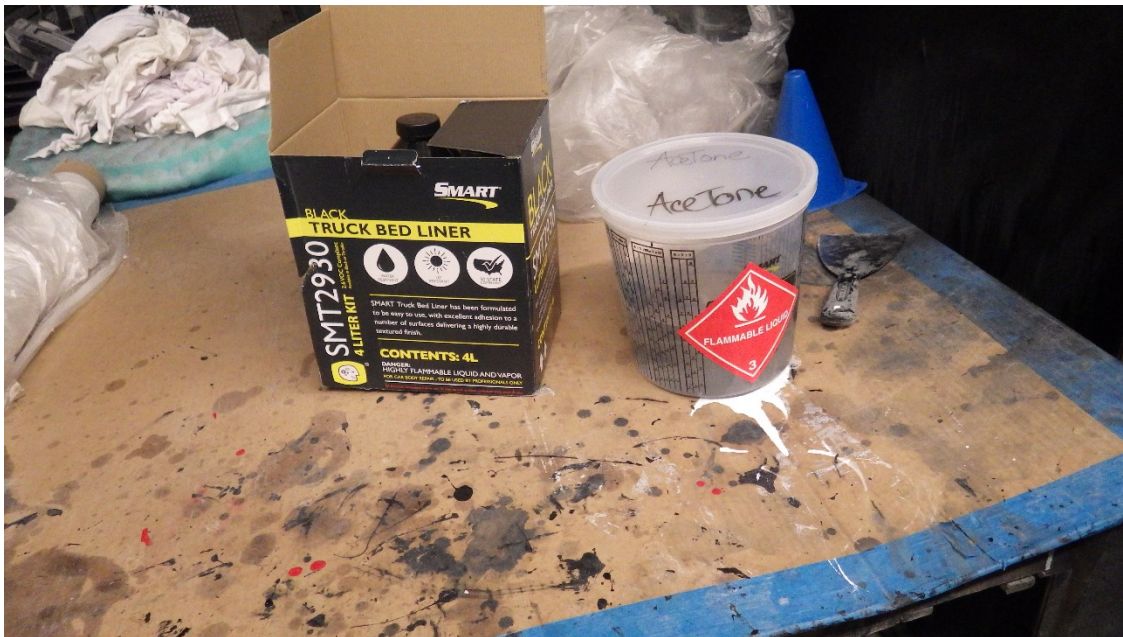
65: RIMG0065

Description: Bedliner area.
