## REGION 10 Enforcement Division

### INSPECTION REPORT

| <b>Company Name:</b> | University of Alaska | | |
| <b>Facility or Site Name:</b> | University of Alaska Fairbanks | | |

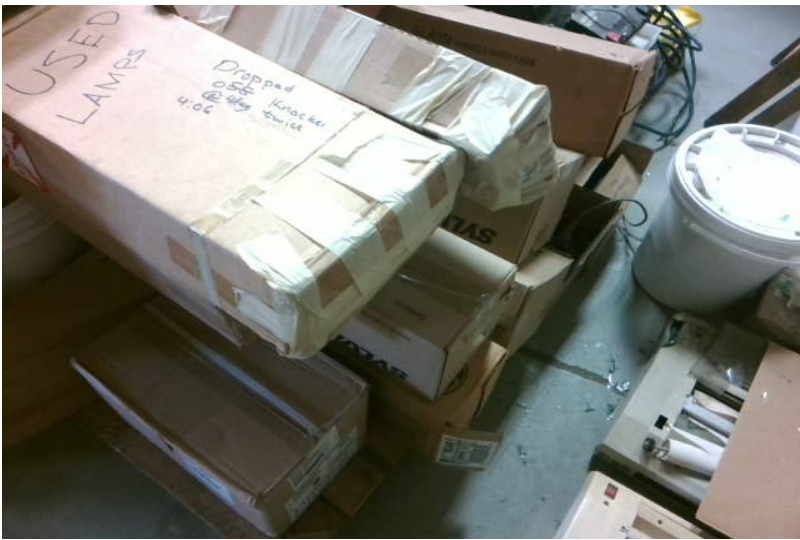
| View of universal waste lamp containers showing that one is not closed, and a couple are not structurally sound. | |

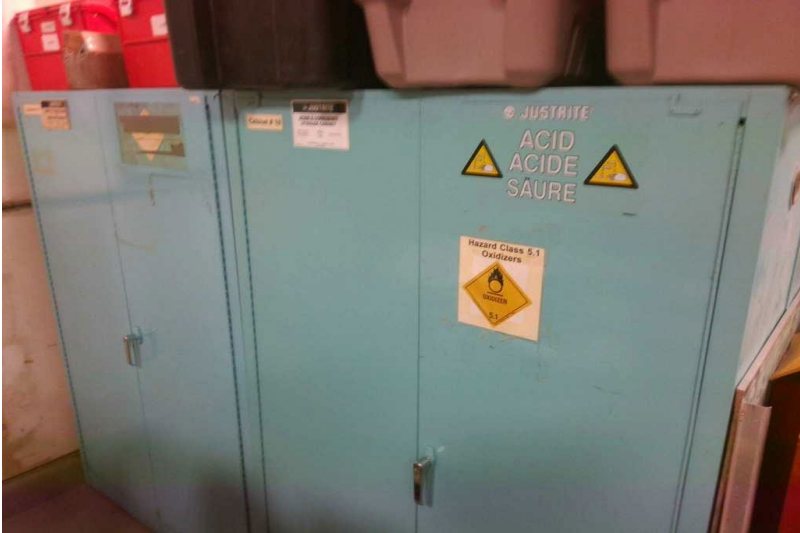
| View of the storage cabinet, showing the hazard indicator on the door of the cabinet vice marking the waste containers stored inside. | |

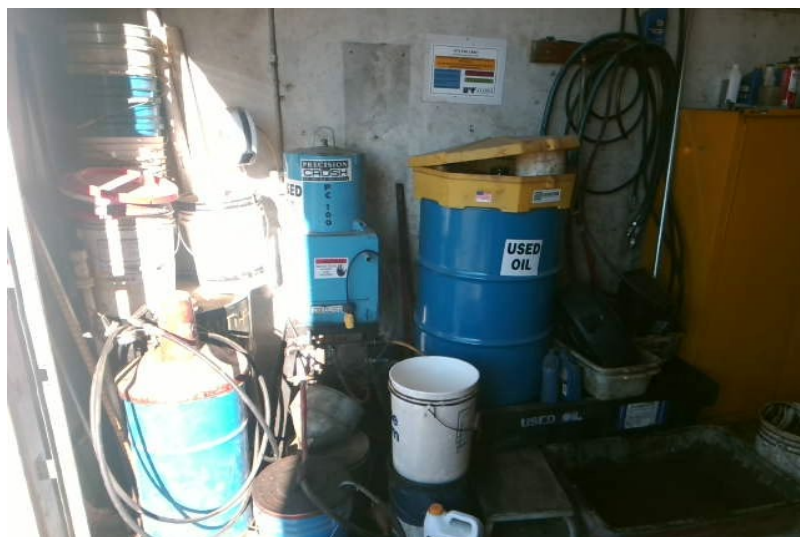
View of a 5-gallon container beneath the oil  
filter crusher that contained used oil and was  
not labeled with the words "Used Oil."

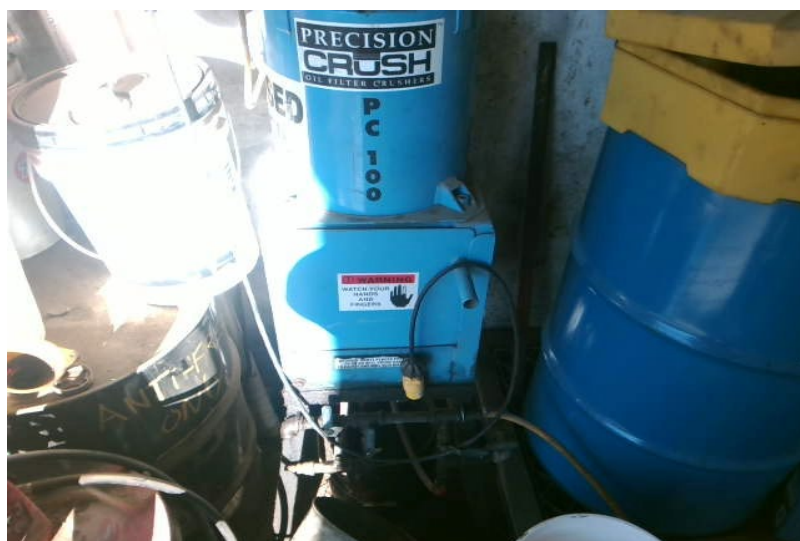
Close-up view of a 5-gallon container beneath  
the oil filter crusher that contained used oil and  
was not labeled with the words "Used Oil."

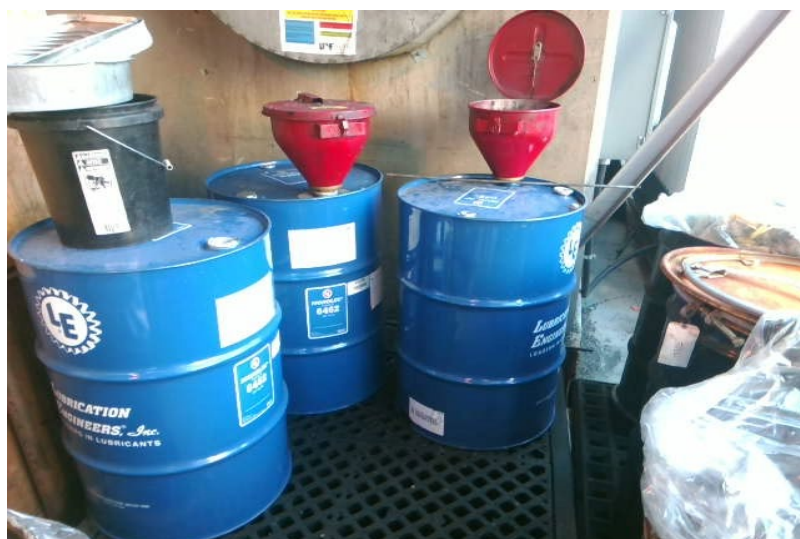
Close-up view of two containers, with red funnels, each holding used turbine oil, and neither is seen here labeled with the words "Used Oil."

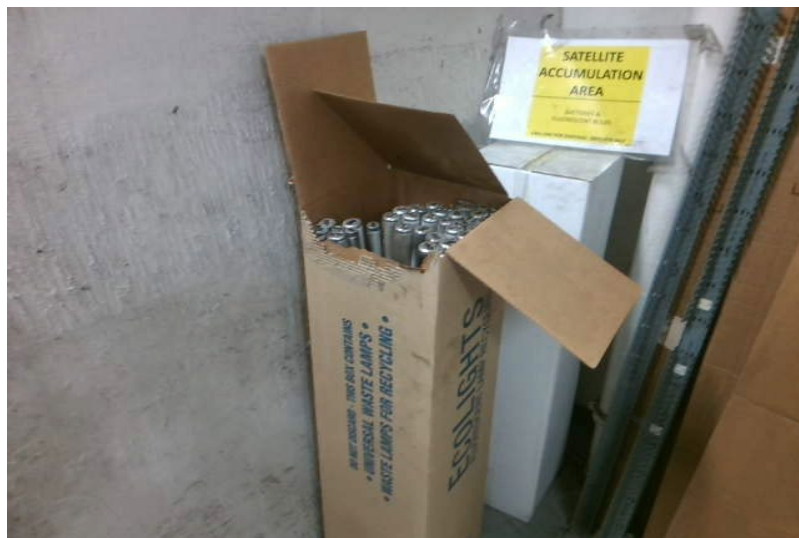
A close-up view showing that the second box of universal waste lamps is not labeled.

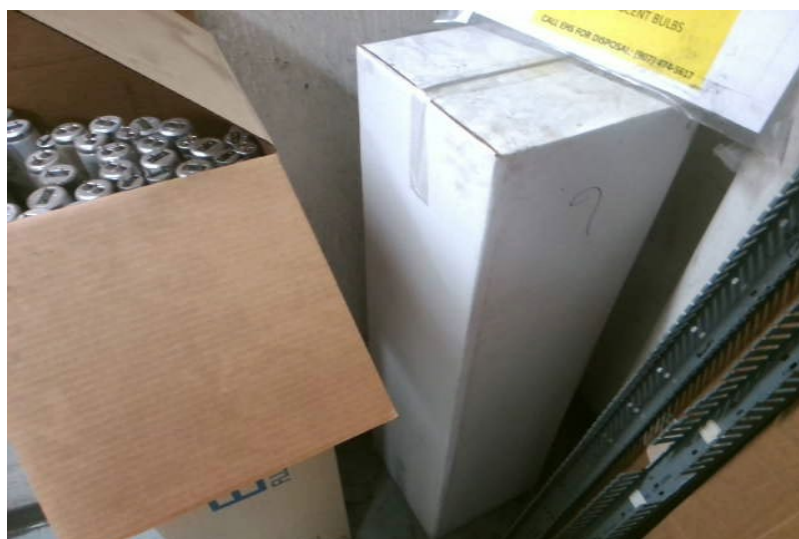
View of the storage cabinets. Wastes inside the cabinets were marked with labels indicating that they were hazardous waste but did not include a hazard indicator. Each cabinet was marked with a hazard indicator.

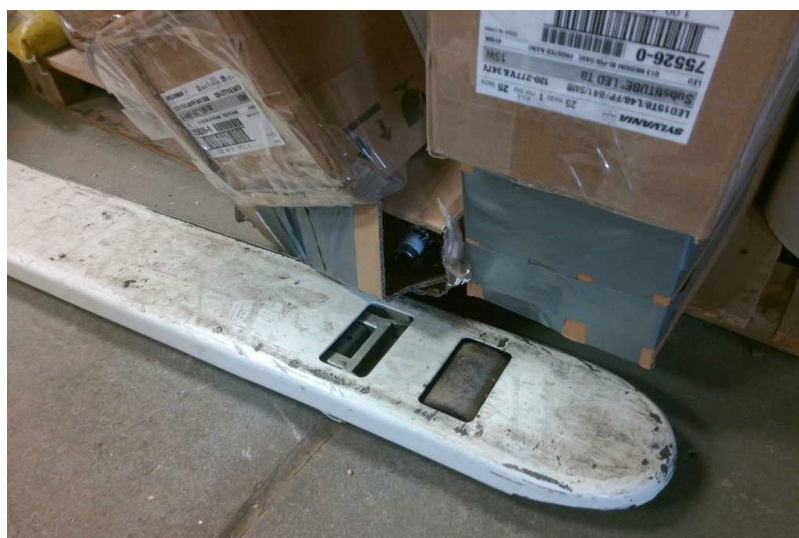
Another close-up view of waste fluorescent  
lamp containers, showing two that were not  
closed.

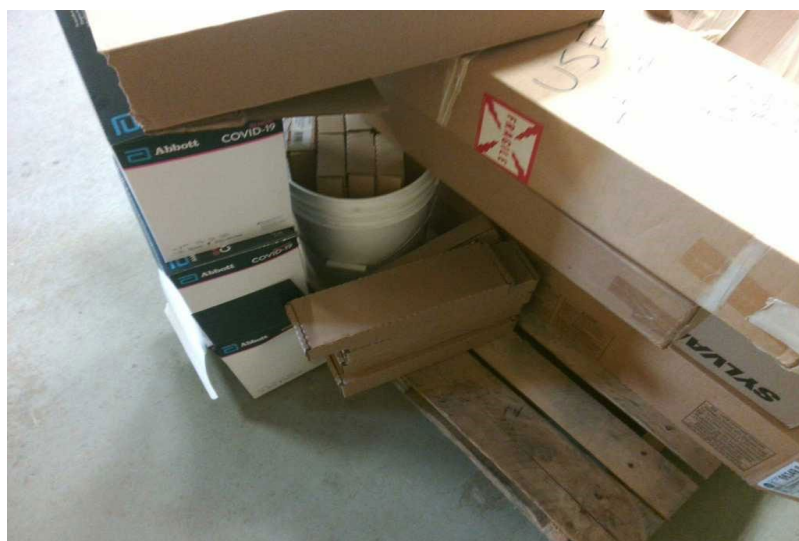
Close-up view of the bucket of ballasts  
containing batteries that were not labeled with  
the words, "Universal Waste - Batteries."

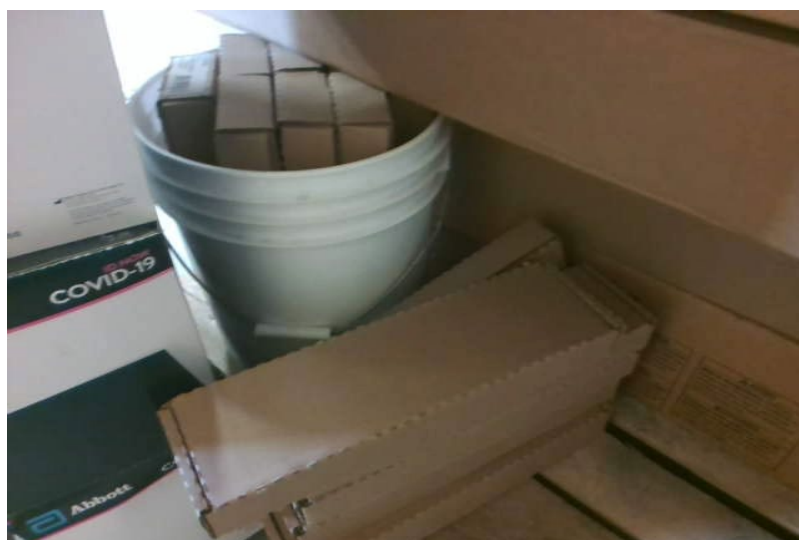
Another view of the same ballasts seen in the previous two photos.

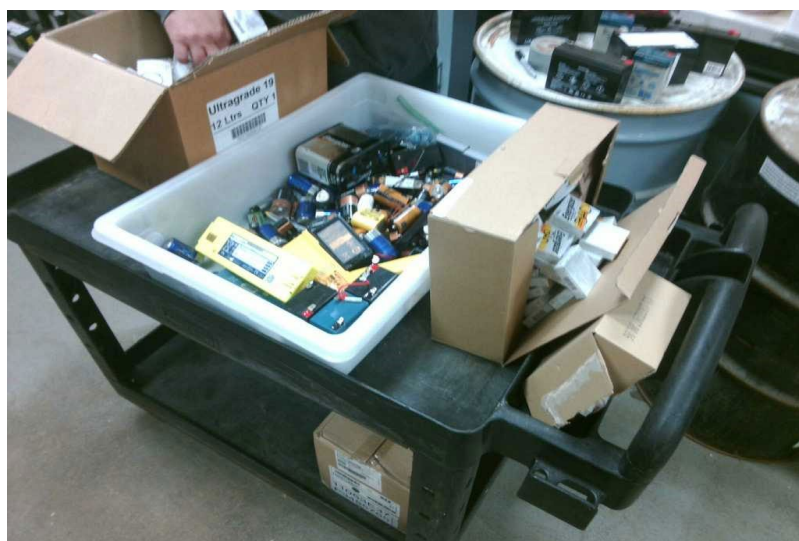
Close-up view of the same unlabeled waste batteries seen in the previous photo.

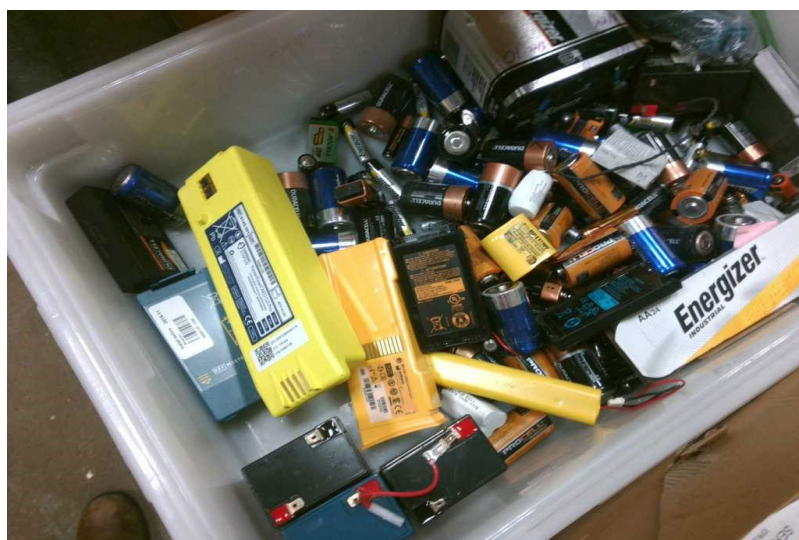
Another close-up view of the same unlabeled  
waste batteries seen in the previous two  
photos.

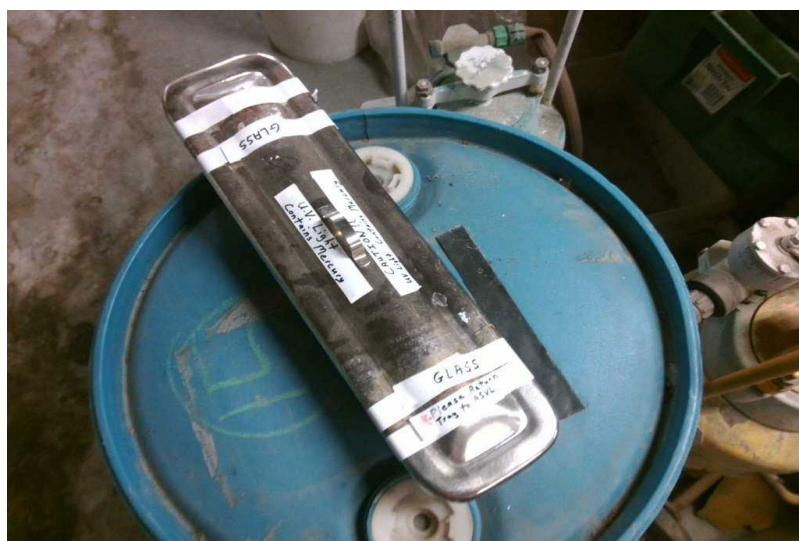
Another view of the same ultraviolet bulb/lamp  
that was not labeled as universal waste.

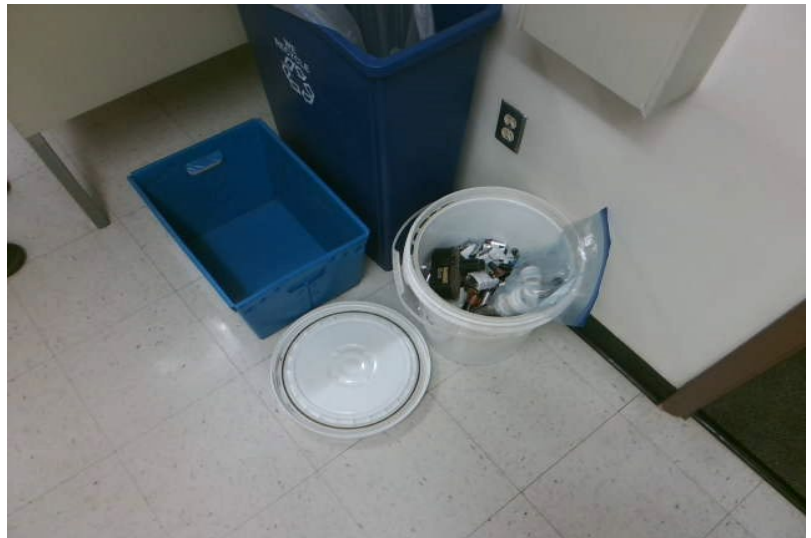
Close-up view of a universal waste battery container that contained waste CFLs and was dated 3/16/20.

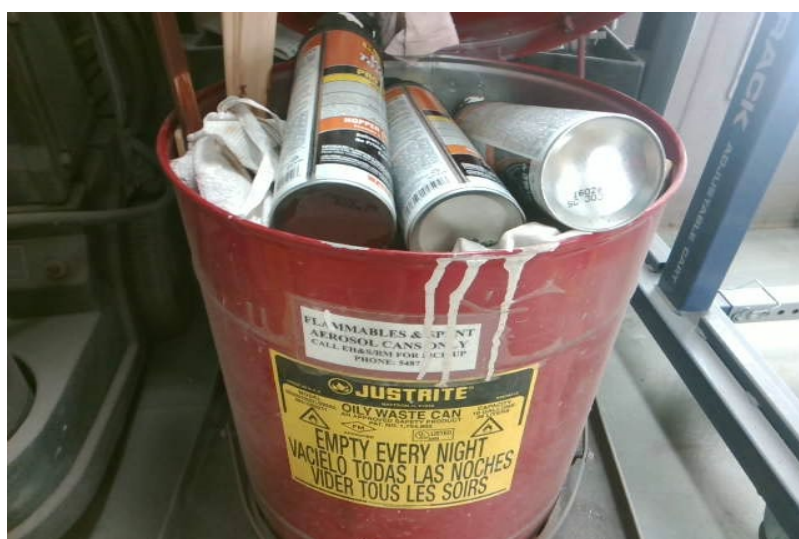
Another close-up view of the same three waste aerosol cans seen in the previous photo.

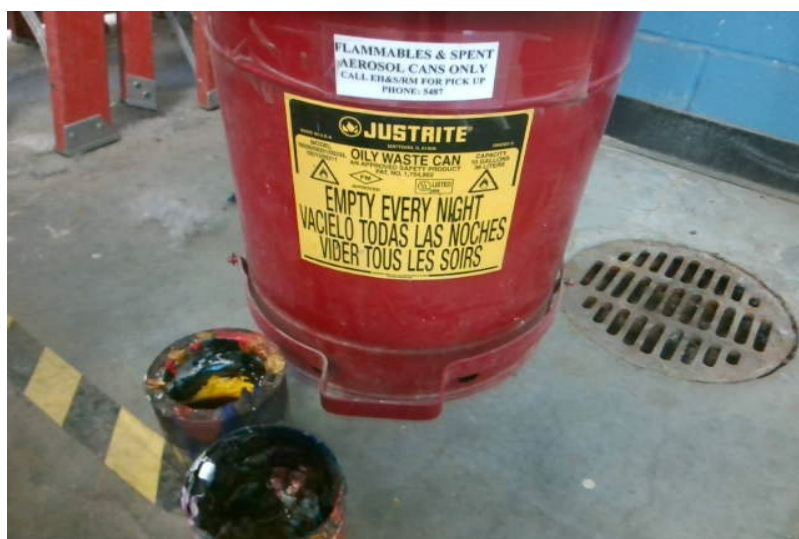
Another close-up view of the waste paint and thinner cans that were removed from the step-can.

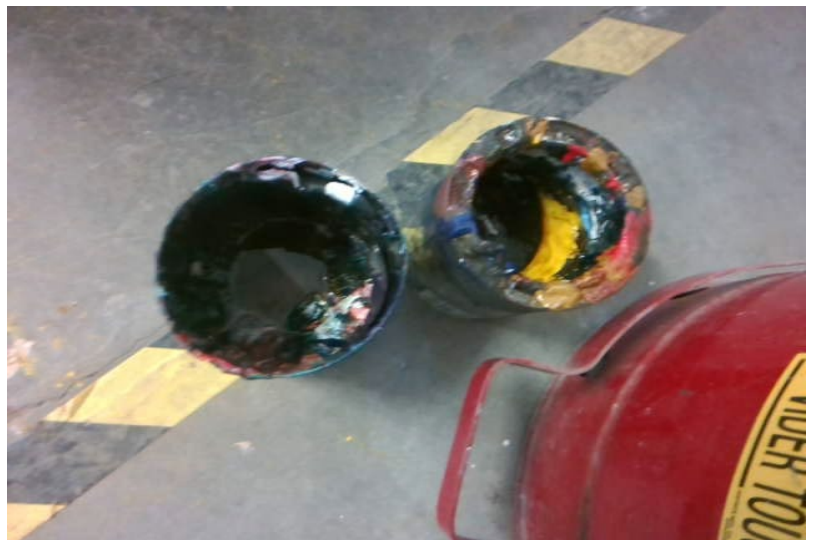
View of a waste aerosol can in the trash.

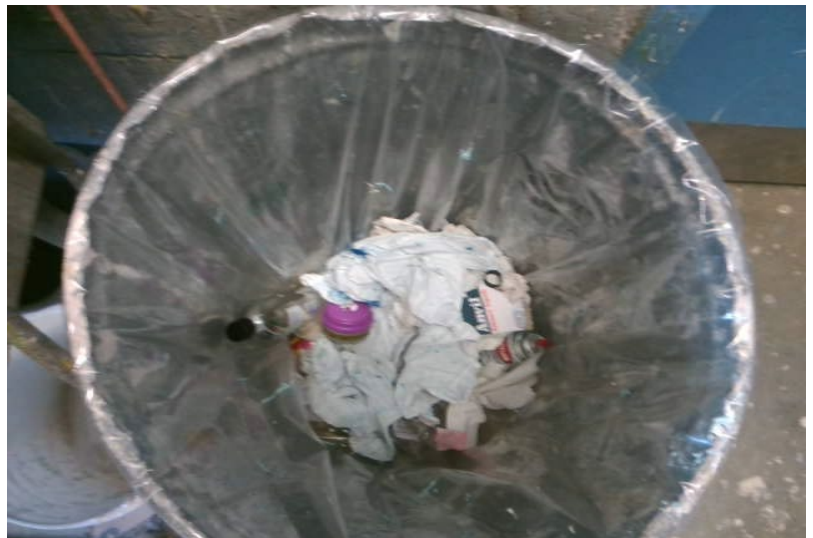
Another view of the same waste aerosol can in the trash.

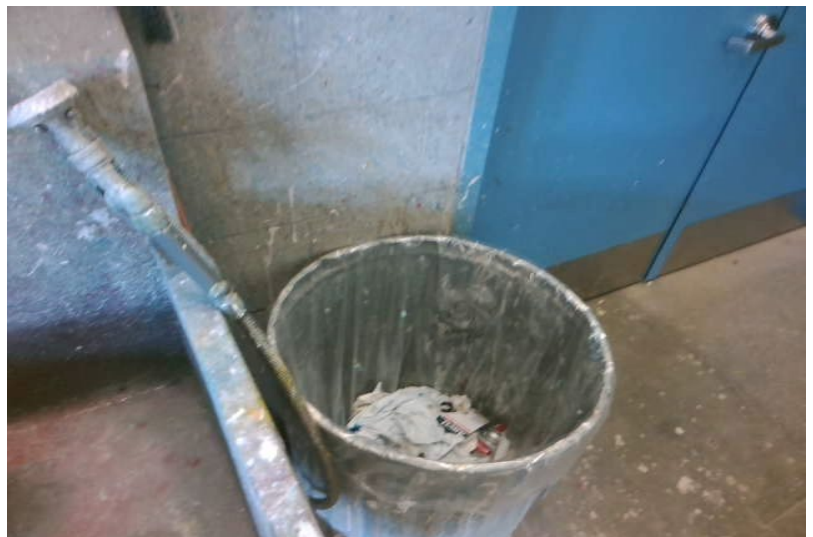
Close-up view of the same waste aerosol can in the trash.

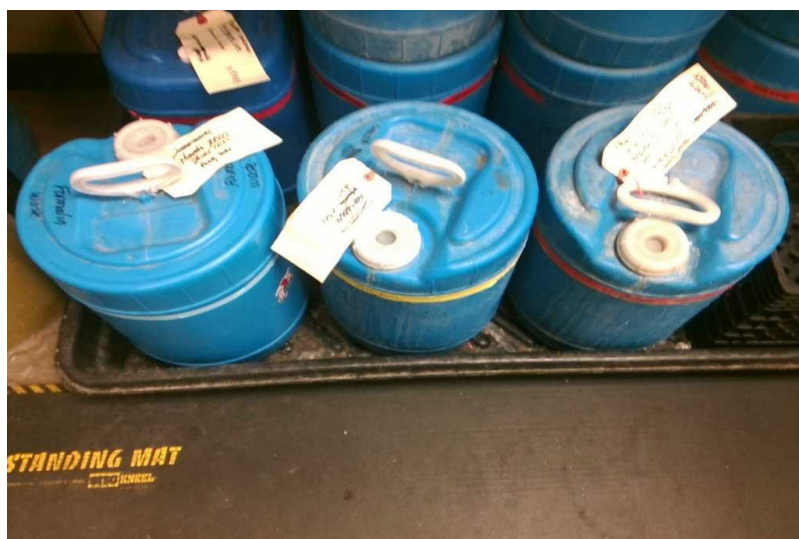
Close-up view of some of the same containers seen in the previous photo.

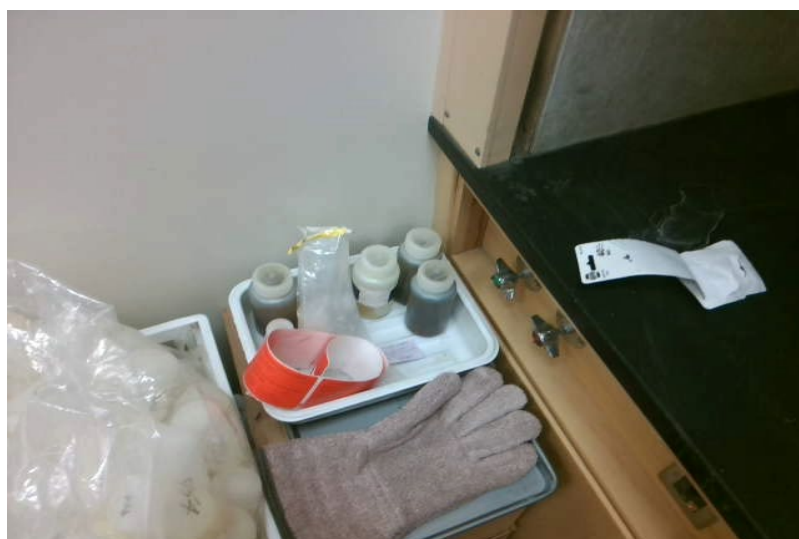
View of a small plastic tray that contained seven small plastic bottles of unknown wastes. There was a handwritten note in the bottom of the tray that read, "These samples are of unknown origin or owner B. M. 8/25/19."

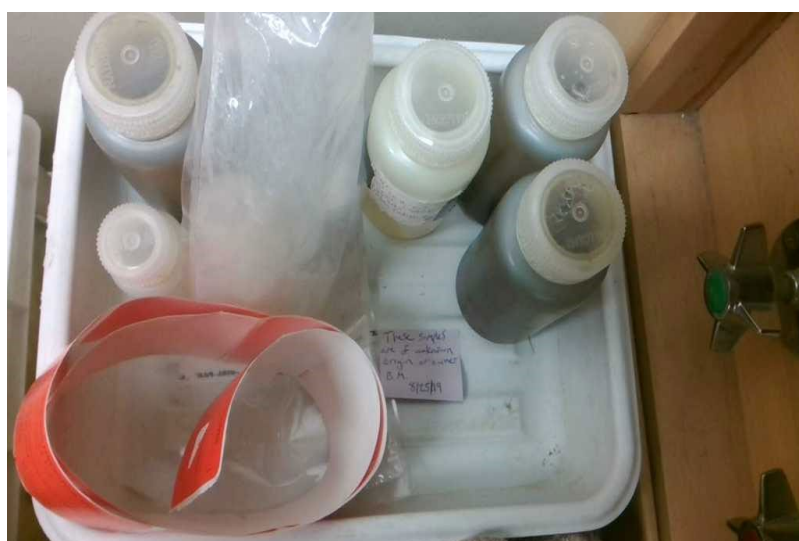
Another view of the same small plastic tray that contained seven small plastic bottles of unknown wastes. There was a handwritten note in the bottom of the tray that read, "These samples are of unknown origin or owner B. M. 8/25/19."

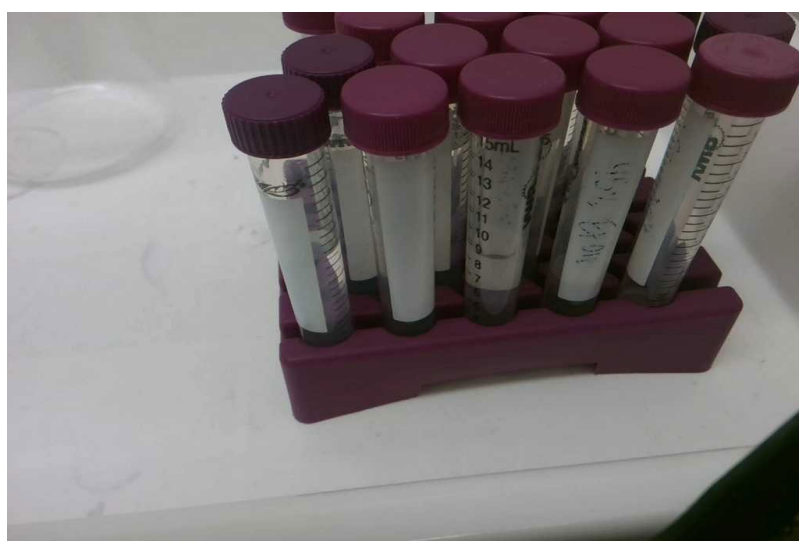
Close-up view of the same vials seen in the previous two photos.

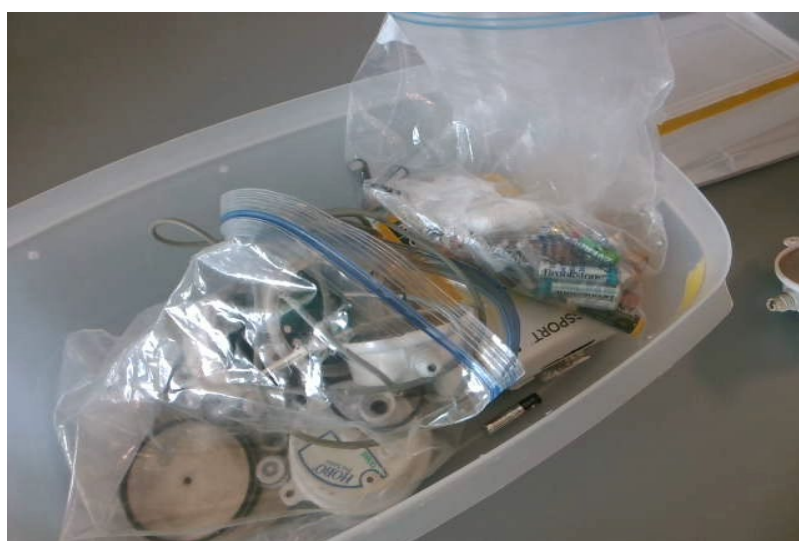
View of a plastic container that was labeled "Waste for pickup - Williams lab." Items in the container included universal waste batteries that were not labeled. At least one battery was a lithium battery.

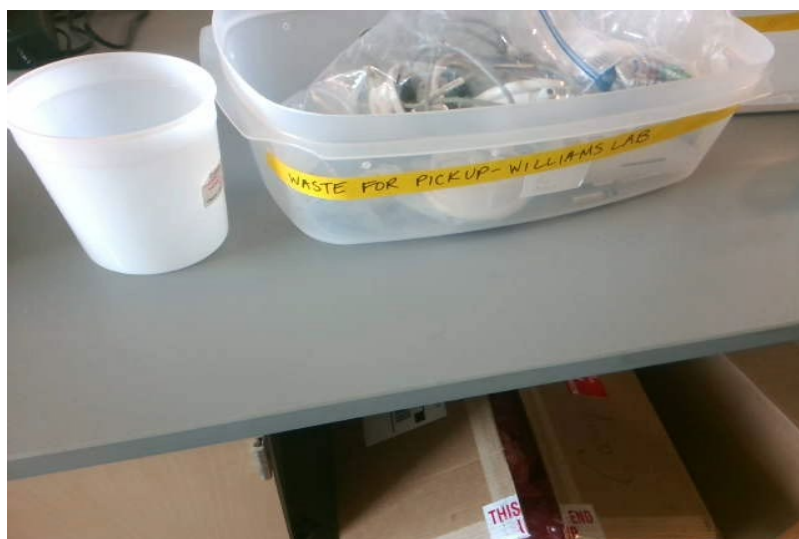
Another view of the same container seen in the previous photo.

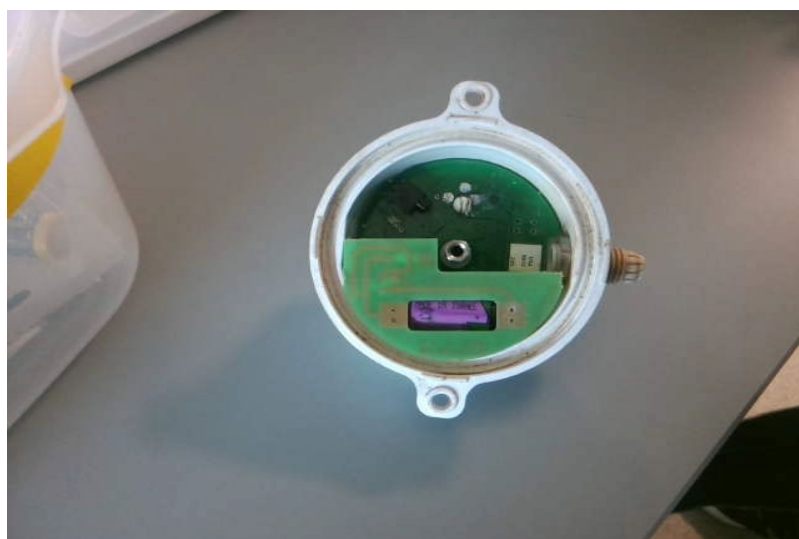
Close-up view of one of the waste batteries (Purple) inside of a device that was in the plastic container seen in the previous two photos.

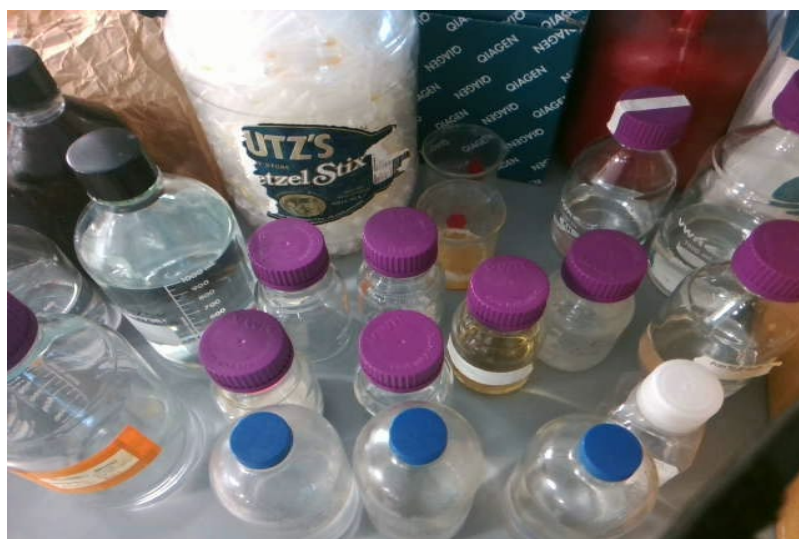
View of an unidentified waste that had crystallized. The container it is in is not closed and not labeled.

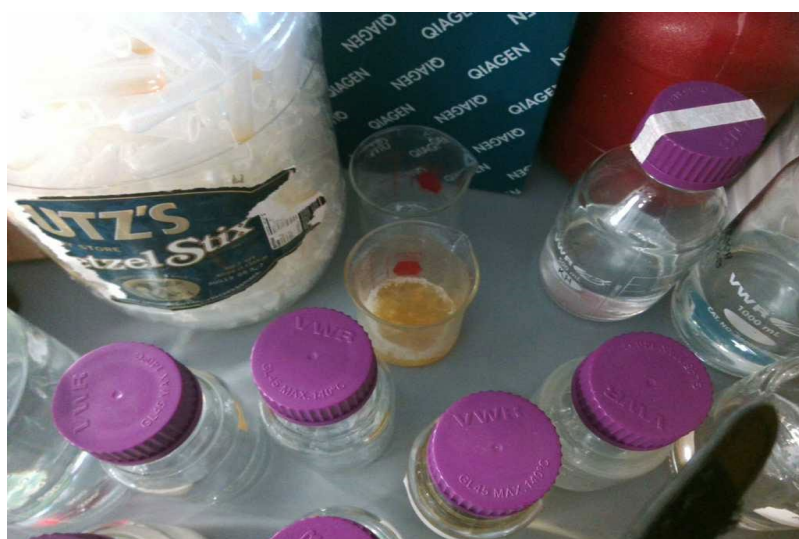
Closer view of the unidentified waste that had crystallized. The container it is in is not closed and not labeled.

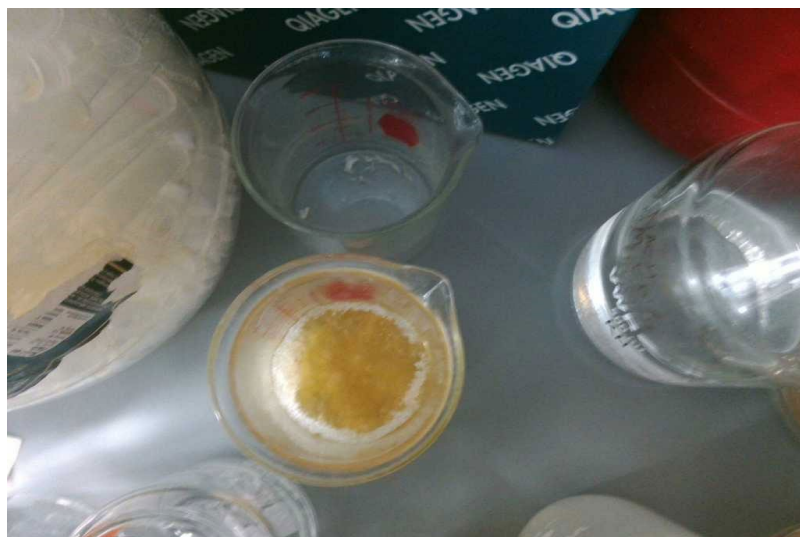
Close-up view of the unidentified waste that had crystalized. The container it is in is not closed and not labeled.

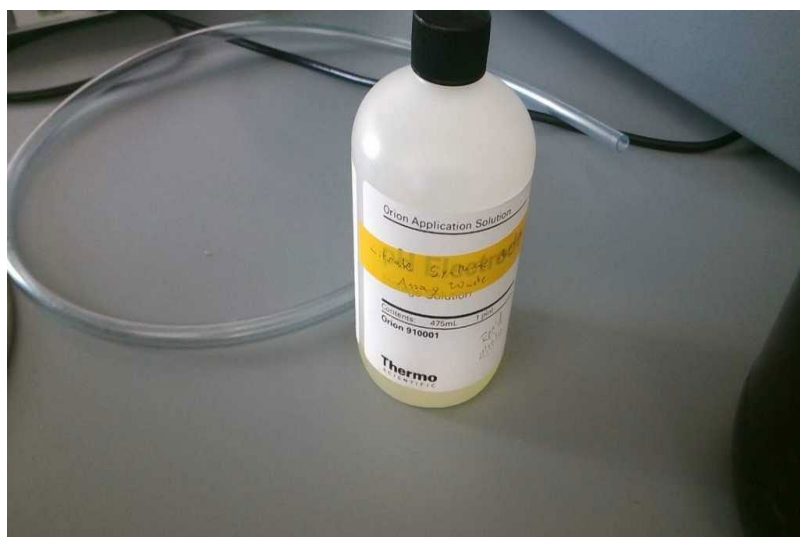
Close-up view of the same waste container seen in the previous photo.

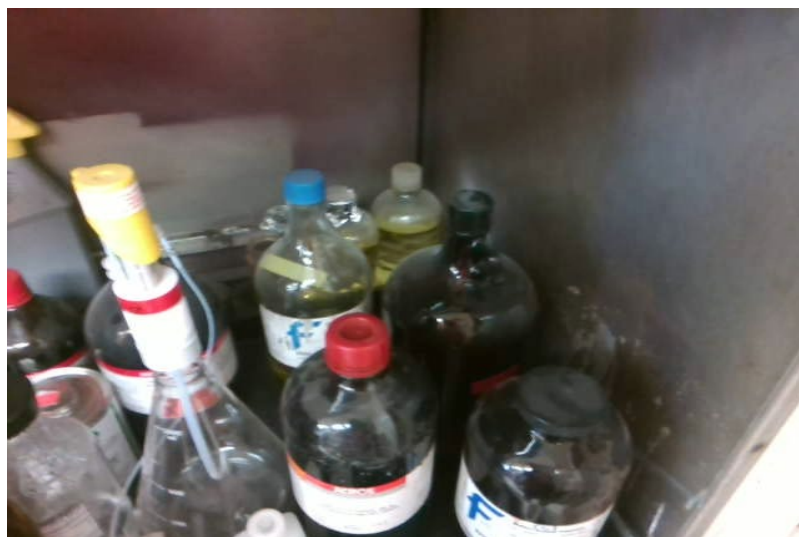
View of two containers, seen behind the container with the blue cap, holding unknown liquids and requiring a waste determination.

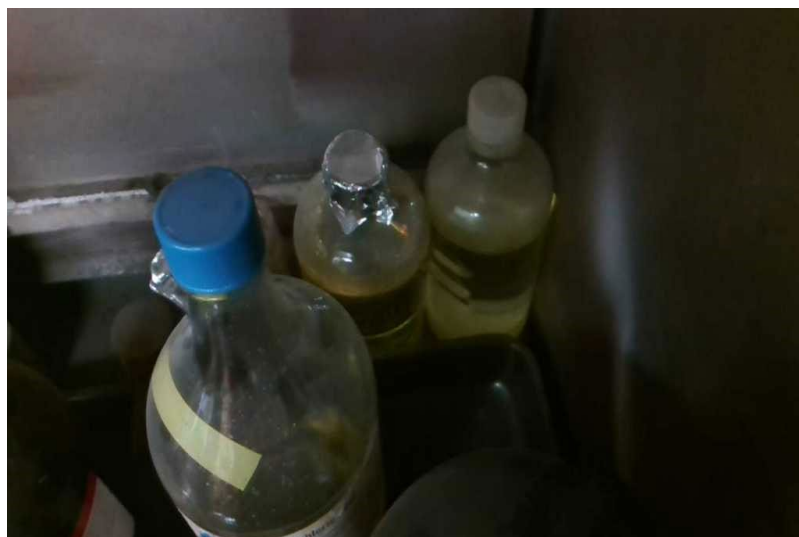
Close-up view of the two containers, seen behind the container with the blue cap, holding unknown liquids.

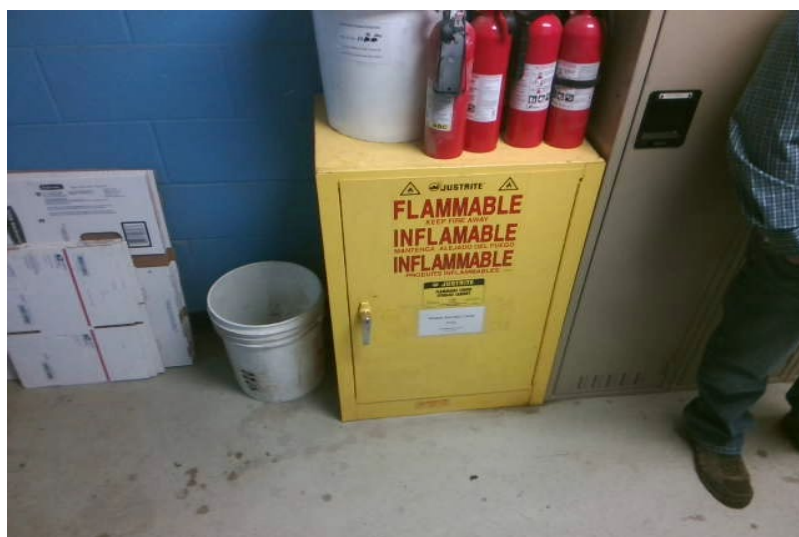
View of flammable storage cabinet containing waste aerosols that is not labeled as "Universal Waste - Aerosols."

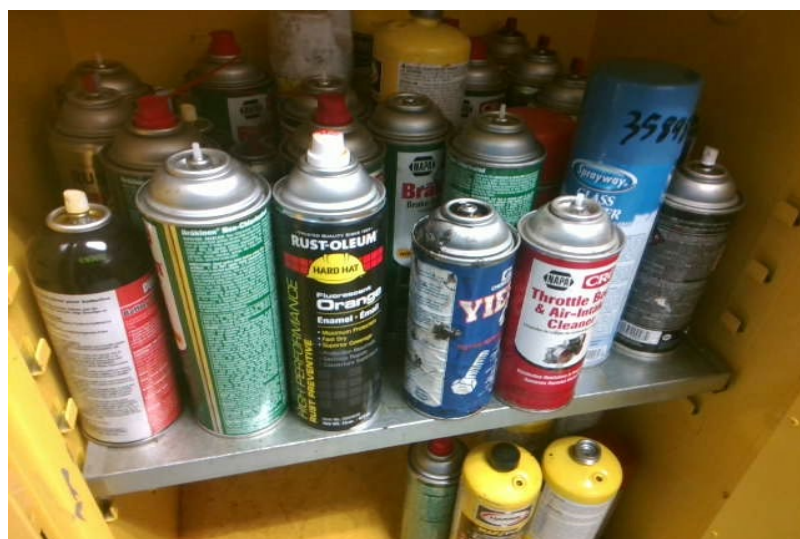
View of the waste aerosol cans inside the  
flammable storage cabinet.

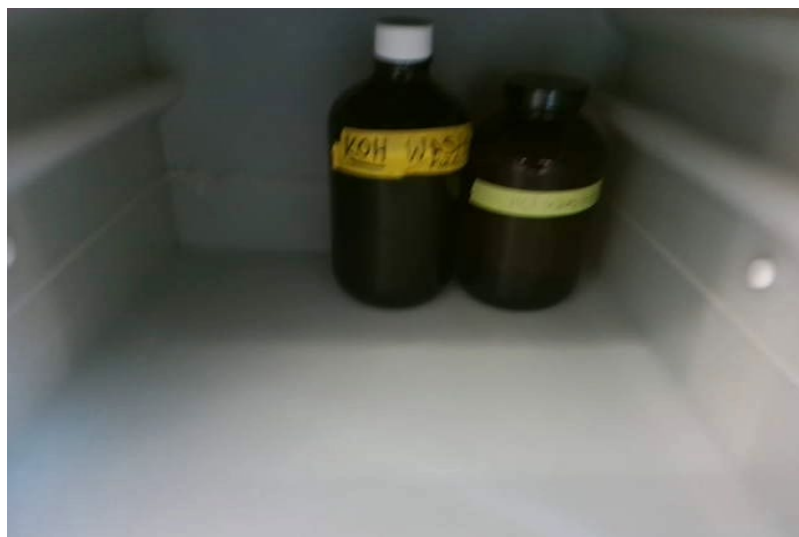
View of waste containers beneath fume hood in Rm 211 that are not labeled with the words "Hazardous Waste" or a hazard indicator.

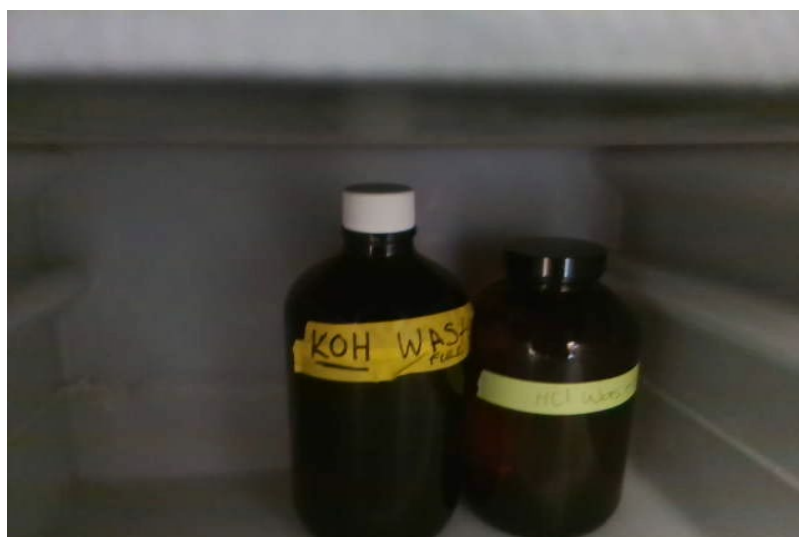
Close-up view of the same waste containers beneath fume hood in Rm 211 that are not labeled with the words "Hazardous Waste" or a hazard indicator.

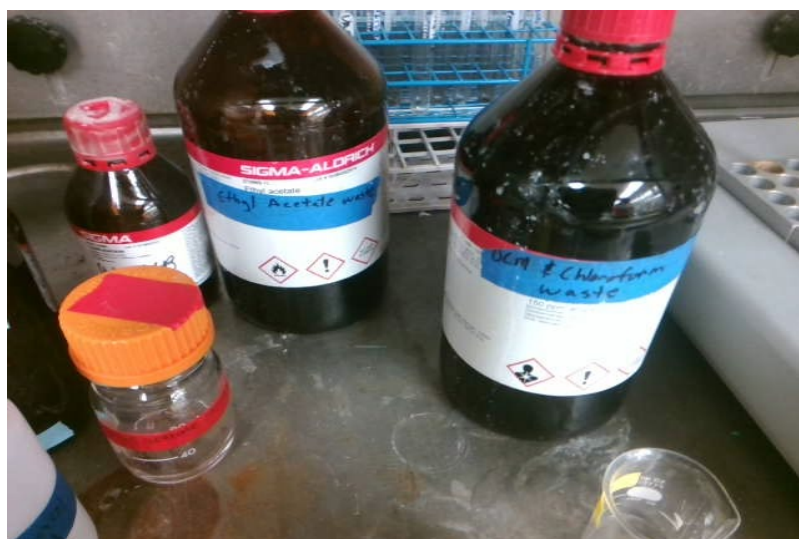
View of waste containers under fume hood that are not labeled with the words "Hazardous Waste" or hazard indicators.

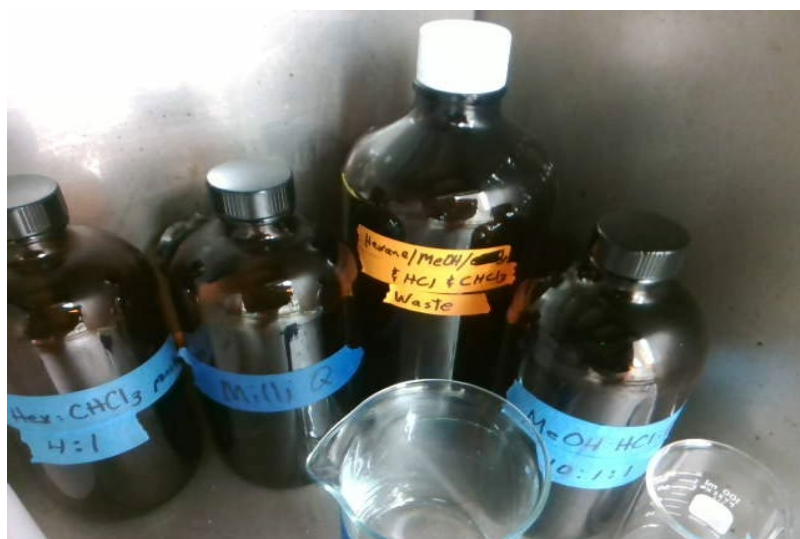
View of waste container marked with orange tape under fume hood that is not labeled with the words "Hazardous Waste" or a hazard indicator.

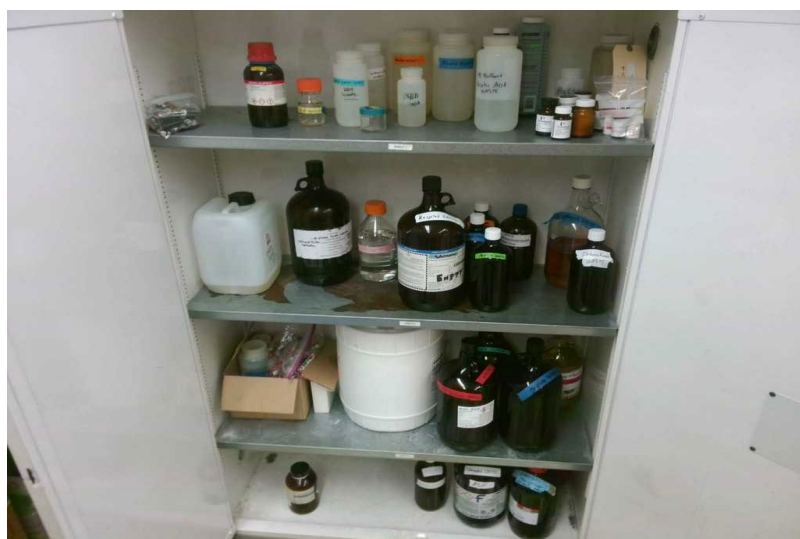
View of the waste containers in the flammable storage cabinet, in Lab B, that were not labeled with the words "Hazardous Waste" or hazard indicators.

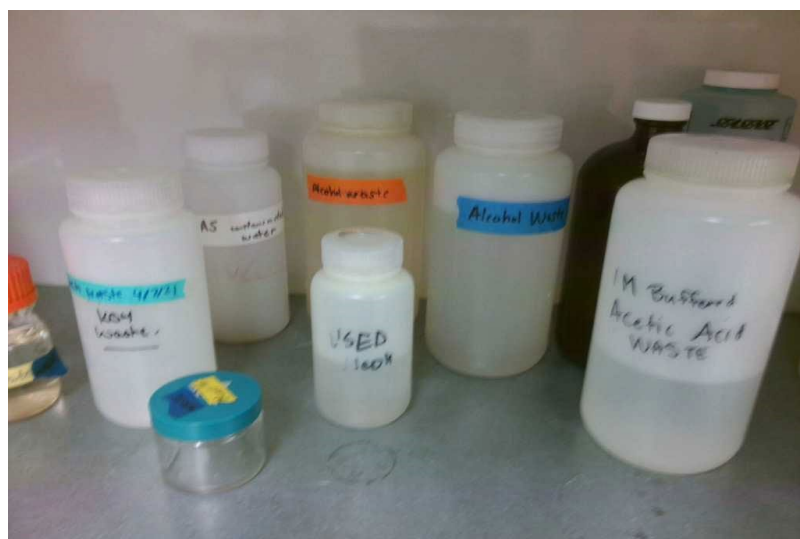
Close-up view of the waste containers in the flammable storage cabinet, in Lab B, that were not labeled with the words "Hazardous Waste" or hazard indicators.

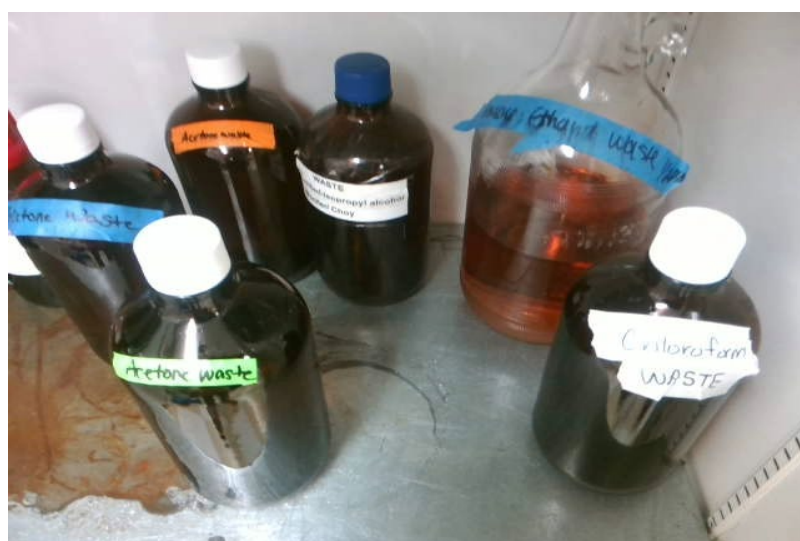
Close-up view of the waste containers in the flammable storage cabinet, in Lab B, that were not labeled with the words "Hazardous Waste" or hazard indicators.

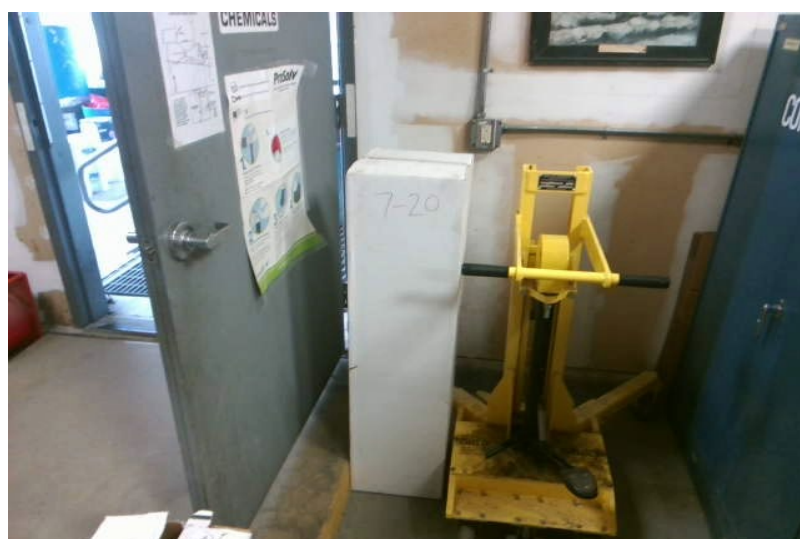
View of a box containing waste fluorescent lamps that has been in storage for greater than one year.

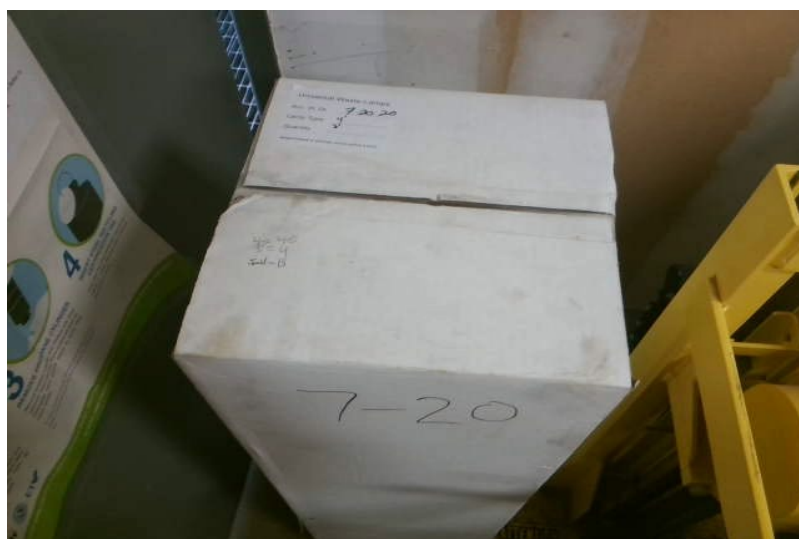
Another view of the same box containing waste fluorescent lamps that has been in storage for greater than one year.

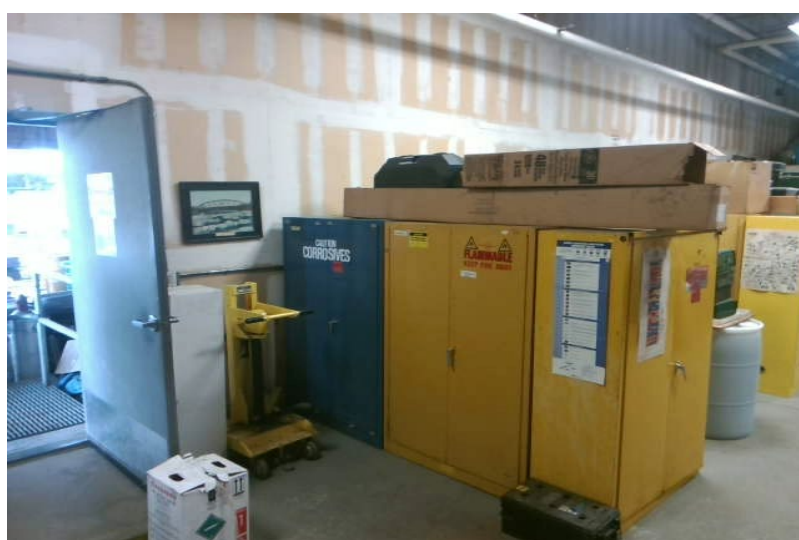
View of a box containing eight-foot waste fluorescent lamps that is seen here on top of the yellow flammable storage cabinet. The waste lamps have been stored for greater than a year.
