# NPDES Compliance Inspection Report

## Ridgefield Heights Ridgefield, Washington

NPDES Permit Tracking Number  
# WAR306634

Inspection Date: 12/20/2022

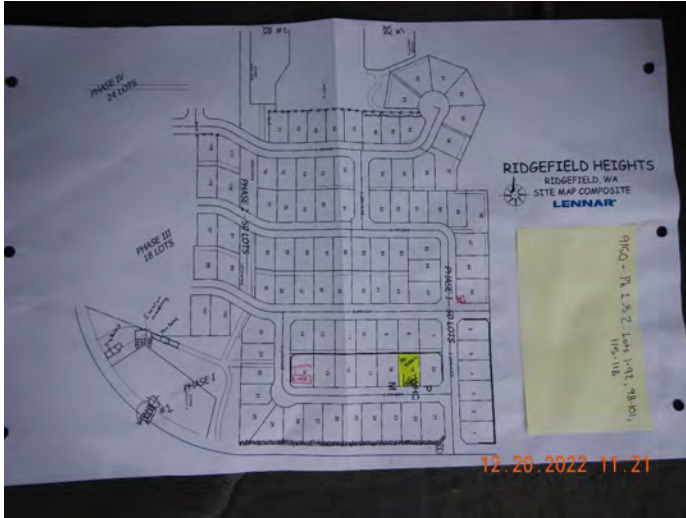
Photo #:01 (DSCN3097)

Description: Photo of the "Site Map Composite." A working/recent copy of the SWPPP map indicating recent BMP installations.

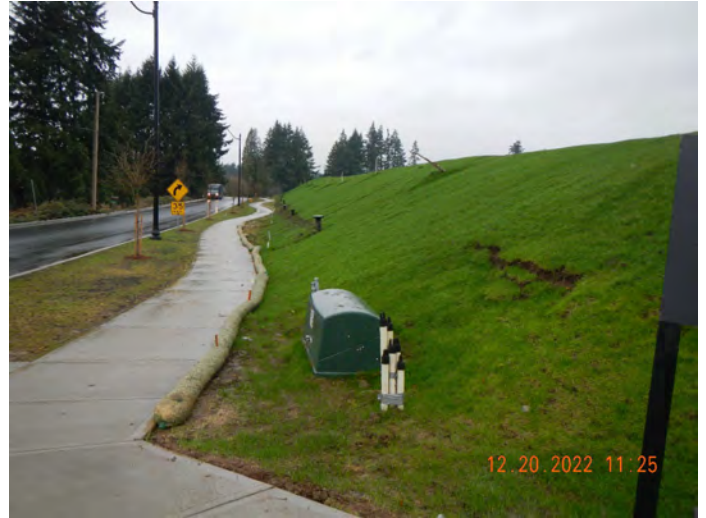
Photo #:02 (DSCN3098)

Description: Facing west, photo of southern sidewalk/slope along S. 10th Way.

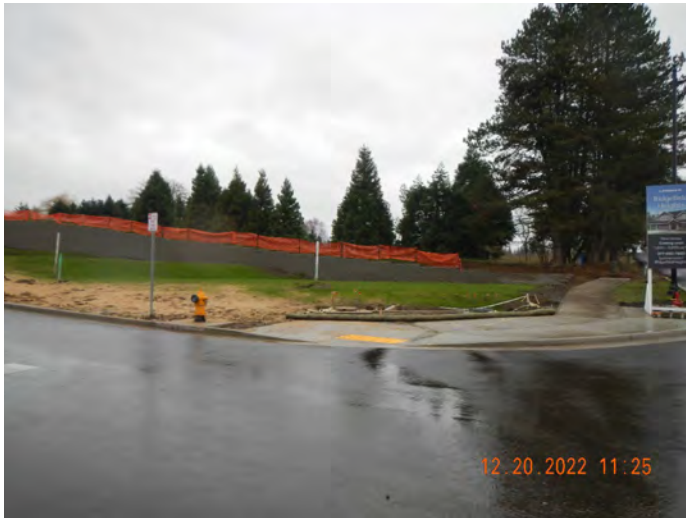
Photo #:03 (DSCN3099)

Description: Facing east, photo of the southeast perimeter and area of sidewalk being repaired by Rotschy Inc. at the time of inspection.

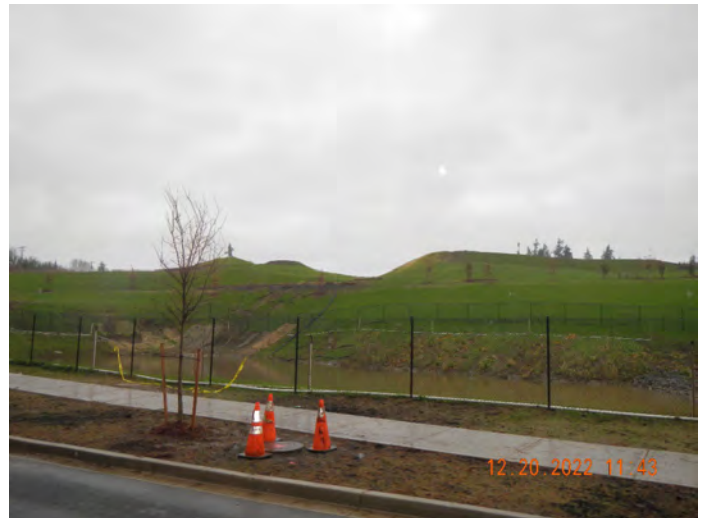
Photo #:08 (DSCN3104)  
Description: Facing north, photo of Pond A.

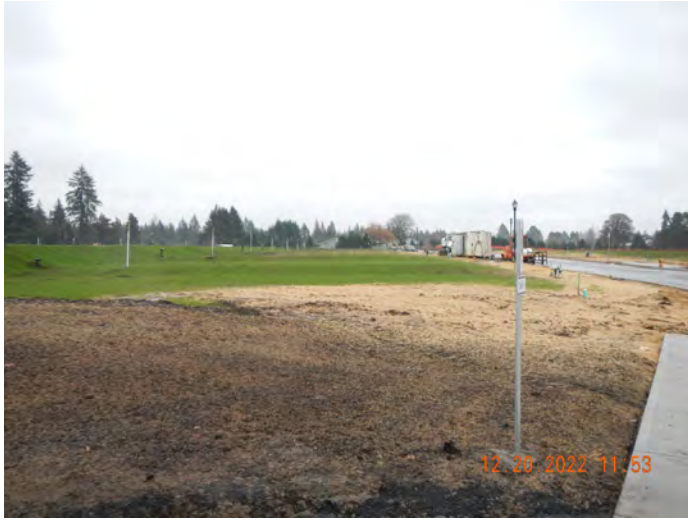
Photo #:13 (DSCN3109)  
Description: Facing east, photo of eastern boundary of Phase 3 adjacent to Phase 2.

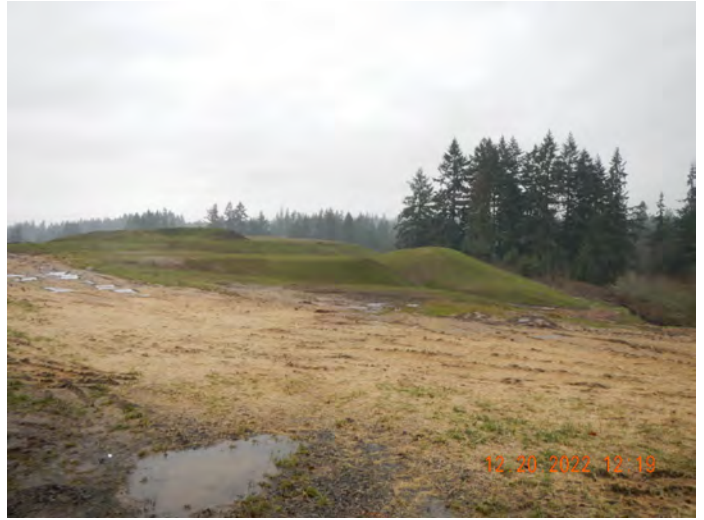
Photo #:18 (DSC3114)  
Description: Facing north, photo taken north of the S. 4<sup>th</sup> Way of areas within Phase 3-5

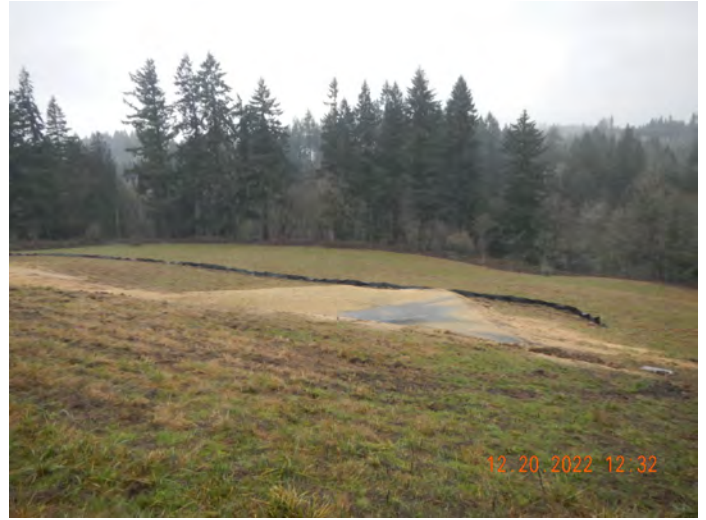
Photo #:22 (DSC3118)  
Description: Facing northwest, photo of the northwestern area of Phase 5 and future Culdesac area.

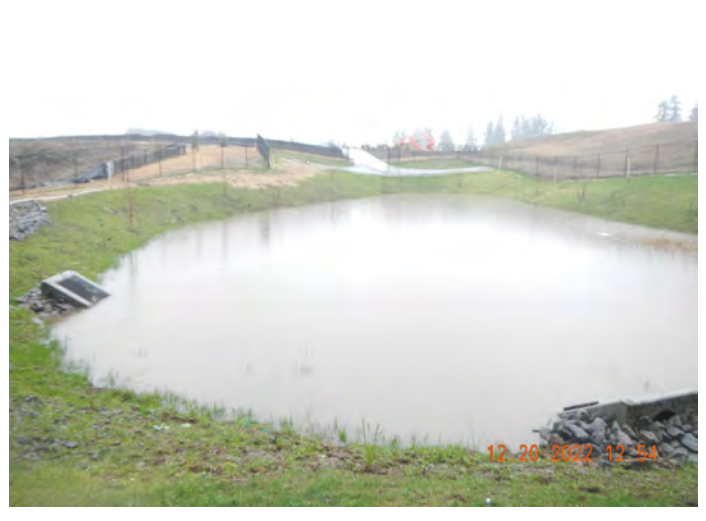
Photo #:24 (DSC3120)  
Description: Facing south photo of Pond B.

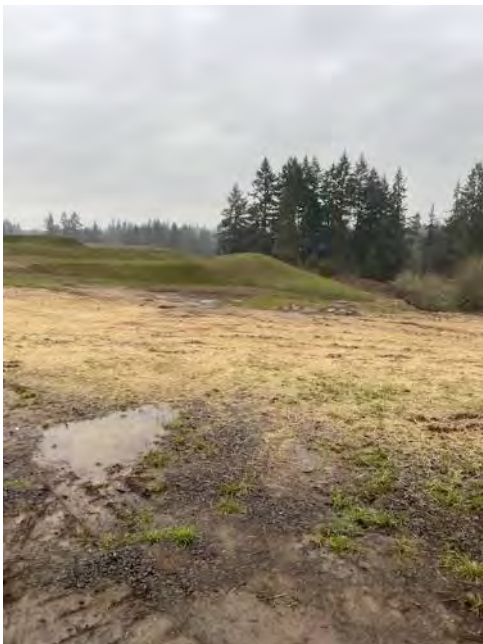
Photo10a – Exposed soil in Phase 5 near S. 4<sup>th</sup> Way.

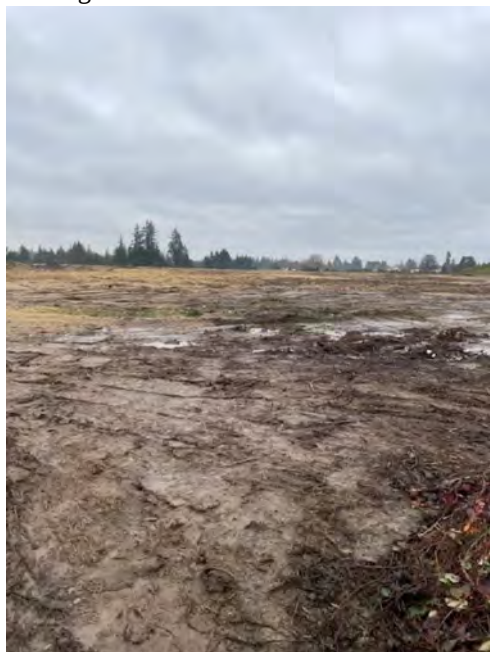
Photo 18a: Phase 3 exposed soil needs straw coverage.
