## MULTI-SECTOR GENERAL PERMIT NON-FILER INSPECTION CHECKLIST

| <b>Inspection Date(s):</b> | 2/6/2023 | |
| <b>Operator Name:</b> | Nolt Services LLC | |

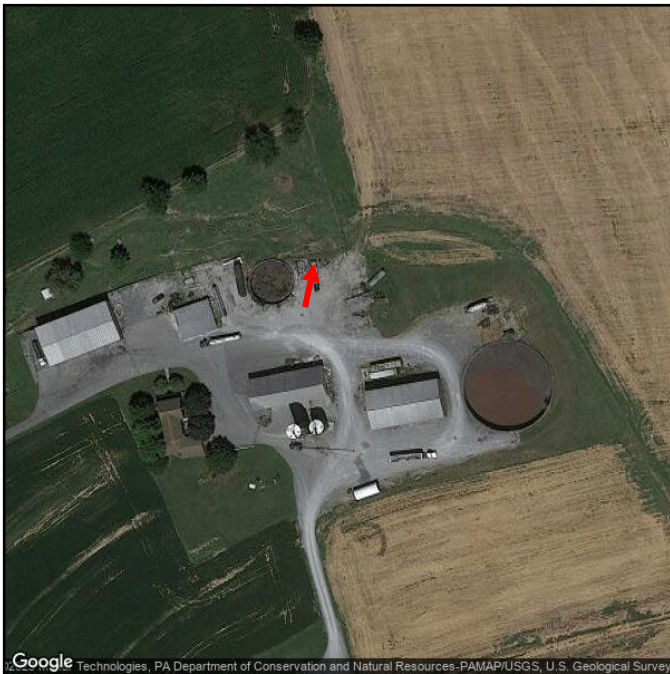
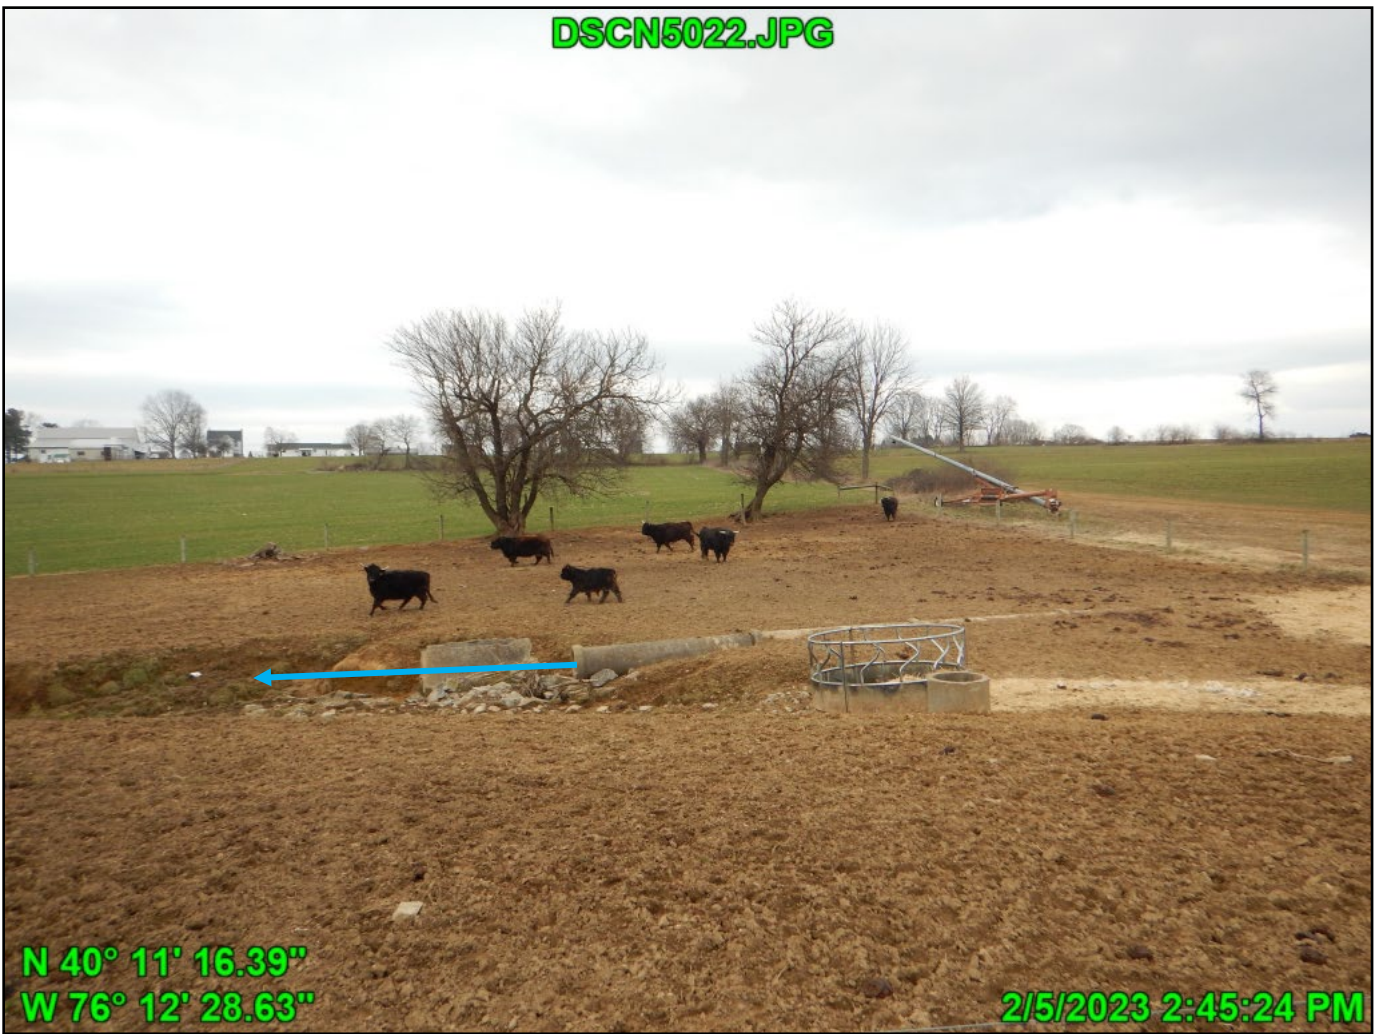
DSCN5022.JPG

| Description | Facility equipment by Tank P2. |

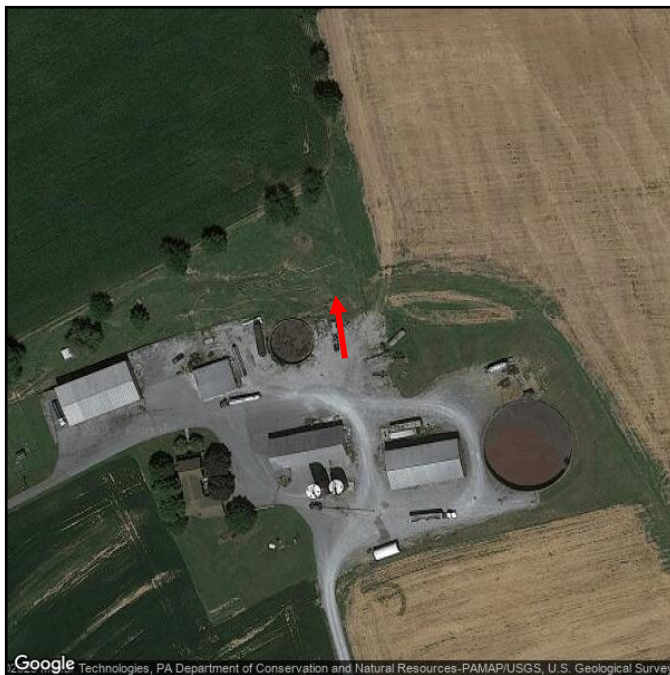
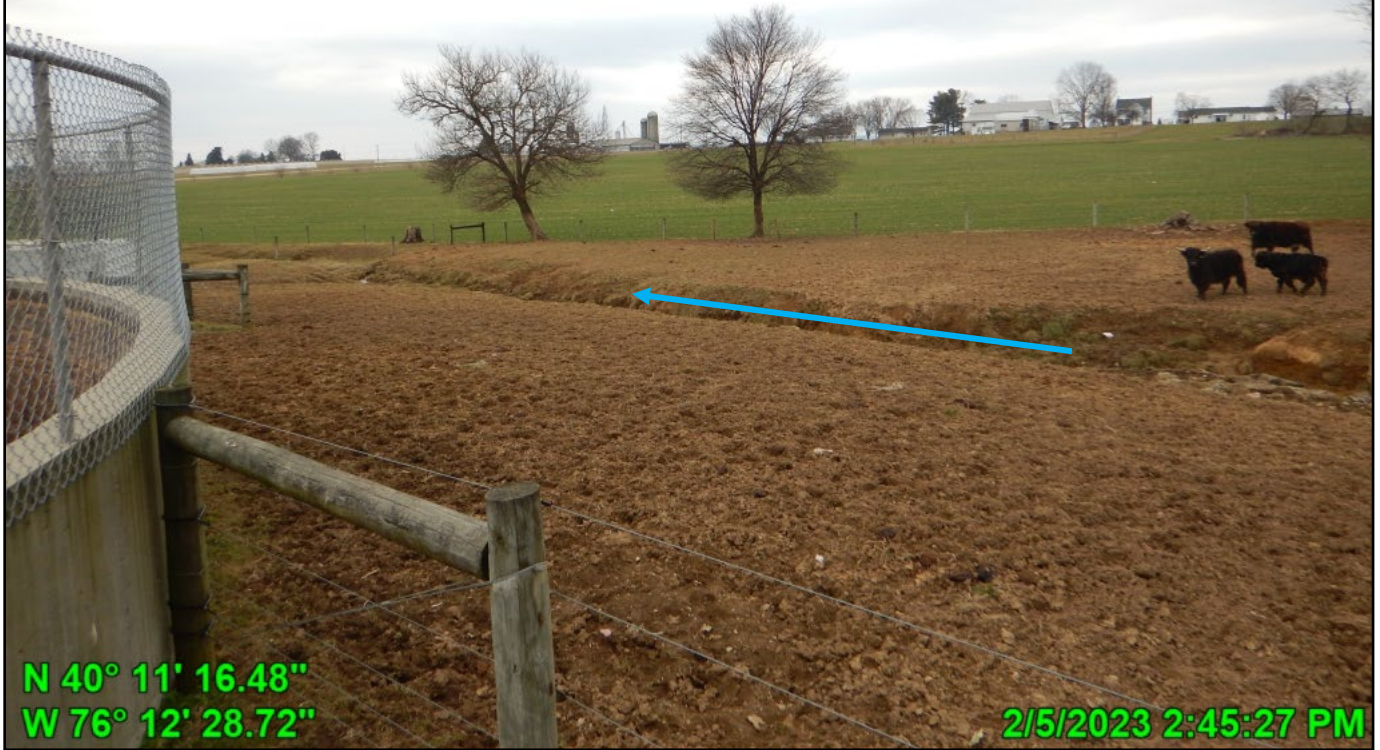
DSCN5023.JPG

| Description | Meadow Run section that is piped flowing from east to west from a residential neighborhood 3,000 feet to the east along the Facility's north boundary. |

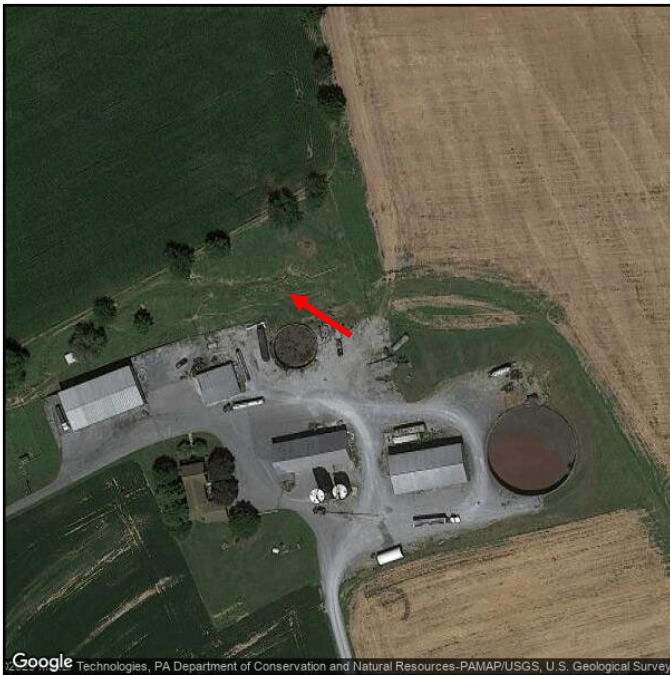
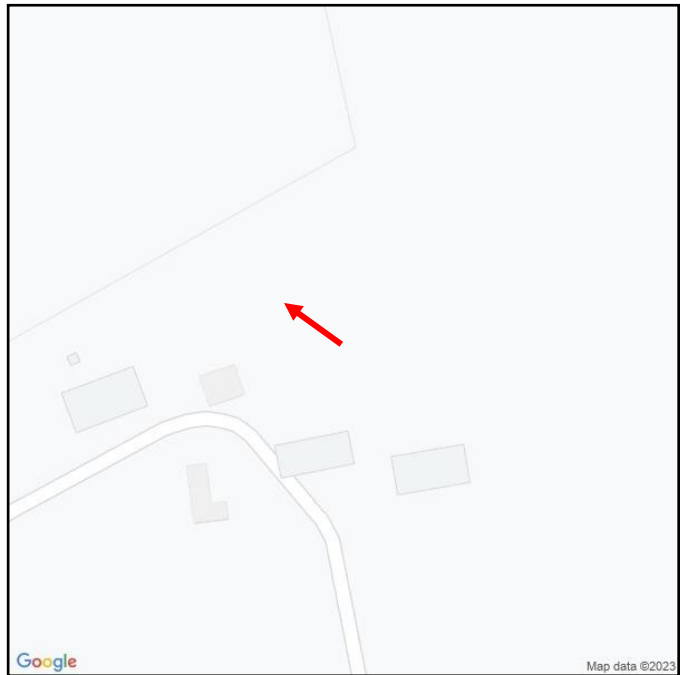
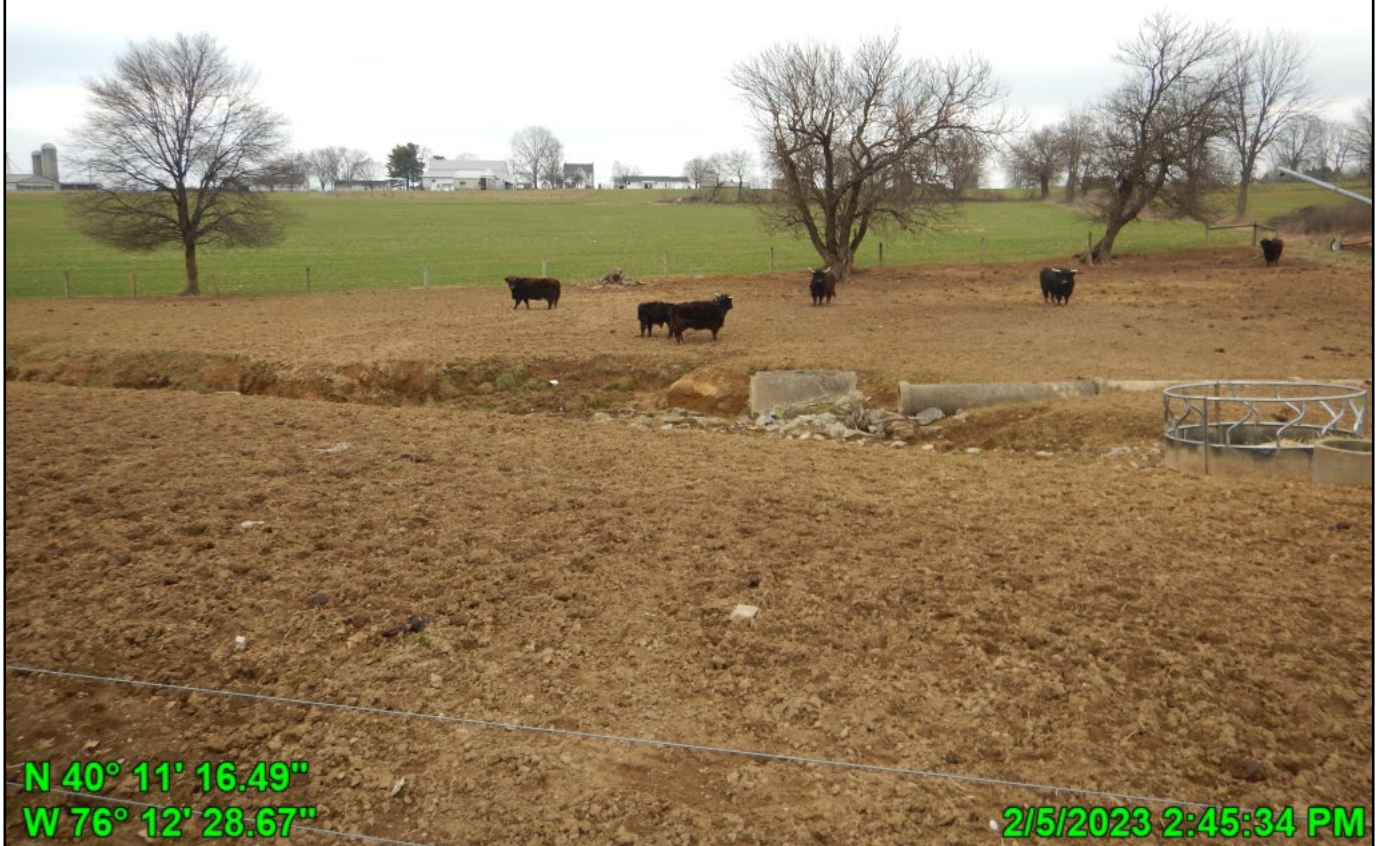
DSCN5024.JPG

| Description | Meadow Run viewed from Tank P2. |

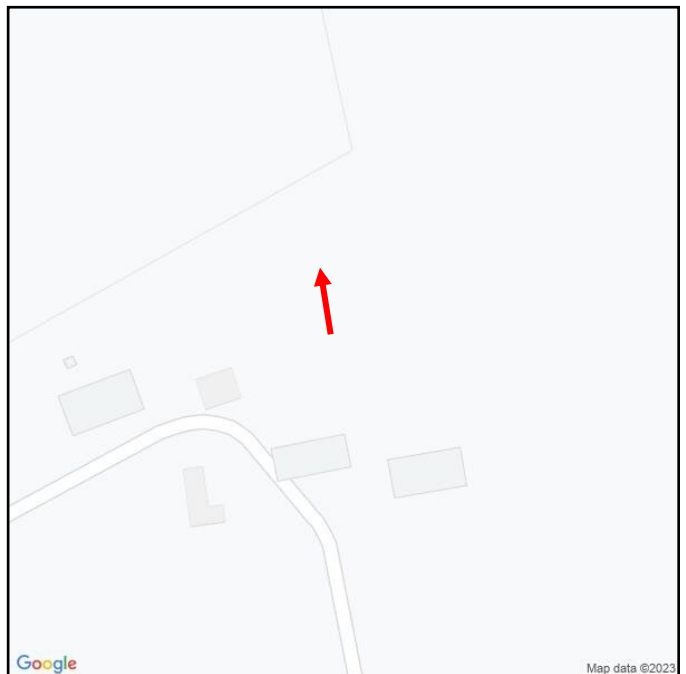
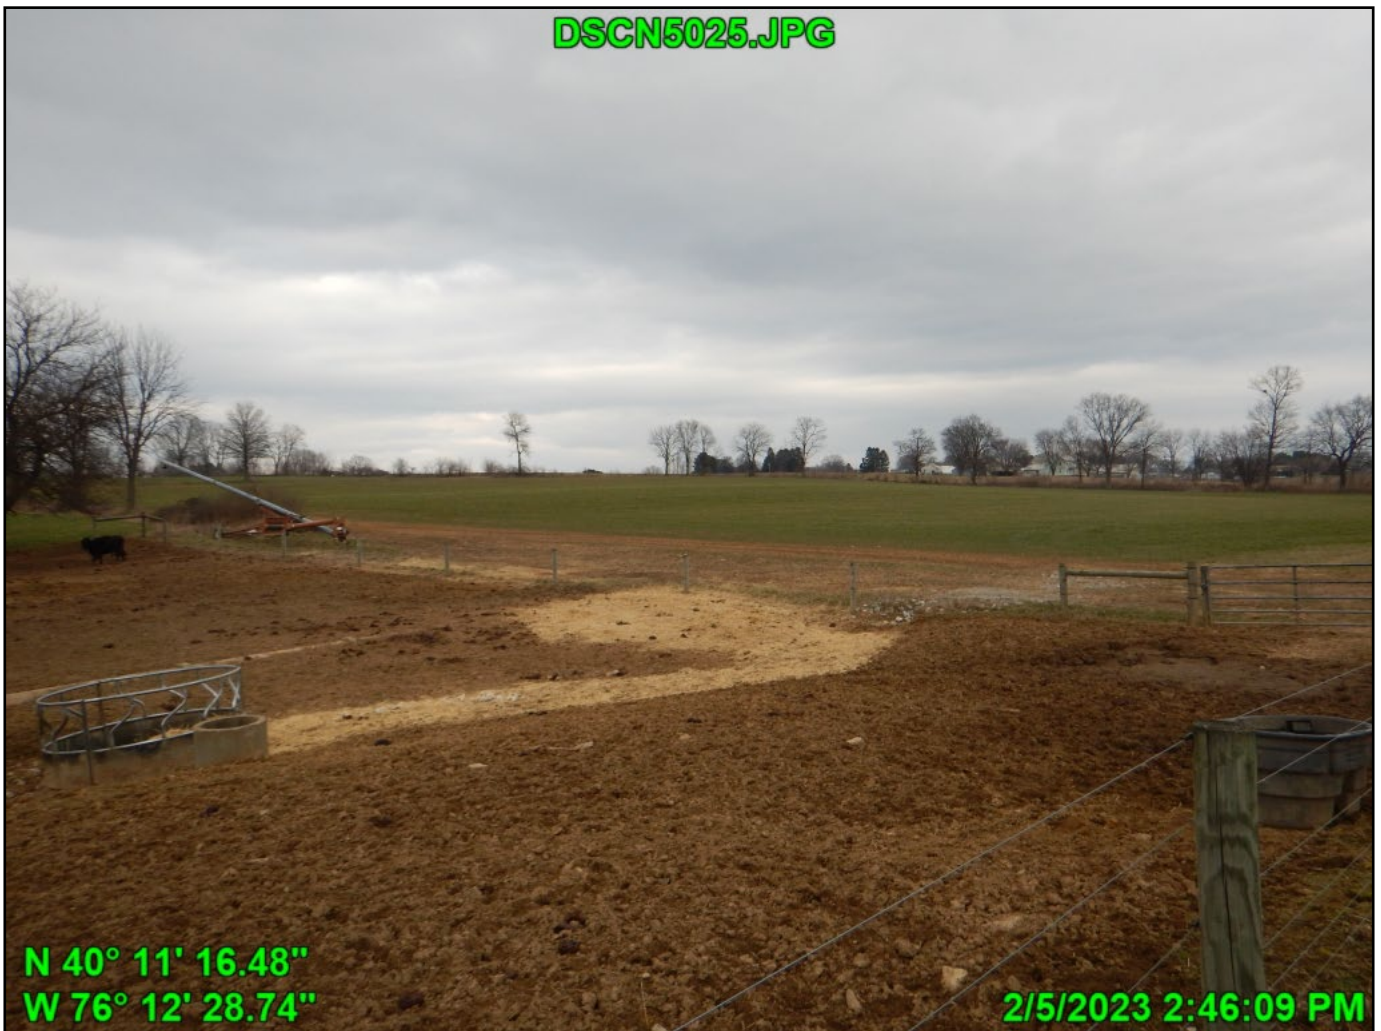
DSCN5025.JPG

| Description | Meadow Run. |

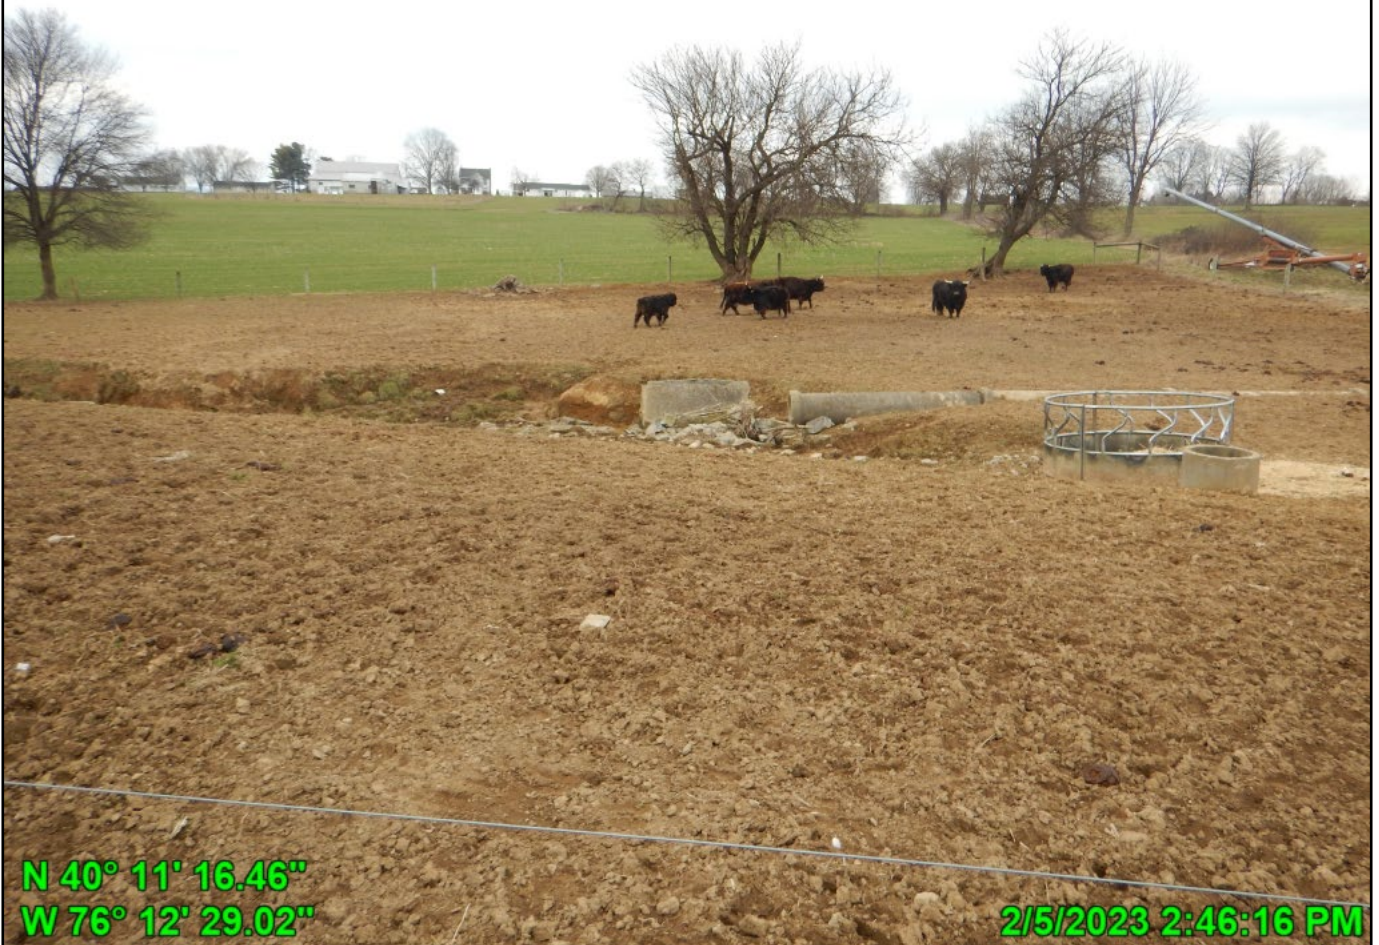
DSCN5026.JPG

| Description | Area upgradient of Meadow Run. |

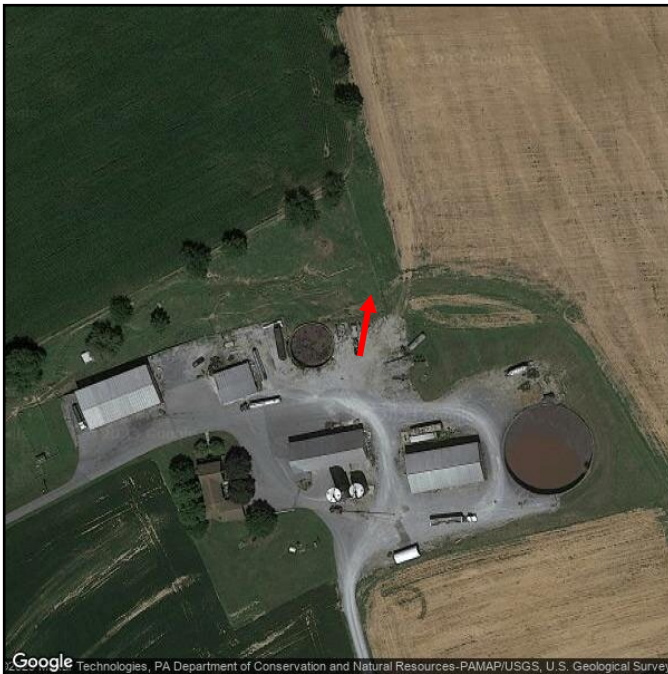
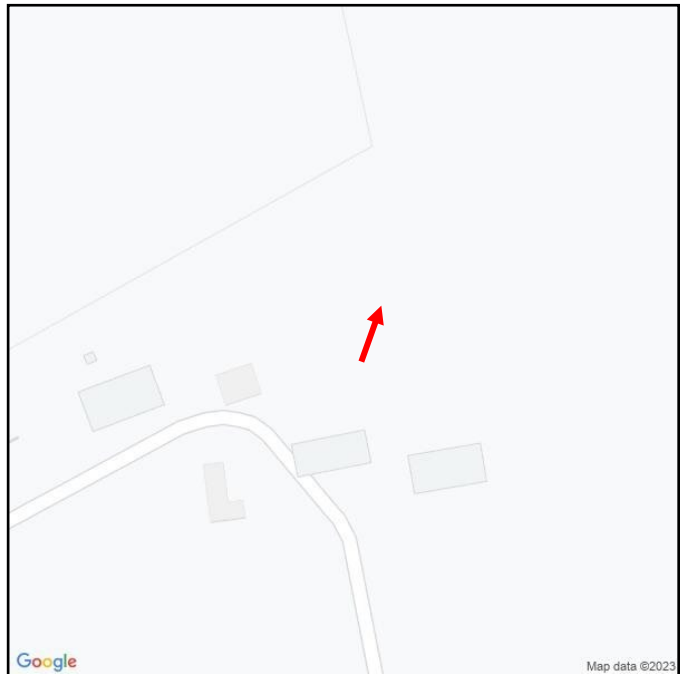
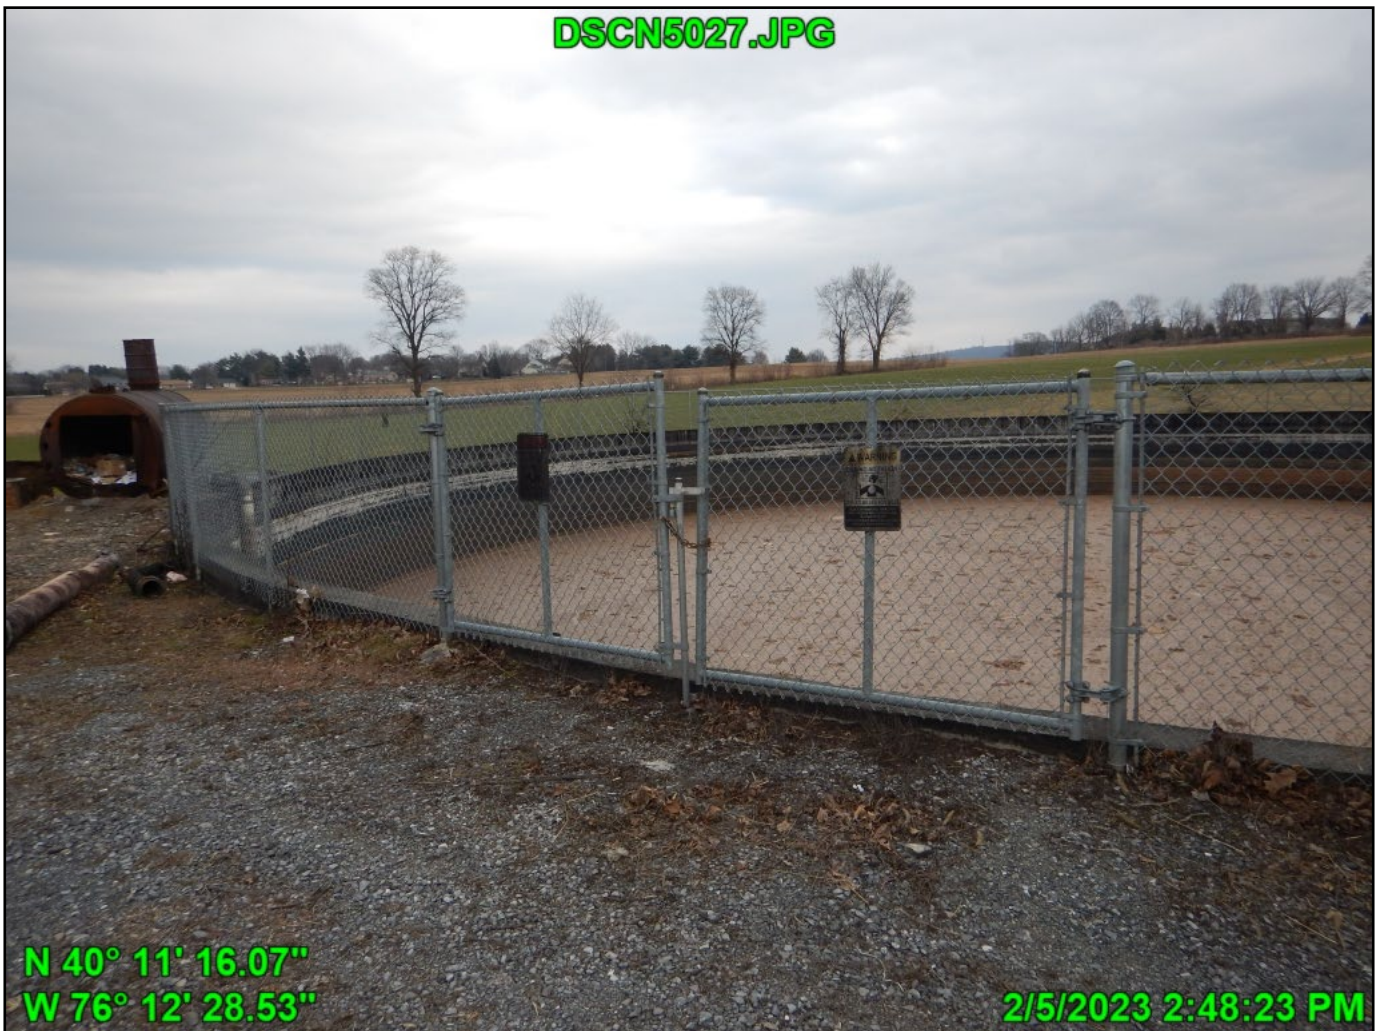
DSCN5027.JPG

| Description | Additional view of Meadow Run with outlet from pipe coming from residential neighborhood located 3,000 feet to the east. |

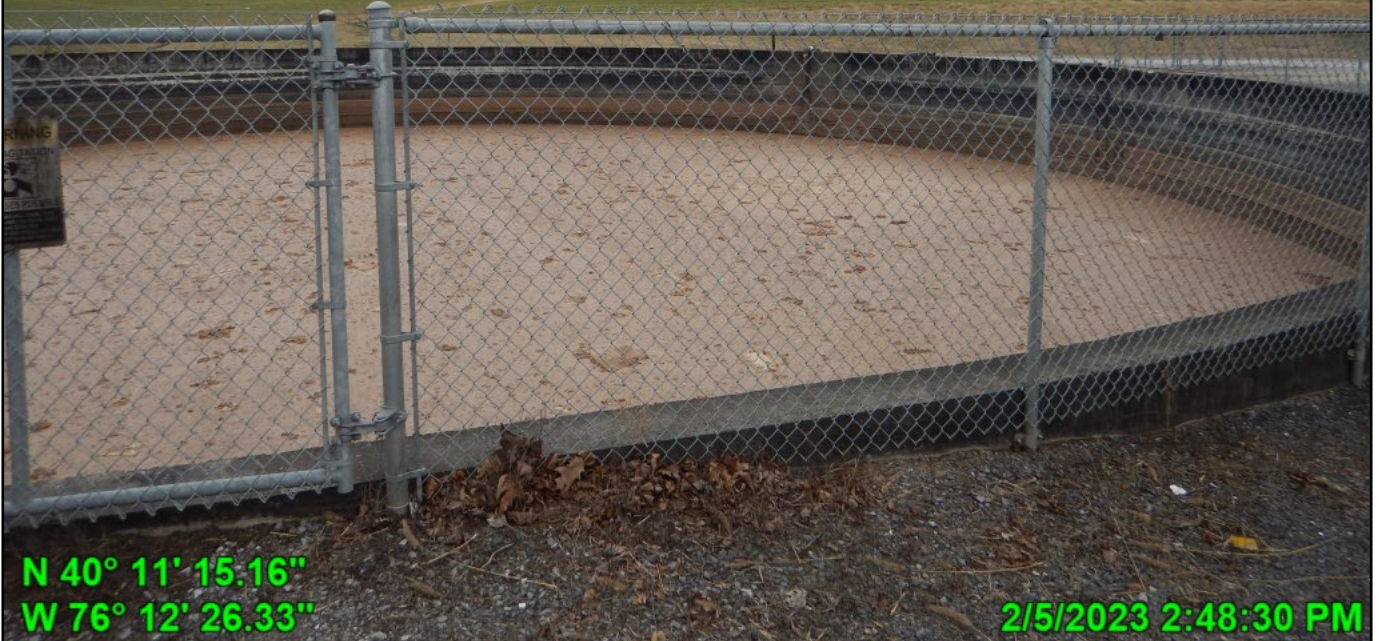
DSCN5028.JPG

| Description | Tank P3, a 1,353,600-gallon tank designed to store and treat biosolids and food processing waste. |

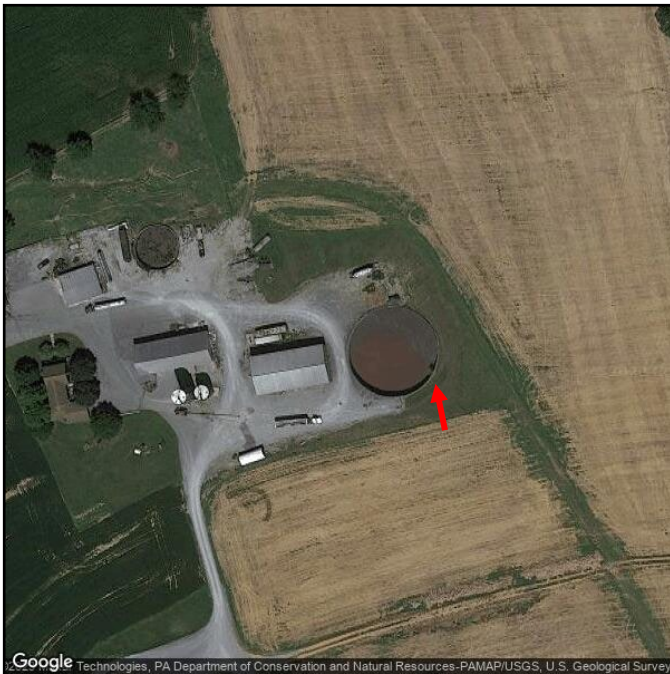
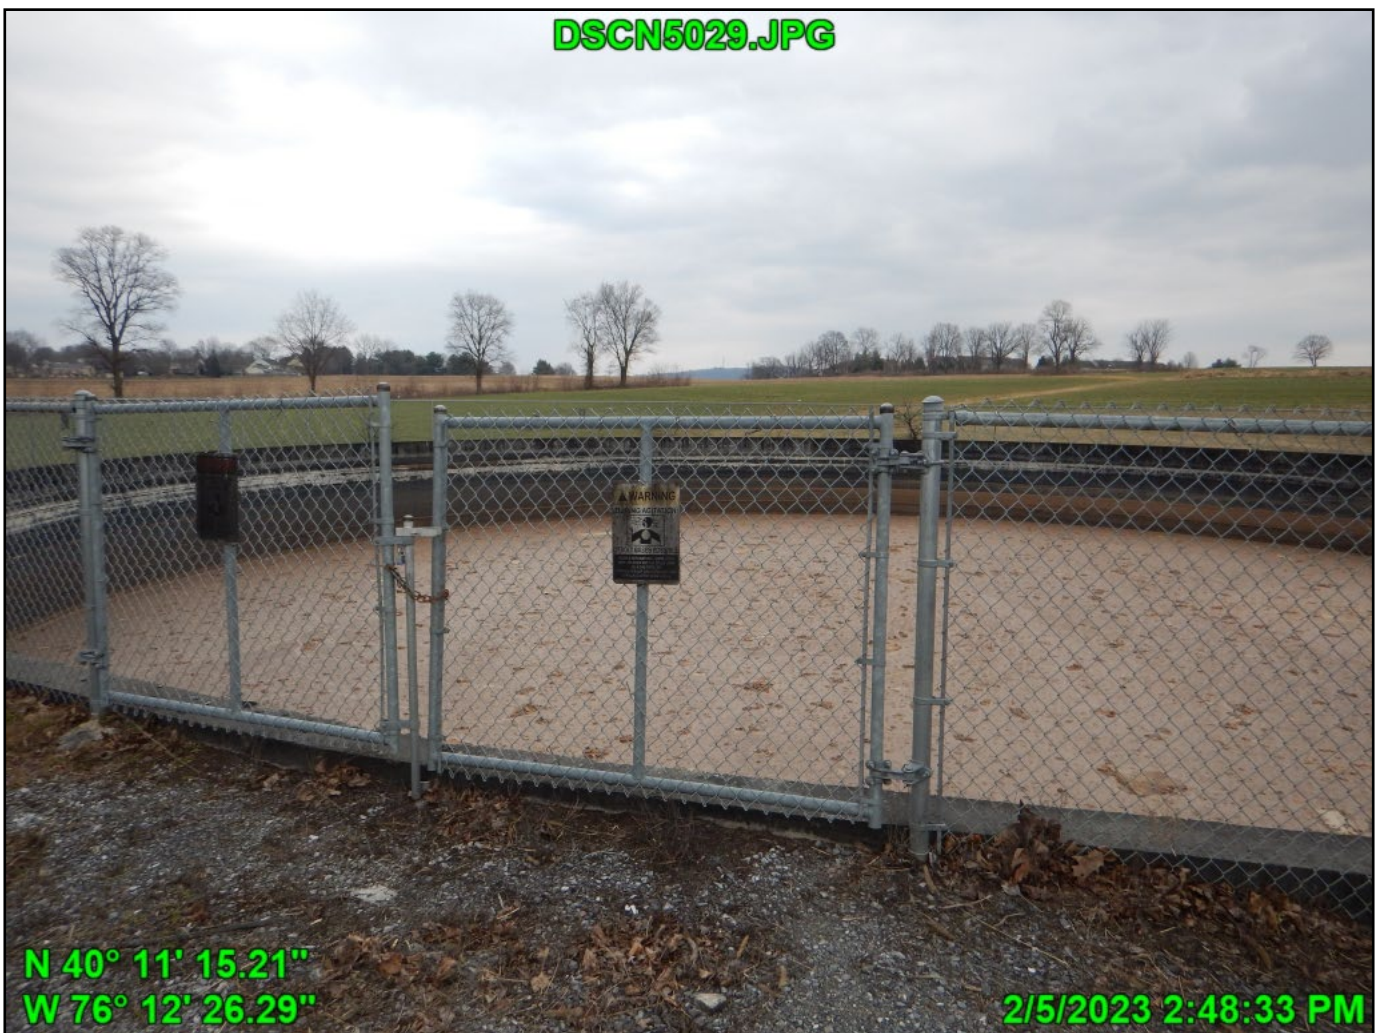
DSCN5029.JPG

| Description | Tank P3. |

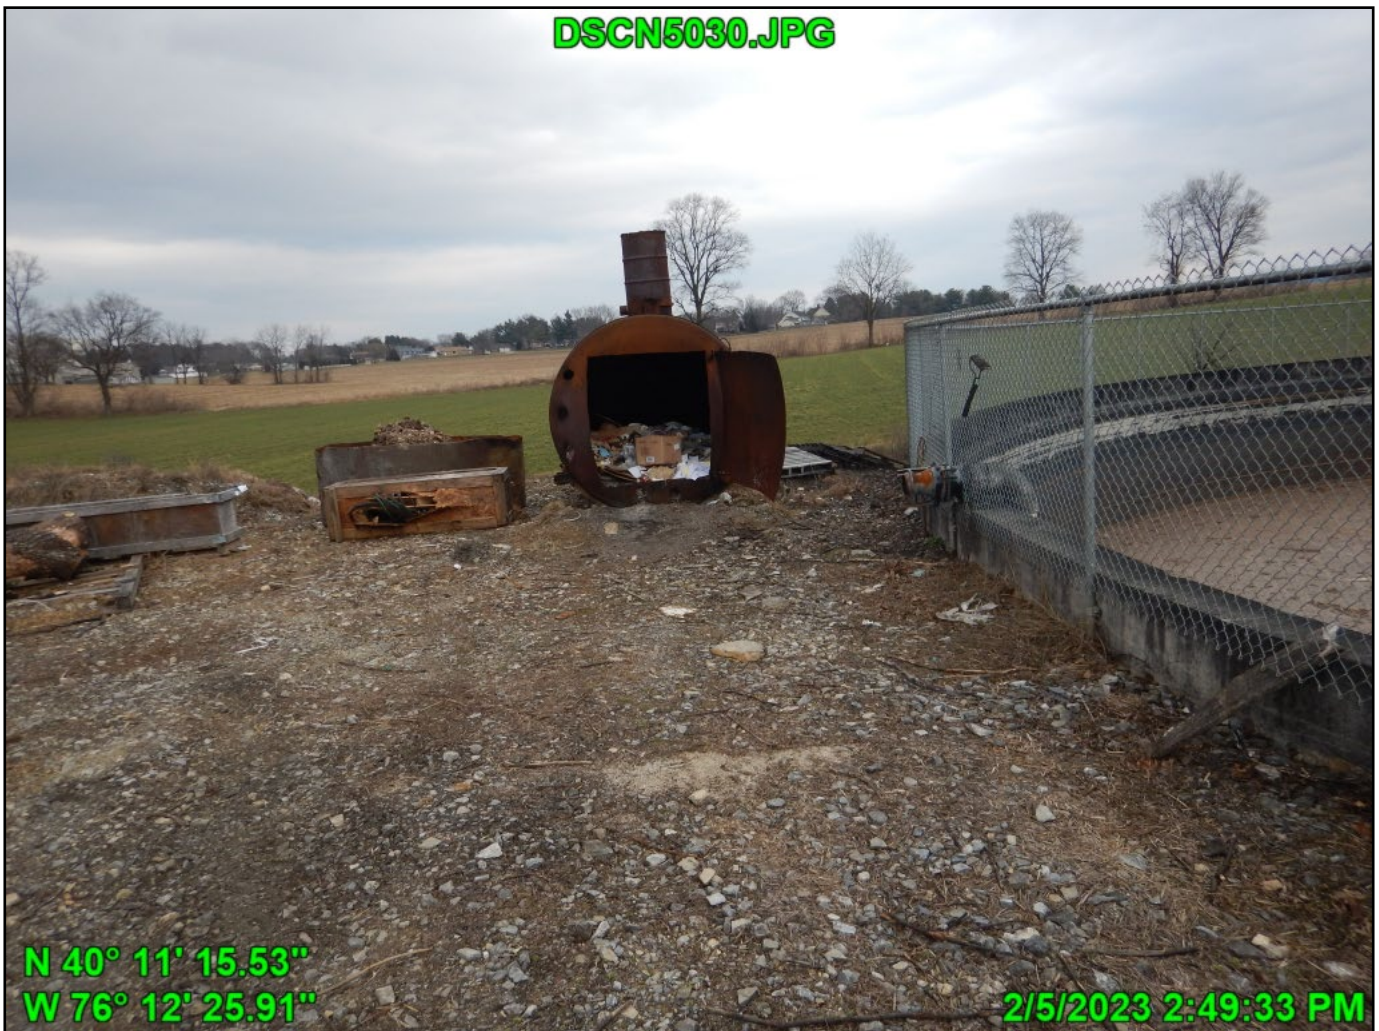
DSCN5030.JPG

| Description | Tank P3. |

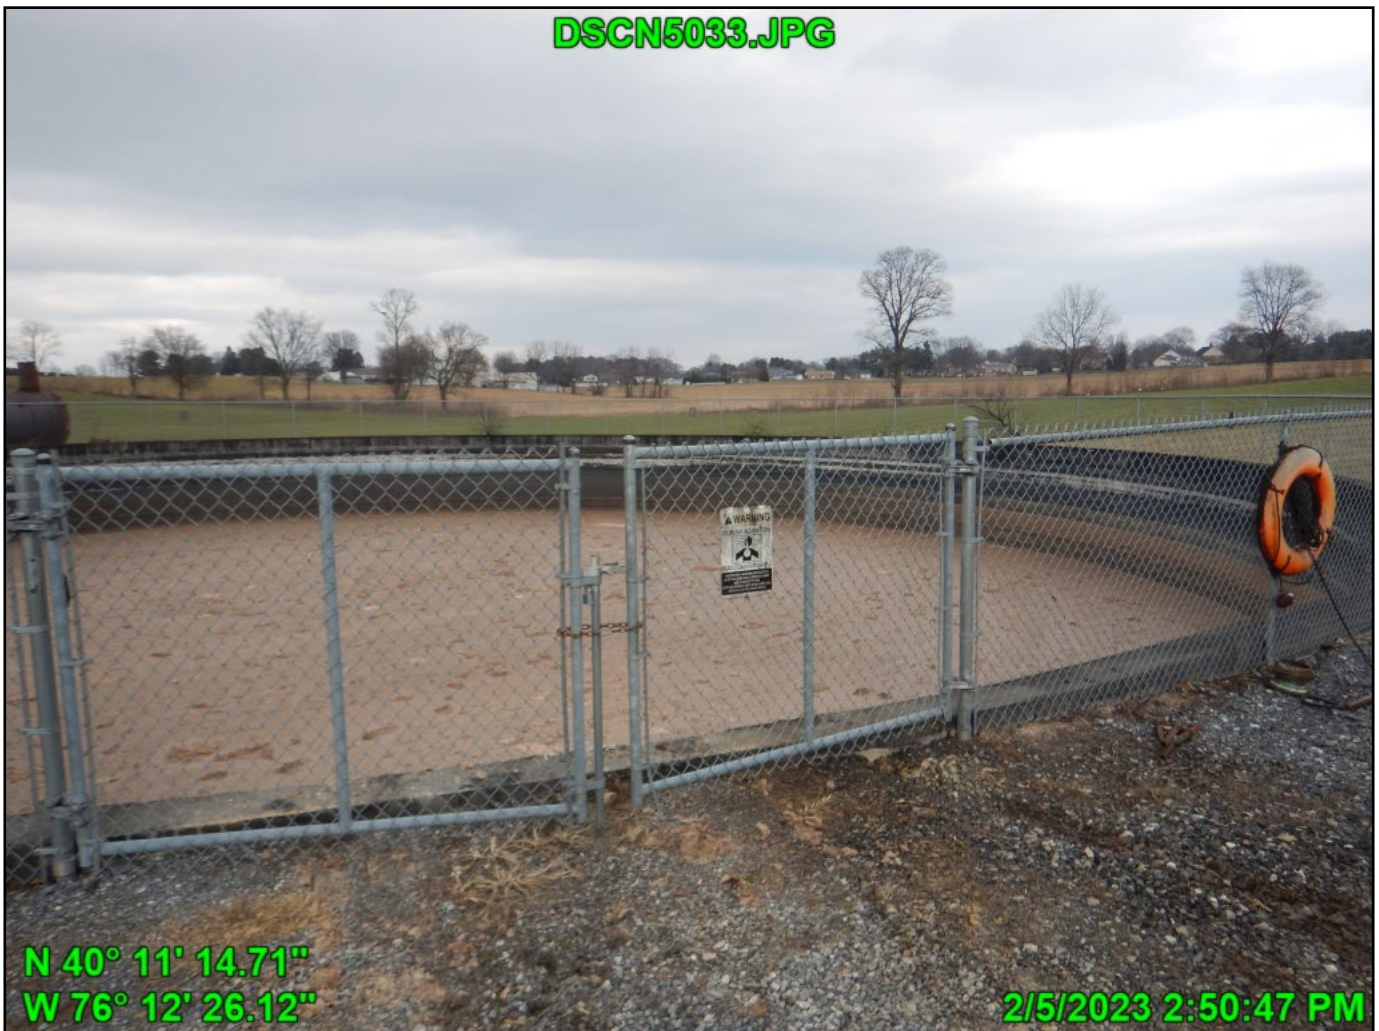
DSCN5034.JPG

| Description | Gate for Tank P3. |

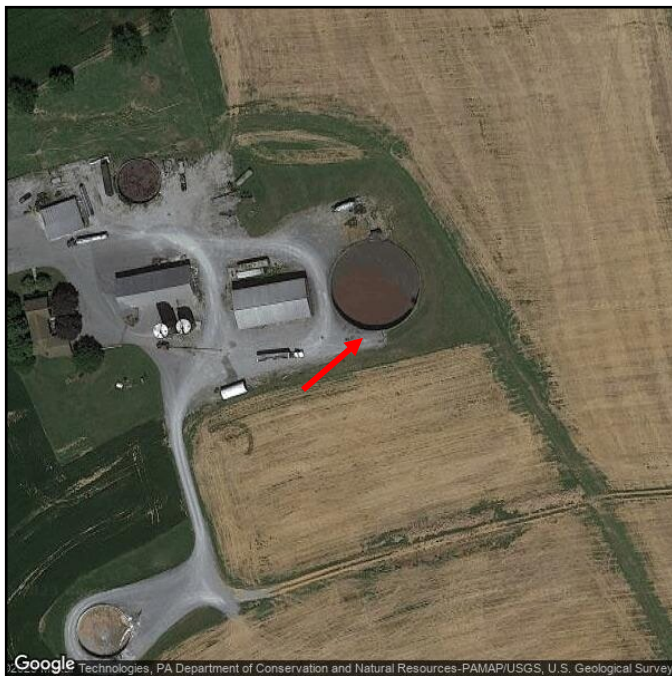
| Description | Spillage staining adjacent to Tank P3. |

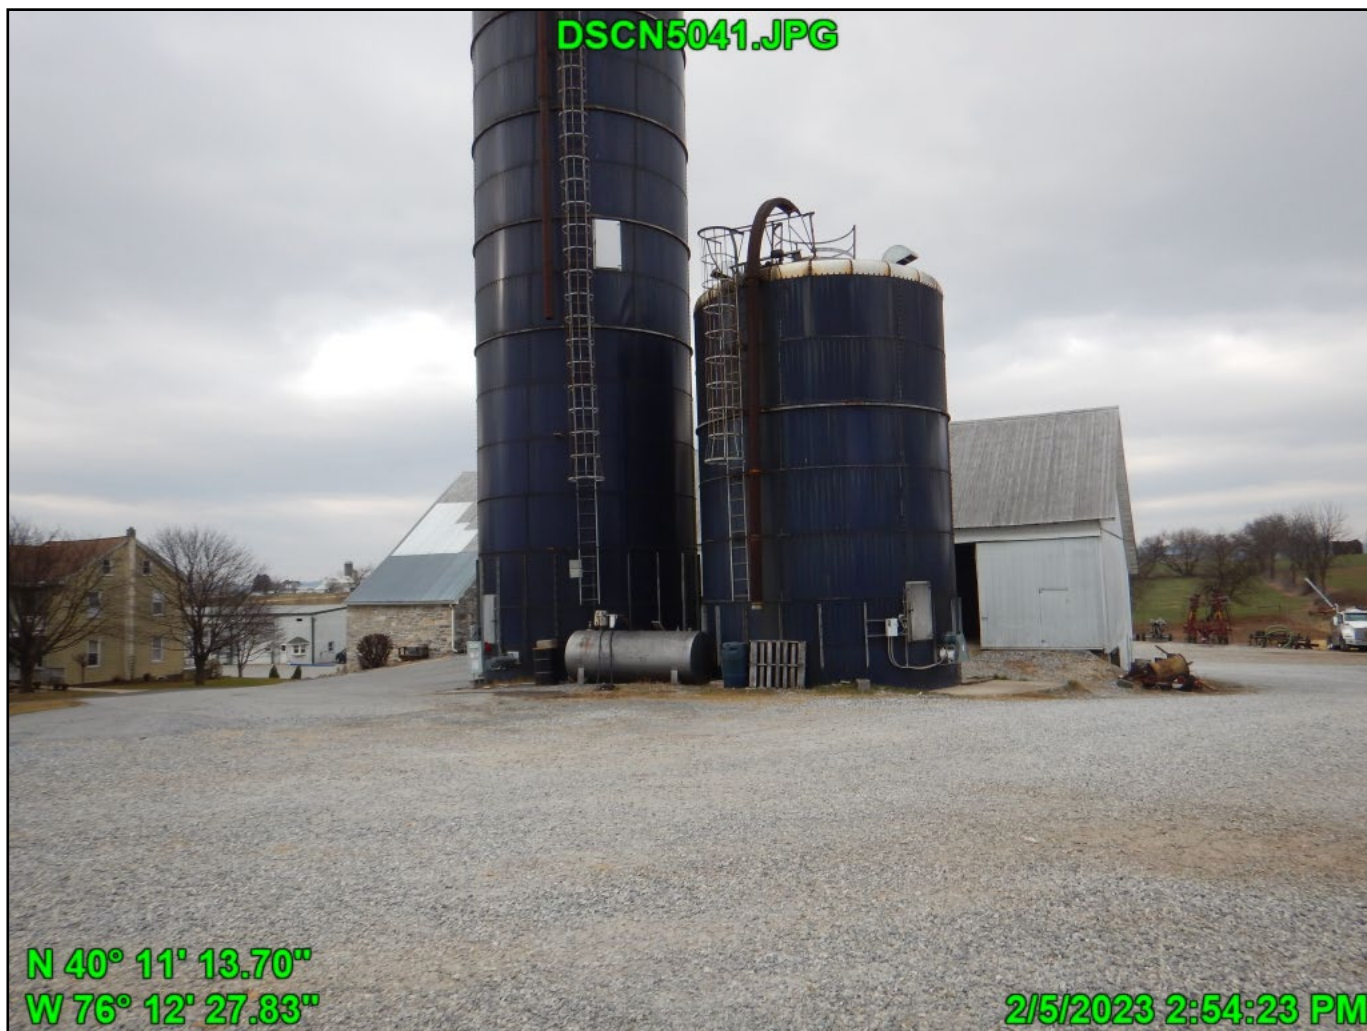
DSCN5042.JPG

| Description | 750-gallon fuel container for farm use, located in front of two silos. |

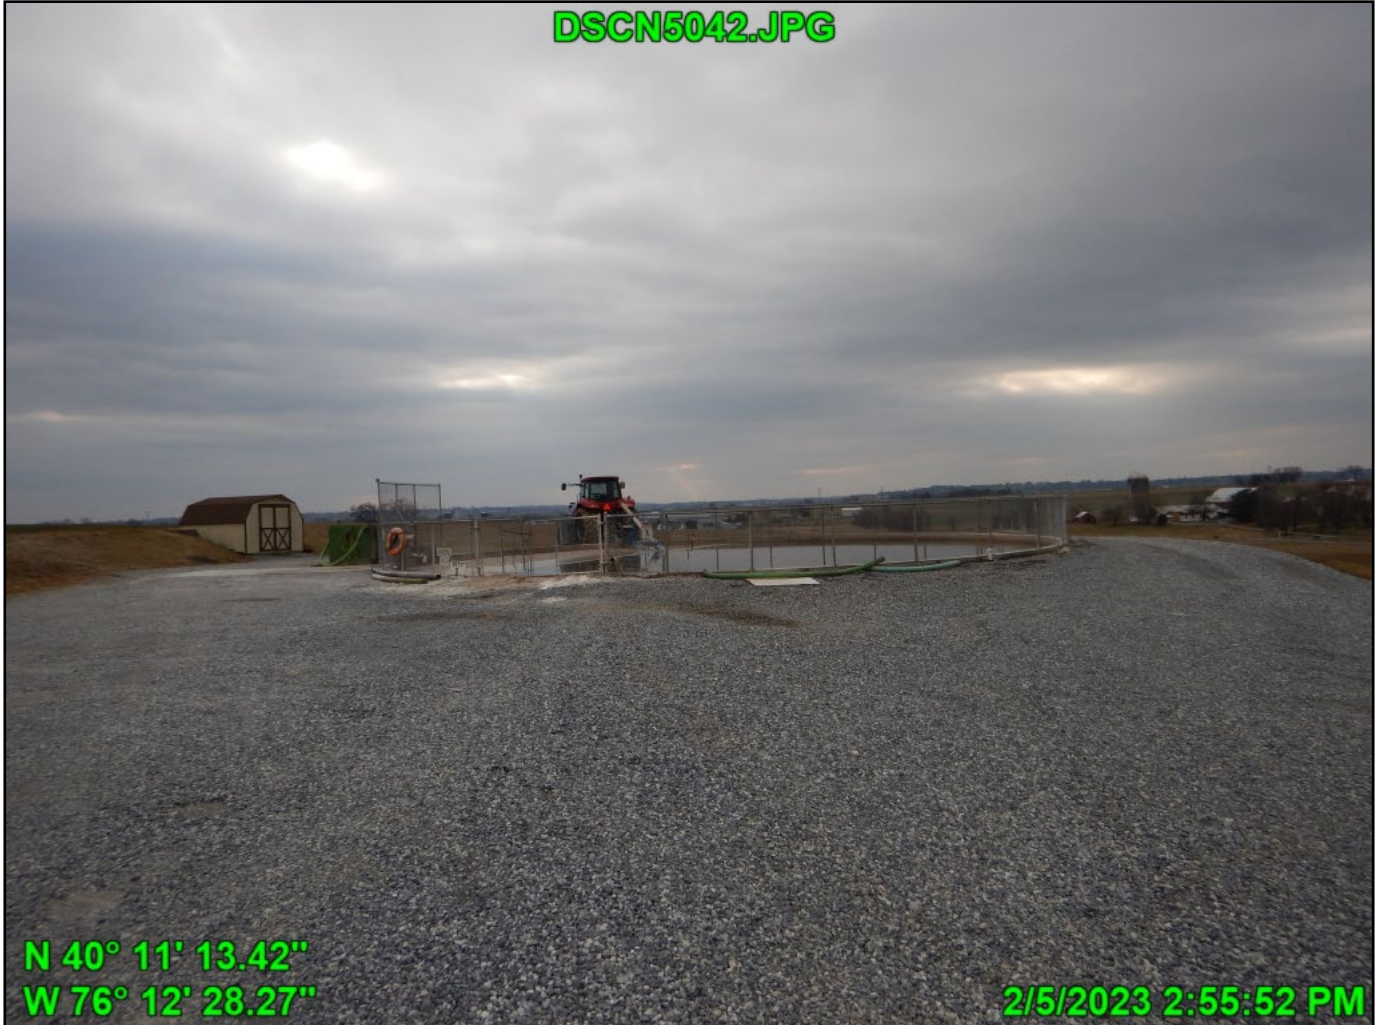
DSCN5043.JPG

| Description | Upgradient view of Tank P3. |

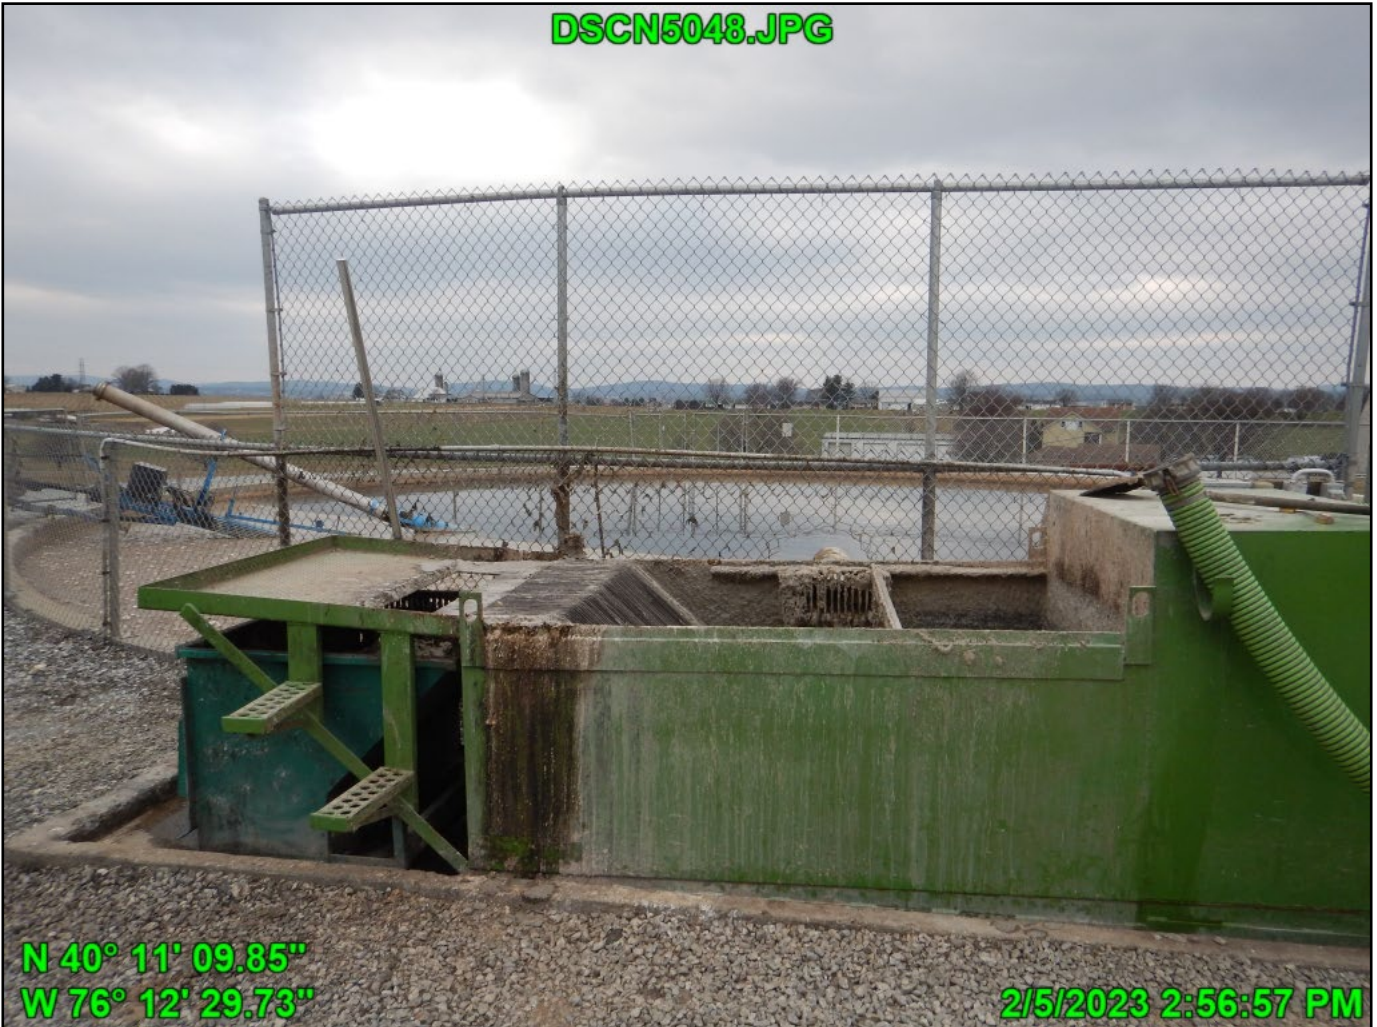
DSCN5049.JPG

| Description | Solids and grit removal machine adjacent to Tank P1. |

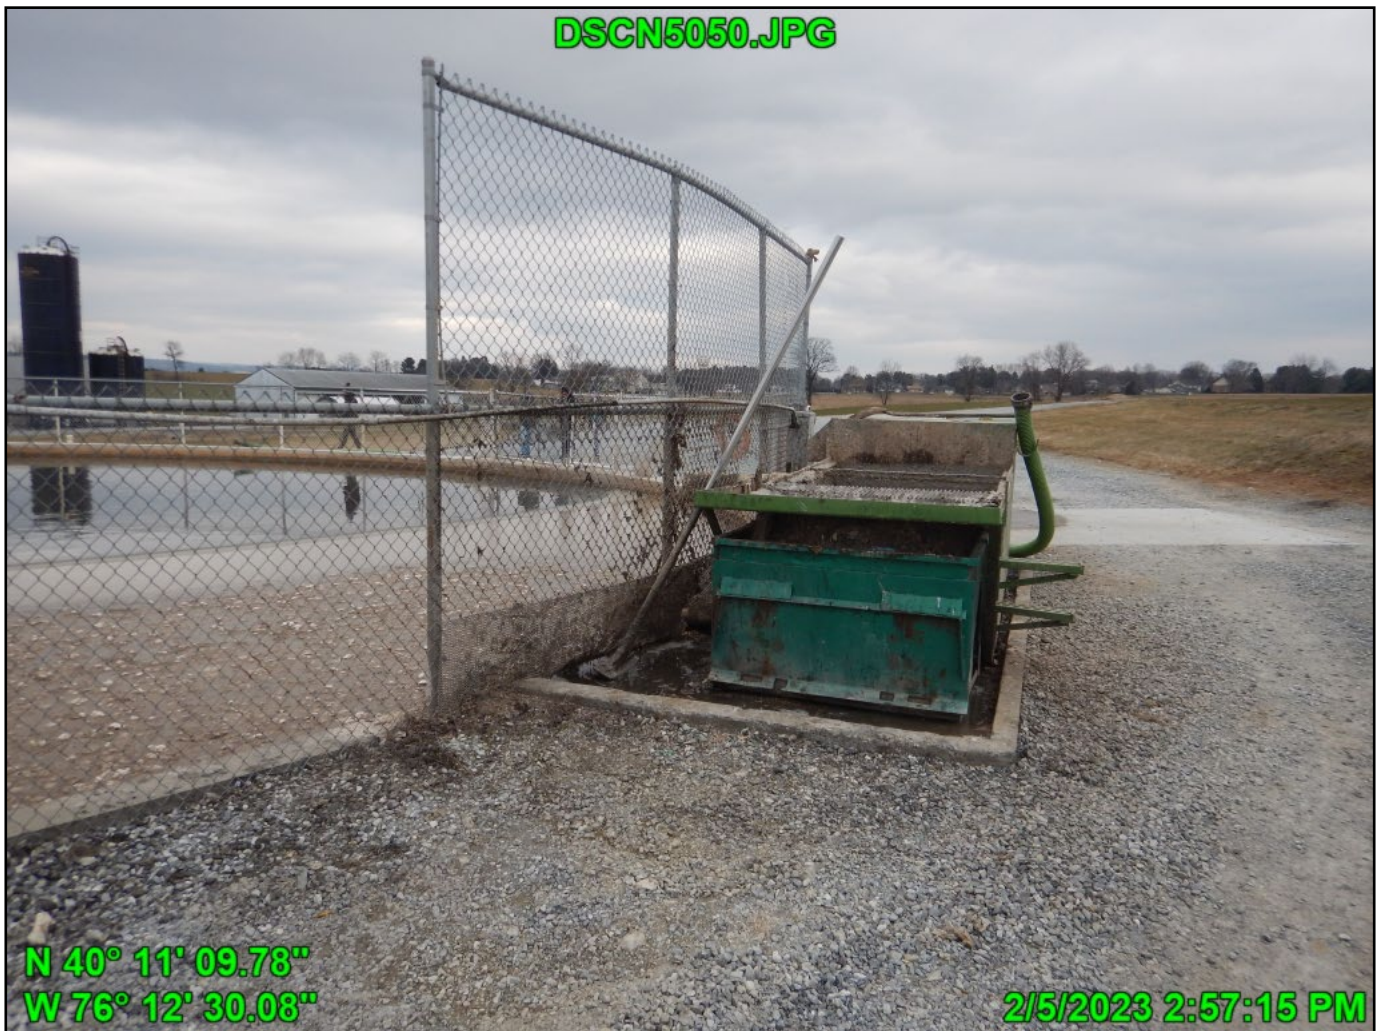
| Description | Pumping equipment for Tank P1. |
