## MULTI-SECTOR GENERAL PERMIT NON-FILER INSPECTION CHECKLIST

| <b>Inspection Date(s):</b> | 2/6/2023 | |
| <b>Operator Name:</b> | Nolt Services LLC | |

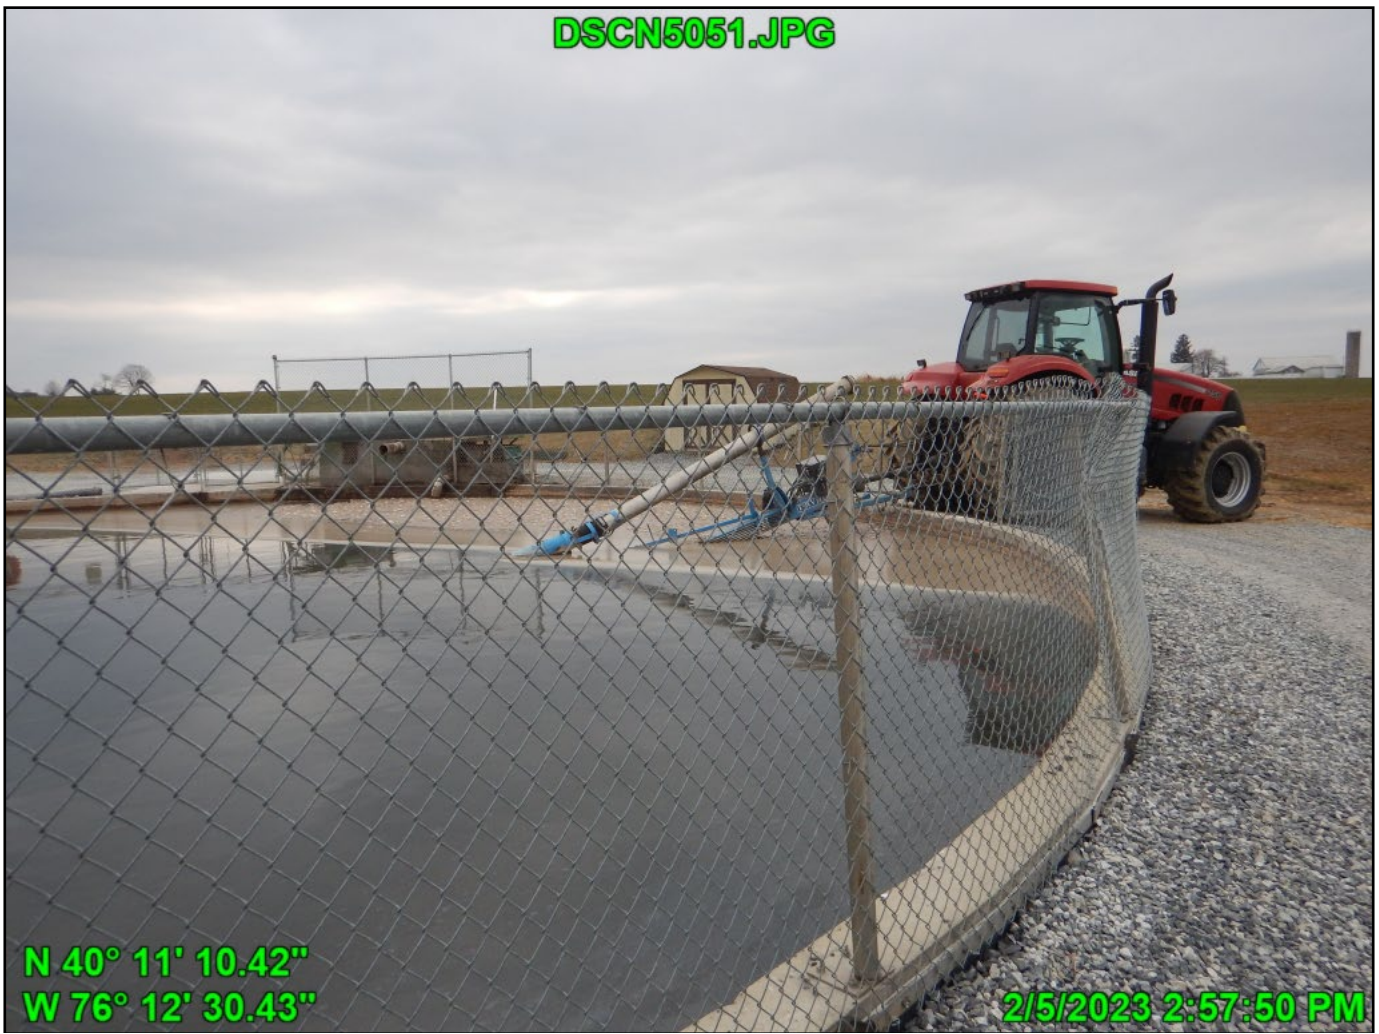
DSCN5051.JPG

| Description | Solids and grit removal machine adjacent to Tank P1. |

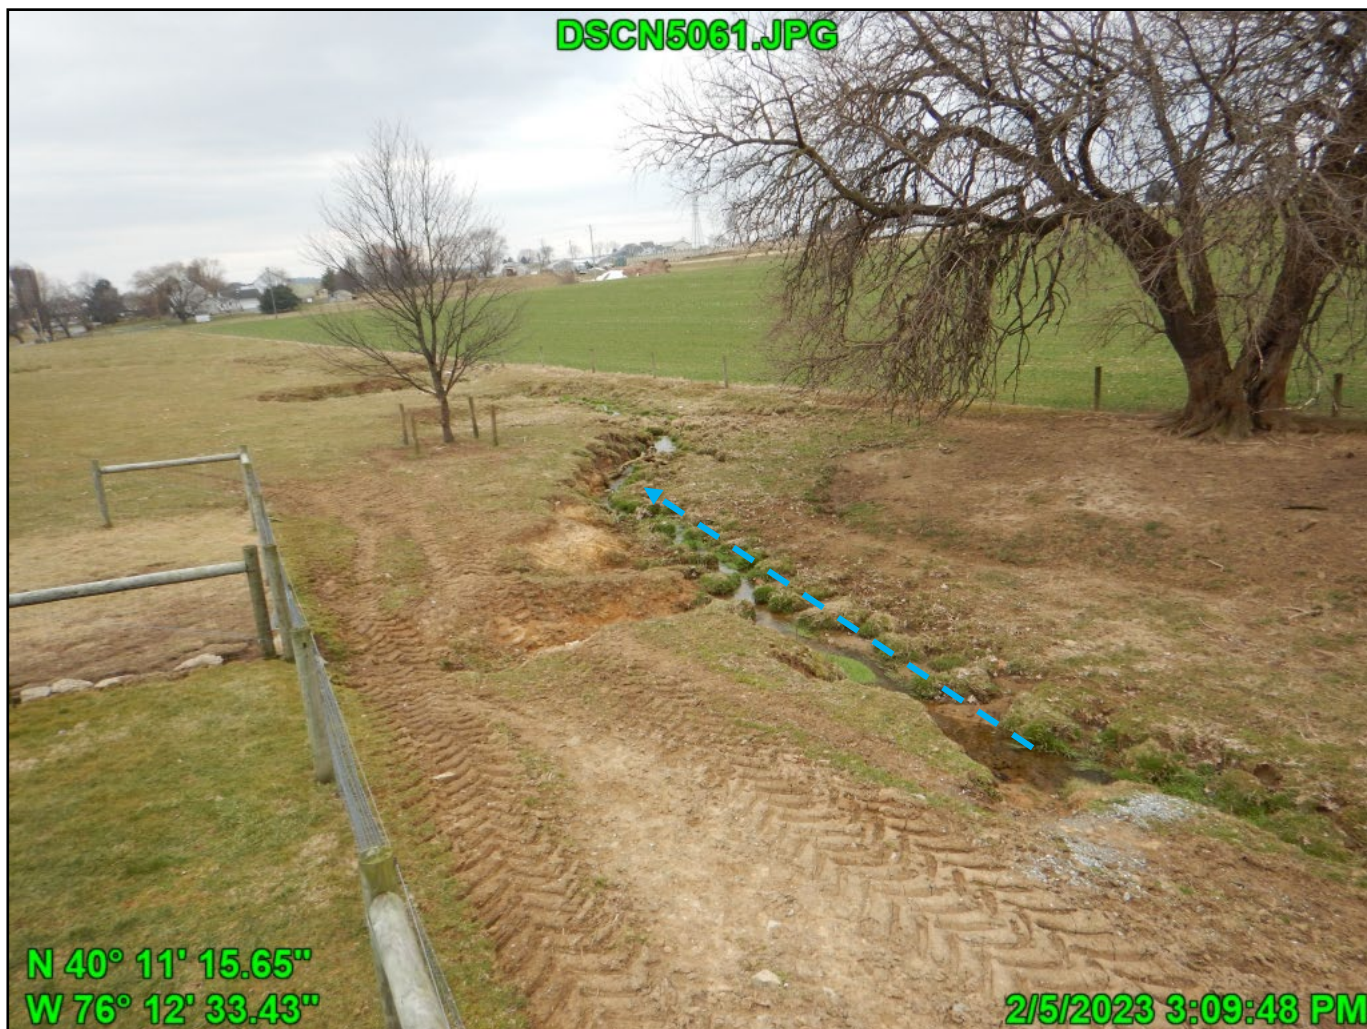
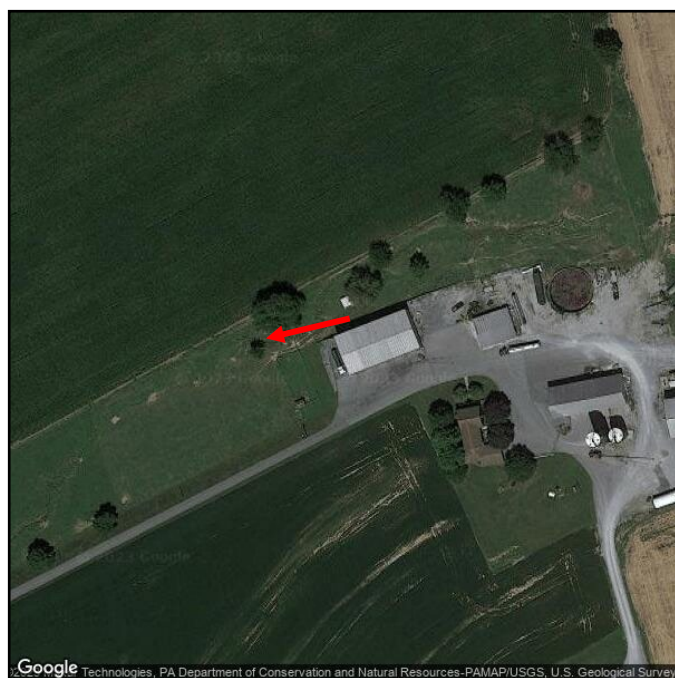
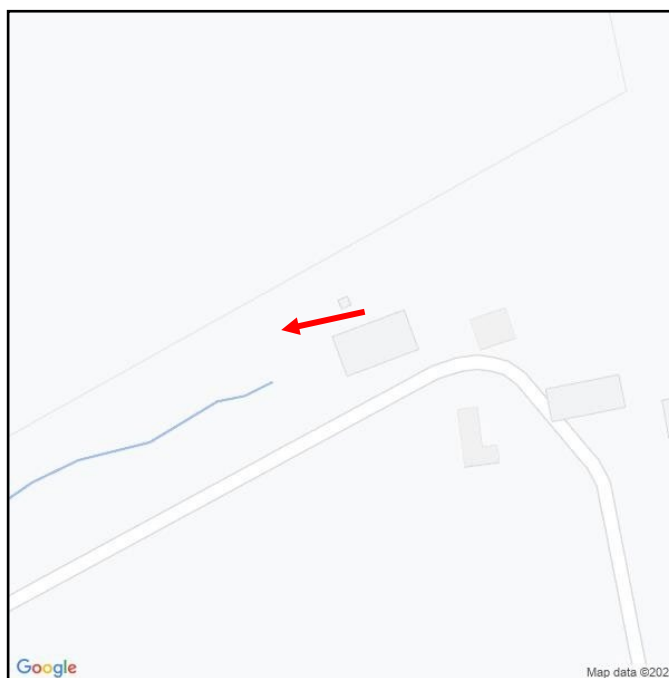
| Description | Downgradient view of Meadow Run. |

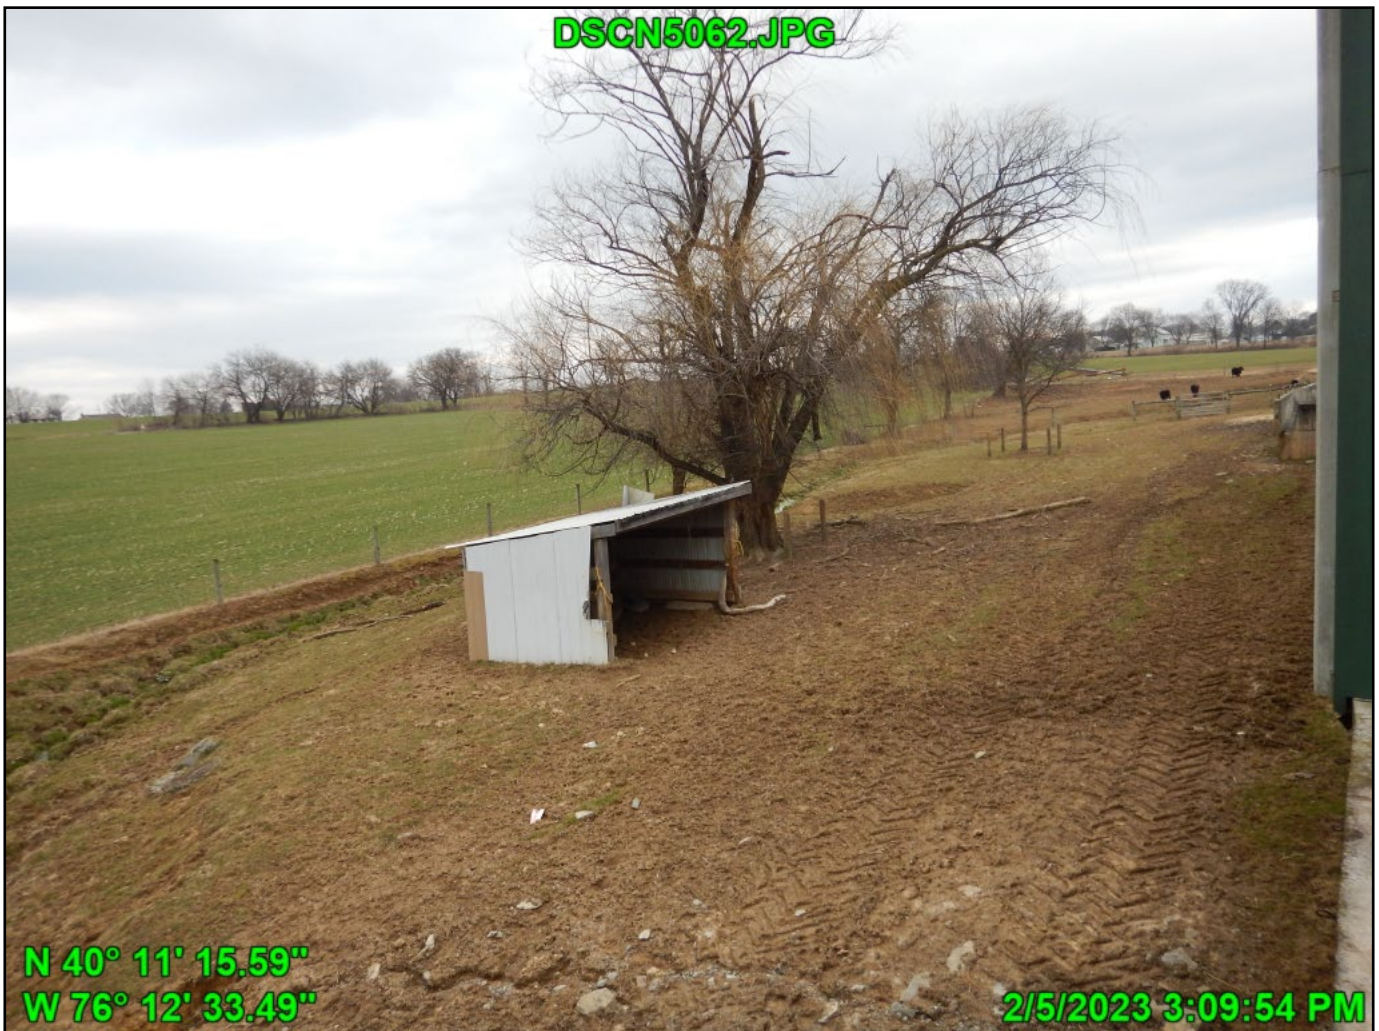
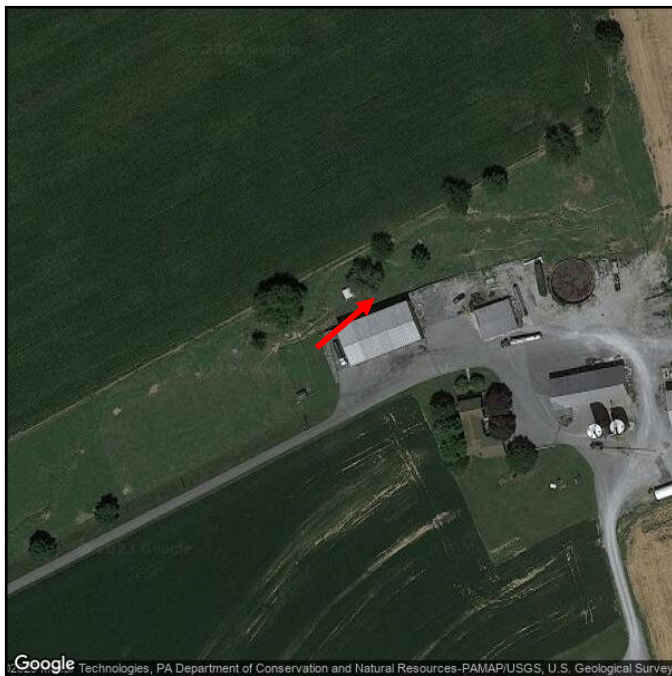
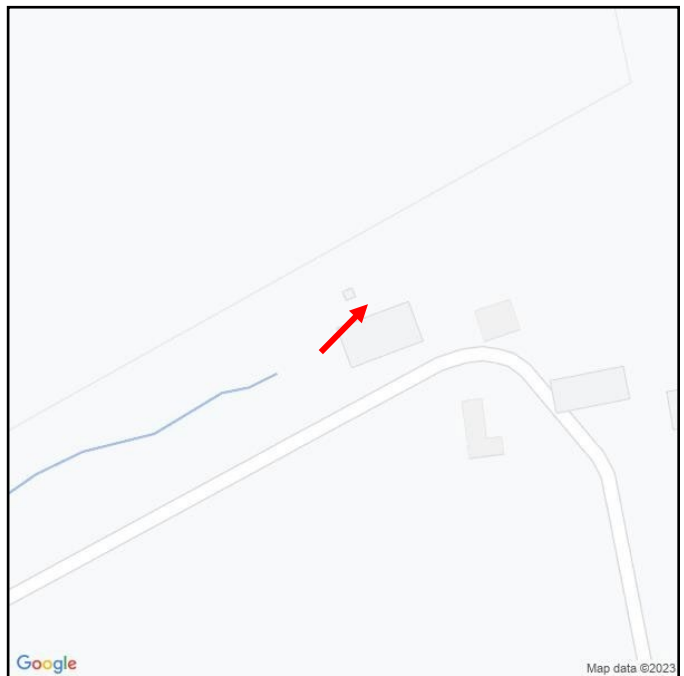
| Description | Upgradient view of Meadow Run to the north of a small white shelter. |

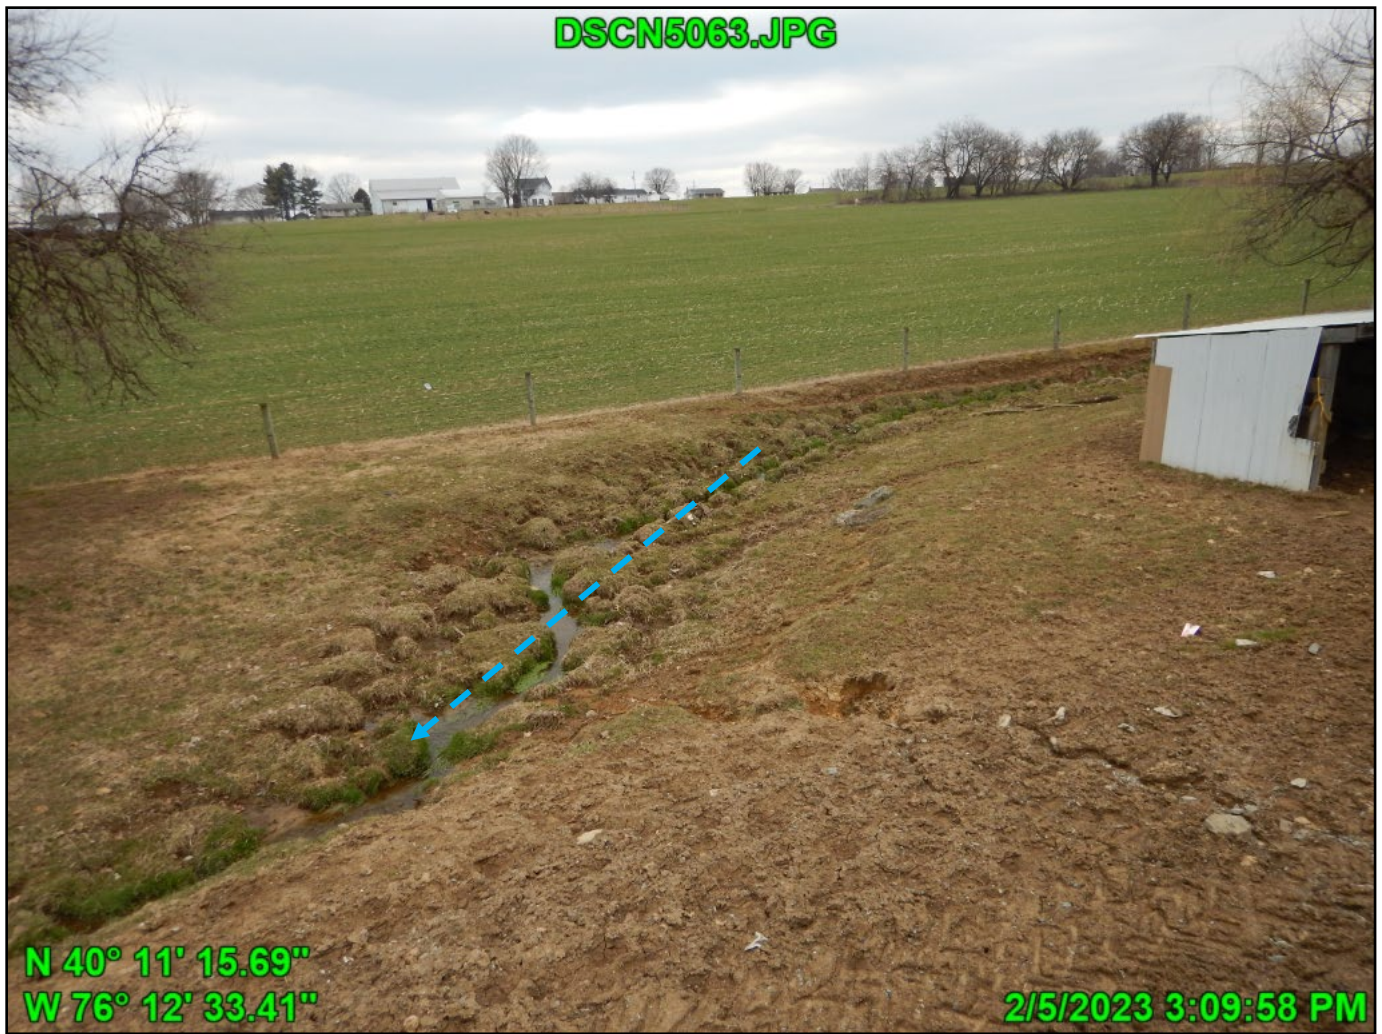
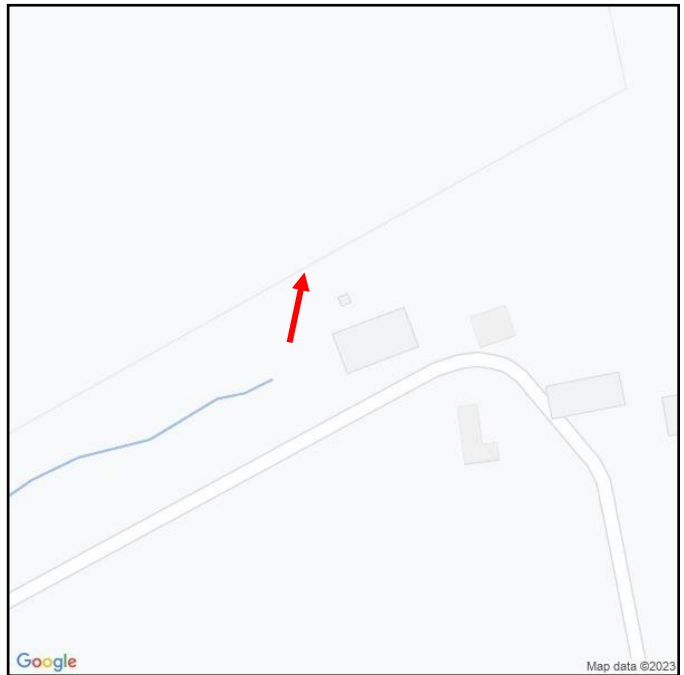
| Description | Upgradient view of Meadow Run. |

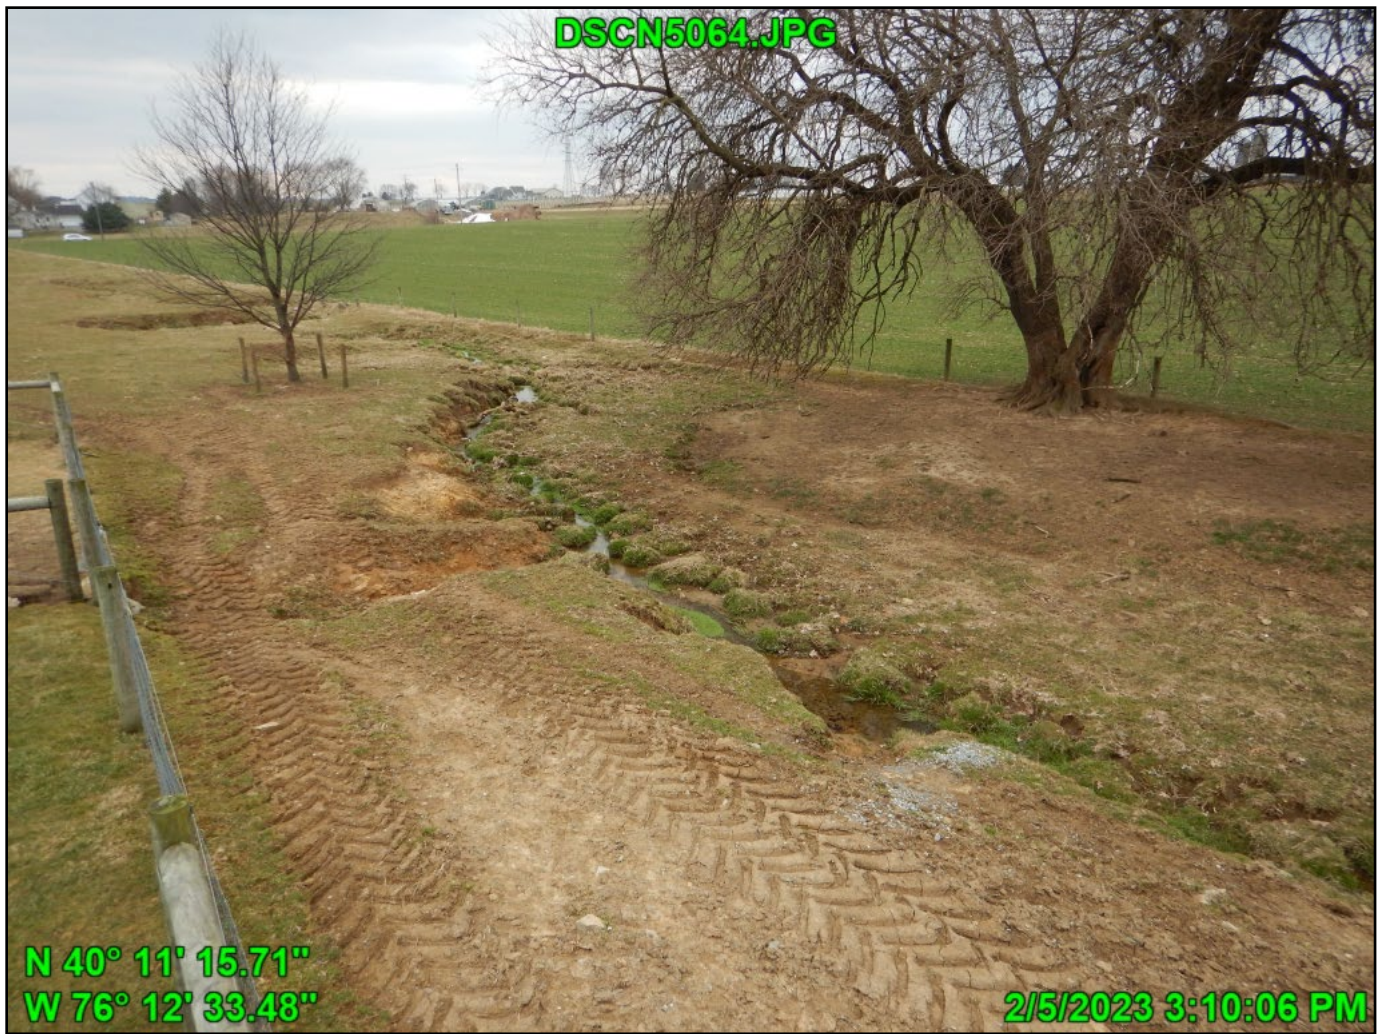
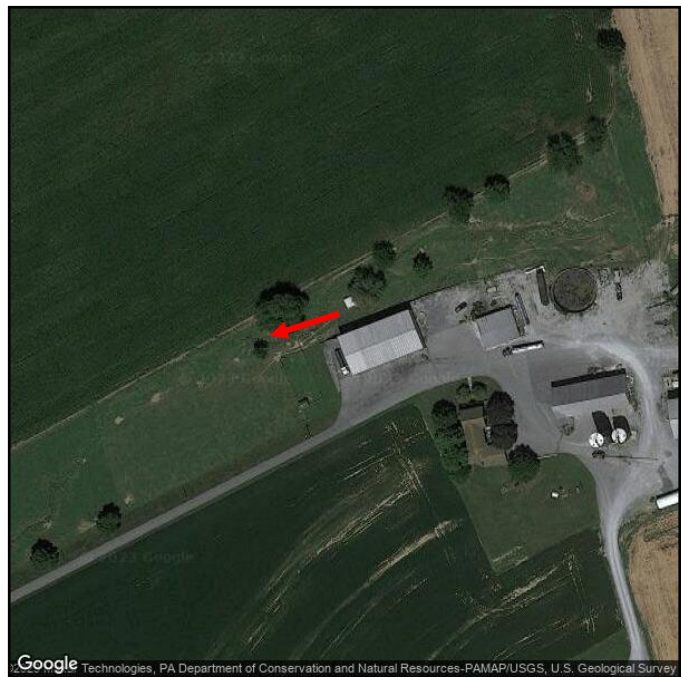
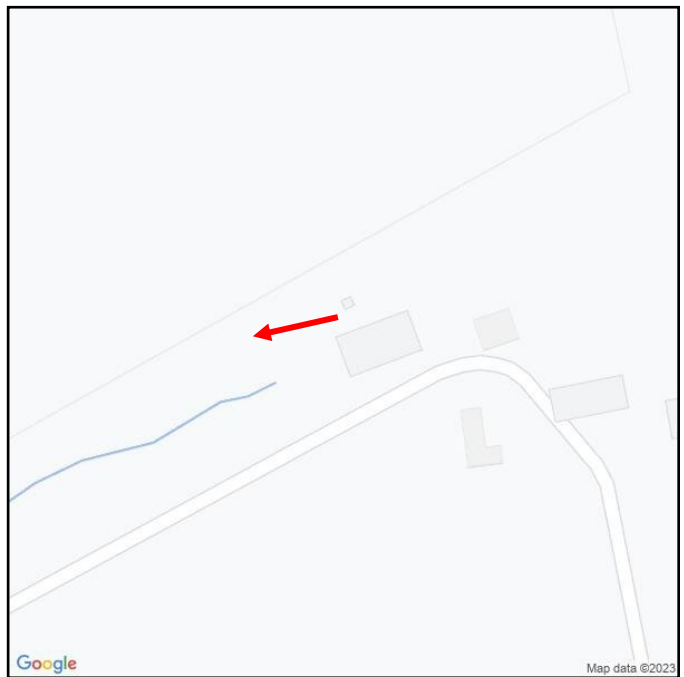
| Description | Downgradient view of Meadow Run flowing from the east to the west. |

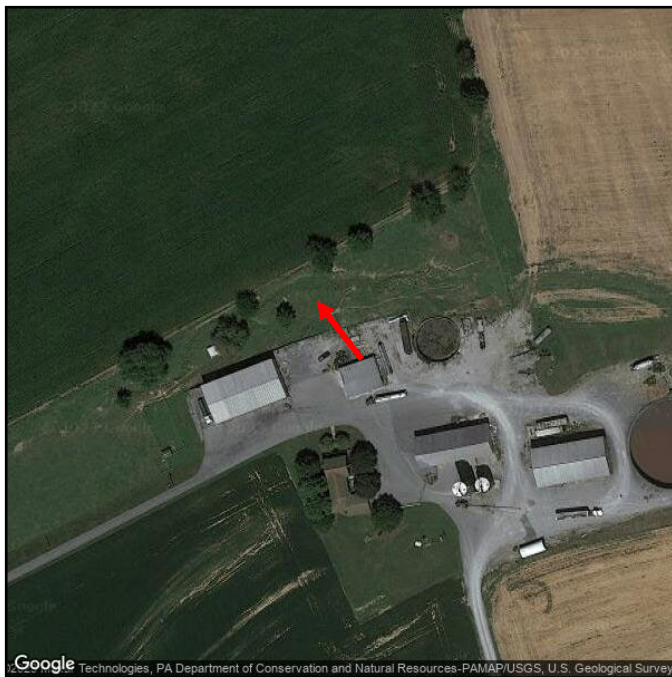
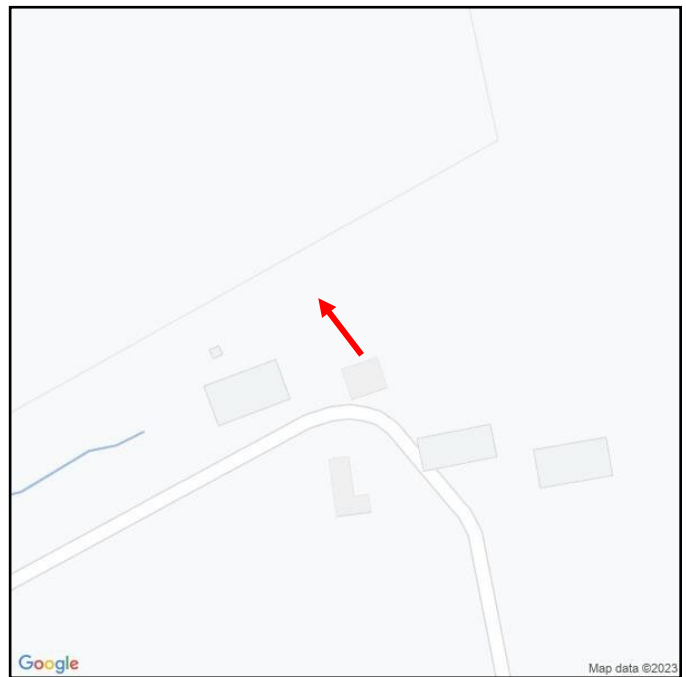
| Description | Direction of sloping terrain from the area adjacent to Tank P2 towards Meadow Run. |

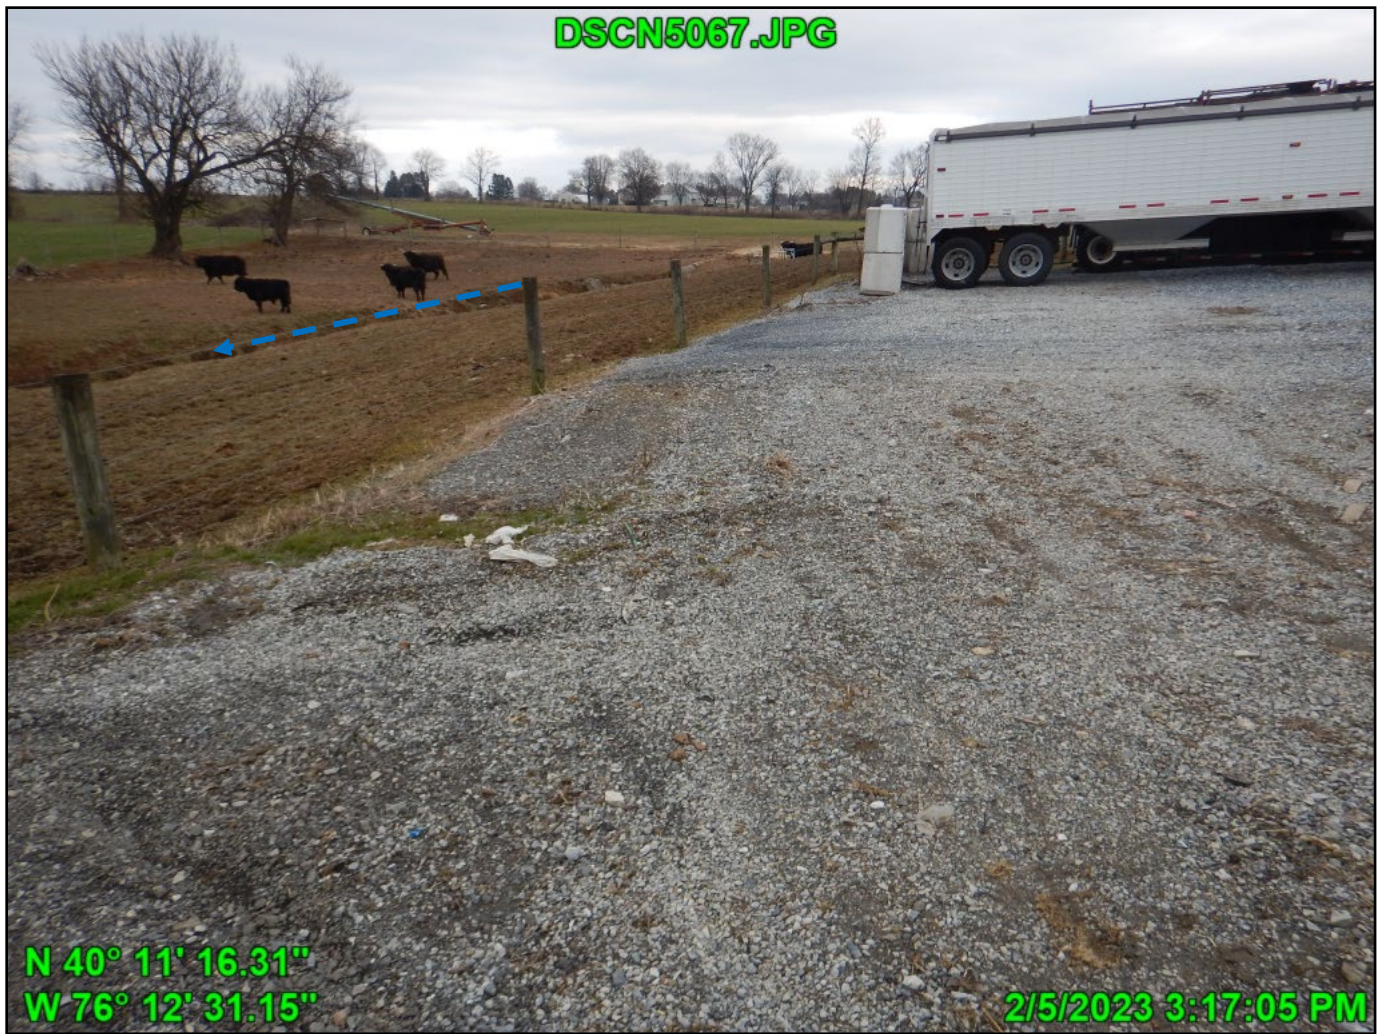
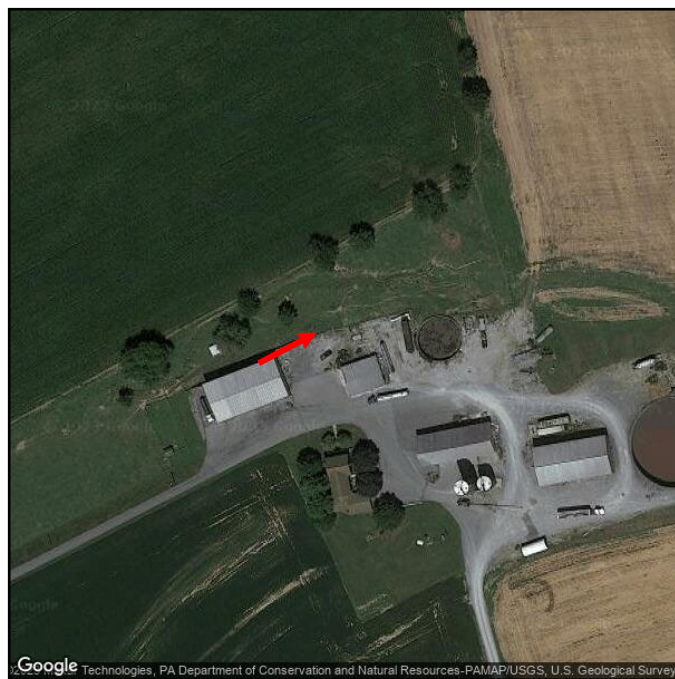
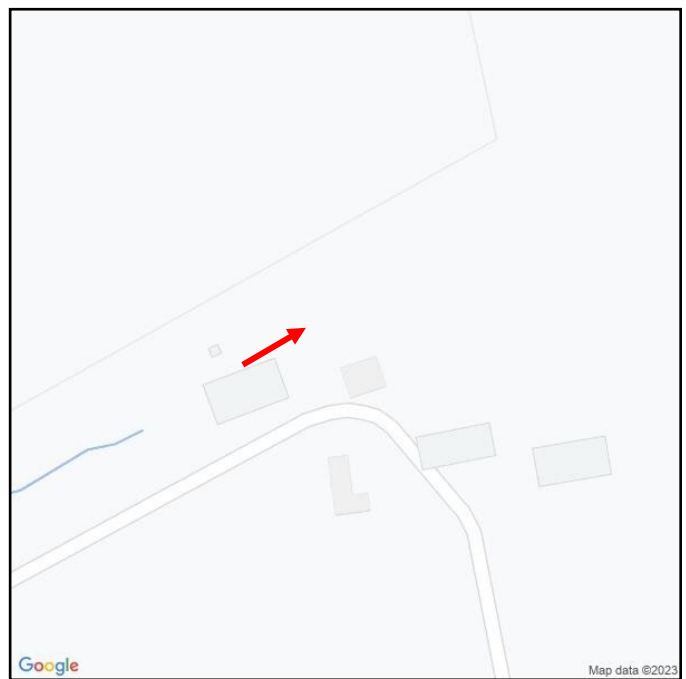
| Description | Meadow Run headwaters and Facility trucking equipment. |

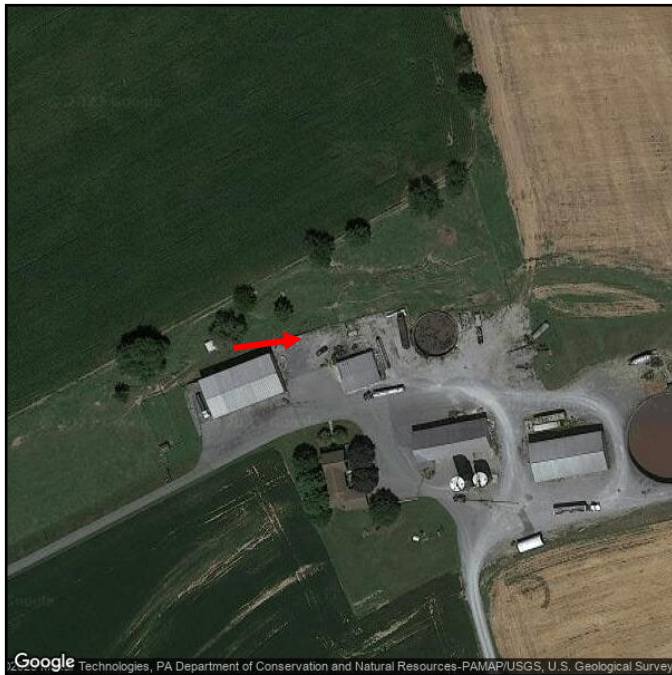
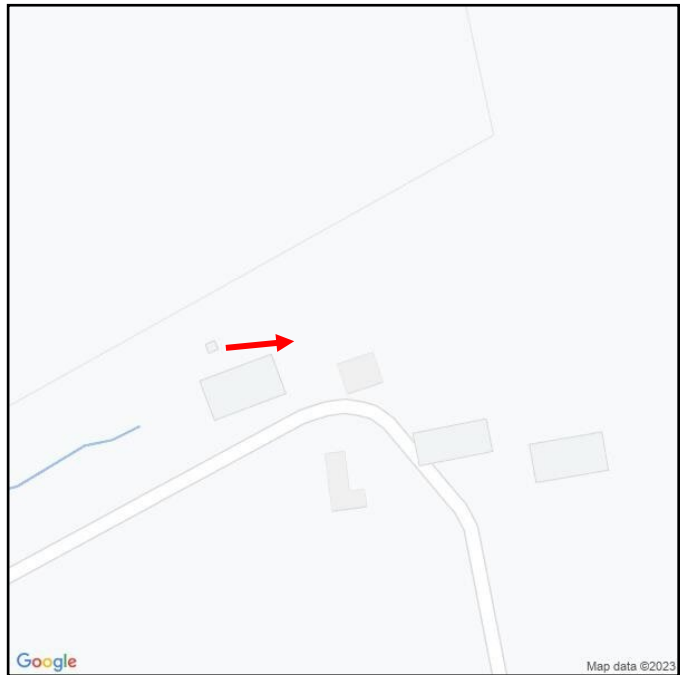
DSCN5068.JPG

| Description |
|---|
| View of Facility trucking equipment. |
